RESEARCH REPORT

DETERMINING BARRIERS TO INDUSTRY DELIVERY OF FIRE-SAFE BUILDINGS IN NEW ZEALAND

FIRE PROTECTION ASSOCIATION OF
NEW ZEALAND

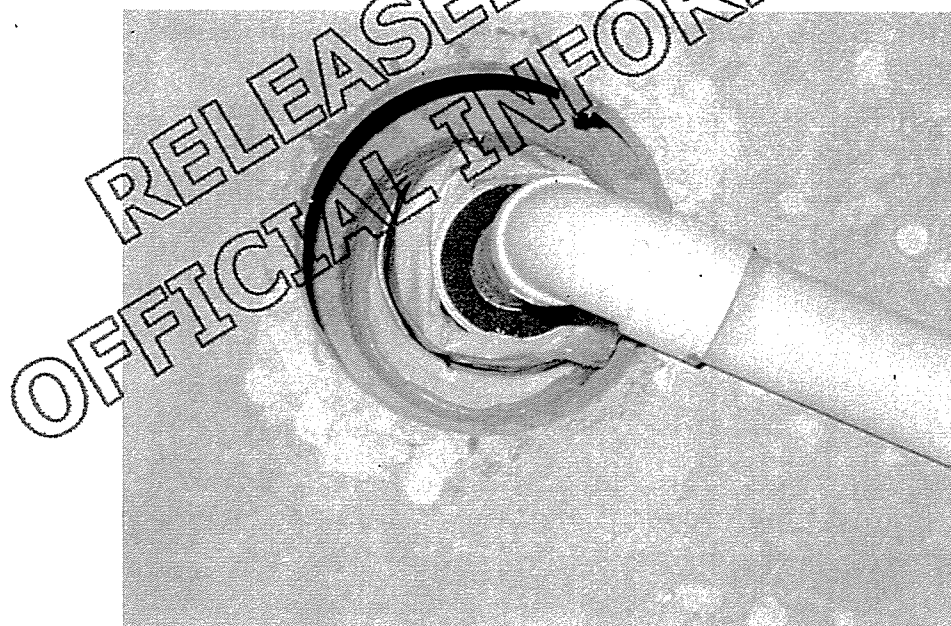
Figure 5.1.1 – Oversize hole for shower waste pipe

In Figure 5.1.1, the larger hole was drilled in the precast concrete floor panel, and an intumescent wrap was placed around the plastic waste pipe. While obviously an attempt had been made to provide integrity of the fire-rated floor element, the wrap was designed for a 100 mm hole, while the actual hole was 200 mm diameter. In a fire the wrap would have been totally ineffective – the gap was so large that the underside of the shower base could be clearly seen from the fire cell below. The other issue is that it is understood that this type of product had not been tested with the partially hollow precast flooring system into which it was installed.

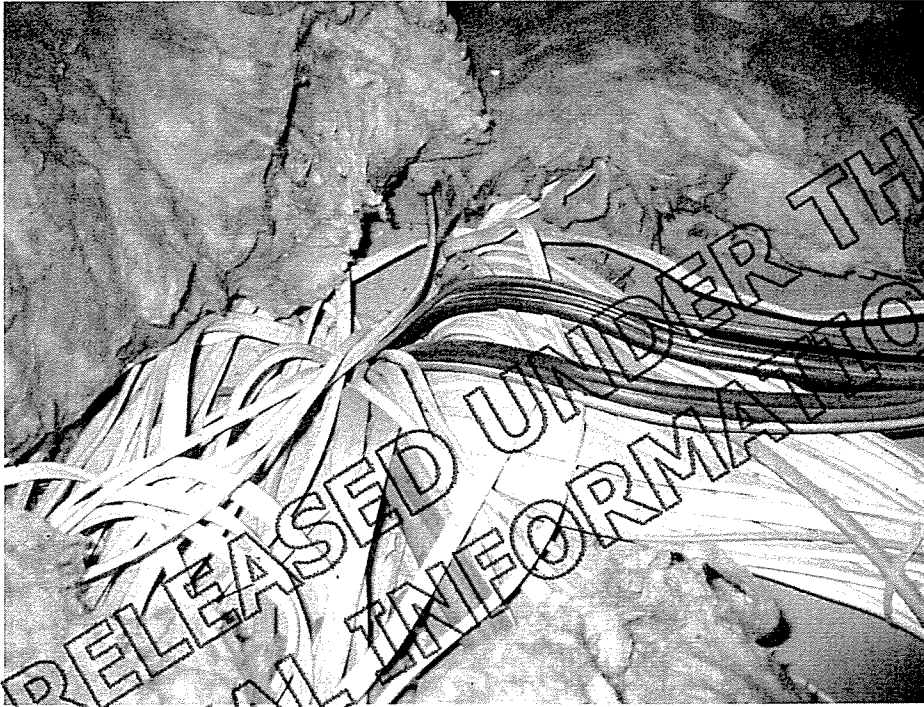
Figure 5.1.2 – Electrical cables in ceiling

In Figure 5.1.2, a large number of electrical cables pass through an unprotected penetration in a ceiling – the common ceiling provided a concealed space by which fire could spread to other fire cells. Concealed spaces can be dangerous from a fire safety perspective in that fire can spread

unseen and unexpectedly. Another issue that is common above ceilings is fire-rated walls that, instead of being continuous up to the underside of the floor, stop at the underside of the ceiling.

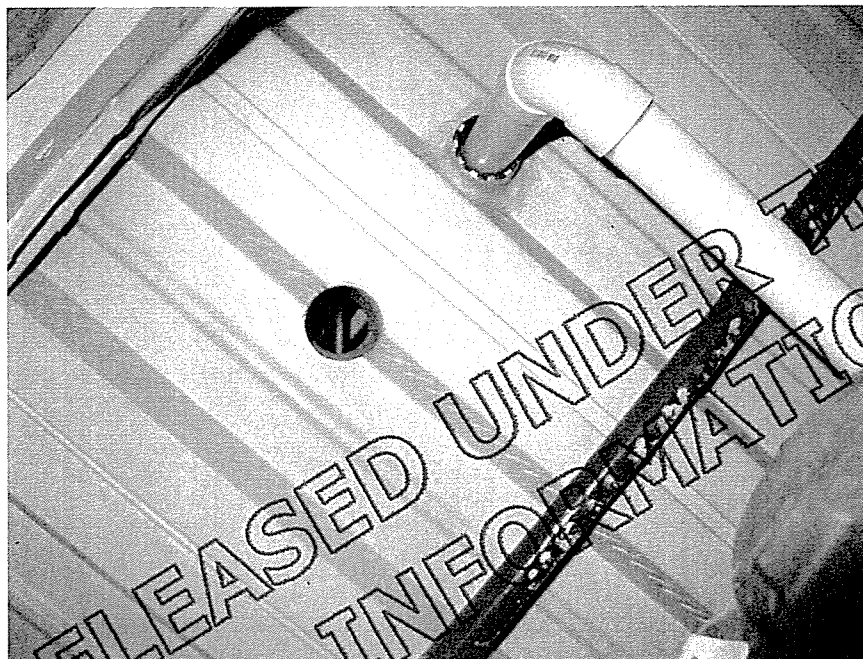
Figure 5.1.4 – Hole in fire-rated floor

While a very good job has been done in fire stopping the plastic pipe penetration shown in Figure 5.1.4, it has been undone by an un-rated penetration immediately adjacent.
