UNDERPASS LATERAL SPREADING

Lateral Spreading Assessment and Mitigation Requirements

UND-02-DES-RP-009

WELLINGTON INNER CITY IMPROVEMENTS
 ENABLING WORKS - 02 GEOTECHNICAL
 ROAD CRACKS
 PLAN

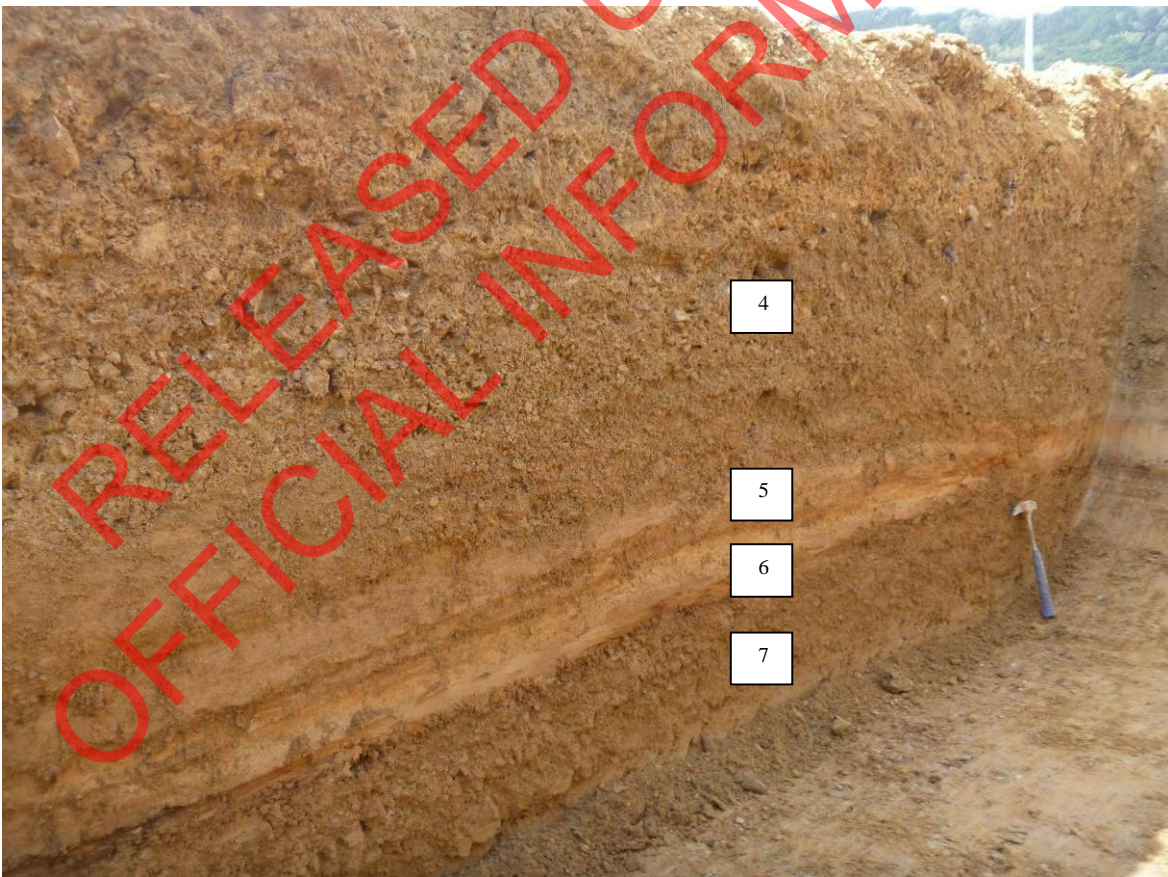
Photograph 2: Alluvium and Marginal Marine Deposit sequence – TPT8

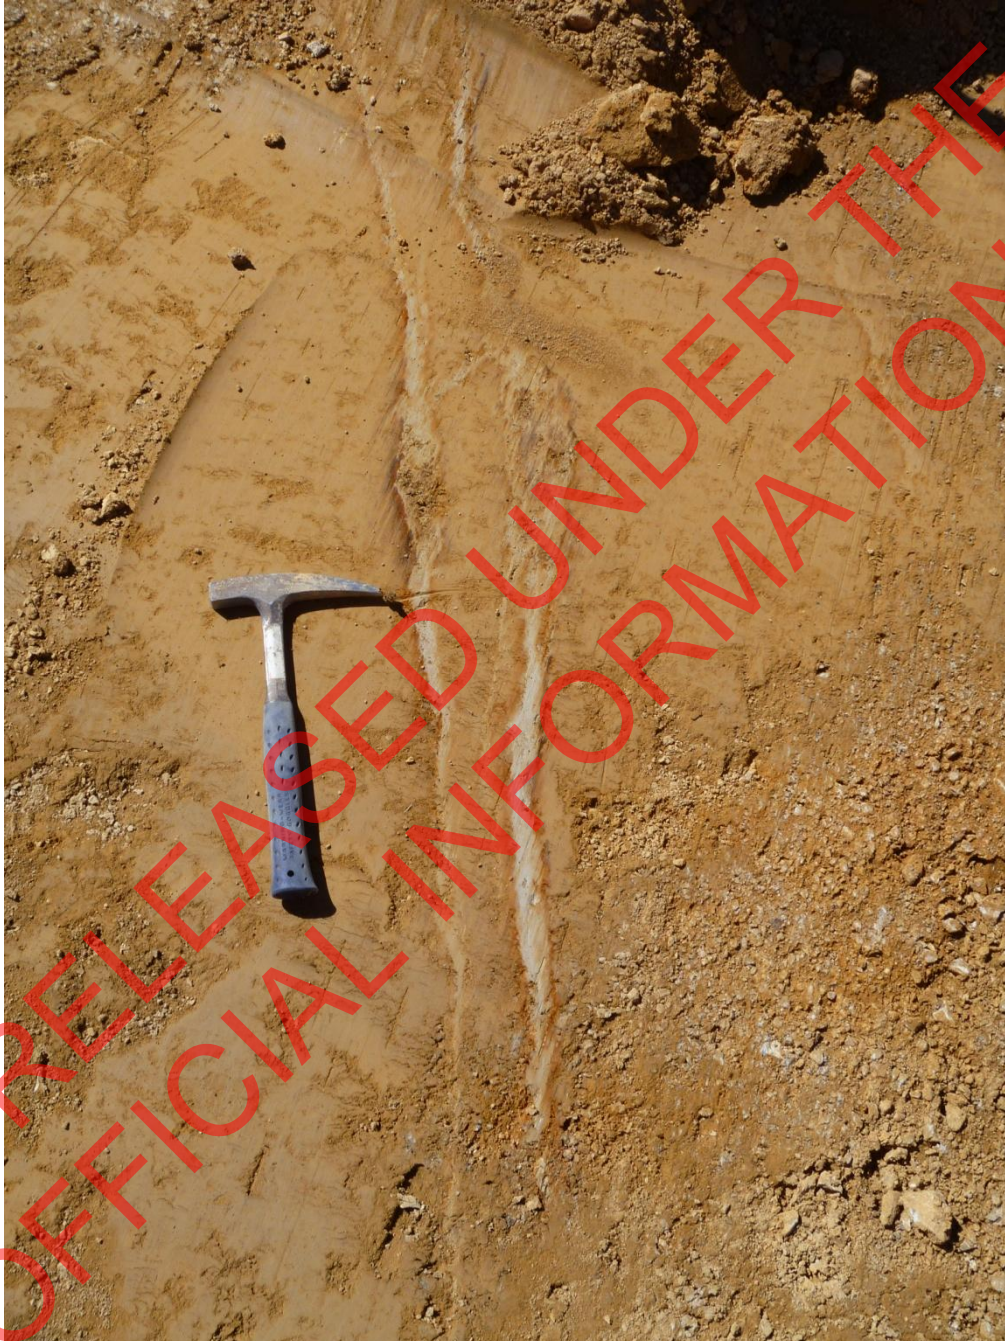
Photograph 3: In filled historic tension cracks.

- In filled tension cracks extend sub vertically through alluvial layers approximately between 0.8 and 2.2m depth.

- Cracks are laterally extensive over tens of metres and are in filled with light grey, cohesive, plastic, organic silt. The cracks are up to 40mm wide and are sub vertical.
- There is negligible off set of the alluvial / marginal marine soil layers in either a horizontal or vertical plane, i.e. they are a pull apart or tension feature.

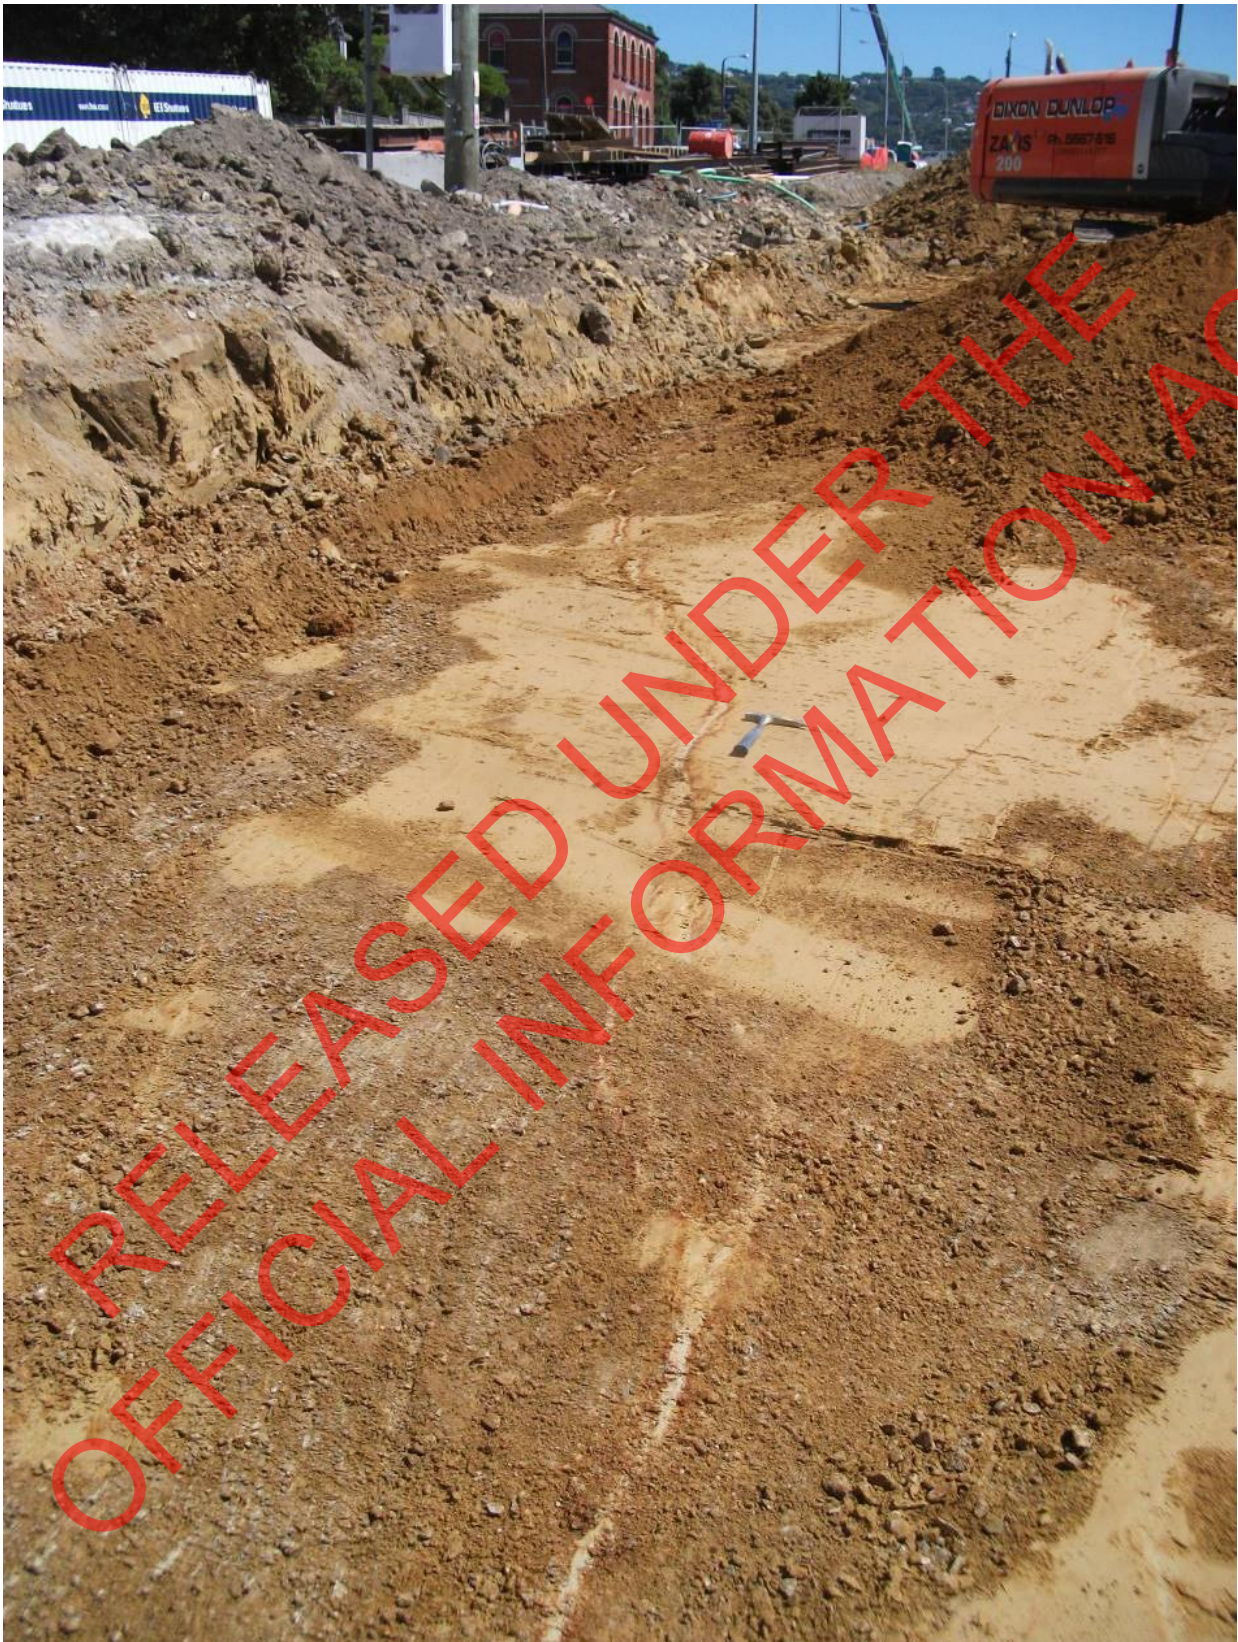
Photograph 5: Large bifurcating crack passing through Layer 2b (gravel) and 3 (sand)

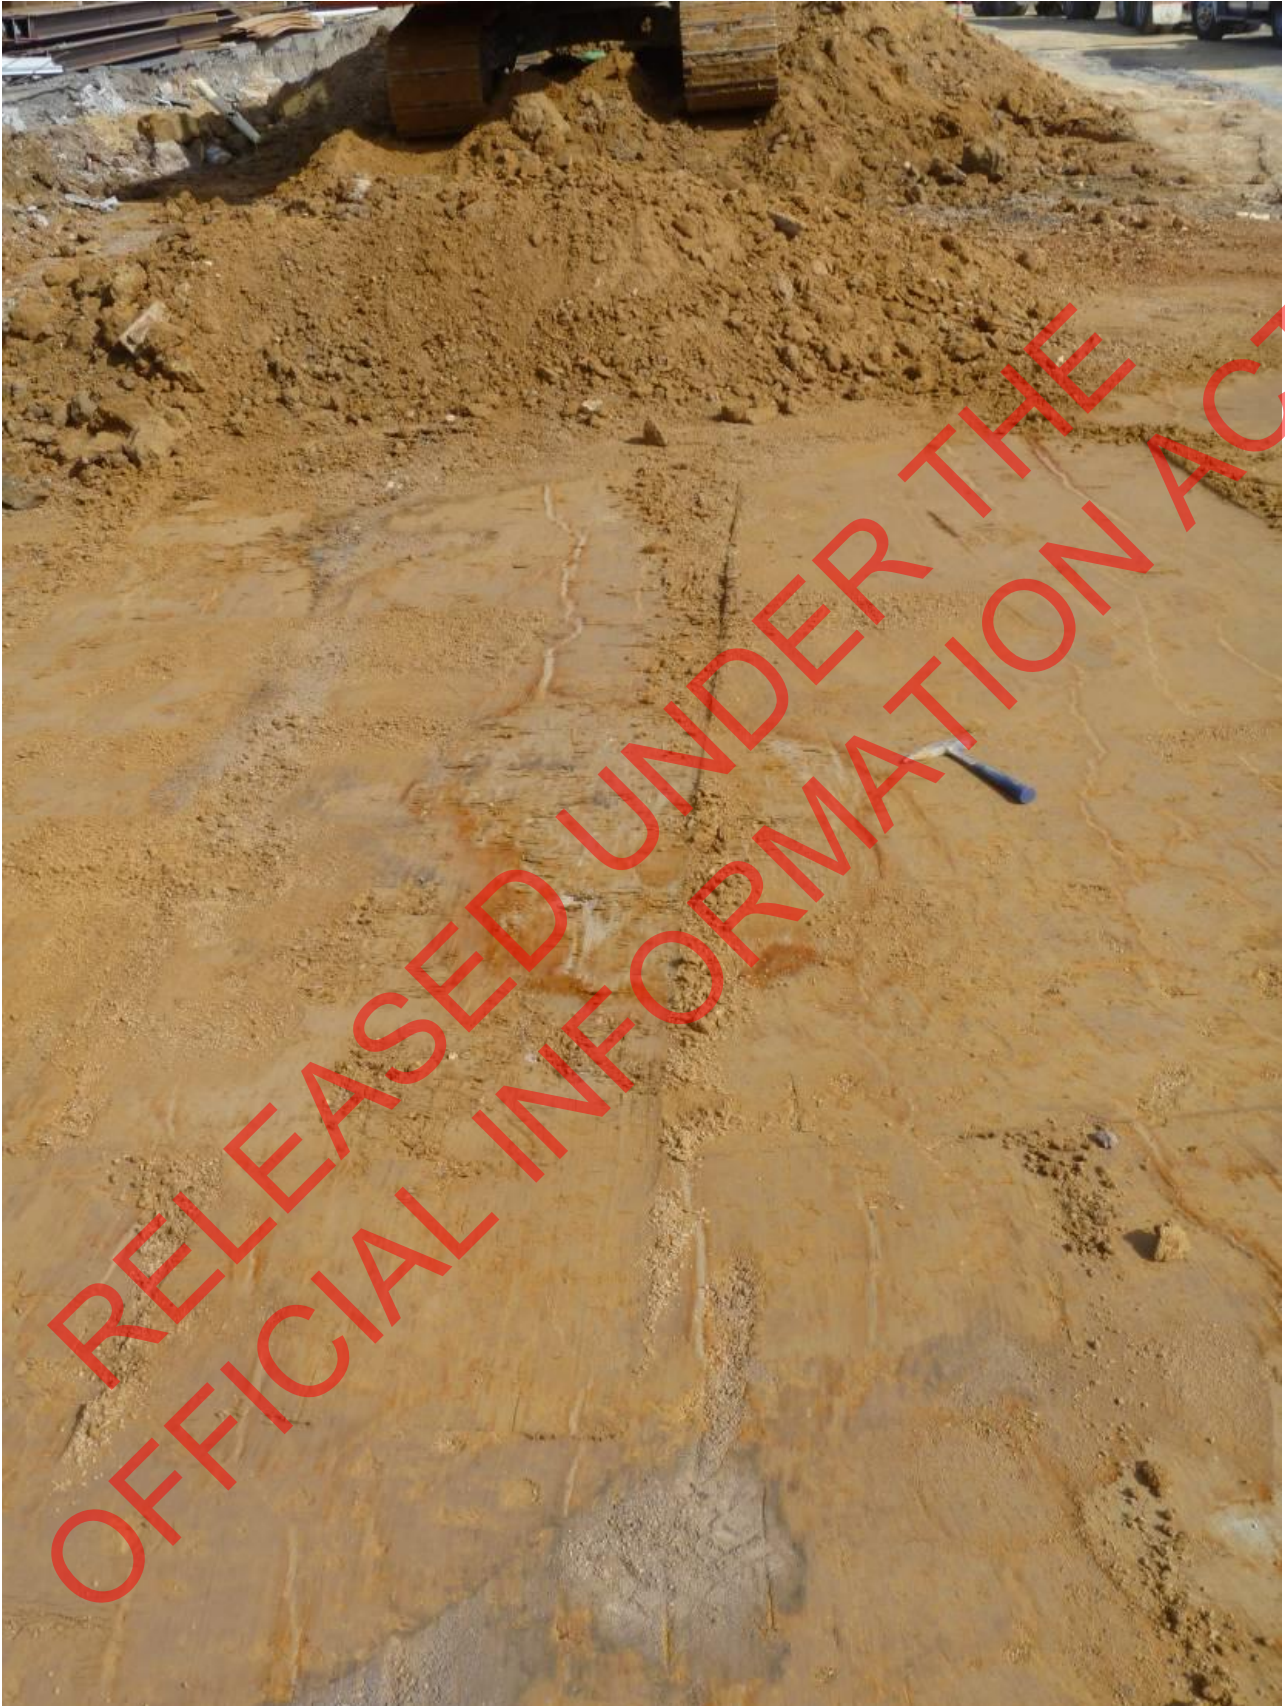
Photograph 9: Crack infill also infilling low spots in top of Layer 3

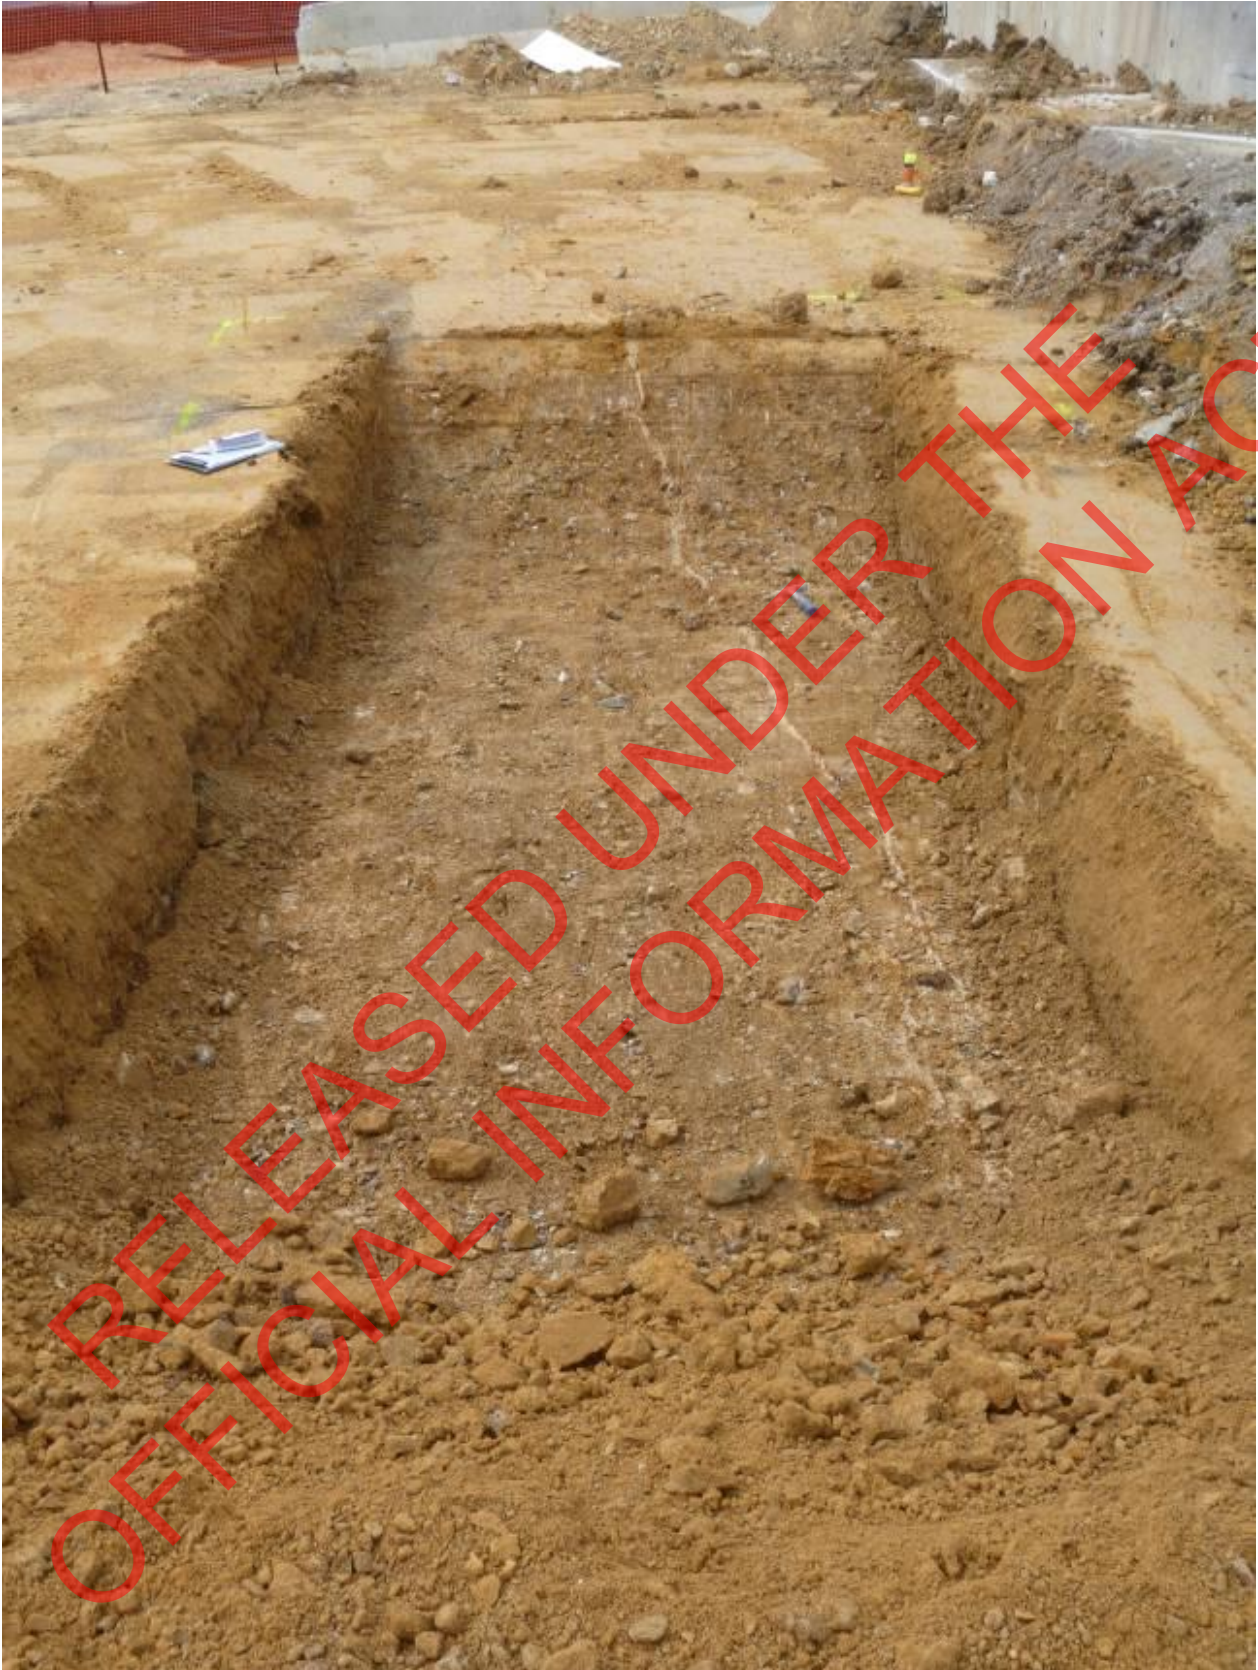
Photograph 10: Large crack extending into Layer 4

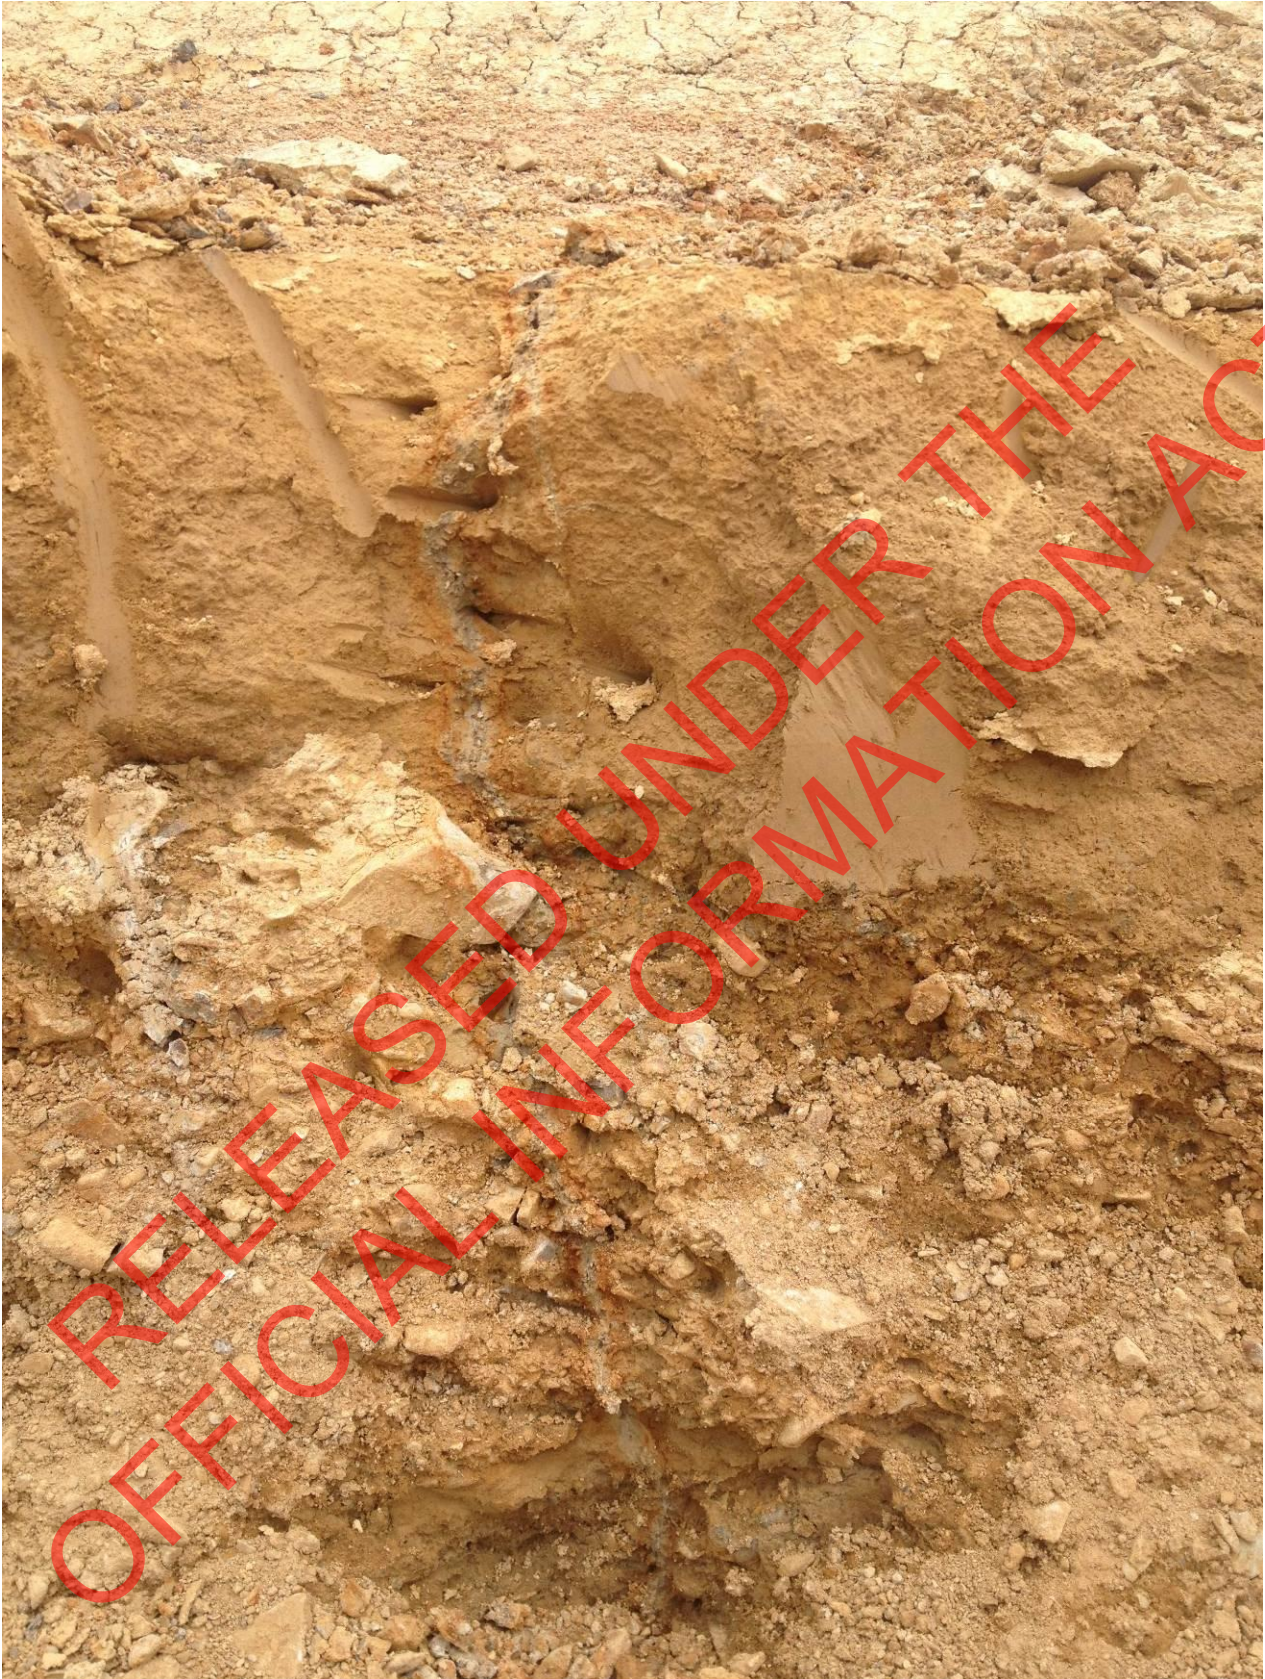
Photograph 11: Large crack extending from Layer 3 into Layer 4

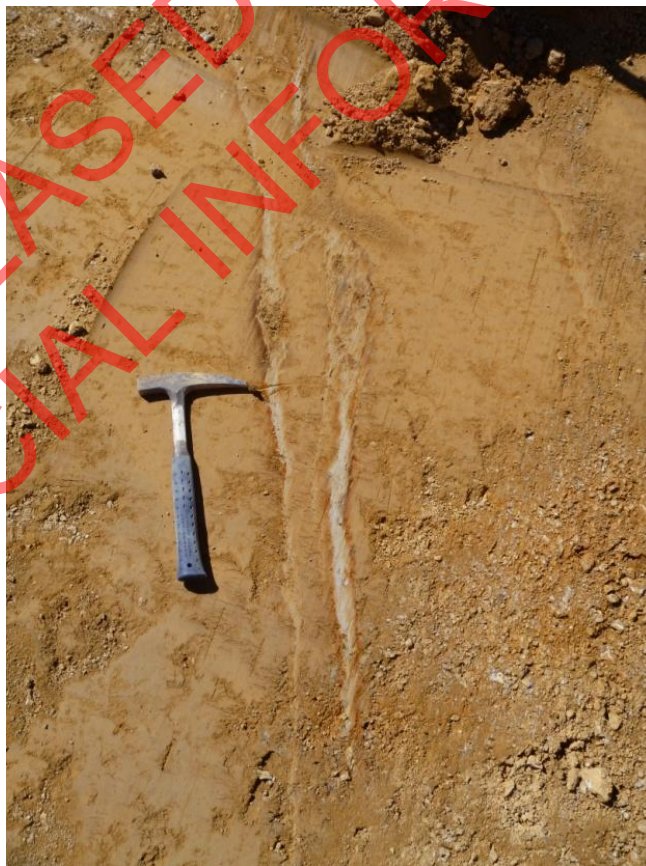
Photograph 13: Large cracks

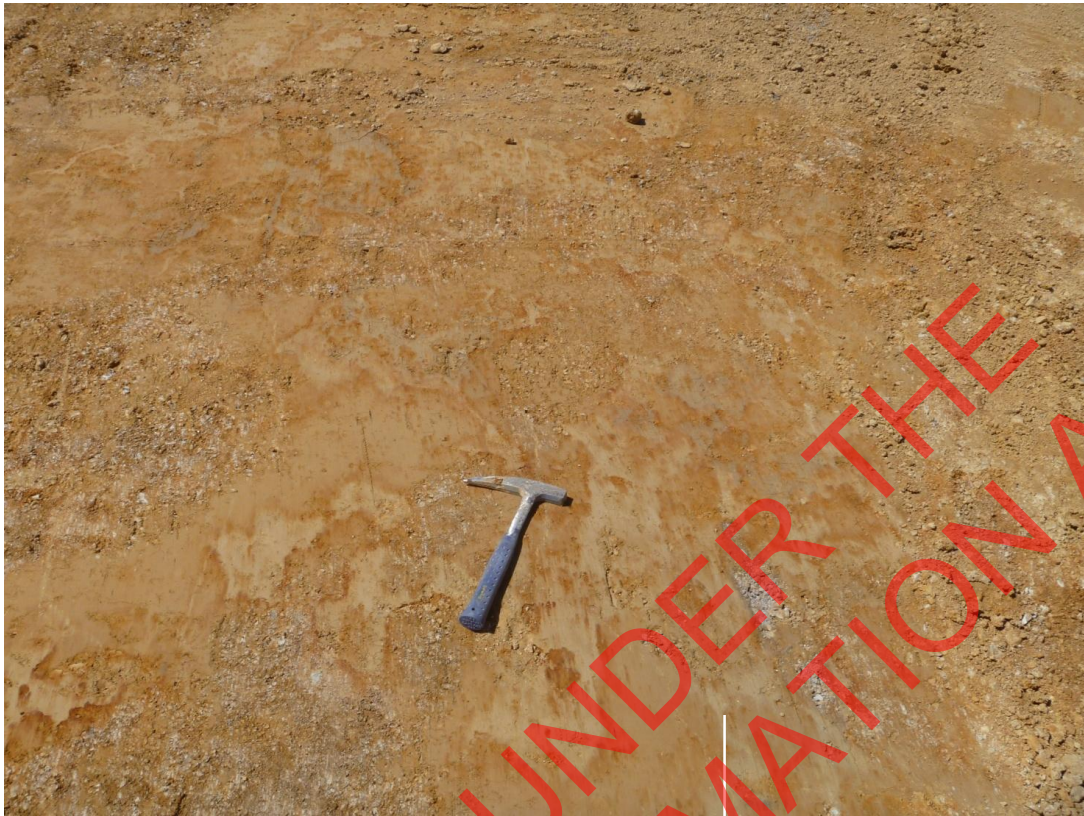
Photograph 14: Clay infill at top of Layer 3

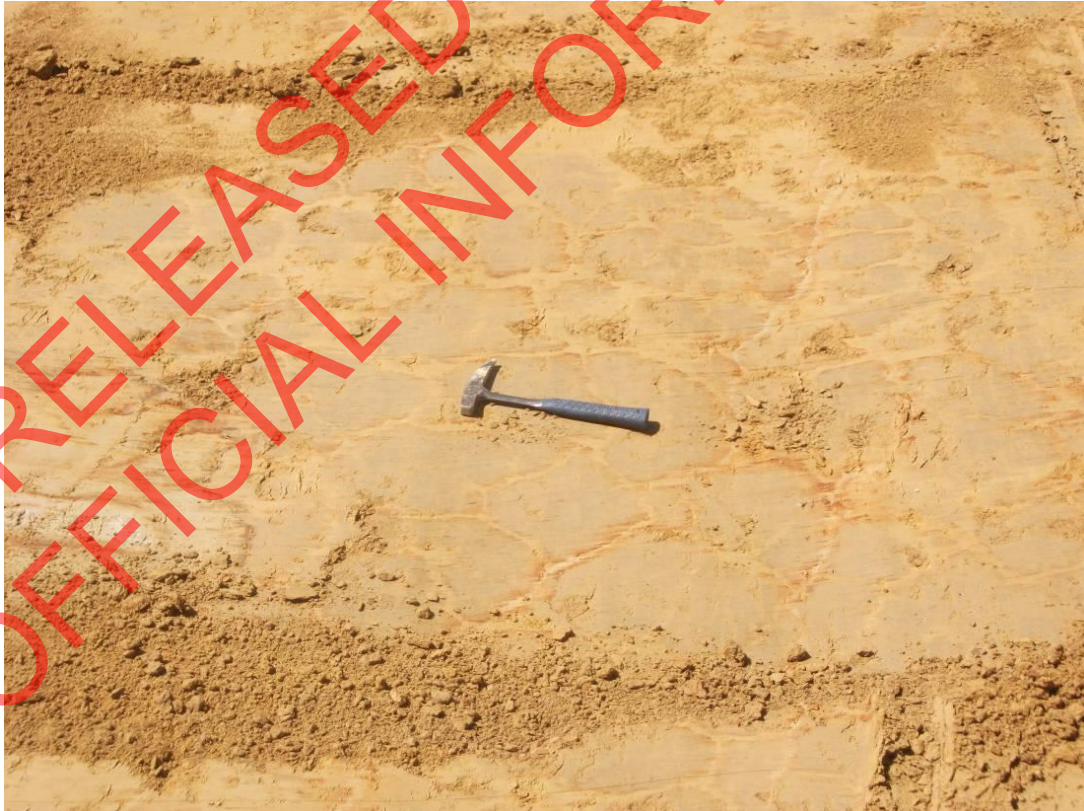
Photograph 15: Clay infill around desiccation cracks at top of Layer 3
