**Twilight Road Cleanfill, Clevedon
Detailed Design Road Safety Audit**

Project: Twilight Road Cleanfill, Brookby
Report title: Detailed Design Road Safety Audit
Document reference: J00539 Twilight Road Cleanfill RSA-final
Date: 20 December 2016

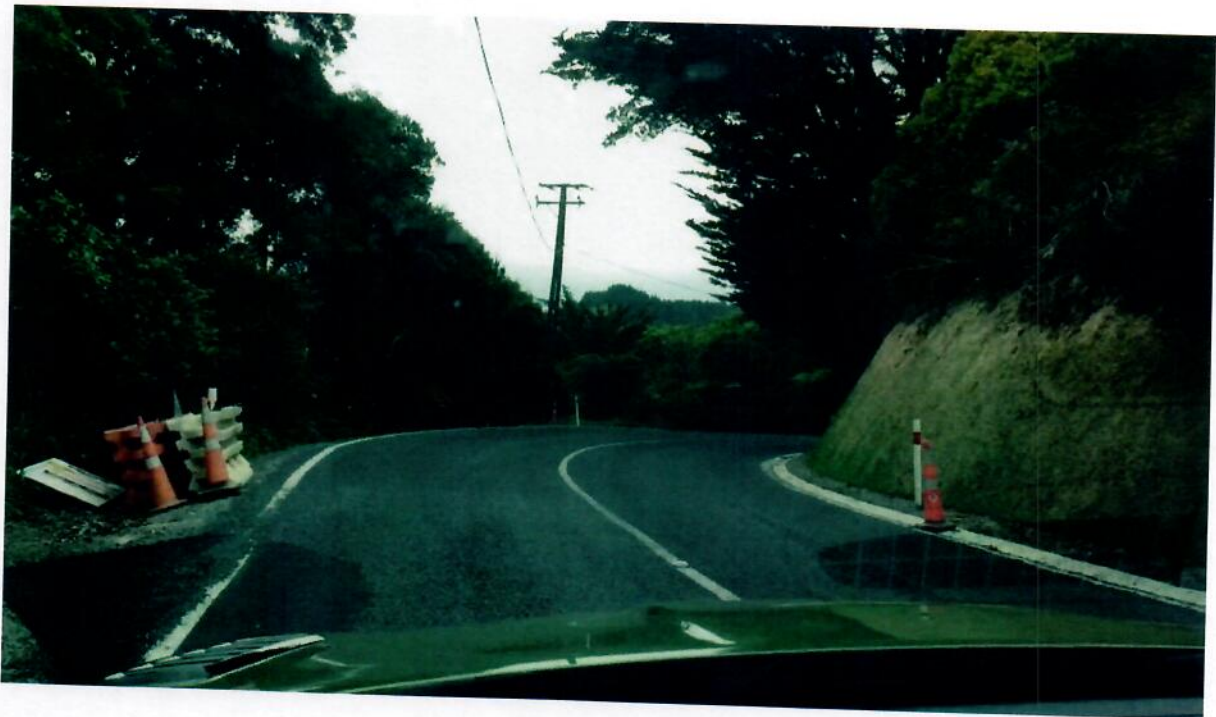
Photograph 1: Power Pole at ch. 660

Power poles on the northern side of Twilight Road are located in very close proximity to the carriageway. The SAT is concerned that vehicles travelling eastbound on Twilight Road may be travelling at higher speed (due to the road widening) and potentially collide with these poles.

- Poles on outside of curve and vehicles potentially losing control and colliding with pole. These poles are located near ch.660, Ch. 760 and ch. 860 – ch. 940.
- Poles on the inside of curve and vehicle potentially cutting the corner and colliding with pole. In some cases the poles did not have any hazard reflectors to warn vehicles of the pole during the night. These poles are located at ch. 720, ch. 1060 – ch. 1100 and ch. 1160. The pole at ch. 1160 appears to be new.

- Provide hazard reflectors on all poles.
- Provide cold applied markings with audio tactile profile to provide delineation for vehicles at night.

- Consider limiting speeds through this section of road (either through speed advisory signage or regulatory signage).

Frequency Rating: Crashes are likely to be Occasional	Severity Rating: Death or serious injury is Very likely
Designer Response: Hazard reflectors have to be added to all power and telecommunication poles where they were missing. Advice from Ross Roadmarking is that ATP markings on chipseal get dislodged and so we do not consider it practical to apply. Speed limit restrictions were discussed with Auckland Council and would be a matter for Auckland Transport.	
Safety Engineer:	Click here to enter text.
Client Decision:	Agreed to install new hazard markers on poles where they are missing
Action Taken:	Hazard markers have be installed.

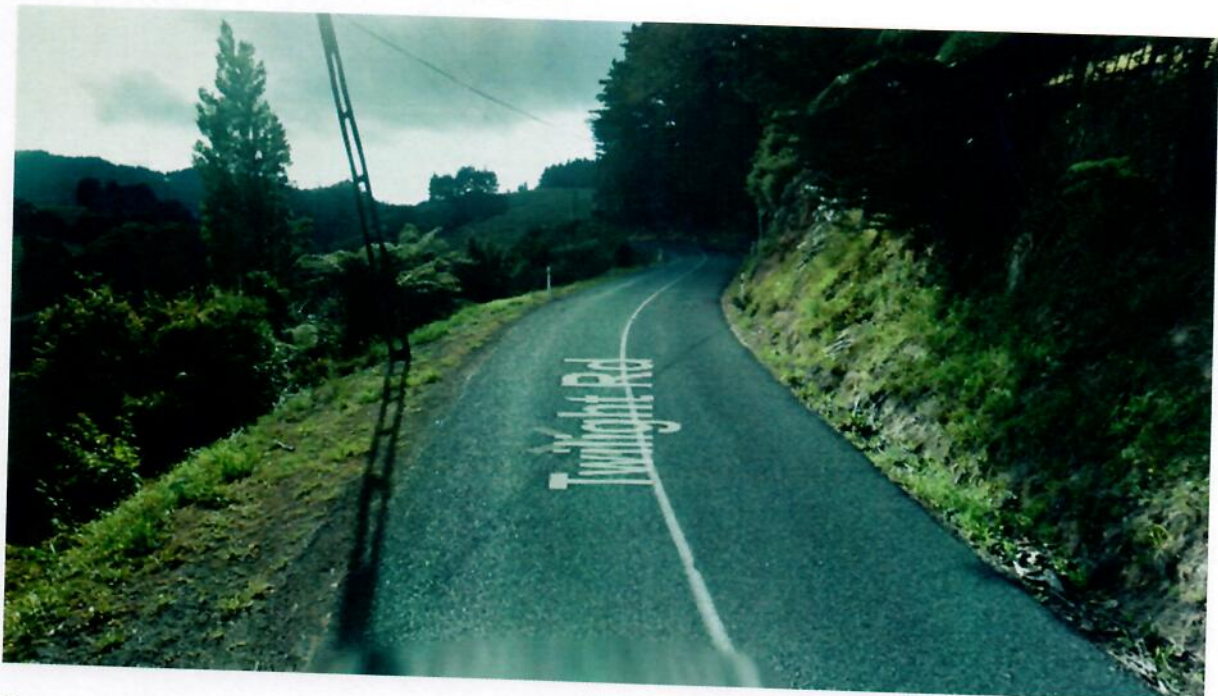
Based on a review of google streetview, it appears that the poles previously had further clearance from the carriageway and the widening has occupied this clearance area. An example is shown in Photograph 7.

Photograph 7: Power Pole at ch. 760 (prior to widening)

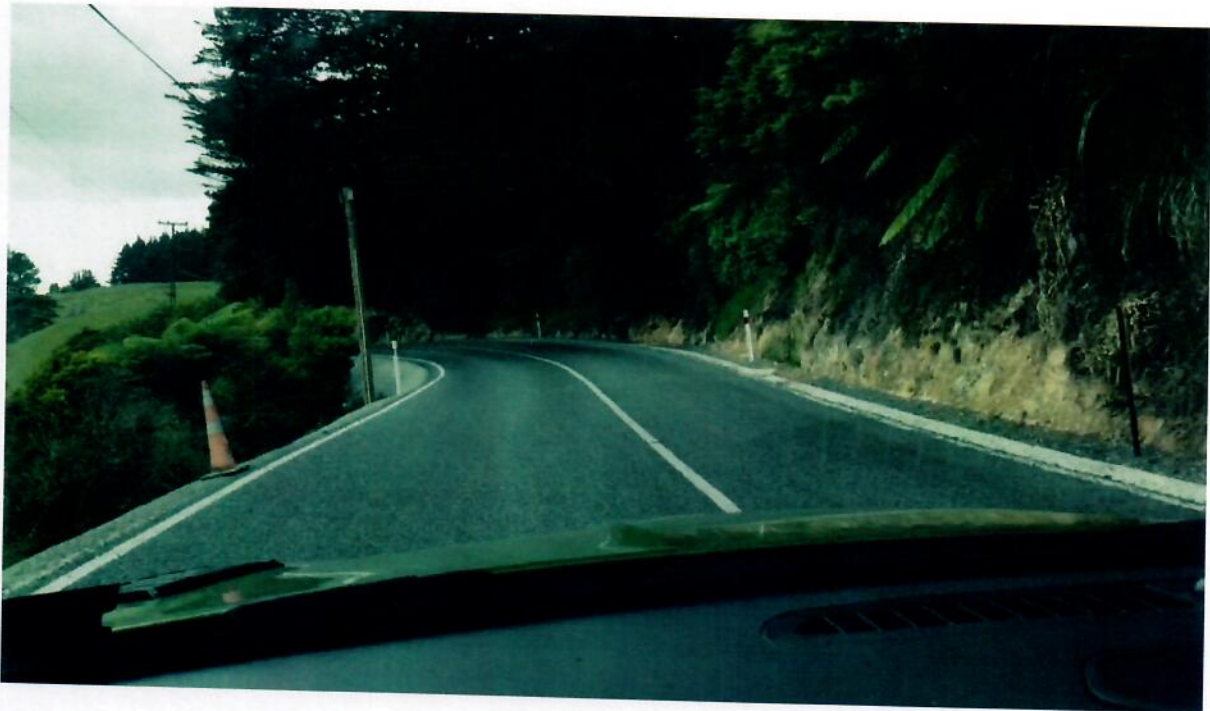
Twilight Road has a number of sections where the road shoulder falls steeply away from the carriageway. These sections are located on the northern side of Twilight Road and while these existed prior to the cleanfill works, the widening has removed clearance areas (albeit small) between the carriageway and batter. Furthermore, the widening is likely to increase operating speeds and increase the potential for loss of control crashes. Photograph 8 shows an example of this steep fall and in this case, the SAT is concerned a vehicle could potentially cut the corner and lose control.

Photograph 8: Steep Fall on Northern Side of Twilight Road

In the event of a loss of control crash, there are likely to be serious injuries if they occur on the northern side of Twilight Road. It is recommended that safety barriers are established on the northern side of Twilight Road on the outside of all bends and on inside of bends where there is potential for vehicles to cut corners. It should be noted that it is not for the SAT to decide who should be responsible for establishing safety barriers however in our opinion, there are two key matters that need to be considered:

- The issue existed prior to the road widening associated with the cleanfill operation i.e. there was an existing road safety issue, and
- The road widening resulting from the cleanfill operation is likely to result in increased operating speeds for general vehicles on Twilight Road due to the wider alignment and improved road condition. Unfortunately, as a consequence of increased operating speeds this may also increase the risk of loss of control crashes.

In addition to safety barriers, it is recommended that the edge lines on both the northern and southern sides of the road use cold applied plastic (CAP) with an audio tactile profile to further reduce the risk of 'run-off road' crashes. The cold applied plastic has been demonstrated to have excellent durability suitable for use in environments with high numbers of heavy vehicles.

- Establish road safety barriers to prevent vehicles running off the road
- Establish cold applied plastic markings, with audio tactile profile, for edgelines on both sides of Twilight Road.

Frequency Rating: Crashes are likely to be Infrequent		Severity Rating: Death or serious injury is Likely	
Designer Response: No work was undertaken to the LHS of Twilight Road so the situation existed prior to the works being undertaken. We have discussed the matter with Auckland Council and consider it a matter for Auckland Transport to assess. Advice from Ross Roadmarking is that ATP markings on chipseal get dislodged and so we do not consider it practical to apply.			
Safety Engineer:		Click here to enter text.	
Client Decision:		Agree with designers comments	
Action Taken:		No action taken

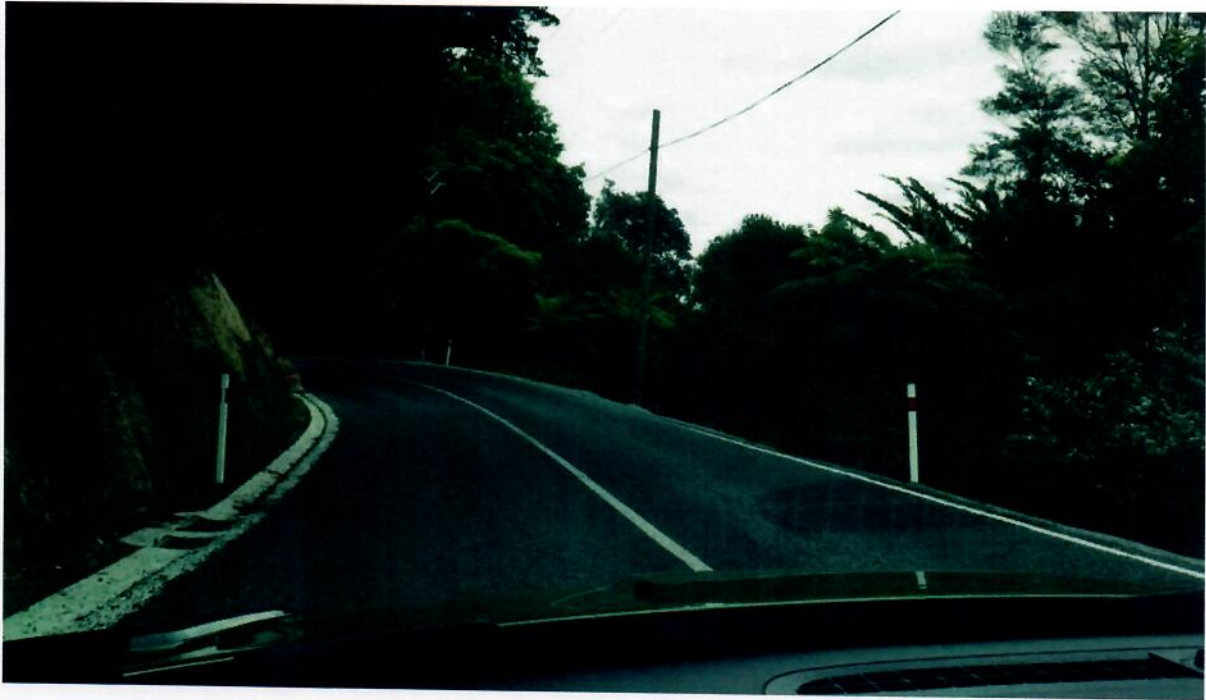
On the southern side of Twilight Road near ch. 650, road works appear to have stopped in the vicinity of an existing large tree. The SAT is concerned that the tree may become unstable due to the recent road widening and should be removed as soon as possible to prevent it collapsing onto the road.

Photograph 9: Tree on Inside of Bend at ch. 650

- Remove tree on southern side of Twilight Road at ch. 650
- Continue drainage channel to west to meet other section of drainage channel and construct appropriate road side batters.

Frequency Rating: Crashes are likely to be Occasional		Severity Rating: Death or serious injury is Very likely
Designer Response:	We agree that the tree should be removed and the channel continued.	
Safety Engineer:	Click here to enter text.	
Client Decision:	Agree to work being completed	
Action Taken:	Tree has been removed, batter formed and the channel continued.

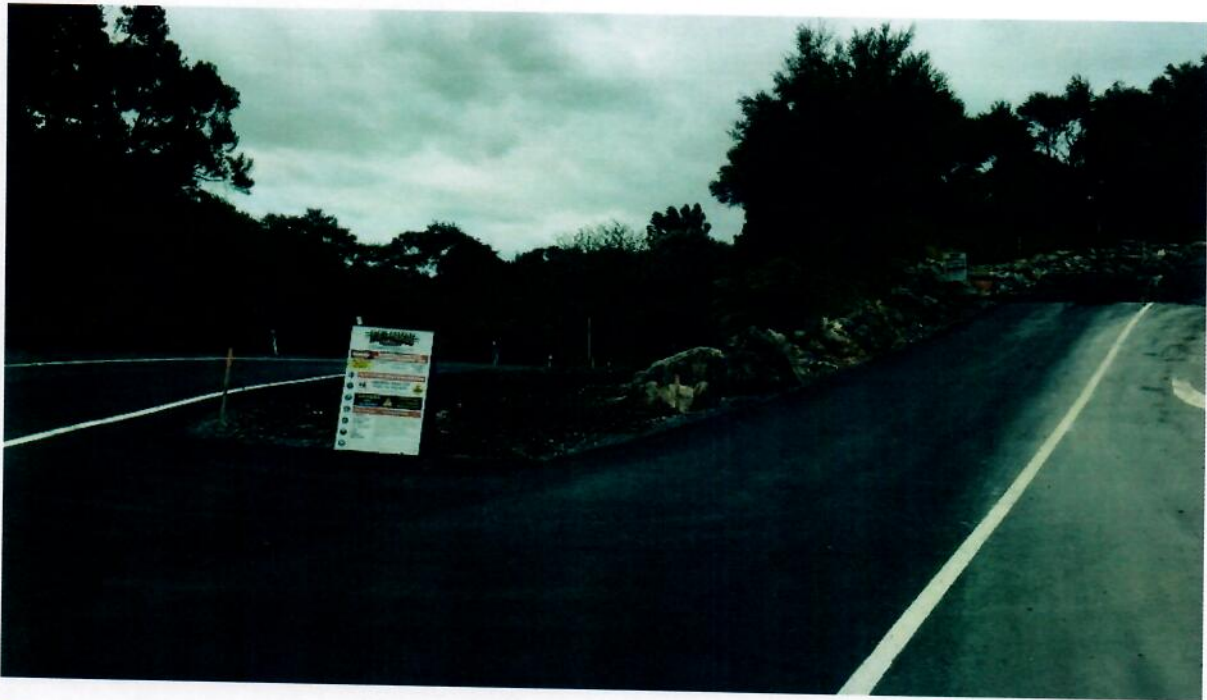
The sight distance at the quarry entry was reviewed and the SAT is concerned that the required visibility (70 m in accordance with consent conditions) is unlikely to be met for light vehicles). Despite the low observed traffic volumes and traffic speeds, and that the sight distance is likely to be acceptable for heavy vehicles, it is considered that the sight distance should apply from a 1.1 m drivers eye height at the access to oncoming vehicles on Twilight Road (also 1.1 m).

Photograph 10: Visibility to East along Twilight Road

- Review available sight distance and confirm a 70 m sight line can be achieved between a light vehicle at the quarry exit (1.1 m eye height) to approaching vehicles on Twilight Road (1.1 m car height).
- Relocate sight access sign so it does not obstruct visibility to oncoming vehicles.

Frequency Rating: Crashes are likely to be Occasional	Severity Rating: Death or serious injury is Unlikely
Designer Response:	Agree that the sight line should be reviewed and the site access sign relocated.
Safety Engineer:	Click here to enter text.
Client Decision:	Agree with designer comments
Action Taken:	Sight line has been reviewed and the bench has been trimmed to achieve the 70m sight distance. The site access sign has been relocated so as not to obstruct visibility for oncoming vehicles.

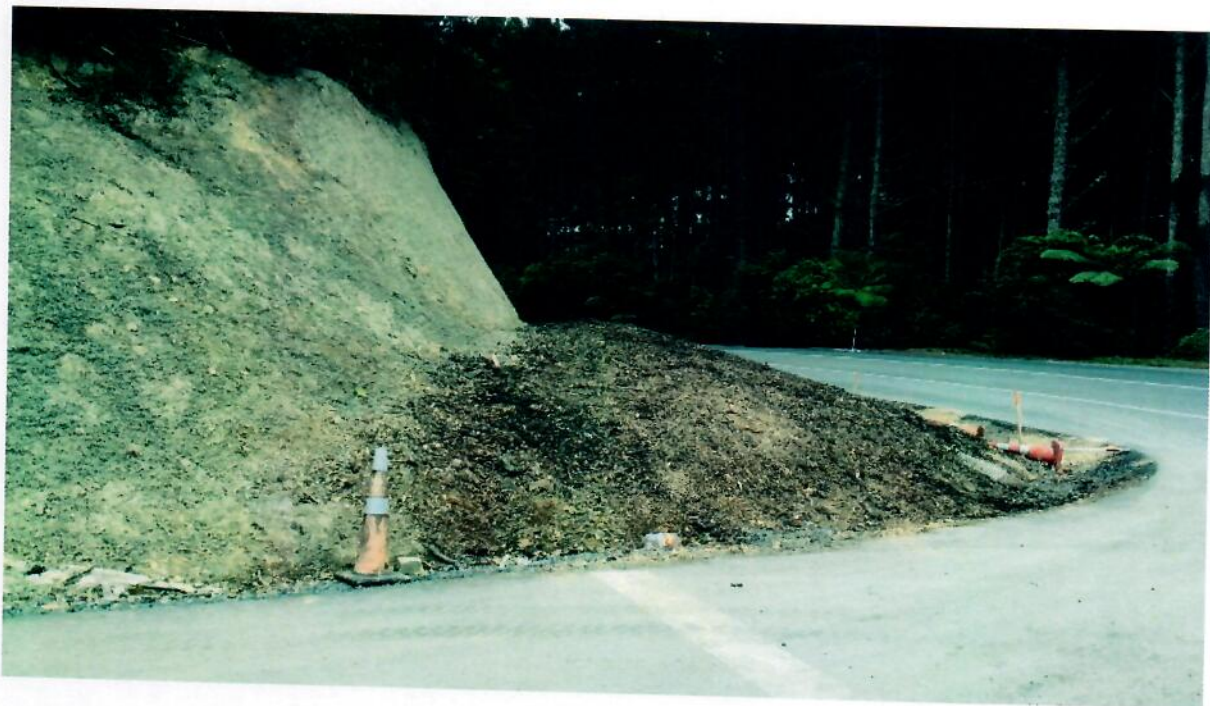
Photograph 11: Visibility to West along Twilight Road

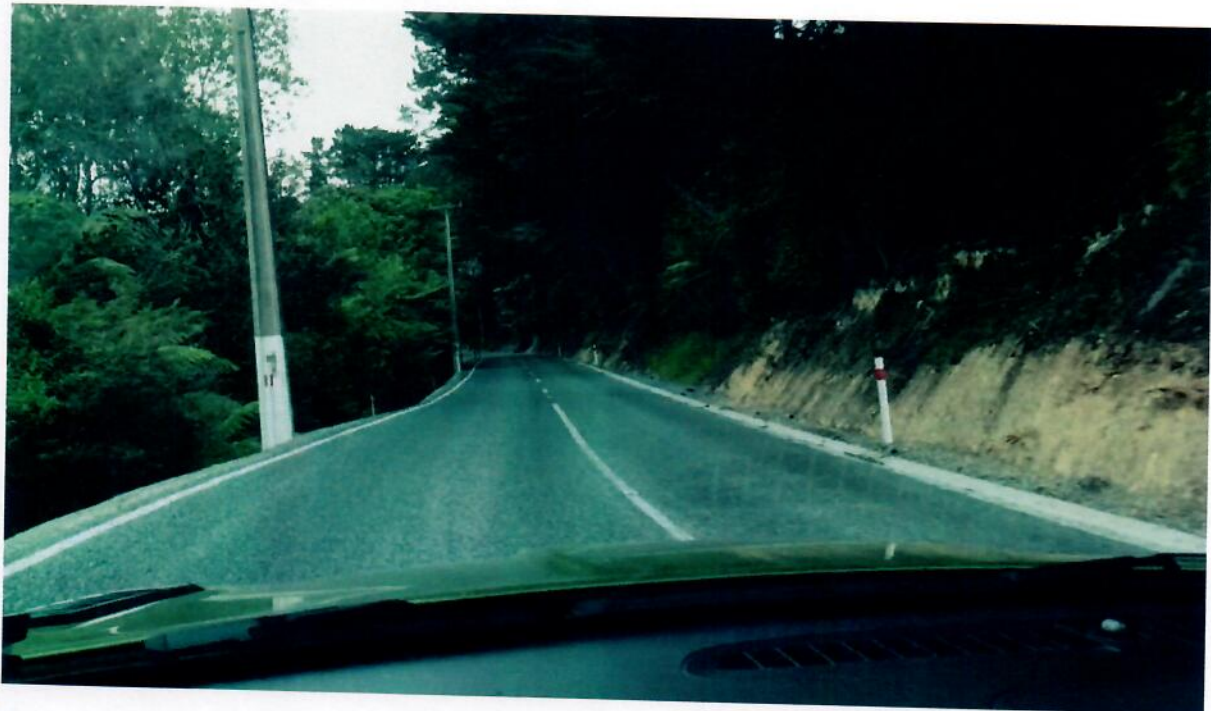
The SAT observed that there were no edge marker posts on the northern side of Twilight Road at approximately ch. 940 and there were no edge line markings on both sides of Twilight Road between approximate ch. 1200 and the quarry access.

Photograph 12 shows the area where no edge marker posts are installed (we note however there were construction markers still on-site and therefore edge marker posts may yet to be installed at this location).

Photograph 12: No Edge Marker Posts (ch.940)

To provide appropriate delineation and prevent run-off road crashes, it is recommended that edge marker posts and edge line markings are installed.

- Establish edge marker posts on the northern side of Twilight Road near ch. 940.
- Establish edge line markings on Twilight Road between ch. 1200 and quarry access.

Frequency Rating: Crashes are likely to be Occasional		Severity Rating: Death or serious injury is Unlikely	
Designer Response: Agree that edge marker posts and edge line markings should be added on both sides of Twilight Road between CH1200 and the cleanfill access			
Safety Engineer:		Click here to enter text.	
Client Decision:		Agree for work to be undertaken	
Action Taken:		Edge lines on both sides of Twilight Road have been added as well as additional edge marker posts.

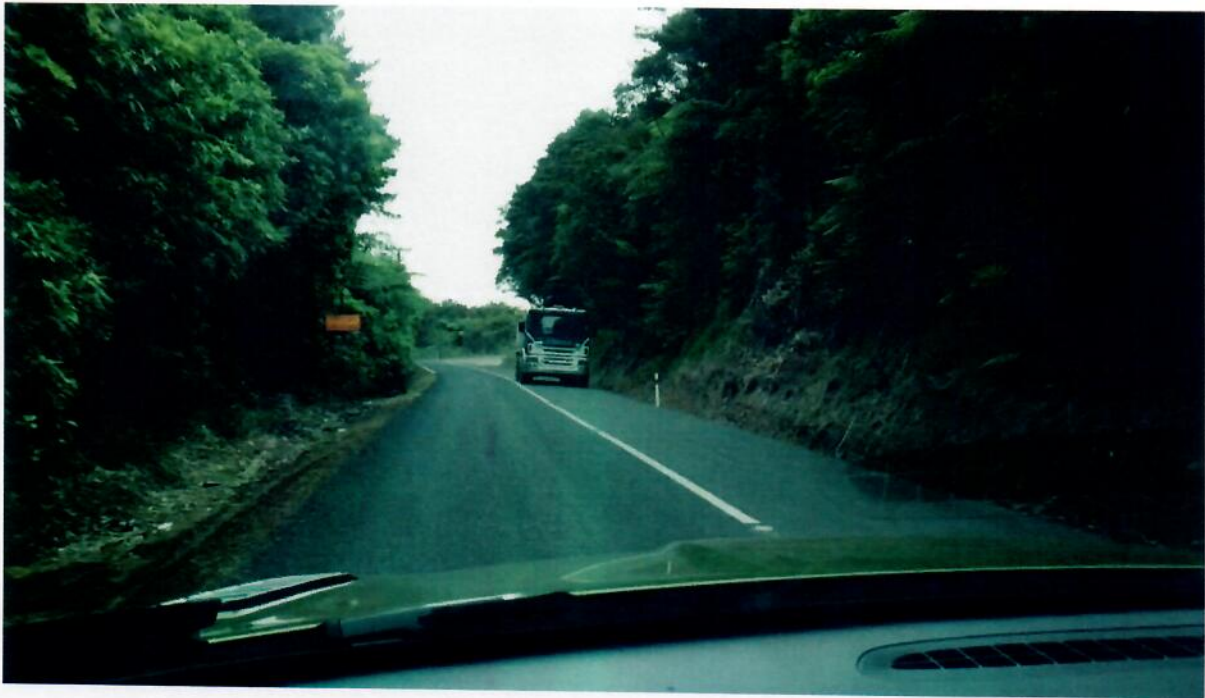
Photograph 13 shows the area where no edge lines are installed. We note this is an existing section of road that was not upgraded however for consistency, we recommend that an edge line (CAP markings with audio-tactile profile) are established on both sides of the road.

Photograph 13: No Edge Line Markings between ch. 1200 and Quarry Access
