Date 06 November 2018
Subject Old Mangere Bridge

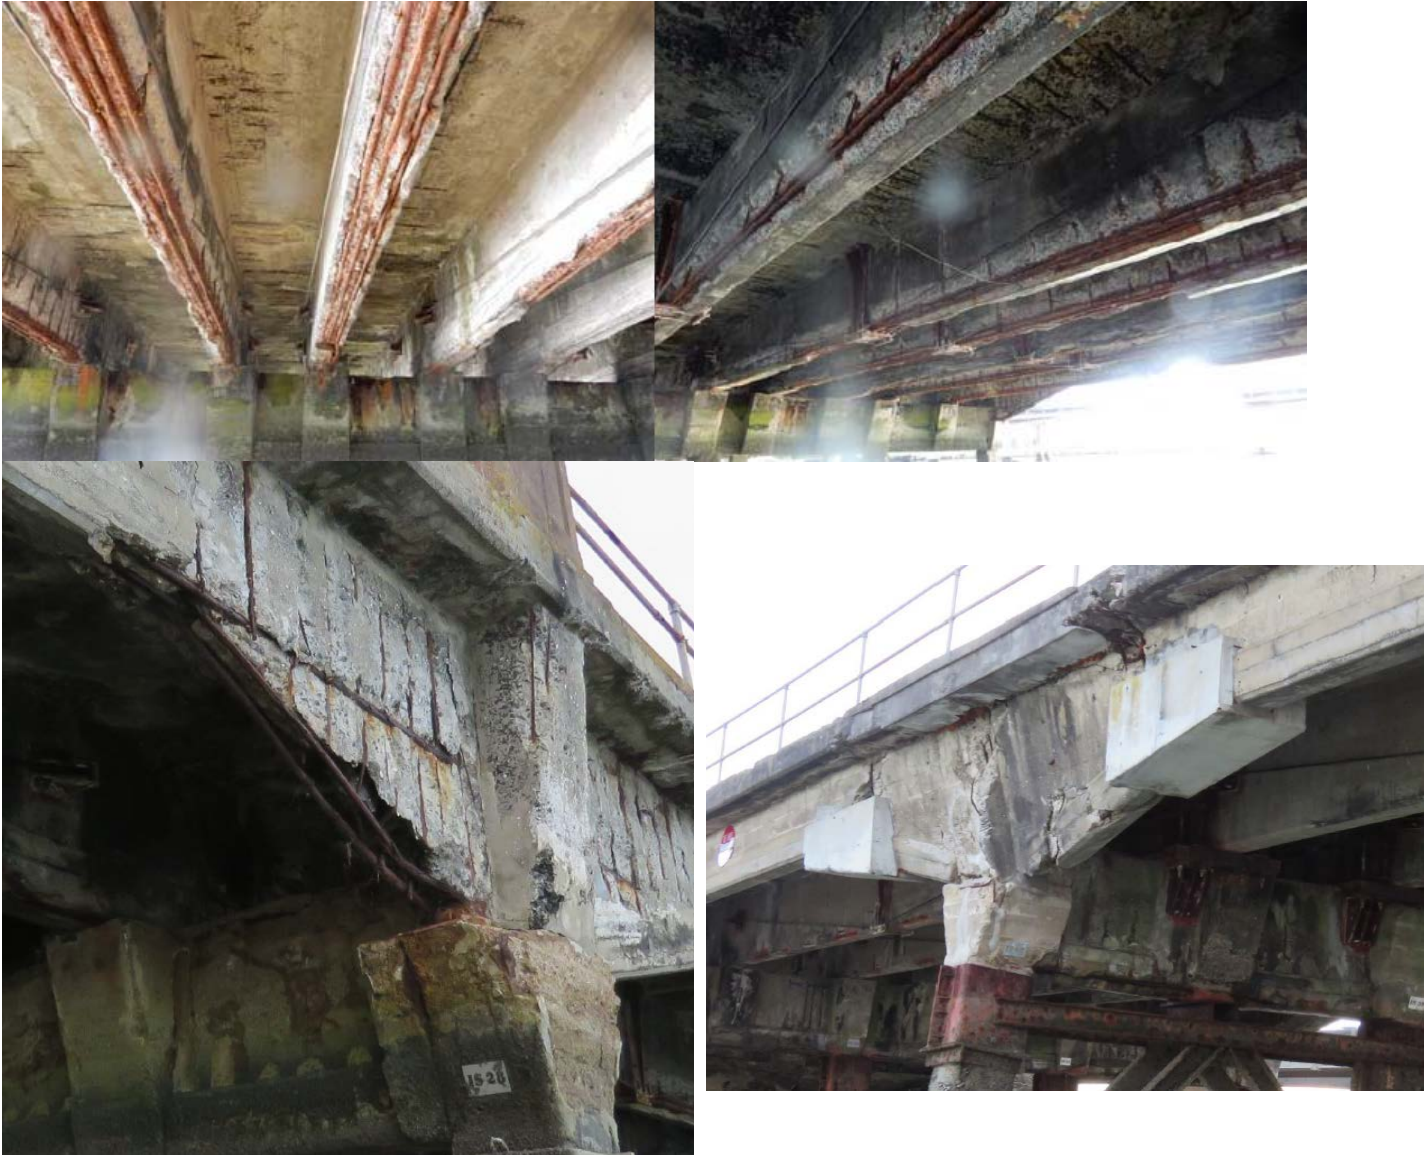
Below are pictures that represent the current condition of the bridge including previous strengthening works that have been completed previously to keep the bridge open.
