Level Crossing Safety Impact Assessment (LCSIA)

Lincoln Road level crossing, Addington, Christchurch

Prepared for Christchurch City Council

Prepared by Beca Limited

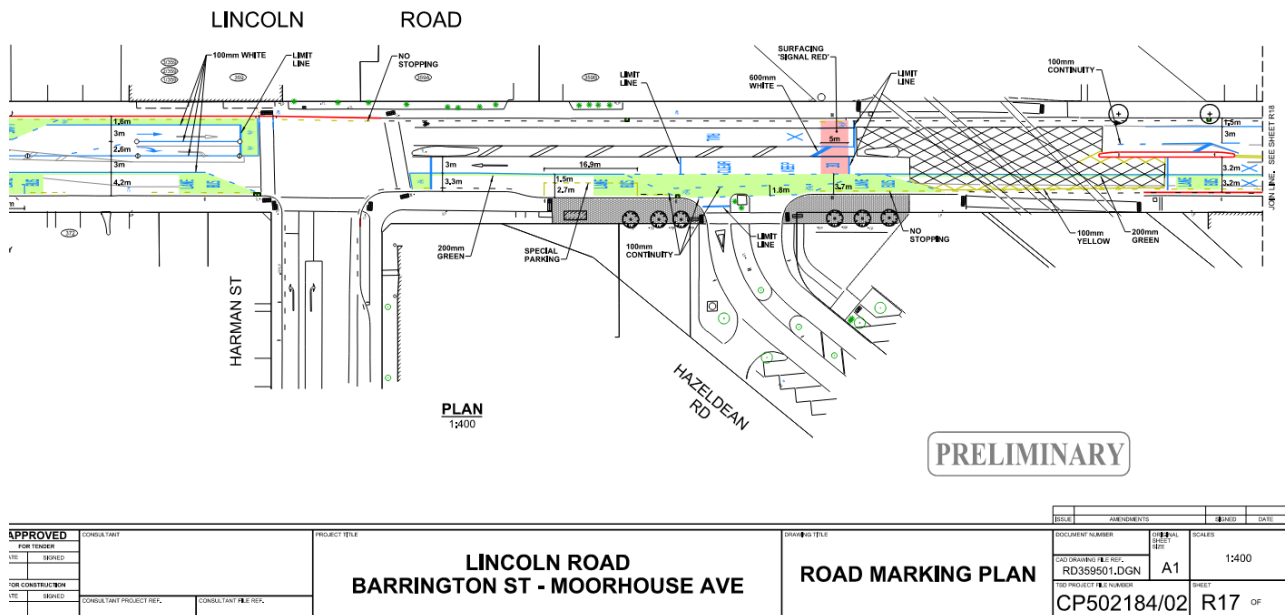
Figure 14: Proposed design for bus lanes on Lincoln Road

The bus lanes are being installed to increase the journey time reliability of bus services that use Lincoln Road. The southbound approach will have a dedicated bus lane and a general traffic lane. The preliminary design is shown in Figure 14.

- Re-align both pedestrian crossings to cross the rail corridor at a more perpendicular angle. The exact angle should be optimised between providing a perpendicular crossing and crossing length. This is due to the splay of the tracks on the west side of the road corridor.
- Install 3.5m wide strail crossings as shared paths to accommodate the high volume of pedestrians and cyclists
- Install dual automatic gates (with emergency exit gate) and pedestrian flashing lights and bells at all crossing points
- Construct paths to new crossing locations with fencing to direct pedestrians and cyclists to the crossing location
