Unit B

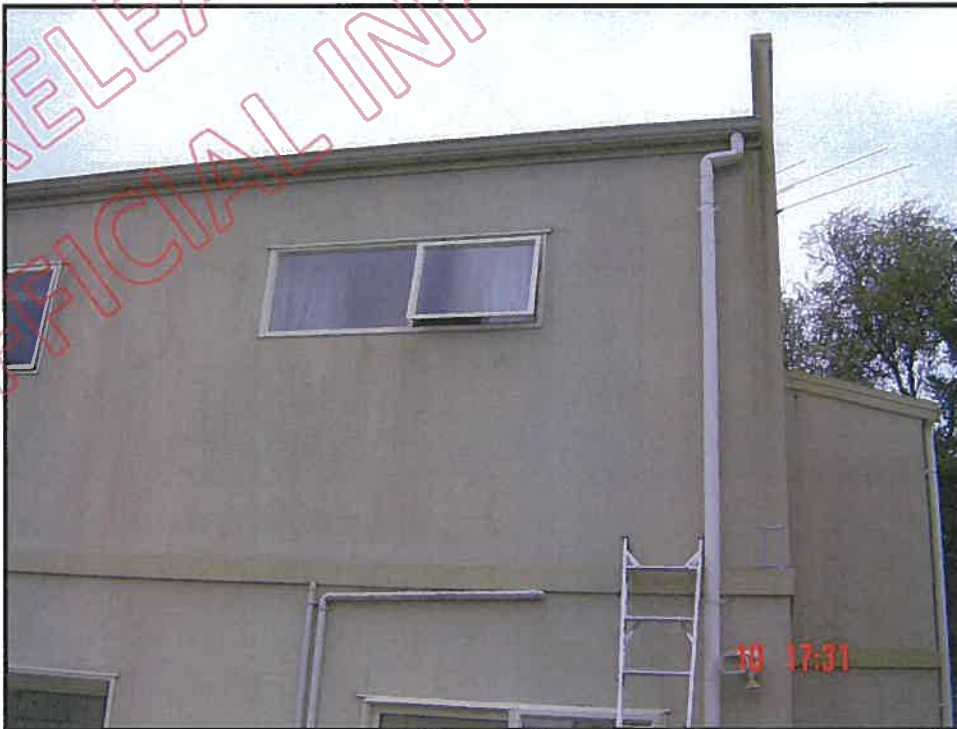
Photograph 3b-76

General view-part rear elevation (west) unit E

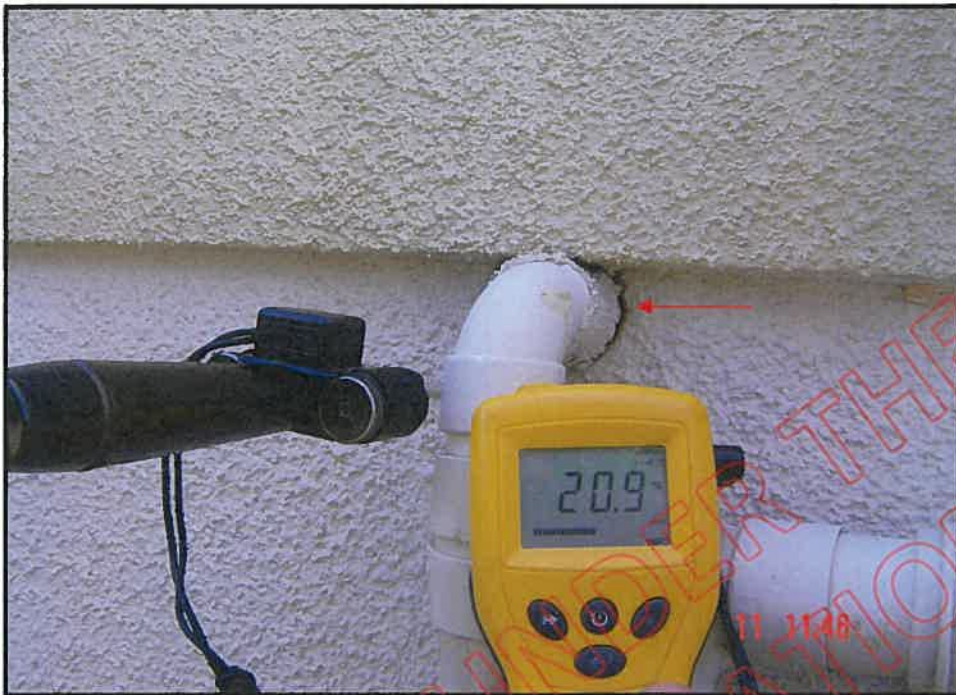
Photograph 3c 83

Probe reading at waste entry point; note waste penetration unsealed

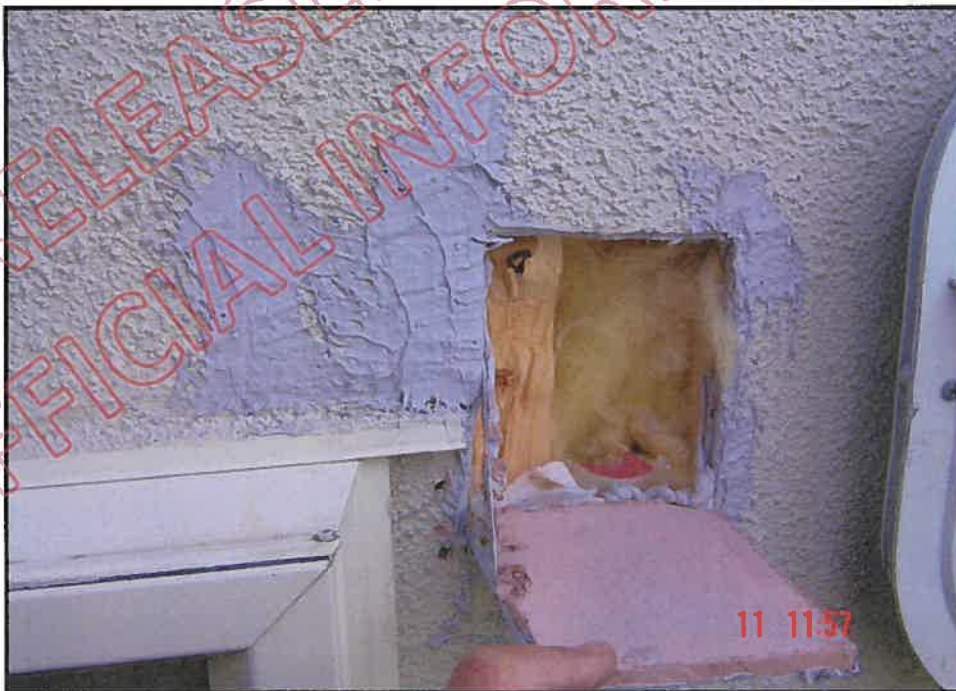
Photograph 3c 84

Reopening of existing previous cut out

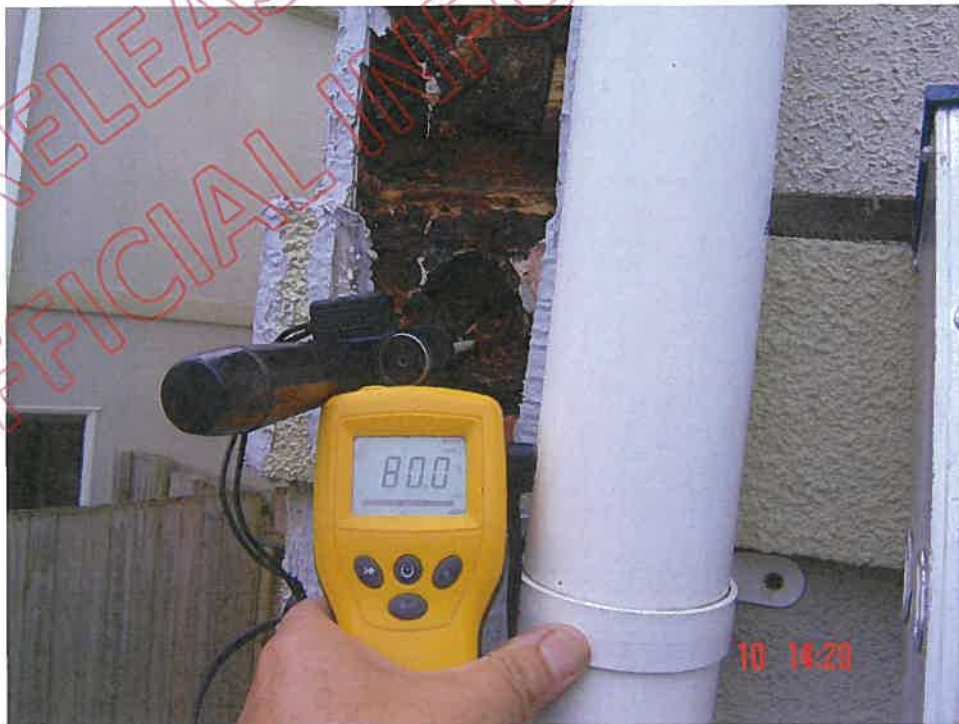
Photograph 3d 90

Cut out and high probe reading; northern corner at inter-storey junction

Cut out No. 10 as at photograph 3d 90 showing total decay of the framing, boundary joist, plates and flooring

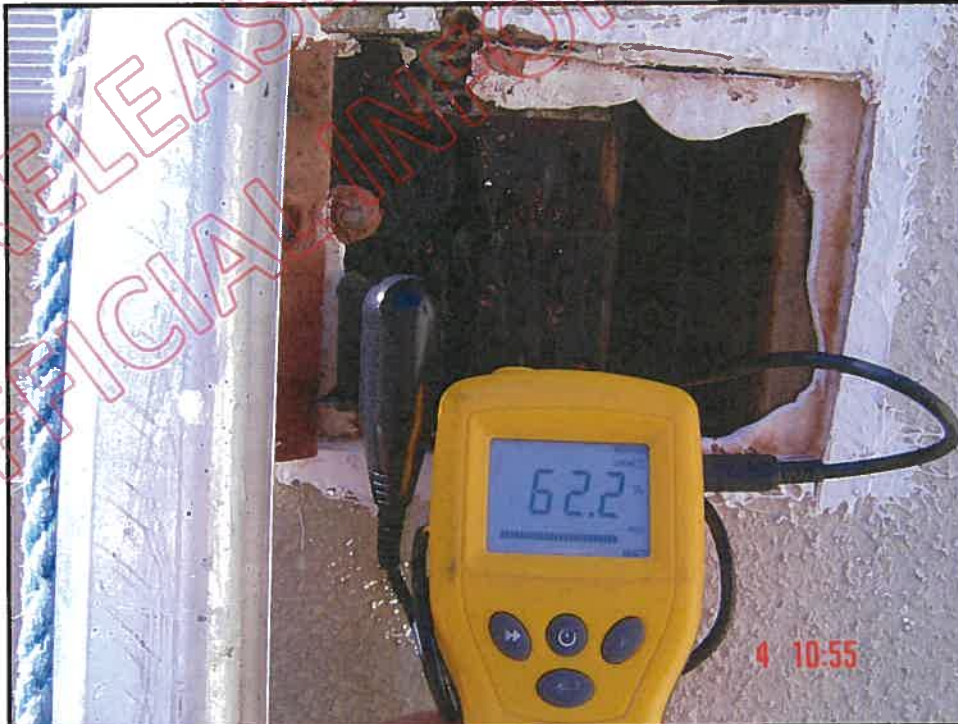
Photograph 5d 112

Cut out and very high probe reading below balcony wall and north wall junction

Close up of 5d 112 showing advanced decay and corrosion to nail plate; note no saddle flashing

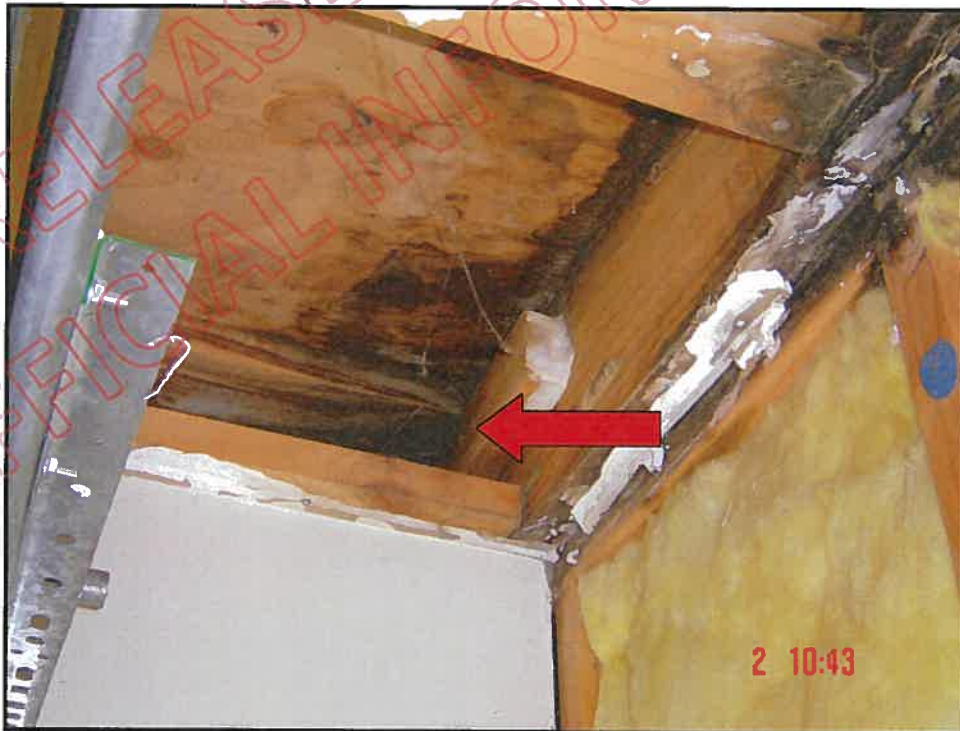
Photograph Internal- c 126

Looking up into cantilevered section of balcony
