## Asbestos Management Survey Report

Whanganui Hospital,  
(Te Awhina)

### **Whanganui Hospital**

### **Te Awhina**

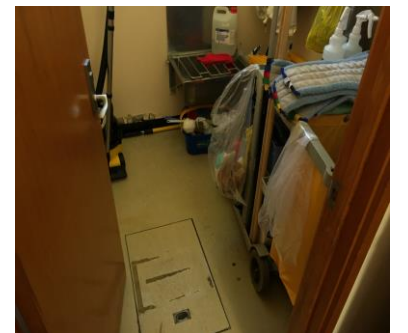
**ID: CARD NO:048**

Photograph No.	048
Location/Area	Staff Area: Cleaners Cupboard
Suspected Material Identified	Vinyl Flooring (Green)
Condition of Material Identified	Good
<b>Categories: (Assessment type).</b> 1: ACM common characteristics or 2: Presumed ACM or 3: Sample collected for analysis	2: Presumed
Sample No.	Sample not taken
Laboratory Analysis Findings	Analysis not conducted
Quantity of Material Identified	3.2m2

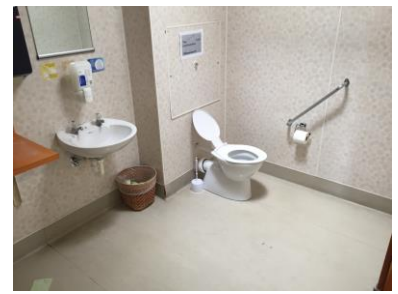
**ID: CARD NO:049**

Photograph No.	049
Location/Area	Staff Area: Unisex Toilet
Suspected Material Identified	Vinyl Flooring (G)
Condition of Material Identified	Good
<b>Categories: (Assessment type).</b> 1: ACM common characteristics or 2: Presumed ACM or 3: Sample collected for analysis	2: Presumed
Sample No.	Sample not taken
Laboratory Analysis Findings	Analysis not conducted
Quantity of Material Identified	6.5m2

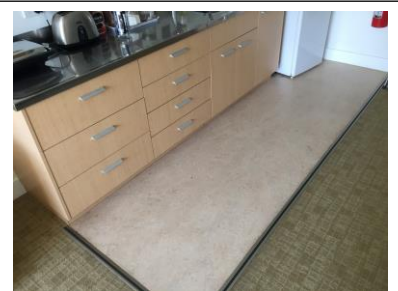
**ID: CARD NO:050**

Photograph No.	050
Location/Area	Staff Area: Staff Lounge Kitchen
Suspected Material Identified	Vinyl Flooring (Cream)
Condition of Material Identified	Good
<b>Categories: (Assessment type).</b> 1: ACM common characteristics or 2: Presumed ACM or 3: Sample collected for analysis	2: Presumed
Sample No.	Sample not taken
Laboratory Analysis Findings	Analysis not conducted
Quantity of Material Identified	4.7m2

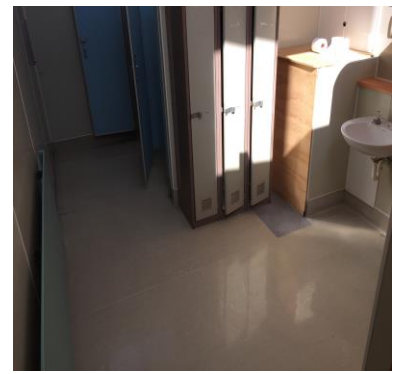
**ID: CARD NO:051**

Photograph No.	051
Location/Area	Staff Area: Male Toilet
Suspected Material Identified	Vinyl Flooring (Cream)
Condition of Material Identified	Good
<b>Categories: (Assessment type).</b> 1: ACM common characteristics or 2: Presumed ACM or 3: Sample collected for analysis	2: Presumed
Sample No.	Sample not taken
Laboratory Analysis Findings	Analysis not conducted
Quantity of Material Identified	14.8m2

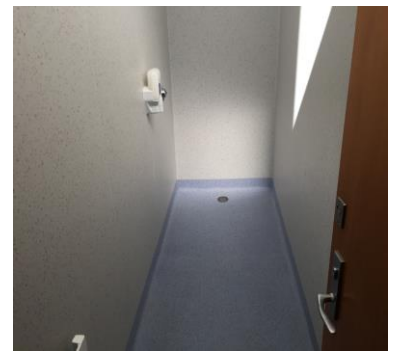
**ID: CARD NO:052**

Photograph No.	052
Location/Area	Staff Area: Shower
Suspected Material Identified	Vinyl Floor/Walls (Blue/Stone)
Condition of Material Identified	Good
<b>Categories: (Assessment type).</b> 1: ACM common characteristics or 2: Presumed ACM or 3: Sample collected for analysis	2: Presumed
Sample No.	Sample not taken
Laboratory Analysis Findings	Analysis not conducted
Quantity of Material Identified	3.6m2 / 21.6m2

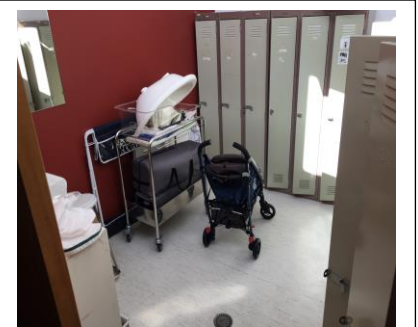
**ID: CARD NO:053**

Photograph No.	053
Location/Area	Staff Area: Locker Room
Suspected Material Identified	Vinyl Flooring (White)
Condition of Material Identified	Good
<b>Categories: (Assessment type).</b> 1: ACM common characteristics or 2: Presumed ACM or 3: Sample collected for analysis	2: Presumed
Sample No.	Sample not taken
Laboratory Analysis Findings	Analysis not conducted
Quantity of Material Identified	10.4m2

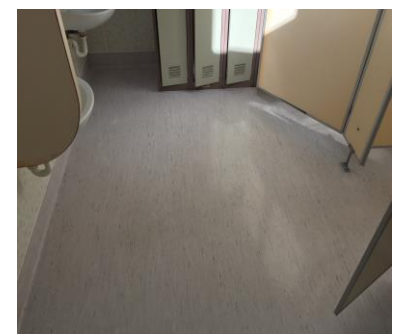
**ID: CARD NO:054**

Photograph No.	054
Location/Area	Staff Area: Female Toilet
Suspected Material Identified	Vinyl Flooring (White)
Condition of Material Identified	Good
<b>Categories: (Assessment type).</b> 1: ACM common characteristics or 2: Presumed ACM or 3: Sample collected for analysis	2: Presumed
Sample No.	Sample not taken
Laboratory Analysis Findings	Analysis not conducted
Quantity of Material Identified	14.7m2

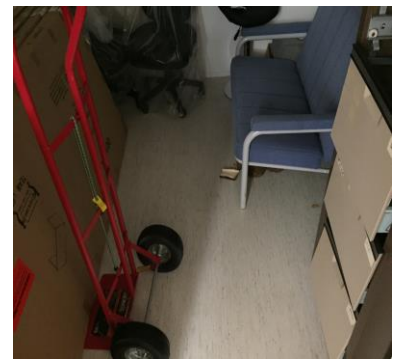
**ID: CARD NO:055**

Photograph No.	055
Location/Area	Staff Area: Store Room
Suspected Material Identified	Vinyl Flooring (White)
Condition of Material Identified	Good
<b>Categories: (Assessment type).</b> 1: ACM common characteristics or 2: Presumed ACM or 3: Sample collected for analysis	2: Presumed
Sample No.	Sample not taken
Laboratory Analysis Findings	Analysis not conducted
Quantity of Material Identified	7.5m2

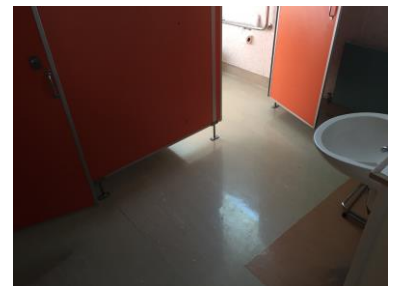
**ID: CARD NO:056**

Photograph No.	056
Location/Area	Day Room: Unisex Toilet
Suspected Material Identified	Vinyl Flooring (Cream/Orange)
Condition of Material Identified	Good
<b>Categories: (Assessment type).</b> 1: ACM common characteristics or 2: Presumed ACM or 3: Sample collected for analysis	2: Presumed
Sample No.	Sample not taken
Laboratory Analysis Findings	Analysis not conducted
Quantity of Material Identified	10.8m2

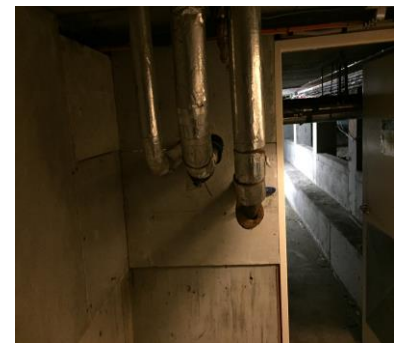
**ID: CARD NO:057**

Photograph No.	057
Location/Area	Sub Floor: Entry
Suspected Material Identified	ACM board
Condition of Material Identified	Good
<b>Categories: (Assessment type).</b> 1: ACM common characteristics or 2: Presumed ACM or 3: Sample collected for analysis	1: ACM common characteristics
Sample No.	Sample not taken
Laboratory Analysis Findings	Analysis not conducted
Quantity of Material Identified	9.0m2

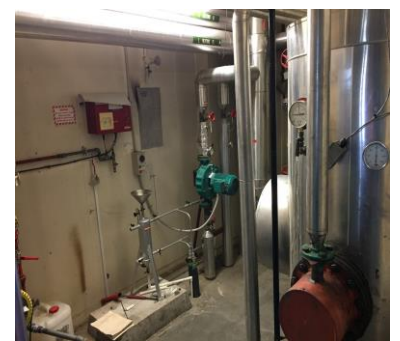
**ID: CARD NO:058**

Photograph No.	058
Location/Area	Boiler Room: Walls
Suspected Material Identified	ACM board
Condition of Material Identified	Good
<b>Categories: (Assessment type).</b> 1: ACM common characteristics or 2: Presumed ACM or 3: Sample collected for analysis	1: ACM common characteristics
Sample No.	Sample not taken
Laboratory Analysis Findings	Analysis not conducted
Quantity of Material Identified	22.5m2

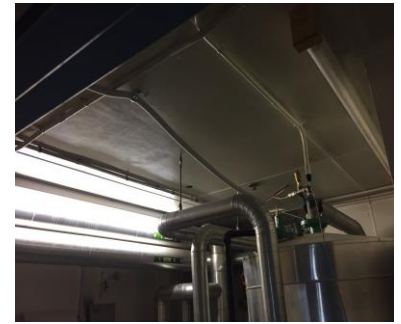
**ID: CARD NO:059**

Photograph No.	059
Location/Area	Boiler Room: Ceiling
Suspected Material Identified	ACM board
Condition of Material Identified	Good
<b>Categories: (Assessment type).</b> 1: ACM common characteristics or 2: Presumed ACM or 3: Sample collected for analysis	1: ACM common characteristics
Sample No.	Sample not taken
Laboratory Analysis Findings	Analysis not conducted
Quantity of Material Identified	10.8m2
