## Asbestos Management Survey Report

### LAMBIE BUILDING MANAGEMENT SURVEY

### **WHANGANUI HOSPITAL**

### **LAMBIE BUILDING-EXTERIOR & INTERNAL**

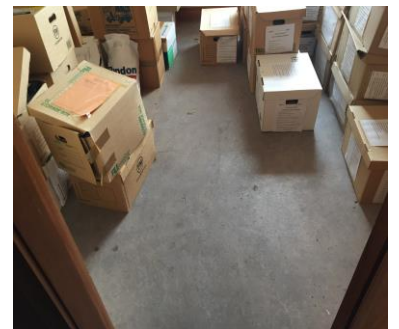
**ID: CARD NO:050**

Floor.	Fourth Floor
Location/Area	Store Room: Floor
Suspected Material Identified	Vinyl Flooring
Condition of Material Identified	Stable
<b>Categories: (Assessment type).</b> 1: ACM common characteristics or 2: Presumed ACM or 3: Sample collected for analysis	2: Presumed ACM
Sample No.	Sample Not Taken
Laboratory Analysis Findings	Analysis Not Conducted
Quantity of Material Identified	12.0m2

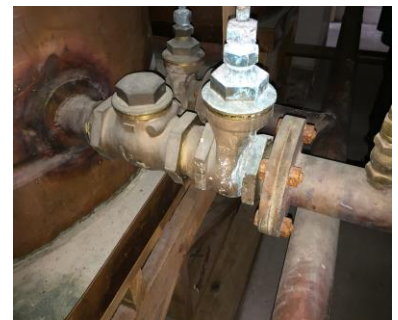
**ID: CARD NO:051**

Floor.	Plant Room
Location/Area	Plant Room: Gaskets
Suspected Material Identified	ACM Gaskets
Condition of Material Identified	Stable
<b>Categories: (Assessment type).</b> 1: ACM common characteristics or 2: Presumed ACM or 3: Sample collected for analysis	2: Presumed ACM
Sample No.	Sample Not Taken
Laboratory Analysis Findings	Analysis Not Conducted
Quantity of Material Identified	20.0m2

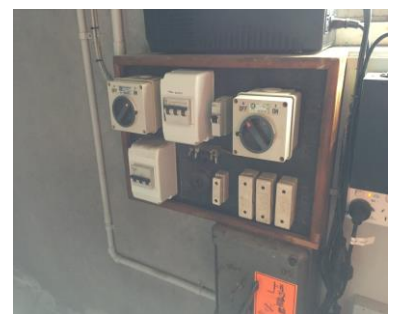
**ID: CARD NO:052**

Floor.	Plant Room
Location/Area	Elevator Room: Fuse board
Suspected Material Identified	ACM Board
Condition of Material Identified	Stable
<b>Categories: (Assessment type).</b> 1: ACM common characteristics or 2: Presumed ACM or 3: Sample collected for analysis	2: Presumed ACM
Sample No.	Sample Not Taken
Laboratory Analysis Findings	Analysis Not Conducted
Quantity of Material Identified	.200m2

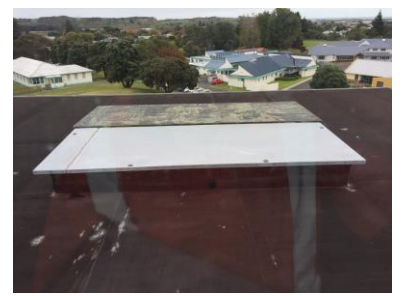
**ID: CARD NO:053**

Floor.	Exterior
Location/Area	Exterior: Roof Top
Suspected Material Identified	Waterproofing (Black)
Condition of Material Identified	Stable
<b>Categories: (Assessment type).</b> 1: ACM common characteristics or 2: Presumed ACM or 3: Sample collected for analysis	2: Presumed ACM
Sample No.	Sample Taken
Laboratory Analysis Findings	Analysis Not Conducted
Quantity of Material Identified	30.0m2
