# Categorisation of Open Stormwater Drains in Waihi Beach, Te Puke, and Maketu

Opus International Consultants Limited  
Tauranga Office  
405 Cameron Road  
PO Box 646  
Tauranga, New Zealand

Date: 8 February 2008  
Reference: g:\5\project\9z178.01\_drains\_phase\_2\final  
Status: FINAL  
document\main document.doc

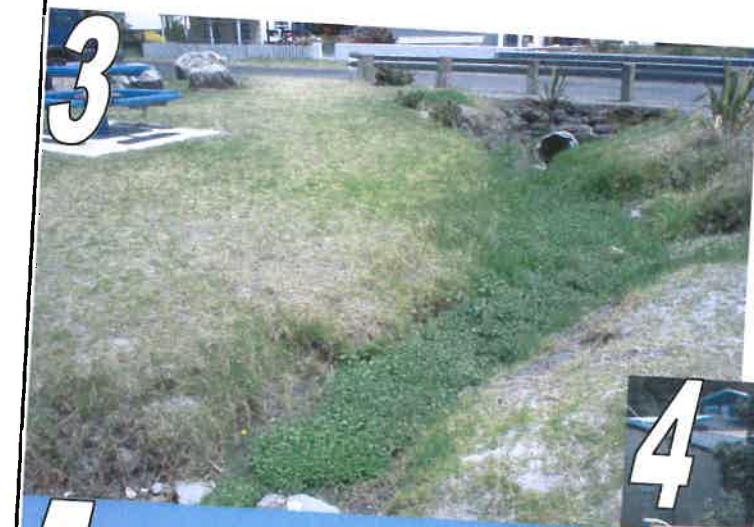
## Drain 2-The Esplanade

PARAMETER	OBSERVATION	RATING
DEPTH	> 1 m	10
BATTER SLOPE	> 1:1	10
DISTANCE ROAD SURFACE AND DRAIN	Perpendicular to road.	0
INLET/OUTLET PROTECTION	Inlet and outlet is part of a road crossing.	0
PROXIMITY TO SENSITIVE FACILITIES	Adjacent to development and beach	10
AESTHETIC CONSIDERATIONS	Excessive growth.	10
HEALTH CONSIDERATIONS	None.	10
ENVIRONMENTAL CONSIDERATIONS	None.	10
PROXIMITY TO DEVELOPMENT	Adjacent to development	0
SAFETY INDEX	The drain is adjacent to a play park and should be better protected	10
DRAIN INDEX		7.15
		7.15

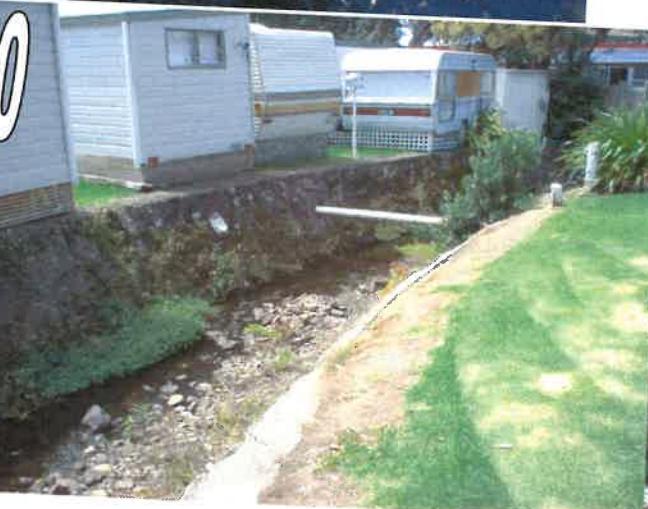
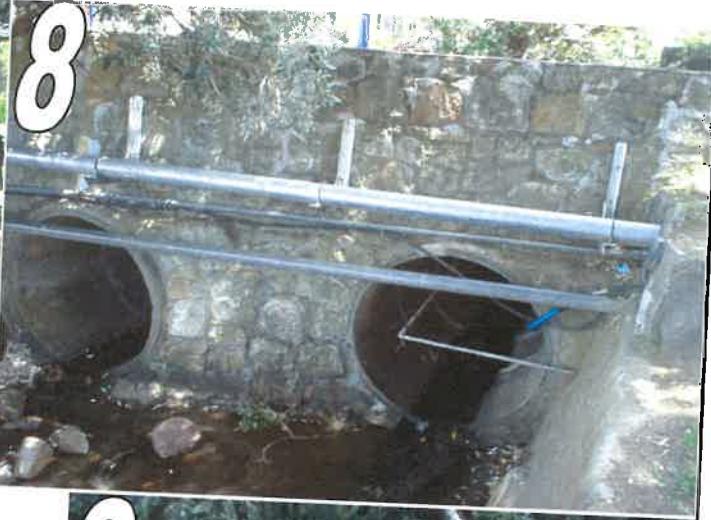
## Drain 4-Camping Site-both sides of Beach Rd

PARAMETER	OBSERVATION	RATING
DEPTH	> 1 m.	10
BATTER SLOPE	> 1:1	10
DISTANCE ROAD SURFACE AND DRAIN	Drain is perpendicular to road.	0
INLET/OUTLET PROTECTION	Inlet and outlet is part of a road crossing.	0
PROXIMITY TO SENSITIVE FACILITIES	Adjacent to development and beach	10
AESTHETIC CONSIDERATIONS	Slight growth	5
HEALTH CONSIDERATIONS	None	0
ENVIRONMENTAL CONSIDERATIONS	None	0
PROXIMITY TO DEVELOPMENT	Adjacent to development	10
SAFETY INDEX	Three children were slightly injured after falling into the open drain during the past holidays.	6.65
DRAIN INDEX		5.40

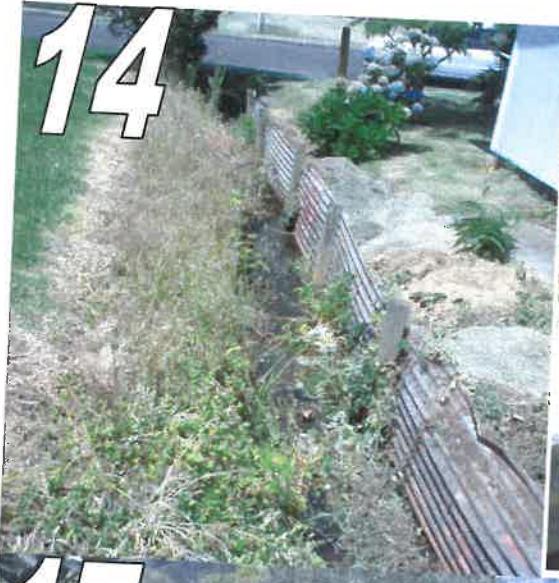
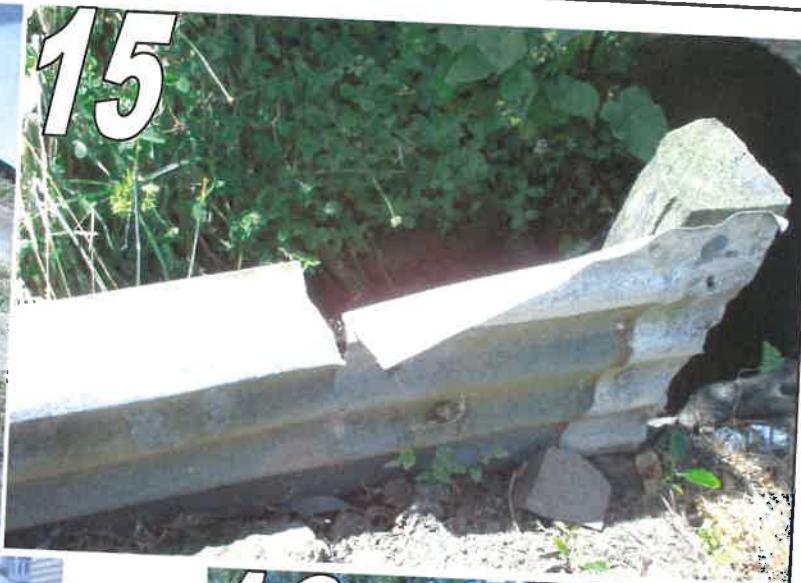
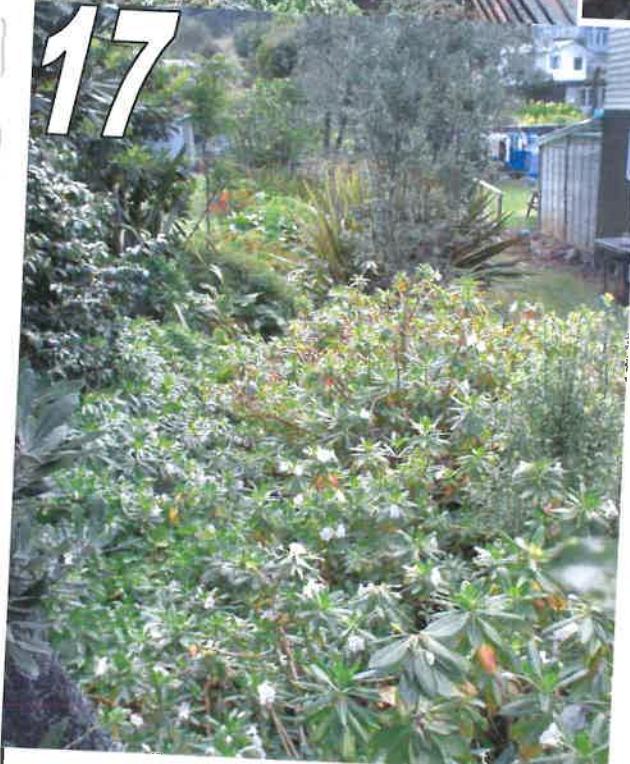
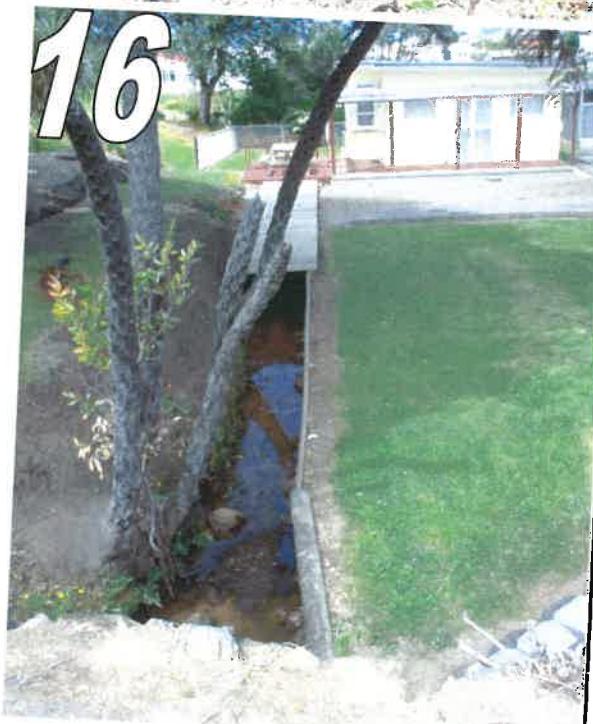
## Drain 6-Perpendicular to Beach Rd

PARAMETER	OBSERVATION	RATING
DEPTH	0.8 m	5
BATTER SLOPE	One side strutted with corrugated iron	10
DISTANCE ROAD SURFACE AND DRAIN	> 4 m	0
INLET/OUTLET PROTECTION	safety rail required at outlet to road crossing	5
PROXIMITY TO SENSITIVE FACILITIES	Next to open park	5
AESTHETIC CONSIDERATIONS	Excessive growth along top section	10
HEALTH CONSIDERATIONS	Standing water	10
ENVIRONMENTAL CONSIDERATIONS	None	0
PROXIMITY TO DEVELOPMENT	Adjacent to development	10
SAFETY INDEX	The corrugated iron battering is a safety concern. The lower section of this drain could be piped	6.86
DRAIN INDEX		6.36

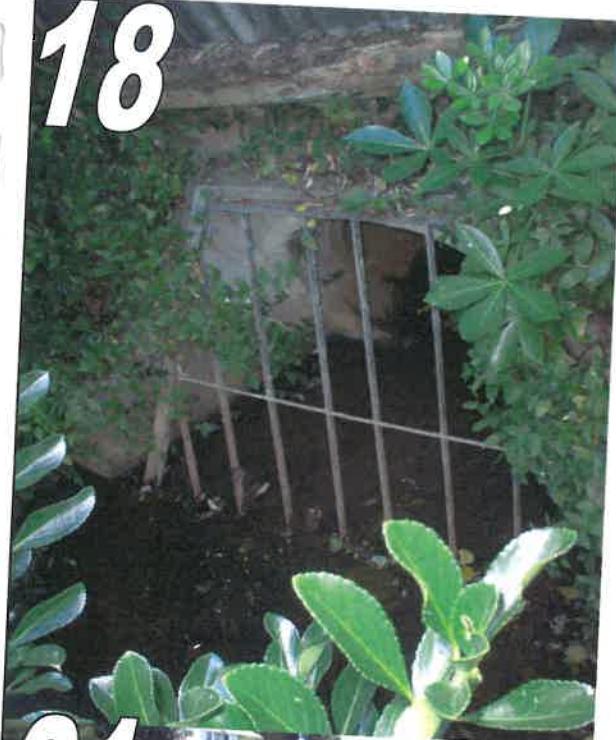
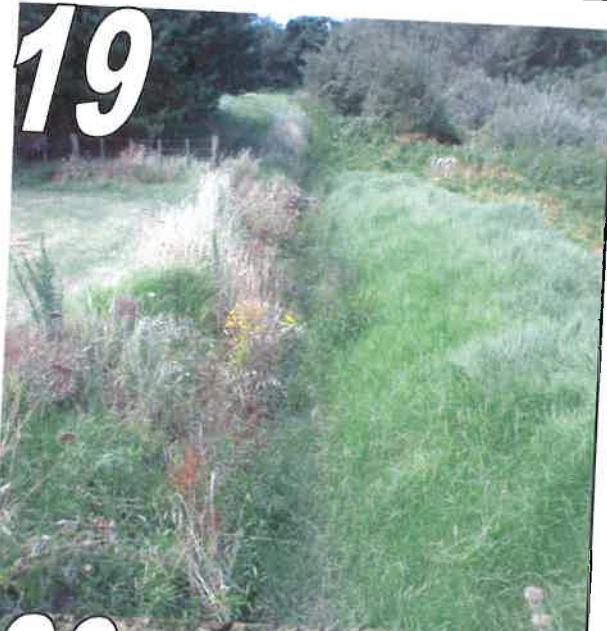
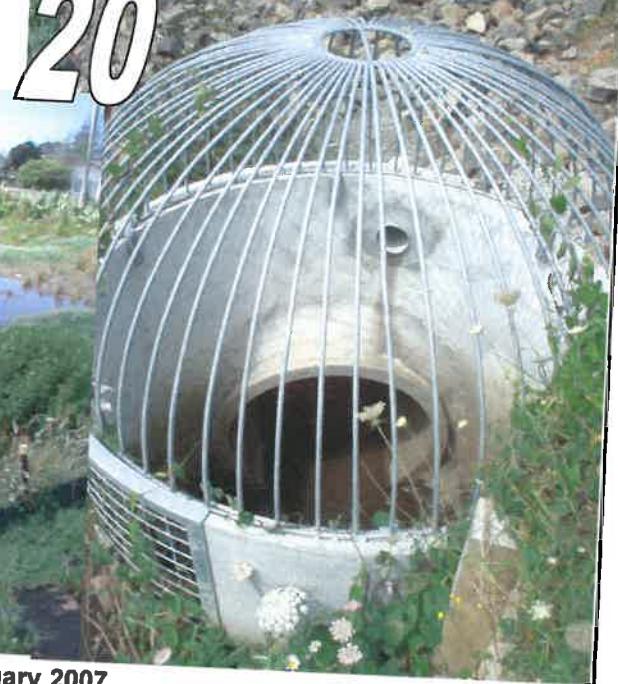
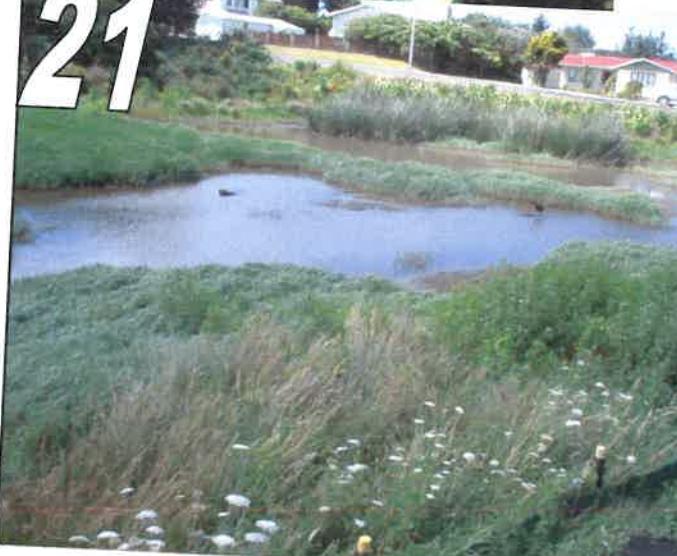
## Drain 7-Beach Rd/Leo St

PARAMETER	OBSERVATION	RATING
DEPTH	1-2 m	9
BATTER SLOPE	> 1:1	10
DISTANCE ROAD SURFACE AND DRAIN	Drain is perpendicular to road	0
INLET/OUTLET PROTECTION	Two inlets are protected	2.5
PROXIMITY TO SENSITIVE FACILITIES	No	0
AESTHETIC CONSIDERATIONS	Slight to excessive growth	5
HEALTH CONSIDERATIONS	Standing water	10
ENVIRONMENTAL CONSIDERATIONS	None	0
PROXIMITY TO DEVELOPMENT	Fair distance from development	5
SAFETY INDEX	The drain is not easily accessible and doesn't constitute a high safety risk	6.12
DRAIN INDEX		5.12

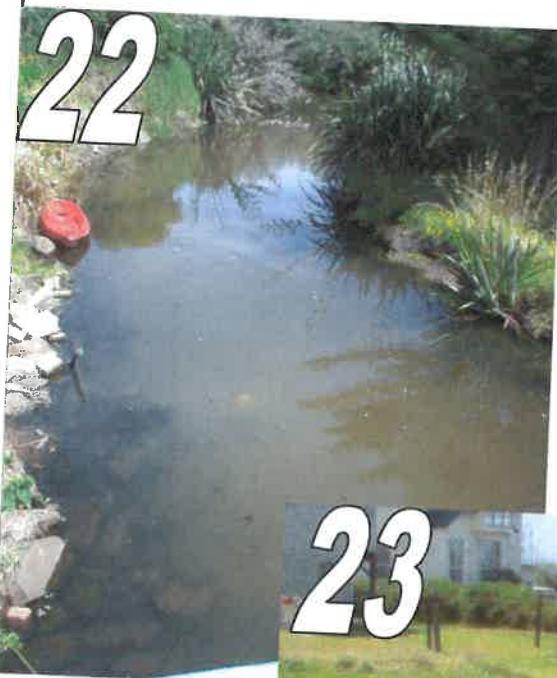
## Drain 8-Between Edinburgh St & Wilson Rd

PARAMETER	OBSERVATION	RATING
DEPTH	> 2m	10
BATTER SLOPE	Vertical along sections	10
DISTANCE ROAD SURFACE AND DRAIN	> 4 m	0
INLET/OUTLET PROTECTION	Inlet and outlet is part of a road crossing.	0
PROXIMITY TO SENSITIVE FACILITIES	Traverses beach	10
AESTHETIC CONSIDERATIONS	Slight growth	10
HEALTH CONSIDERATIONS	Standing water	5
ENVIRONMENTAL CONSIDERATIONS	None	10
PROXIMITY TO DEVELOPMENT	Adjacent to development and beach	0
SAFETY INDEX	The drain traverses private properties where no easements exist	10
DRAIN INDEX		6.40

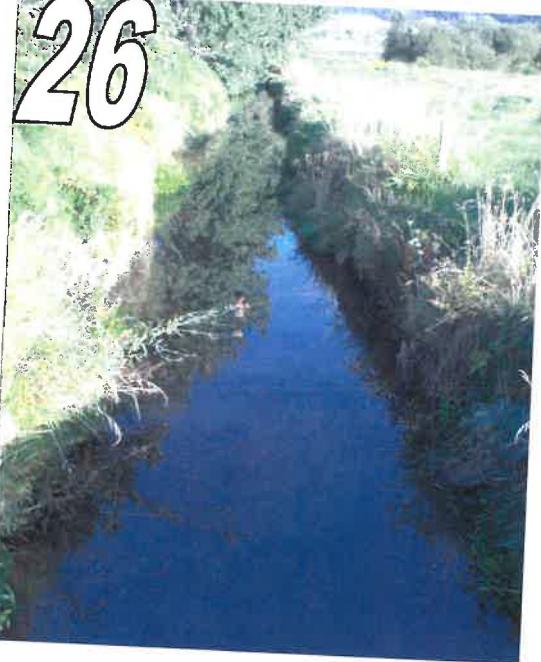
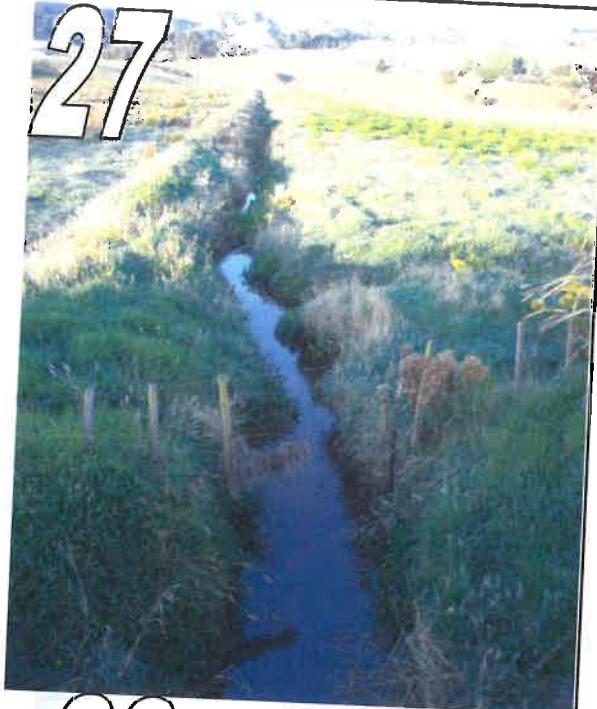
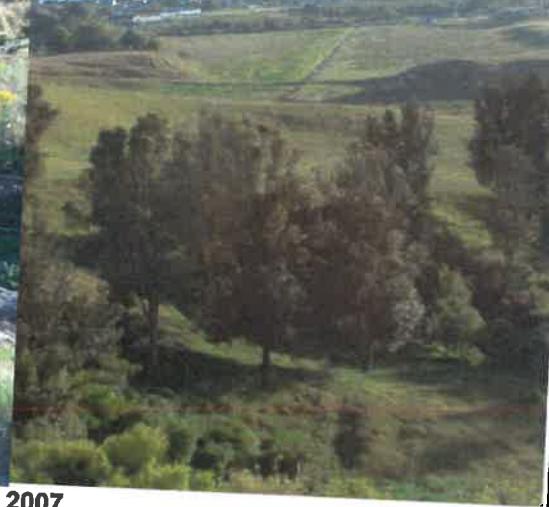
## Drain 13-Adjacent to Waihi Beach Road

PARAMETER	OBSERVATION	RATING
DEPTH	2.5 m along sections	10
BATTER SLOPE	Vertical along sections	10
DISTANCE ROAD SURFACE AND DRAIN	Perpendicular to road	0
INLET/OUTLET PROTECTION	Inlets and outlets are part of road crossings.	5
PROXIMITY TO SENSITIVE FACILITIES	Removed from sensitive facilities	0
AESTHETIC CONSIDERATIONS	Normal growth	5
HEALTH CONSIDERATIONS	Standing water	10
ENVIRONMENTAL CONSIDERATIONS	None	0
PROXIMITY TO DEVELOPMENT	Removed from development	0
SAFETY INDEX	This drain is in open veld and would be very difficult to secure even if it was required which it is not	5.40
DRAIN INDEX		5.65

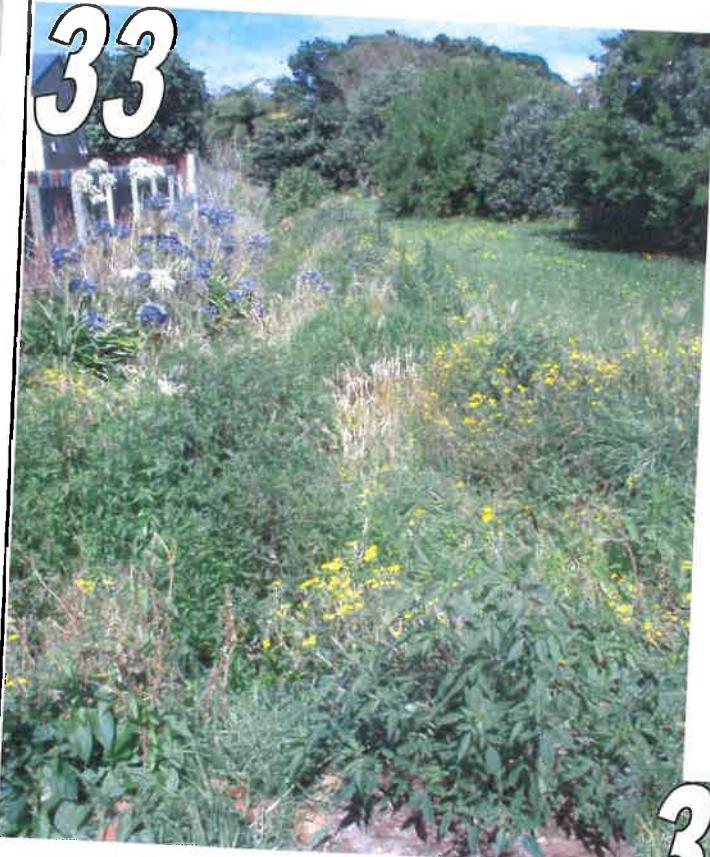
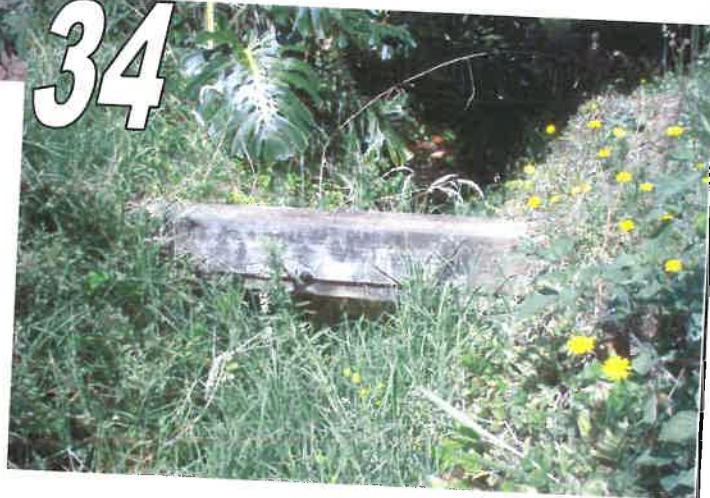
## Drain 17-Between Otto Rd & Patterson Place

PARAMETER	OBSERVATION	RATING
DEPTH	> 2 m	10
BATTER SLOPE	Vertical along sections	10
DISTANCE ROAD SURFACE AND DRAIN	> 4 m	0
INLET/OUTLET PROTECTION	Inlet not protected but not required as per Report	0
PROXIMITY TO SENSITIVE FACILITIES	Removed from sensitive facilities	0
AESTHETIC CONSIDERATIONS	Excessive growth	10
HEALTH CONSIDERATIONS	None	0
ENVIRONMENTAL CONSIDERATIONS	None	0
PROXIMITY TO DEVELOPMENT	Within development	0
SAFETY INDEX	Drain is situated within easement. Access to the easement could be restricted	10
DRAIN INDEX		4.65
		4.65

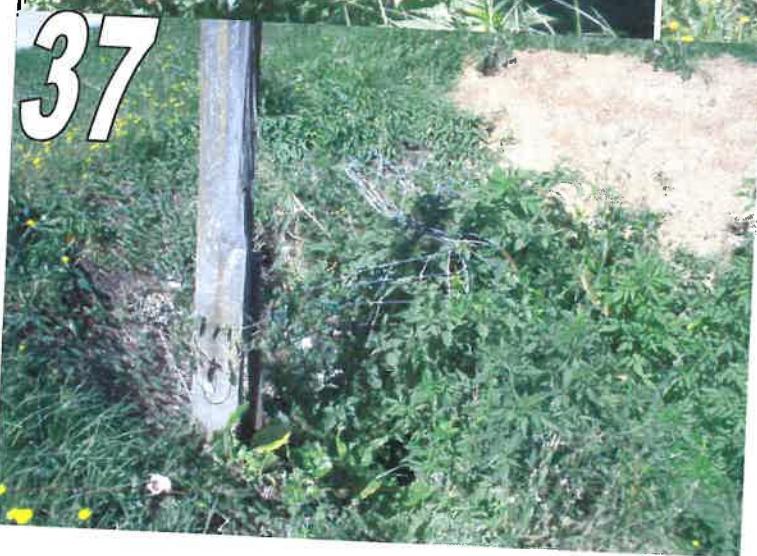
## Drain 18-Between Snell Cres & Hereford Place

PARAMETER	OBSERVATION	RATING
DEPTH	2.5 m along sections	10
BATTER SLOPE	Vertical along sections	10
DISTANCE ROAD SURFACE AND DRAIN	> 4 m	0
INLET/OUTLET PROTECTION	Outlet not protected	0
PROXIMITY TO SENSITIVE FACILITIES	Removed from sensitive facilities	0
AESTHETIC CONSIDERATIONS	Excessive growth	10
HEALTH CONSIDERATIONS	None	0
ENVIRONMENTAL CONSIDERATIONS	None	0
PROXIMITY TO DEVELOPMENT	Within development	0
SAFETY INDEX	Drain is situated within easement. Access to the easement could be restricted	10
DRAIN INDEX		6.15
		6.15

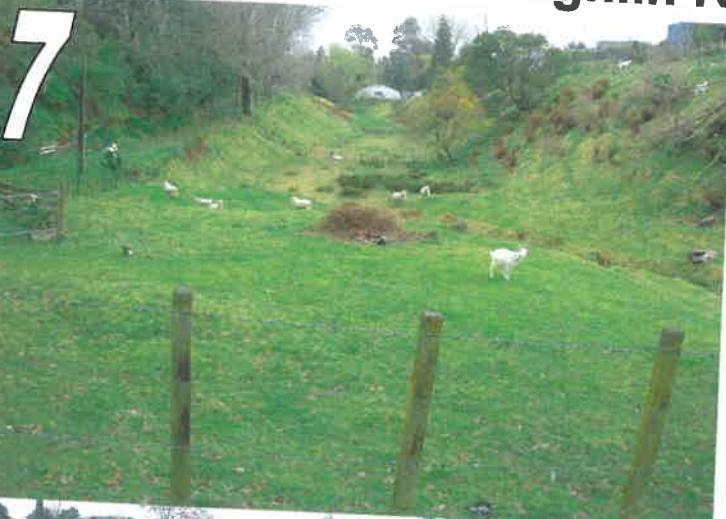
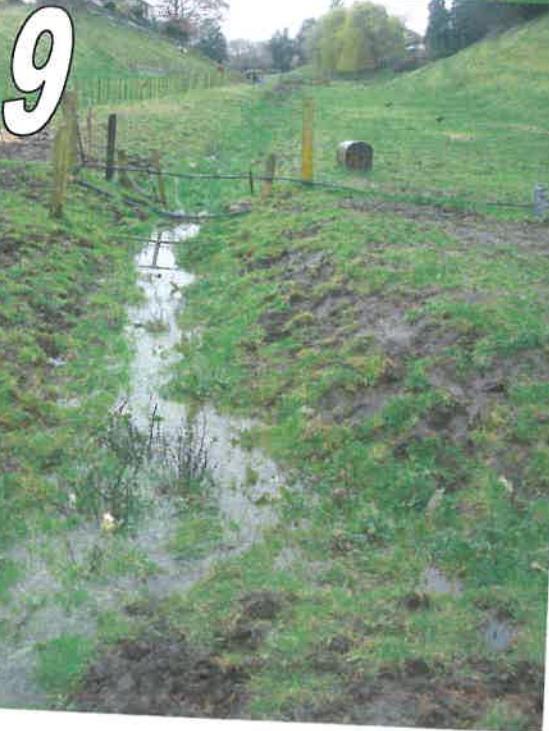
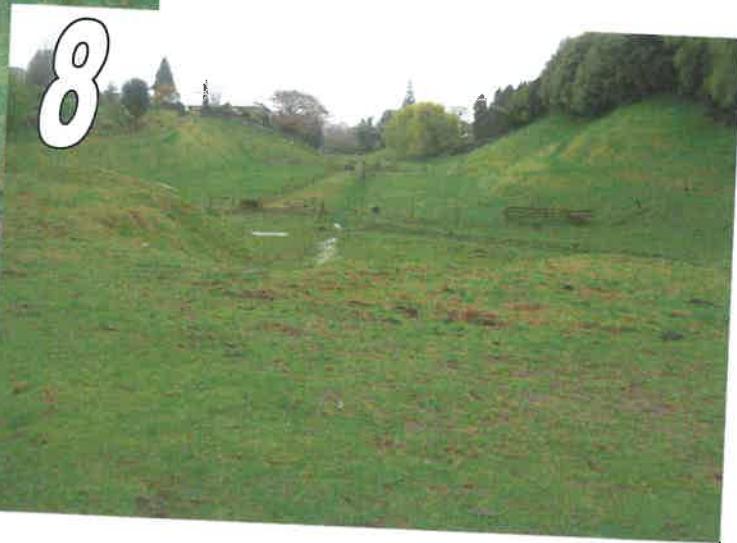
# Drain 3A-Between Hayward Court and Valley Road Macloughlin Road End

PARAMETER	OBSERVATION	RATING
DEPTH	< 0.5 m	0
BATTER SLOPE	< 2:1	0
DISTANCE ROAD SURFACE AND DRAIN	> 4 m	0
INLET/OUTLET PROTECTION	Inlet not protected but not required as per Report	0
PROXIMITY TO SENSITIVE FACILITIES	Removed from sensitive facilities	0
AESTHETIC CONSIDERATIONS	Pleasing	0
HEALTH CONSIDERATIONS	None	0
ENVIRONMENTAL CONSIDERATIONS	None	0
PROXIMITY TO DEVELOPMENT	Not easily accessible to the public	0
SAFETY INDEX	The drain is situated on undulating terrain with no safety risks.	5
DRAIN INDEX		0.75
		0.00

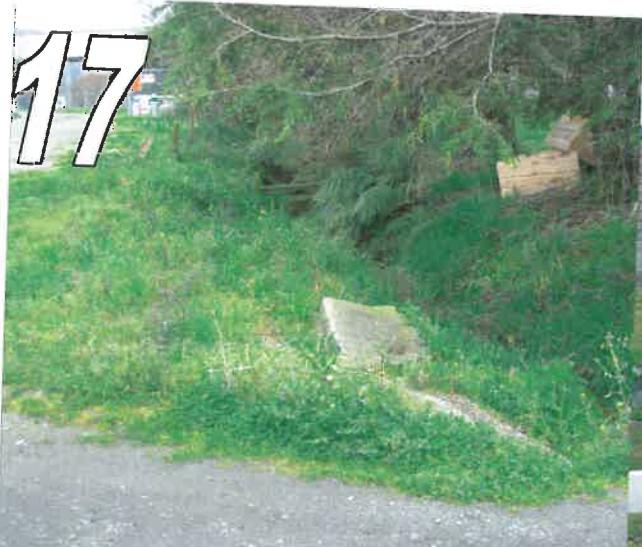
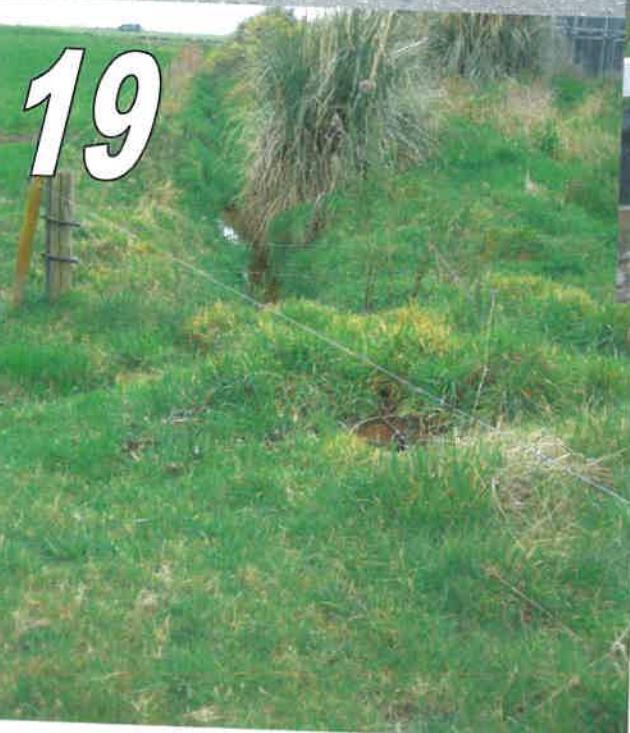
## Drain 8-End of Washer Road

PARAMETER	OBSERVATION	RATING
DEPTH	1 - 2 m	9
BATTER SLOPE	Steeper than 45 degrees	10
DISTANCE ROAD SURFACE AND DRAIN	2 - 4 m	5
INLET/OUTLET PROTECTION	Inlet and outlet is part of a road crossing.	0
PROXIMITY TO SENSITIVE FACILITIES	Situated inside an industrial area	0
AESTHETIC CONSIDERATIONS	Slight growth	5
HEALTH CONSIDERATIONS	Standing water	0
ENVIRONMENTAL CONSIDERATIONS	None	0
PROXIMITY TO DEVELOPMENT	Situated inside an industrial area	5
SAFETY INDEX	No significant safety risk	3.92
DRAIN INDEX		3.92

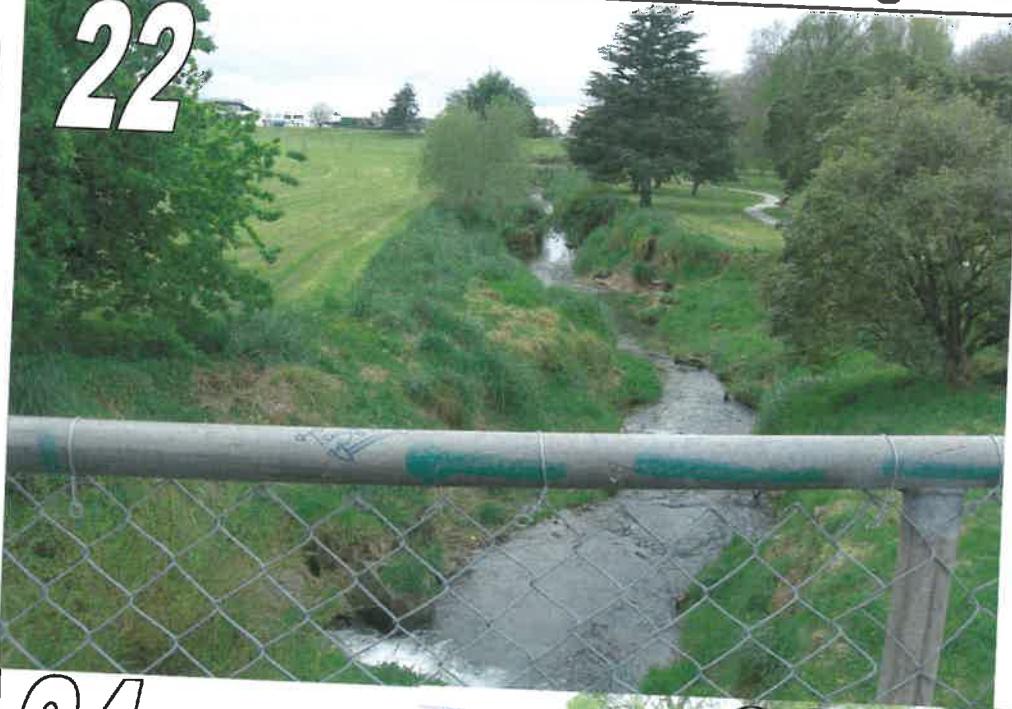
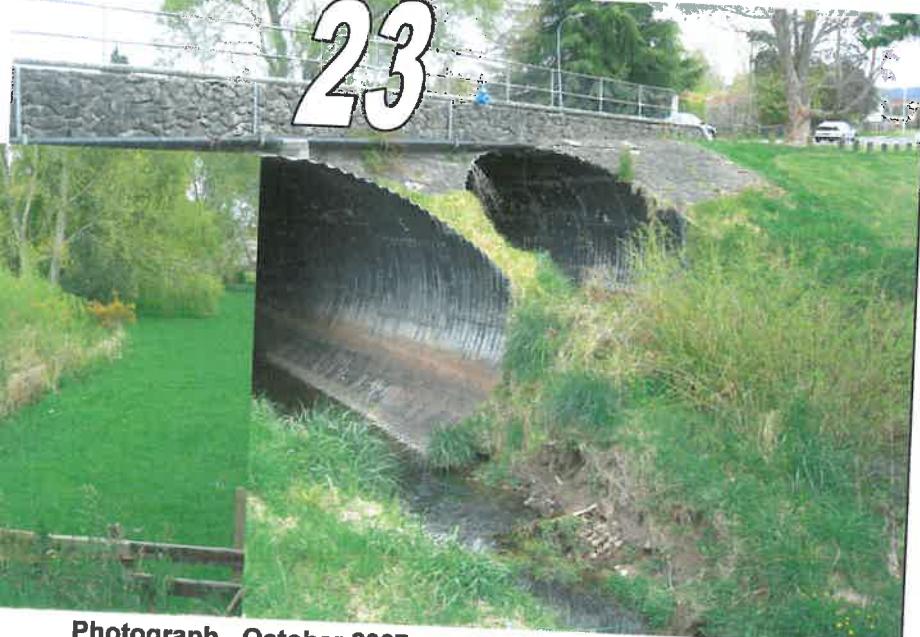
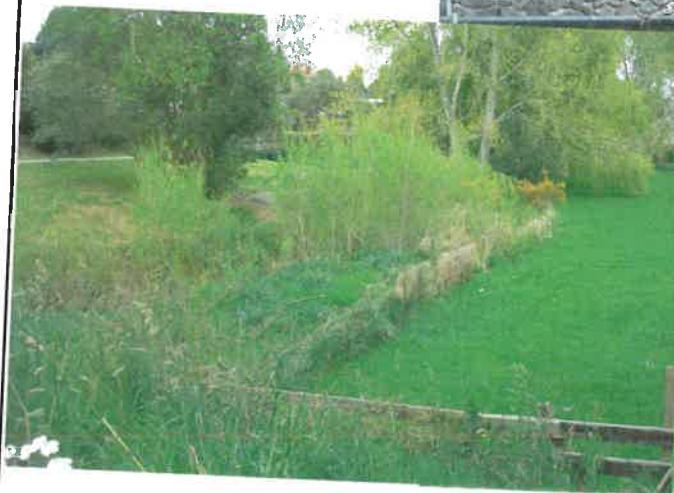
## Drain 10- Ohineagaanga Park

PARAMETER	OBSERVATION	RATING
DEPTH	0.5 - 1 m	5
BATTER SLOPE	2:1-1:1	5
DISTANCE ROAD SURFACE AND DRAIN	> 4 m	0
INLET/OUTLET PROTECTION	Inlet not protected but not required as per Report	0
PROXIMITY TO SENSITIVE FACILITIES	Removed from sensitive facilities	0
AESTHETIC CONSIDERATIONS	Normal growth	5
HEALTH CONSIDERATIONS	Standing water	10
ENVIRONMENTAL CONSIDERATIONS	In open veld	0
PROXIMITY TO DEVELOPMENT	Removed from development	0
<b>SAFETY INDEX</b>	This Drain discharges into Drain 13 and is a secondary Drain	2.58
<b>DRAIN INDEX</b>		3.33

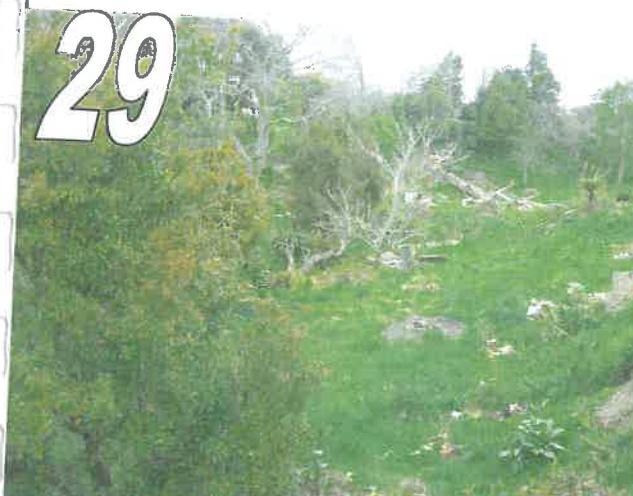
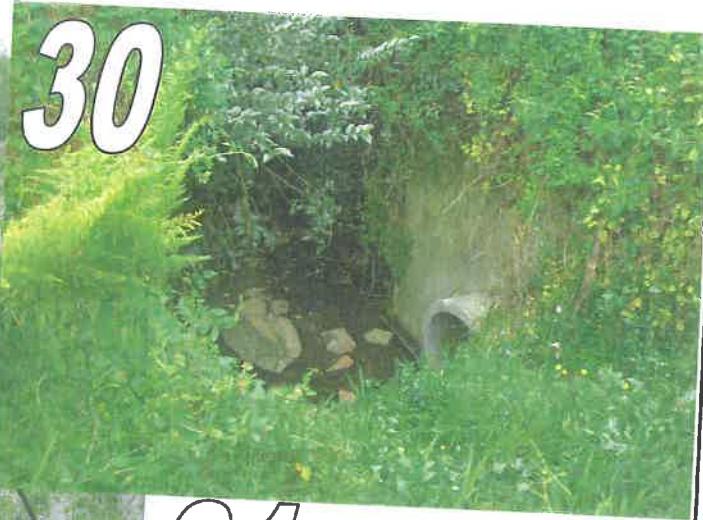
## Drain 12B-Crossing with Tui Street

PARAMETER	OBSERVATION	RATING
DEPTH	0.5 - 1.0 m	5
BATTER SLOPE	2:1 - 1:1	5
DISTANCE ROAD SURFACE AND DRAIN	Perpendicular to road	0
INLET/OUTLET PROTECTION	Inlet and outlet is part of a road crossing.	0
PROXIMITY TO SENSITIVE FACILITIES	Not close	0
AESTHETIC CONSIDERATIONS	Fair	5
HEALTH CONSIDERATIONS	None	0
ENVIRONMENTAL CONSIDERATIONS	None	0
PROXIMITY TO DEVELOPMENT	Between residential properties	0
SAFETY INDEX	The drain does require access protection where it crosses Tui Street	2.33
DRAIN INDEX		2.33

12B	<p><b>Position:</b></p> <p>The crossing of Drain 12 with Tui Street</p> <p><b>Depth/Batter Slope:</b></p> <p>The depth and batter slope of the Drain is within limits with the exception of the drain immediately to the north of Tui Street. It can be seen in photo 31 that a wooden barrier has been damaged.</p> <p><b>Safety:</b></p> <p>A wooden barrier has to be repaired.</p>	<p><b>Depth/Batter Slope:</b></p> <p>The wooden barrier as shown in photo 31 has to be reinstated. There is a steep fall from the road surface to the invert of the drain at this point.</p>
12C	<b>Position:</b>	<b>Depth/Batter Slope:</b>

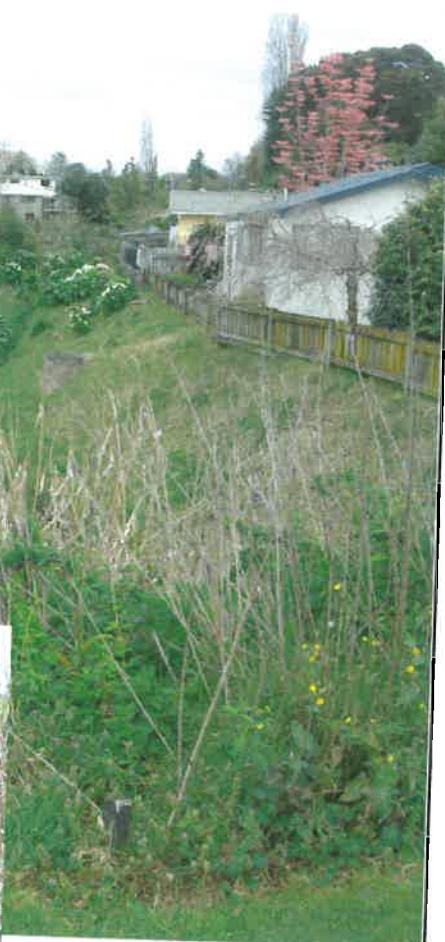
PARAMETER	OBSERVATION	RATING
DEPTH	0.5 - 1.0 m	5
BATTER SLOPE	2:1 - 1:1	5
DISTANCE ROAD SURFACE AND DRAIN	Perpendicular to road	0
INLET/OUTLET PROTECTION	Inlet and outlet is part of a road crossing.	0
PROXIMITY TO SENSITIVE FACILITIES	Not close	0
AESTHETIC CONSIDERATIONS	Fair	5
HEALTH CONSIDERATIONS	Standing water	10
ENVIRONMENTAL CONSIDERATIONS	None	
PROXIMITY TO DEVELOPMENT	Within developed area	0
SAFETY INDEX	The protection of the drain where it crosses the road should be enhanced	3.33
DRAIN INDEX		3.33

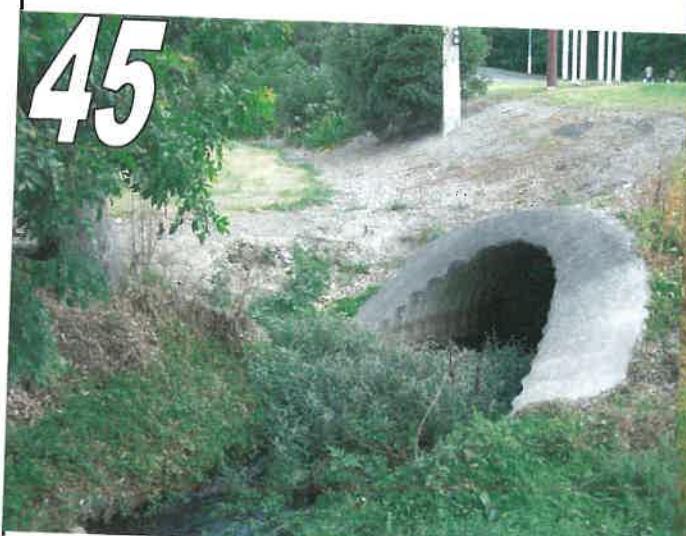
## Drain 15-Landscape Road

PARAMETER	OBSERVATION	RATING
DEPTH	1 - 2 m	9
BATTER SLOPE	>1:1	10
DISTANCE ROAD SURFACE AND DRAIN	> 4 m	0
INLET/OUTLET PROTECTION	Inlet and outlet is part of a road crossing.	0
PROXIMITY TO SENSITIVE FACILITIES	Removed from sensitive facilities	0
AESTHETIC CONSIDERATIONS	Normal to slightly more than normal growth	5
HEALTH CONSIDERATIONS	Standing water	10
ENVIRONMENTAL CONSIDERATIONS	None	0
PROXIMITY TO DEVELOPMENT	Fair distance from development	5
SAFETY INDEX	The section between the culvert and the pedestrian bridge should be protected.	4.74
DRAIN INDEX		4.74

15	<p><b>Position:</b> This Drain is the continuation of Drain 14 but just on the northern side of the main road. The Drain is reasonably sheltered from development.</p> <p><b>Depth:</b> The section of the Drain between the outlet of the culvert and the pedestrian bridge is accessible to public being adjacent to a public park. This is also the deepest section of the Drain.</p> <p><b>Safety:</b> It is recommended that a section of the Drain be fenced.</p>	<p><b>Depth:</b> The Drain is protected from the public park after it crosses the pedestrian bridge. The more accessible and deepest section of the Drain however is before the pedestrian bridge.</p> <p>This section should be provided with a similar barrier as is the case for the section beyond the pedestrian bridge.</p>

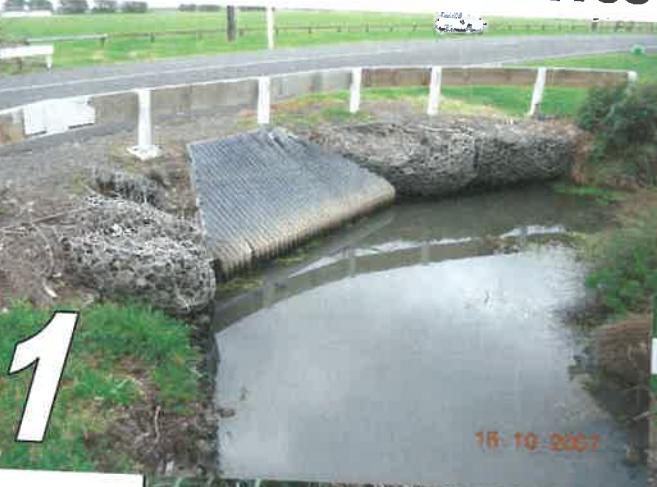
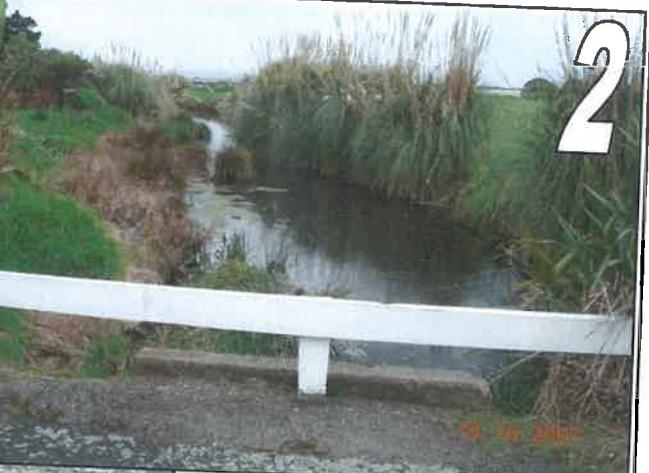
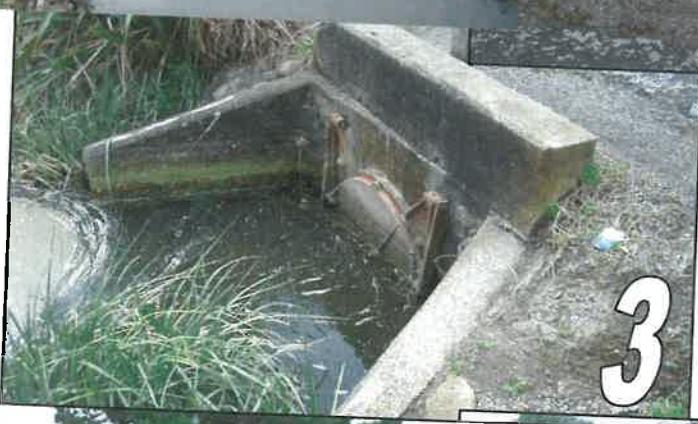
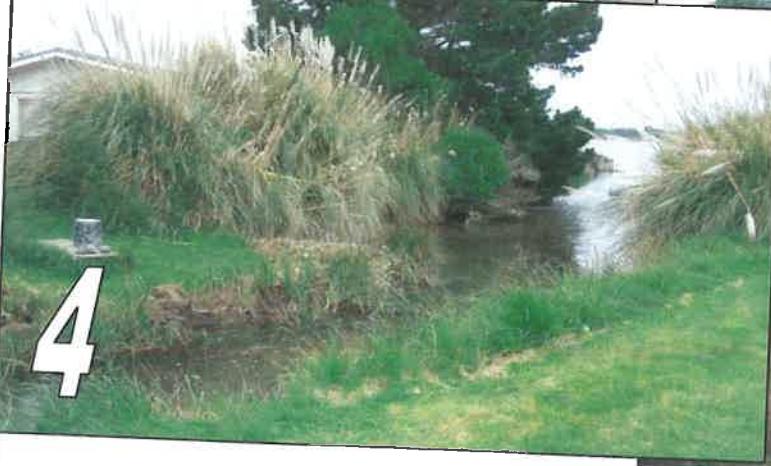
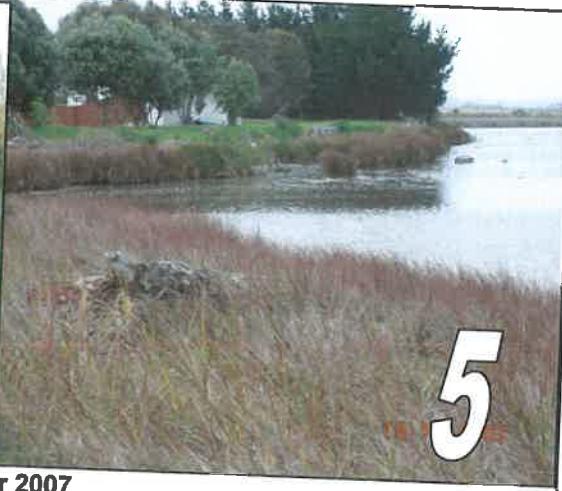
## Drain 1A - West of Maketu Rd

PARAMETER	OBSERVATION	RATING
DEPTH	1-2 m	
BATTER SLOPE	2:1 - 1:1	9
DISTANCE ROAD SURFACE AND DRAIN	2-4 m	0
INLET/OUTLET PROTECTION	Protection fair, some sight railing present	0
PROXIMITY TO SENSITIVE FACILITIES	Adjacent to Maketu Sports Ground	5
AESTHETIC CONSIDERATIONS	Fair, some growth in middle of drain	10
HEALTH CONSIDERATIONS	Standing water/mosquito breeding	5
ENVIRONMENTAL CONSIDERATIONS	None	10
PROXIMITY TO DEVELOPMENT	Adjacent houses are at sea level or slightly above	0
SAFETY INDEX	The drain is adjacent to a the sports grounds. Slight possibility of flooding for one or two homes.	10
DRAIN INDEX		7.04
		5.79

APPENDIX 2C – MAKETU: DISCUSSION OF DRAIN CONDITION AND REMEDIAL ACTION REQUIRED		
Drain No	Discussion	Remedial Action Required
1A	<p><b>Position:</b></p> <p>The Drain runs from Maketu Rd west into the estuary and is situated adjacent to the Maketu Sports Ground on one side. On the other side, the Drain is in close proximity to a few homes. From the outlet of the 600mm pipe, the Drain flows for about 100m until it empties into the estuary. There are a couple of houses adjacent to this part of the Drain that may be susceptible to flooding (Photo 4).</p> <p><b>Inlet/Outlet Protection:</b></p> <p>The tidal flap valve on the 600mm pipe looks to be in good condition. However, standing water in the Drains upstream warrant a look into its usefulness in keeping water from travelling upstream during the incoming tide.</p> <p><b>Health Considerations:</b></p> <p>There was standing water in the Drain but this is mainly due to the incoming tide.</p> <p><b>Aesthetic Considerations:</b></p> <p>There is vegetation growing in the middle of the Drain (Photo 2) that may cause some disturbance of flow but the drain is fairly aesthetically pleasing.</p>	<p><b>Inlet/Outlet Protection:</b></p> <p>The usefulness of the tidal flap valve at the outlet of the 600mm pipe under Maketu Rd should be investigated. The reason for the installation of the tidal flap valve at this location could be warranted but looks to be causing standing water upstream.</p> <p><b>Health Considerations:</b></p> <p>If the tidal flap valve is removed, potentially less water will build up against the wingwall adjacent to Maketu Rd.</p> <p><b>Aesthetic Considerations:</b></p> <p>Removal of vegetation in the middle of the drain would provide better storage of tide water and a more aesthetically pleasing waterway.</p>

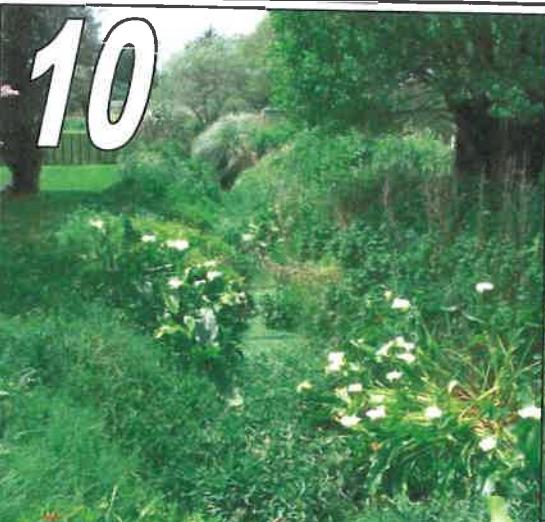
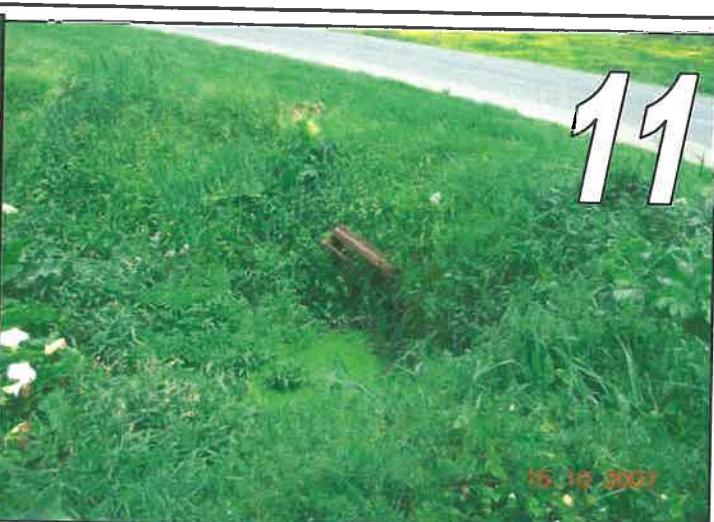
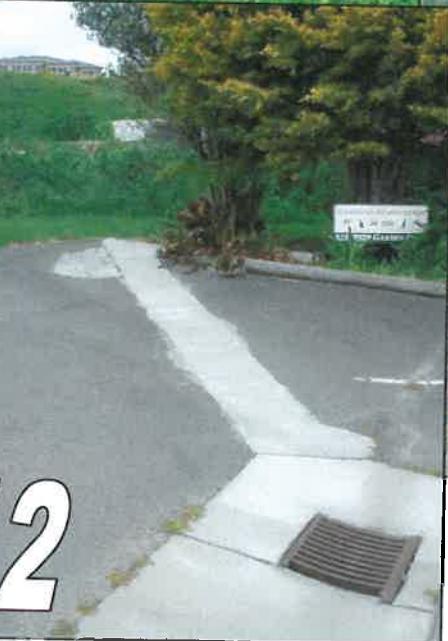
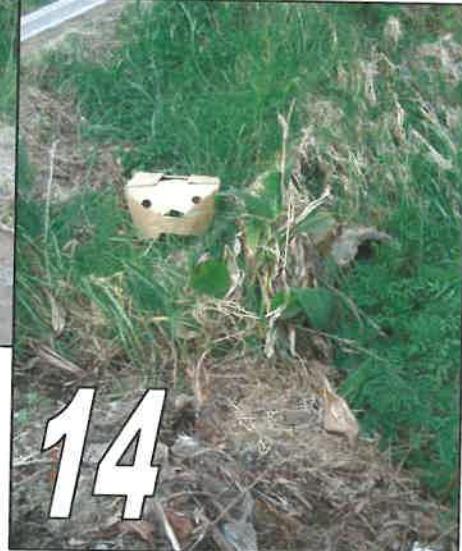
## Drain 1C - Between Wilson Rd Nth & Church Rd

PARAMETER	OBSERVATION	RATING
DEPTH	2-4 m	10
BATTER SLOPE	>1:1	10
DISTANCE ROAD SURFACE AND DRAIN	>4 m	0
INLET/OUTLET PROTECTION	No safety railing at Wilson Rd Nth & Church Rd	10
PROXIMITY TO SENSITIVE FACILITIES	Removed from sensitive facilities	0
AESTHETIC CONSIDERATIONS	Excessive growth	10
HEALTH CONSIDERATIONS	Standing water/Chance of water pollution	10
ENVIRONMENTAL CONSIDERATIONS	None	0
PROXIMITY TO DEVELOPMENT	Adjacent to houses and empty lots	10
<b>SAFETY INDEX</b>	A deep drain near several homes that is severely overgrown.	12.15
<b>DRAIN INDEX</b>		7.15

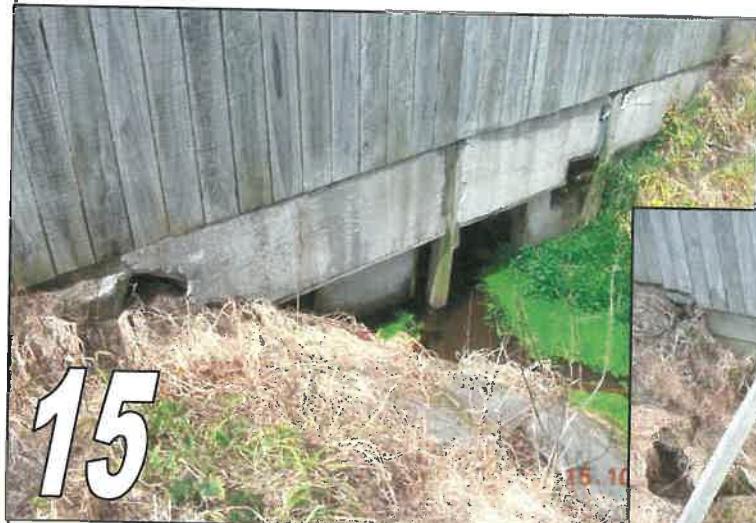
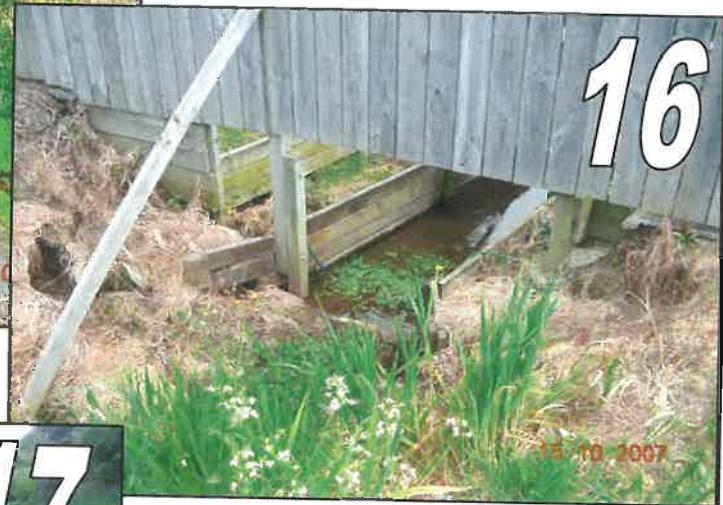
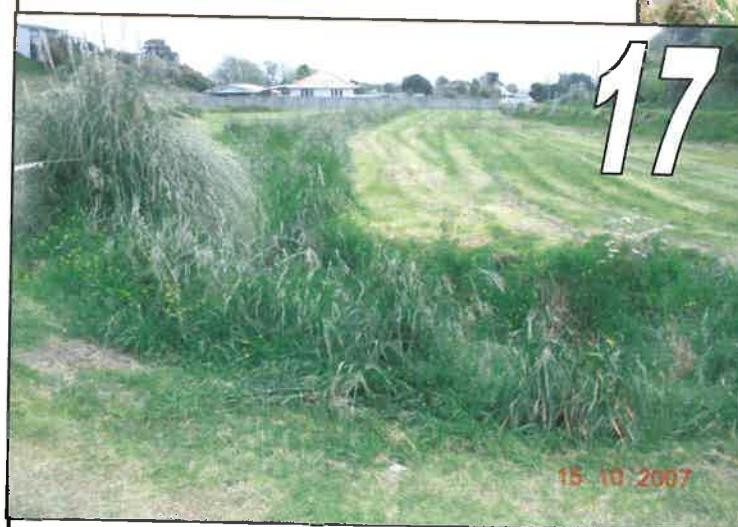
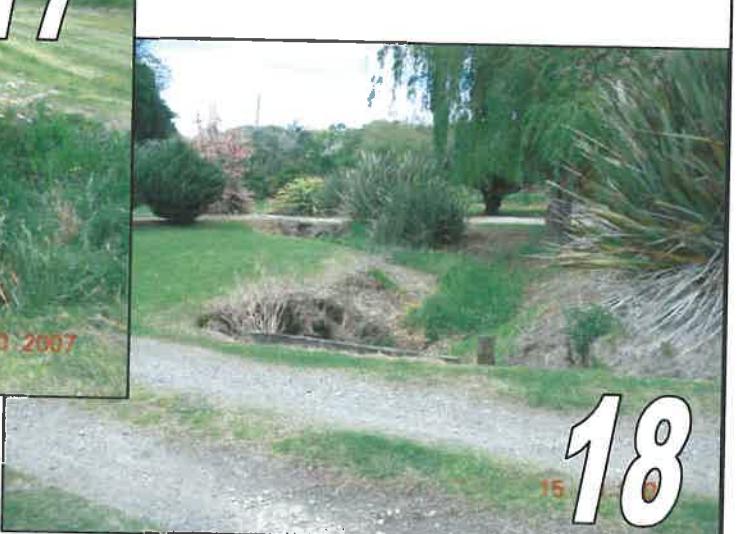
## Drain 1D - East of Church Rd

PARAMETER	OBSERVATION	RATING
DEPTH	2-4 m	10
BATTER SLOPE	>1:1	10
DISTANCE ROAD SURFACE AND DRAIN	>4 m	0
INLET/OUTLET PROTECTION	No safety railing at culvert inverts	10
PROXIMITY TO SENSITIVE FACILITIES	Removed from sensitive facilities	0
AESTHETIC CONSIDERATIONS	Excessive growth	5
HEALTH CONSIDERATIONS	Standing water/Chance of water pollution	10
ENVIRONMENTAL CONSIDERATIONS	None	0
PROXIMITY TO DEVELOPMENT	Adjacent to houses and empty lots	10
<b>SAFETY INDEX</b>	A deep drain near several homes that is severely overgrown.	7.15
<b>DRAIN INDEX</b>		6.40

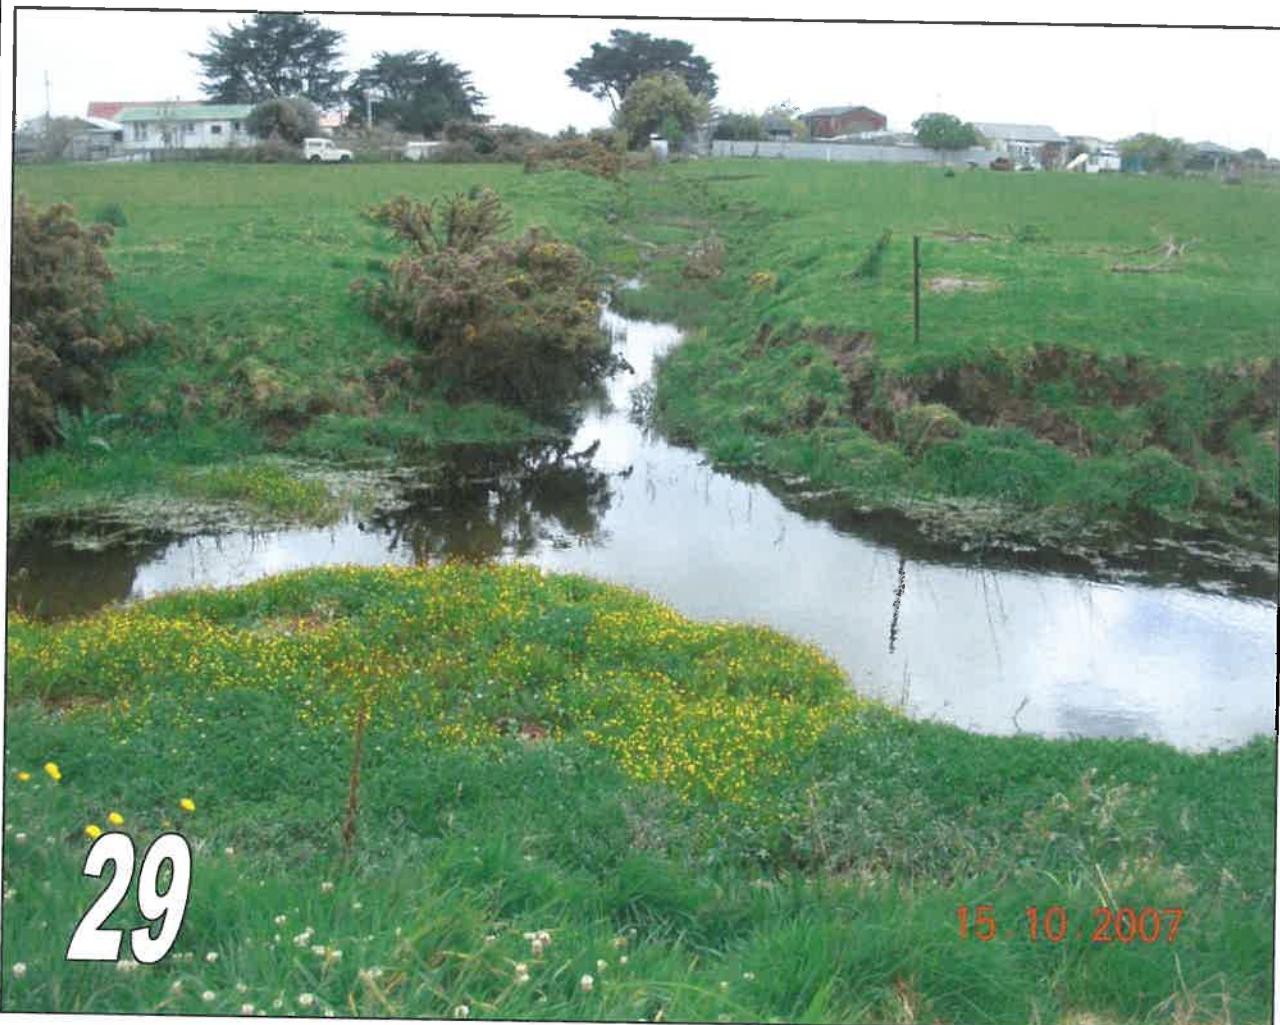
## Drain 4 - Between Drain 1b & Maketu Rd

PARAMETER	OBSERVATION	RATING
DEPTH	0 - 0.5m	0
BATTER SLOPE	< 2:1	0
DISTANCE ROAD SURFACE AND DRAIN	Not applicable	0
INLET/OUTLET PROTECTION	Not applicable	0
PROXIMITY TO SENSITIVE FACILITIES	Not applicable	0
AESTHETIC CONSIDERATIONS	Slight growth	5
HEALTH CONSIDERATIONS	Standing water/Chance of water pollution	10
ENVIRONMENTAL CONSIDERATIONS	Slight erosion	5
PROXIMITY TO DEVELOPMENT	Not easily accessible, mostly on private property	0
<b>SAFETY INDEX</b>	The drain is cut between two properties and connects to Drain 3 at Maketu Rd.	1.00
<b>DRAIN INDEX</b>		2.25
