# Categorisation of Open Stormwater Drains in Waihi Beach, Te Puke, and Maketu

Opus International Consultants Limited  
Tauranga Office  
405 Cameron Road  
PO Box 646  
Tauranga, New Zealand

Date: 8 February 2008  
Reference: g:\5\project\9z178.01\_drains\_phase\_2\final  
Status: FINAL  
document\main document.doc

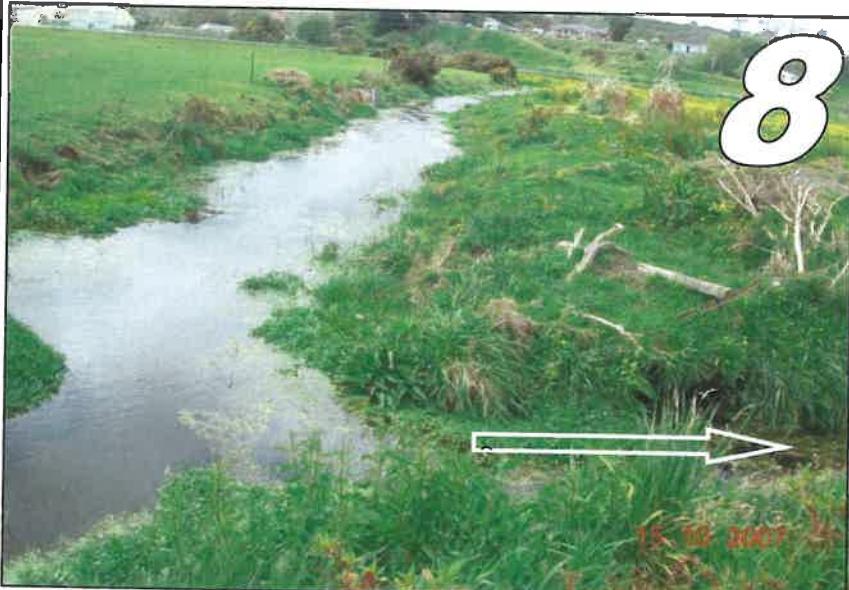
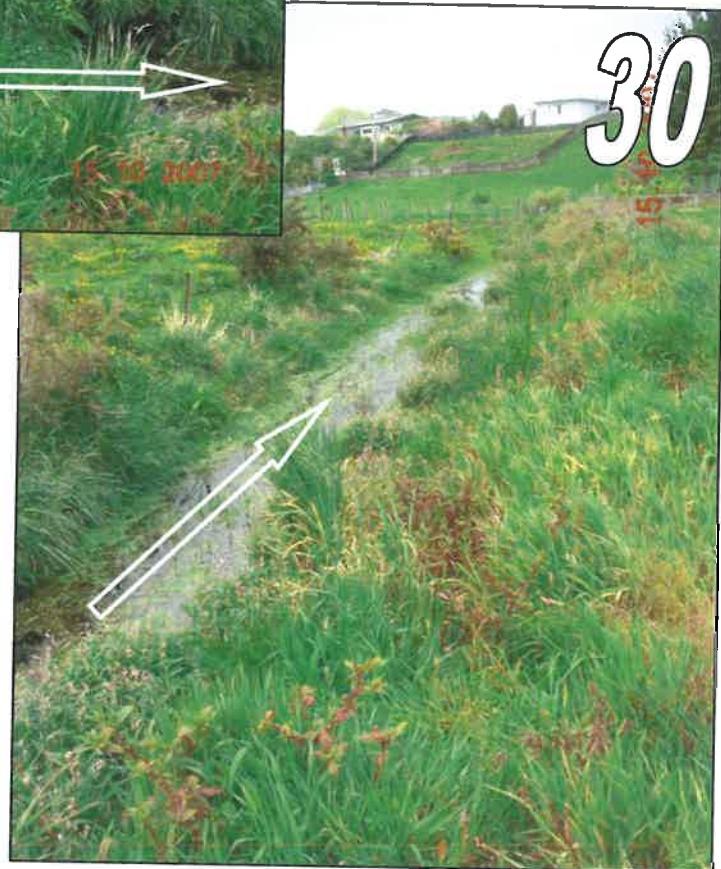
## Drain 5 - Off-shoot South of Drain 1b

PARAMETER	OBSERVATION	RATING
DEPTH	1-2 m	5
BATTER SLOPE	2:1 - 1:1	0
DISTANCE ROAD SURFACE AND DRAIN	Not applicable	0
INLET/OUTLET PROTECTION	Not applicable	0
PROXIMITY TO SENSITIVE FACILITIES	Not applicable	0
AESTHETIC CONSIDERATIONS	None	0
HEALTH CONSIDERATIONS	Standing water/Chance of water pollution	10
ENVIRONMENTAL CONSIDERATIONS	None	0
PROXIMITY TO DEVELOPMENT	Not easily accessible, mostly on private property	0
SAFETY INDEX	The drain is an off-shoot from Drain 1b.	1.79
DRAIN INDEX		1.79

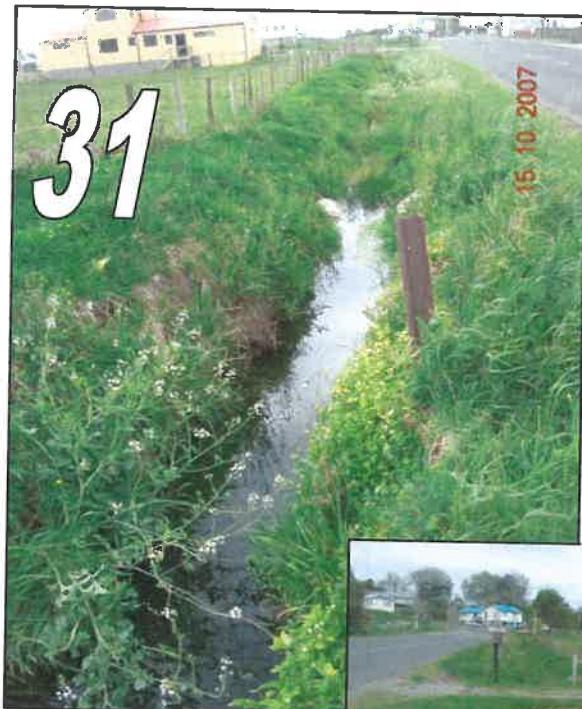
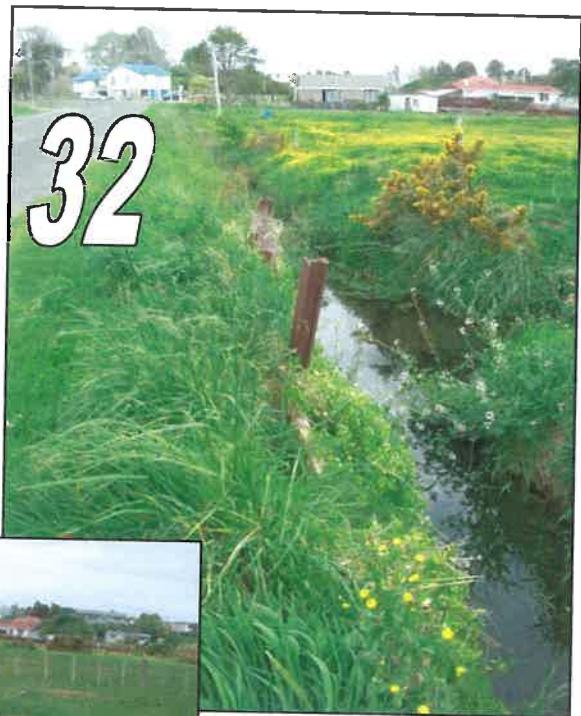
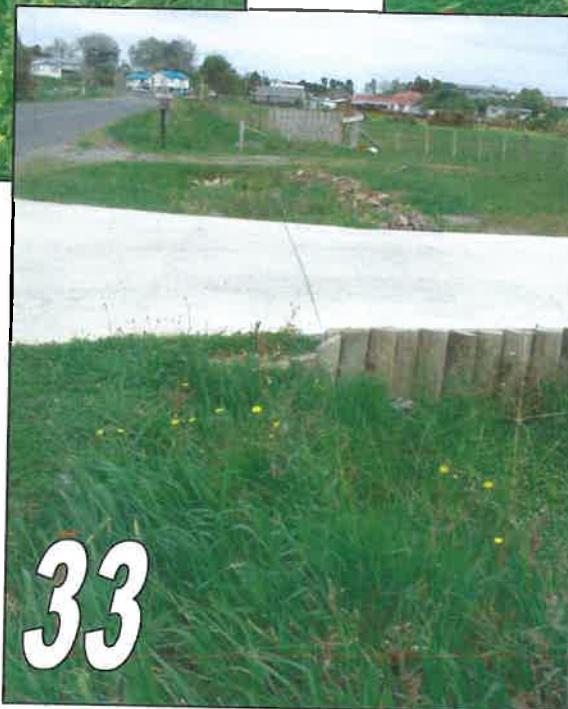
## Drain 6 - Parallel to West Side of Wilson Rd Nth

PARAMETER	OBSERVATION	RATING
DEPTH	0.5-2 m	9
BATTER SLOPE	> 1:1	10
DISTANCE ROAD SURFACE AND DRAIN	2-4 m	5
INLET/OUTLET PROTECTION	No safety rails	5
PROXIMITY TO SENSITIVE FACILITIES	Not applicable	0
AESTHETIC CONSIDERATIONS	Slight growth	5
HEALTH CONSIDERATIONS	Standing water	10
ENVIRONMENTAL CONSIDERATIONS	None	0
PROXIMITY TO DEVELOPMENT	Adjacent to a house at the shallow end of drain.	0
<b>SAFETY INDEX</b>	This drain is located along mostly paddock with one house in close proximity.	5.42
<b>DRAIN INDEX</b>		5.67

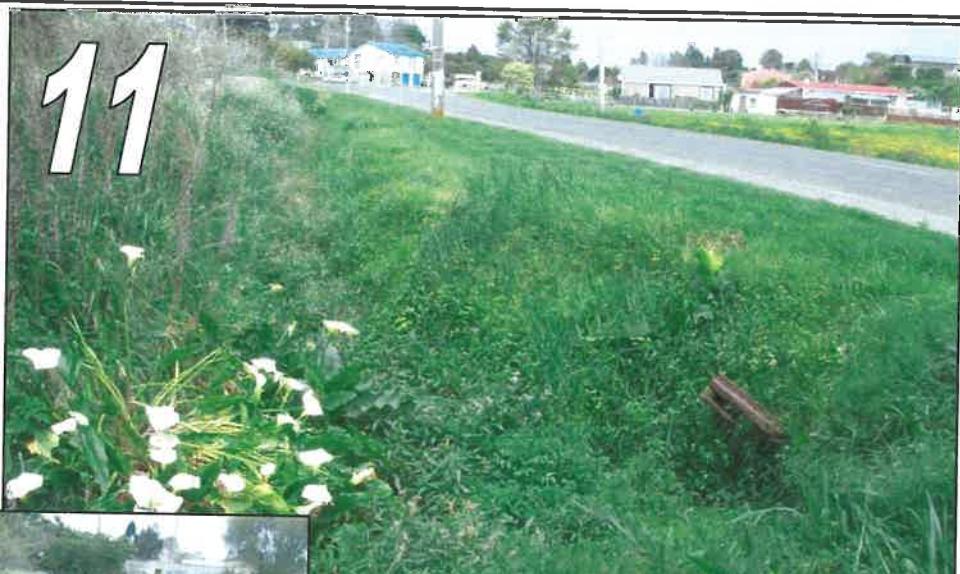
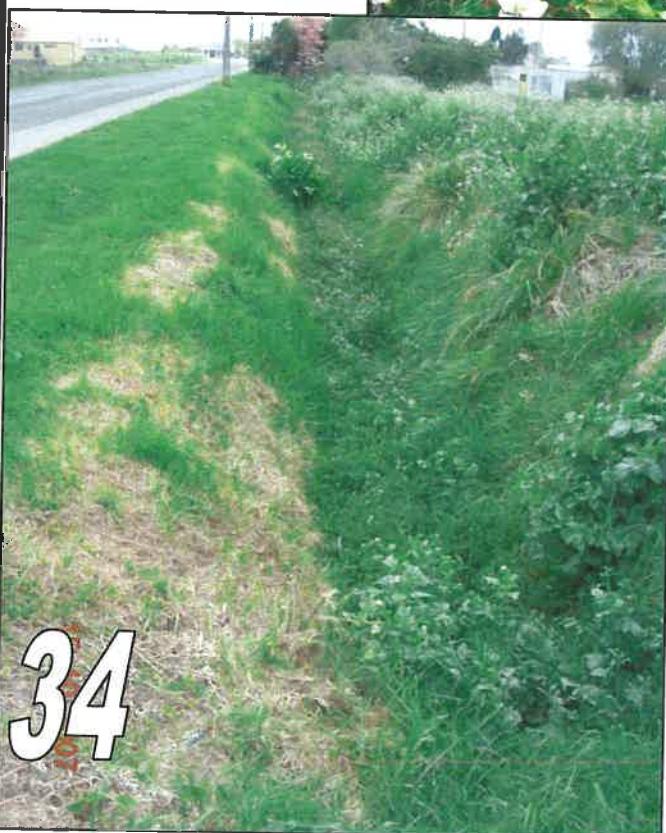
## Drain 7 - Parallel to East Side of Wilson Rd Nth

PARAMETER	OBSERVATION	RATING
DEPTH	>2 m	10
BATTER SLOPE	>1:1	10
DISTANCE ROAD SURFACE AND DRAIN	2-4 m	5
INLET/OUTLET PROTECTION	No safety rails	5
PROXIMITY TO SENSITIVE FACILITIES	Not applicable	0
AESTHETIC CONSIDERATIONS	Slight growth	5
HEALTH CONSIDERATIONS	Standing water	10
ENVIRONMENTAL CONSIDERATIONS	None	0
PROXIMITY TO DEVELOPMENT	Not applicable	0
<b>SAFETY INDEX</b>	This is a short drain opposite Drain 4a with very little water present.	5.08
<b>DRAIN INDEX</b>		5.83

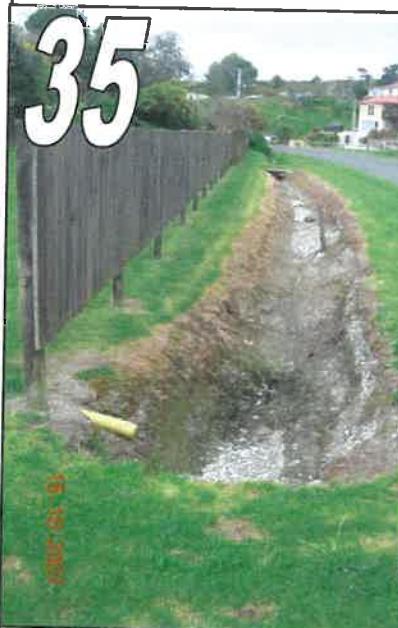
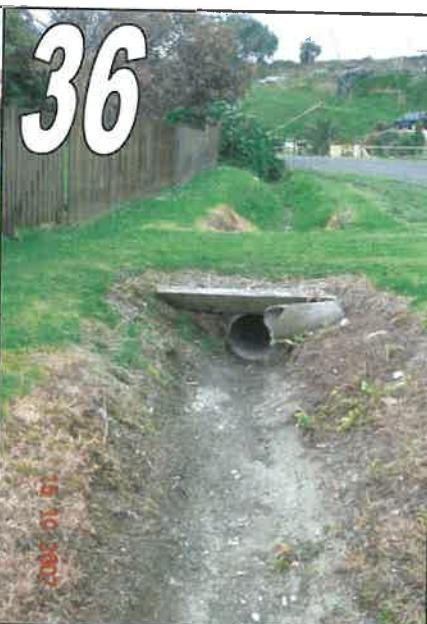
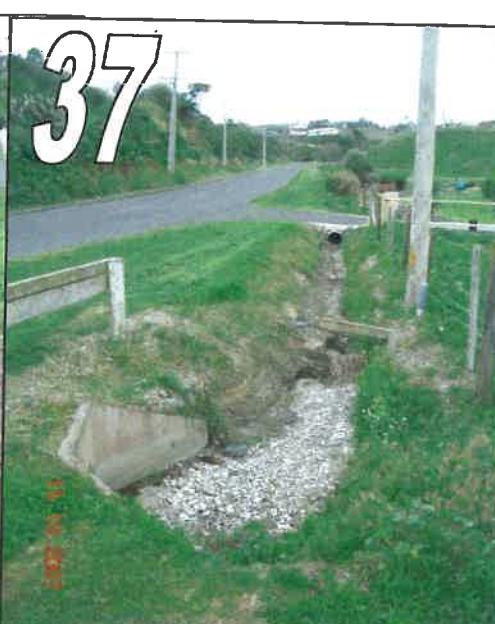
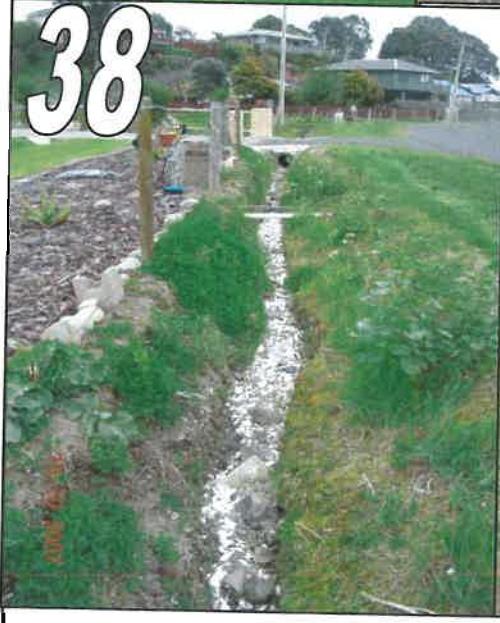
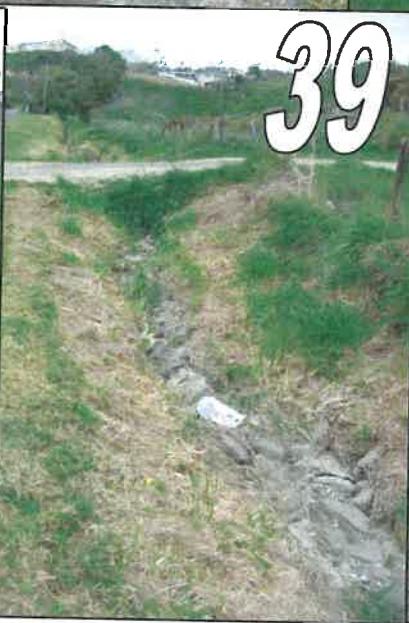
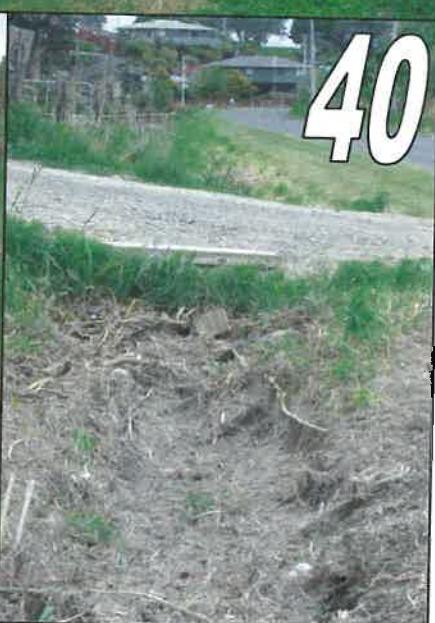
## Drain 8 - Adjacent to Town Point Road

PARAMETER	OBSERVATION	RATING
DEPTH	0.5-1 m	5
BATTER SLOPE	2:1 - 1:1	5
DISTANCE ROAD SURFACE AND DRAIN	2-4 m	5
INLET/OUTLET PROTECTION	Not applicable	0
PROXIMITY TO SENSITIVE FACILITIES	Not applicable	0
AESTHETIC CONSIDERATIONS	Excessive growth along top section	0
HEALTH CONSIDERATIONS	None	0
ENVIRONMENTAL CONSIDERATIONS	None	0
PROXIMITY TO DEVELOPMENT	Adjacent to houses on lower end.	10
SAFETY INDEX	The drain is pretty clean, inlet and outlet under gravel driveway at no. 13 needs to be cleared.	3.75
DRAIN INDEX		1.75
