BC90898 (Radio New Zealand House)

Site Specific Asbestos Management Plan

**155 The Terrace, Wellington Central,
Wellington 6011**

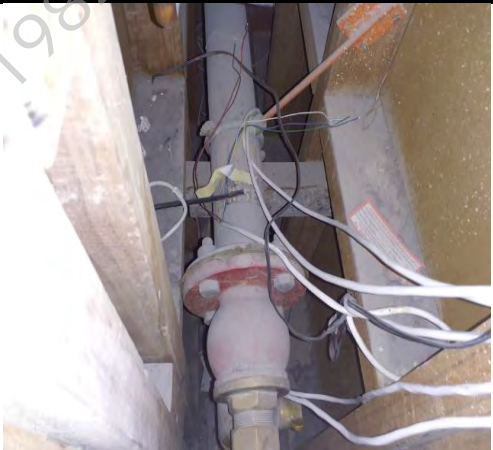
Item #	Level	Material Location	Material Description	Extent	Material Assessment					Accessibility	Labelling Status	Actual Photo
					Product	Extent of Damage	Surface Treatment	Score				
028	General items	Internal – Gaskets throughout site	Gaskets	Unquantifiable	2	1	1	4	M	Not possible to label

Control Measures		The condition of this material will be monitored – do not disturb										
Planned Removal / Remediation		To be tested or removed under appropriate control prior to any works that may cause disturbance.										
Reason for decision		Asbestos status unknown throughout most of the building. Increased risk of exposure during removal. Low risk of exposure when the gaskets are fully intact and inserted between mating surfaces which restricts access to workers.										
Date of Re-Assessment		July 2022	Remediation time scale			As required

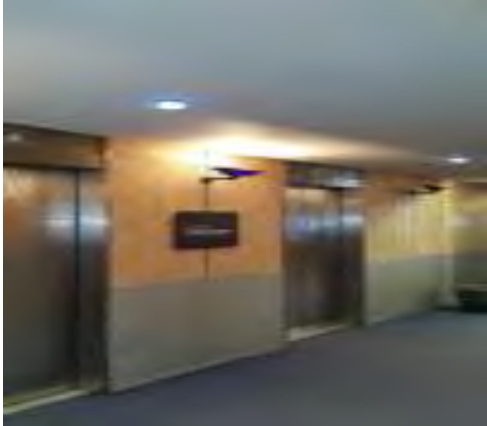
Item #	Level	Material Location	Material Description	Extent	Material Assessment					Accessibility	Labelling Status	Actual Photo
					Product	Extent of Damage	Surface Treatment	Score				
064	General items	Lifts – Access within lift shafts	Presumed: No Access Gained	Unquantifiable	3	3	3	9	D	Not possible to label

Control Measures		Presume Asbestos unless proven otherwise.										
Planned Removal / Remediation		Area to be inspected and assessed by a competent person prior to any works that may disturb the area										
Reason for decision		Asbestos status unknown										
Date of Re-Assessment		July 2022	Remediation time scale			As required

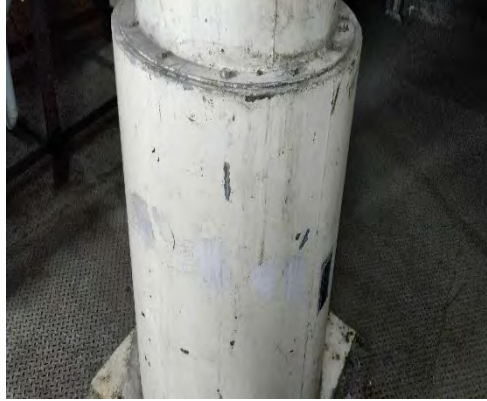
Item #	Level	Material Location	Material Description	Extent	Material Assessment				Accessibility	Labelling Status	Actual Photo
					Product	Extent of Damage	Surface Treatment	Score			
123	General items	Throughout building – Plant, Generators and Machinery	Presumed Asbestos Internally	Unquantifiable	2	0	1	3	D	Not possible to label

Control Measures		Presumed to contain asbestos unless proven otherwise - do not carry out any work that would cause disturbance to these materials without testing.									
Planned Removal / Remediation		To be inspected and/or tested prior to any works that may cause disturbance.									
Reason for decision		Asbestos status unknown.									
Date of Re-Assessment		July 2022	Remediation time scale		As required

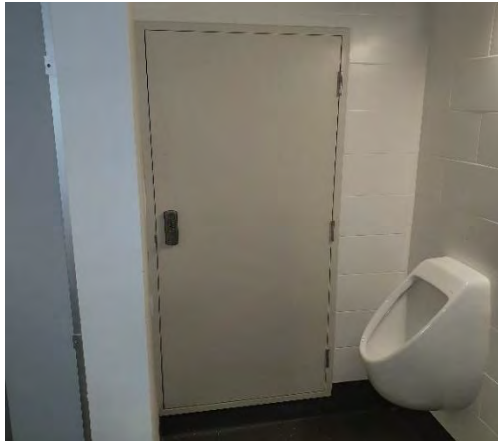
Item #	Level	Material Location	Material Description	Extent	Material Assessment				Accessibility	Labelling Status	Actual Photo
					Product	Extent of Damage	Surface Treatment	Score			
139	Multiple Floors	Internal – Access within plumbing riser to affected levels: basement, 1 st , 2 nd , 3 rd , 5 th , 6 th , 7 th , 8 th , 9 th , 10, 11 th , 12 th	No Access Gained	Unquantifiable	3	3	3	9	D	Not possible to label

Control Measures		Presume Asbestos unless proven otherwise. Presumed to be contaminated with AIB and Sprayed Insulation as per inspected levels.									
Planned Removal / Remediation		Area to be inspected and assessed by a competent person prior to any works that may disturb the area									
Reason for decision		Asbestos status unknown.									
Date of Re-Assessment		July 2022	Remediation time scale		As required

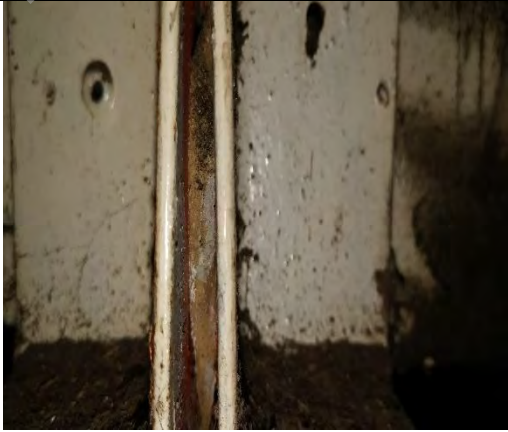
Item #	Level	Material Location	Material Description	Extent	Material Assessment				Accessibility	Labelling Status	Actual Photo
					Product	Extent of Damage	Treatment Surface	Score			
032	14 th Floor	HVAC machine room at top of plumbing riser – Seals to HVAC equipment throughout site	Mastics	Unquantifiable	1	0	0	1	M	Not possible to label

Control Measures		Do not disturb the material – condition to be monitored.									
Planned Removal / Remediation		Remove prior to any works that may cause a disturbance									
Reason for decision		Increased risk of exposure during removal. Low risk of exposure due to material type and in a reasonable condition.									
Date of Re-Assessment		July 2022	Remediation time scale		As required

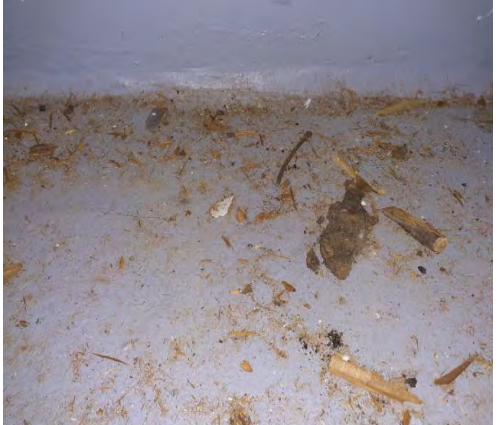
Item #	Level	Material Location	Material Description	Extent	Material Assessment				Accessibility	Labelling Status	Actual Photo
					Product	Extent of Damage	Surface Treatment	Score			
048	13 th Floor	Internal – Debris to rear of boiler room	Fibre cement	5m2	1	3	1	5	E	Not possible to label

Control Measures		Do not disturb the material – access should be restricted, and the product removed.									
Planned Removal / Remediation		Removal and environmental clean by minimal 'Class B' Licensed Asbestos Removal Contractor. Warning signage will be displayed.									
Reason for decision		Elevated risk of exposure due to damage of the material									
Date of Re-Assessment		July 2022	Remediation time scale			3 Months

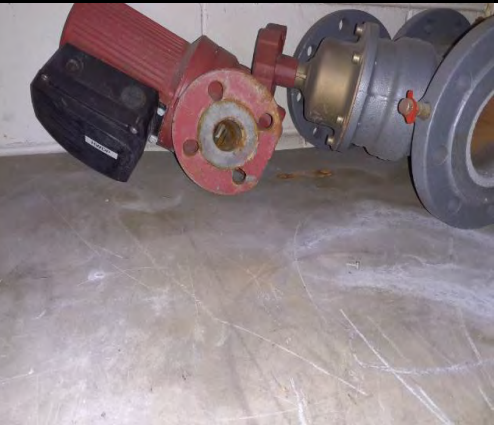
Item #	Level	Material Location	Material Description	Extent	Material Assessment				Accessibility	Labelling Status	Actual Photo
					Product	Extent of Damage	Surface Treatment	Score			
047	13 th Floor	Internal – Gasket residue to redundant flange in boiler room	Gaskets	Unquantifiable	2	3	2	7	E	Not possible to label

Control Measures		Do not disturb the material – material is in a poor condition; access should be restricted, and the product removed by a suitably licensed removal contractor.									
Planned Removal / Remediation		Removal and environmental clean by 'Class A' Licensed Asbestos Removal Contractor. Localized disturbances will be risk assessed by a competent person to identify the appropriate control measures.									
Reason for decision		High risk material type and elevated risk of exposure due to damage.									
Date of Re-Assessment		July 2022	Remediation time scale			3 Months

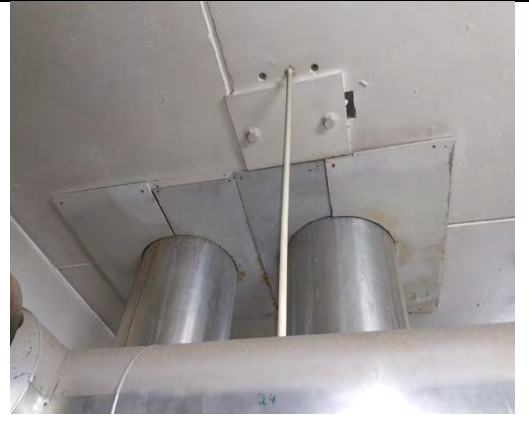
Item #	Level	Material Location	Material Description	Extent	Material Assessment				Accessibility	Labelling Status	Actual Photo
					Product	Extent of Damage	Treatment Surface	Score			
045	13 th Floor	Internal – Panels to centre of boiler room ceiling around flue penetrations	Fibre cement	1m2	1	1	1	3	D	Labelled

Control Measures		Label the material and avoid disturbance – condition to be monitored									
Planned Removal / Remediation		Panels to be encapsulated as a minimum by a 'Class B' licensed removal contractor. To be removed under appropriate control prior to any works that may cause disturbance. Labels applied in visible locations.									
Reason for decision		Elevated risk of exposure as the material is not sealed/encapsulated									
Date of Re-Assessment		July 2022	Remediation time scale			6 Months

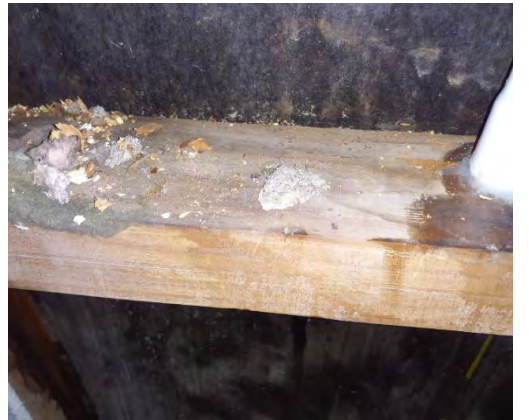
Item #	Level	Material Location	Material Description	Extent	Material Assessment				Accessibility	Labelling Status	Actual Photo
					Product	Extent of Damage	Treatment Surface	Score			
033	13 th Floor	Internal – AIB debris in corner of main HVAC	Insulating Board	1m2	2	3	2	7	E	Not possible to label

Control Measures		Do not disturb the material – material is in a poor condition; access should be restricted, and the product removed.									
Planned Removal / Remediation		Removal and environmental clean by 'Class A' Licensed Asbestos Removal Contractor. Localized disturbances will be risk assessed by a competent person to identify the appropriate control measures. Warning signage will be displayed.									
Reason for decision		High risk material type and elevated risk of exposure due to damage.									
Date of Re-Assessment		July 2022	Remediation time scale			6 Months

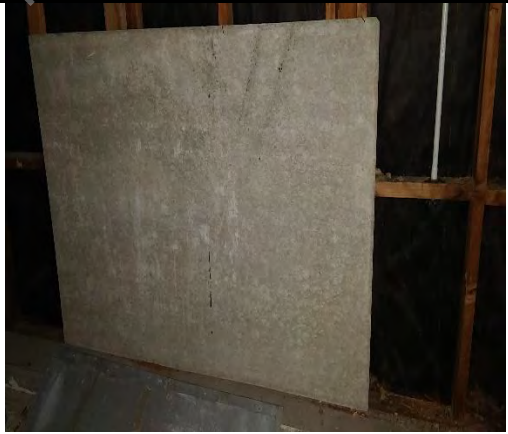
Item #	Level	Material Location	Material Description	Extent	Material Assessment				Accessibility	Labelling Status	Actual Photo
					Product	Extent of Damage	Surface Treatment	Score			
034	13 th Floor	Internal – Debris and redundant panel in corner of main HVAC room	Fibre cement	10m2	1	3	1	5	E	Not labelled

Control Measures		Do not disturb the material – access should be restricted, and the product removed.									
Planned Removal / Remediation		Removal of redundant panel and environmental clean during works for sprayed coating and AIB debris removal in same location.									
Reason for decision		Elevated risk of exposure due to damage of the material									
Date of Re-Assessment		July 2022	Remediation time scale		6 Months

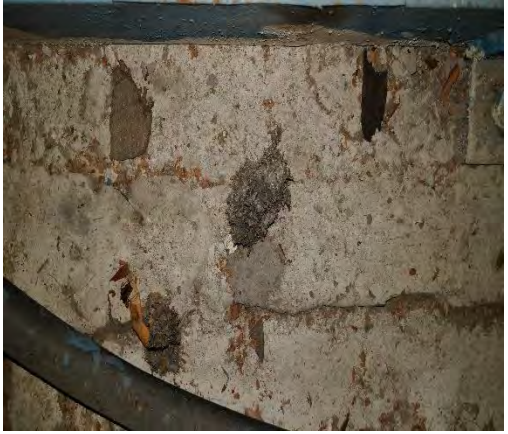
Item #	Level	Material Location	Material Description	Extent	Material Assessment				Accessibility	Labelling Status	Actual Photo
					Product	Extent of Damage	Surface Treatment	Score			
036	13 th Floor	Internal – Debris to corner of main HVAC room	Sprayed Coating	1m2	3	3	3	9	E	Not possible to label

Control Measures		Do not disturb the material – material is in a poor condition; access should be restricted, and the product removed.									
Planned Removal / Remediation		Removal and environmental clean by 'Class A' Licensed Asbestos Removal Contractor. Localized disturbances will be risk assessed by a competent person to identify the appropriate control measures. Warning signage will be displayed.									
Reason for decision		High risk material type and elevated risk of exposure due to damage.									
Date of Re-Assessment		July 2022	Remediation time scale		6 Months

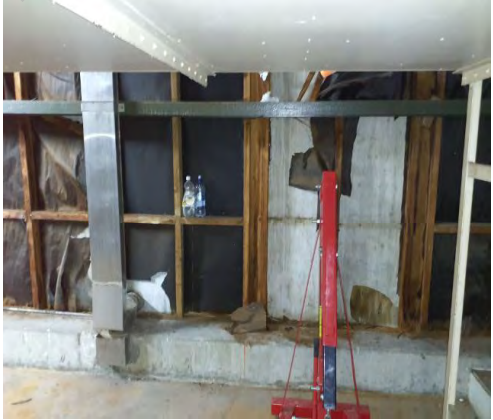
Item #	Level	Material Location	Material Description	Extent	Material Assessment				Accessibility	Labelling Status	Actual Photo
					Product	Extent of Damage	Surface Treatment	Score			
037	13 th Floor	Internal – Wall linings throughout where not replaced, see plan for exact locations	Fibre cement	200m2	1	3	1	5	E	Not labelled

Control Measures		Do not disturb the material – access should be restricted until material is repaired. Material should then be labelled and monitored.									
Planned Removal / Remediation		Repairs should be undertaken by minimum 'Class B' Licensed Asbestos Removal Contractor									
Reason for decision		Elevated risk of exposure due to damage of the material									
Date of Re-Assessment		July 2022	Remediation time scale			6 Months

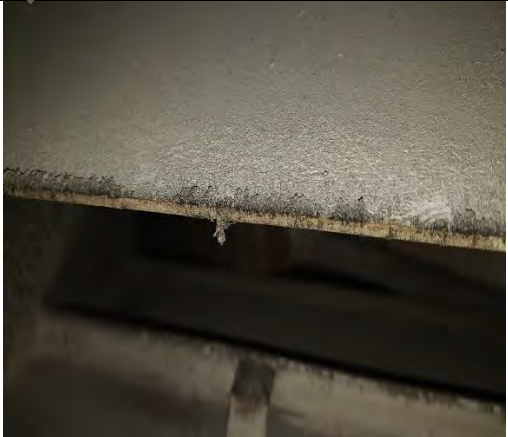
Item #	Level	Material Location	Material Description	Extent	Material Assessment					Accessibility	Labelling Status	Actual Photo
					Product	Extent of Damage	Surface Treatment	Score				
054	12 th Floor	Internal – Debris to vent in ceiling void	Insulating Board	Unquantifiable	2	3	2	7	D	Not possible to label

Control Measures		Do not disturb the material – material is in a poor condition; access should be restricted, and the product removed.										
Planned Removal / Remediation		Removal and environmental clean by 'Class A' Licensed Asbestos Removal Contractor. Localized disturbances will be risk assessed by a competent person to identify the appropriate control measures.										
Reason for decision		High risk material type and elevated risk of exposure due to damage.										
Date of Re-Assessment		July 2022	Remediation time scale		As required

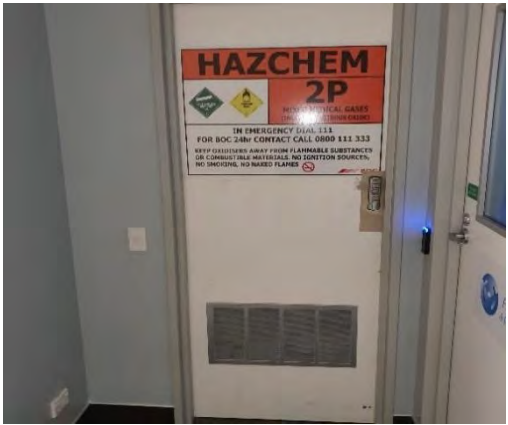
Item #	Level	Material Location	Material Description	Extent	Material Assessment				Accessibility	Labelling Status	Actual Photo
					Product	Extent of Damage	Treatment Surface	Score			
140	11 th Floor	Internal – Access within Hazchem cupboard	Presumed: No Access Gained	Unquantifiable	3	3	3	9	D	Not possible to label

Control Measures		Presume Asbestos unless proven otherwise.									
Planned Removal / Remediation		Area to be inspected and assessed by a competent person prior to any works that may disturb the area									
Reason for decision		Asbestos status unknown.									
Date of Re-Assessment		July 2022	Remediation time scale		As required

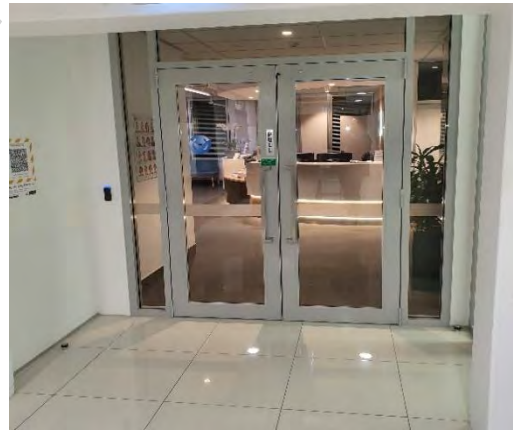
Item #	Level	Material Location	Material Description	Extent	Material Assessment					Accessibility	Labelling Status	Actual Photo
					Product	Extent of Damage	Treatment Surface	Score				
100	11 th Floor	Fertility tenancy – Access into tenancy	Presumed: No Access Gained	Unquantifiable	2	3	2	7	D	Not possible to label

Control Measures		Presume Asbestos unless proven otherwise.										
Planned Removal / Remediation		Area to be inspected and assessed by a competent person prior to any works that may disturb the area.										
Reason for decision		Asbestos status unknown.										
Date of Re-Assessment		July 2022	Remediation time scale			As required

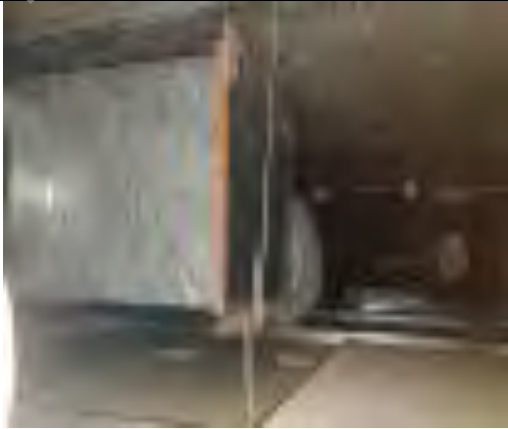
Item #	Level	Material Location	Material Description	Extent	Material Assessment					Accessibility	Labelling Status	Actual Photo
					Product	Extent of Damage	Treatment Surface	Score				
014	10 th Floor	Internal – Access into ceiling voids throughout floor	Presumed: Limited Access Gained	Unquantifiable	2	3	2	7	D	Not possible to label

Control Measures		Presume Asbestos unless proven otherwise.										
Planned Removal / Remediation		Area to be inspected and assessed by a competent person prior to any works that may disturb the area.										
Reason for decision		Asbestos status unknown.										
Date of Re-Assessment		July 2022	Remediation time scale		As required

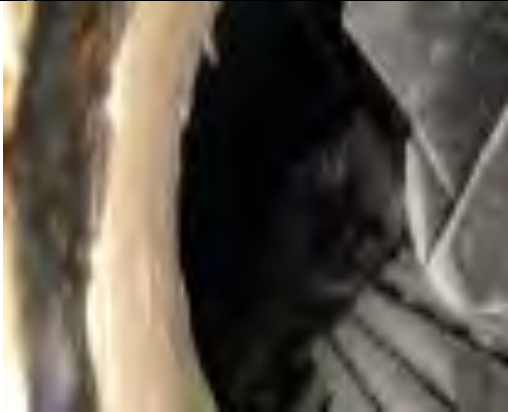
Item #	Level	Material Location	Material Description	Extent	Material Assessment					Accessibility	Labelling Status	Actual Photo
					Product	Extent of Damage	Surface Treatment	Score				
114	9 th Floor	Internal – Access into ceiling spaces throughout floor	Presumed: Limited Access Gained	Unquantifiable	2	3	2	7	D	Not possible to label

Control Measures		Presume Asbestos unless proven otherwise.										
Planned Removal / Remediation		Area to be inspected and assessed by a competent person prior to any works that may disturb the area.										
Reason for decision		Asbestos status unknown.										
Date of Re-Assessment		July 2022	Remediation time scale		As required

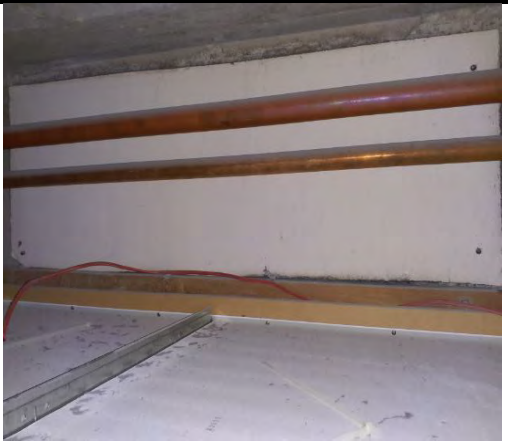
Item #	Level	Material Location	Material Description	Extent	Material Assessment					Accessibility	Labelling Status	Actual Photo
					Product	Extent of Damage	Surface Treatment	Score				
011	9 th Floor	Internal – Panel in ceiling void above defense cabinet	Insulating board	1m2	2	3	2	7	M	Labelled

Control Measures		Do not disturb the material – access should be restricted, and the debris removed, and the panel encapsulated.										
Planned Removal / Remediation		Encapsulation of the panel and removal of the debris by a “Class A” Licensed Asbestos Removal Contractor. Localized disturbances will be risk assessed by a competent person to identify the appropriate control measures.										
Reason for decision		High risk material type and elevated risk of exposure due to location of panel.										
Date of Re-Assessment		July 2022	Remediation time scale		6 Months

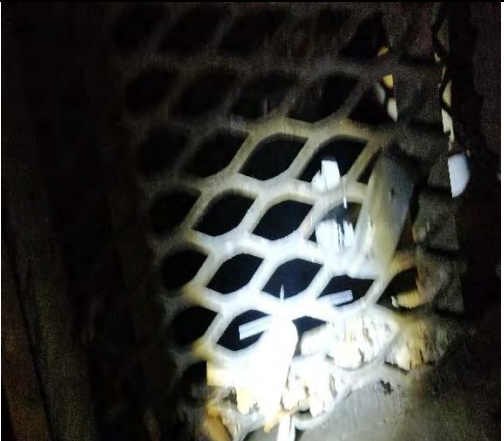
Item #	Level	Material Location	Material Description	Extent	Material Assessment				Accessibility	Labelling Status	Actual Photo
					Product	Extent of Damage	Surface Treatment	Score			
073	8 th Floor	Plumbing riser accessed via cleaner's cupboard – Debris to flat surfaces	Sprayed Coating Debris	Unquantifiable	3	3	3	9	E	Not possible to label

Control Measures		Do not disturb the material – material is in a poor condition; access should be restricted, and the product removed.									
Planned Removal / Remediation		Removal and environmental clean by "Class A" Licensed Asbestos Removal Contractor. Localized disturbances will be risk assessed by a competent person to identify the appropriate control measures. Warning signage will be displayed.									
Reason for decision		High risk material type and elevated risk of exposure due to damage.									
Date of Re-Assessment		July 2022	Remediation time scale			6 Months

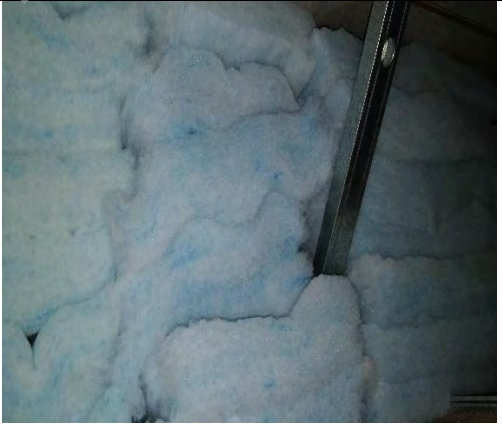
Item #	Level	Material Location	Material Description	Extent	Material Assessment					Accessibility	Labelling Status	Actual Photo
					Product	Extent of Damage	Surface Treatment	Score				
025	7 th Floor	Internal – Access into ceiling spaces throughout floor	Presumed: Limited Access Gained	Unquantifiable	2	3	2	7	D	Not possible to label

Control Measures		Presume Asbestos unless proven otherwise.										
Planned Removal / Remediation		Area to be inspected and assessed by a competent person prior to any works that may disturb the area.										
Reason for decision		Asbestos status unknown.										
Date of Re-Assessment		July 2022	Remediation time scale		As required

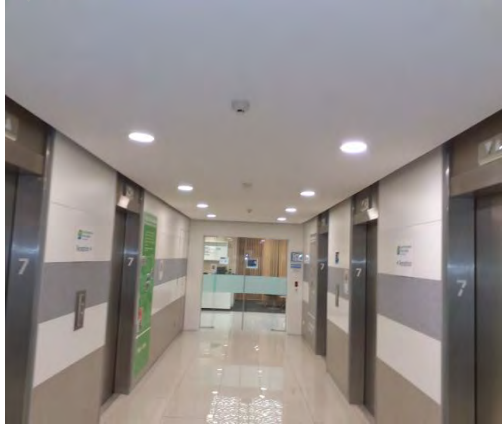
Item #	Level	Material Location	Material Description	Extent	Material Assessment				Accessibility	Labelling Status	Actual Photo
					Product	Extent of Damage	Treatment Surface	Score			
027	7 th Floor	Lift foyer – Secondary ceiling above plasterboard ceiling based on findings from other floors	Presumed: Fibre Cement	24m2	1	0	1	2	D	Not labelled

Control Measures		Presume Asbestos unless proven otherwise.									
Planned Removal / Remediation		Area to be inspected and assessed by a competent person prior to any works that may disturb the area.									
Reason for decision		Asbestos status unknown.									
Date of Re-Assessment		July 2022	Remediation time scale			As required

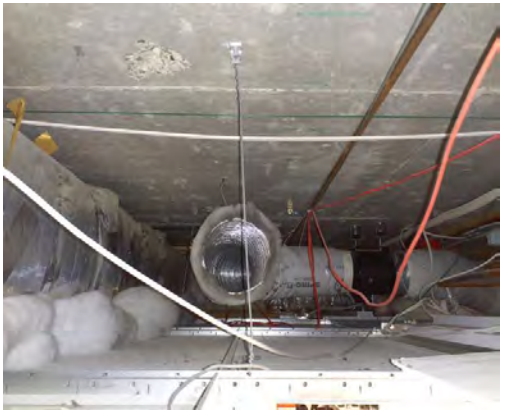
Item #	Level	Material Location	Material Description	Extent	Material Assessment					Accessibility	Labelling Status	Actual Photo
					Product	Extent of Damage	Treatment Surface	Score				
023	6 th Floor	Internal – Access within ceiling space	Presumed: Limited Access Gained	Unquantifiable	2	3	2	7	D	Not possible to label

Control Measures		Presume Asbestos unless proven otherwise.										
Planned Removal / Remediation		Area to be inspected and assessed by a competent person prior to any works that may disturb the area.										
Reason for decision		Asbestos status unknown.										
Date of Re-Assessment		July 2022	Remediation time scale			As required

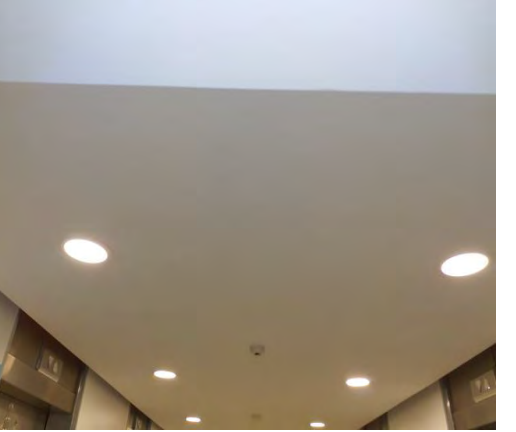
Item #	Level	Material Location	Material Description	Extent	Material Assessment					Accessibility	Labelling Status	Actual Photo
					Product	Extent of Damage	Treatment Surface	Score				
026	6 th Floor	Lift Foyer – Secondary ceiling above plasterboard ceiling based on findings from other floors	Presumed: Fibre cement	24m2	2	3	2	7	D	Not possible to label

Control Measures		Presume Asbestos unless proven otherwise.										
Planned Removal / Remediation		Area to be inspected and assessed by a competent person prior to any works that may disturb the area.										
Reason for decision		Asbestos status unknown.										
Date of Re-Assessment		July 2022	Remediation time scale			As required

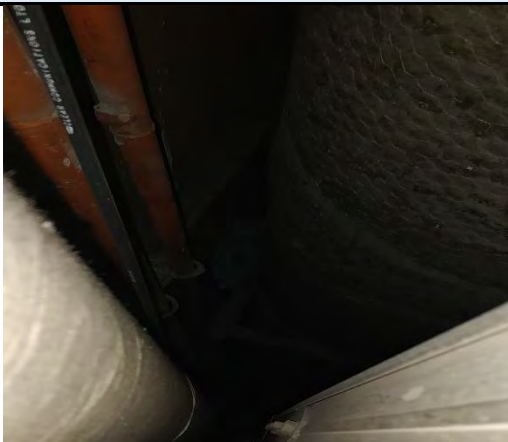
Item #	Level	Material Location	Material Description	Extent	Material Assessment				Accessibility	Labelling Status	Actual Photo
					Product	Extent of Damage	Surface Treatment	Score			
078	6 th Floor	Plumbing riser accessed via cleaner's cupboard – Debris to flat surface	Sprayed Coating Debris	Unquantifiable	3	3	3	9	E	Not possible to label

Control Measures		Do not disturb the material – material is in a poor condition; access should be restricted, and the product removed.									
Planned Removal / Remediation		Removal and environmental clean by “Class A” Licensed Asbestos Removal Contractor. Localized disturbances will be risk assessed by a competent person to identify the appropriate control measures. Warning signage will be displayed.									
Reason for decision		High risk material type and elevated risk of exposure due to damage.									
Date of Re-Assessment		July 2022	Remediation time scale			6 Months

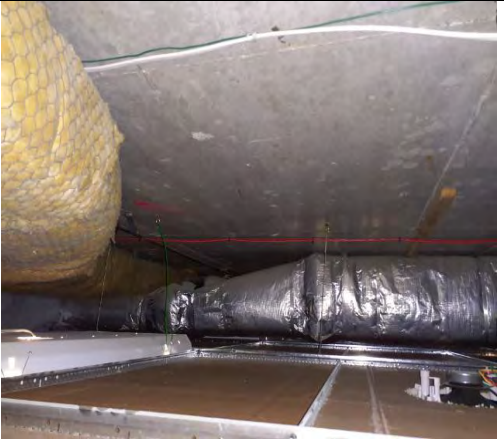
Item #	Level	Material Location	Material Description	Extent	Material Assessment				Accessibility	Labelling Status	Actual Photo
					Product	Extent of Damage	Treatment Surface	Score			
016	5 th Floor	Internal – Access into ceiling spaces throughout floor	Presume: Limited Access Gained	Unquantifiable	2	3	2	7	D	Not possible to label

Control Measures		Presume Asbestos unless proven otherwise.									
Planned Removal / Remediation		Area to be inspected and assessed by a competent person prior to any works that may disturb the area.									
Reason for decision		Asbestos status unknown.									
Date of Re-Assessment		July 2022	Remediation time scale		As required

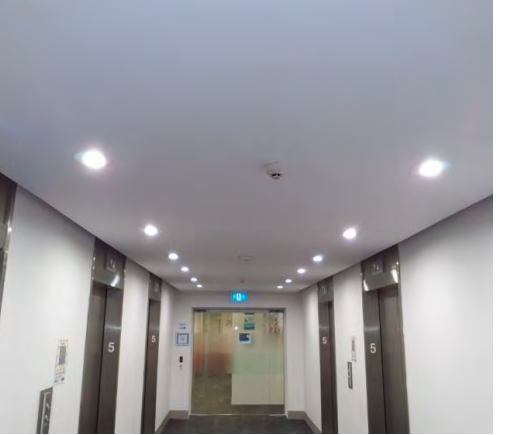
Item #	Level	Material Location	Material Description	Extent	Material Assessment					Accessibility	Labelling Status	Actual Photo
					Product	Extent of Damage	Treatment Surface	Score				
021	5 th Floor	Lift Foyer – Secondary ceiling above plasterboard ceiling based on findings from other floors	Presumed: Fibre cement	24m2	1	0	1	2	D	Not possible to label

Control Measures		Presume Asbestos unless proven otherwise.										
Planned Removal / Remediation		Area to be inspected and assessed by a competent person prior to any works that may disturb the area.										
Reason for decision		Asbestos status unknown.										
Date of Re-Assessment		July 2022	Remediation time scale			As required

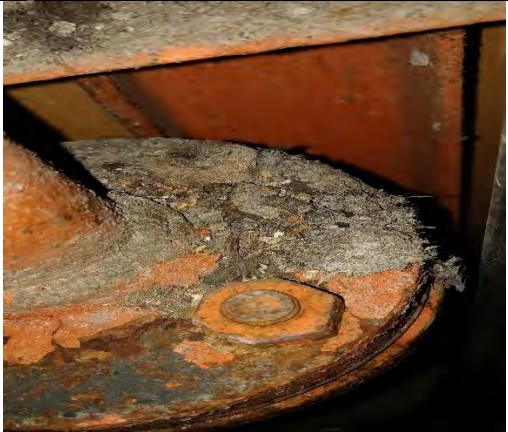
Item #	Level	Material Location	Material Description	Extent	Material Assessment				Accessibility	Labelling Status	Actual Photo
					Product	Extent of Damage	Surface Treatment	Score			
079	5 th Floor	Plumbing riser accessed via cleaner's cupboard – Debris to flat surfaces	Sprayed Coating Debris	Unquantifiable	3	3	3	9	E	Not possible to label

Control Measures		Do not disturb the material – material is in a poor condition; access should be restricted, and the product removed.									
Planned Removal / Remediation		Removal and environmental clean by "Class A" Licensed Asbestos Removal Contractor. Localized disturbances will be risk assessed by a competent person to identify the appropriate control measures. Warning signage will be displayed.									
Reason for decision		High risk material type and elevated risk of exposure due to damage.									
Date of Re-Assessment		July 2022	Remediation time scale			6 Months

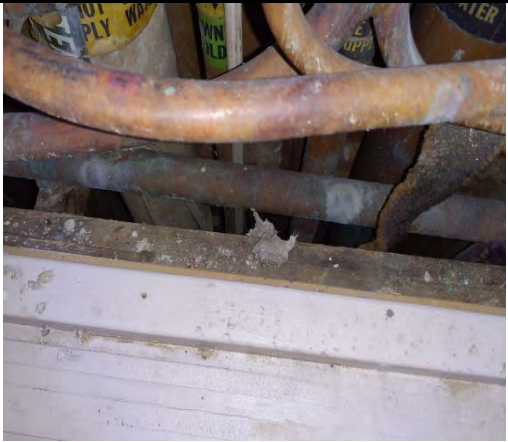
Item #	Level	Material Location	Material Description	Extent	Material Assessment				Accessibility	Labelling Status	Actual Photo
					Product	Extent of Damage	Surface Treatment	Score			
093	5 th Floor	Riser accessed in stairwell B – Insulation debris	Sprayed Coating	Unquantifiable	3	3	3	9	E	Not possible to label

Control Measures		Do not disturb the material – material is in a poor condition; access should be restricted, and the product removed.									
Planned Removal / Remediation		Removal and environmental clean by "Class A" Licensed Asbestos Removal Contractor. Localized disturbances will be risk assessed by a competent person to identify the appropriate control measures. Warning signage will be displayed.									
Reason for decision		High risk material type and elevated risk of exposure due to damage.									
Date of Re-Assessment		July 2022	Remediation time scale			6 Months

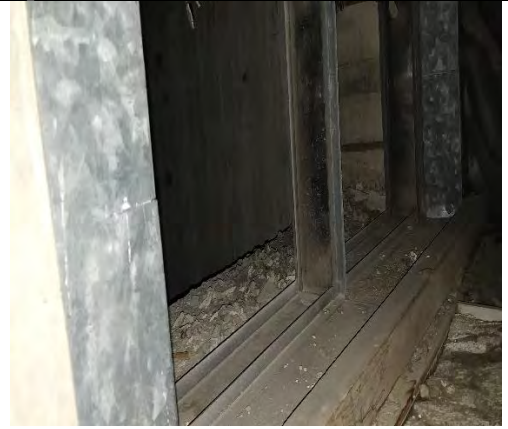
Item #	Level	Material Location	Material Description	Extent	Material Assessment				Accessibility	Labelling Status	Actual Photo
					Product	Extent of Damage	Surface Treatment	Score			
102	4 th Floor	Internal – AIB debris in ceiling void	Insulating Board	Unquantifiable	2	3	2	7	M	Not possible to label

Control Measures		Do not disturb the material – material is in a poor condition; access should be restricted, and the product removed.									
Planned Removal / Remediation		Removal and environmental clean by “Class A” Licensed Asbestos Removal Contractor. Localized disturbances will be risk assessed by a competent person to identify the appropriate control measures. Warning signage will be displayed.									
Reason for decision		High risk material type and elevated risk of exposure due to damage.									
Date of Re-Assessment		July 2022	Remediation time scale			6 Months

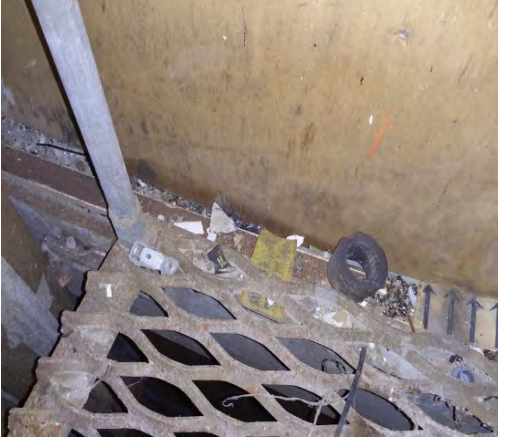
Item #	Level	Material Location	Material Description	Extent	Material Assessment				Accessibility	Labelling Status	Actual Photo
					Product	Extent of Damage	Surface Treatment	Score			
087	4 th Floor	Plumbing riser accessed via male toilets – Debris to flat surfaces	Insulating Board	Unquantifiable	2	3	2	2	D	Not possible to label

Control Measures		Do not disturb the material – material is in a poor condition; access should be restricted, and the product removed.									
Planned Removal / Remediation		Removal and environmental clean by “Class A” Licensed Asbestos Removal Contractor. Localized disturbances will be risk assessed by a competent person to identify the appropriate control measures. Warning signage will be displayed.									
Reason for decision		High risk material type and elevated risk of exposure due to damage.									
Date of Re-Assessment		July 2022	Remediation time scale		6 Months

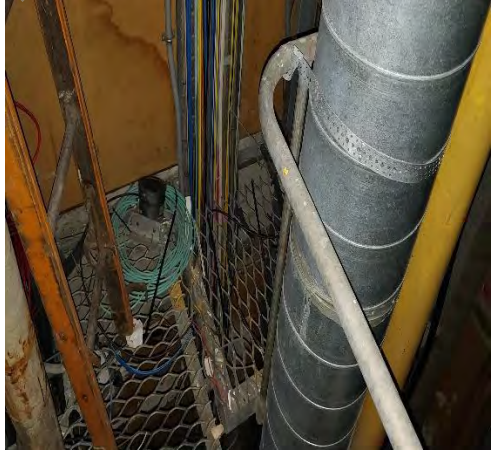
Item #	Level	Material Location	Material Description	Extent	Material Assessment				Accessibility	Labelling Status	Actual Photo
					Product	Extent of Damage	Surface Treatment	Score			
081	3 rd Floor	Plumbing riser accessed via cleaner's cupboard – Debris to flat surfaces	Sprayed Coating Debris	Unquantifiable	3	3	3	9	E	Not possible to label

Control Measures		Do not disturb the material – material is in a poor condition; access should be restricted, and the product removed.									
Planned Removal / Remediation		Removal and environmental clean by “Class A” Licensed Asbestos Removal Contractor. Localized disturbances will be risk assessed by a competent person to identify the appropriate control measures. Warning signage will be displayed.									
Reason for decision		High risk material type and elevated risk of exposure due to damage.									
Date of Re-Assessment		July 2022	Remediation time scale			6 Months

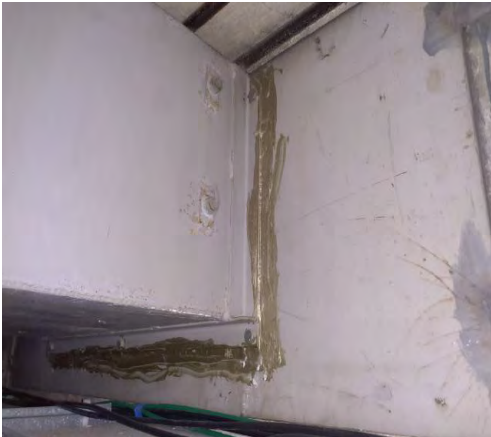
Item #	Level	Material Location	Material Description	Extent	Material Assessment				Accessibility	Labelling Status	Actual Photo
					Product	Extent of Damage	Treatment Surface	Score			
015	2 nd Floor	Internal – Mastic around old ducting	Mastics	Unquantifiable	1	0	0	1	D	Not possible to label

Control Measures		Label the material and avoid disturbance – condition to be monitored.									
Planned Removal / Remediation		Any future works that involves disturbance to these areas will need to be fully risk assessed for asbestos risk and appropriate controls will need to be implemented, as necessary.									
Reason for decision		Low risk of exposure to workers and occupants due to being inaccessible under normal circumstances.									
Date of Re-Assessment		July 2022	Remediation time scale		As required

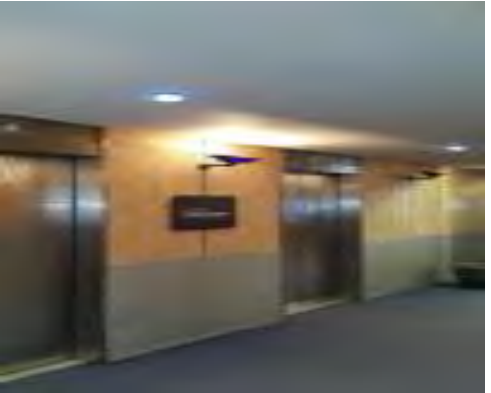
Item #	Level	Material Location	Material Description	Extent	Material Assessment				Accessibility	Labelling Status	Actual Photo
					Product	Extent of Damage	Treatment Surface	Score			
041	2 nd Floor	Lift foyer – Secondary ceiling above plasterboard ceiling based on findings from other floors	Presumed: Fibre Cement	24m2	1	0	1	2	D	Not possible to label

Control Measures		Presume Asbestos unless proven otherwise.									
Planned Removal / Remediation		Area to be inspected and assessed by a competent person prior to any works that may disturb the area.									
Reason for decision		Asbestos status unknown.									
Date of Re-Assessment		July 2022	Remediation time scale		As required

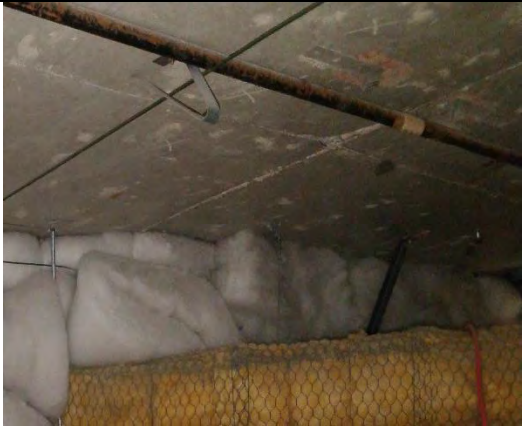
Item #	Level	Material Location	Material Description	Extent	Material Assessment					Accessibility	Labelling Status	Actual Photo
					Product	Extent of Damage	Surface Treatment	Score				
125	2 nd Floor	Internal – Access within ceiling space	Presumed: Limited Access gained	Unquantifiable	2	3	2	7	D	Not possible to label

Control Measures		Presume Asbestos unless proven otherwise.										
Planned Removal / Remediation		Area to be inspected and assessed by a competent person prior to any works that may disturb the area										
Reason for decision		Asbestos status unknown										
Date of Re-Assessment		July 2022	Remediation time scale			As required

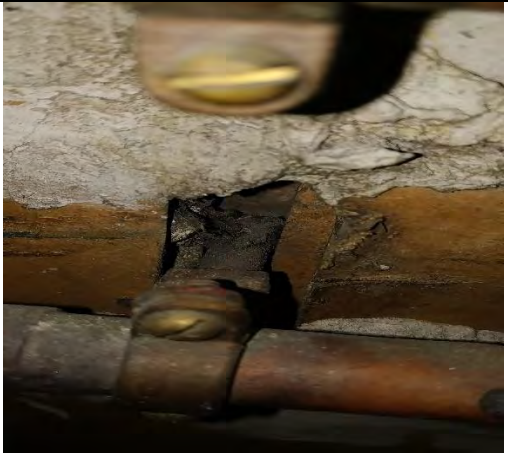
Item #	Level	Material Location	Material Description	Extent	Material Assessment					Accessibility	Labelling Status	Actual Photo
					Product	Extent of Damage	Treatment Surface	Score				
082	1 st Floor	Plumbing riser accessed via cleaner's cupboard – Debris to flat surfaces	Sprayed Coating Debris	Unquantifiable	3	3	3	9	E	Not possible to label

Control Measures		Do not disturb the material – material is in a poor condition; access should be restricted, and the product removed.										
Planned Removal / Remediation		Removal and environmental clean by “Class A” Licensed Asbestos Removal Contractor. Localized disturbances will be risk assessed by a competent person to identify the appropriate control measures. Warning signage will be displayed.										
Reason for decision		High risk material type and elevated risk of exposure due to damage.										
Date of Re-Assessment		July 2022	Remediation time scale		6 Months

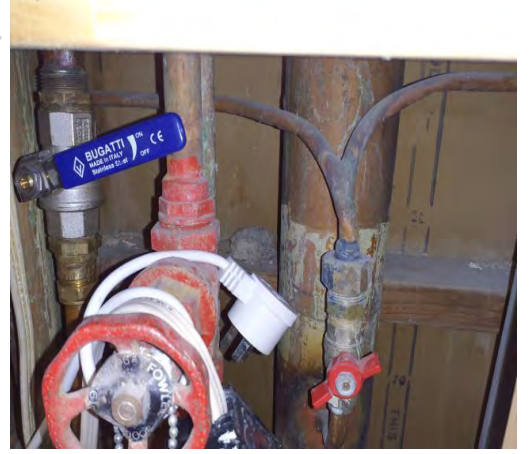
Item #	Level	Material Location	Material Description	Extent	Material Assessment				Accessibility	Labelling Status	Actual Photo
					Product	Extent of Damage	Surface Treatment	Score			
095	1 st Floor	Riser accessed in stairwell B – Insulation debris	Sprayed Coating	Unquantifiable	3	3	3	9	E	Not possible to label

Control Measures		Do not disturb the material – material is in a poor condition; access should be restricted, and the product removed.									
Planned Removal / Remediation		Removal and environmental clean by “Class A” Licensed Asbestos Removal Contractor. Localized disturbances will be risk assessed by a competent person to identify the appropriate control measures. Warning signage will be displayed.									
Reason for decision		High risk material type and elevated risk of exposure due to damage.									
Date of Re-Assessment		July 2022	Remediation time scale			6 Months

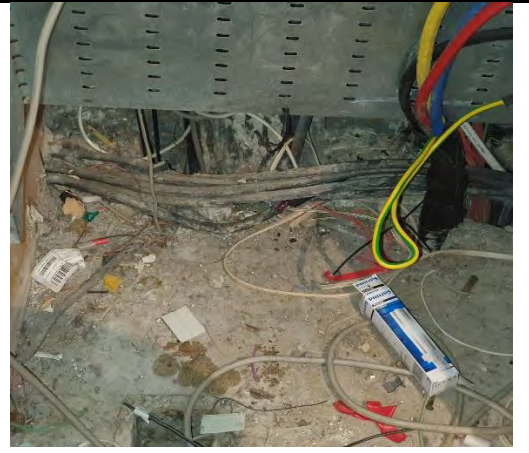
Item #	Level	Material Location	Material Description	Extent	Material Assessment				Accessibility	Labelling Status	Actual Photo
					Product	Extent of Damage	Surface Treatment	Score			
068	Ground Floor	Electrical riser – Debris to flat surfaces	Sprayed Coating Debris	Unquantifiable	3	3	3	9	E	Not possible to label

Control Measures		Do not disturb the material – material is in a poor condition; access should be restricted, and the product removed.									
Planned Removal / Remediation		Removal and environmental clean by “Class A” Licensed Asbestos Removal Contractor. Localized disturbances will be risk assessed by a competent person to identify the appropriate control measures. Warning signage will be displayed.									
Reason for decision		High risk material type and elevated risk of exposure due to damage.									
Date of Re-Assessment		July 2022	Remediation time scale			3 Months

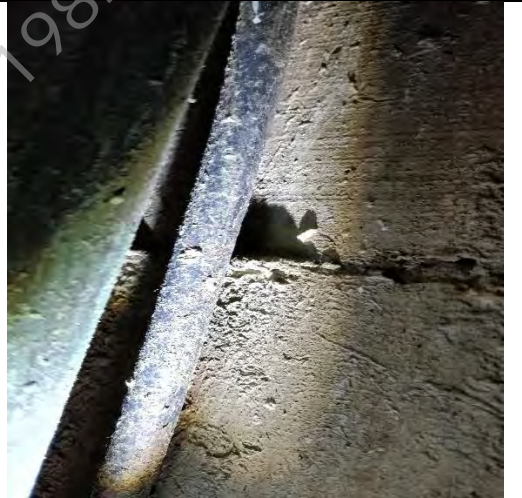
Item #	Level	Material Location	Material Description	Extent	Material Assessment					Accessibility	Labelling Status	Actual Photo
					Product	Extent of Damage	Surface Treatment	Score				
143	Ground Floor	Internal – Debris within plumbing riser accessed via male toilets	Sprayed Coating	Unquantifiable	3	3	3	9	E	Not possible to label

Control Measures		Do not disturb the material – material is in a poor condition; access should be restricted, and the product removed.										
Planned Removal / Remediation		Removal and environmental clean by “Class A” Licensed Asbestos Removal Contractor. Localized disturbances will be risk assessed by a competent person to identify the appropriate control measures. Warning signage will be displayed.										
Reason for decision		High risk material type and elevated risk of exposure due to damage.										
Date of Re-Assessment		July 2022	Remediation time scale			6 Months

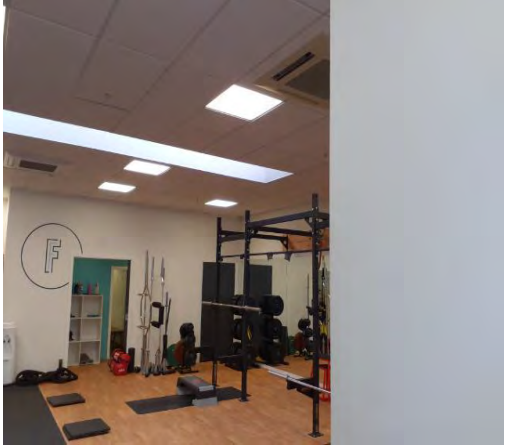
Item #	Level	Material Location	Material Description	Extent	Material Assessment					Accessibility	Labelling Status	Actual Photo
					Product	Extent of Damage	Surface Treatment	Score				
089	Ground Floor	Foundation’s gym internal – Access to ceilings throughout	Presumed: No Access Gained	Unquantifiable	1	0	1	2	D	Not possible to label

Control Measures		Presume Asbestos unless proven otherwise.										
Planned Removal / Remediation		Area to be inspected and assessed by a competent person prior to any works that may disturb the area										
Reason for decision		Asbestos status unknown										
Date of Re-Assessment		July 2022	Remediation time scale			As required

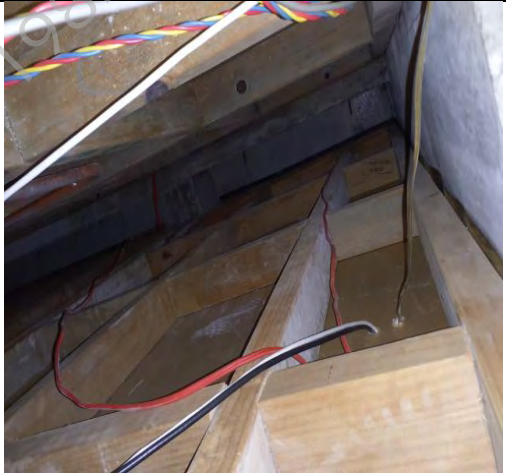
Item #	Level	Material Location	Material Description	Extent	Material Assessment					Accessibility	Labelling Status	Actual Photo
					Product	Extent of Damage	Surface Treatment	Score				
007	Ground Floor	Foyer dry riser – Packing to timber stud framework	Presumed: Bituminous Product	Unquantifiable	1	0	0	1	D	Not possible to label

Control Measures		Presume Asbestos unless proven otherwise.										
Planned Removal / Remediation		To be tested or removed under appropriate control prior to any works that may cause disturbance.										
Reason for decision		Low risk of exposure to workers and occupants due to being inaccessible under normal occupancy.										
Date of Re-Assessment		July 2022	Remediation time scale			As required

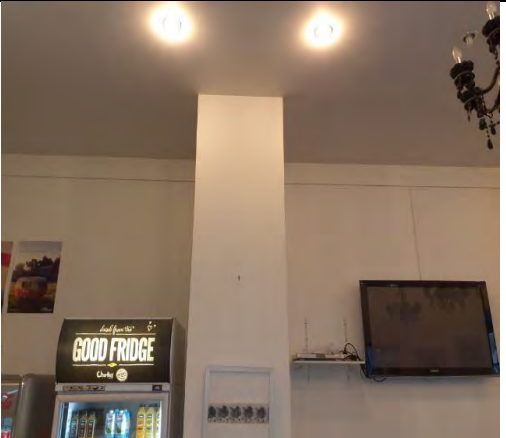
Item #	Level	Material Location	Material Description	Extent	Material Assessment					Accessibility	Labelling Status	Actual Photo
					Product	Extent of Damage	Surface Treatment	Score				
002	Ground Floor	Internal – Access to ceilings throughout floor	Presumed: No Access Gained	Unquantifiable	3	3	3	9	D	Not possible to label

Control Measures		Presume Asbestos unless proven otherwise.										
Planned Removal / Remediation		Area to be inspected and assessed by a competent person prior to any works that may disturb the area										
Reason for decision		Asbestos status unknown										
Date of Re-Assessment		July 2022	Remediation time scale			As required

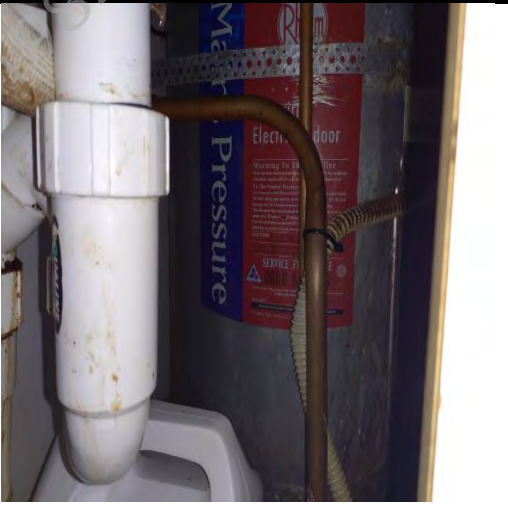
Item #	Level	Material Location	Material Description	Extent	Material Assessment					Accessibility	Labelling Status	Actual Photo
					Product	Extent of Damage	Surface Treatment	Score				
004	Ground Floor	Internal – Hot water cylinder below sink in cafe	Presumed Asbestos Internally	Unquantifiable	2	0	1	3	D	Not labelled

Control Measures		Presume as asbestos containing unless proven otherwise and do not disturb.										
Planned Removal / Remediation		To be tested or removed under appropriate control prior to any works that may cause disturbance.										
Reason for decision		Asbestos status unknown but disturbance is very unlikely under normal occupancy, therefore only a risk if planned works affect water cylinder.										
Date of Re-Assessment		July 2022	Remediation time scale			As required

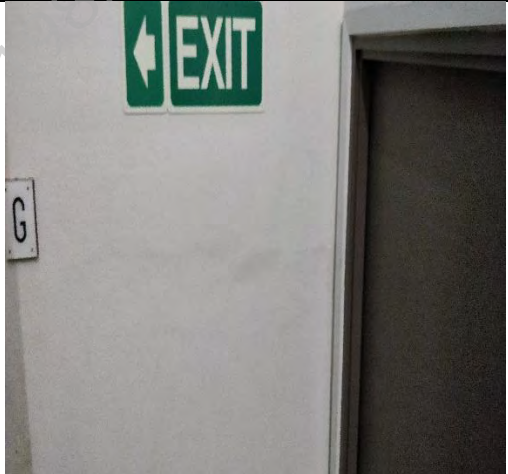
Item #	Level	Material Location	Material Description	Extent	Material Assessment					Accessibility	Labelling Status	Actual Photo
					Product	Extent of Damage	Surface Treatment	Score				
083	Ground Floor	Plumbing riser accessed via cleaner's cupboard – Access within plumbing riser via cleaner's cupboard	Presumed: No Access Gained	Unquantifiable	3	3	3	9	E	Not possible to label

Control Measures		Presume Asbestos unless proven otherwise.										
Planned Removal / Remediation		Area to be inspected and assessed by a competent person prior to any works that may disturb the area										
Reason for decision		Asbestos status unknown										
Date of Re-Assessment		July 2022	Remediation time scale			As required

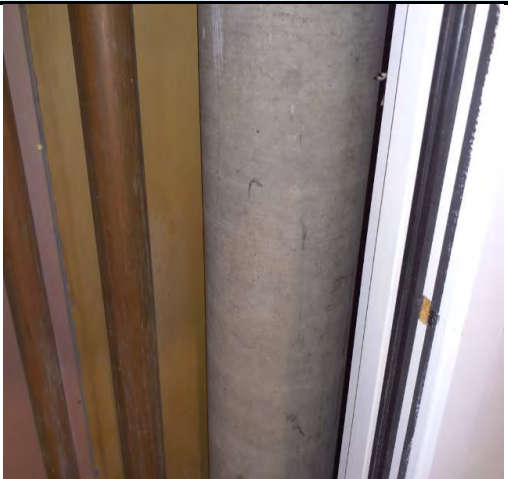
Item #	Level	Material Location	Material Description	Extent	Material Assessment					Accessibility	Labelling Status	Actual Photo
					Product	Extent of Damage	Surface Treatment	Score				
098	Ground Floor	Riser accessed in foyer of men's toilets - Downpipe	Fibre cement	Unquantifiable	1	1	1	3	E	Not labelled

Control Measures		Label the material and avoid disturbance – condition to be monitored										
Planned Removal / Remediation		To be encapsulated and labelled by a minimum 'Class B' licensed removal contractor. To be removed under appropriate control prior to any works that may cause disturbance.										
Reason for decision		Elevated risk of exposure as the material is not sealed/encapsulated										
Date of Re-Assessment		July 2022	Remediation time scale			12 Months

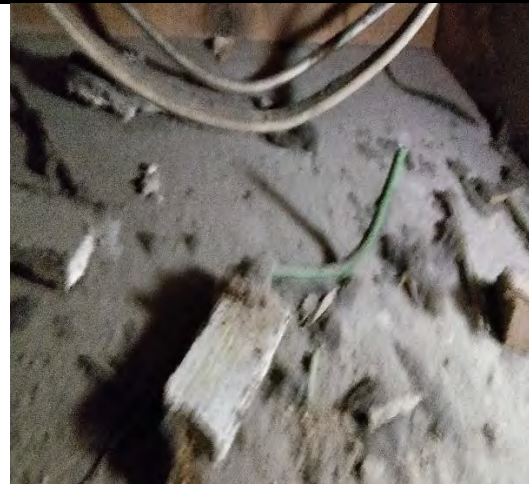
Item #	Level	Material Location	Material Description	Extent	Material Assessment					Accessibility	Labelling Status	Actual Photo
					Product	Extent of Damage	Surface Treatment	Score				
124	Ground Floor	Lift Foyer – Ceiling above textured ceiling	Fibre cement	24m2	1	3	1	5	D	Not possible to label

Control Measures		Do not disturb the material – access should be restricted, and the product removed.										
Planned Removal / Remediation		Removal by a minimum 'Class B' licensed removal contractor prior to any works that may cause disturbance. Warning signage will be displayed, and labels applied in visible locations.										
Reason for decision		Elevated risk of exposure due to damage of the material										
Date of Re-Assessment		July 2022	Remediation time scale			As required

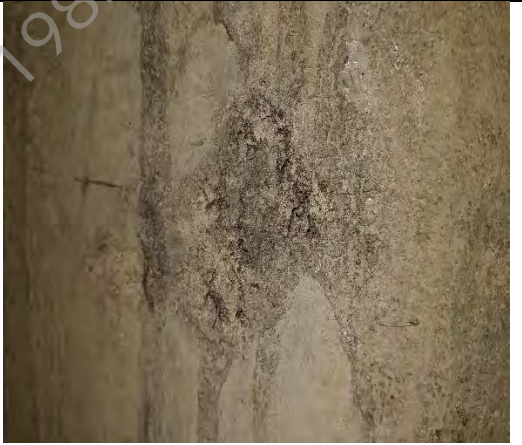
Item #	Level	Material Location	Material Description	Extent	Material Assessment				Accessibility	Labelling Status	Actual Photo
					Product	Extent of Damage	Surface Treatment	Score			
050	Basement	Internal – Debris and residue to surfaces throughout air supply chamber	Sprayed Coating	Unquantifiable	3	3	3	9	E	Not possible to label

Control Measures		Do not disturb the material – material is in a poor condition; access should be restricted, and the product removed.									
Planned Removal / Remediation		Removal and environmental clean by “Class A” Licensed Asbestos Removal Contractor. Localized disturbances will be risk assessed by a competent person to identify the appropriate control measures. Warning signage will be displayed.									
Reason for decision		High risk material type and elevated risk of exposure due to damage.									
Date of Re-Assessment		July 2022	Remediation time scale			6 Months

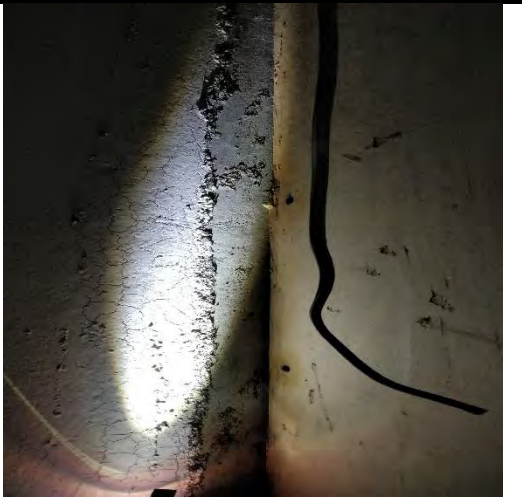
Item #	Level	Material Location	Material Description	Extent	Material Assessment				Accessibility	Labelling Status	Actual Photo
					Product	Extent of Damage	Surface Treatment	Score			
051	Basement	Internal – Debris and residue to surfaces throughout foyer adjacent air chambers	Sprayed Coating	Unquantifiable	3	3	3	9	E	Not possible to label

Control Measures		Do not disturb the material – material is in a poor condition; access should be restricted, and the product removed.									
Planned Removal / Remediation		Removal and environmental clean by “Class A” Licensed Asbestos Removal Contractor. Localized disturbances will be risk assessed by a competent person to identify the appropriate control measures. Warning signage will be displayed.									
Reason for decision		High risk material type and elevated risk of exposure due to damage.									
Date of Re-Assessment		July 2022	Remediation time scale			6 Months

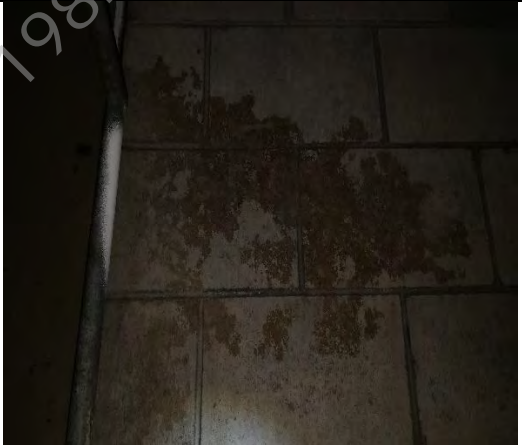
Item #	Level	Material Location	Material Description	Extent	Material Assessment					Accessibility	Labelling Status	Actual Photo
					Product	Extent of Damage	Surface Treatment	Score				
049	Basement	Internal – Debris and residue to surfaces throughout return air chamber	Sprayed Coating	Unquantifiable	3	3	3	9	E	Not possible to label

Control Measures		Do not disturb the material – material is in a poor condition; access should be restricted, and the product removed.										
Planned Removal / Remediation		Removal and environmental clean by “Class A” Licensed Asbestos Removal Contractor. Localized disturbances will be risk assessed by a competent person to identify the appropriate control measures. Warning signage will be displayed.										
Reason for decision		High risk material type and elevated risk of exposure due to damage.										
Date of Re-Assessment		July 2022	Remediation time scale			As required

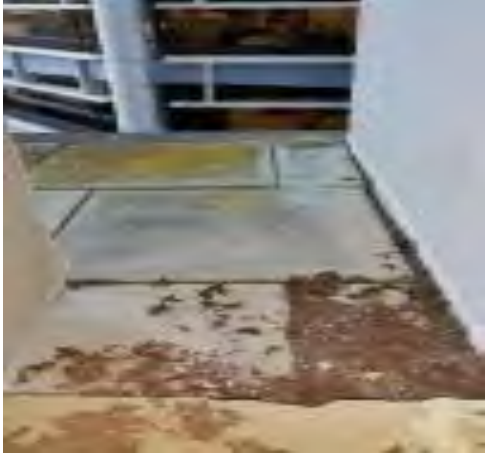
Item #	Level	Material Location	Material Description	Extent	Material Assessment					Accessibility	Labelling Status	Actual Photo
					Product	Extent of Damage	Surface Treatment	Score				
118	Basement	External -Tiles outside of metal louver window	Presumed: Fibre Cement	Unquantifiable	1	0	1	2	D	Not possible to label

Control Measures		Presume as asbestos containing unless proven otherwise and do not disturb.										
Planned Removal / Remediation		To be tested or removed under appropriate control prior to any works that may cause disturbance.										
Reason for decision		Asbestos status unknown.										
Date of Re-Assessment		July 2022	Remediation time scale			As required
