BC90898 (Radio New Zealand House)

Site Specific Asbestos Management Plan

**155 The Terrace, Wellington Central,
Wellington 6011**

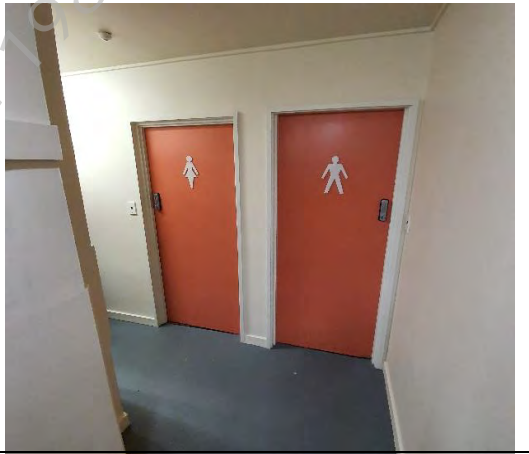
Item #	Level	Material Location	Material Description	Extent	Material Assessment					Accessibility	Labelling Status	Actual Photo
					Product	Extent of Damage	Surface Treatment	Score				
128	Basement	Internal – Access into male toilets below stairwell	Presumed: No Access Gained	Unquantifiable	3	3	3	9	D	Not possible to label

Control Measures		Presume Asbestos unless proven otherwise.										
Planned Removal / Remediation		Area to be inspected and assessed by a competent person prior to any works that may disturb the area										
Reason for decision		Asbestos status unknown										
Date of Re-Assessment		July 2022	Remediation time scale		As required

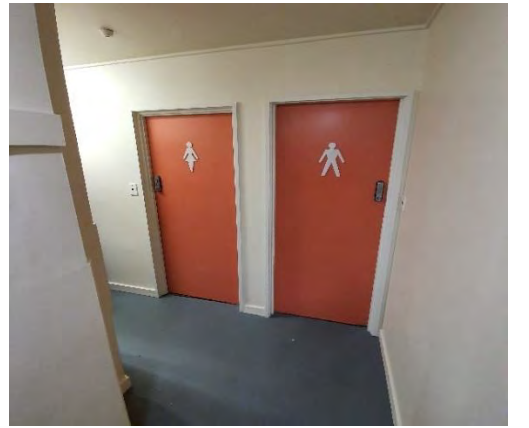
Item #	Level	Material Location	Material Description	Extent	Material Assessment					Accessibility	Labelling Status	Actual Photo
					Product	Extent of Damage	Surface Treatment	Score				
129	Basement	Internal – Access into female toilets below stair well	Presumed: No Access Gained	Unquantifiable	3	3	3	9	D	Not possible to label

Control Measures		Presume Asbestos unless proven otherwise.										
Planned Removal / Remediation		Area to be inspected and assessed by a competent person prior to any works that may disturb the area										
Reason for decision		Asbestos status unknown										
Date of Re-Assessment		July 2022	Remediation time scale		As required

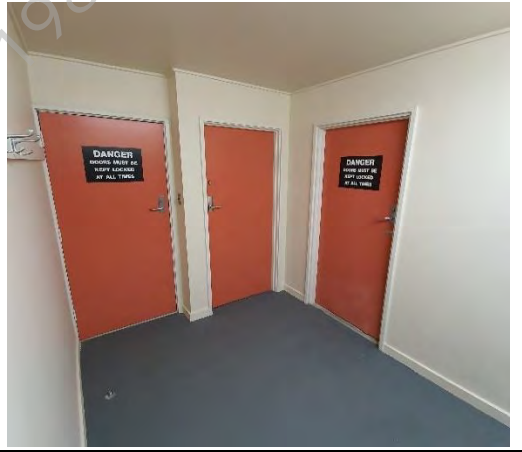
Item #	Level	Material Location	Material Description	Extent	Material Assessment					Accessibility	Labelling Status	Actual Photo
					Product	Extent of Damage	Surface Treatment	Score				
130	Basement	Internal – Access into LHS door labelled ‘Danger...’ below stairwell	Presumed: No Access Gained	Unquantifiable	3	3	3	9	D	Not possible to label

Control Measures		Presume Asbestos unless proven otherwise.										
Planned Removal / Remediation		Area to be inspected and assessed by a competent person prior to any works that may disturb the area										
Reason for decision		Asbestos status unknown										
Date of Re-Assessment		July 2022	Remediation time scale		As required

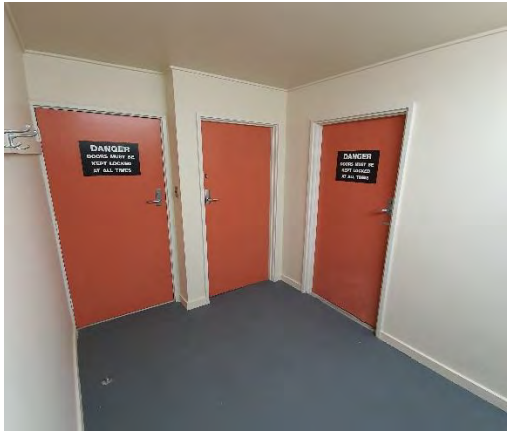
Item #	Level	Material Location	Material Description	Extent	Material Assessment					Accessibility	Labelling Status	Actual Photo
					Product	Extent of Damage	Surface Treatment	Score				
131	Basement	Internal – Access into RHS door labelled ‘Danger...’ below stairwell	Presumed: No Access Gained	Unquantifiable	3	3	3	9	D	Not possible to label

Control Measures		Presume Asbestos unless proven otherwise.										
Planned Removal / Remediation		Area to be inspected and assessed by a competent person prior to any works that may disturb the area										
Reason for decision		Asbestos status unknown										
Date of Re-Assessment		July 2022	Remediation time scale		As required

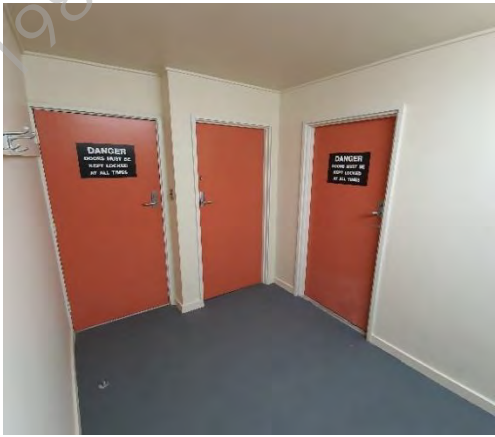
Item #	Level	Material Location	Material Description	Extent	Material Assessment					Accessibility	Labelling Status	Actual Photo
					Product	Extent of Damage	Surface Treatment	Score				
132	Basement	Internal – Access into room between door labelled 'Danger...' below stairwell	Presumed: No Access Gained	Unquantifiable	3	3	3	9	D	Not possible to label

Control Measures		Presume Asbestos unless proven otherwise.										
Planned Removal / Remediation		Area to be inspected and assessed by a competent person prior to any works that may disturb the area										
Reason for decision		Asbestos status unknown										
Date of Re-Assessment		July 2022	Remediation time scale			As required

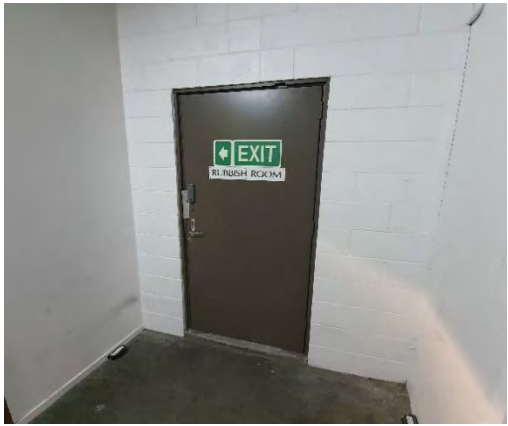
Item #	Level	Material Location	Material Description	Extent	Material Assessment					Accessibility	Labelling Status	Actual Photo
					Product	Extent of Damage	Surface Treatment	Score				
133	Basement	Internal – Access into rubbish room	Presumed: No Access Gained	Unquantifiable	3	3	3	9	D	Not possible to label

Control Measures		Presume Asbestos unless proven otherwise.										
Planned Removal / Remediation		Area to be inspected and assessed by a competent person prior to any works that may disturb the area										
Reason for decision		Asbestos status unknown										
Date of Re-Assessment		July 2022	Remediation time scale			As required

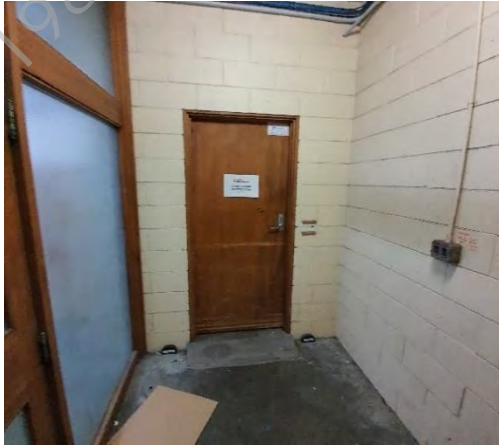
Item #	Level	Material Location	Material Description	Extent	Material Assessment					Accessibility	Labelling Status	Actual Photo
					Product	Extent of Damage	Surface Treatment	Score				
134	Basement	Internal – Access into meeting room	Presumed: No Access Gained	Unquantifiable	3	3	3	9	D	Not possible to label

Control Measures		Presume Asbestos unless proven otherwise.										
Planned Removal / Remediation		Area to be inspected and assessed by a competent person prior to any works that may disturb the area										
Reason for decision		Asbestos status unknown										
Date of Re-Assessment		July 2022	Remediation time scale		As required

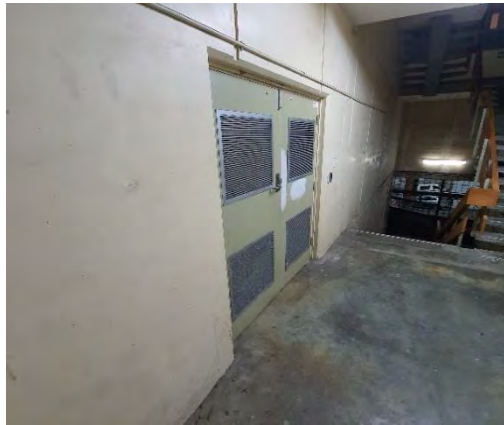
Item #	Level	Material Location	Material Description	Extent	Material Assessment					Accessibility	Labelling Status	Actual Photo
					Product	Extent of Damage	Surface Treatment	Score				
135	Basement	Internal – Access into louver door room within large concrete staircase area	Presumed: No Access Gained	Unquantifiable	3	3	3	9	D	Not possible to label

Control Measures		Presume Asbestos unless proven otherwise.										
Planned Removal / Remediation		Area to be inspected and assessed by a competent person prior to any works that may disturb the area										
Reason for decision		Asbestos status unknown										
Date of Re-Assessment		July 2022	Remediation time scale		As required

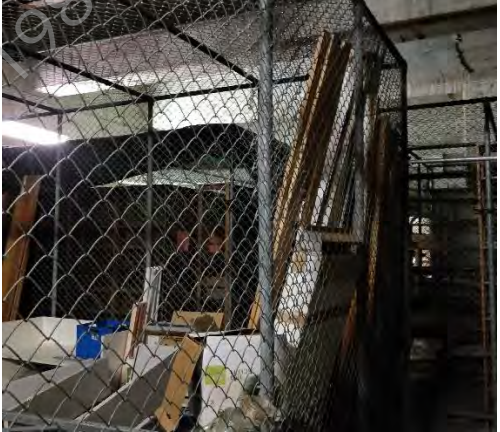
Item #	Level	Material Location	Material Description	Extent	Material Assessment					Accessibility	Labelling Status	Actual Photo
					Product	Extent of Damage	Surface Treatment	Score				
136	Basement	Internal – Access into room within large concrete staircase area with door labelled ‘No smoking...’	Presumed: Limited Access Gained	Unquantifiable	2	1	2	9	D	Not possible to label

Control Measures		Presume Asbestos unless proven otherwise.										
Planned Removal / Remediation		Area to be inspected and assessed by a competent person prior to any works that may disturb the area										
Reason for decision		Asbestos status unknown										
Date of Re-Assessment		July 2022	Remediation time scale			As required

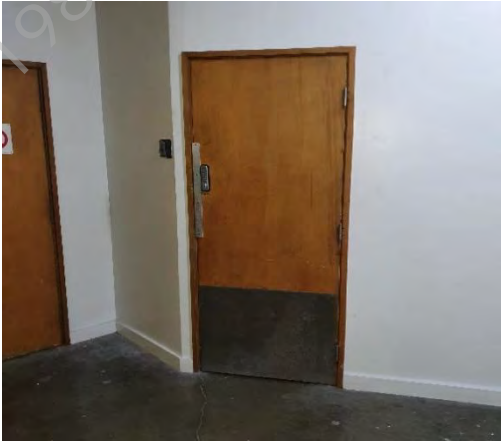
Item #	Level	Material Location	Material Description	Extent	Material Assessment					Accessibility	Labelling Status	Actual Photo
					Product	Extent of Damage	Treatment Surface	Score				
138	Basement	Internal – Access into room adjacent main plant room access	Presumed: No Access Gained	Unquantifiable	3	3	3	9	D	Not possible to label

Control Measures		Presume Asbestos unless proven otherwise.										
Planned Removal / Remediation		Area to be inspected and assessed by a competent person prior to any works that may disturb the area										
Reason for decision		Asbestos status unknown										
Date of Re-Assessment		July 2022	Remediation time scale			As required

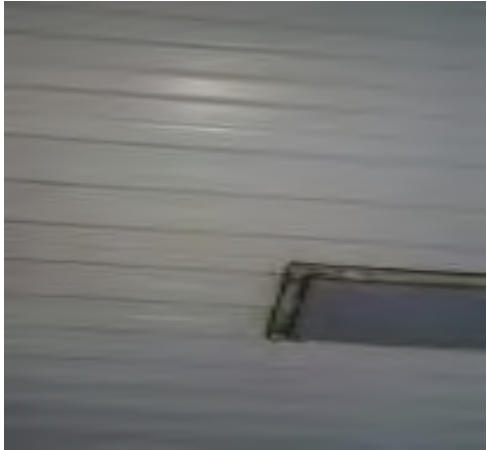
Item #	Level	Material Location	Material Description	Extent	Material Assessment					Accessibility	Labelling Status	Actual Photo
					Product	Extent of Damage	Treatment Surface	Score				
116	Basement	External – Soffits to perimeter of building as marked on plan on ground floor	Fibre Cement	200m2	1	1	1	3	D	Not labelled

Control Measures		Label the material and avoid disturbance – condition to be monitored										
Planned Removal / Remediation		To be removed by a minimum 'Class B' licensed removal contractor under appropriate control prior to any works that may cause disturbance. Labels to be applied in visible locations.										
Reason for decision		Asbestos status unknown but disturbance is unlikely under normal occupancy, therefore only a risk if planned works affect the soffits										
Date of Re-Assessment		July 2022	Remediation time scale			As required

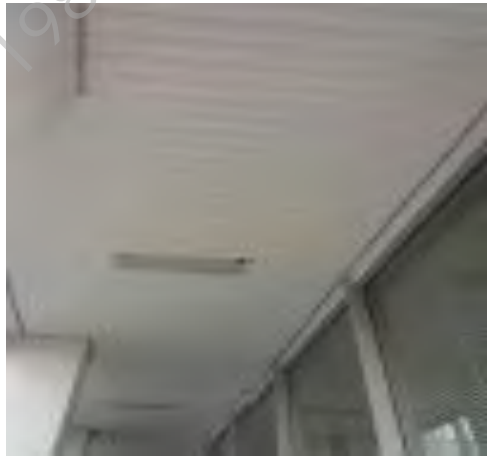
Item #	Level	Material Location	Material Description	Extent	Material Assessment					Accessibility	Labelling Status	Actual Photo
					Product	Extent of Damage	Surface Treatment	Score				
115	External	External first floor balcony – Soffits around balcony	Fibre Cement	200m2	1	1	1	3	D	Not labelled

Control Measures		Label the material and avoid disturbance – condition to be monitored										
Planned Removal / Remediation		To be removed by a minimum 'Class B' licensed removal contractor under appropriate control prior to any works that may cause disturbance. Labels to be applied in visible locations.										
Reason for decision		Asbestos status unknown but disturbance is unlikely under normal occupancy, therefore only a risk if planned works affect the soffits										
Date of Re-Assessment		July 2022	Remediation time scale			As required

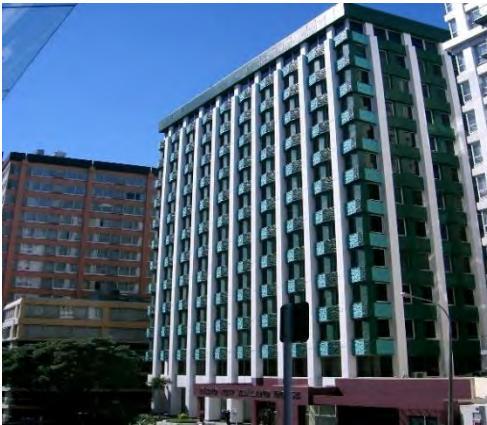
Item #	Level	Material Location	Material Description	Extent	Material Assessment					Accessibility	Labelling Status	Actual Photo
					Product	Extent of Damage	Surface Treatment	Score				
151	External	High level areas- No access to inspect high level due to height restrictions	Presumed: No Access Gained	Unquantifiable	1	0	1	2	D	Not possible to label

Control Measures		Presume Asbestos unless proven otherwise.										
Planned Removal / Remediation		Area to be inspected and assessed by a competent person prior to any works that may disturb the area										
Reason for decision		Asbestos status unknown										
Date of Re-Assessment		July 2022	Remediation time scale			As required

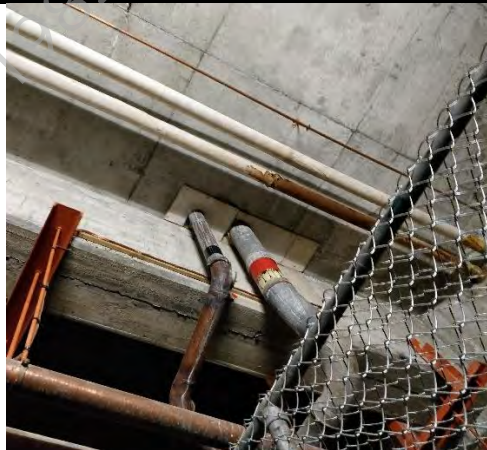
Item #	Level	Material Location	Material Description	Extent	Material Assessment					Accessibility	Labelling Status	Actual Photo
					Product	Extent of Damage	Surface Treatment	Score				
160	Basement	Internal – Panels to pipe penetrations in ceiling within large storeroom above right hand side storage cage	Presumed: Insulating Board	0.5m2	2	1	2	5	D	Not labelled

Control Measures		Presumed to contain asbestos unless proven otherwise - do not carry out any work that would cause disturbance to these materials without testing.										
Planned Removal / Remediation		To be tested or removed under appropriate control prior to any works that may cause disturbance.										
Reason for decision		Asbestos status unknown										
Date of Re-Assessment		July 2022	Remediation time scale		As required

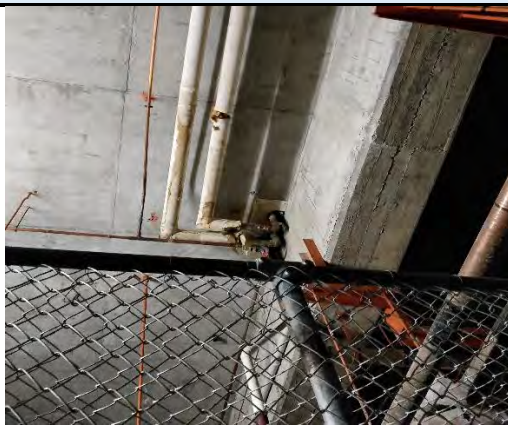
Item #	Level	Material Location	Material Description	Extent	Material Assessment					Accessibility	Labelling Status	Actual Photo
					Product	Extent of Damage	Surface Treatment	Score				
161	Basement	Internal – Panels to pipe penetrations in ceiling within large storeroom above left hand side storage cage	Presumed: Insulating Board	0.5m2	2	1	2	5	D	Not labelled

Control Measures		Presumed to contain asbestos unless proven otherwise - do not carry out any work that would cause disturbance to these materials without testing.										
Planned Removal / Remediation		To be tested or removed under appropriate control prior to any works that may cause disturbance.										
Reason for decision		Asbestos status unknown										
Date of Re-Assessment		July 2022	Remediation time scale		As required

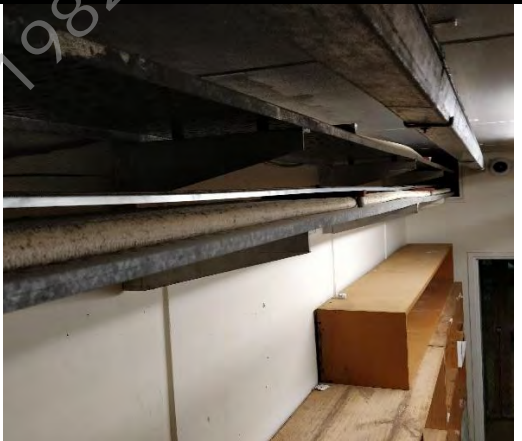
Item #	Level	Material Location	Material Description	Extent	Material Assessment					Accessibility	Labelling Status	Actual Photo
					Product	Damage	Extent of Treatment	Surface	Score			
156	Basement	Internal – Wraps to cables leading from inaccessible room at high level, through loading bay and through LINZ storage areas	Woven Textile	240linm	2	1	2	5	D	Not labelled

Control Measures		Encapsulate/seal, label the material and avoid disturbance – condition to be monitored										
Planned Removal / Remediation		Material to be encapsulated/sealed and labelled by a licensed 'Class A' removal contractor under suitably controlled conditions. To be removed under appropriate control prior to any works that may cause disturbance.										
Reason for decision		Elevated risk of exposure as the material is not sealed/encapsulated										
Date of Re-Assessment		July 2022	Remediation time scale			As required

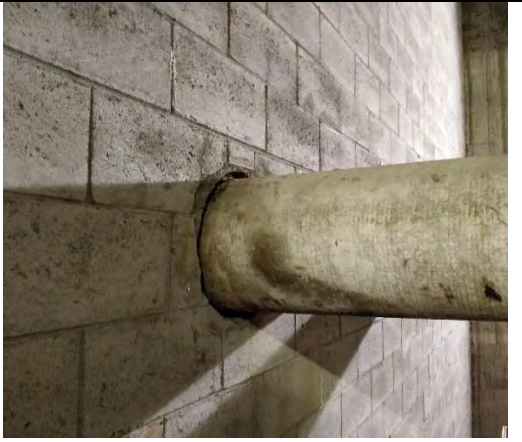
Item #	Level	Material Location	Material Description	Extent	Material Assessment					Accessibility	Labelling Status	Actual Photo
					Product	Damage	Extent of Treatment	Surface	Score			
157	Basement	Internal – Downpipe which runs into area from floor above, through storeroom and then into the gym and through the wall	Fibre Cement	50linm	1	1	1	3	M	Not labelled

Control Measures		Encapsulate/seal, label the material and avoid disturbance – condition to be monitored										
Planned Removal / Remediation		Material to be encapsulated/sealed and labelled by a minimum licensed 'Class B' removal contractor. To be removed under appropriate control prior to any works that may cause disturbance. Labels to be applied in visible locations.										
Reason for decision		Elevated risk of exposure as the material is not sealed/encapsulated										
Date of Re-Assessment		July 2022	Remediation time scale			As required

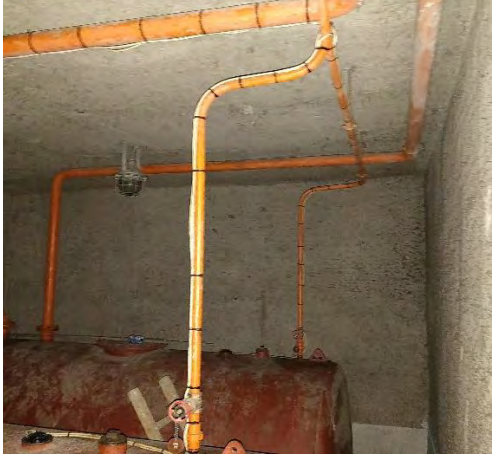
Item #	Level	Material Location	Material Description	Extent	Material Assessment				Accessibility	Labelling Status	Actual Photo
					Product	Extent of Damage	Surface Treatment	Score			
158	Basement	Internal – Highly damaged coating to ceiling and walls within tank room adjacent rear loading bay	Sprayed Coating	Unquantifiable	3	3	3	9	E	Not possible to label

Control Measures		Do not disturb the material – access should be restricted, and the product removed.									
Planned Removal / Remediation		Removal by 'Class A' Licensed Asbestos Removal Contractor. Localized disturbances will be risk assessed by a competent person to identify the appropriate control measures. Warning signage will be displayed.									
Reason for decision		High risk material type and elevated risk of exposure due to damage.									
Date of Re-Assessment		July 2022	Remediation time scale			6 Months

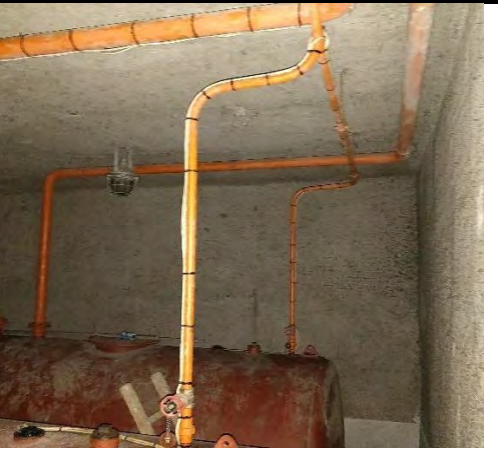
Item #	Level	Material Location	Material Description	Extent	Material Assessment				Accessibility	Labelling Status	Actual Photo
					Product	Extent of Damage	Surface Treatment	Score			
161	Basement	Internal – Debris to flat surfaces	Sprayed Coating Debris	Unquantifiable	3	3	3	9	E	Not possible to label

Control Measures		Do not disturb the material – access should be restricted, and the product removed.									
Planned Removal / Remediation		Removal by 'Class A' Licensed Asbestos Removal Contractor. Localized disturbances will be risk assessed by a competent person to identify the appropriate control measures. Warning signage will be displayed, and labels applied in visible locations.									
Reason for decision		High risk material type and elevated risk of exposure due to damage.									
Date of Re-Assessment		July 2022	Remediation time scale			6 Months

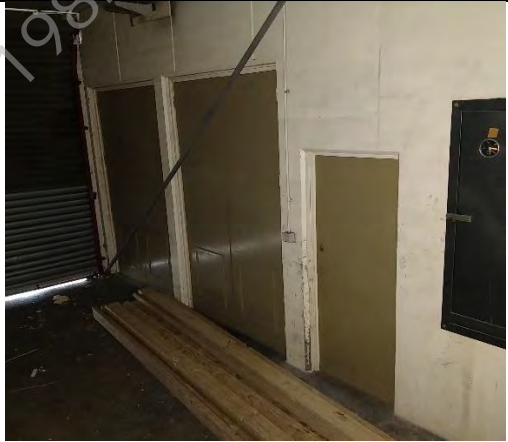
Item #	Level	Material Location	Material Description	Extent	Material Assessment					Accessibility	Labelling Status	Actual Photo
					Product	Extent of Damage	Surface Treatment	Score				
162	Basement	Internal – Access into suspected substation adjacent rear loading bay	Presumed: No Access Gained	Unquantifiable	3	3	3	9	D	Not possible to label

Control Measures		Presume Asbestos unless proven otherwise.										
Planned Removal / Remediation		Area to be inspected and assessed by a competent person prior to any works that may disturb the area										
Reason for decision		Asbestos status unknown										
Date of Re-Assessment		July 2022	Remediation time scale			As required

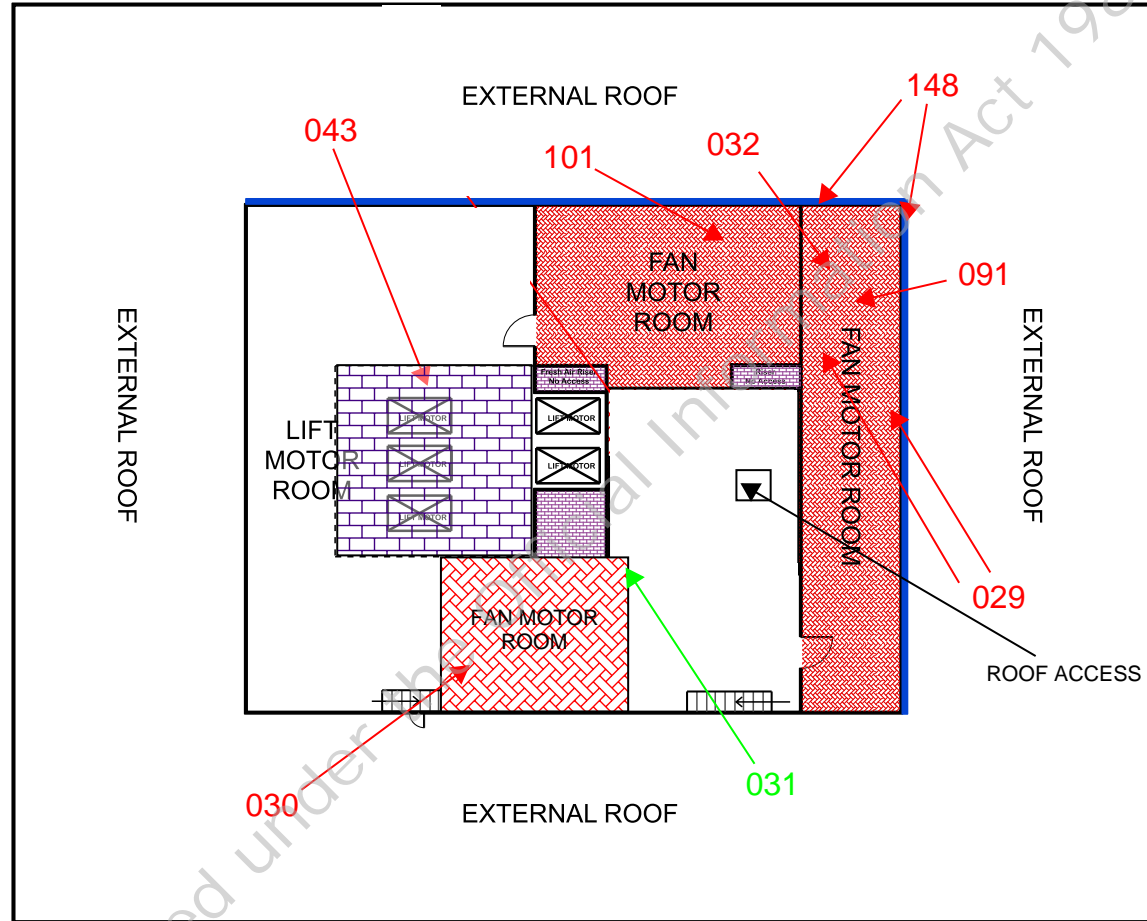
AC2497 - 155 The Terrace - Level 14 - Item Location Plan

- 123 - Presumed asbestos within plant and equipment throughout site
- 108 - Plasters GIB Stopping compounds throughout site
- 028 - Gaskets throughout site
- 121 - HVAC internals throughout site have been presumed to be contaminated with asbestos

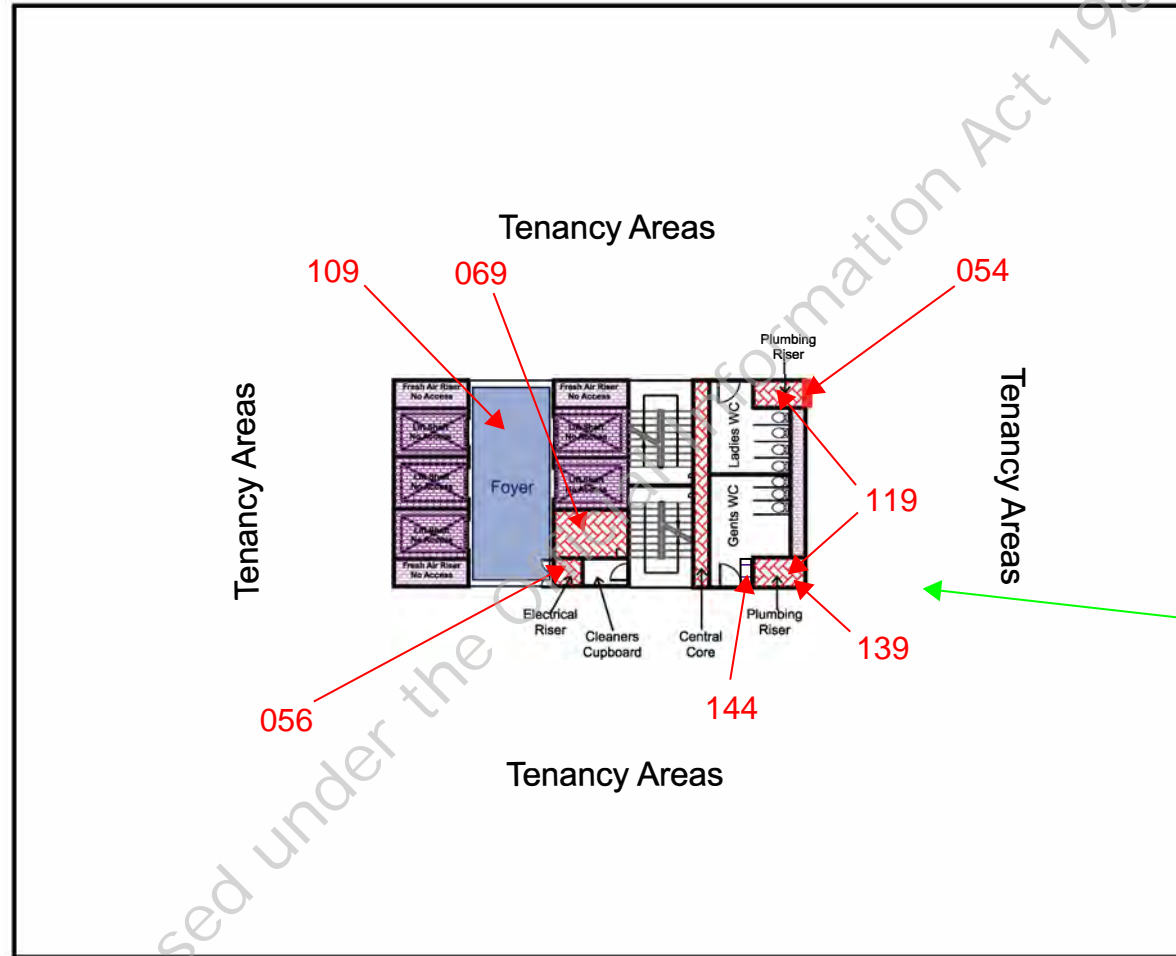
064 - No access within lift shafts

055 - Limited access within ceiling void throughout floor

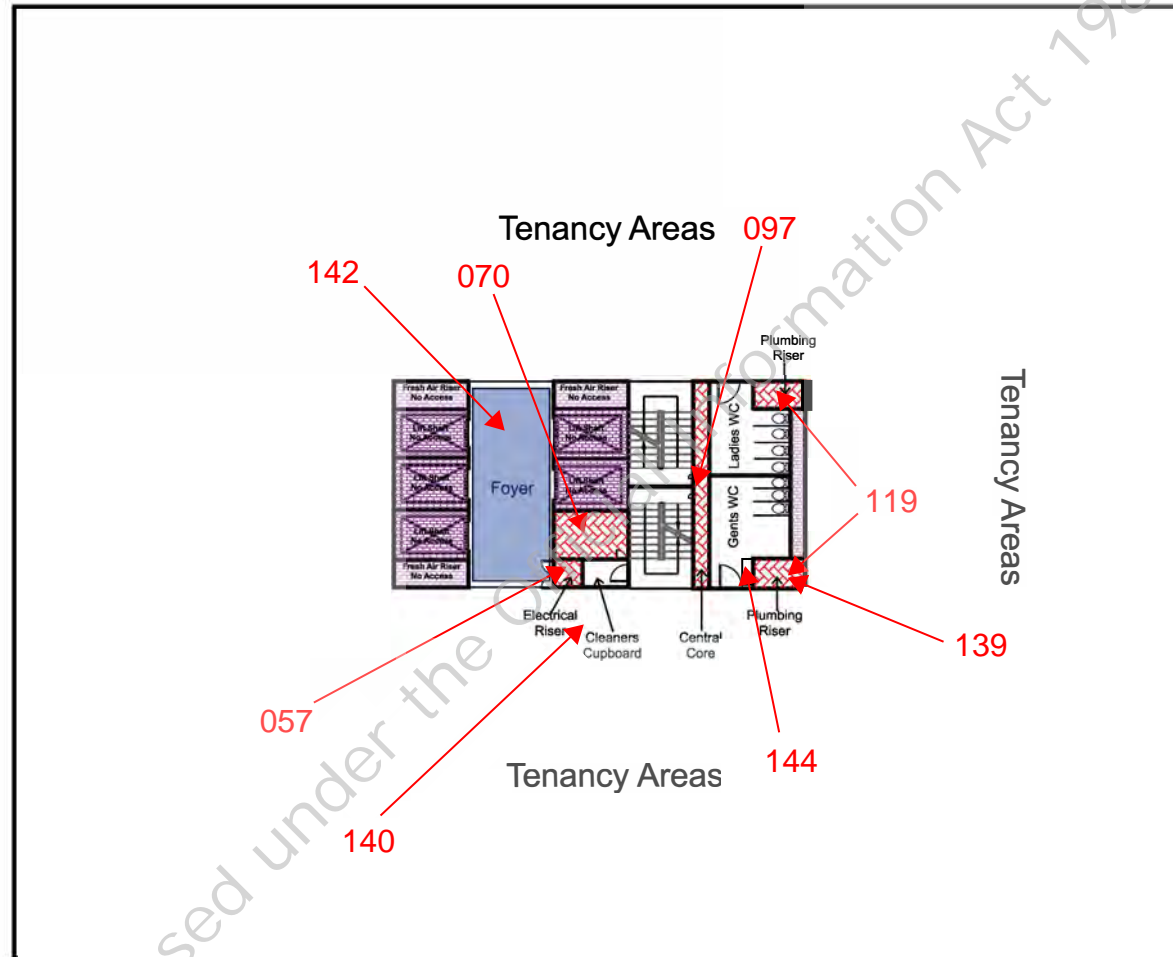
100 - No access within Fertility tenancy

141 - No access above fixed ceilings adjacent toilets

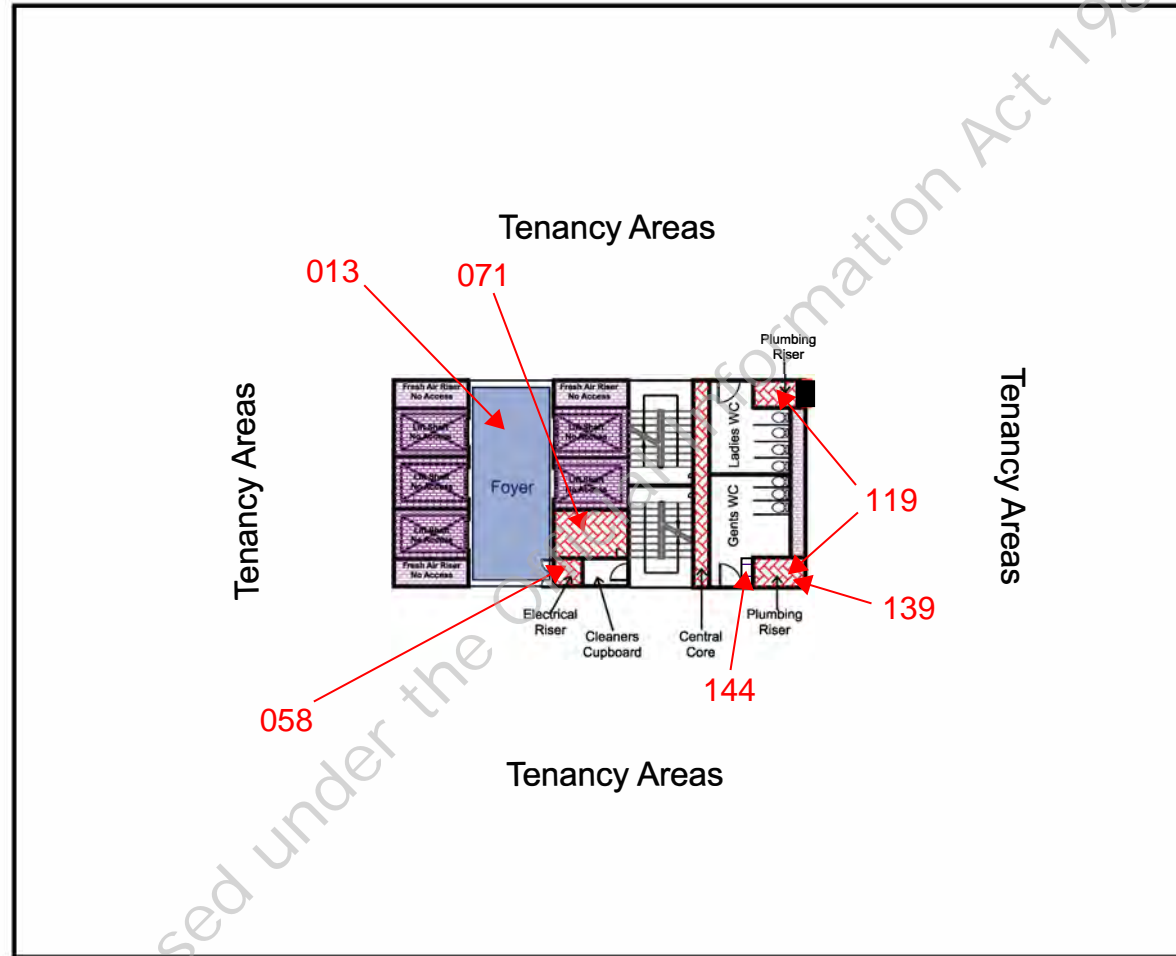
064 - No access within lift shafts

014 - Limited access within ceiling void throughout floor

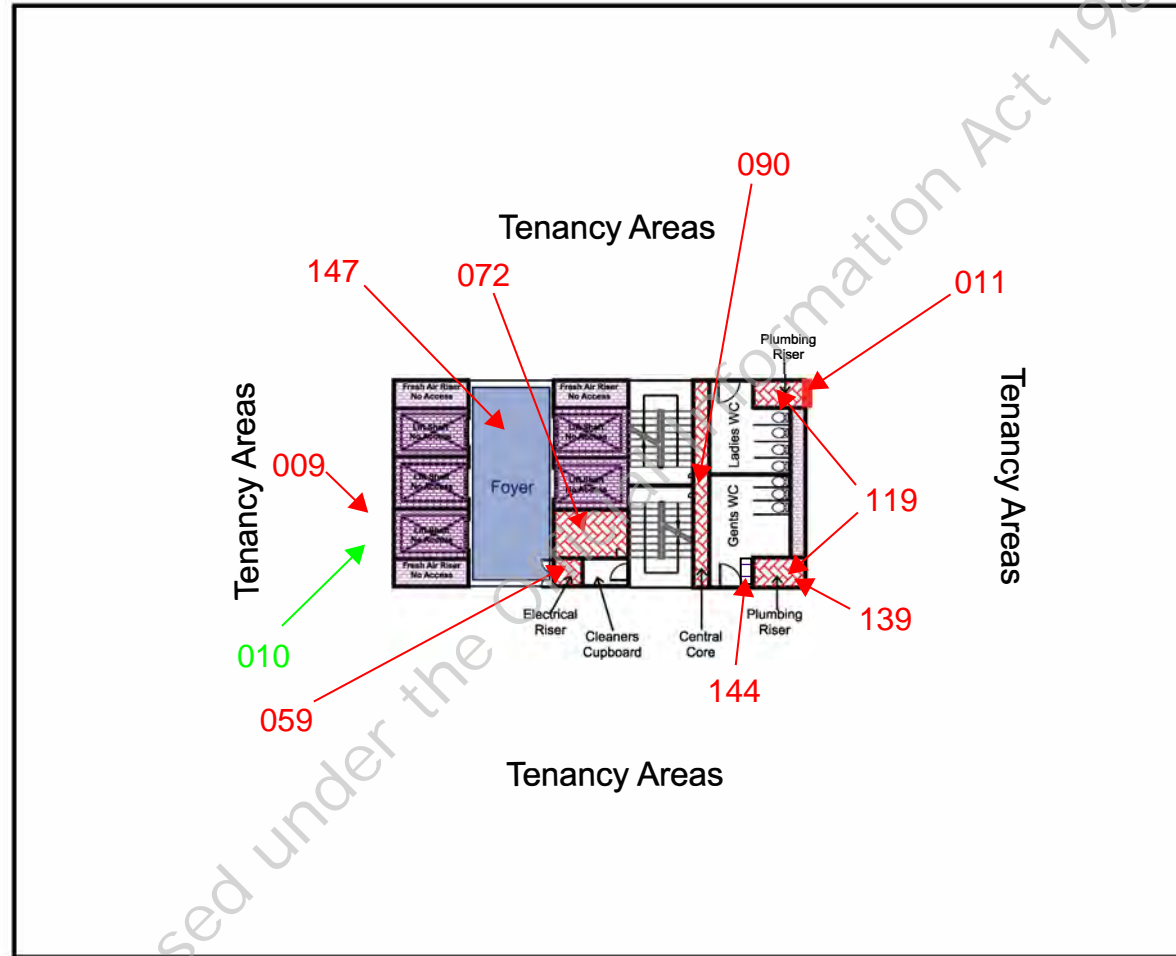
064 - No access within lift shafts

114 - Limited access within ceiling void throughout floor

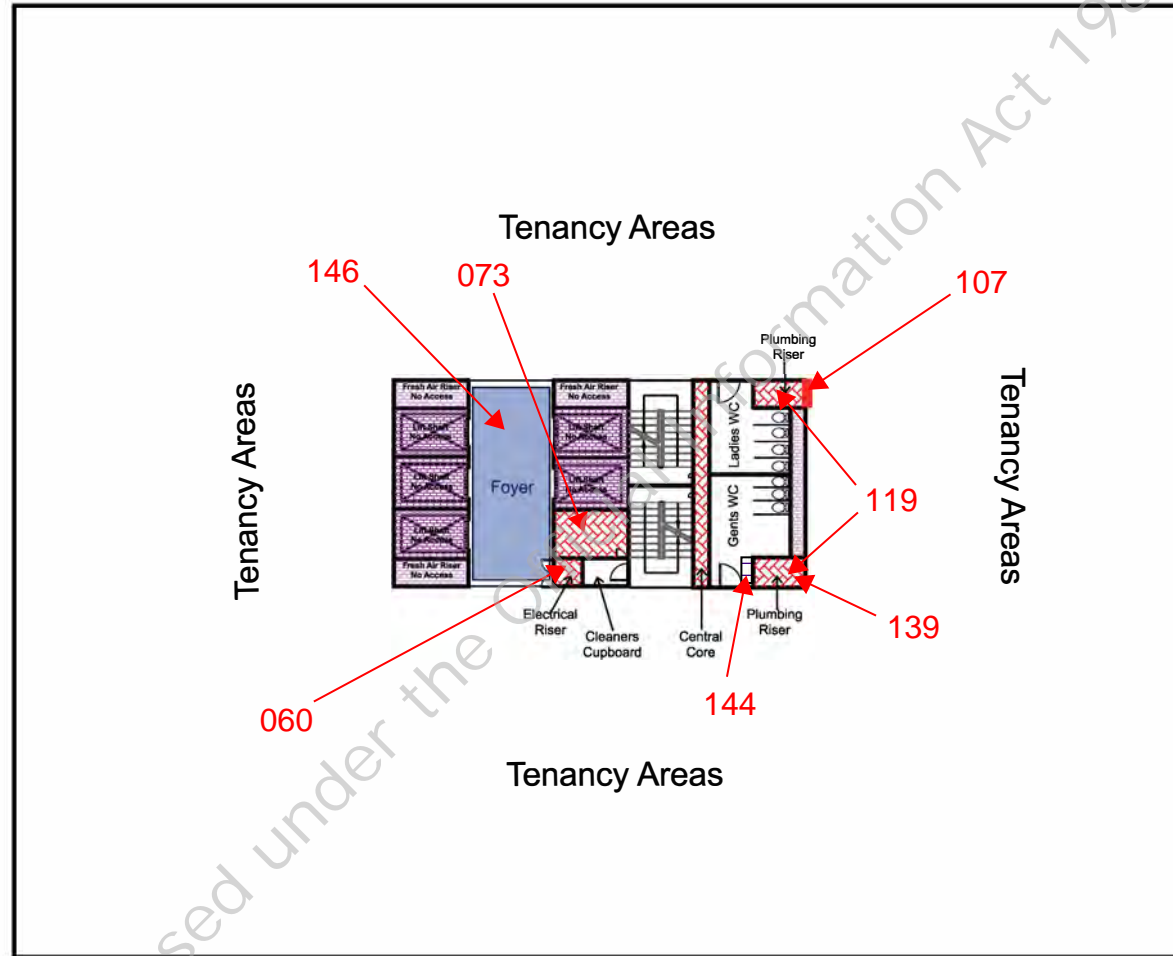
064 - No access within lift shafts

113 - Limited access within ceiling void throughout floor

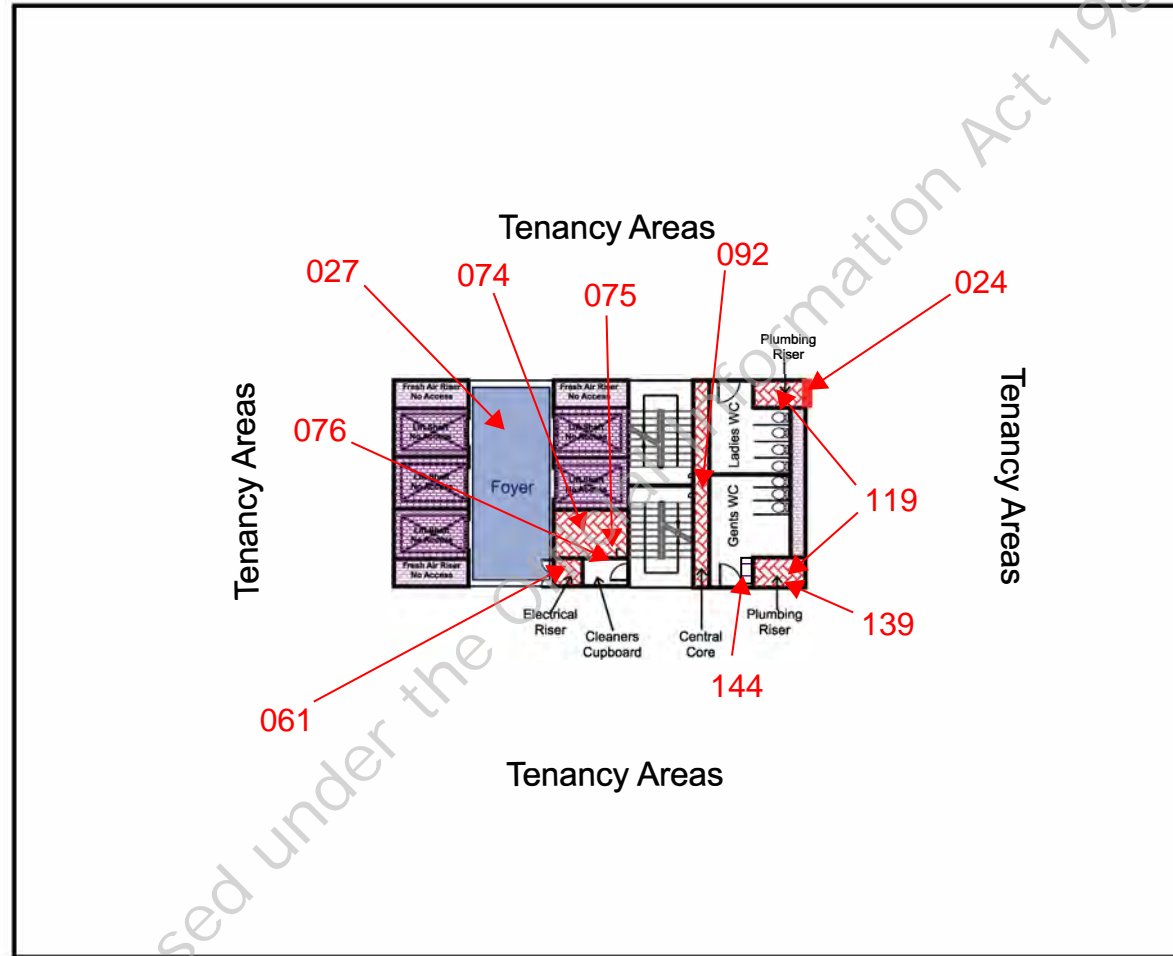
064 - No access within lift shafts

025 - Limited access within ceiling void throughout floor

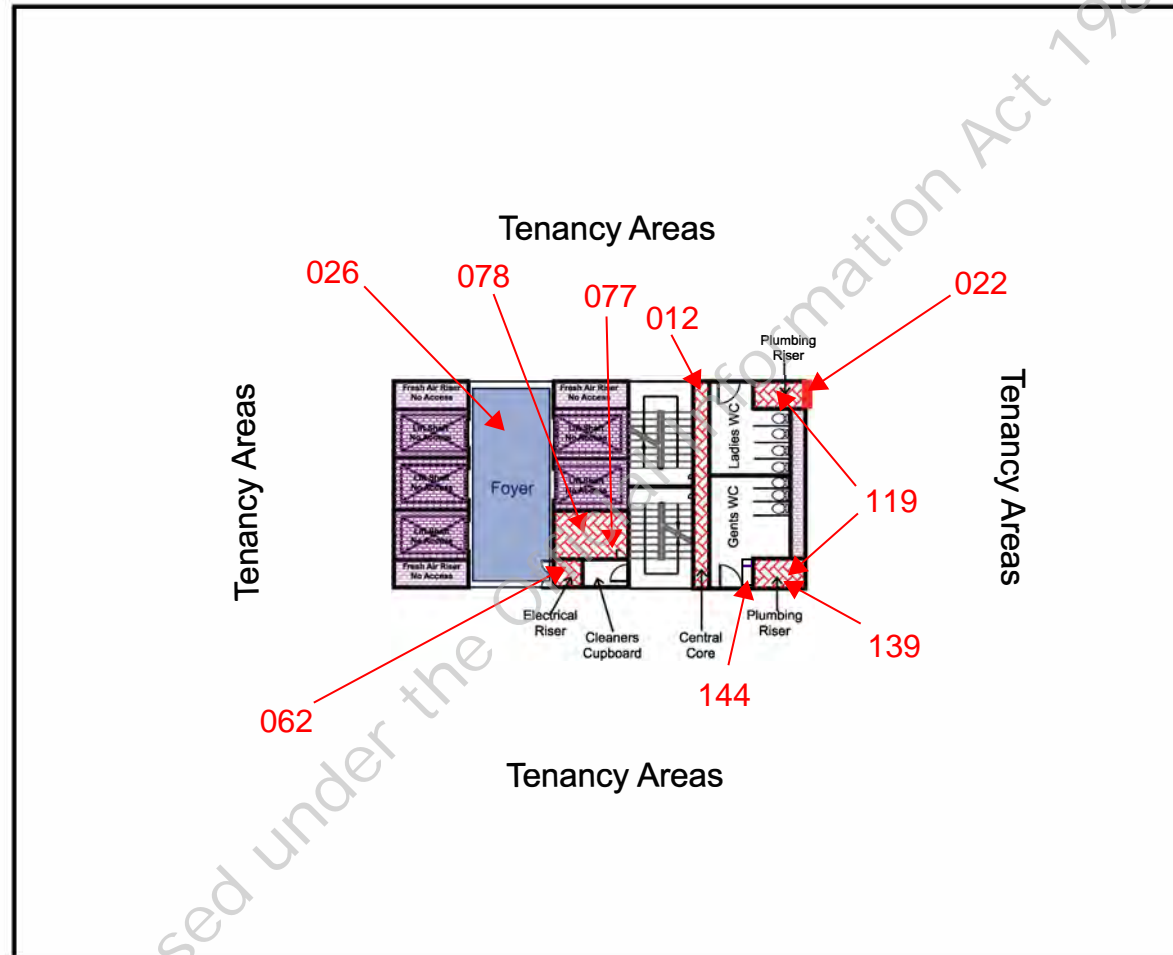
064 - No access within lift shafts

023 - Limited access within ceiling void throughout floor

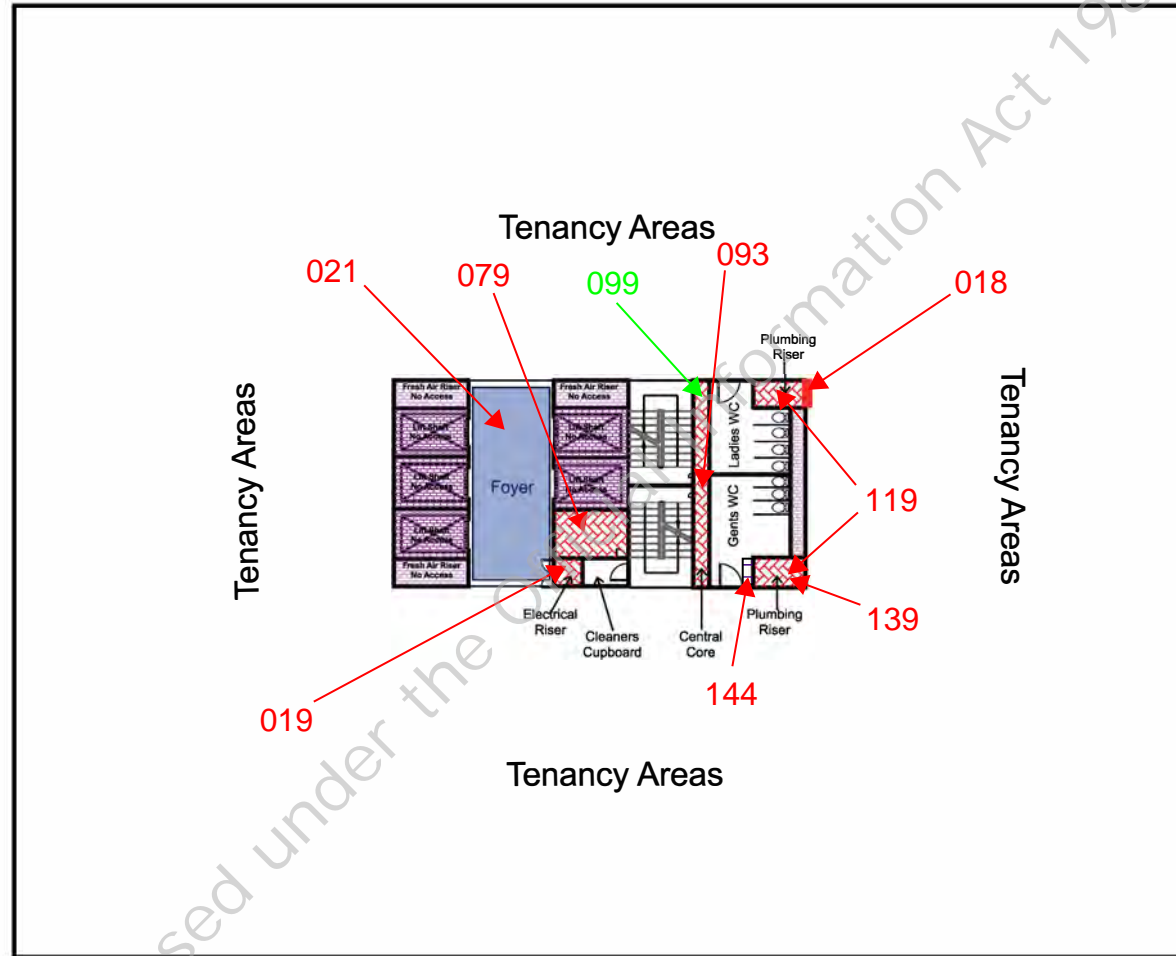
064 - No access within lift shafts

016 - Limited access within ceiling void throughout floor

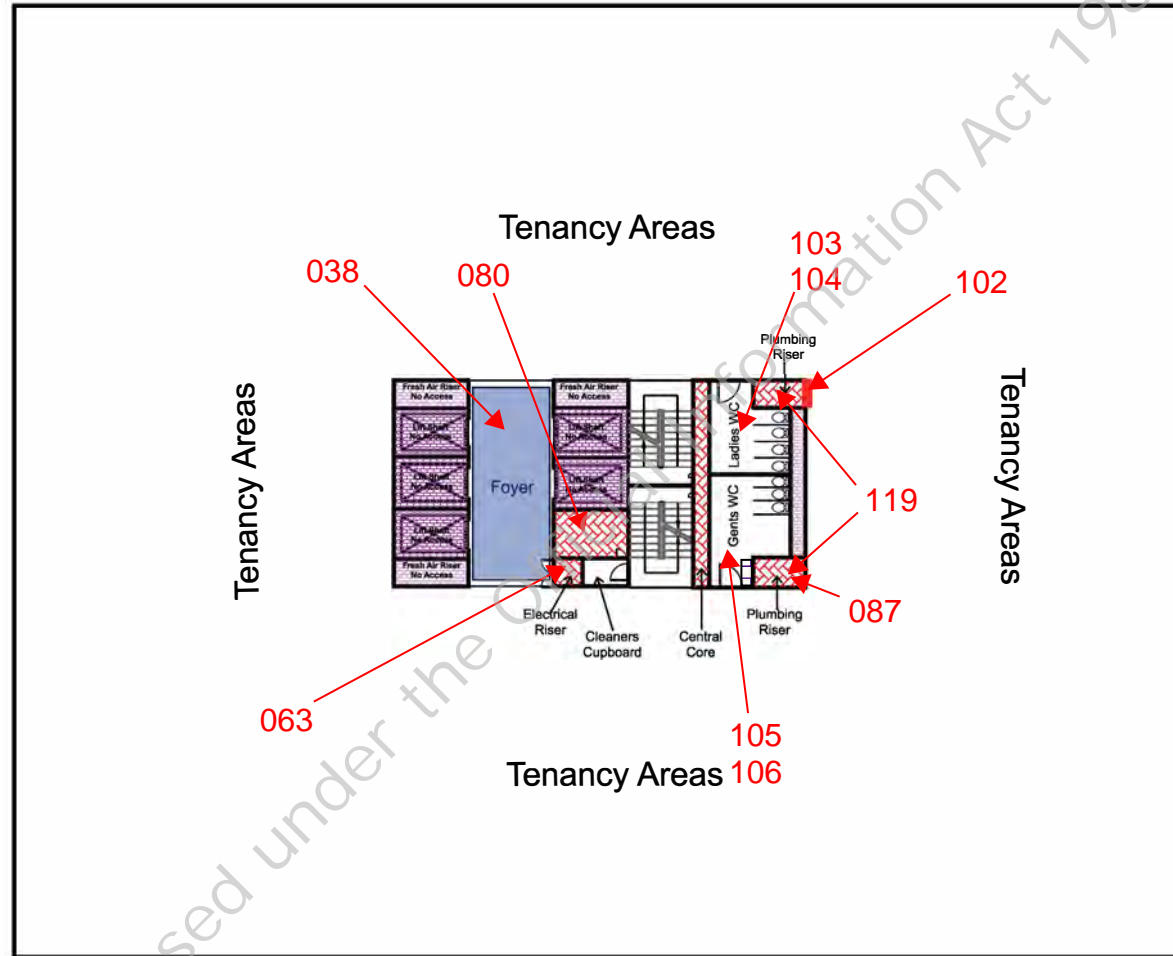
064 - No access within lift shafts

112 - Limited access within ceiling void throughout floor

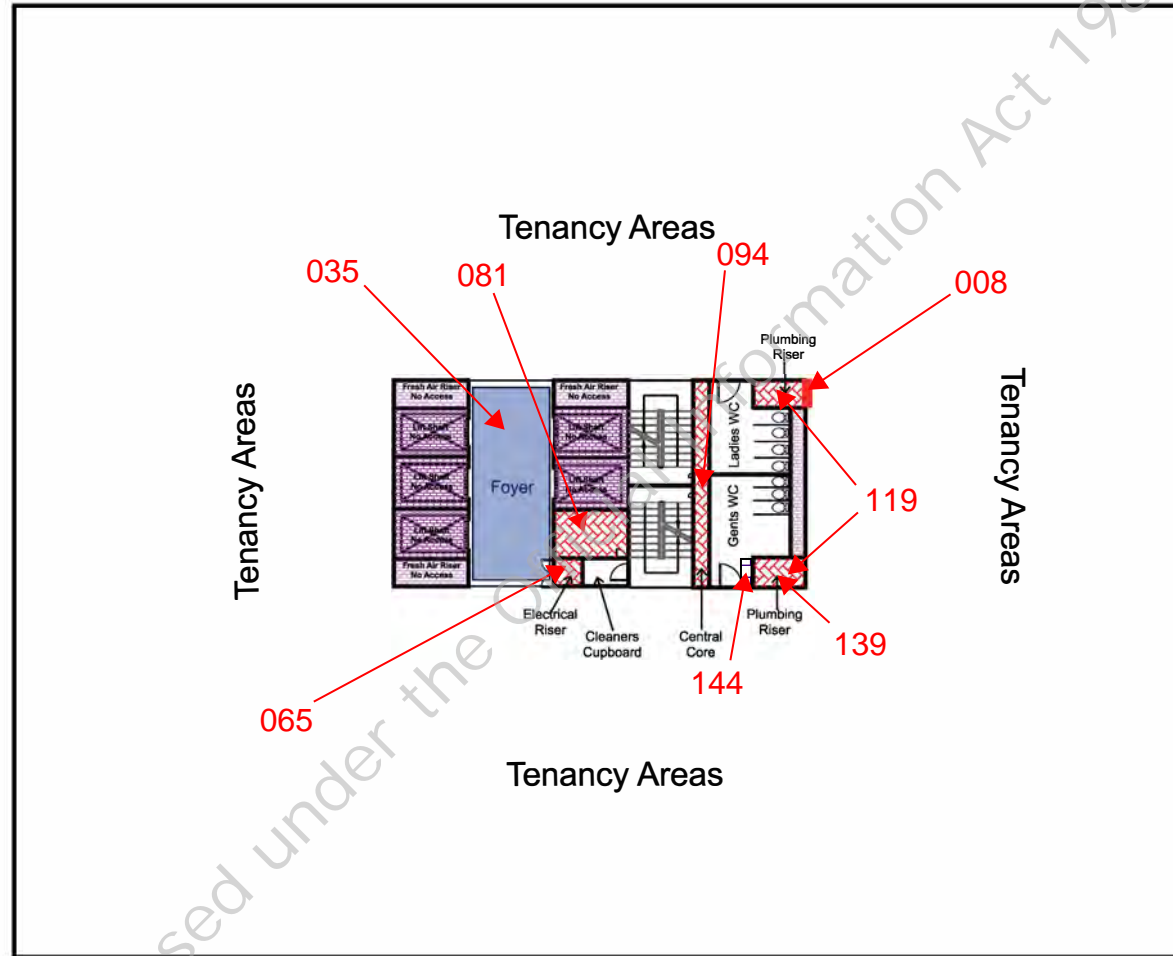
064 - No access within lift shafts

111 - Limited access within ceiling void throughout floor

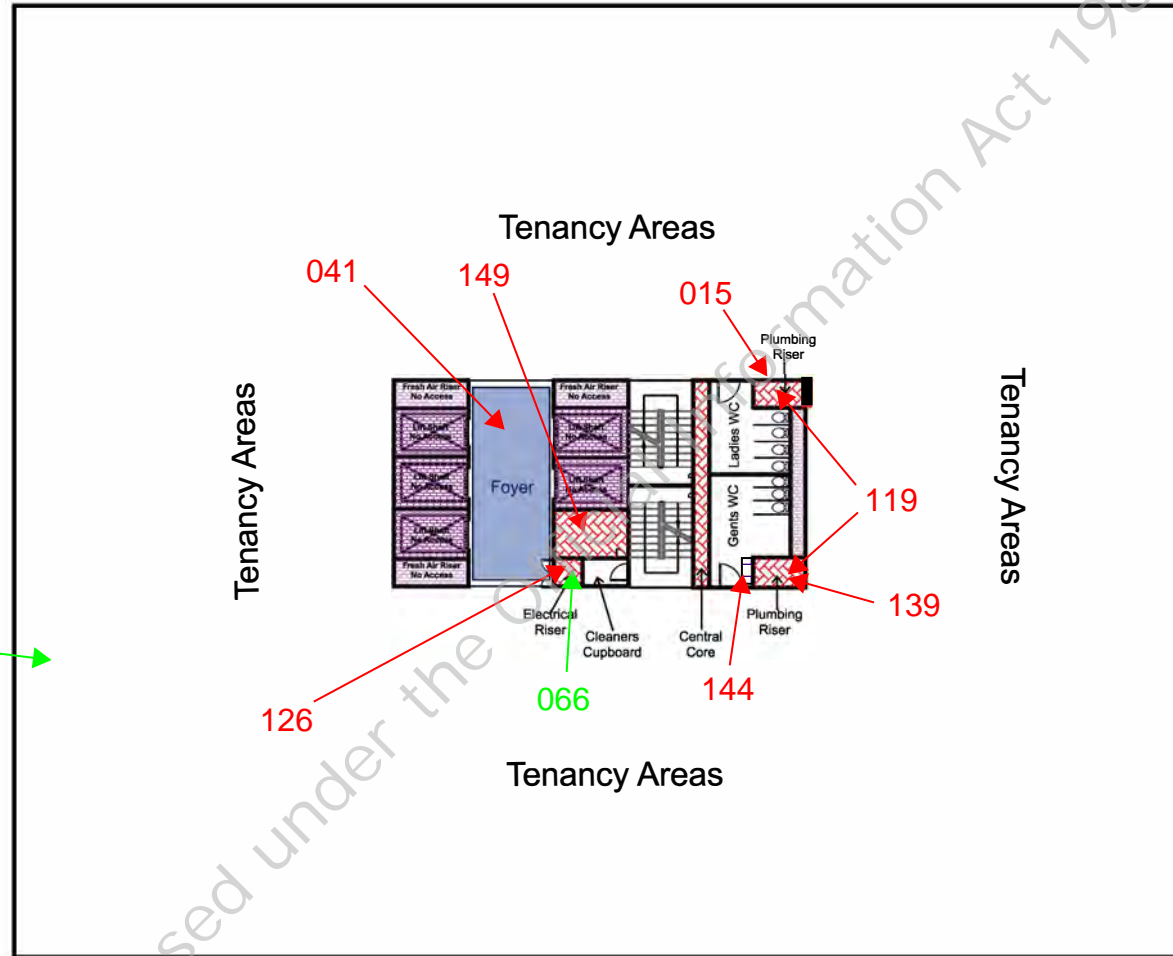
125 - Limited access within ceiling void throughout floor
