BC90898 (Radio New Zealand House)

Site Specific Asbestos Management Plan

**155 The Terrace, Wellington Central,
Wellington 6011**

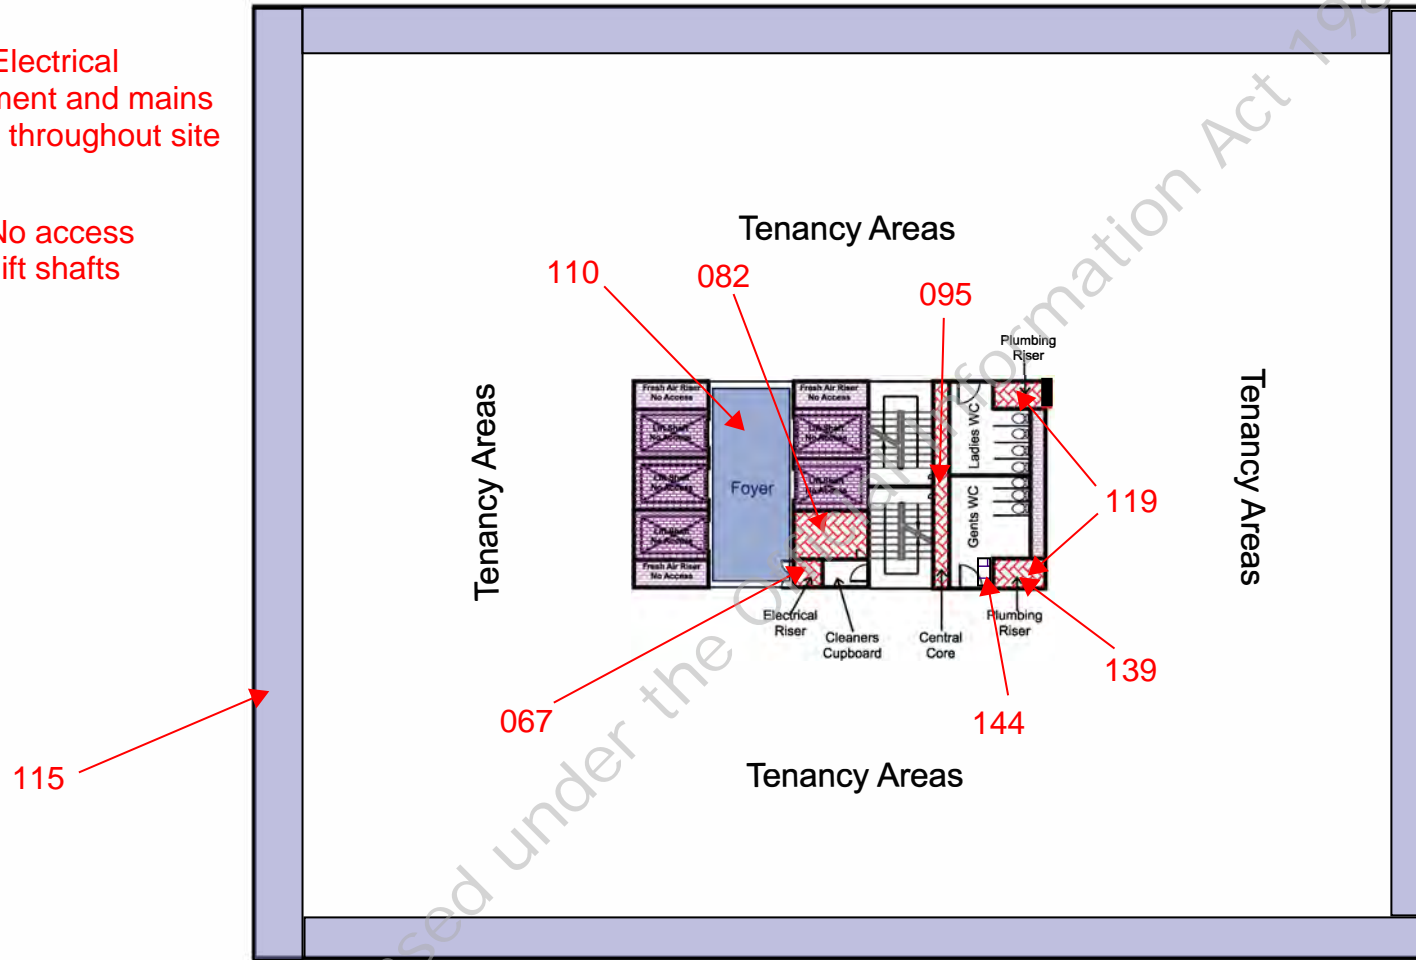
020 - Electrical equipment and mains cables throughout site

064 - No access within lift shafts

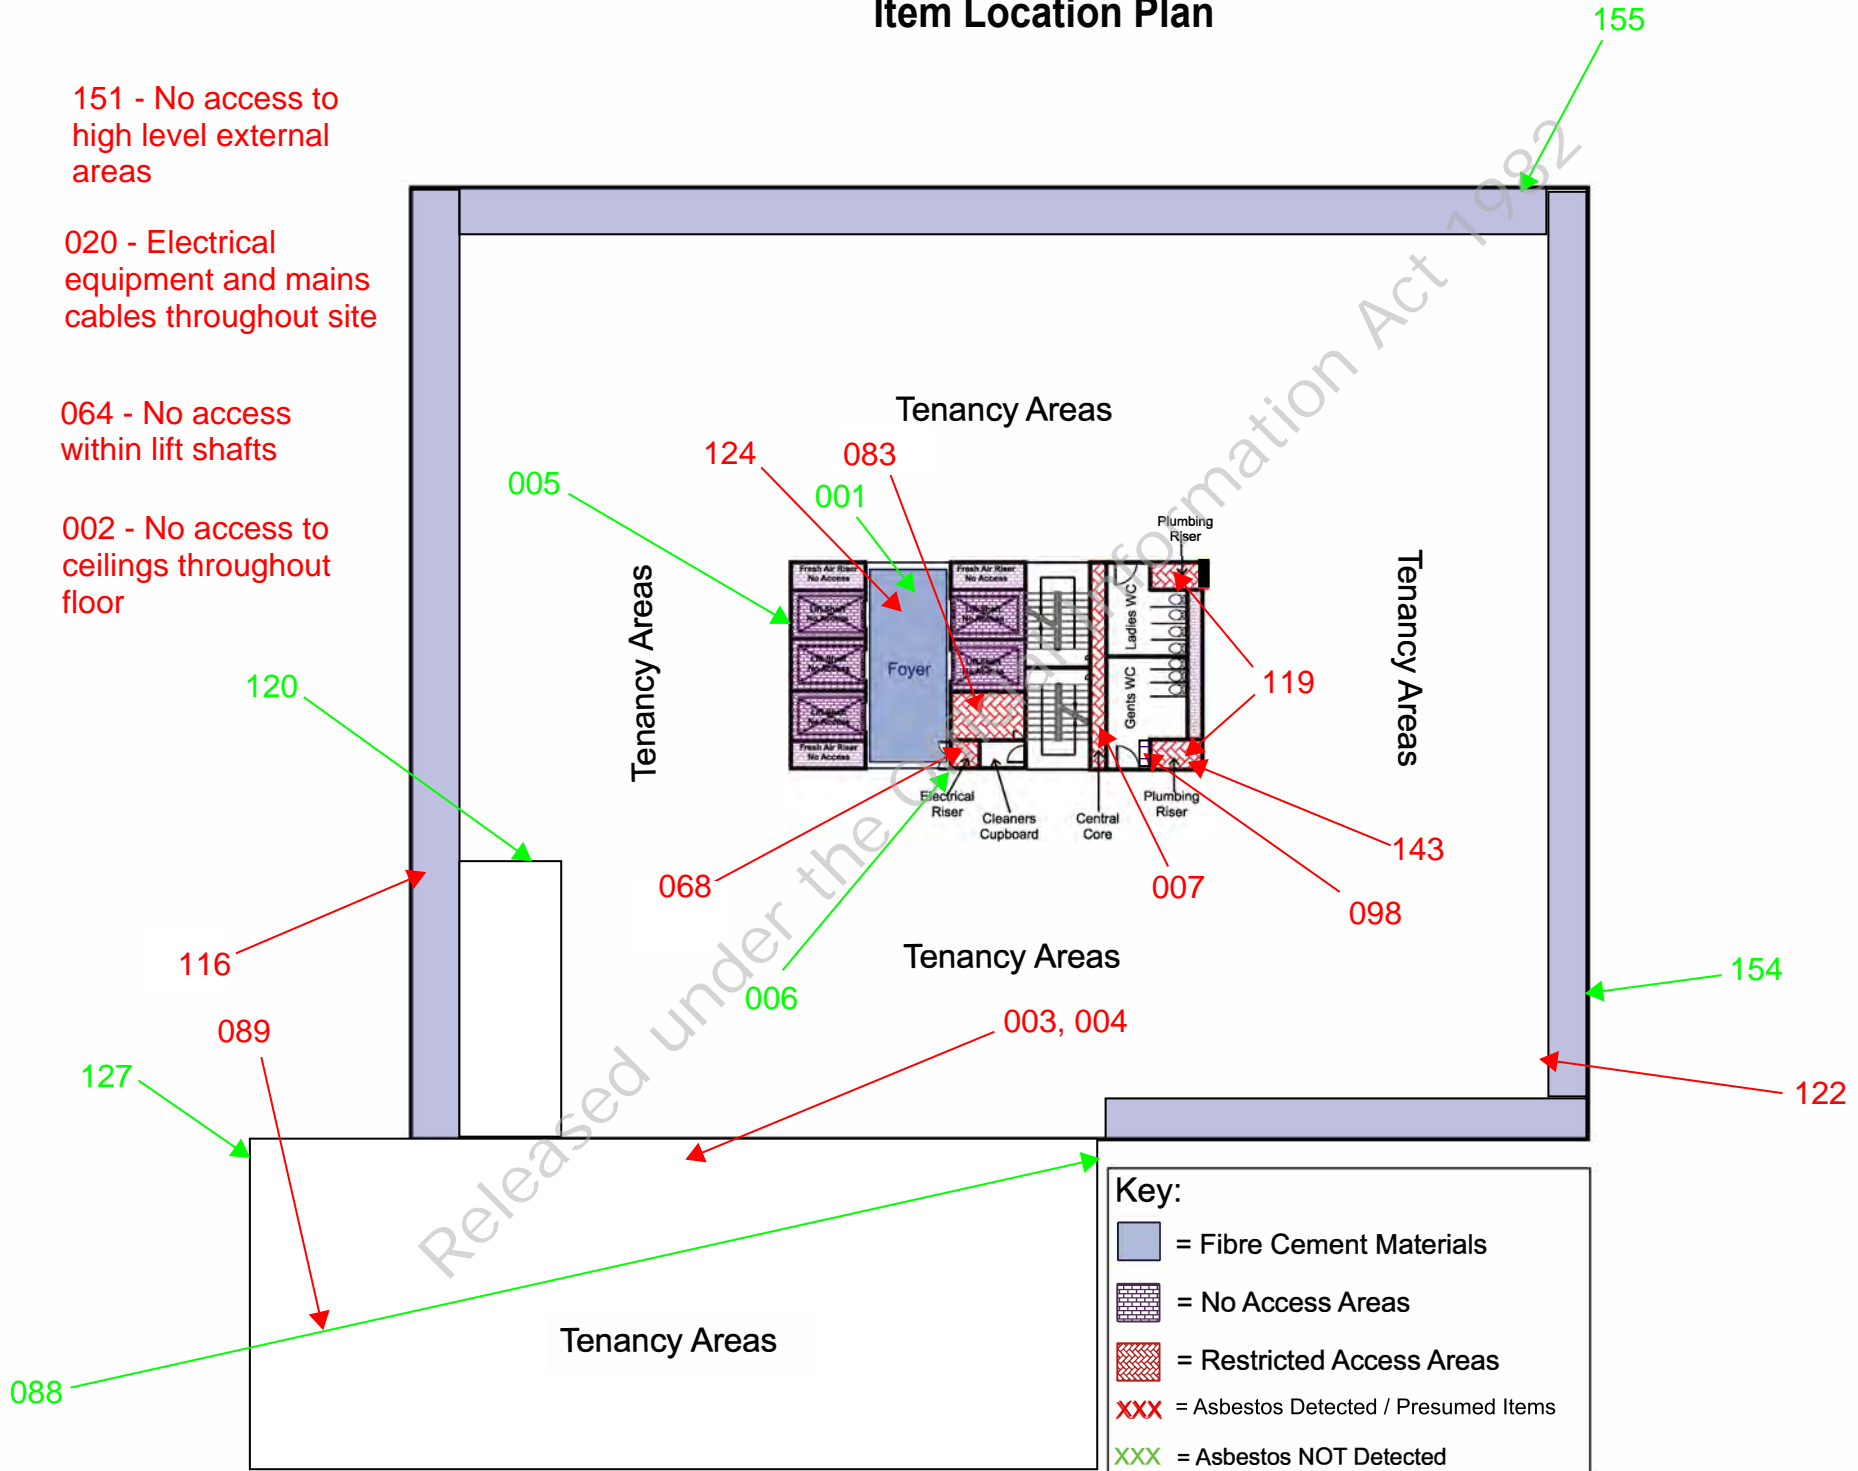
064 - No access within lift shafts

002 - No access to ceilings throughout floor
