Napier Rainfall Event November 2020

Hazard Report

Hawkes Bay Regional Council Publication No. 5551

Jim Tetlow, Toa Consulting
Craig Goodier, Team Leader Engineering
Lisa Pearse, Team Leader Hazard Reduction

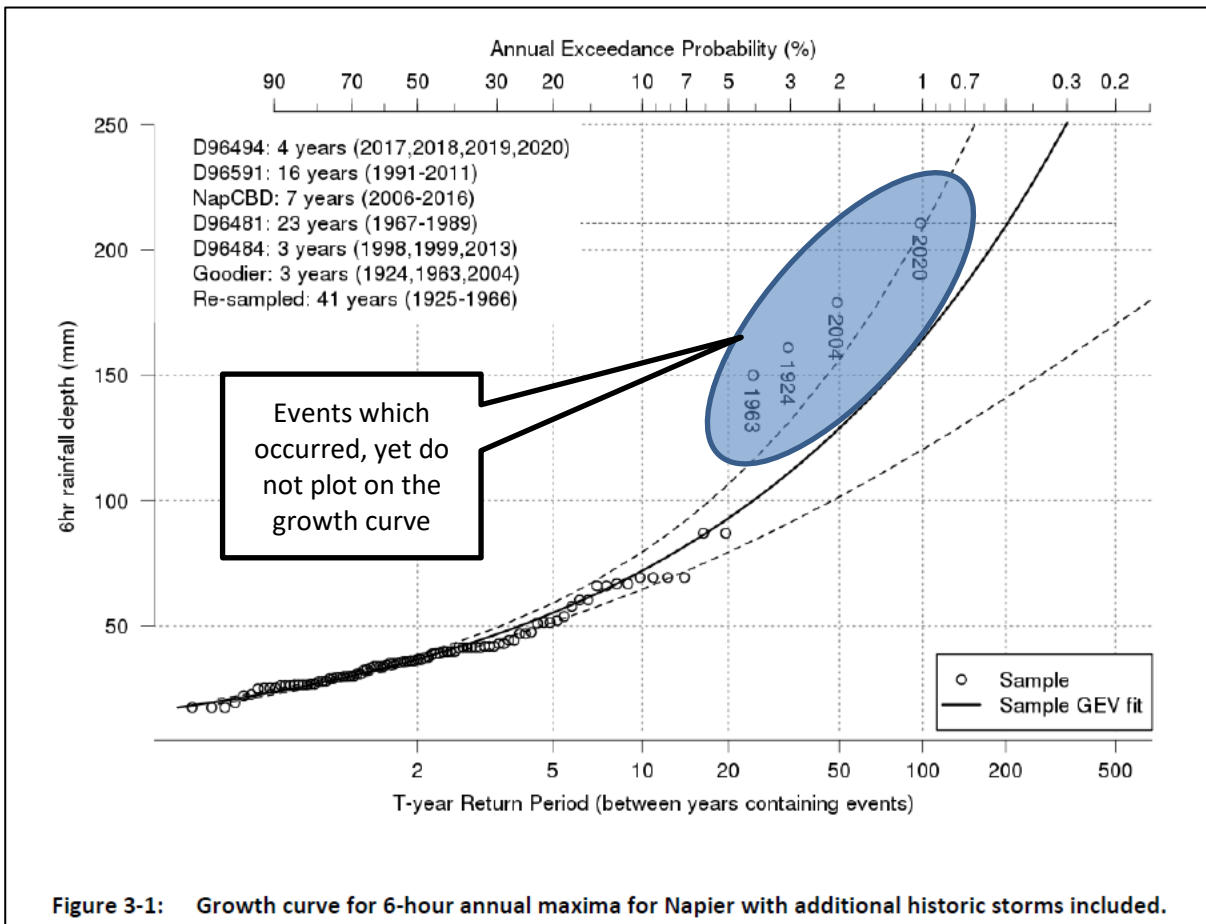
The problem with curve fitting to limited data can be seen in the chart provided by Cary-Smith, shown in Figure 9, where the highest 4 values recorded in the area do not plot on the curve generated from the Generalised Extreme Value (GEV) fit to the data.

Figure 9: Growth curve for 6-hour annual maxima for Napier with historic storms included (NIWA, 2021)

It can be seen from Figure 9 that the return period for the 6-hour maxima November 2020 event may have a range from 100 years to well over 500 years. This variation shows the difficulty in allocating a return period for an event based on rainfall statistics.

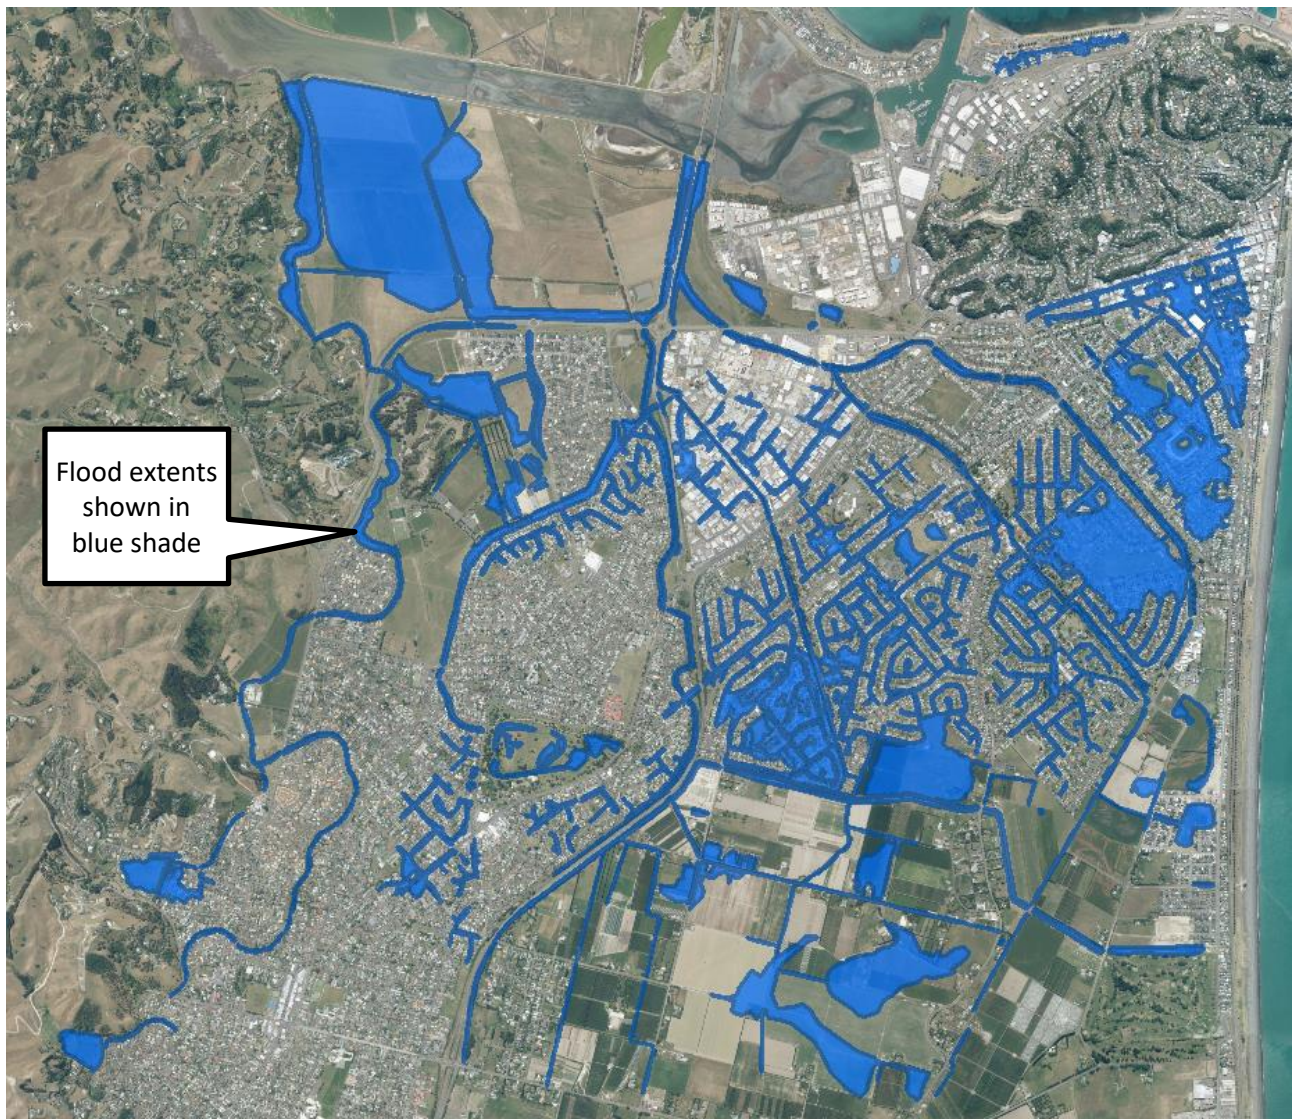
The main areas of flooding are shown in the image below. The areas shaded in light blue show where ponding of flood waters occurred during the event. In some areas the flood waters filled the streets but did not inundate homes or properties. Flooding on properties in some areas was exacerbated by vehicles creating waves as they tried to travel along flooded streets.

Figure 10: Flood extents from the 9th November rainfall event

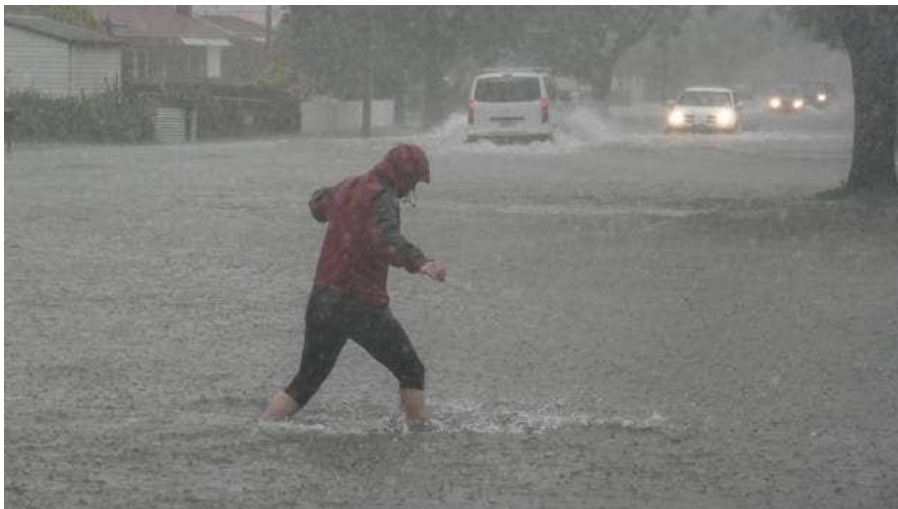
Maraenui was the worst area of flooding, with large areas inundated. The water remained for several days following the initial rainfall and many areas were unable to be accessed until nearly 36 hours after the event occurred. This area experienced peak flood levels between 1.4m and 2.2m (NZVD2016 vertical datum) during the event, with water depths up to 0.75m experienced in parts. A large majority of the impacted homes were in this area of the city.

Figure 11: A person crosses Nuffield Avenue during the event, 9th November 2020

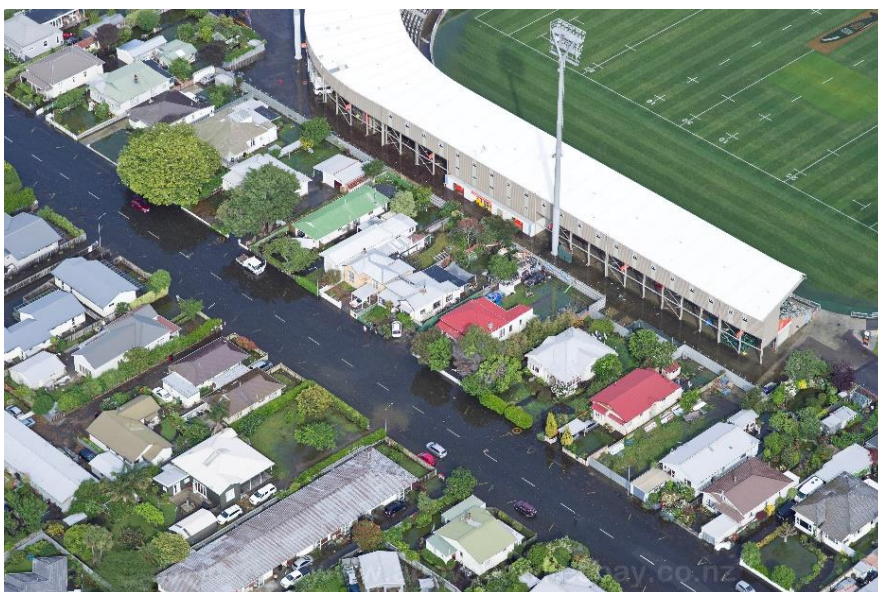
The suburb of Napier South was also severely impacted by the event, particularly in areas near Latham Street and along George's Drive. These areas experienced peak flood levels of up to 2.8m (NZVD2016), with water depths between 0.6m and 0.75m in some parts.

Figure 12: Latham Street and McLean Park flooding, 10th November 2020 (Photo credit – Peter Scott)

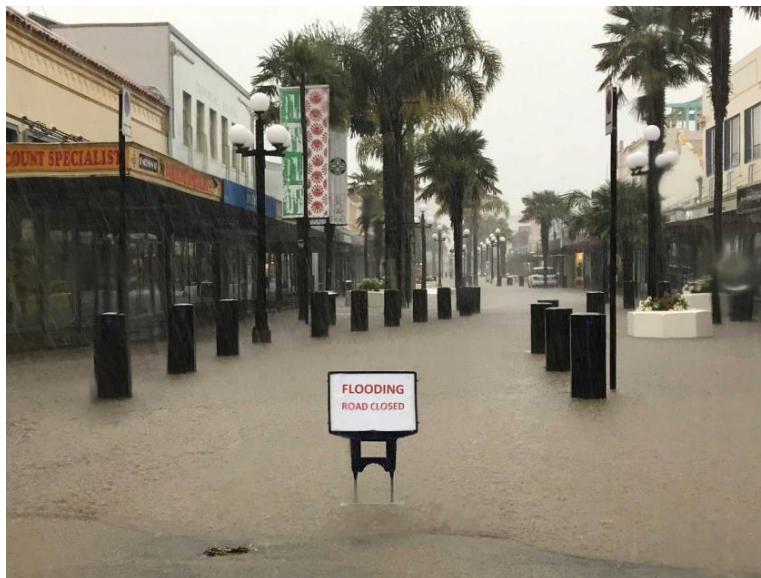
The Napier CBD experience severe rainfall and widespread surface flooding late in the afternoon of the 9th November. The worst surface flooding occurred in a number of streets including Thackery Street, Carlyle Street, Tennyson Street, Emerson Street, Munroe Street and Dalton Street. Water depths within the Napier CBD ranged between 0.2 – 0.7m, with the higher depths experienced in the south of the CBD.

Figure 13: Emerson Street flooding, 9th November 2020

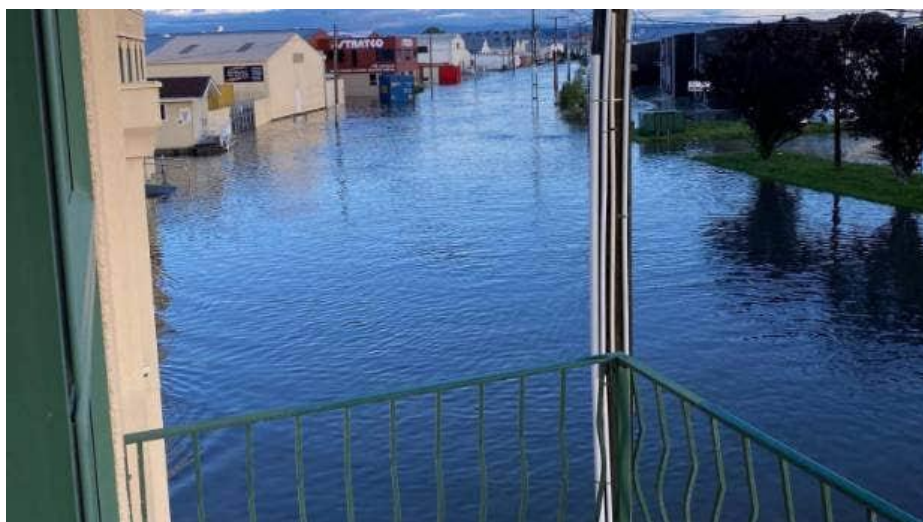
The industrial area of Onekawa experienced severe flooding in the vicinity of Ford Rd, Wakefield Street and Niven Street, resulting in flooding of several commercial properties. Water depths between 0.3m – 0.8m were experience in the area.

Figure 14: flooding on Niven Street, 10th November 2020

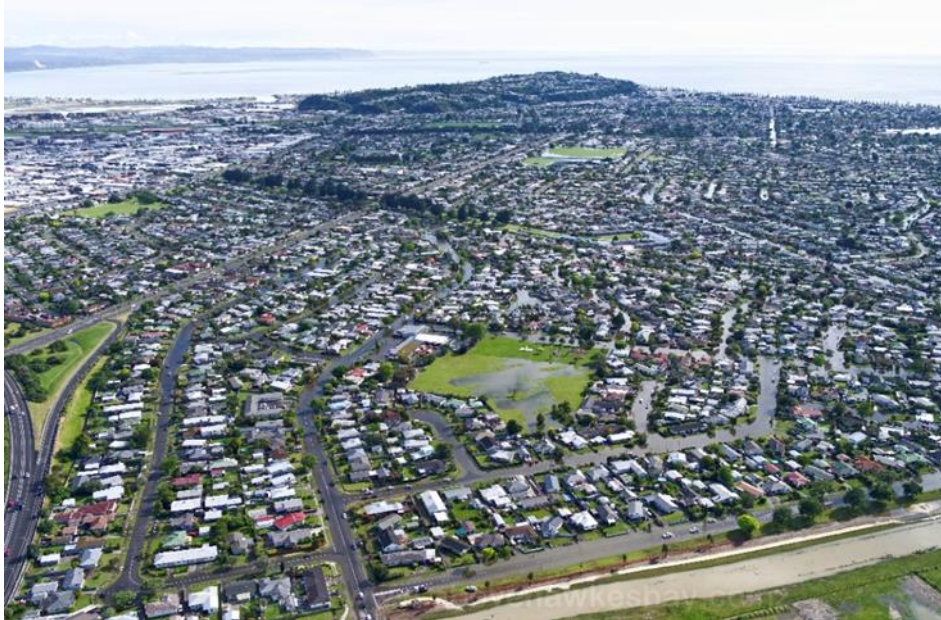
The suburb of Pirimai was impacted worst in the south of the suburb in the areas of Harold Holt Avenue and Bill Hercock Street. Flood levels in this area reached up to 0.9m in parts.

Figure 15: Flooding in southern Pirimai, 10th November 2021 (Photo credit – Peter Scott)

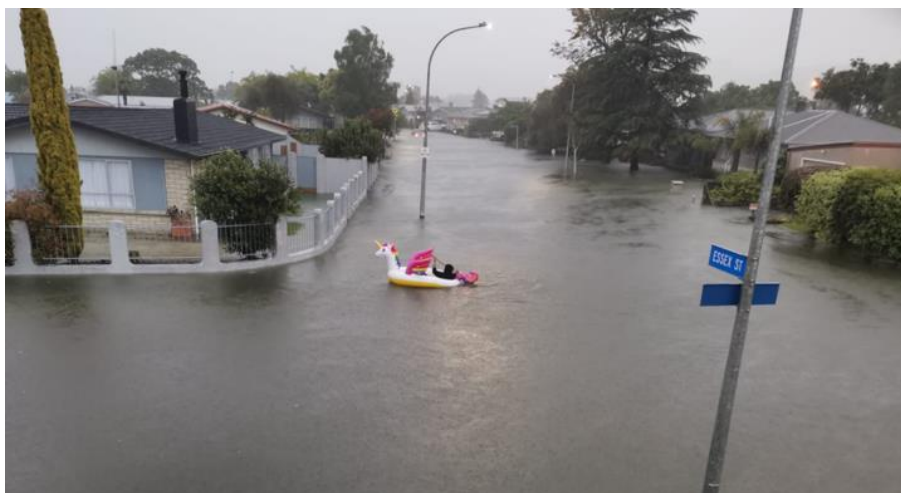
The area of Tamatea experienced surface flooding on a number of streets in the vicinity of Westminster Avenue and the Saltwater Creek. Water depths up to 0.2m were experienced in these areas.

Figure 16: Flooding in Exeter Street, 9th November 2021

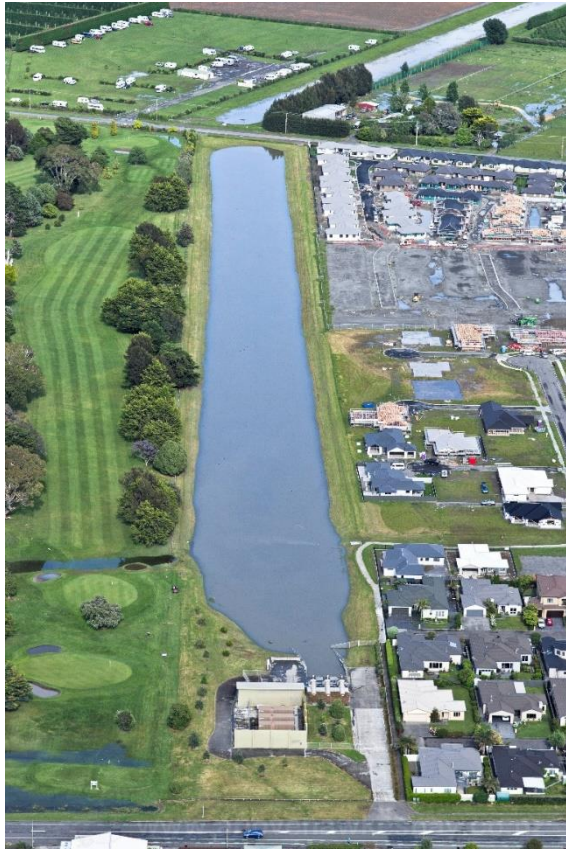
Figure 18: Cross Country pumping station, 10th November 2020 (Photo credit – Peter Scott).

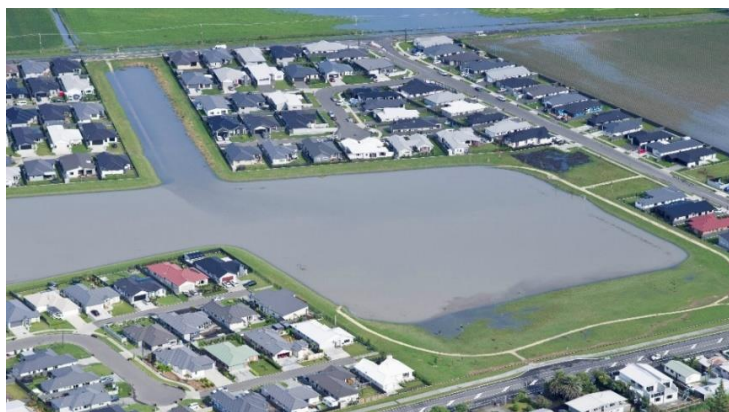
Figure 19: Stormwater storage pond, Te Awa, 10th November 2020 (Photo credit – Peter Scott).

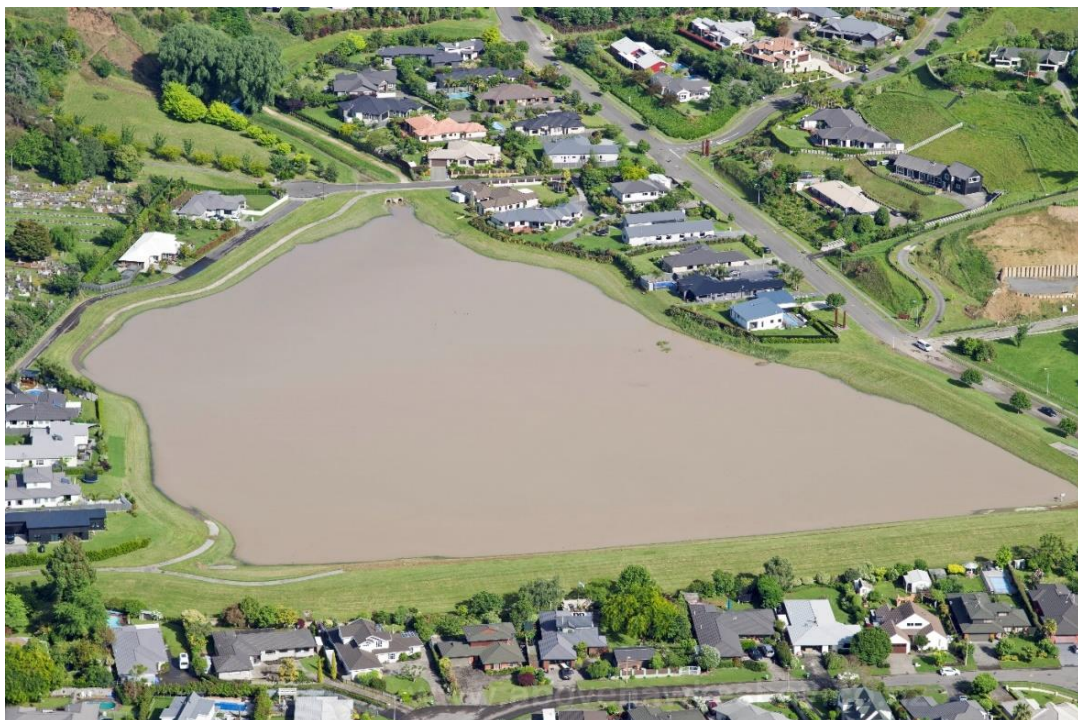
The flood level within the dam impoundment area reached just to the spillway crest level (~elev. 6.6m (NZVD16). Figure 26 shows the dam partly full on the morning after the flood (10th Nov.), while Figure 27 shows the record of the water level in the dam, and the times when the gate position was altered.

Figure 26 Halliwell Dam post flood, 9am 10th November (Photo credit – Peter Scott).

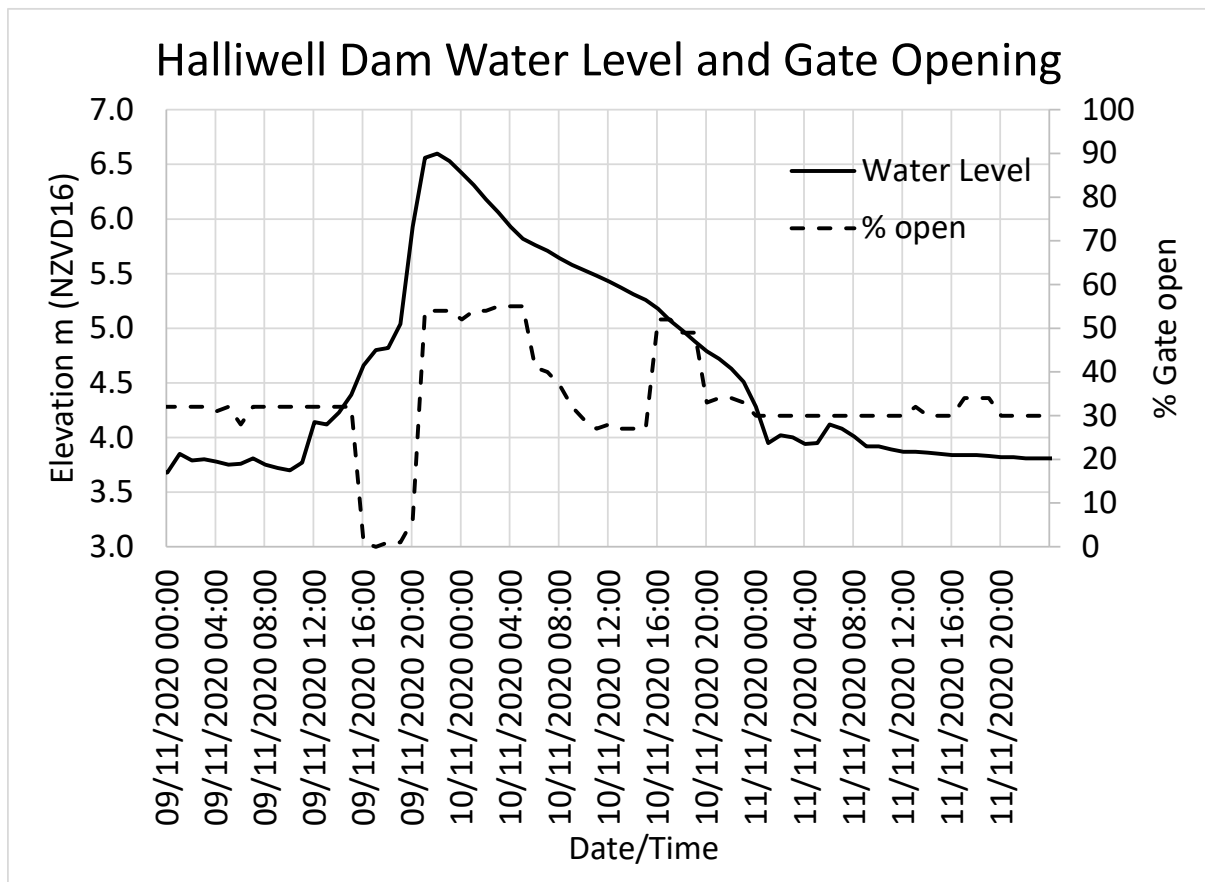
Figure 27: Halliwell Water level in dam, and % gate open

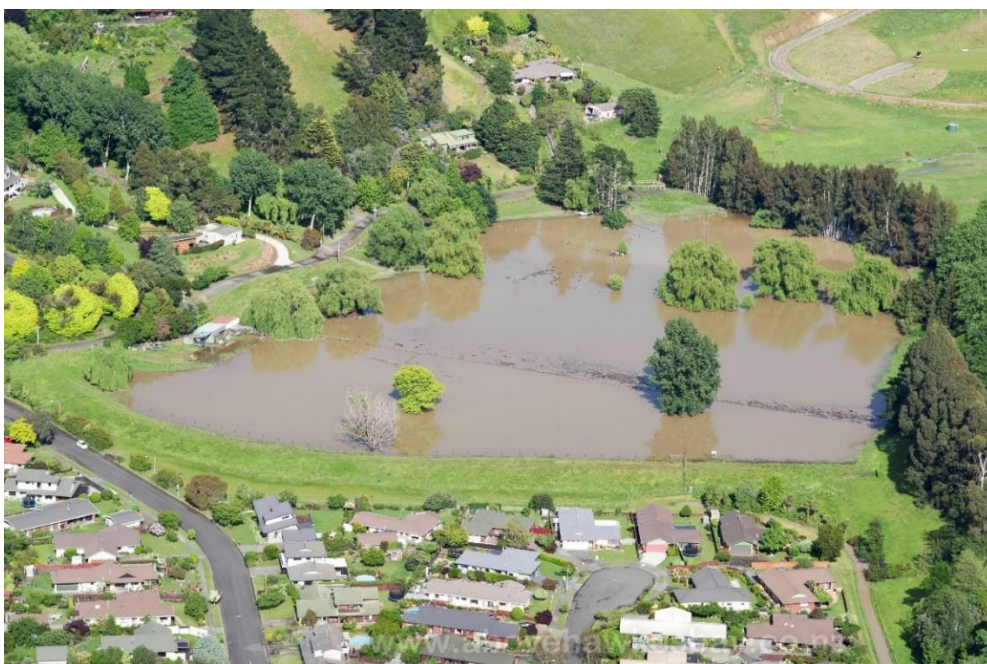
Figure 28 shows O’Dowd dam partly full on the morning after the flood (10th Nov.), while Figure 29 shows the record of the water level in the dam, and the times when the gate position was altered.

Figure 28: O’Dowd Dam post flood, 9am 10th November (Photo credit – Peter Scott).

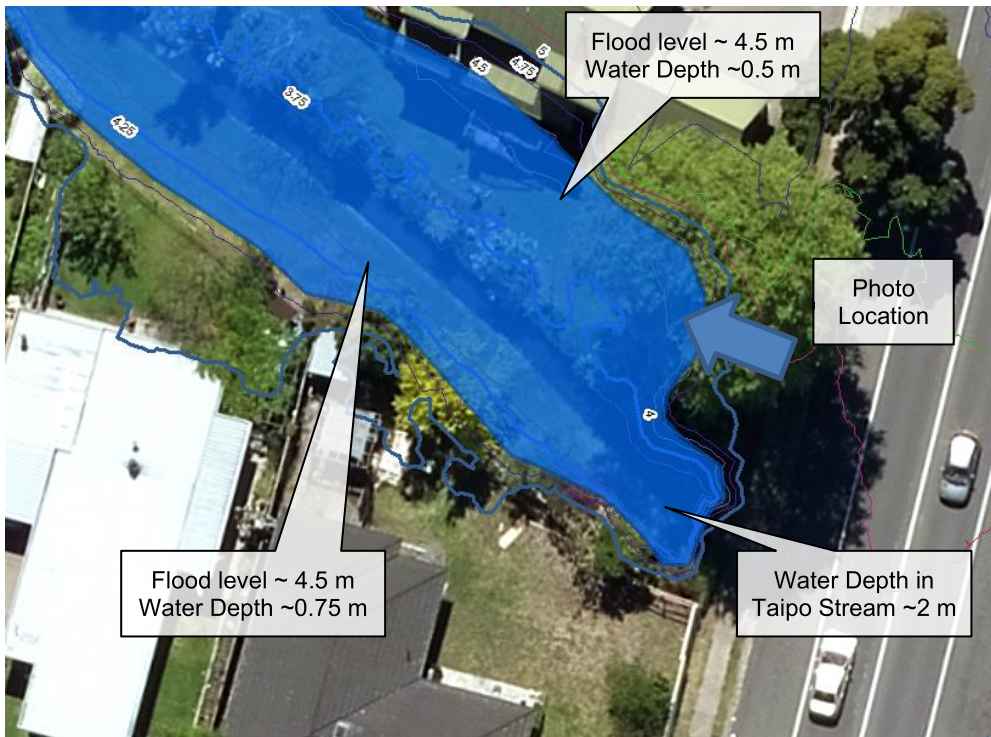
Along the Taipo Stream, water levels were high, with flood levels above the normal low flow channel, rising to cover the berm areas in most places. A comparison of observed flood levels to modelled flood levels at the lower Church Road bridge indicates the return period for the flooding along the Taipo stream is in the order of 10 years in this location. At the Ngarimu Road/Church Road crossing the observed flood level was approximately elev. 4.5m. At this location, the modelled 50-year flood level is elev. 4.85m, indicating the event likely had a return period of less than 50 years in this location. Figures 30 and 31 show the details of this location.

Figure 31: Taipo Stream flood extents u/s Church Road near Ngarimu Cres.

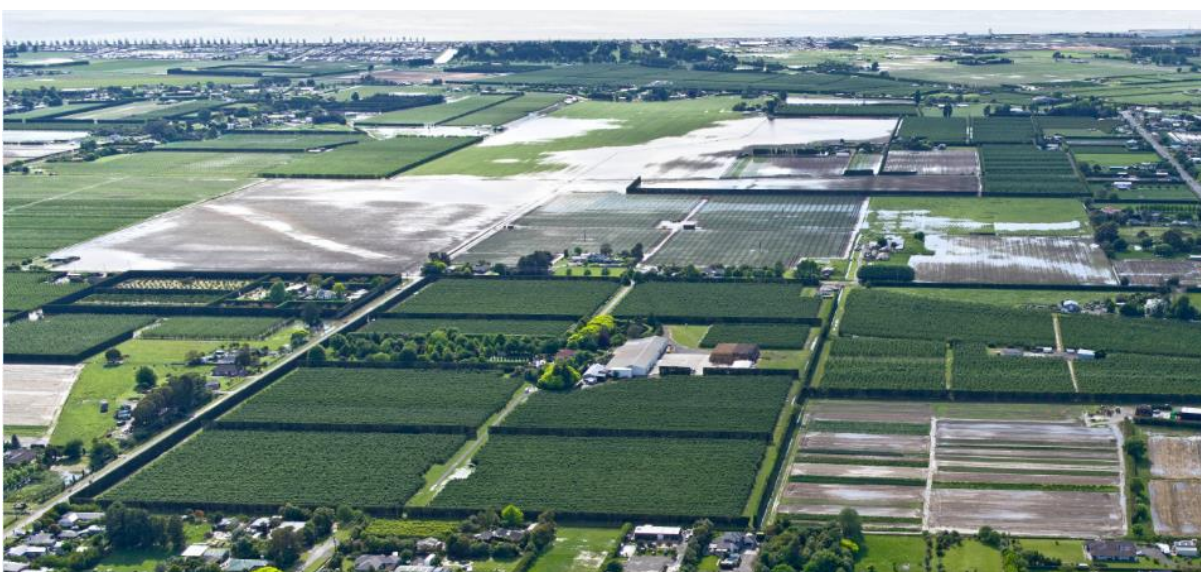
In the Meeanee area, upstream of the Waverly pump station, there was significant flooding of the rural land as seen in Figure 35 and Figure 36.

Figure 35: Flooding in Meeanee Catchment (taken 9:30 am, 10th November) (Photo credit – Peter Scott).

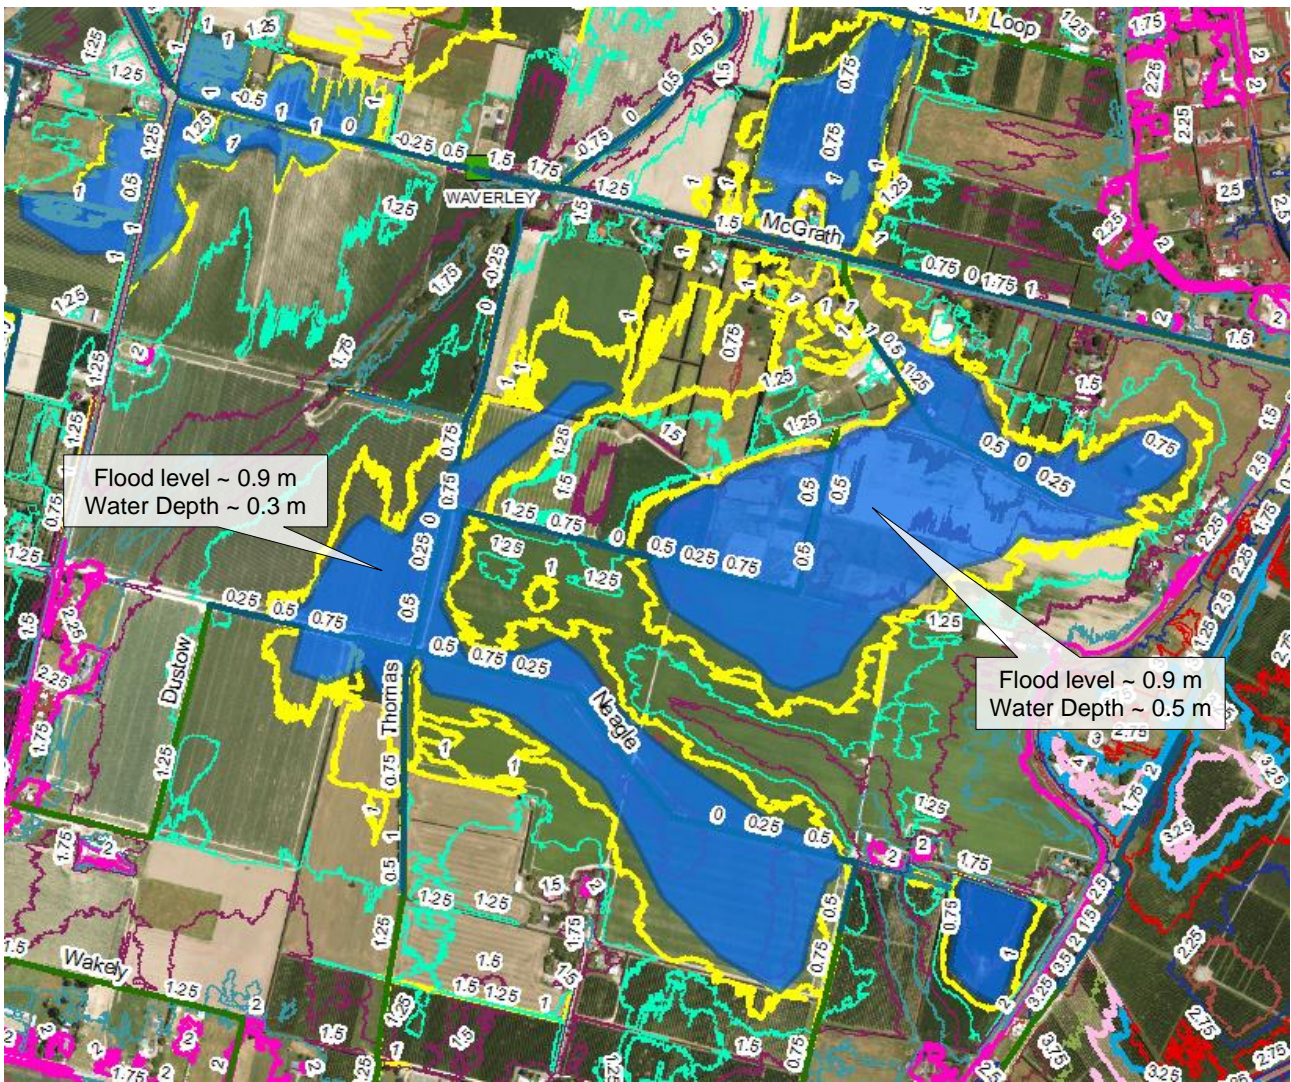
Figure 36: Flood extents in Meeanee catchment

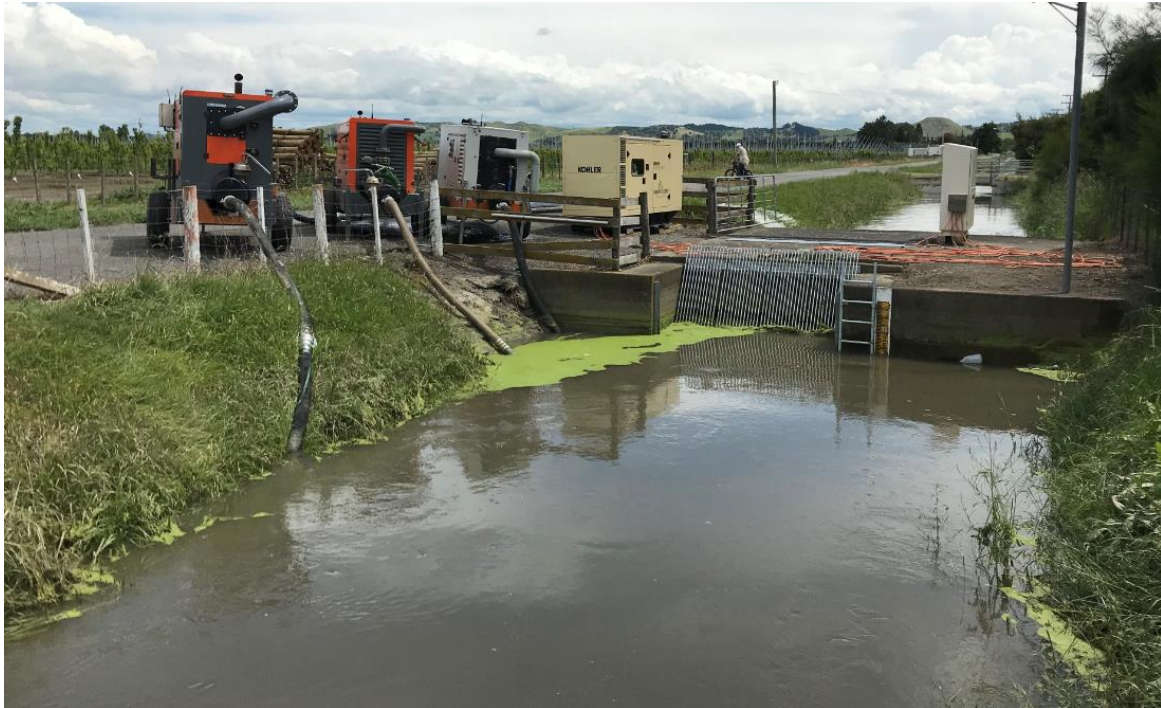
The Waverley pump station suffered a power outage at 8:53pm 9th November until 6:05 am 10th November. A generator was brought in to power the station and three mobile pumps were also temporarily located at the Waverly pump station in order to help speed the clearance of the flooded rural areas (Figure 36).

Figure 37 Mobile pumps and generator at Waverely pump station

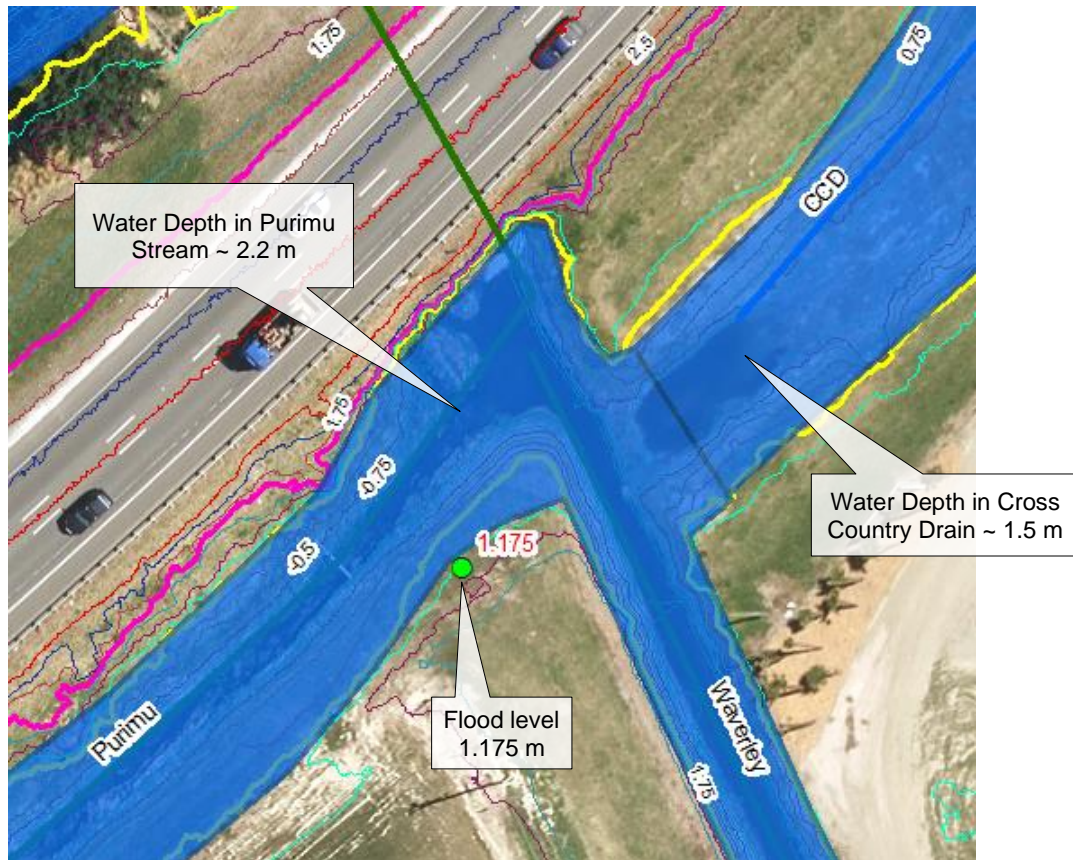
The Purimu Stream has an overflow to the Cross-Country Drain (CCD) just upstream of the Hawke's Bay Expressway, as shown in Figure 38. The overflow starts activating when the water level rises above elevation -0.3m (NZVD16). Note the elevation of this overflow is below sea level (-0.3m), as are most of the invert of the drainage system in the Napier/Meeanee catchment. Figure 39 shows the observed flood extents and the surveyed flood level of elevation 1.175 m (NZVD16). Figure 40 shows the area from the air the following morning.

Figure 39: Flood extents and level at Purimu overflow to CCD (contour datum NZVD16)

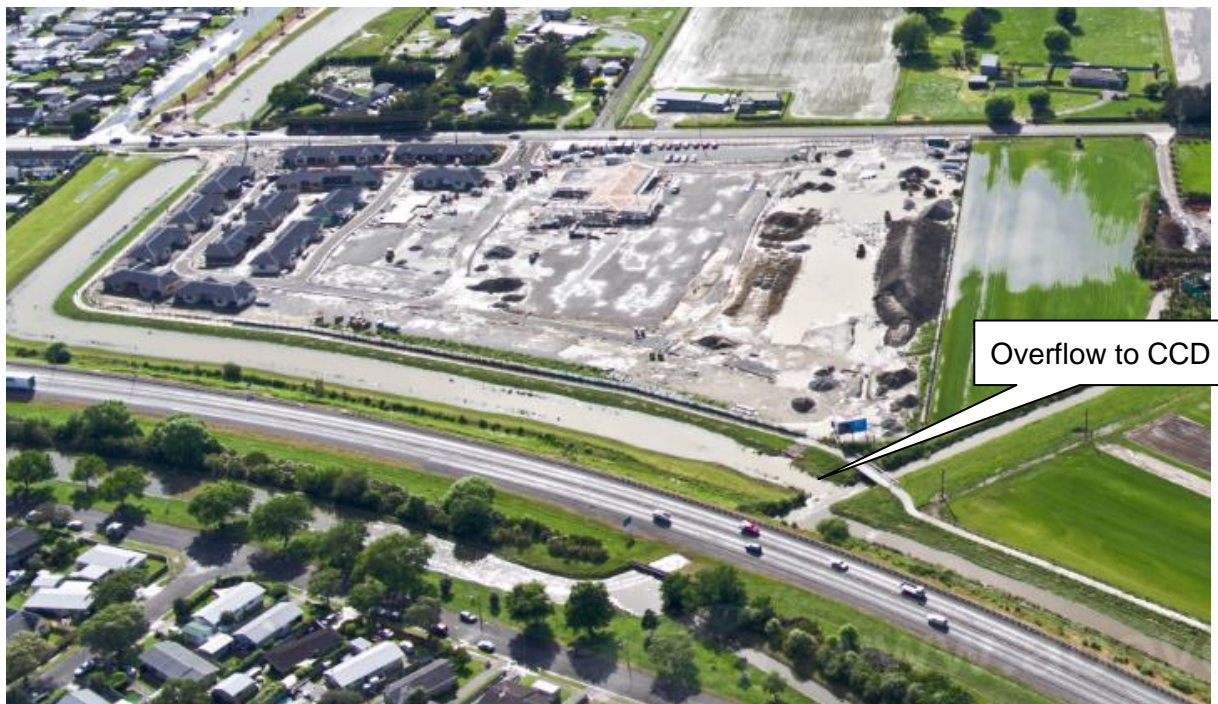
Figure 40: Purimu overflow to CCD Nov. 10, 9am (Photo credit – Peter Scott).

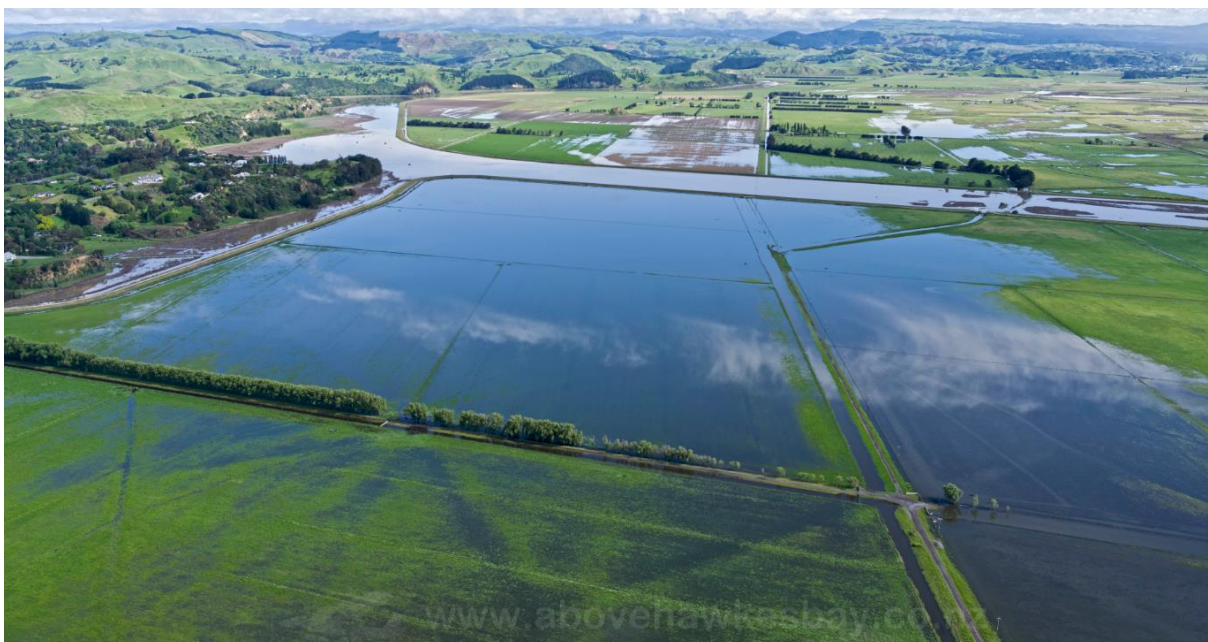
Figure 46: Flooding in Lagoon Farm (photo taken 8.17am 10th November)

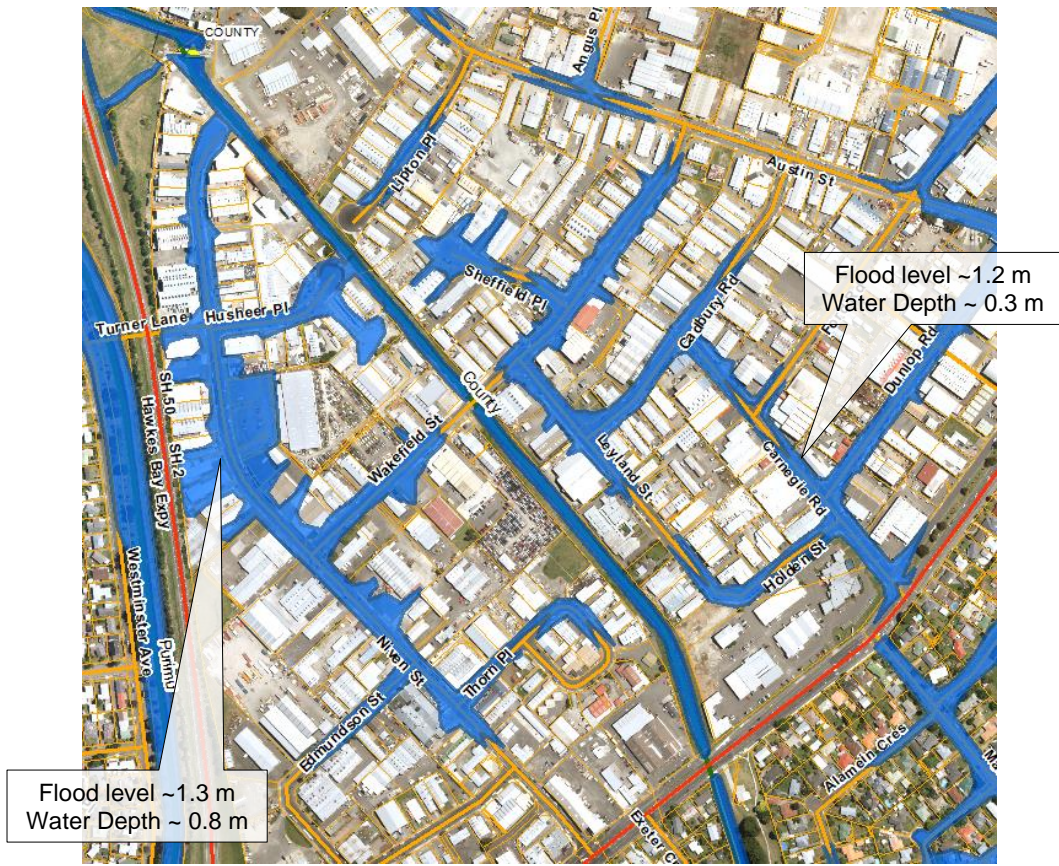
The Onekawa Industrial area had significant surface flooding, with flood extents shown in Figure 56, and an example of flooding with a floating container along Niven Street in Figure 57.

Figure 56: Flood extents Onekawa Industrial (datum NZVD16)

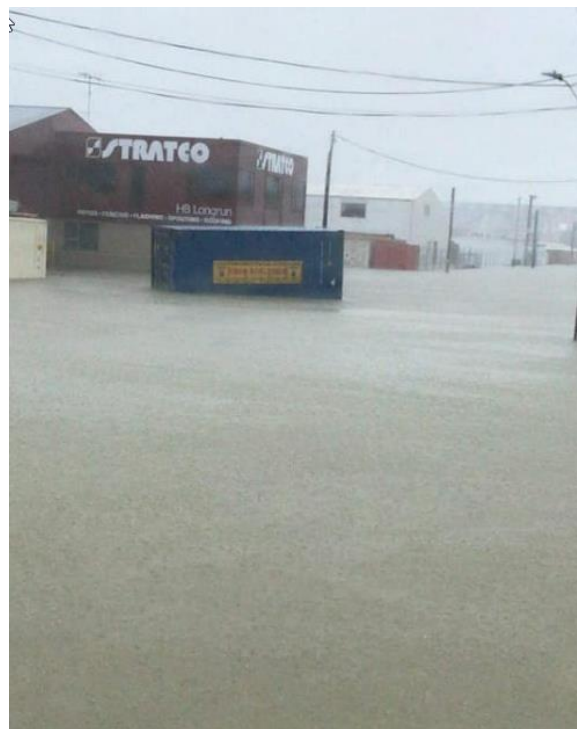
Figure 57: Flooding on Niven Street, Onekawa Industrial

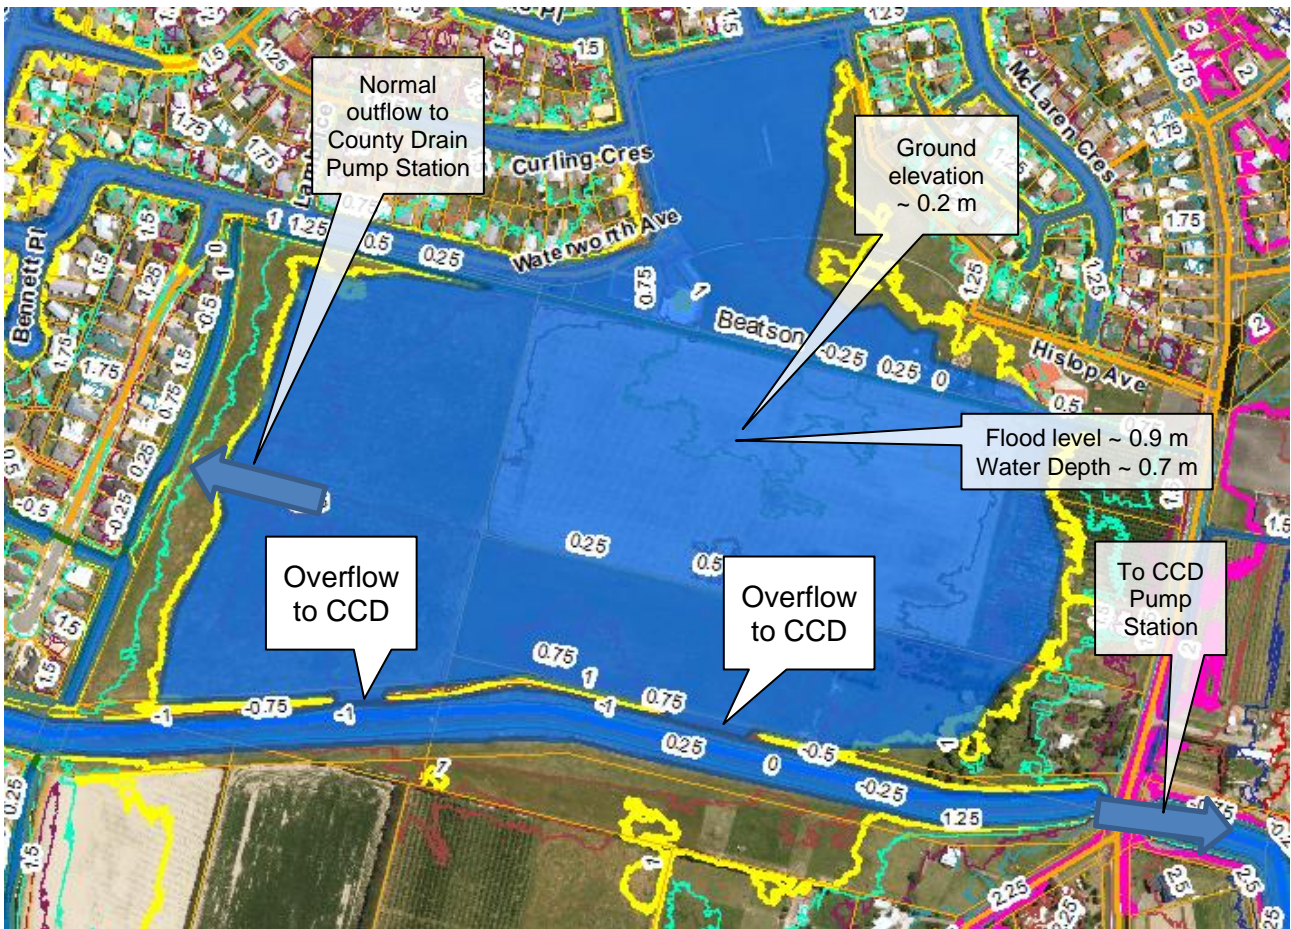
The Beatson Drain catchment is the lowest lying area in the County catchment, with ground levels starting at elevation 0.25m (NZVD16), as shown in Figure 58. The overland flow is from east to west, with outflow to the County Drain.

Flooding in this portion of the catchment was significant, with the extents shown in Figure 58, and evidence of overflow to the Cross Country Drain shown in Figure 59.

Figure 58: Flood extents, Beatson Drain (contour datum NZVD16)

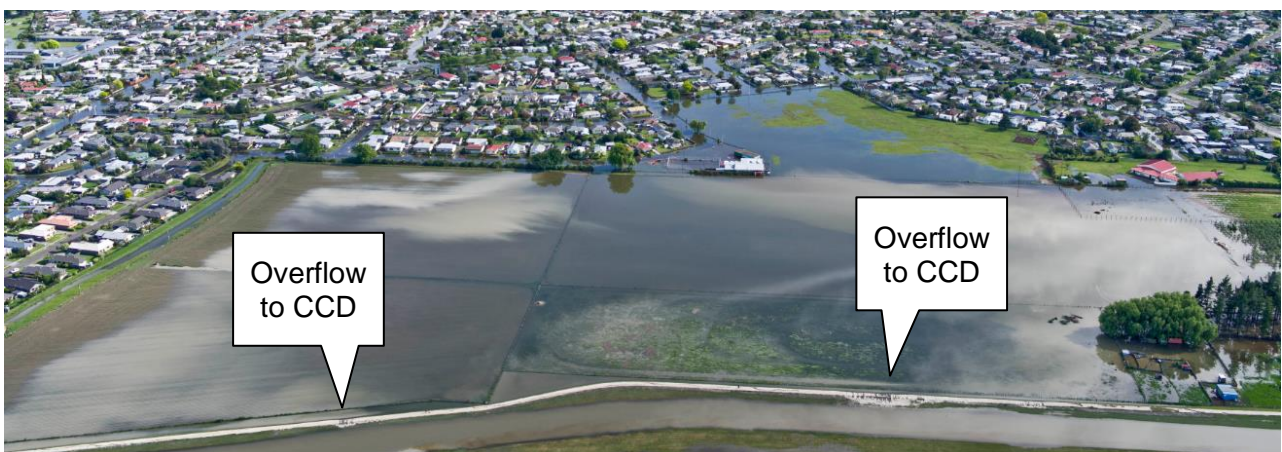
Figure 59: Photo of Flood extents, Beatson Drain 8am, 10th November (Photo Credit – Peter Scott)

The overflow evidence indicates the peak water level in the area reached just below elevation 1.0m (NZVD16), with water overtopping the CCD stop bank in the areas where the bank is just below elevation 1m.

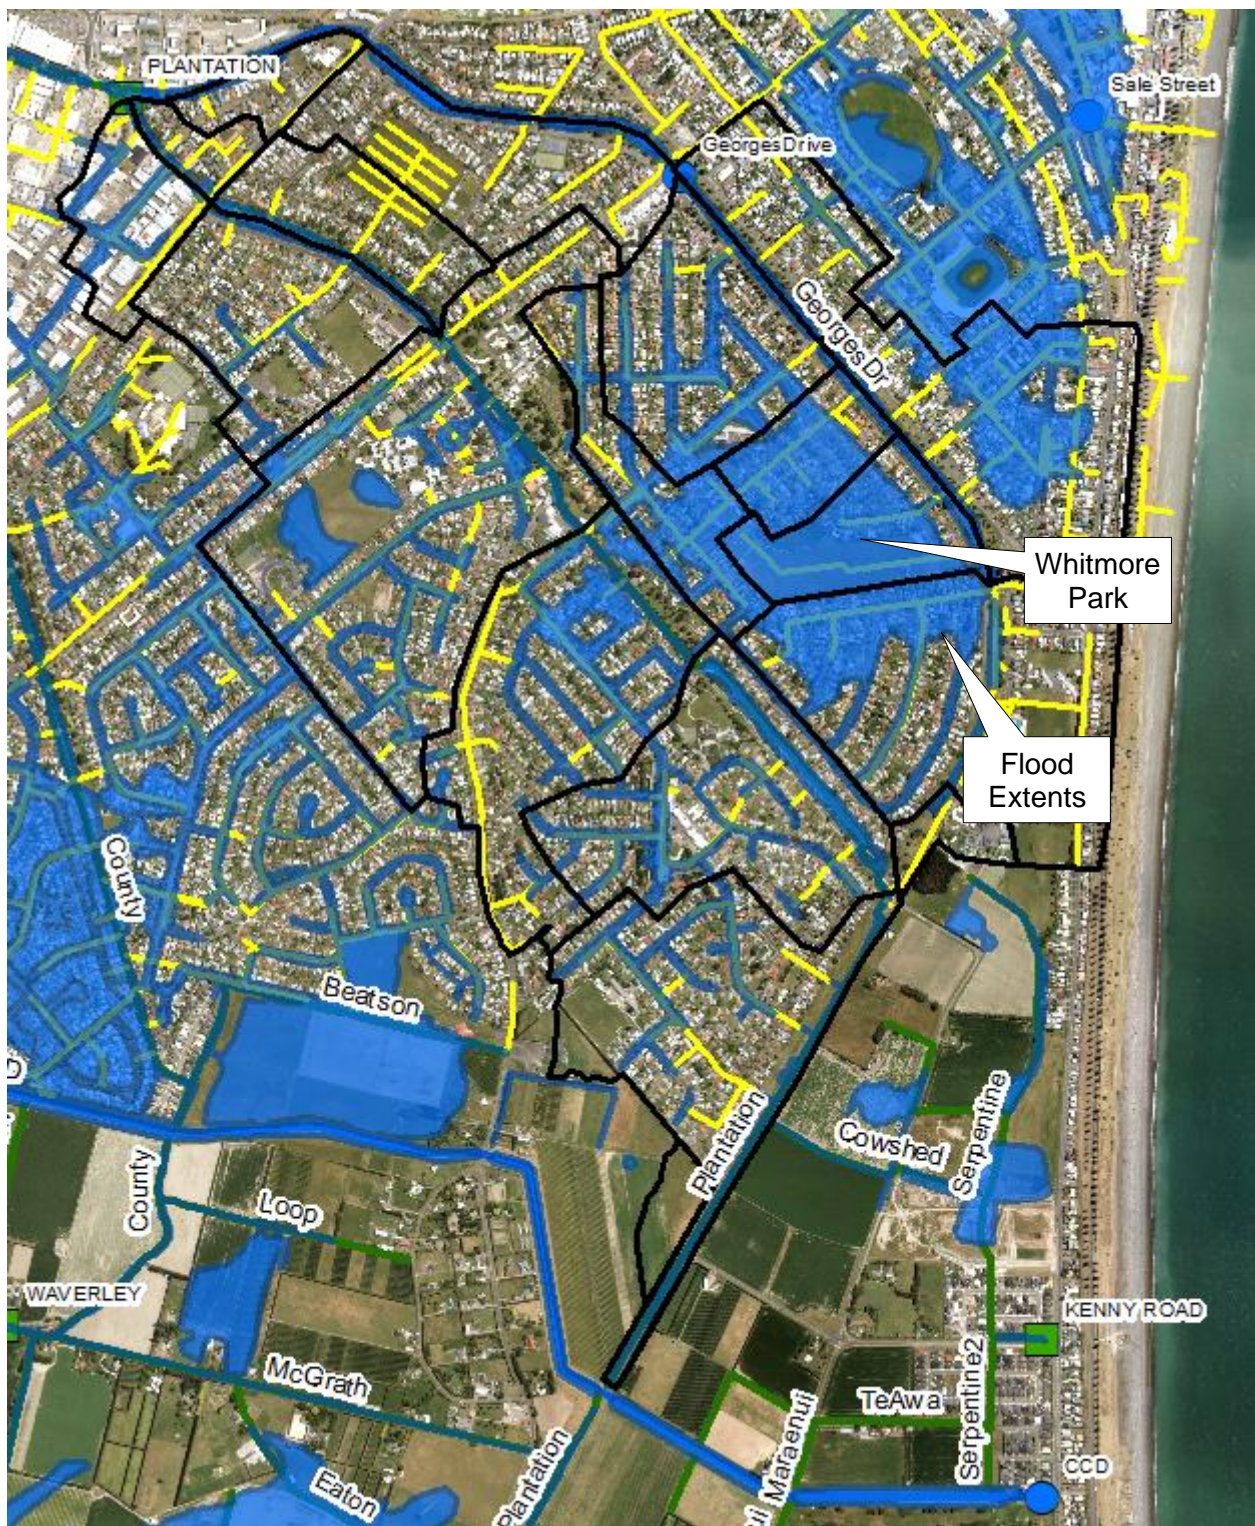
Flooding in this area was severe, in particular in the Whitmore Park and surrounding suburbs, as shown in Figure 64. Numerous properties suffered from surface ponding, and many houses and other buildings were inundated to various levels.

Figure 64: Flood extents in Plantation and Georges Drive Catchments
