Napier Rainfall Event November 2020

Hazard Report

Hawkes Bay Regional Council Publication No. 5551

Jim Tetlow, Toa Consulting
Craig Goodier, Team Leader Engineering
Lisa Pearse, Team Leader Hazard Reduction

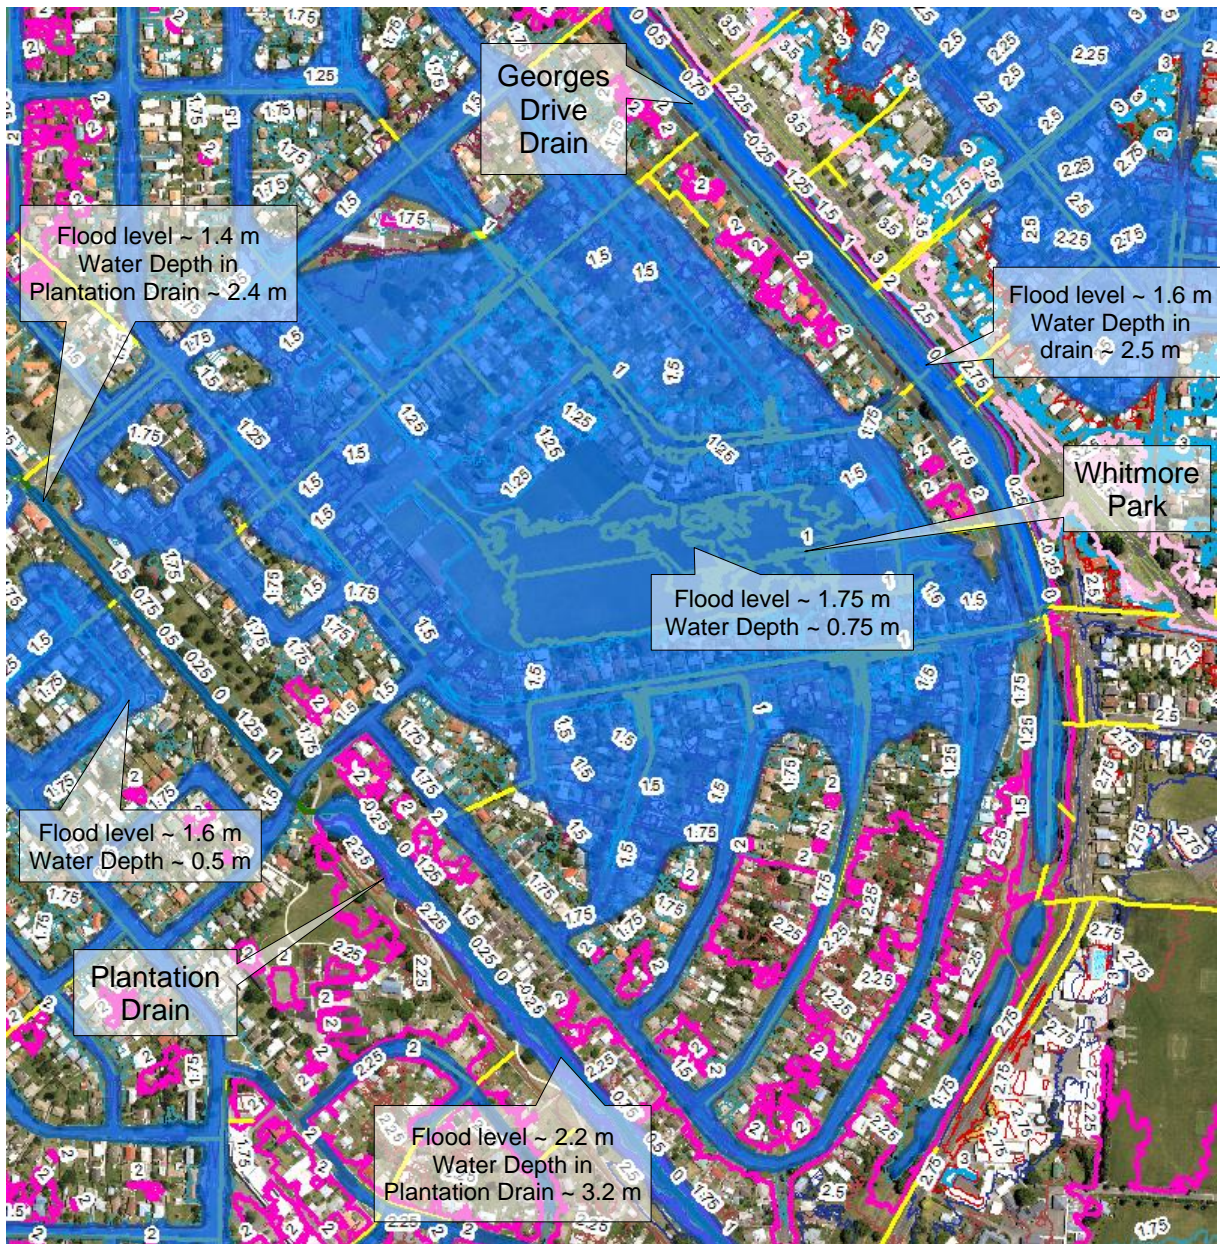
Figure 65 shows the ground level contours in this area, with the lowest elevations being at 1m above sea level (NZVD16) around Whitmore Park. Flood levels in this area peaked around elevation 1.75m.

Figure 65: Flood extents in Plantation and Georges Drive Catchments (contour datum NZVD16)

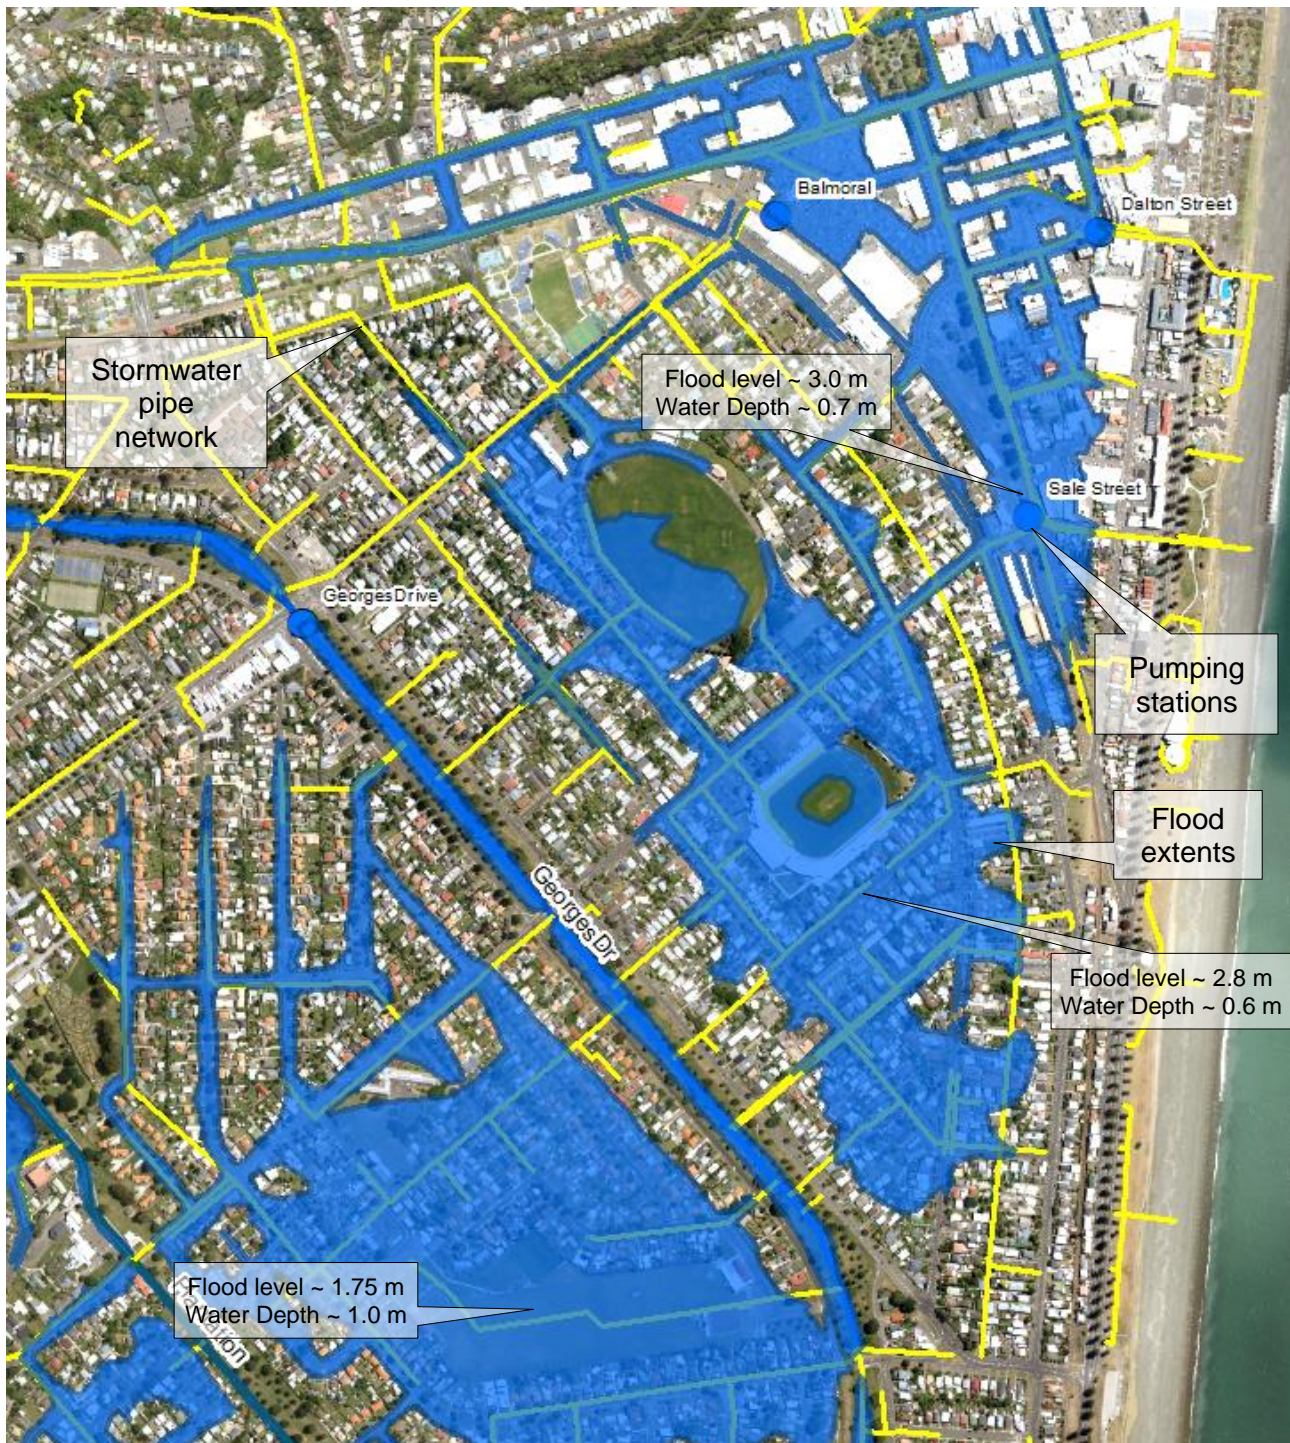
Figure 69: Flood Extents for Napier CBD and Napier South (datum NZVD16)

The CBD is mostly impervious surfaces, and surface flooding occurred very quickly as the stormwater flowed off the southern part of Napier Hill and into the streets. Flooding extents are shown in Figure 69.

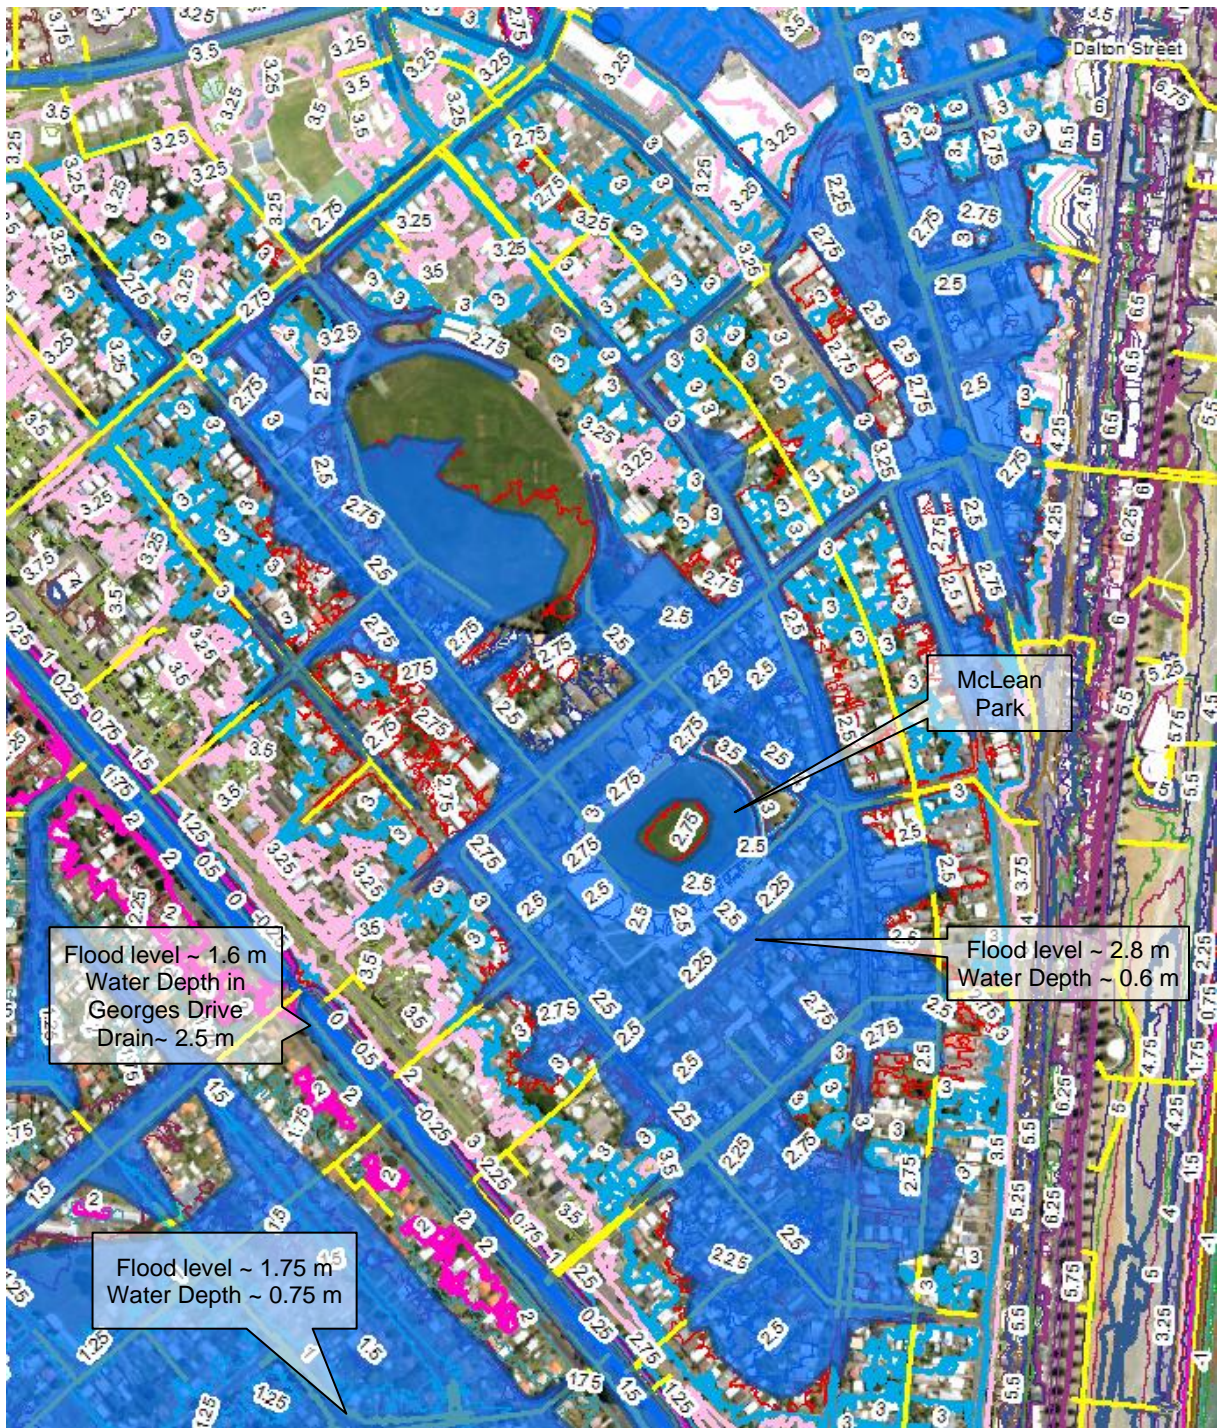
Figure 70: Flood Extents Napier South – (contour datum NZVD16)

In Napier south, extensive flooding of property including many houses occurred in the area from Nelson Park to the south of McLean Park, as shown in Figure 70.

It can be seen clearly from the contours the area around McLean Park is a basin surrounded by land at about elevation 3m (blue contour). The exits for stormwater from this area are from the pump station at Sale St, or by the pipe network connected by gravity to Georges Drive drain, which is then pumped. The combination of water from this area of Napier South and Marewa arriving at Georges Drive pumping station results in delays in removing the stormwater in the area. It is quite likely that the delays in removing the flood waters from the Whitmore Park area (peak flood level ~1.75m) would have been exacerbated from the higher flood waters from around McLean Park (peak flood level ~ 2.8m). The approximate 1m higher water levels would essentially continue to hold the Whitmore levels high, until the McLean Park levels were reduced.

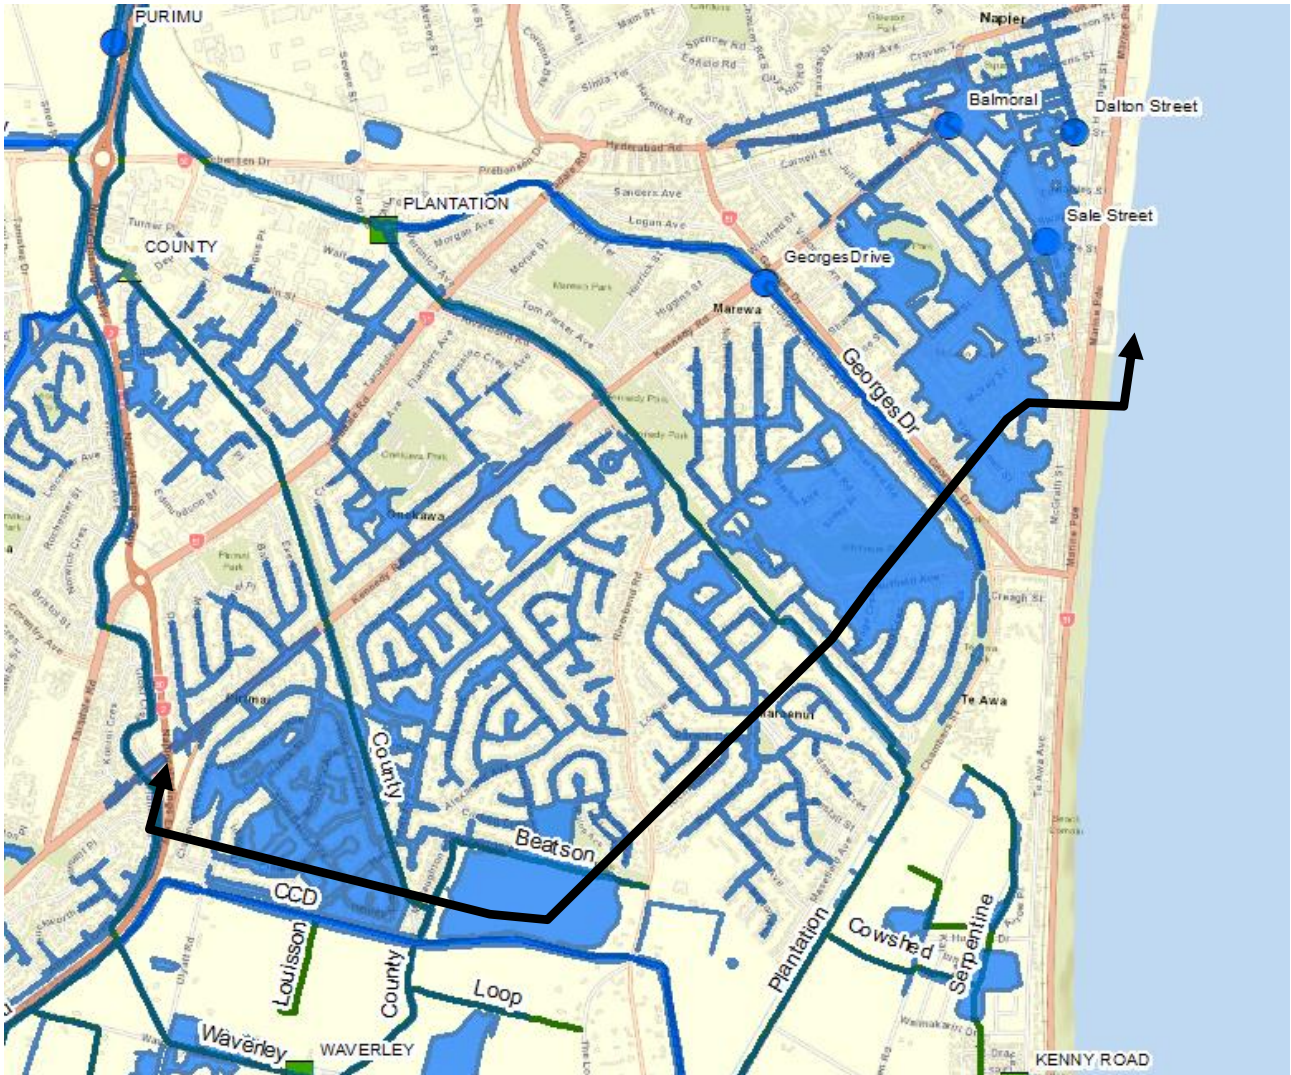
Figure 71: Location of Profile across Napier Suburbs

Figure 71 and Figure 72 shows the location and profile of the ground levels across Napier suburbs from the Motorway to the sea. The profile shows the various flood levels across Napier, including the issue described above where flood water from Napier South is higher in elevation, and would flow to Georges Drive Drain and maintain the high levels around Whitmore Park.

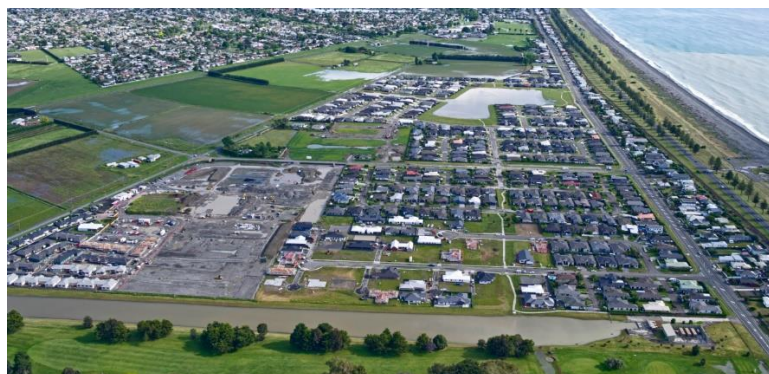
Figure 75: Te Awa subdivision showing detention pond, 8am 10th November (Photo Credit – Peter Scott)

Figure 75 shows the area in the morning after the event. While the pond area filled quickly, there were no reports of inundation of houses in this area.

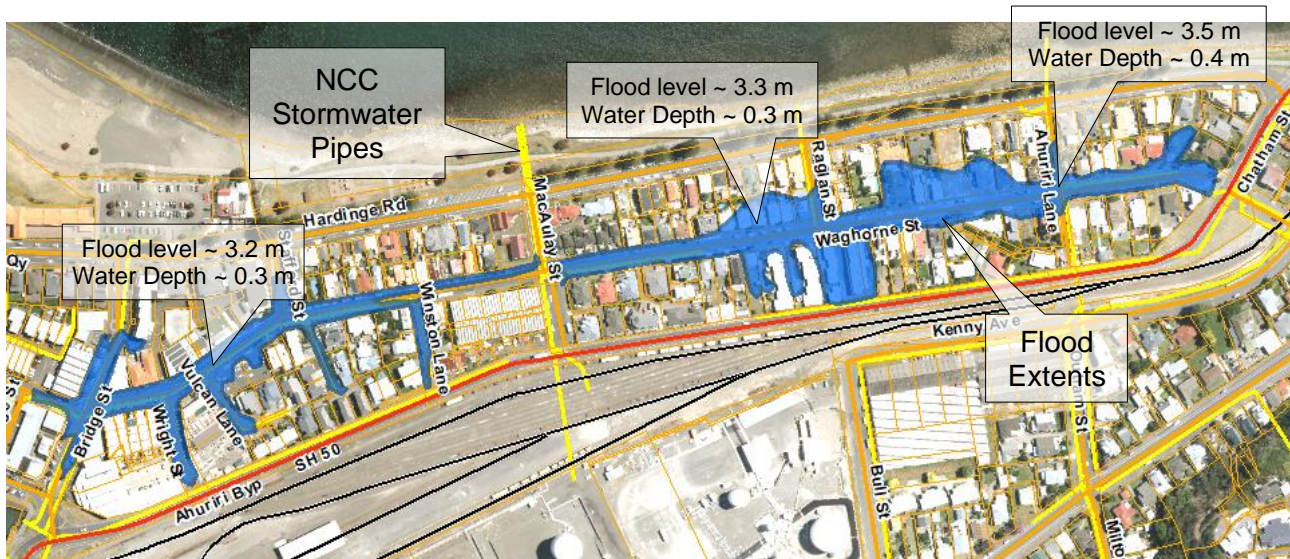
Figure 76: Flood extents in Ahuriri (contour datum NZVD16)

Waghorne Street in Ahuriri suffered significant flooding, with many properties and several houses inundated, as shown in Figure 76.

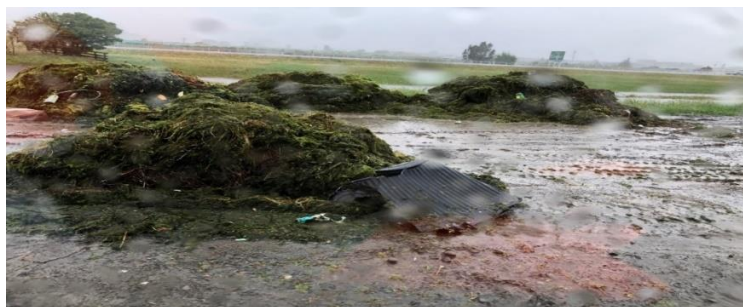
The majority of the flood water was removed in three days, with pump stations operating continuously. Power interruptions at some sites during the event may have resulted in some additional ponding within areas, but even without these interruptions it is highly likely the flooding would have still occurred on a similar scale. Debris clearance was an ongoing issue from the start of the event, and this required continual maintenance at sites to keep debris grates clear and pumps operating to their full capacity.

Figure 79: Debris removed from the inlet grates at the Purimu pump station, 9th November 2020

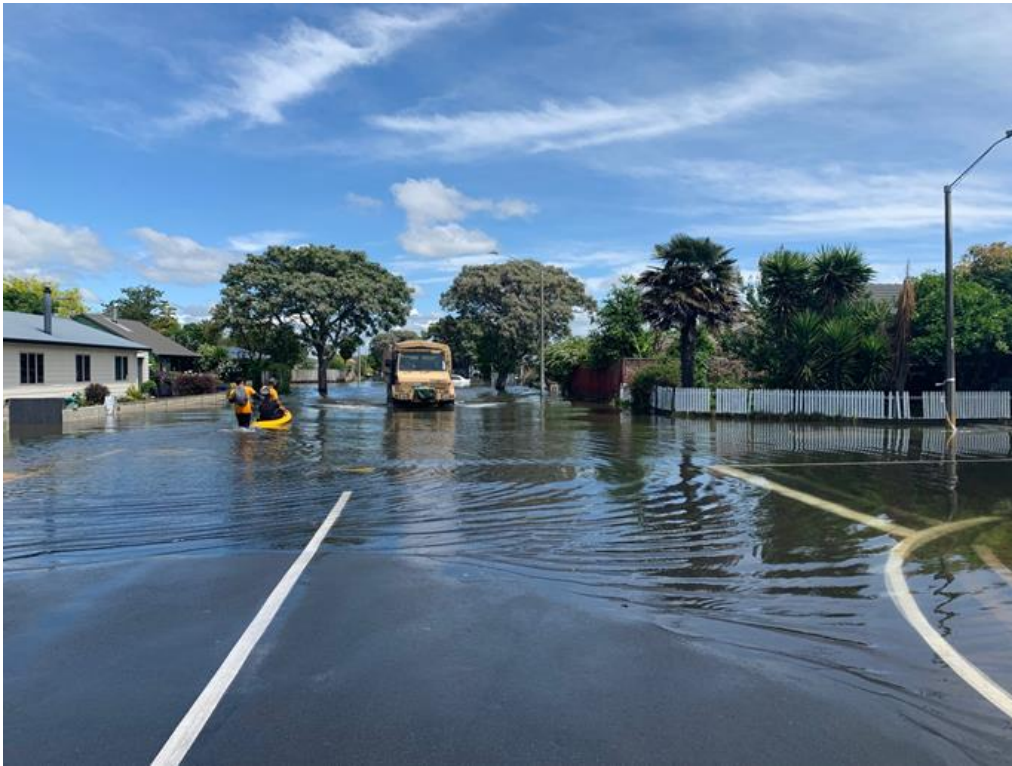
Figure 82: A New Zealand Defence Force Unimog supports people in flooded areas, Tuesday 10th November 2020

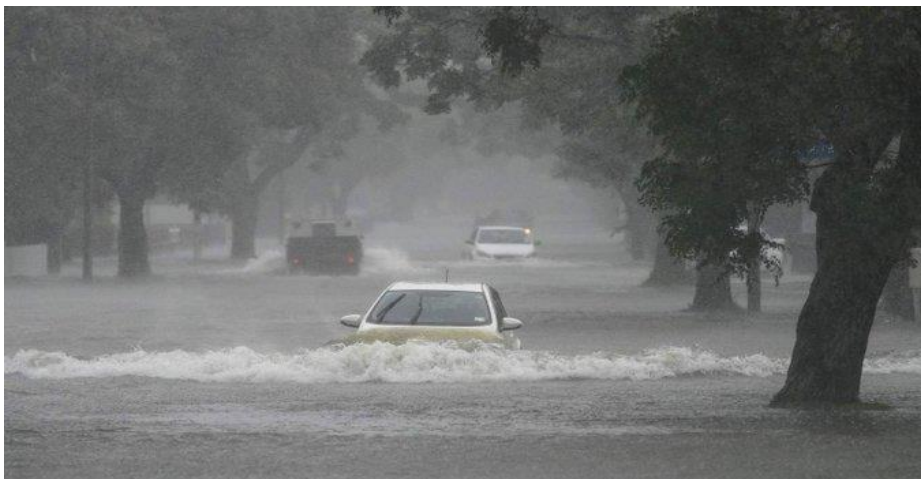
A high number of vehicle damage claims as a result of water damage were lodged following the event. In total 1447 claims were made for vehicle damage totalling \$12,214,302 in insured losses.

Figure 88: A car attempts to drive down Nuffield Avenue, 9th November 2020

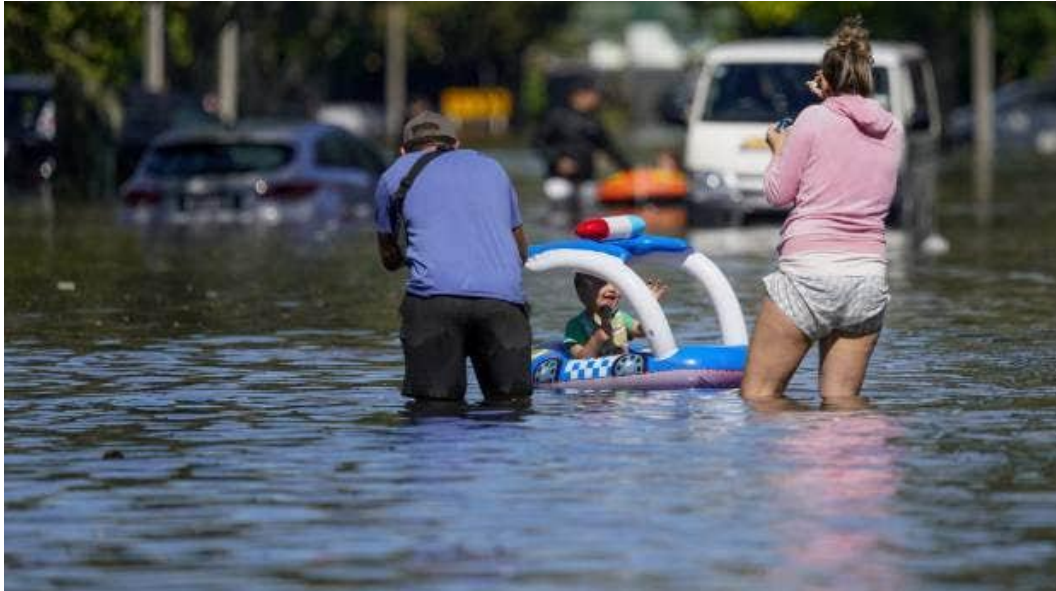
During the event Public Health and Napier City Council issued warnings regarding potential contamination within the flood waters and advised residents to keep out of the water. Many children and adults were seen within the flood waters over the following days. It is unknown if any illnesses occurred as a result of this.

Figure 89: A couple play with their child in the flood water.

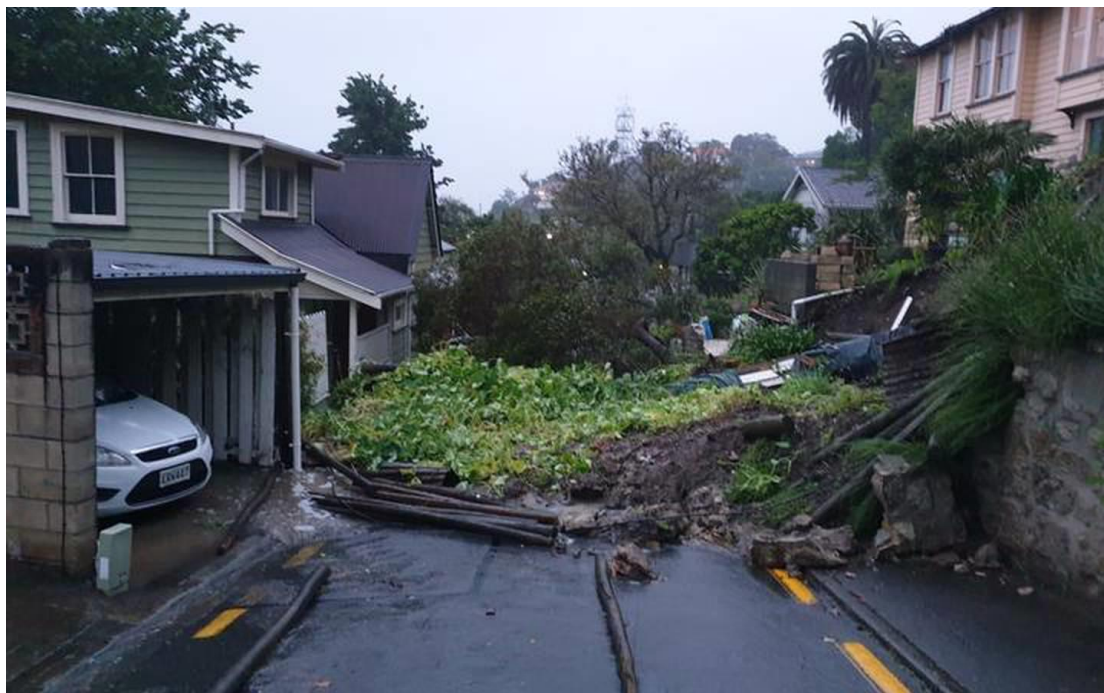
A large slip has affected houses on Brewster Street, Napier. Photo / RNZ

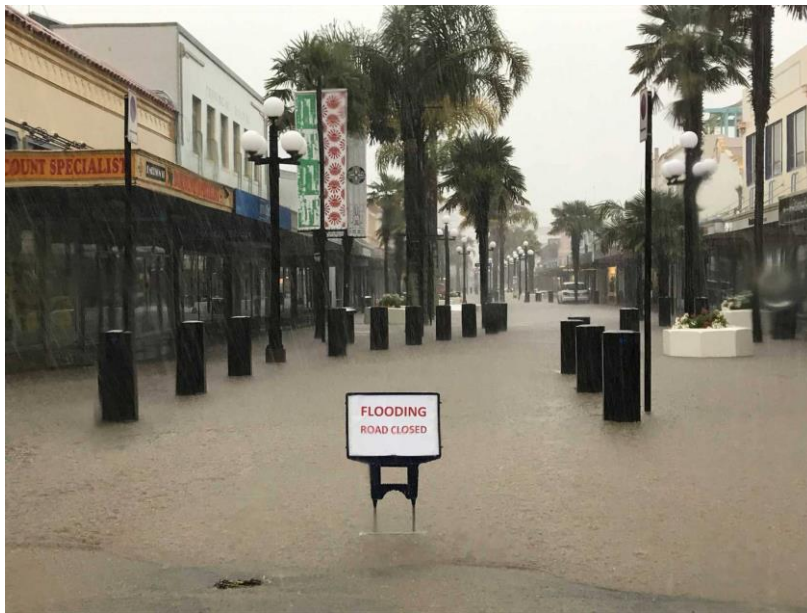
Much of central Napier is in flood after heavy rainfall in the city. Photo / Warren Buckland

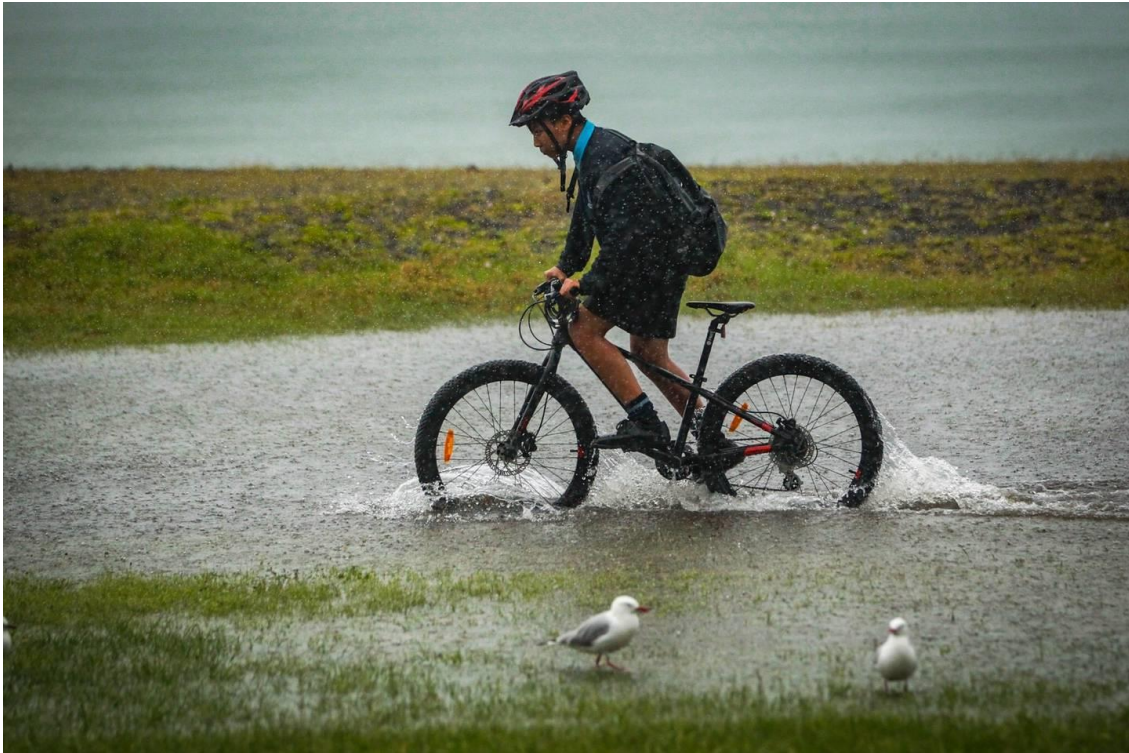
The effects of the heavy rainfall were evident on Marine Parade. Photo / Paul Taylor

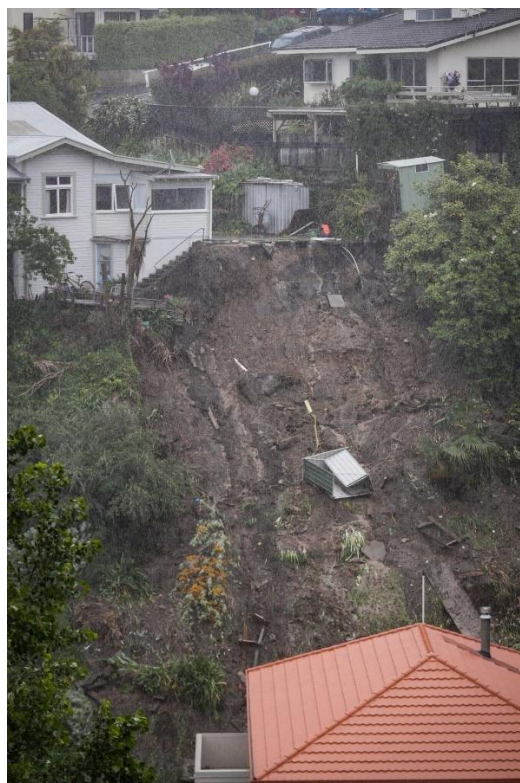
A number of slips have been reported across Napier. Photo / Warren Buckland

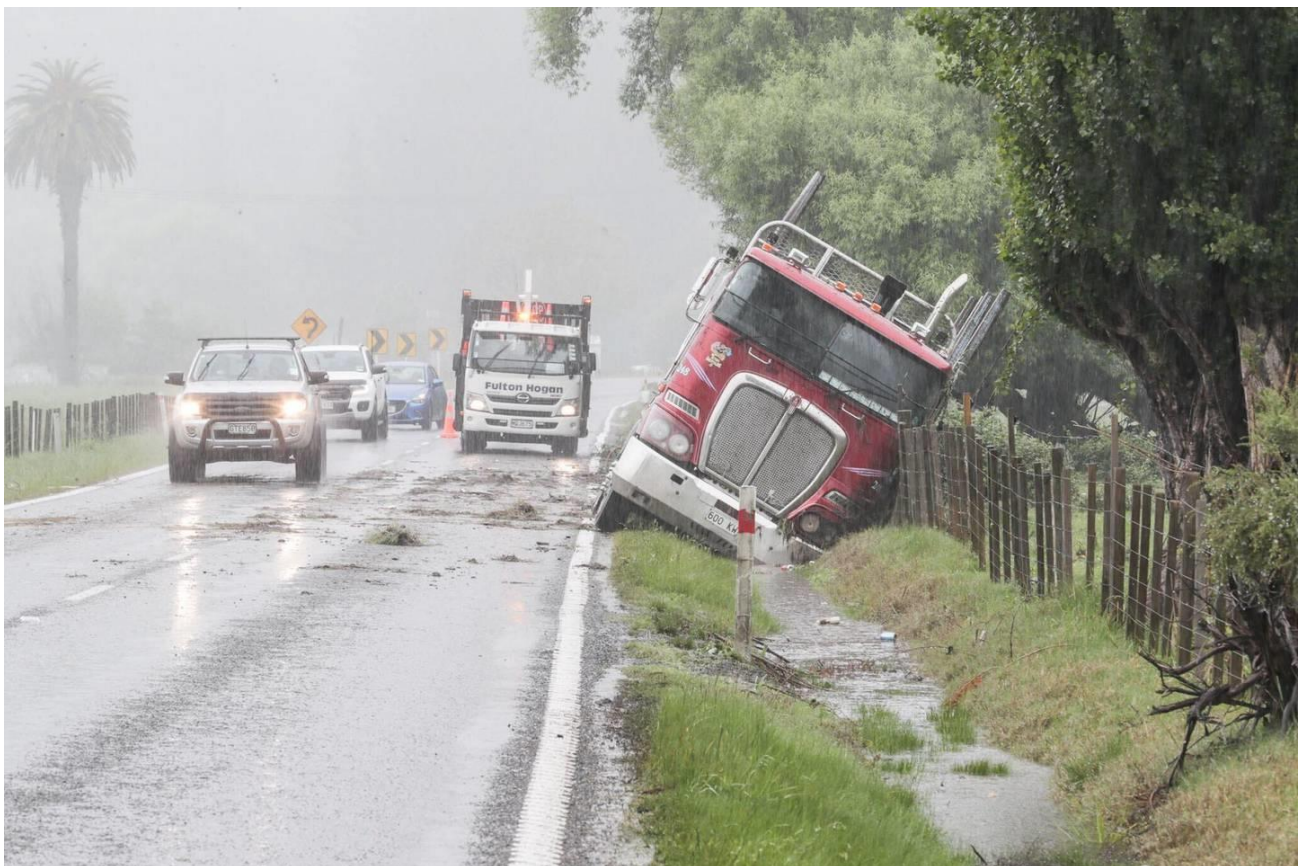
A logging truck ended up in a ditch on SH2 in wet road conditions on Monday morning. Photo / Warren Buckland

The northbound lane of State Highway 2, near Tangoio, was blocked after a logging truck slid into a roadside ditch.

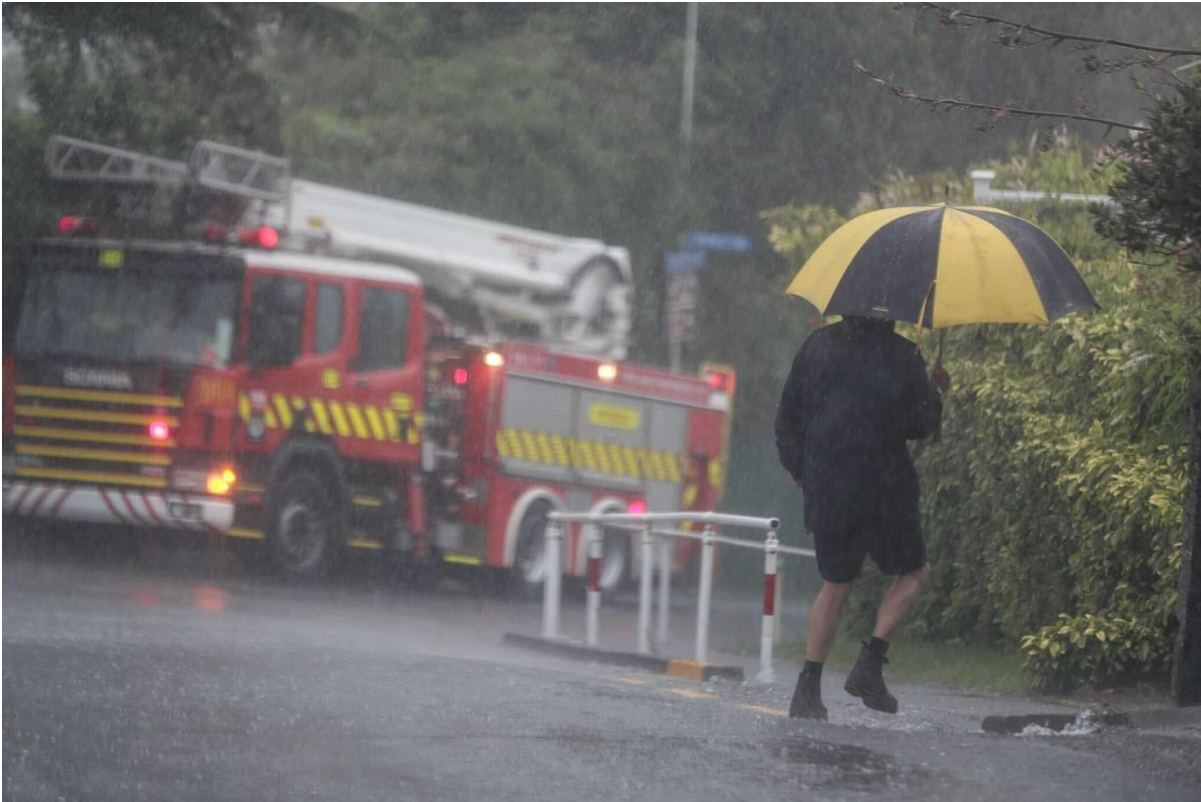
Firefighters responded to at least 150 weather-related callouts across the city. Photo / Warren Buckland

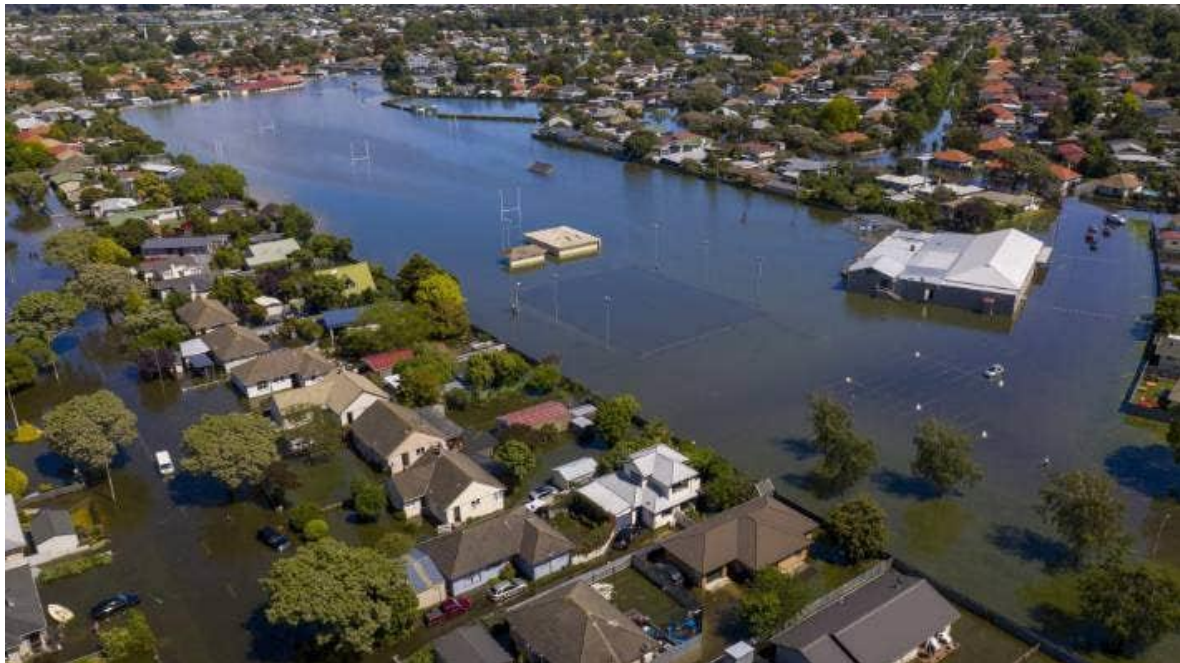
Last month's floods damaged about 600 properties, leaving many households still in short-term accommodation.

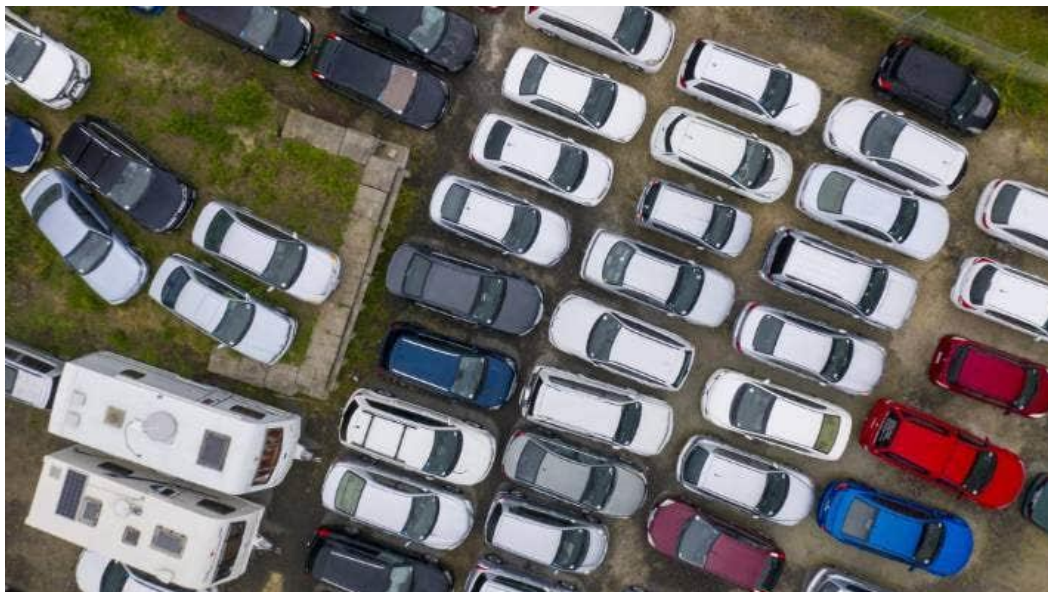
Written off cars from the Napier floods await their fate in Hawke's Bay car yards.

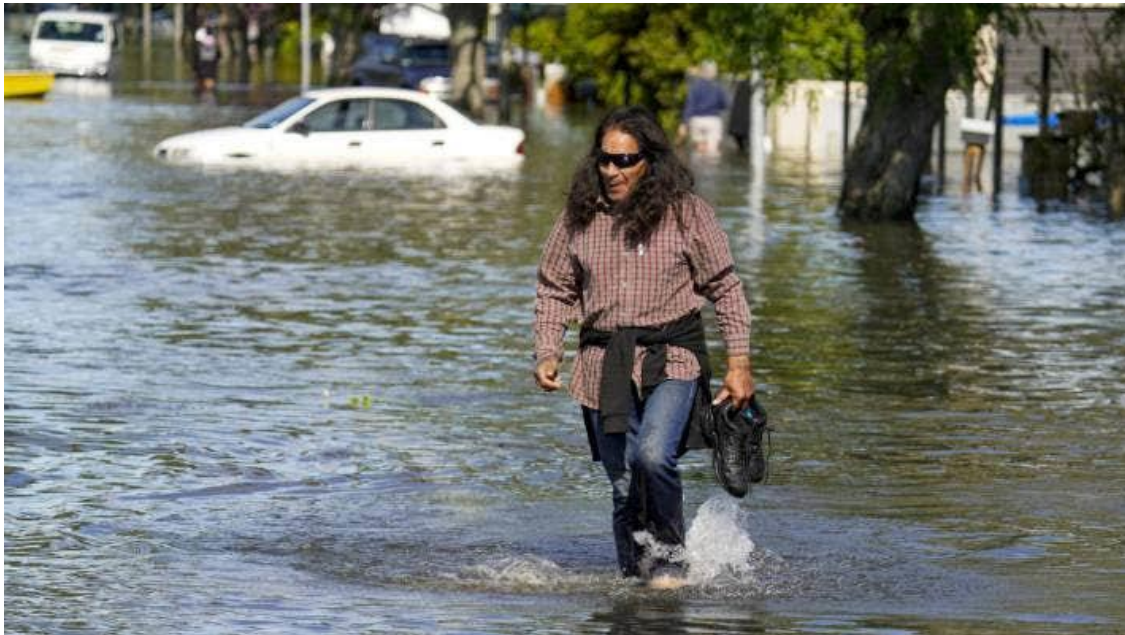
A Napier resident slogs their way through floodwaters on November 9.
