## Treatment Options for Coastal Erosion at Plimmerton Fire Station

Greater Wellington

09/02/2012

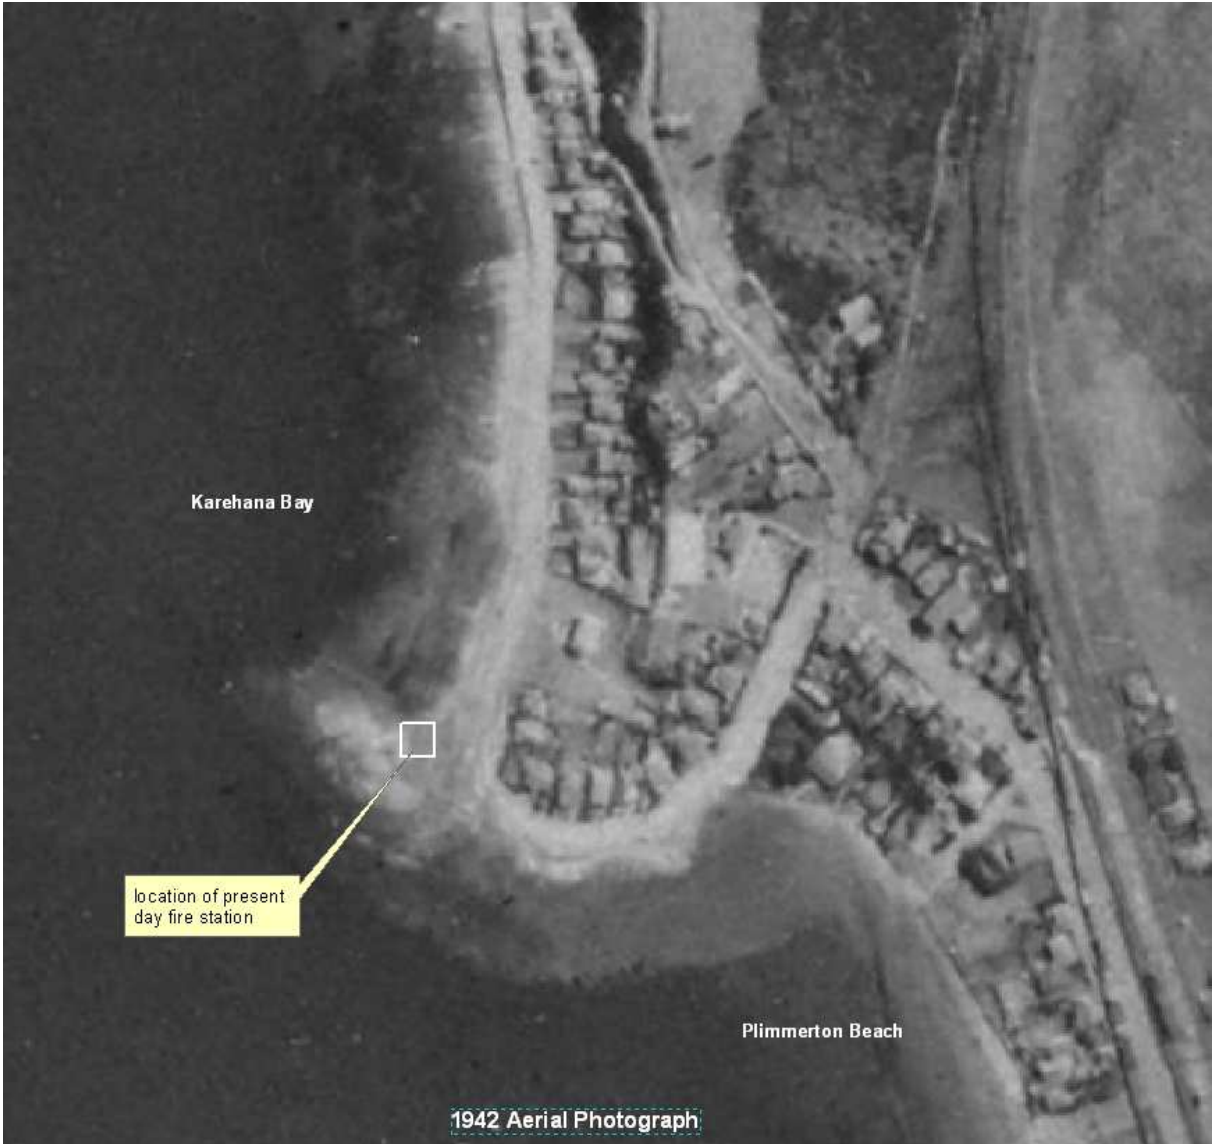
There are historical accounts that sand was present along the shore. This is supported by aerial photographs dating from 1942, but they do not indicate there was a dune system (aside from a few low sand hummocks) at this site prior to construction of the station (Figure 1).

**Figure 1:** 1942 Aerial photograph showing location of present day fire station which was constructed on the beach and shore platform on the point between Plimmerton Beach and Karehana Bay.
