Inquiry 11-003: In-flight break-up ZK-HMU, Robinson R22,
near Mount Aspiring, 27 April 2011

Final Report

Aviation inquiry 11-003
In-flight break-up ZK-HMU, Robinson R22,
near Mount Aspiring,
27 April 2011

Approved for publication: February 2014

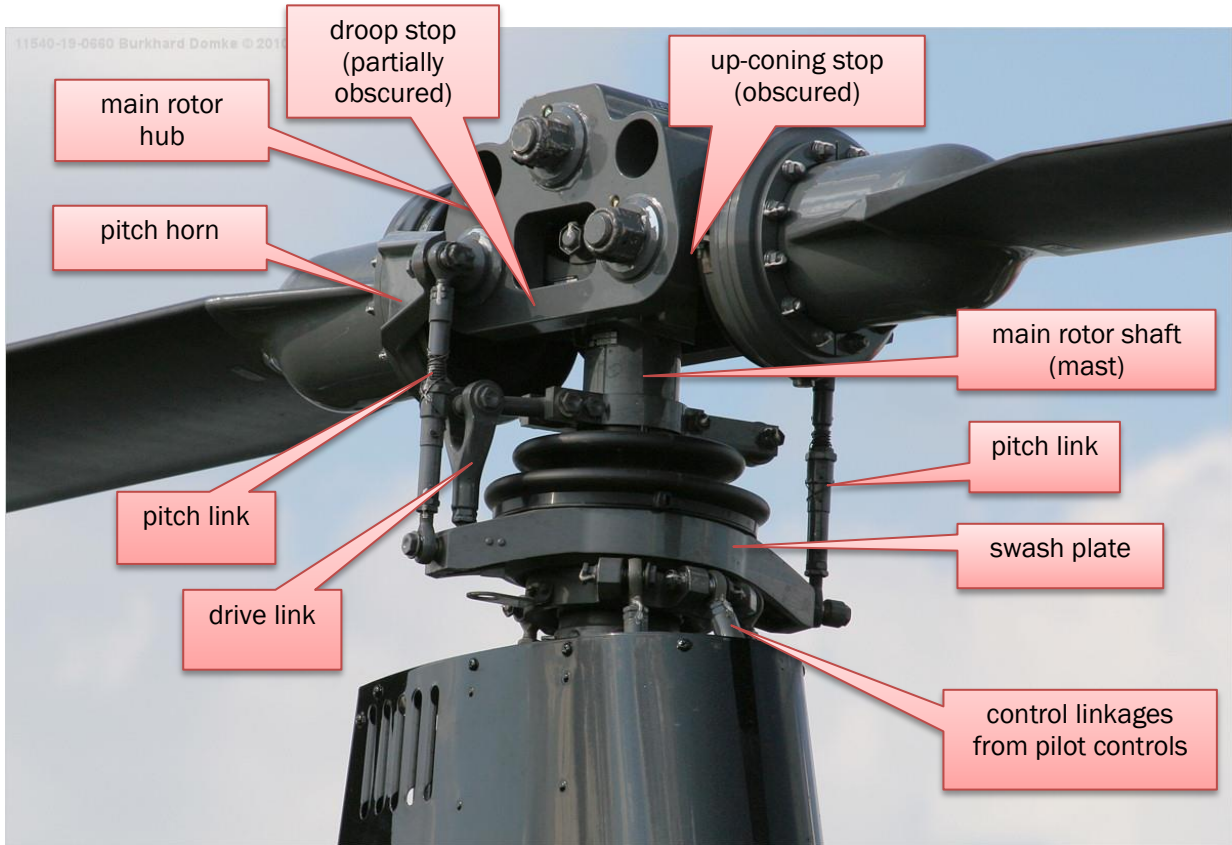
Figure 2
R22 rotor head control linkages
(Image provided with permission by Burkhard Domke)

- 3.2.6. Figures 2 and 3 show how the main rotor blades are connected to the helicopter at the main rotor head assembly. The main rotor hub is attached to the main rotor shaft (mast) by the teeter bolt, which allows the main rotor hub and main rotor blades to tilt together. The 2 main rotor blades are attached (hinged) to the main rotor hub by coning bolts, which allow them to flap independently up and down on the rotor hub. The rotor hub and main rotor blades are said to rotate in a disc (the rotor disc). The direction of the helicopter is controlled by tilting the rotor disc forward, back, left or right from its usual position. The helicopter travels in the direction in which the disc is tilted.

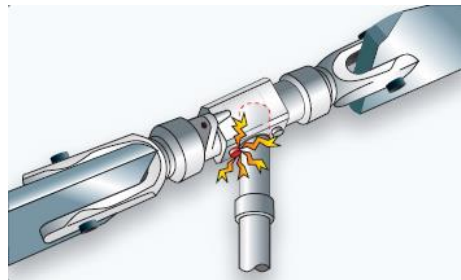
Figure 4
Mast bumping

- 3.2.9. Mast bumping occurs when the main rotor blade exceeds its flapping limits, causing the main rotor hub to “bump” into the main rotor shaft as shown in the diagram below⁶. The condition can lead to complete failure of the hollow main rotor shaft, resulting in the main rotor blade breaking away from the helicopter.

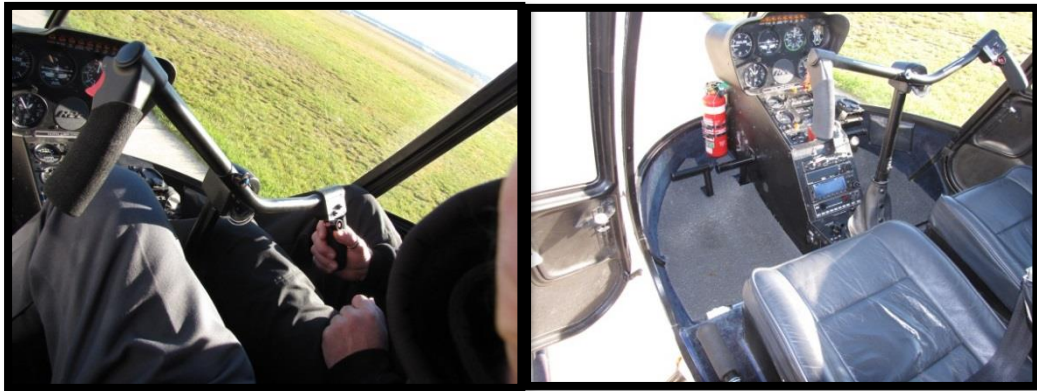
Figure 9
R22 cyclic control

- 4.3.20. The New Zealand situation did not therefore address the FAA's concern about reaction time. An instructor can "guard" the cyclic control against over-controlling by the trainee, but this can be challenging because of the cyclic control design. The cyclic control is pivoted on a central pedestal between the pilots. The pilot who is flying pulls their control handle down to a natural and comfortable flying position, which raises the other pilot's handle. Robinson recommends that in turbulence the pilot steady their right arm against their thigh. This has the effect of further raising the cyclic control for the non-flying pilot and, depending on the height of the pilot flying, putting it beyond comfortable reach (Figure 9).
