**PRELIMINARY DESIGN GEOTECHNICAL ASSESSMENT REPORT  
FOR PROPOSED MANGAPAPA SCHOOL RE-DEVELOPMENT  
5 RUA STREET, MANGAPAPA, GISBORNE**

Project Reference: 15344  
26 July 2019

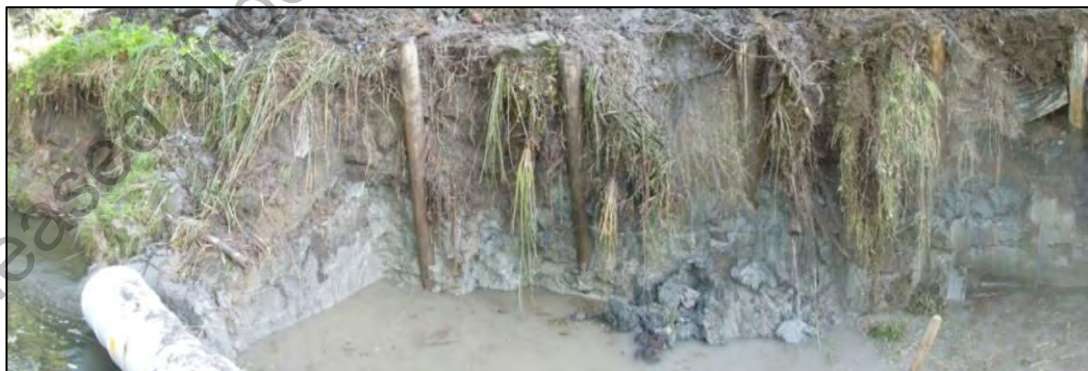
2. A combination of a **timber pole palisade wall**, **reno-mattress** and **gabion baskets** were recommended, modelled and specified in the LDE Ltd 2011 and 2012 reports with subsequent construction and monitoring occurring May 2012 (Figure 5a – 5i). The design drawings (Appendix F) specify either 150mm SED timber poles installed at 1.5m centres or 200mm SED poles at 2.0m centres to 5.0m depth. Note that a review of our construction records and PS4 certificate did not establish which timber poles were installed as per the specification, with the only apparent photos of the area suggesting undersized poles (possibly 100mm SED at 1.0m centres) (Figure 5c).

Figure 5c: 16/05/2012: General view of excavation with possible timber pole driven piles exposed in excavation wall.

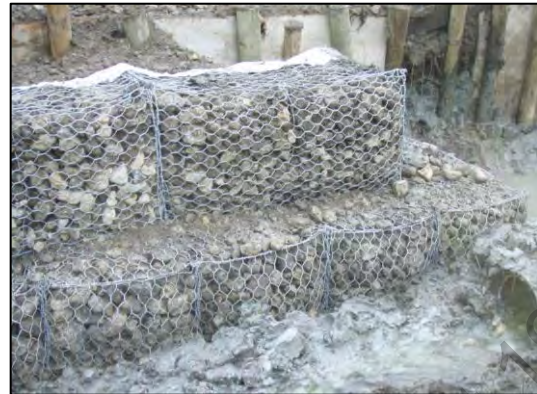
It should be noted that the wall has been in place since 2009 and gabions since 2012 with the only minor slumping in the gabions observed, likely to be due to poor packing of the rip-rap gravel within. Otherwise the wall and gabions appear in good condition with no evidence of subsidence, overturning, bulging, rotation, or other deformation of the walls.

Figure 5e: 22/05/2012 – completed segment of gabions. Note old wooden piles and concrete behind gabion.

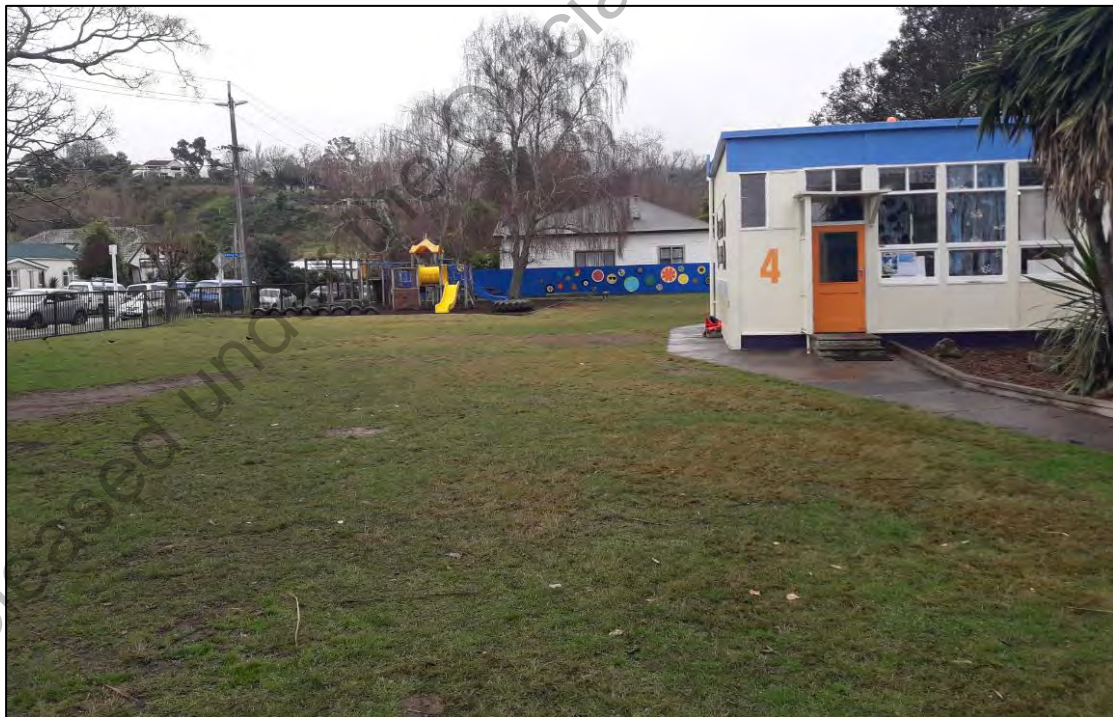
**Figure 6:** General current view of proposed classroom 'New Teaching 2'. Photograph taken facing northeast. Note Rua Street in the left-hand-side of image.

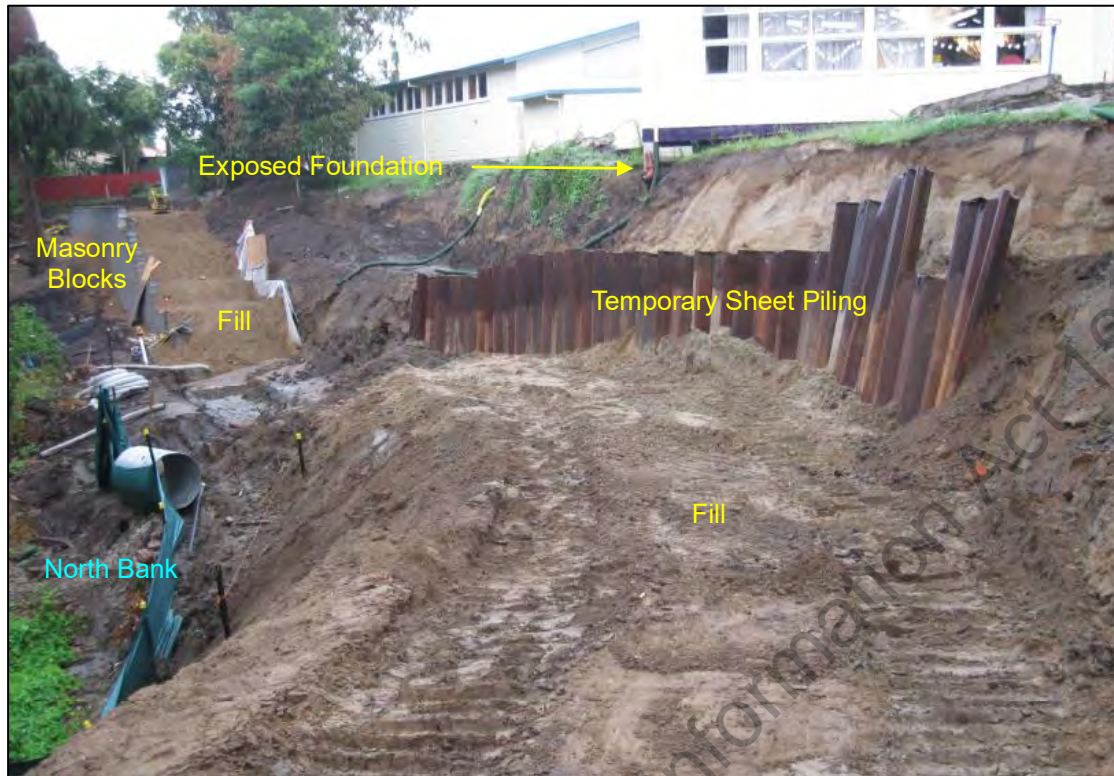
**Figure 7:** General view of segmental retaining wall during construction c 2009 – photograph supplied to LDE Ltd.

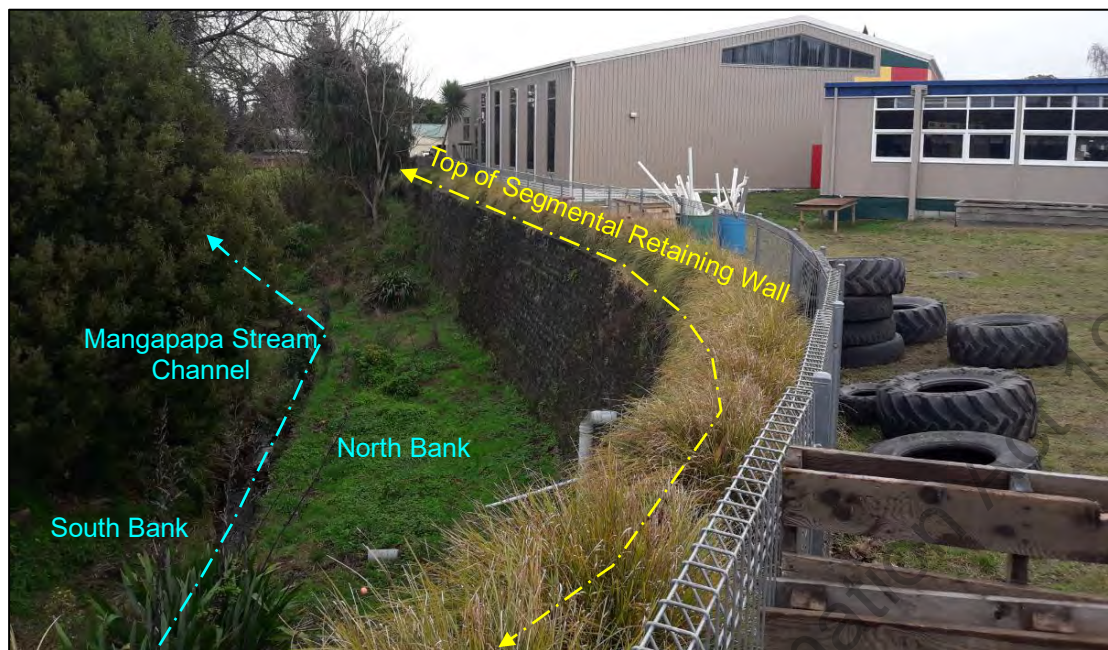
Figure 9: General view from top of segmental retaining wall facing south.

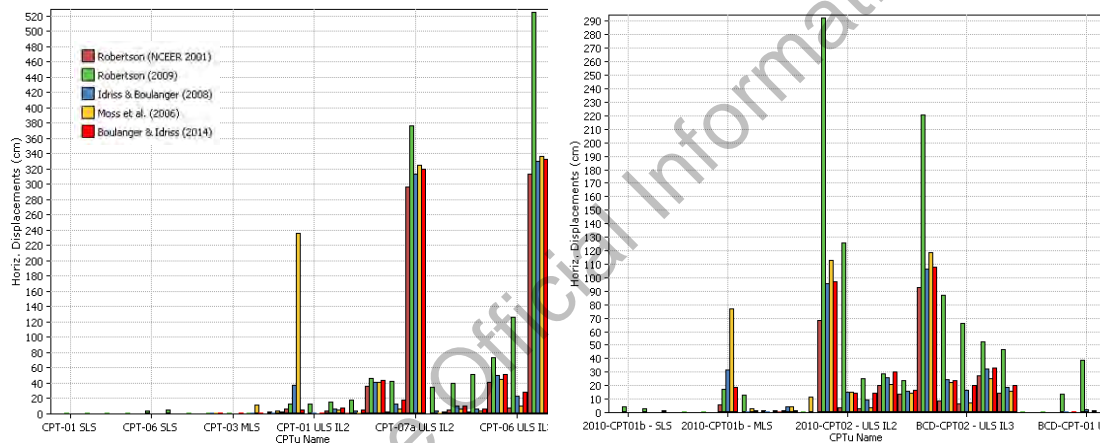
A TC3 category site performance for the foregoing has been applied in respect of lateral stretch. A sensitivity analysis was also undertaken which involved overall parametric analysis utilising different liquefaction calculation methodologies all four scenarios examined (Figures 14). The analysis shows that the selected methodology is not over reporting values in respect of the other methodologies.

**Figure 14:** Overall parametric assessment of various liquefaction calculation methodologies in respective of lateral displacements for all four assessment criteria (SLS, MLS, ULS IL2 and ULS IL3). Note the red columns are representative of the B&I 2014 methodology which this assessment is based on.
