# OPERATIONAL REVIEW

Level 2 Vegetation Incident

F3138746

Matakana Island, Tauranga

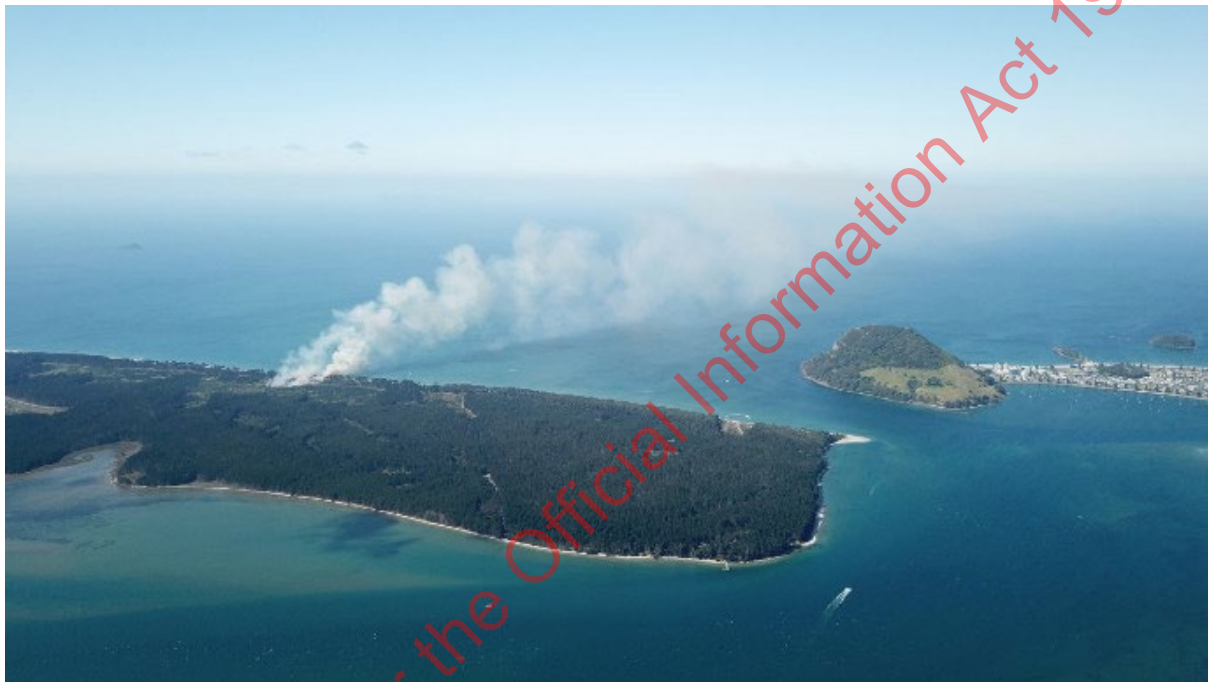
There were Sector Commanders in place, but there wasn't any communication between them or the helicopters operating within the various sectors. Some noted that because the pilots weren't briefed or presented a plan, they dropped water where they assumed it was required.

The lack of a plan and management structure also confused replacement Senior officers. Having no plan or documentation of events resulted in many assumptions of things being done, crew location, resources on the island, and what was required going forward.

*Figure-6, Aerial footage of the fire*

The [REDACTED] did not consider it necessary to support the [REDACTED]. Unfortunately, this was probably an error as the [REDACTED] did not have the knowledge and experience to make the right tactical decisions. There did not appear to be a strategy other than to extinguish the fire using firefighting buckets. Water drops alone will not extinguish a fire; it relies on skilled ground crews who have a good understanding of deep-seated fires to follow the drops and turnover the ground. However, the fast deployment crew with these skills from [REDACTED] based in Murupara were stood down on day one. If they had attended, they could have commenced this work and supported the original suppression activities. The review team were told these actions alone could have had the fire fully extinguished in a couple of days saving considerable expense.
