6.1 TITAHİ BAY BEACH COMMUNITY SAFETY AUDIT

Titahi Bay beach Community Safety Audit – Findings report

November 2021

TITAHI BAY BEACH LIGHTING
CPTED LIGHTING ASSESSMENT

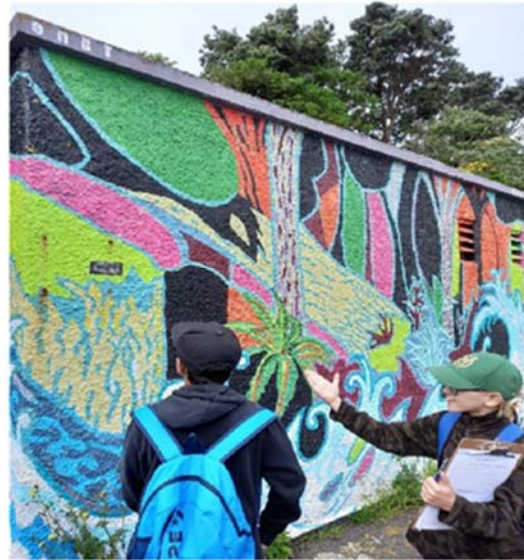
Young people investigating the Vella Street toilets

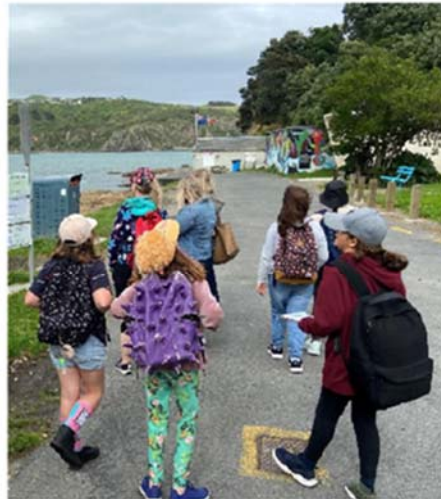
Young people talking about the drop onto the beach from Vella Street

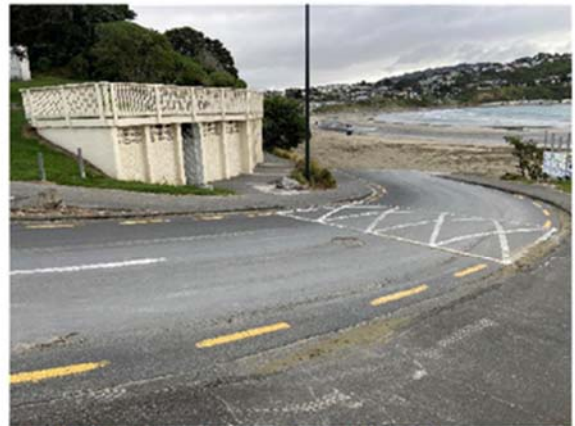
Bay Drive Toilets and pathway leading to beach

- a. Both public toilets (Bay Drive and Vella Street) present entrapment risks for the public and are not illuminated.
- b. It was noted that there were several people sitting in parked cars on both Vella Street and Bay Drive and combined with the lack of lighting it made the space feel unsafe.
- c. The pedestrian pathway at the back of the boat sheds presents both trip and entrapment hazards.
- d. The street lights on Vella Street are blocked by vegetation.
- e. The pathway behind the boatsheds is not lit, people were using their phones as torches at night
- f. Diagonal parking bays along Bay Drive required vehicles to reverse, which presents higher risks for vehicles and pedestrians and the standard considers that angled parked cars offer more opportunities for concealed activities.

- a. Trim the trees which cause obstructions to street lights at Vella Street) and Bay Drive car parks, footpaths, 21 Bay Drive and behind the boatsheds.
- b. Trial closing Vella Street toilets at night, aligned with the gate closing times
- c. Working with Police, Maori Wardens and Pacific Patrols to look at increasing the night time presence

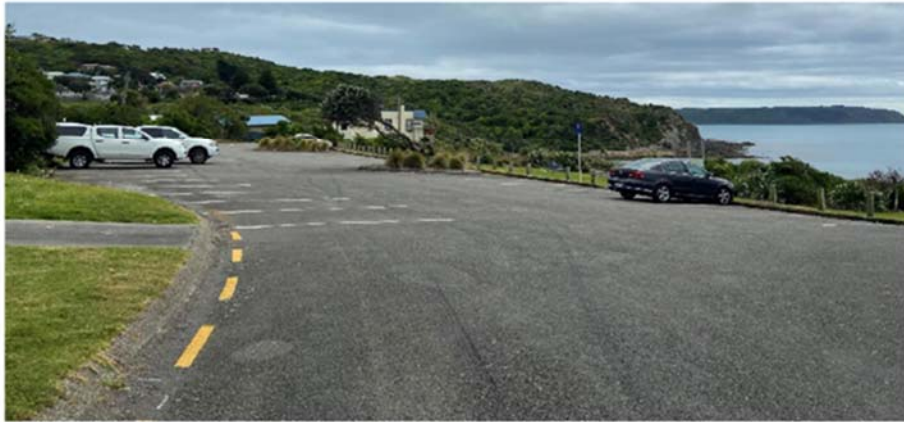
Carpark with cars parked up

This behaviour was not observed during the night time audit, but broken alcohol bottles in the carpark were noted during the day and on a day time site visit noted numerous cars parked up with groups congregating, smoking and playing music, and someone sitting in the carpark drinking alcohol.

- a. Further investigation, including consultation with immediate residents as to the benefits of locking off public access to the carpark at night or lighting the carpark area to deter anti-social behaviour.
- b. Investigate ways to enhance the area that would encourage legitimate users and increase passive surveillance in the space such as picnic tables on the lawn area
- c. Replace existing wayfinding signage to improve look, feel and tone and consider the use of educational and informational signage
- d. Review both pathways to the beach and recommend pathway improvements and maintenance improvements. This would include consideration of lighting report recommendations, in sequence with carpark lighting decisions.

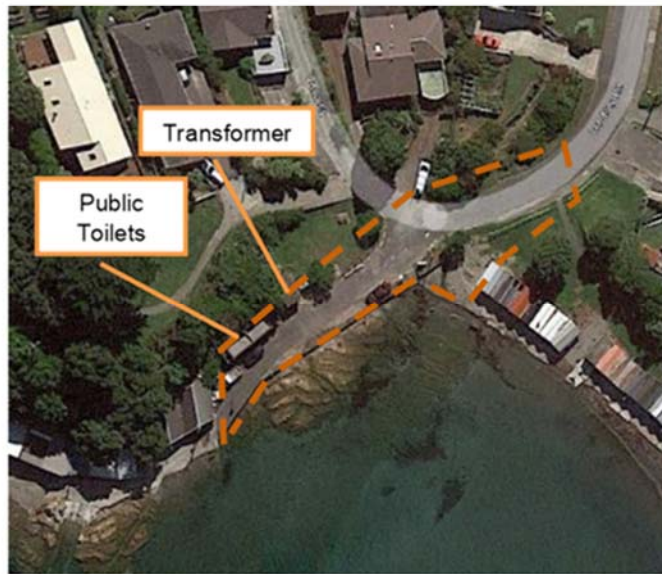
Area 1: North End - Lambley Road to Public Toilets

Extent of the area

This area is lit with 3 pole mounted LED street lights. Light is blocked by vegetation creating a dark area on Lambley Road.

- Add presence-controlled lighting to meet PR2 subcategory criteria.
- Close the public toilets at night
- Trim tree blocking light

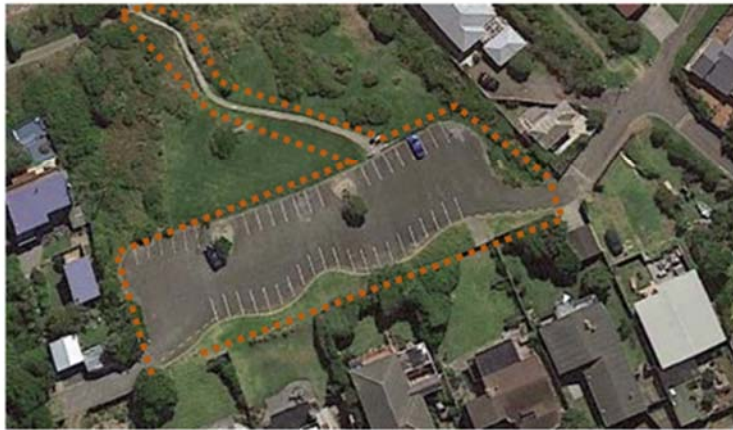
This carpark can be accessed by car via Bothamley Lane or Windley Avenue. A pathway leads to the beach. No lighting is installed on both car park and pathway to the beach.

Add lighting to comply with the PP3 subcategory except if Bothamley Car Park is not illuminated.

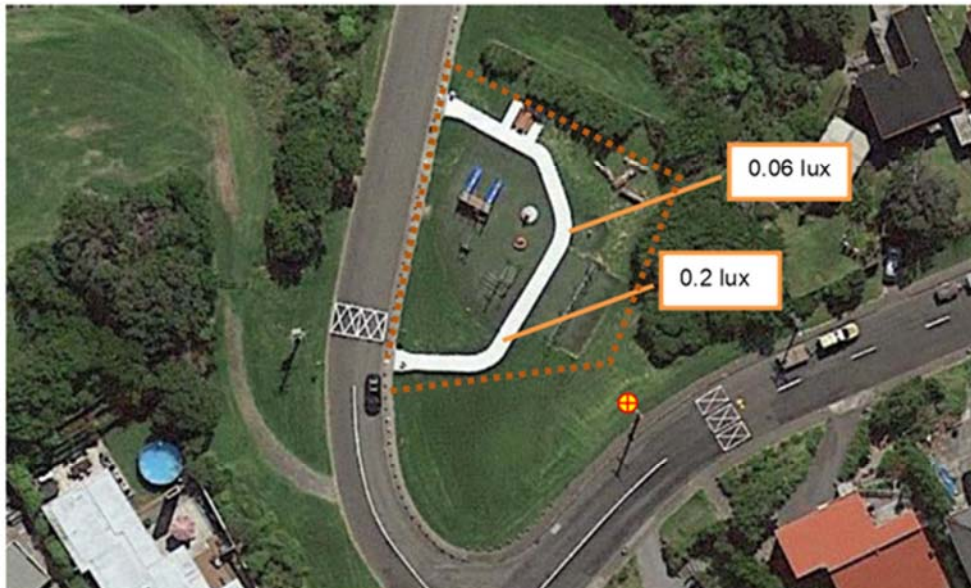
Area 5 : South beach access playground

Some undesirable activities have been reported. The only light close to the playground is situated on Tiretti Road. Tiretti Road's ground level is higher than the playground. The backlight from the light provides a very low 0.2 lux to the lower half of the playground. We consider this space is not illuminated.

The lack of light deters the use of the playground at night and the associated noise.

The playground area is not illuminated and enables undesirable activities. We recommend adding lighting specifically to the pathway in order to increase passive surveillance into this area.
