INVESTIGATION DETAILS

1. MATTER UNDER INVESTIGATION

On Saturday 13 January 2018 at approximately 19:55, Mr John Sprague, a 45 year old hobby photographer, was hit by a competition stock car vehicle while he was taking photographs from a position on the infield of the racetrack at Waikaraka Family Speedway.

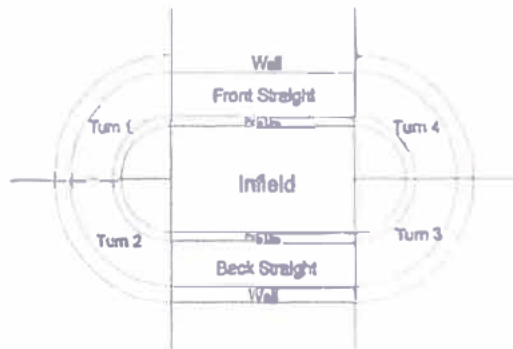
Fig. 2
Diagram of track layout
Image from SNZ Rule Book ²¹

The vehicle was at approximately a ninety degree angle to the Pole Line (see Fig.2 for location of Pole Line). Its nose was facing the infield and the two front wheels were across the pole line.
(70007/6/2)

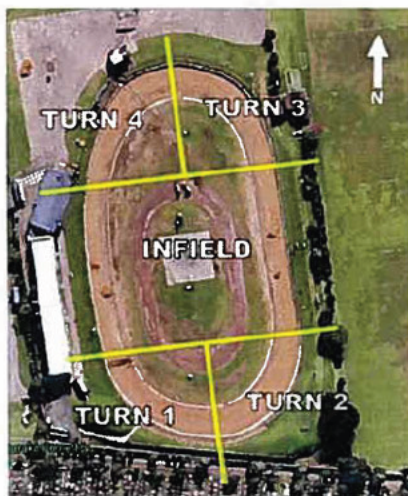
Fig. 3
Track layout
Waikaraka Family Speedway.
Image produced from Google maps

The image above shows that the infield at Waikaraka Family Speedway is grass. It contains a smaller dirt track, which is used for speedway motorbike racing, and a concrete 'skid' which is used as a staging area for emergency crew vehicles.

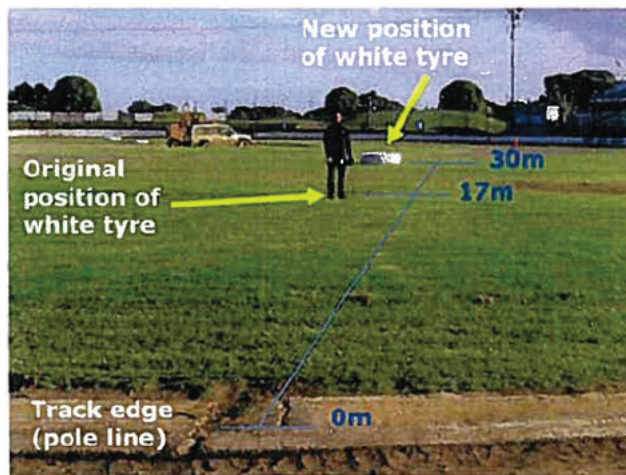
An inspection of the site on 19 March 2018 confirmed this.

Fig. 22
Waikaraka Family Speedway infield. This image showing measurements is created using a scene photo.
