Detailed Seismic Assessment

Waitomo District Council –Administrative Building (for IL2)

Waitomo District Council

18 April 2023

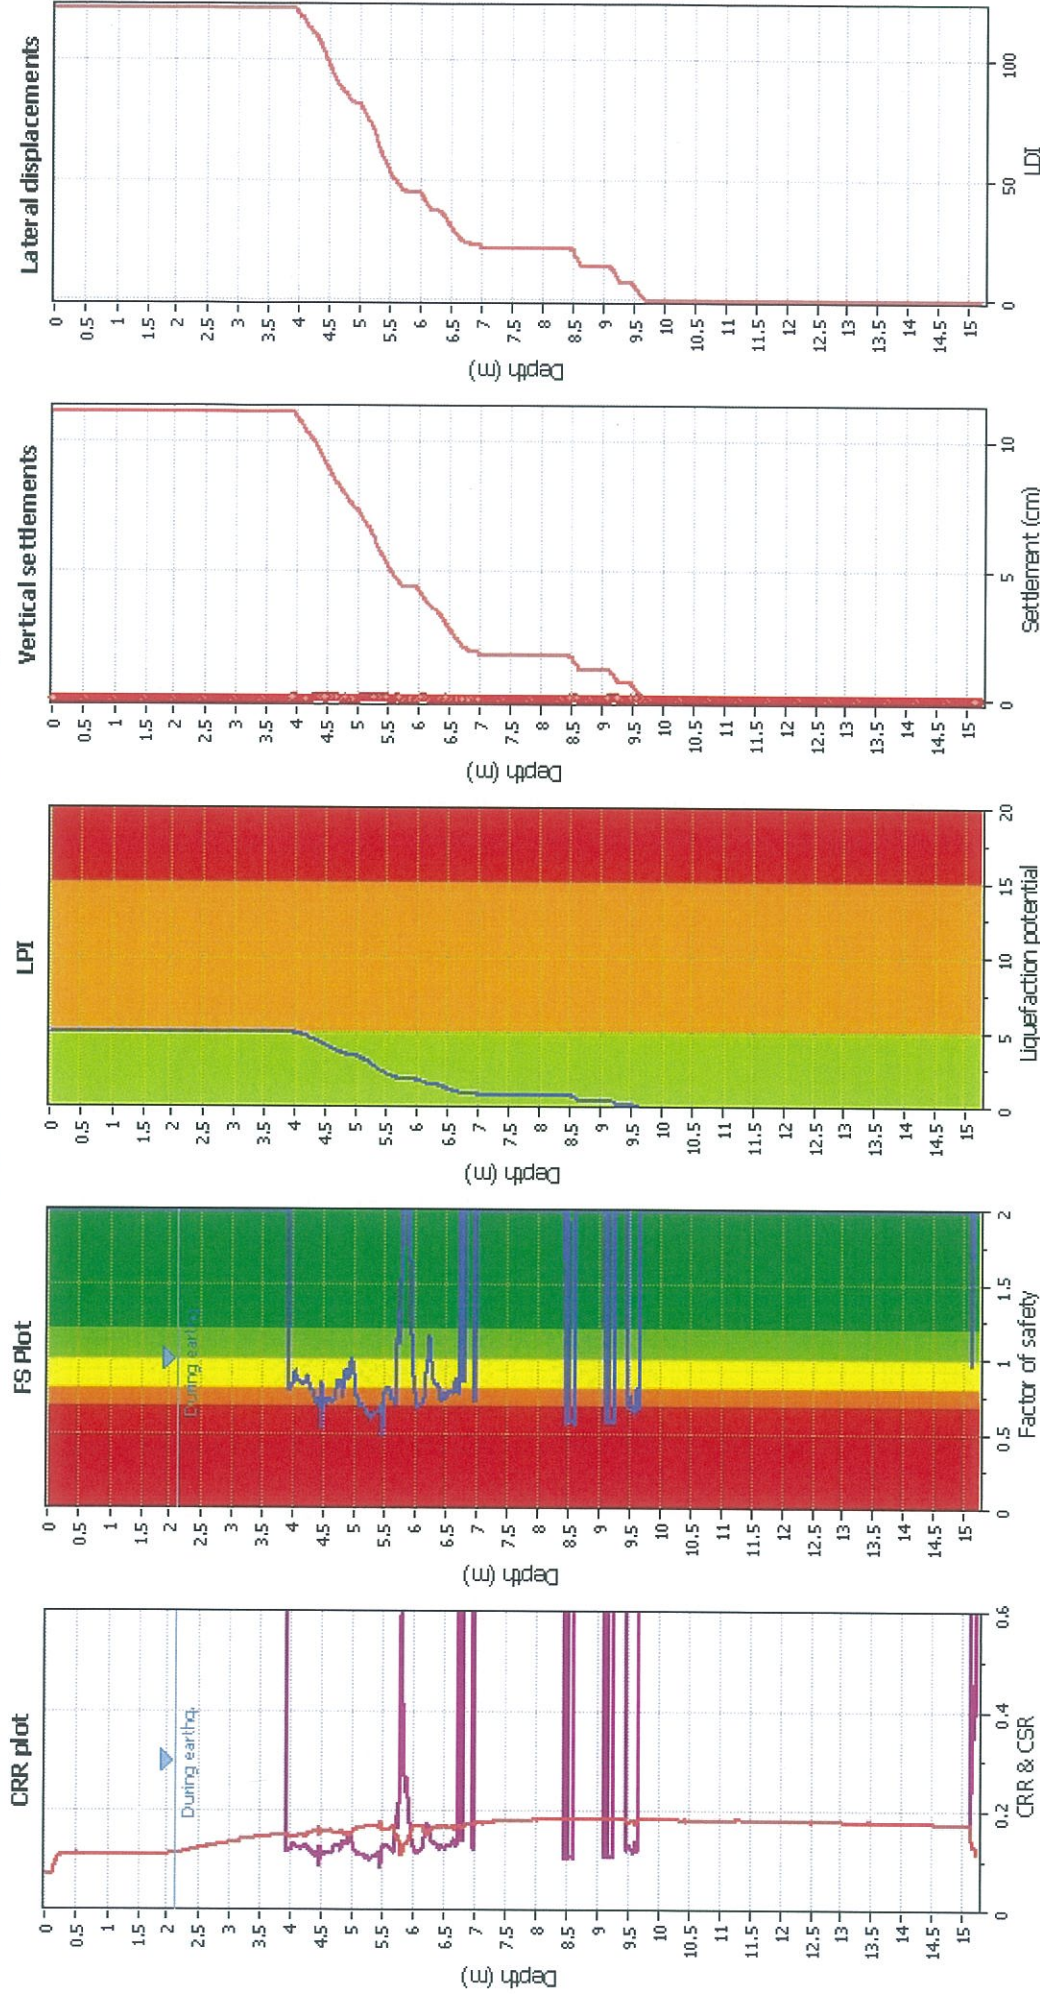
Liquefaction analysis overall plot

Analysis method: B&I (2014)
 Fines correction method: B&I (2014)
 Points to test: Based on Ic value
 Earthquake magnitude M_w : 6.00
 Peak ground acceleration: 0.21
 Depth to water table (insttu): 2.10 m

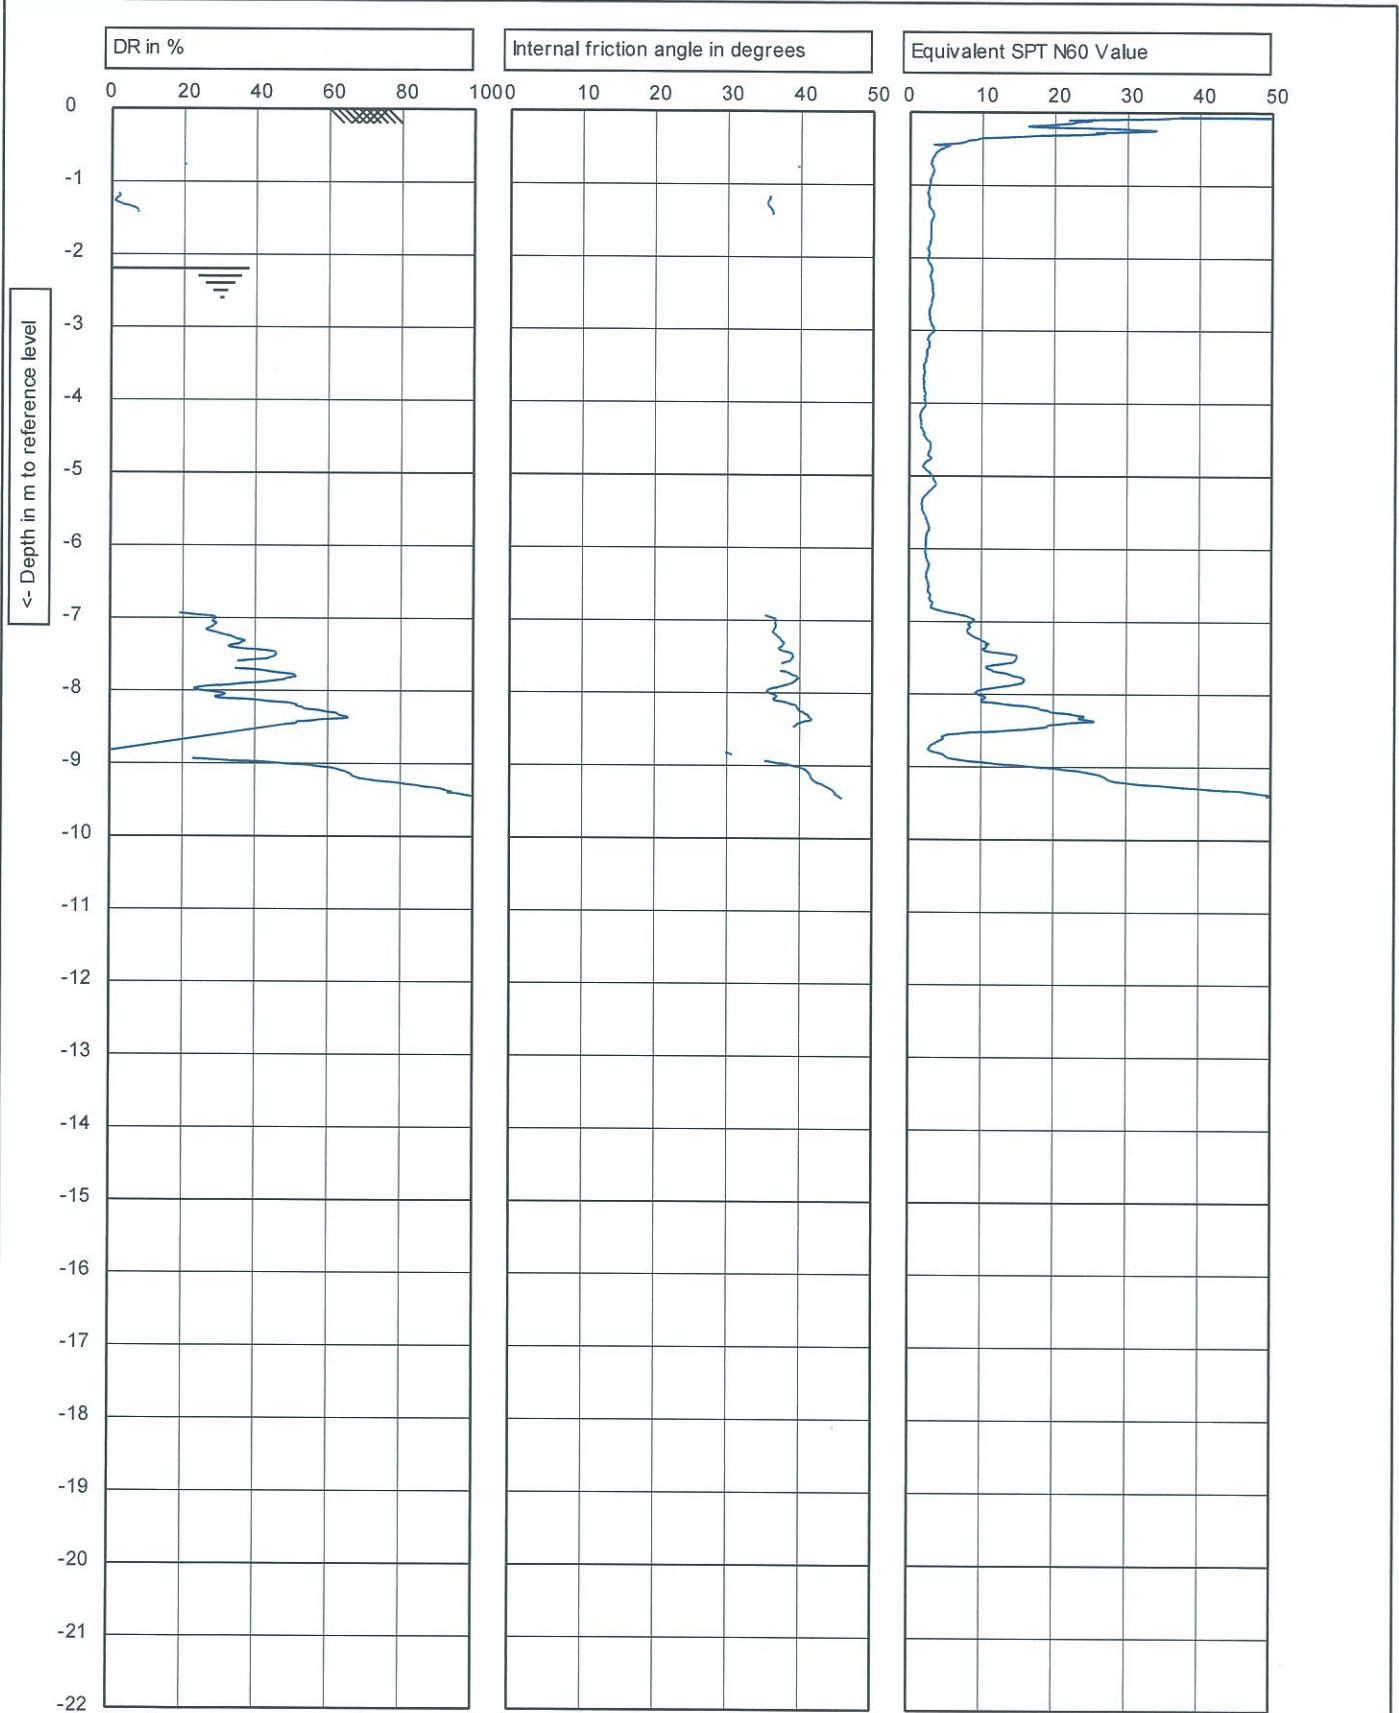
CPT1 Fig. B-1A

Refusal (qc 40+ MPa)

EOH - Dipped - GWL @ 2.2m

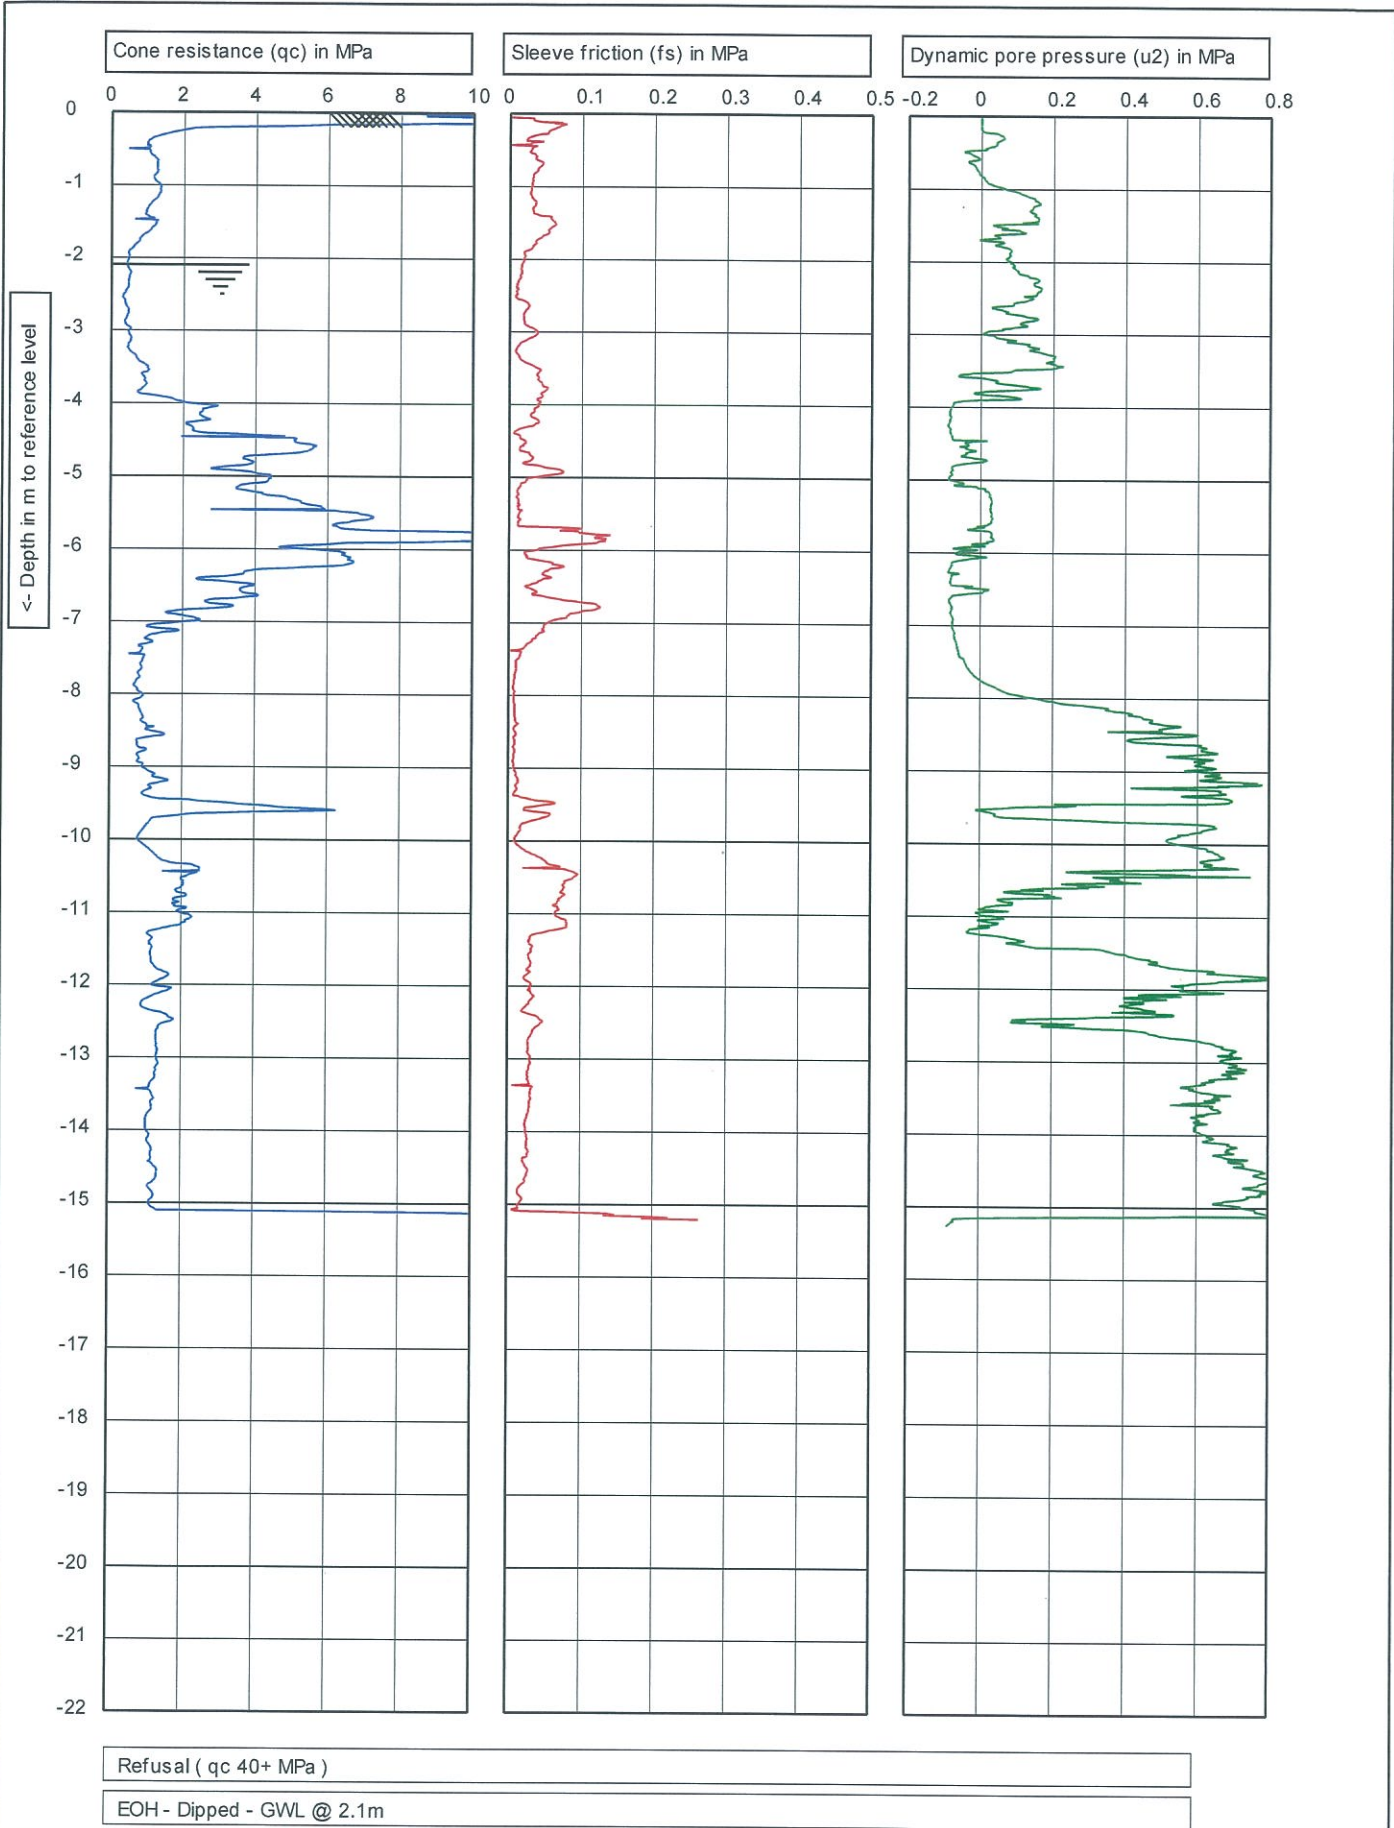
CPT1 Fig. B-1B

Refusal (qc 40+ MPa)

EOH - Dipped - GWL @ 2.1m
