Ngā Ūranga ki Pito-One Shared Path 30% Detailed Design

Prepared for Te Ara Tupua Alliance Prepared by Beca Ltd

5 September 2022

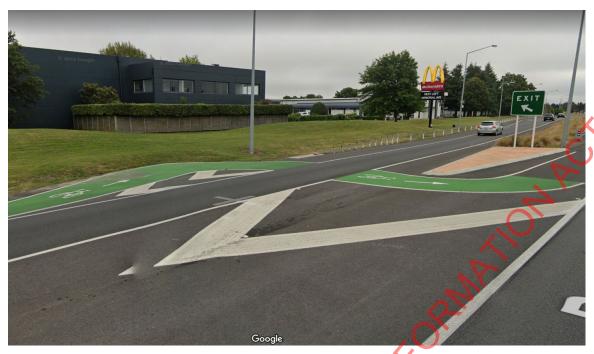
Figure 10: Example of bicycle crossing at off ramp at 90degrees to the movement

- that this access from the shoulder be a subtle (i.e.) last resort) exit.
- Include appropriate signage installed at the Northern end of SH2 that encourages all cyclists to use the shared path and not SH2 as well as appropriate signage to indicate to any cyclists on SH2 that they must exit at this location before going onto the Thorndon Quay raised motorway.
- Include appropriate design elements to avoid conflict between KiwiRail users and cyclists such as giveway and warning signage and markings.
- It is recommended that the movement path for cyclists across the access lane should be at 90 degrees to the vehicle movements. An example of this layout is shown in Figure 9.
