FIRE INVESTIGATION REPORT

50 Rawhiti Road, Manly, Auckland

F3756563

Suspicious Fire

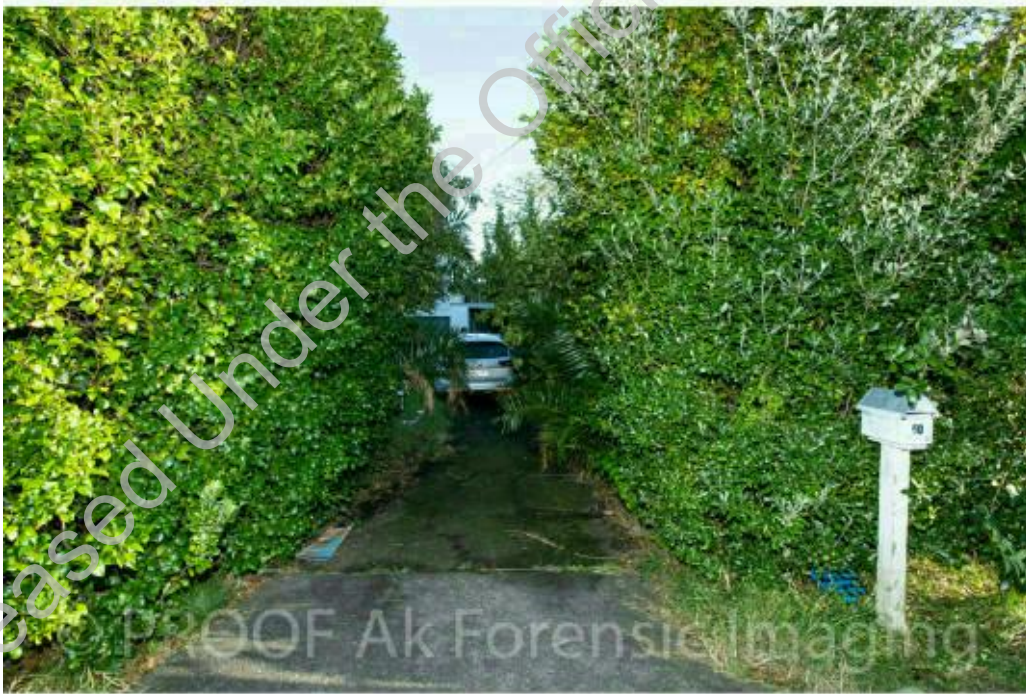
Photograph 1: Entry to the dwelling. (Courtesy of Police)

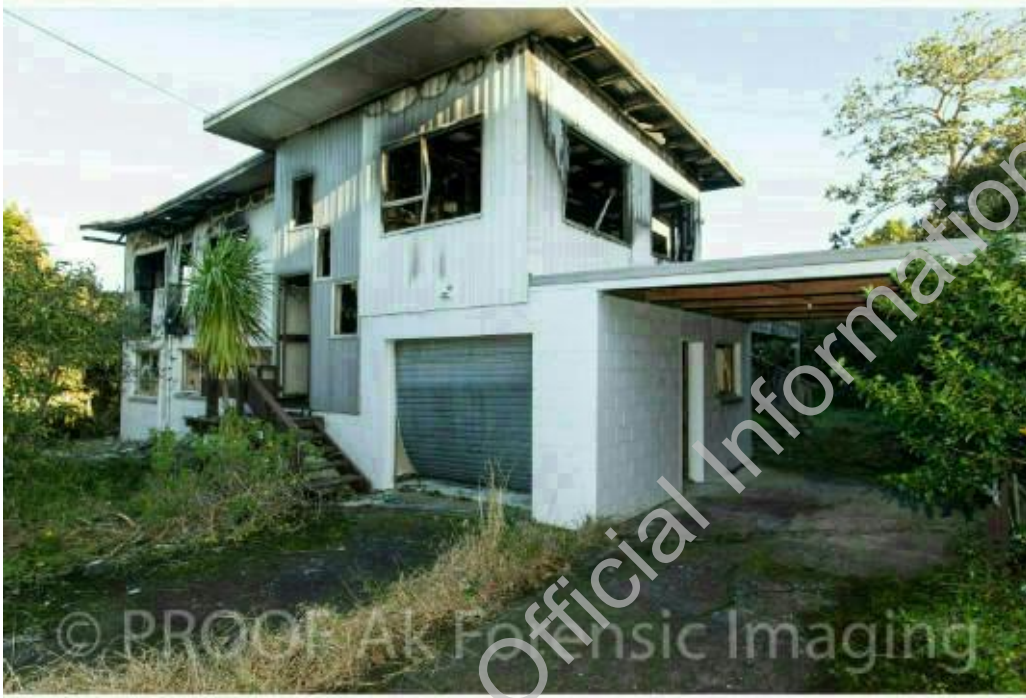
Photograph 6: View from the south-eastern profile. (Courtesy of Police)

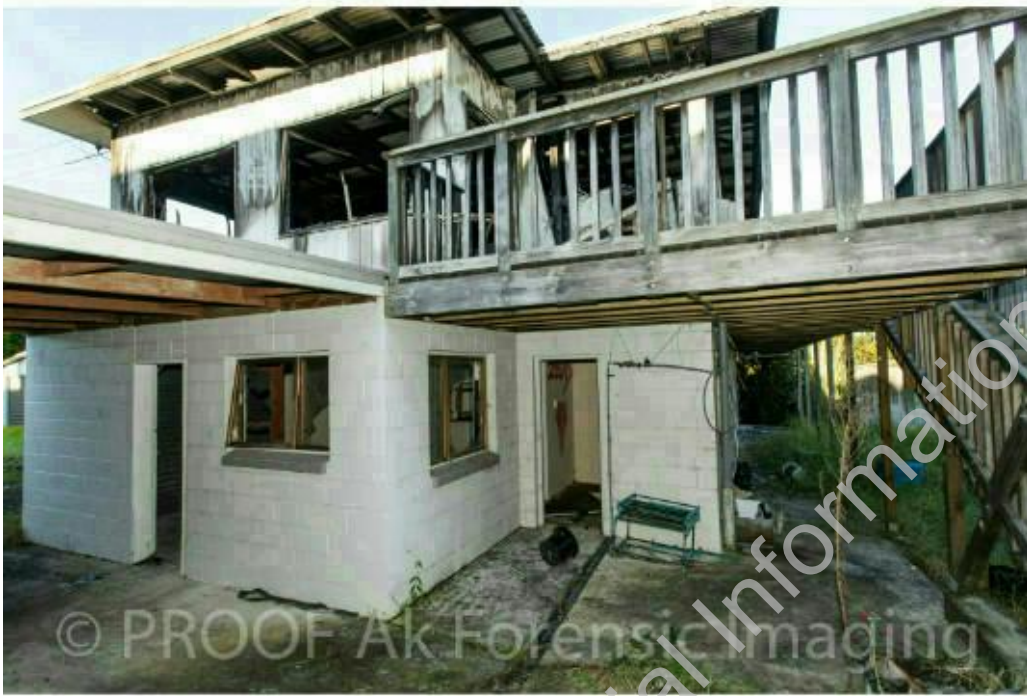
On the east profile of the dwelling, the aluminium window frames remained intact at the top of the windows, which indicated that the heat and fire intensity were greater on the west profile. Photograph 4 of the window on the west profile clearly shows the window frame melted approximately three-quarters of the way down, indicating the intense heat experienced in that area.

Photograph 9: East profile of the dwelling. (Courtesy of Police)

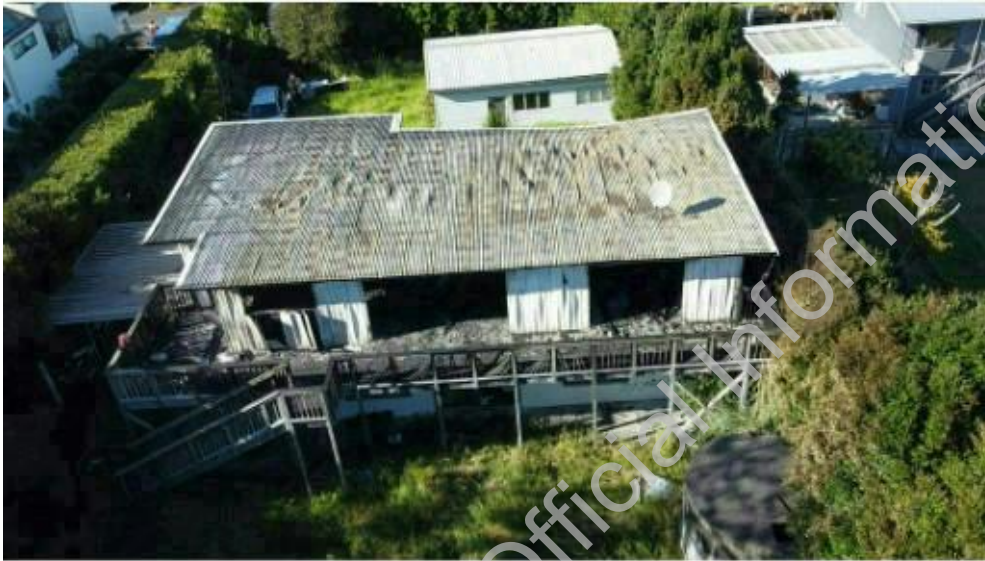
Upper Level: Fire damage was observed on all walls and windows on the upper level of the dwelling, indicating the widespread fire in this area. The presence of two large aluminium ranch sliding windows, once broken, would have provided a ventilation pathway for the fire, which would have contributed to the fire intensity.

Additionally, a large wooden deck covering the entire length of the dwelling was located on the upper level of the north profile. This deck exhibited greater amounts of charring towards the west profile of the dwelling, indicating the path of the fire. Other than the charring the deck was still mostly intact.

The fire intensity on the north profile of the dwelling was particularly severe due to the strong gusting winds at the time of the fire. These winds had forced the fire to spread from the south to the north, causing increased heat and flames on the north-facing side of the dwelling in turn creating the visible fire damage.

Photograph 11: North profile of the dwelling.

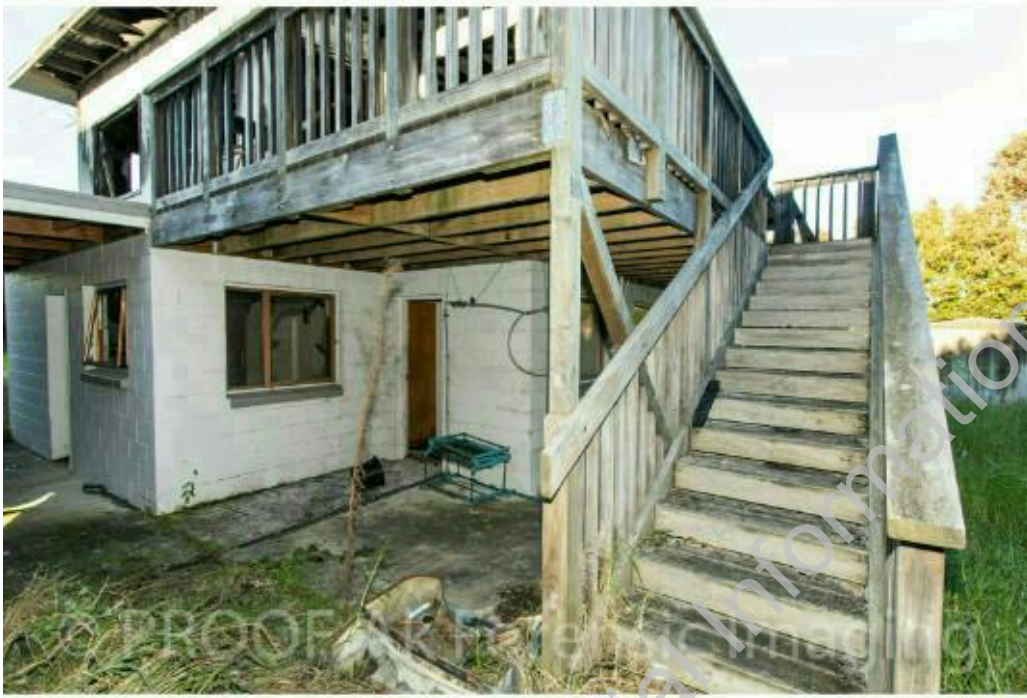
Photograph 15: Stairs leading to upper-level deck. (Courtesy of Police)

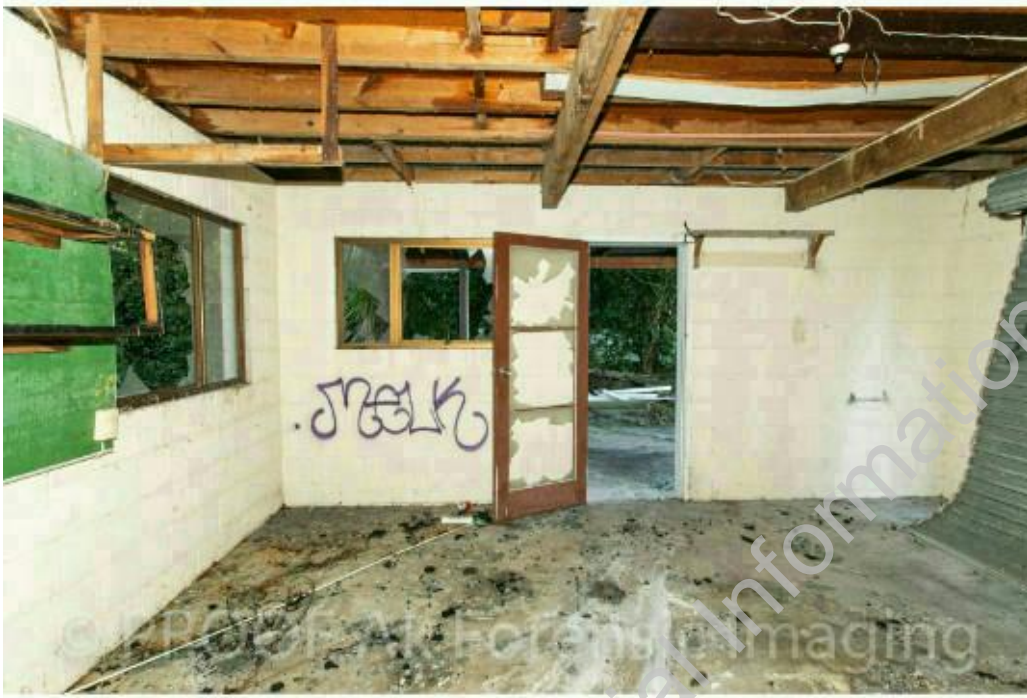
Garage: The garage area of the dwelling, located on the east profile, did not show any signs of fire damage. It appeared that the garage door had been damaged prior to the fire incident.

There was some fire debris observed in the garage, which likely fell from the upper level of the dwelling. This was due to the flooring of the upper level collapsing in several spots. The fallen debris indicated the extent of the fire's impact on the upper level and its subsequent effects on the lower areas, including the garage.

Photograph 16: Garage area of the dwelling. (Courtesy of Police)

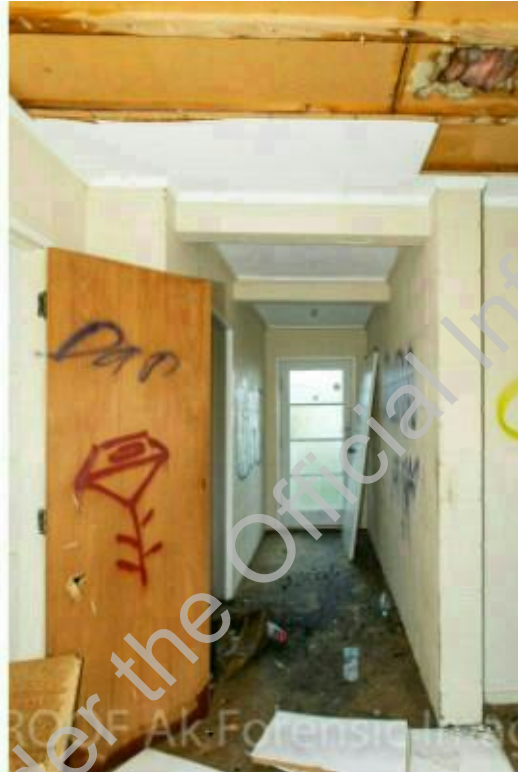
Front door and entrance way lower ground: No signs of a smoke or fire damage were observed in this area.

Photograph 18: Front door and entry way into the dwelling. (Courtesy of Police)

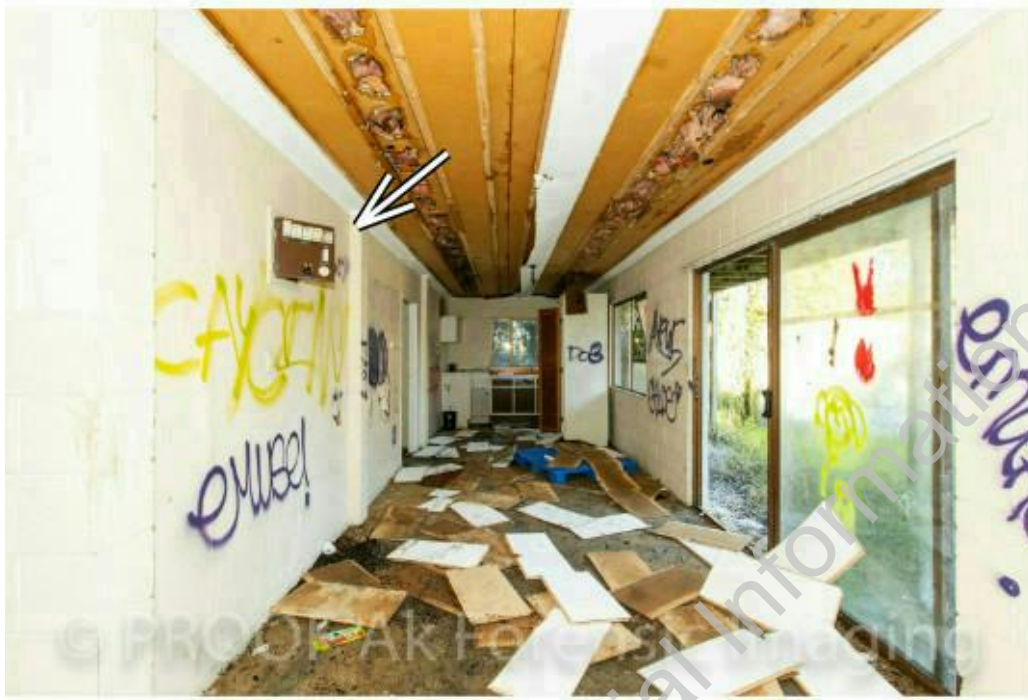
The main fuse board for the dwelling, located on the wall in the lower ground living area, was examined and showed no signs of fire damage.

Photograph 19: Living area on the lower ground floor. Arrow indicating located of the fuse board. (Courtesy of Police)

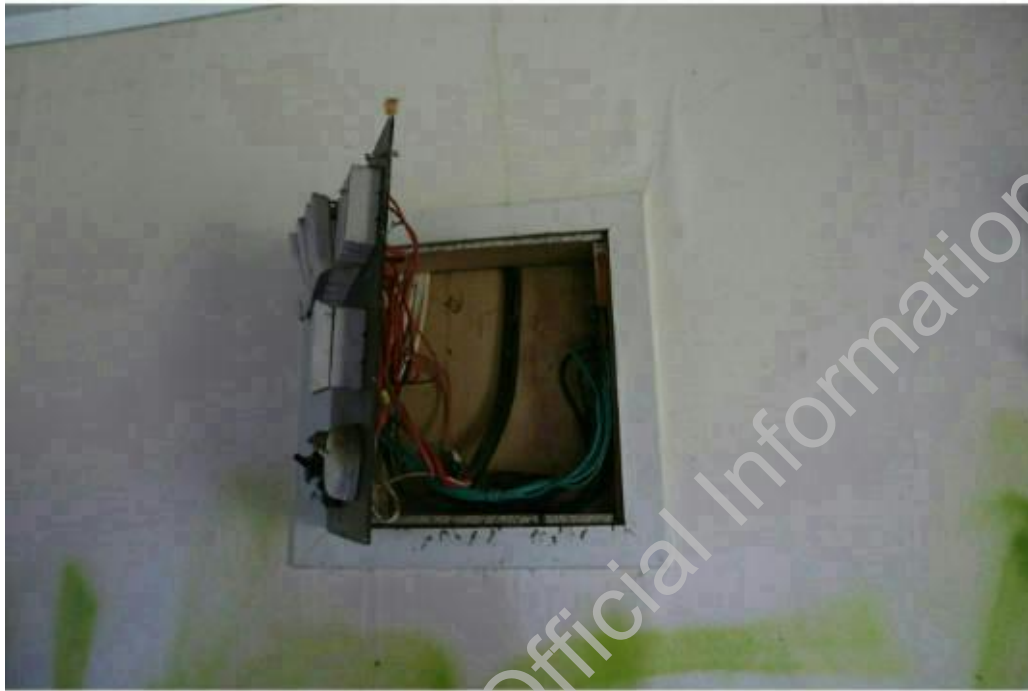
Photograph 21: Cables at the rear of the fuse board.

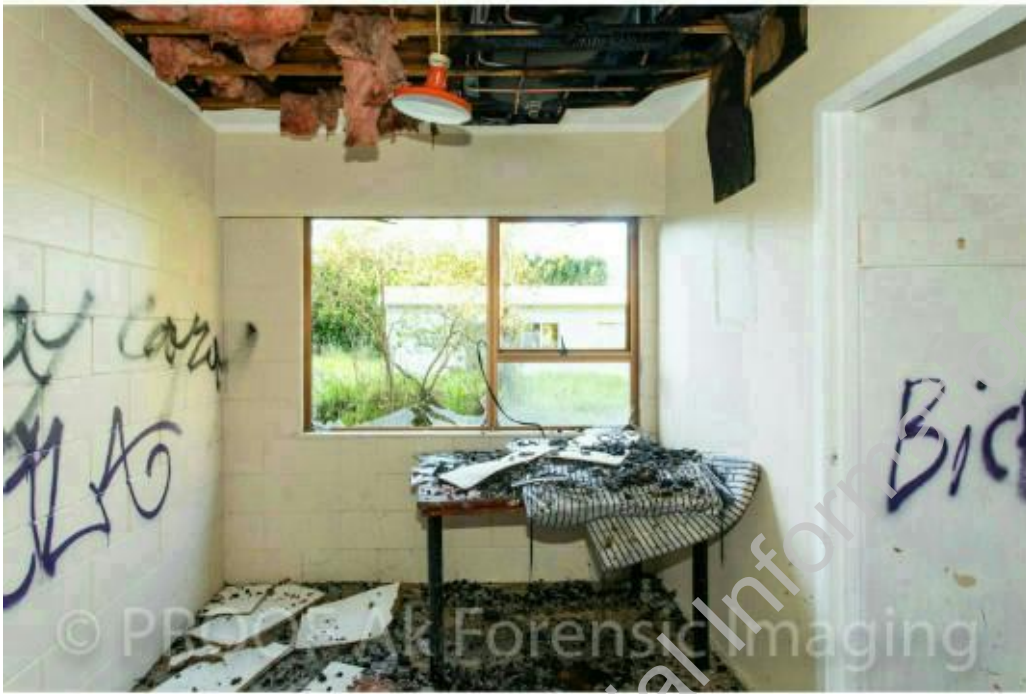
Bedroom 1 lower ground: A small table was located in the room and the bedroom windows appeared to have been mechanically broken.

There was some fire debris observed on the floor, which likely fell from the upper level of the dwelling. This was due to the flooring of the upper-level collapsing in several spots.

Located directly above bedroom 1 was the upper-level bathroom. Witness 2 stated that the flooring around the bath area was rotting away. Upon inspection, it was evident that the flooring in this area had failed and given way, creating a hole in the floor. The exposed timber joists were significantly charred indicating a fire burning above them in this area.

Photograph 22: Bedroom 1 lower ground floor. (Courtesy of Police)

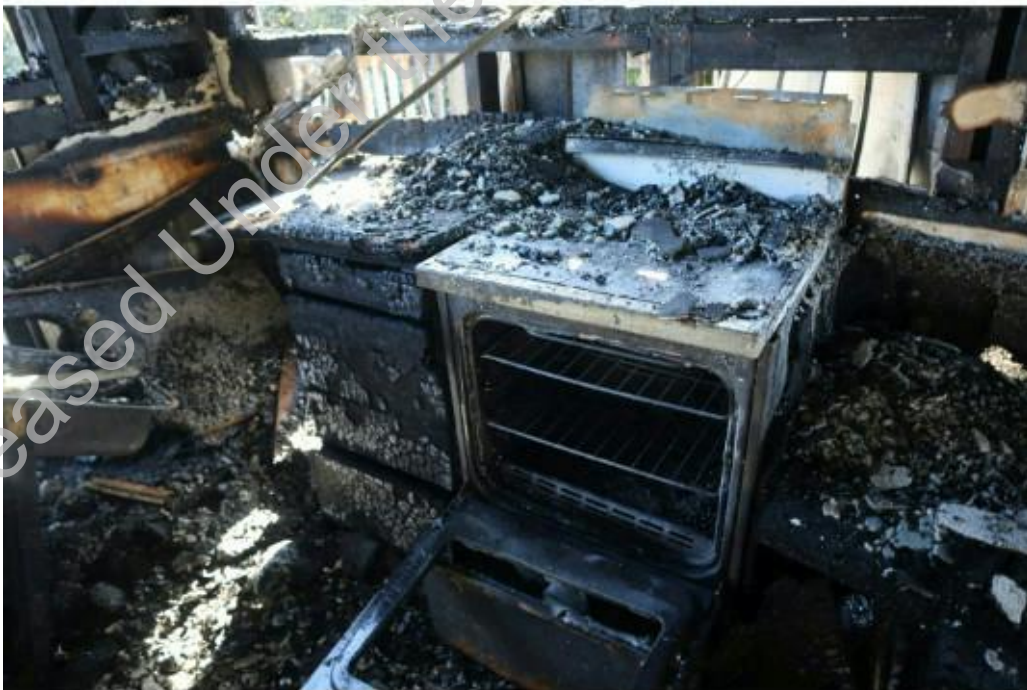
Photograph 29: Kitchen appliances unused for some time.

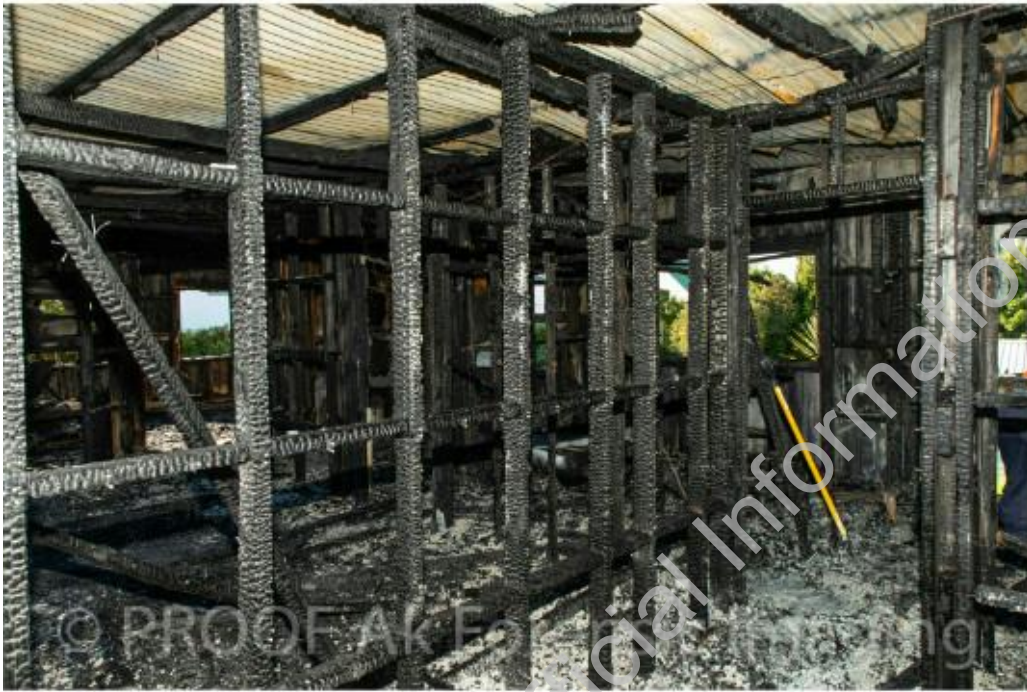
Photograph 33: Hallway area leading to bedrooms and area of origin. (Courtesy of Police)
