FIRE INVESTIGATION REPORT

1 Balmoral Drive, Tokoroa, South Waikato District

F3860442

Suspicious Fire

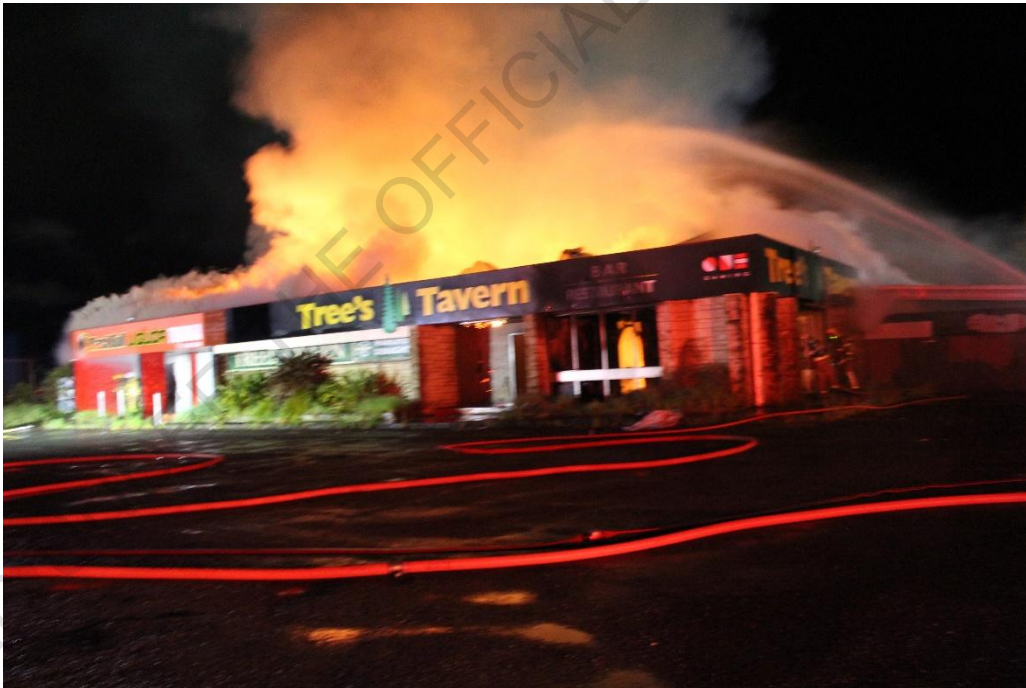
I commenced an exterior preliminary examination from the front (east) of the tavern facing SH1. The fire inside the tavern was still evident and would take some time to extinguish. I noted that some of the doors along the front of the tavern had been forced open by the firefighters.

Photo 3: Trees Tavern frontage facing SH 1 (East).

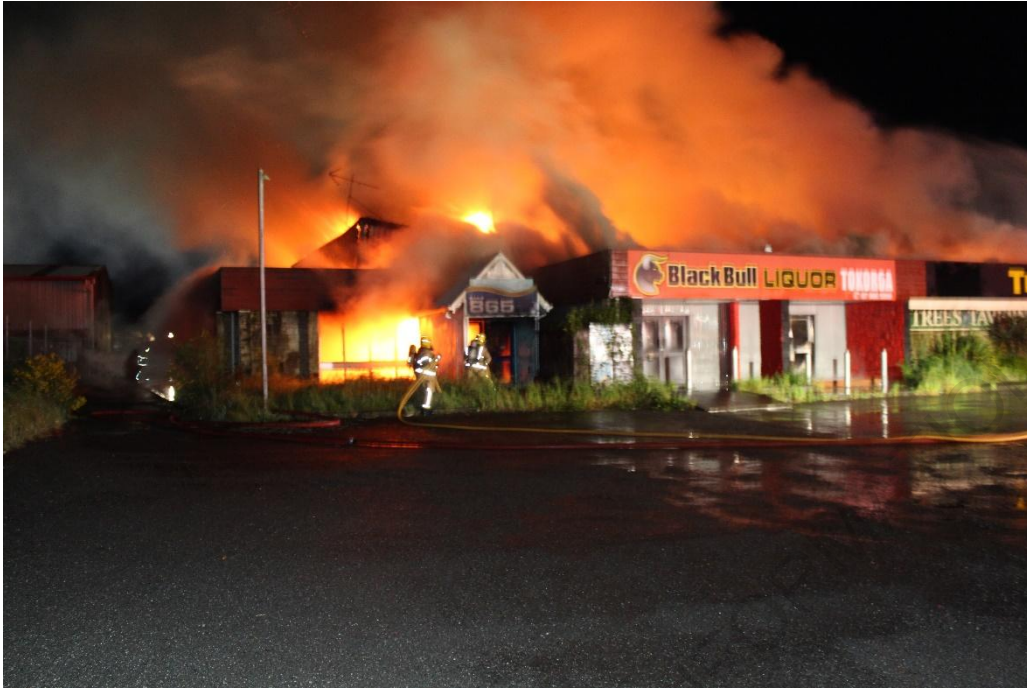
I moved around to the northeast side of the tavern which was known as Club 865 and the fire within this area was still intense and still developing.

Photo 4: Southeast side of tavern (Club 865).

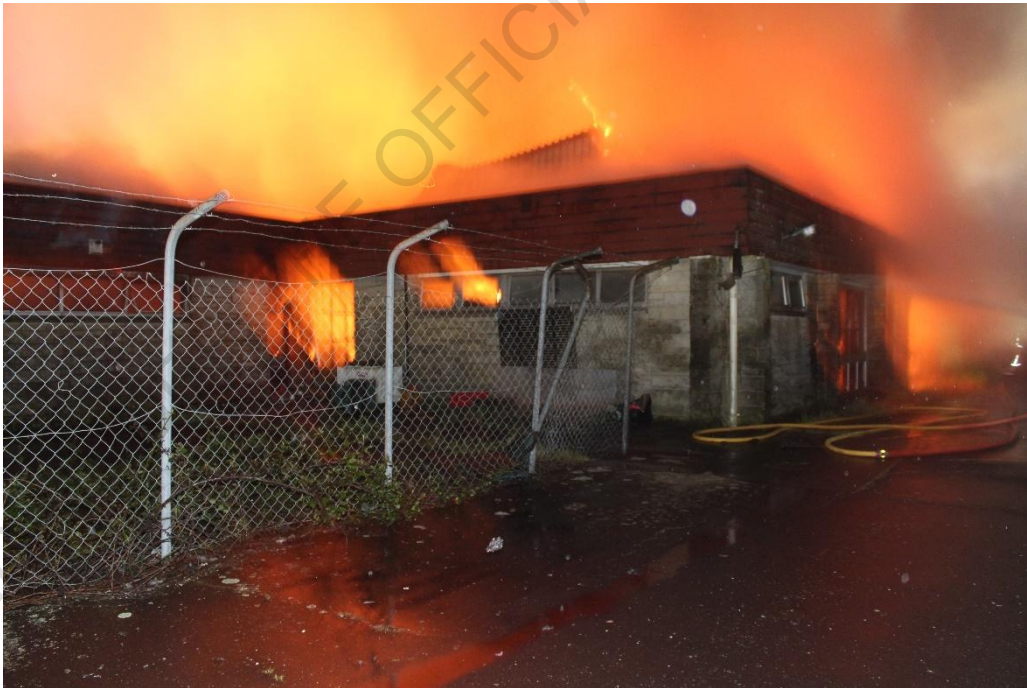
The fire in the south side of the Club 865 and the rear storage was also still developing.

Photo 5: Southside of tavern. Rear of Club 865.

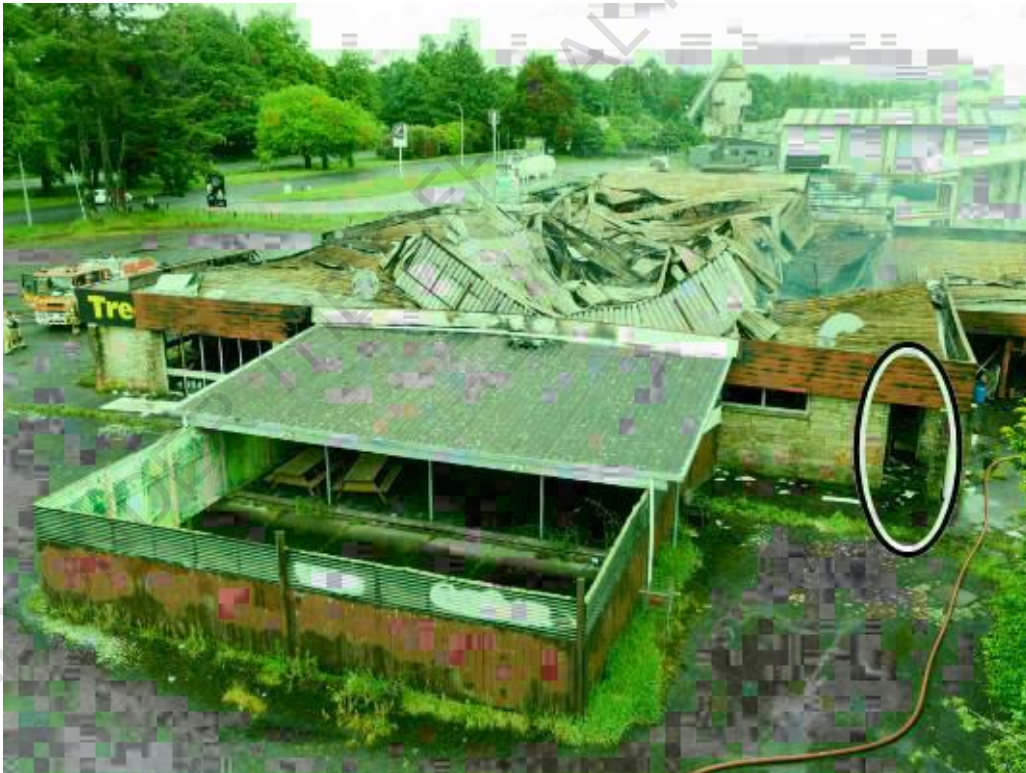
I examined the covered smoking area including the external aluminium sliding doors that open from the tavern into the smoking area. There was no evidence of forced entry from the sliding doors along the north wall and the sliding doors glass panes were still intact.

Photo 7: North side of Tavern. (Photo courtesy of Police.)

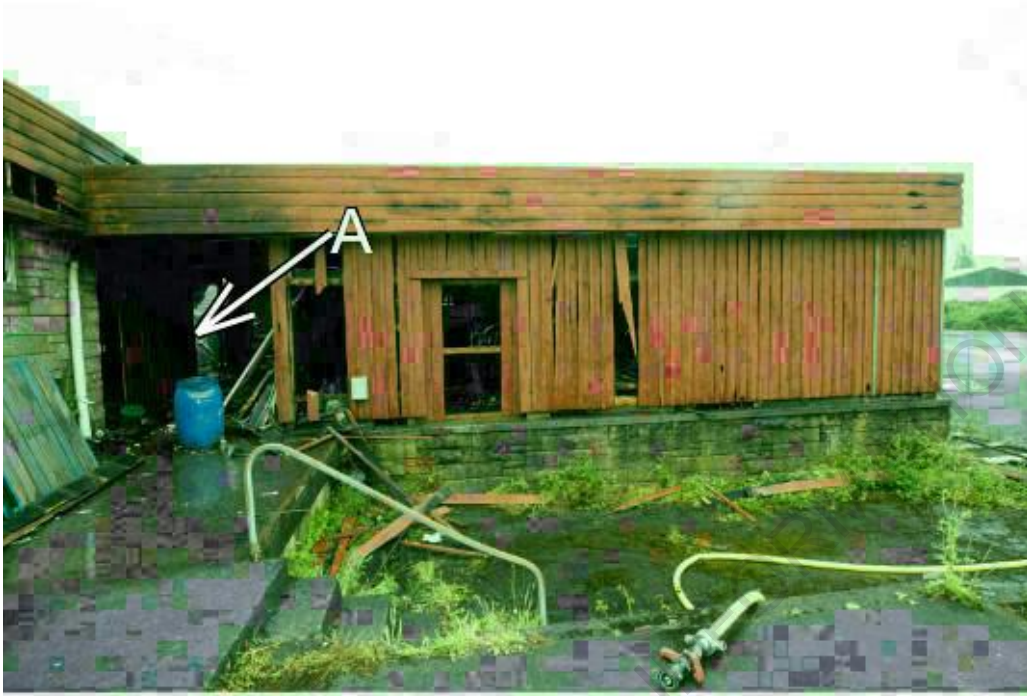
Photo 9: "A" Northwest corner of tavern rear entrance. (Photo courtesy of Police.)

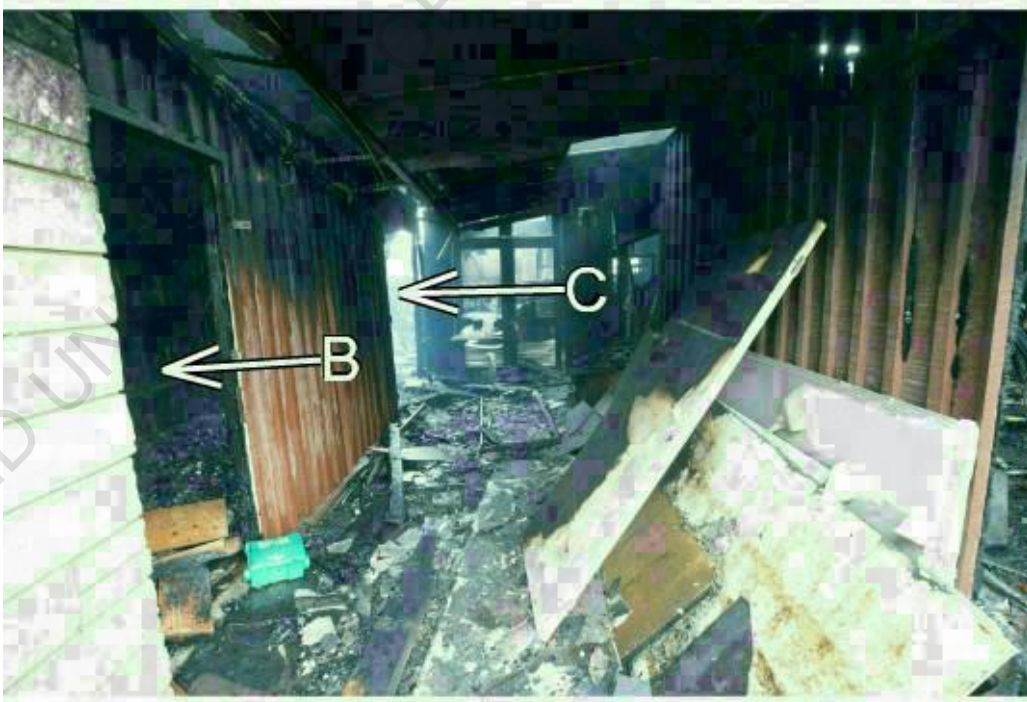
The right side of the passage provided access through a set of doors into a large storage room. I noted that the double doors to the storeroom were damaged and open during my examination.

Photo 10: Internal passage to rear of tavern. "B" Entrance to kitchen. "C" Entrance door to inside rear of the tavern.

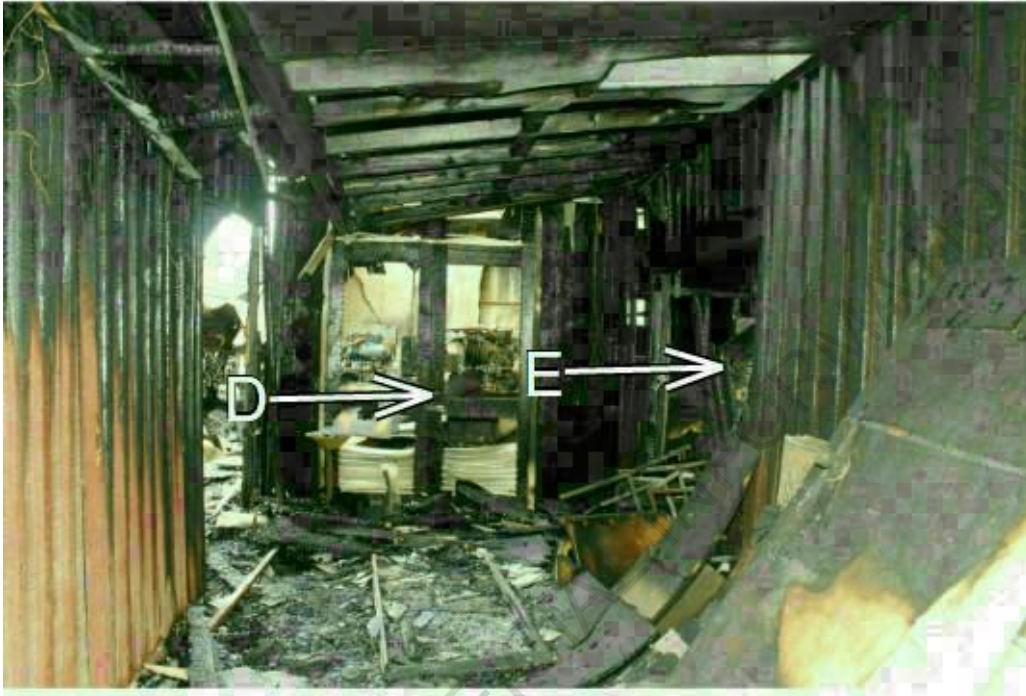
At the end of the passage was a double set of doors that provided access to the refrigeration/generator room. The double doors to the refrigeration room were still locked and secure.

Witness 1 (OIC) confirmed that when they arrived at the fire, the doors off the passage were all secure and locked.

Photo 11: "D" refrigeration/generator. "E" Entrance doors to storeroom.

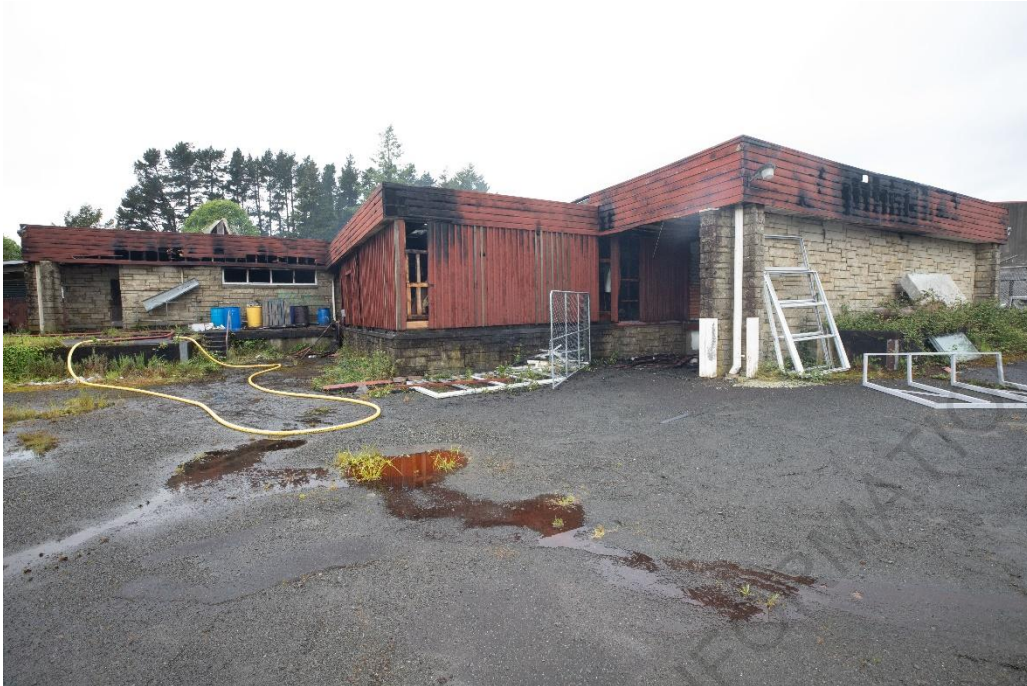
I moved around to the rear, west side of the tavern. I noted that the west side of the tavern had been the least damaged by fire and the fire patterns showed that the fire had spread to the west side of the tavern.

There was a steel gate was in a partially opened position. I examined the gate, chain, and padlock. I noted that a chain link that was attached to the timber post that was against the building had been cut. I checked with the firefighters who were working within this area, and they confirmed that they did not cut the chain to the gate.

Photo 12: West side of the tavern. (Photo courtesy of Police.)

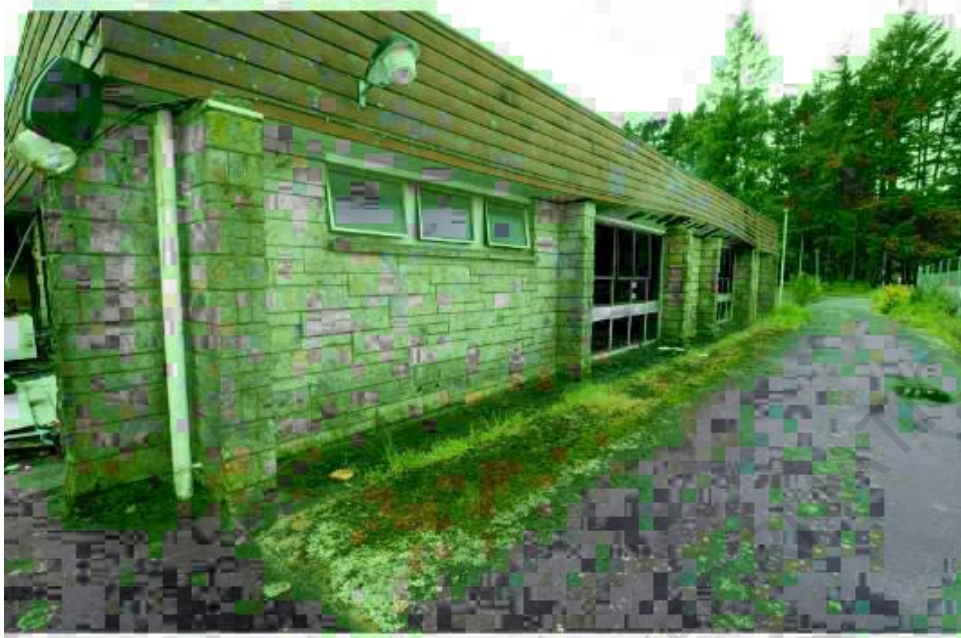
The Club 865 south wall runs towards the east end of the building facing SH 1. Some of the window sashes along the south wall were slightly opened and security staves were installed.

Photo 16: South wall of Club 865

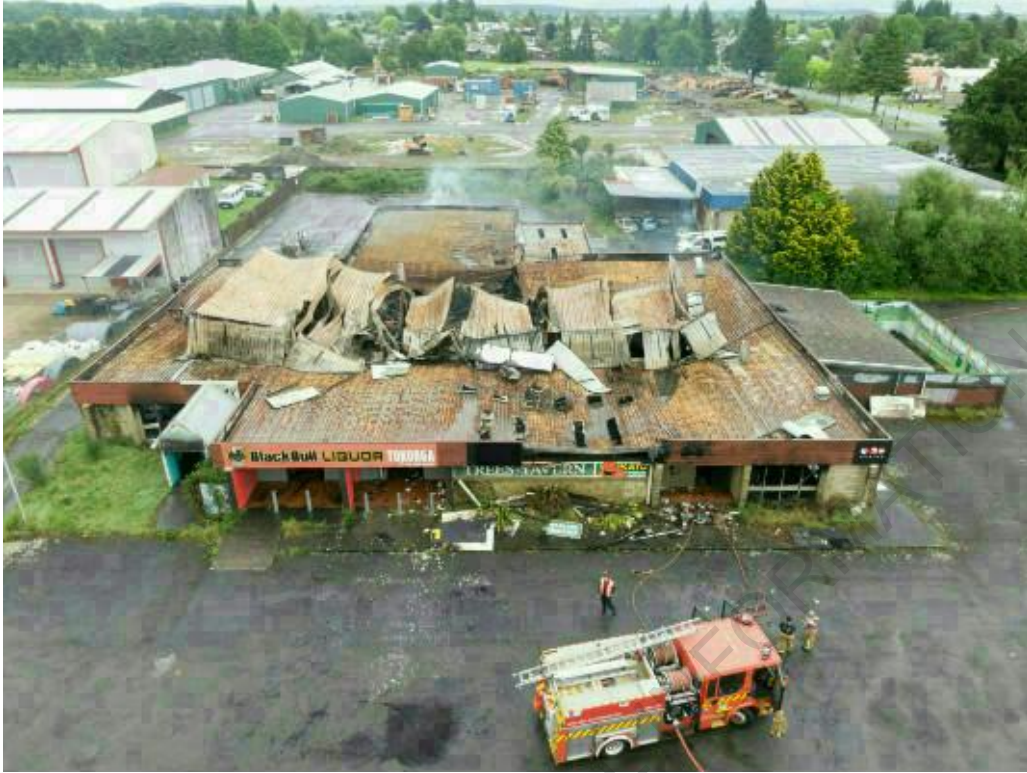
I examined the timber doors inside the entrance to the club and aluminium window frames, including the glass windowpanes, and there was no evidence of forced entry.

Photo 17: East side of tavern facing SH 1. (Photo courtesy of Police).

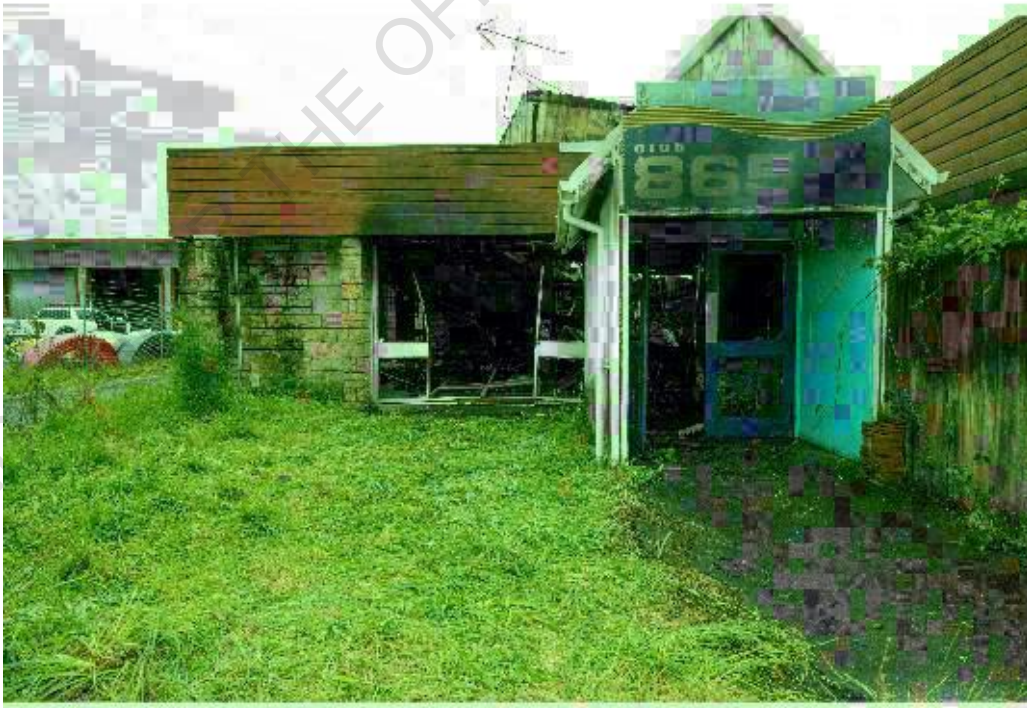
Photo 17: Club 865 on the south side of the tavern.

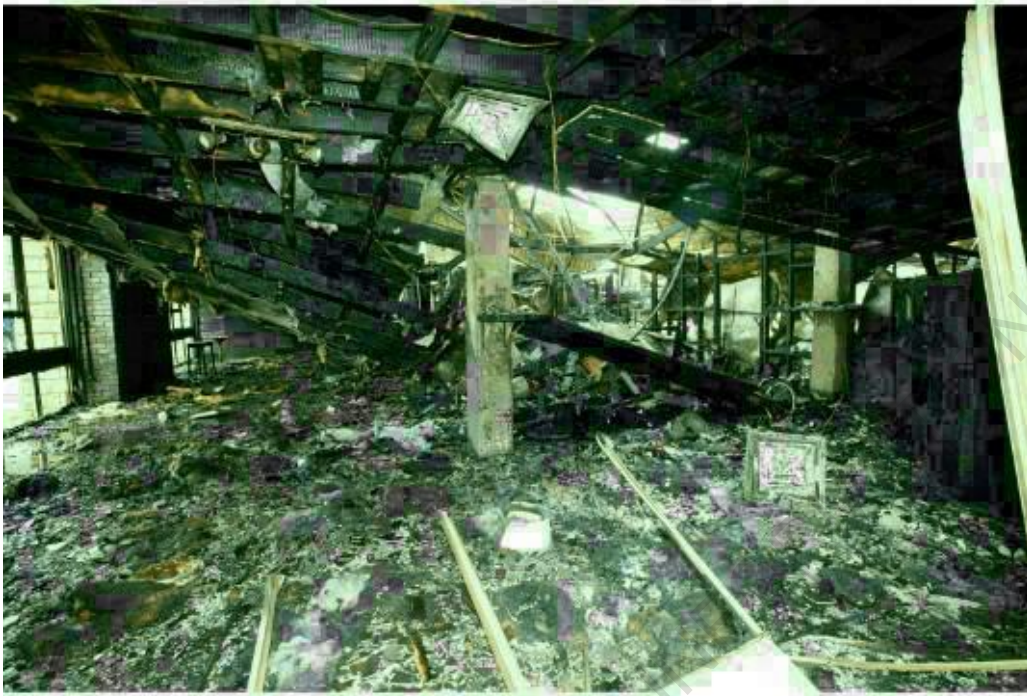
I viewed the interior of the club from the windows and doors. While the interior damage was extensive, I confirmed that the fire had spread to the club and had not originated inside. Witness 1 confirmed that the fire was not visible inside the club on their arrival.

Photo 19: Interior of Club 865. (Photo courtesy of Police).

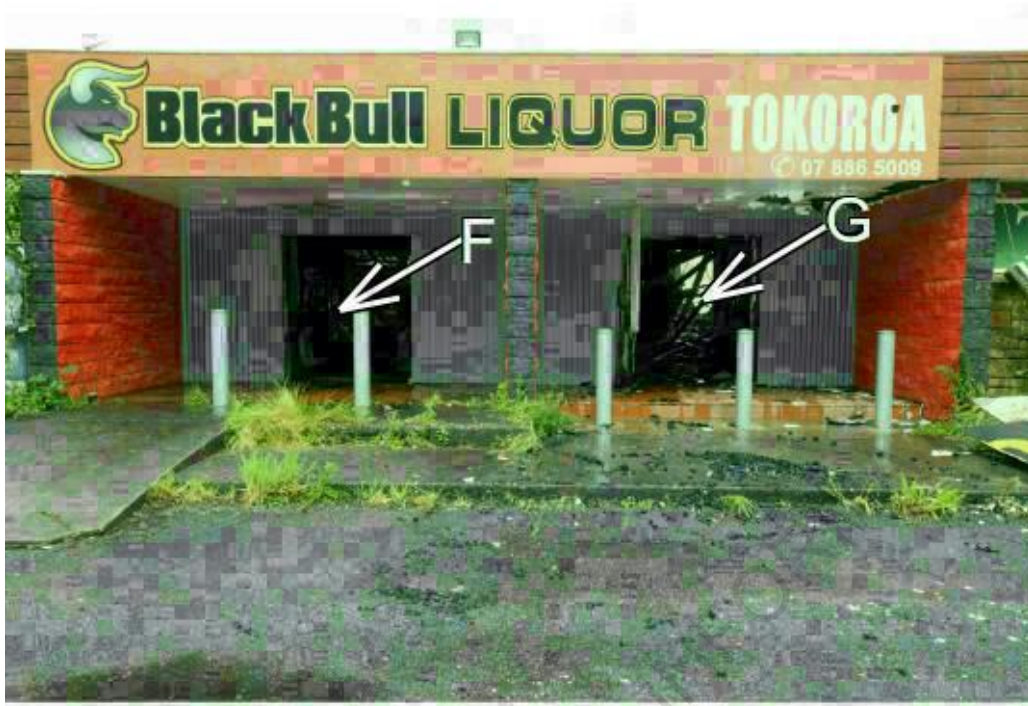
Reviewing the fire damage within the outlet, I believe the fire had spread to the liquor shop and had not originated inside.

I noted there were electrical appliances, including freezers, inside the outlet. Given the electricity was not operating inside the tavern beyond the electrical cabinet, I ruled out an electrical event inside the Black Bull Liquor store.

The Back Bull Liquor outlet was eliminated as an area of origin.

Photo 20: "F" Black bull liquor outlet. "G" Entrance to the tavern. (Photo courtesy of Police).

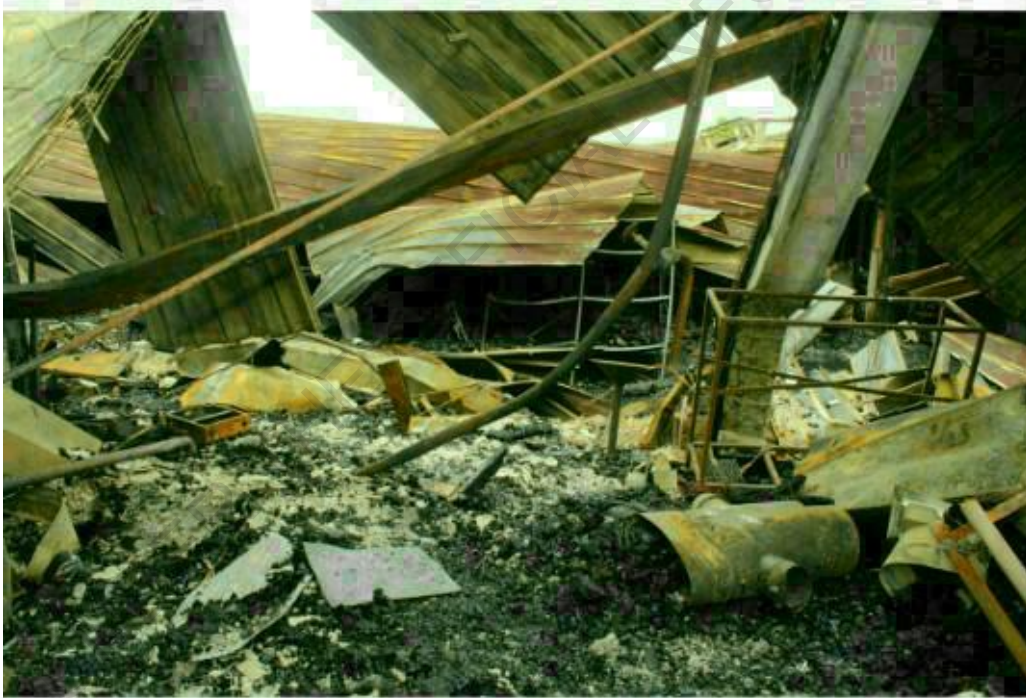
I moved into the west side of the tavern which was the location of the two tavern bars and gaming room further to the east towards SH 1. Due to the extensive fire damage and risk of collapse and the amount of debris on the floor, it was not practical to conduct a full internal examination and delay the debris.

I was of the opinion that an internal examination of the tavern to determine the area or point of origin was not credible.

Photo 29: Area in front of the west side tavern bar.

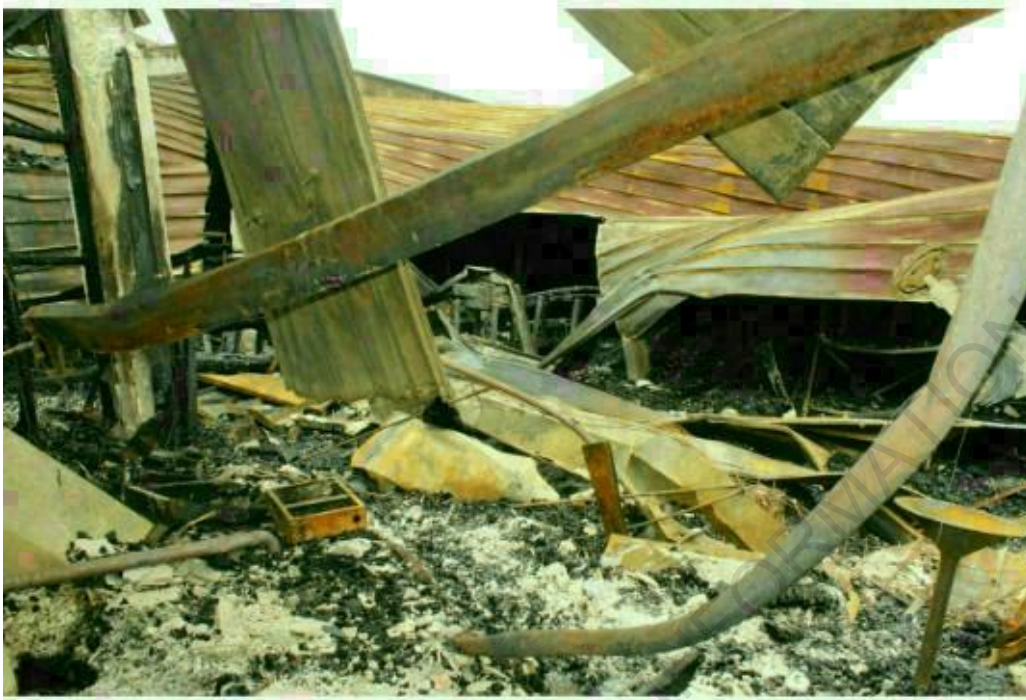
Photo 30: Area if front of the southside tavern bar

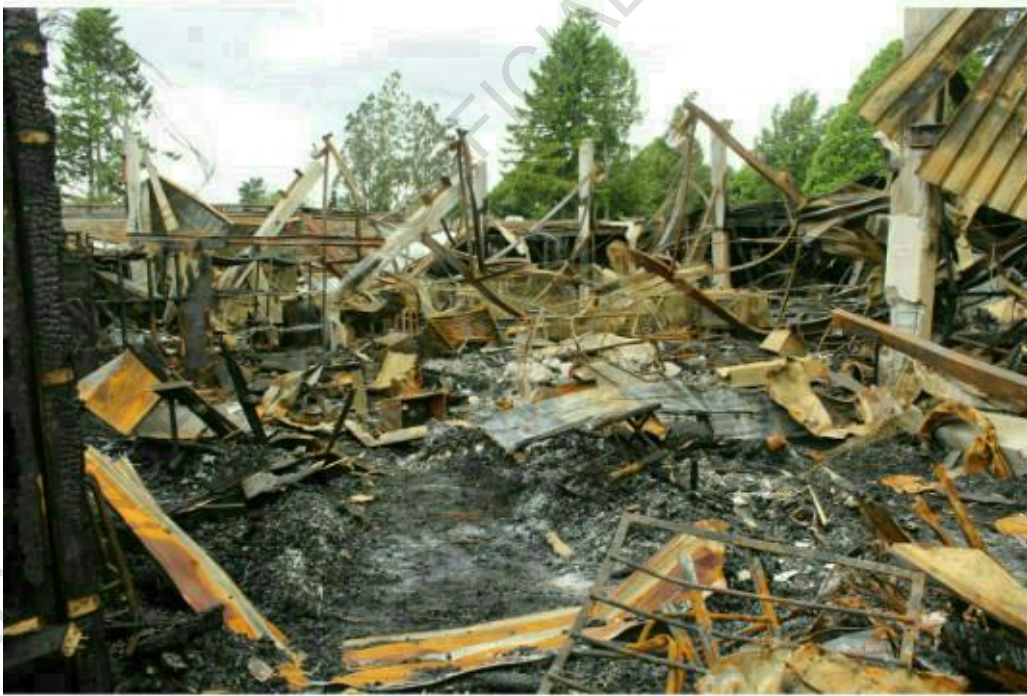
After reviewing the fire damage, it was still not credible to determine a defined area or point of origin to an acceptable level.

Photo 34: Interior of tavern after the removal of iron and debris.

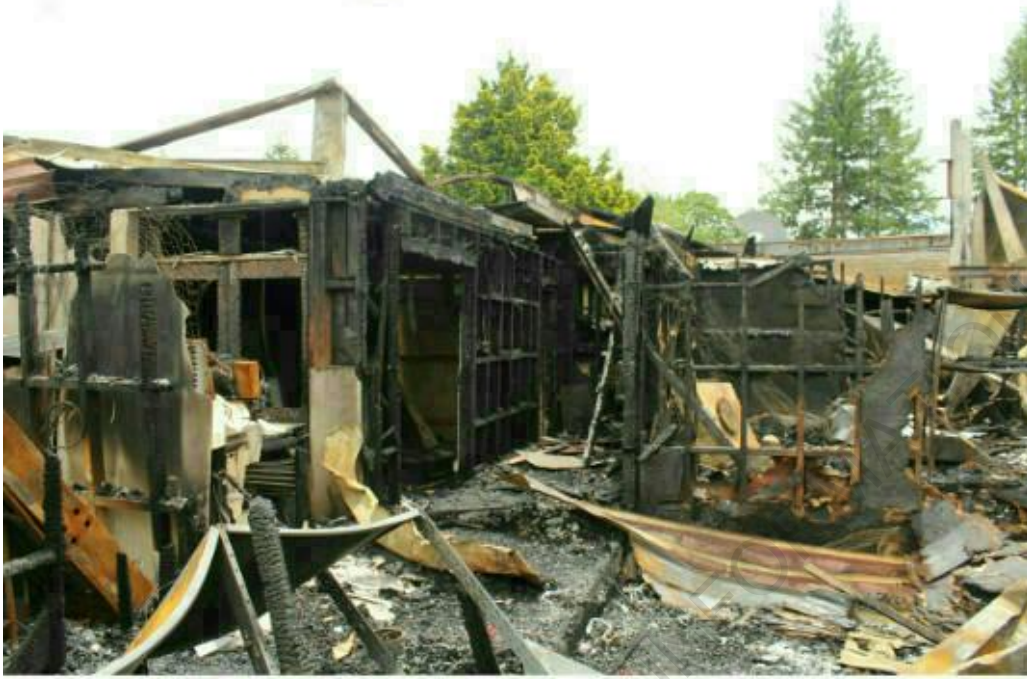
Photo 35: Northwest of tavern looking towards the kitchen and rear entrance.
