CASH SETTLED CLAIM(S)

Statement of Claim Checklist / Repair Strategy

CLM/2010/102220

RG Bull
 28 MALTA CRESCENT
 SOUTH NEW BRIGHTON
 CHRISTCHURCH

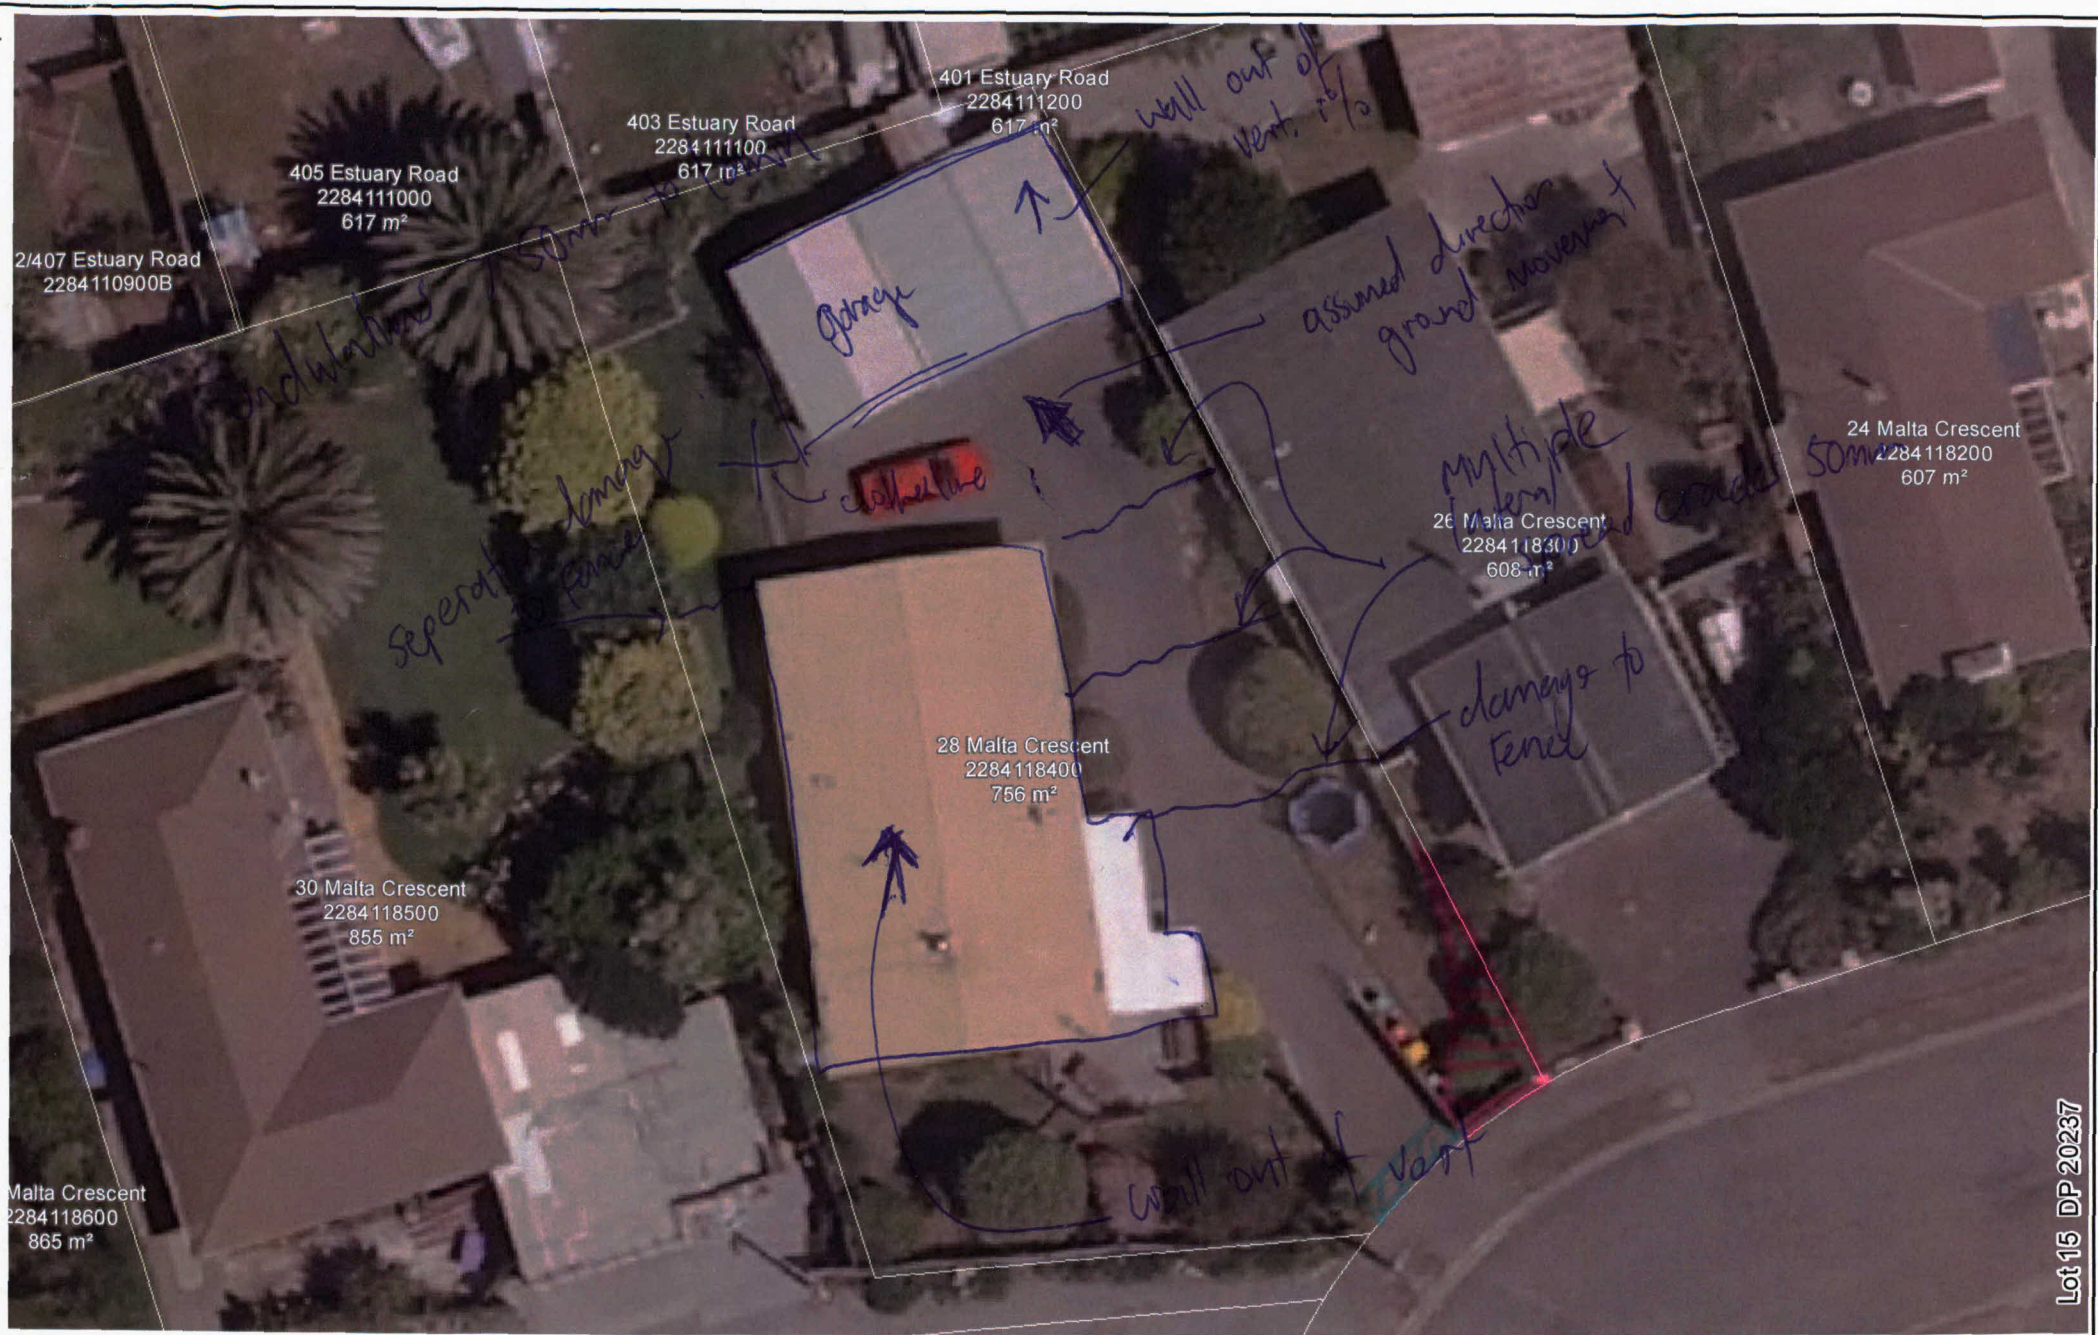
Lot 15 DP 20267

| LIQUEFACTION/Flat land damage comments: <i>LATERAL SPREADS / UNDISTURBED LAND</i> | |

| Remedial Option: Description..... | TBC (excluding GST) EARTHWORKS: fill cracks & remove undulations |
