ROYAL NEW ZEALAND NAVY
PHILOMEL
MINUTE

ACCIDENT REPORT (OP POSEIDON - 06 APR 13)

ACCIDENT INVESTIGATION REPORT

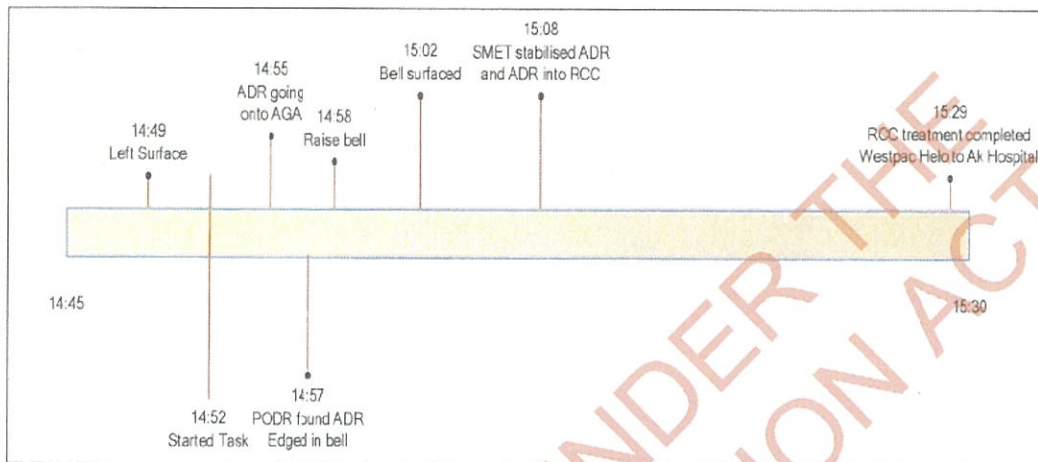
Figure 1: Accident Timeline

13. The accident timeline (Figure 1) shows that both divers arrived at the seabed safely at 1452 and that the accident occurred within the next three minutes.

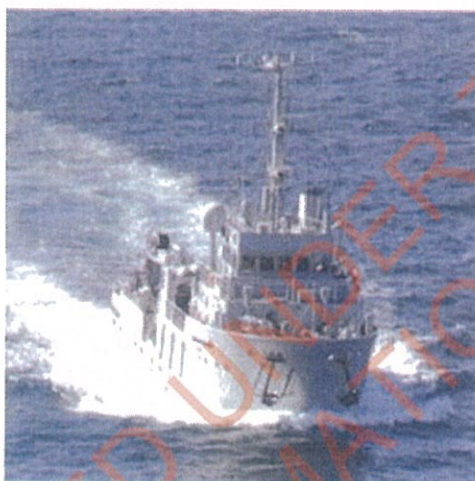
Figure 2: HMNZS Manawanui

22. Unusual diving incident or accidents are reported using a RNZN 1333 form and this report gave the environmental conditions. They appear unremarkable and could be described as good conditions for divers and for the dive platform, MAN.

23. The environmental conditions were Sunny 1-1.5m swell, sea state 2; Tide LW 1334, Depth 55.4m; underwater visibility 3m, sandy bottom, hard and compact.

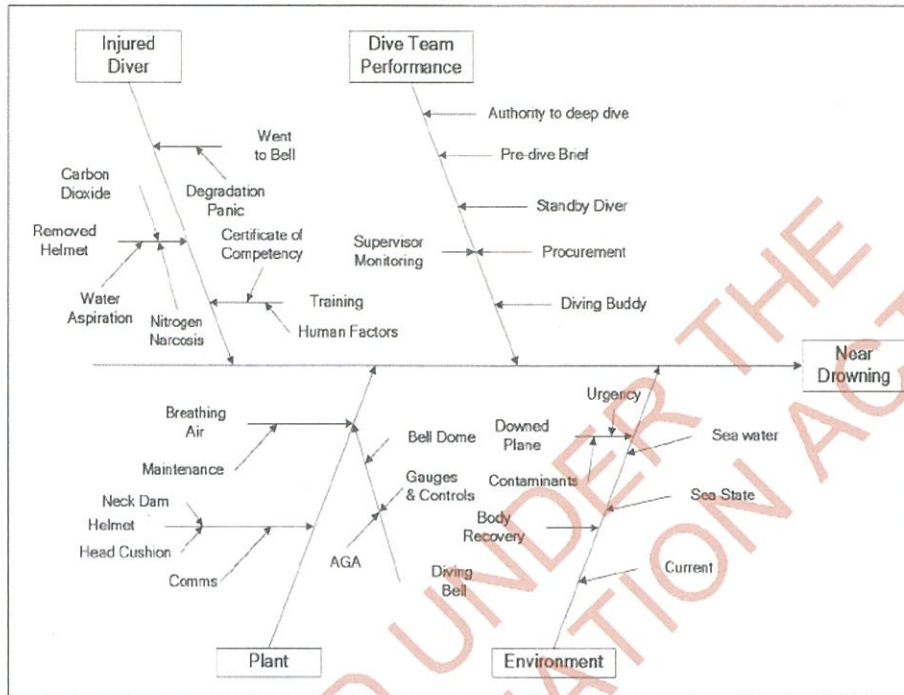
Figure 7: cause and effect diagram

116. The cause and effect below summarises this accident.

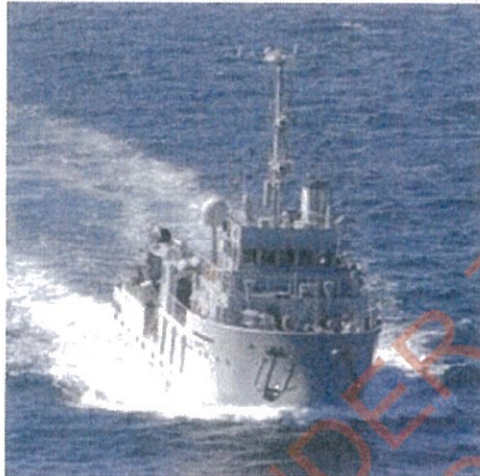
Figure 2: HMNZS Manawanui

Fig 2 shows the RNZN dive platform used, HMNZS Manawanui. Fig 3 shows the helmet worn and the neck dams examined as part of a detailed accident investigation. The position of the oral nasal mask and the dive helmet head cushion can also be seen in the photo.
