# Asset Assessment Report

## Waiau Pa Domain Reserve

### Clarks Beach Road, Waiau Pa

Date: 03/05/2017 Assessor : S7(2)(a) Privacy

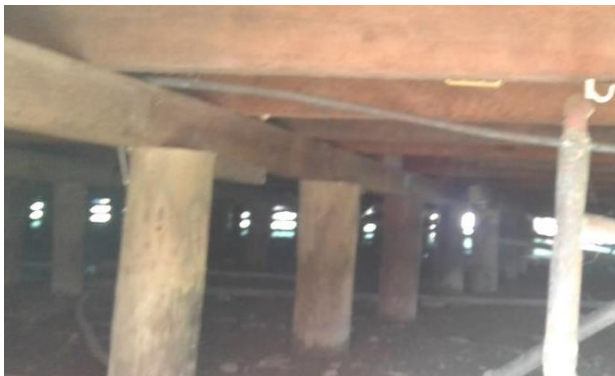
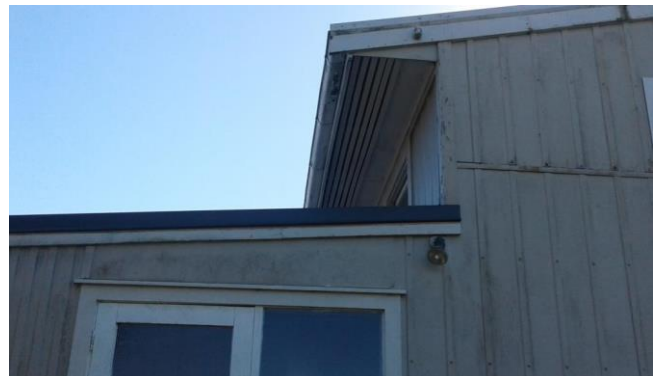
The building is of light weight timber frame construction supported by timber piles. The cladding of the building is fibrolite and is direct fixed to the timber frame wall. The roof is clad with iron roofing with PVC spouting and downpipes. The floor is constructed of timber floorboards on timber joists. Windows are of timber casement type with single glazing.
