### 7-9 Fanshawe Street Typical Floor Layout

### 7-9 Fanshawe Street – Basement to Level 5 Rear Staircase – Dust Sampling

## Clearance Certificate

# Clearance Certificate Friable Asbestos

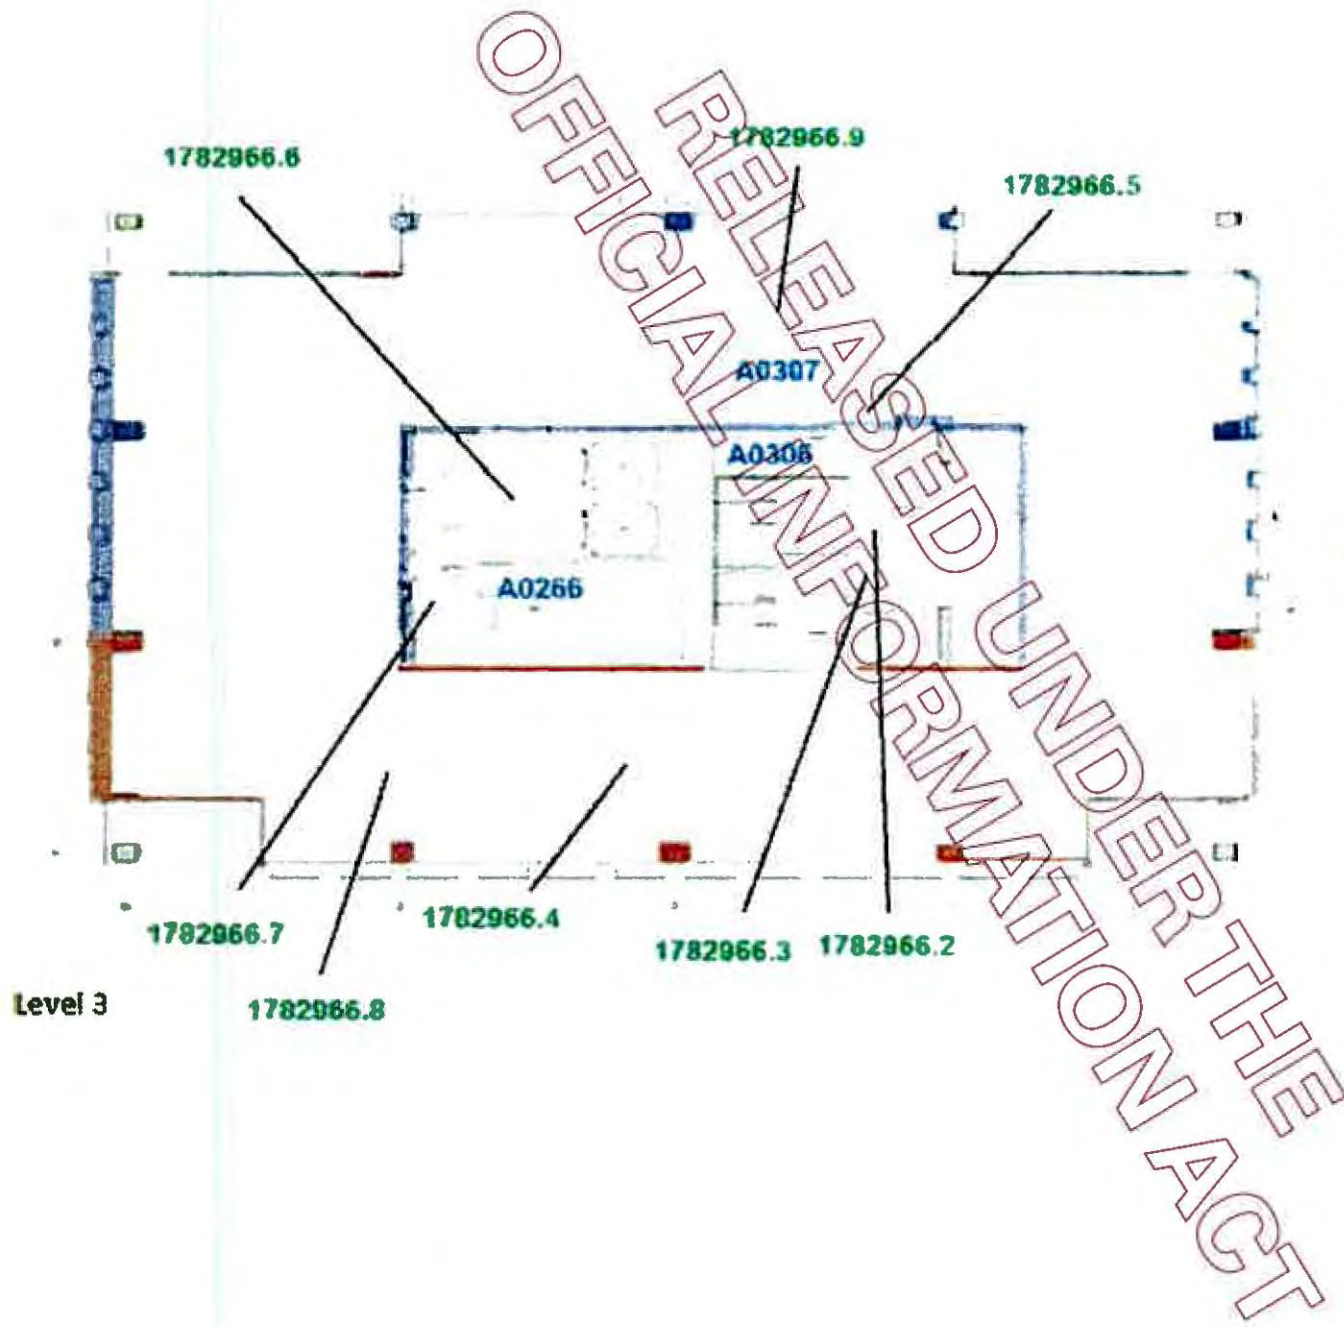
**XXX.X - Debris sample (Lab  
Number) - Positive for  
asbestos**
