File Title: 5720037 - Unknown PCBU, please update - Response

Location: 19 Wentworth Street, Gore

# Asbestos Sampling Survey

19 Wentworth St, Gore

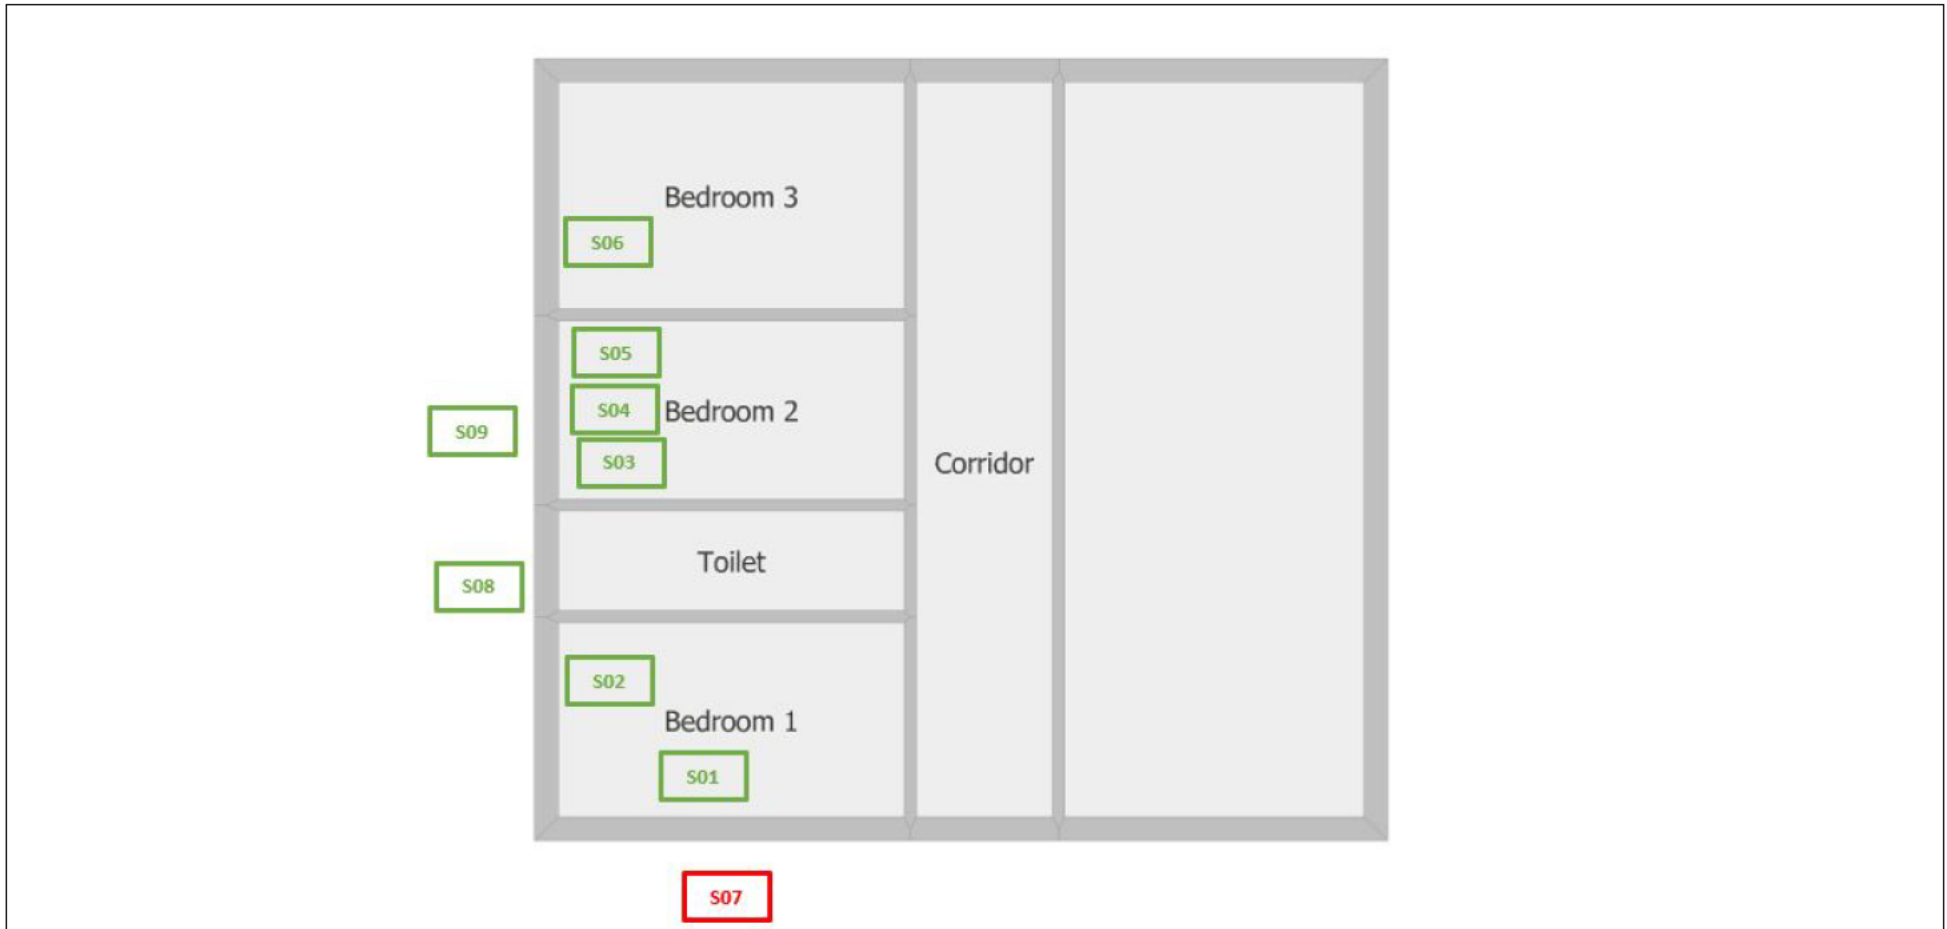
# Appendix 4 – Site Plans

Floor plan is not to scale. Prepared as a visual representation of the areas surveyed only	National Office, Level 6, 86 Customhouse Quay, Wellington
