# Old Mangere Numerical Capacity Review

## January 2016

**AMA – SPECIAL INSPECTION**
**Old Mangere Bridge**

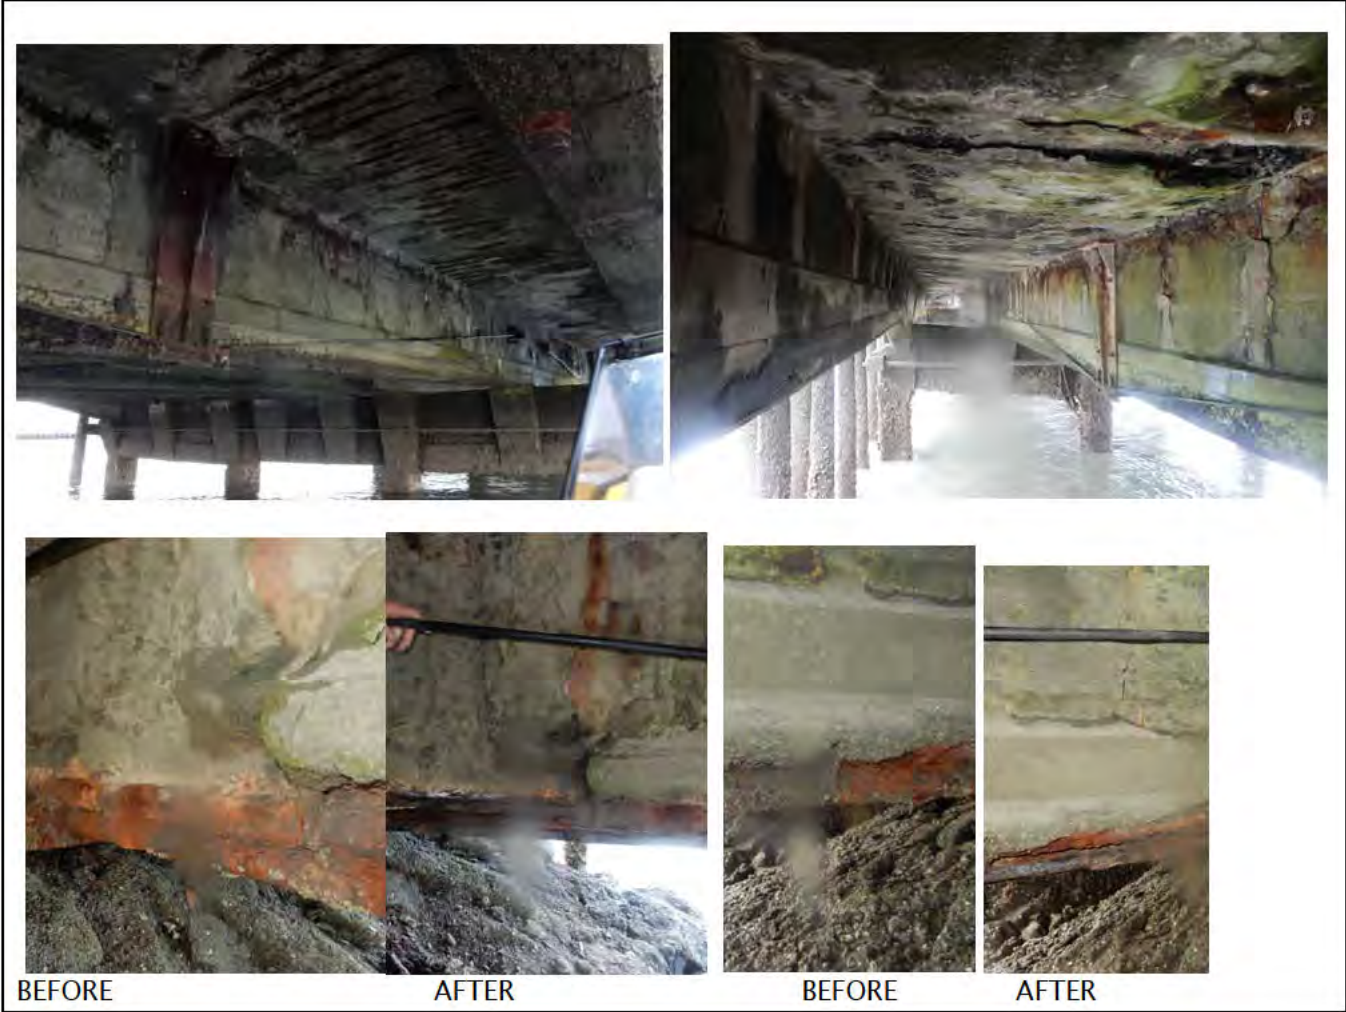
Comments: Heavy delamination of concrete and reinforcement throughout the span. The pictures below show the level of loss of section to the main tensile reinforcement following a strike with a hand held hammer. The main reinforcement has loss in excess of 50% and is no longer bonded to the concrete beams. Generally all the concrete sounded spongy/brittle when struck with a hammer.

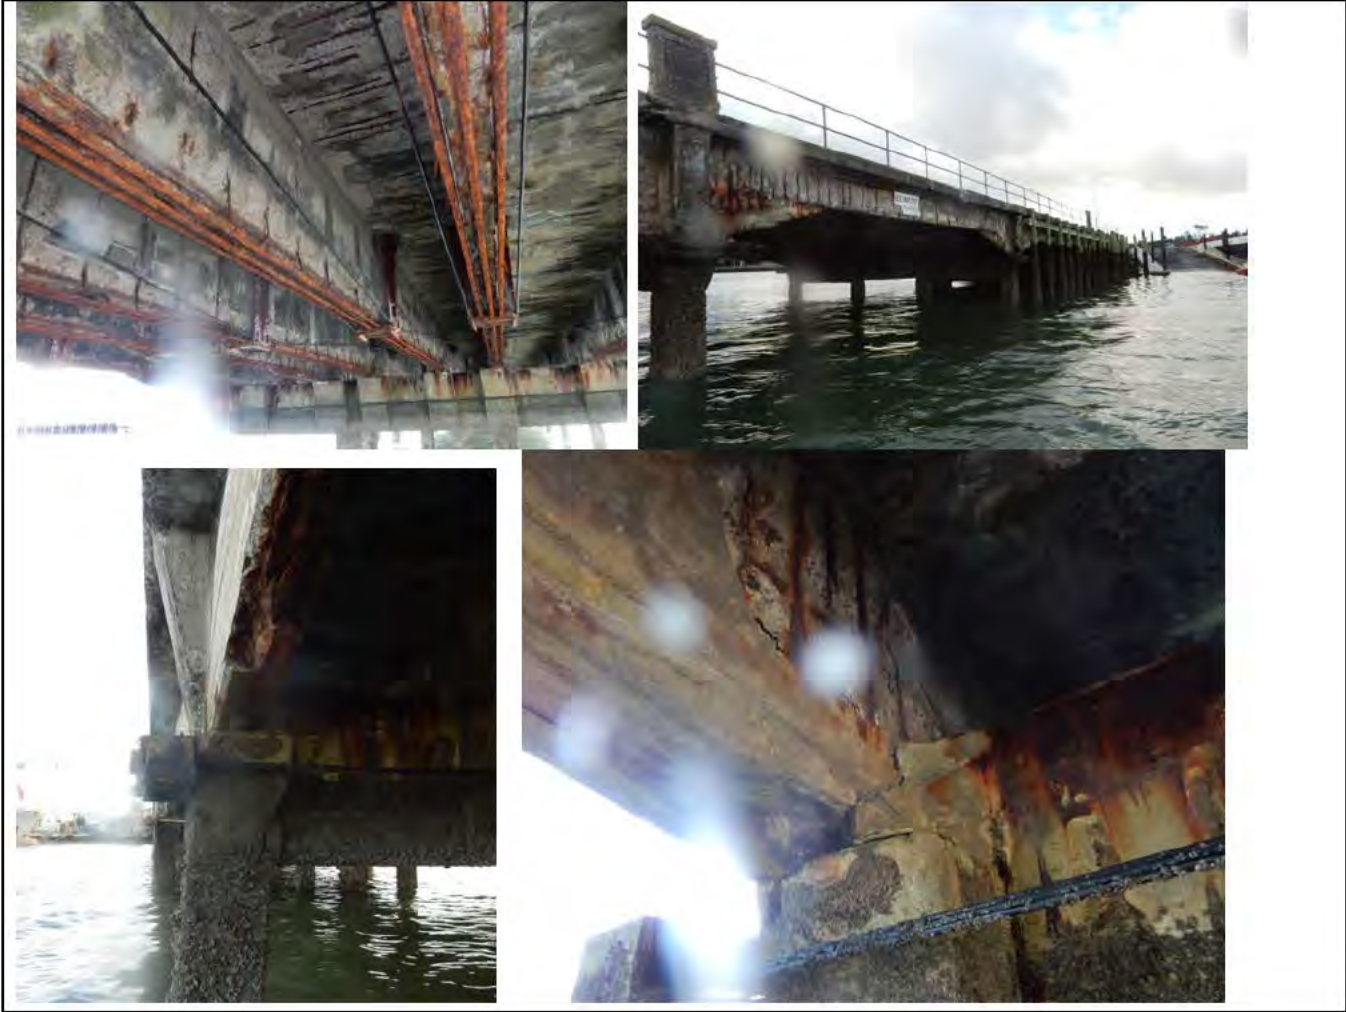
Comments: All elements on the deck have areas of delamination and loss of section to reinforcement. The majority of the beams bottom reinforcement are floating in mid-air with 100% section loss to the shear links

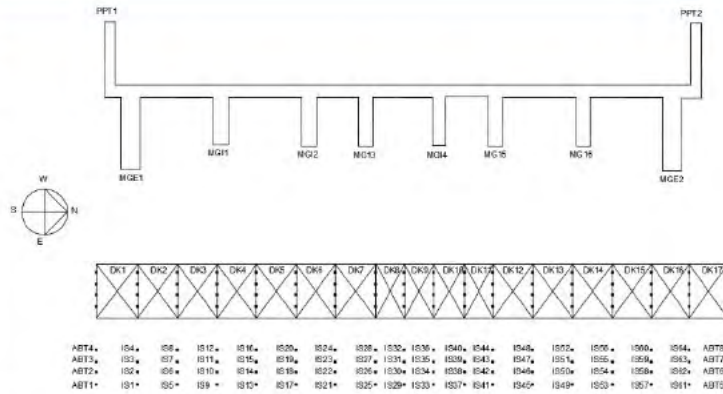
Comments: All elements on the deck have areas of delamination and loss of section to reinforcement. The majority of the beams bottom reinforcement are floating in mid-air with 100% section loss to the shear links.

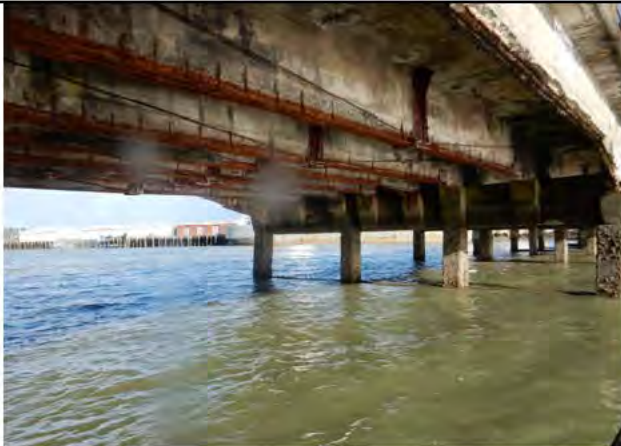
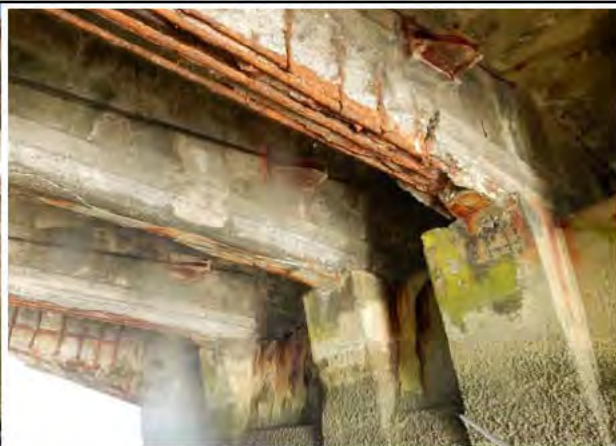
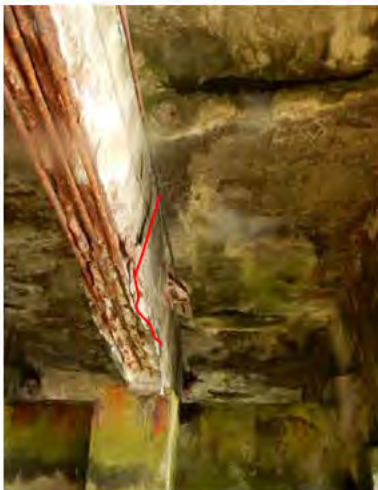
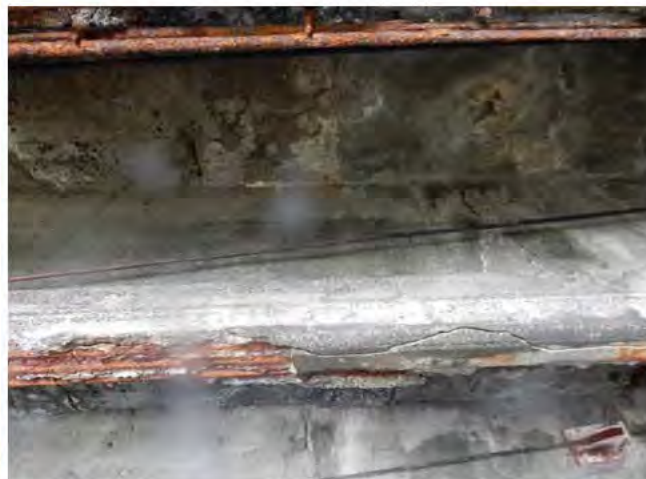
Comments: IS24 is no longer vertical/plum, initially due to a boat impact. There is a large crack the full depth of the cross head. Areas broke loose when struck with a hammer revealing corroded reinforcement. Cracking was also noted on IS21, it is assumed the reinforcement behind is corroded with loss of section.

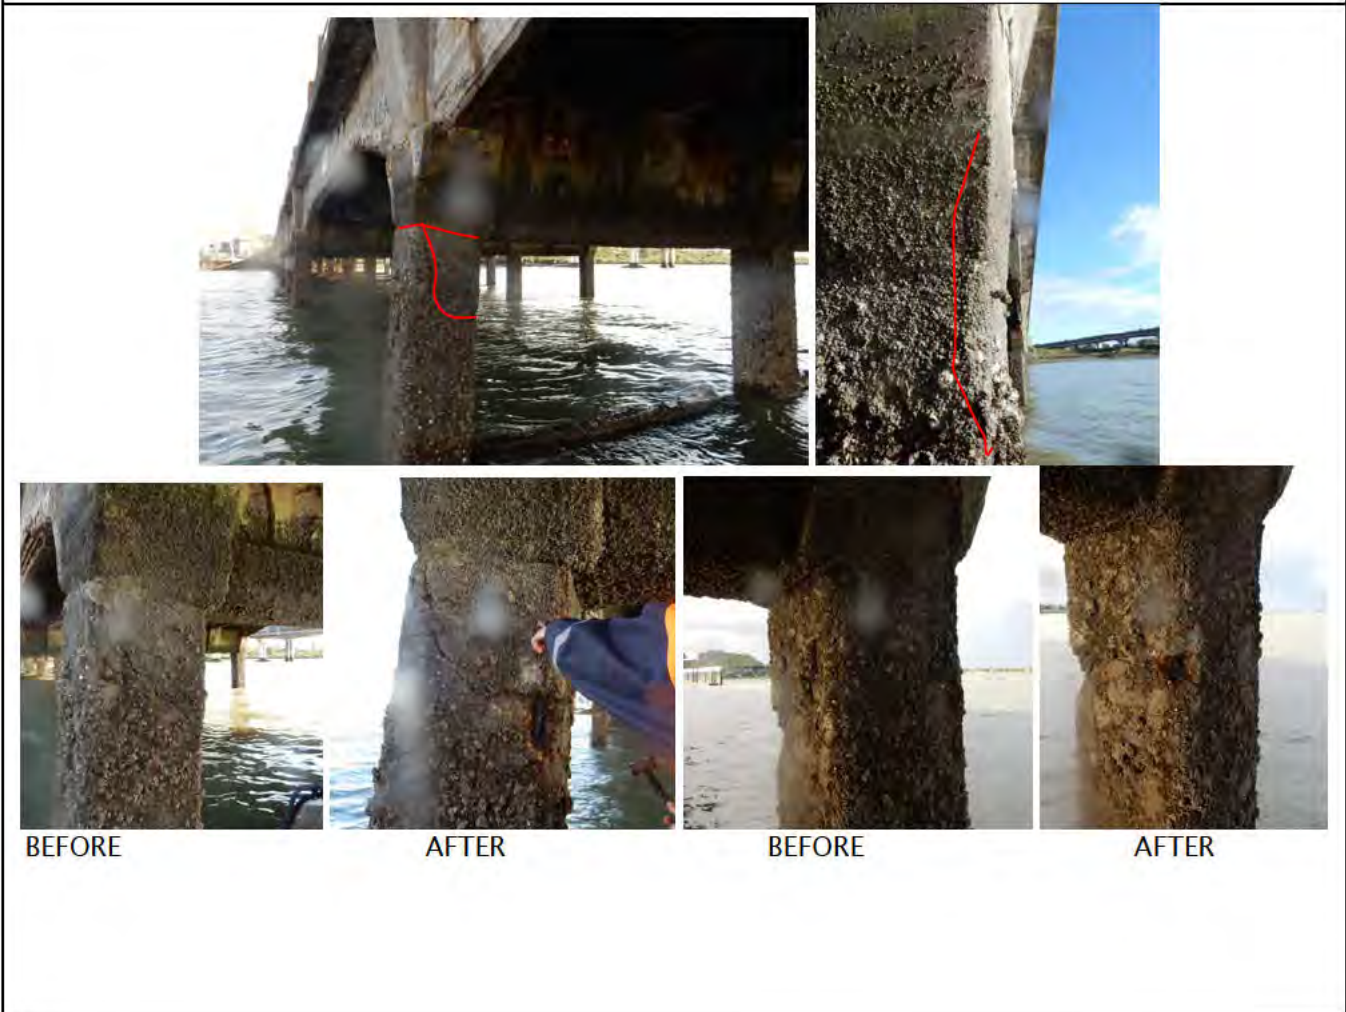
Comments: All elements on the deck have areas of delamination and loss of section to reinforcement. The majority of the beams bottom reinforcement are floating in mid-air with 100% section loss to the shear links. The reinforcement in MG1 has completely deteriorated with 100% section loss to a number of bars

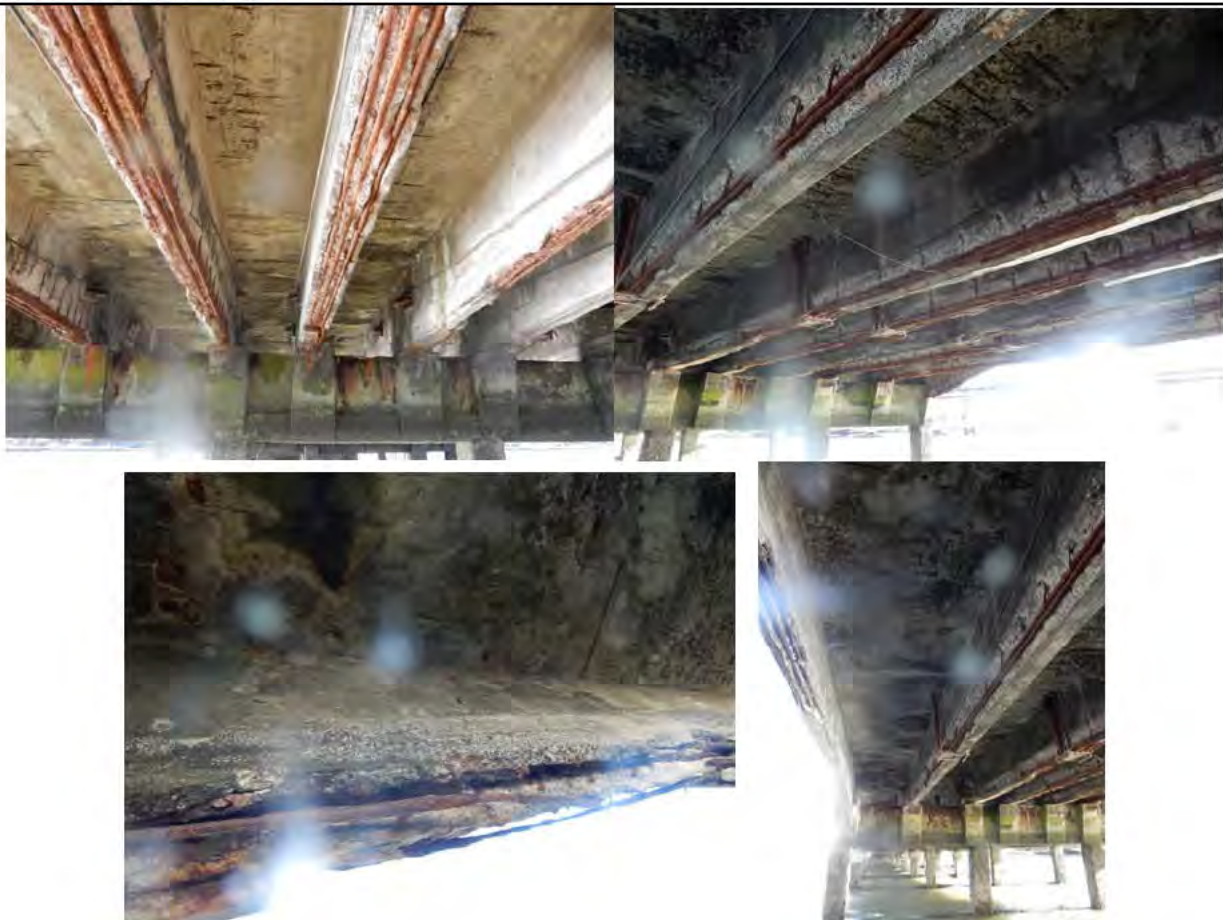
Comments: All elements on the deck have areas of delamination and loss of section to reinforcement.

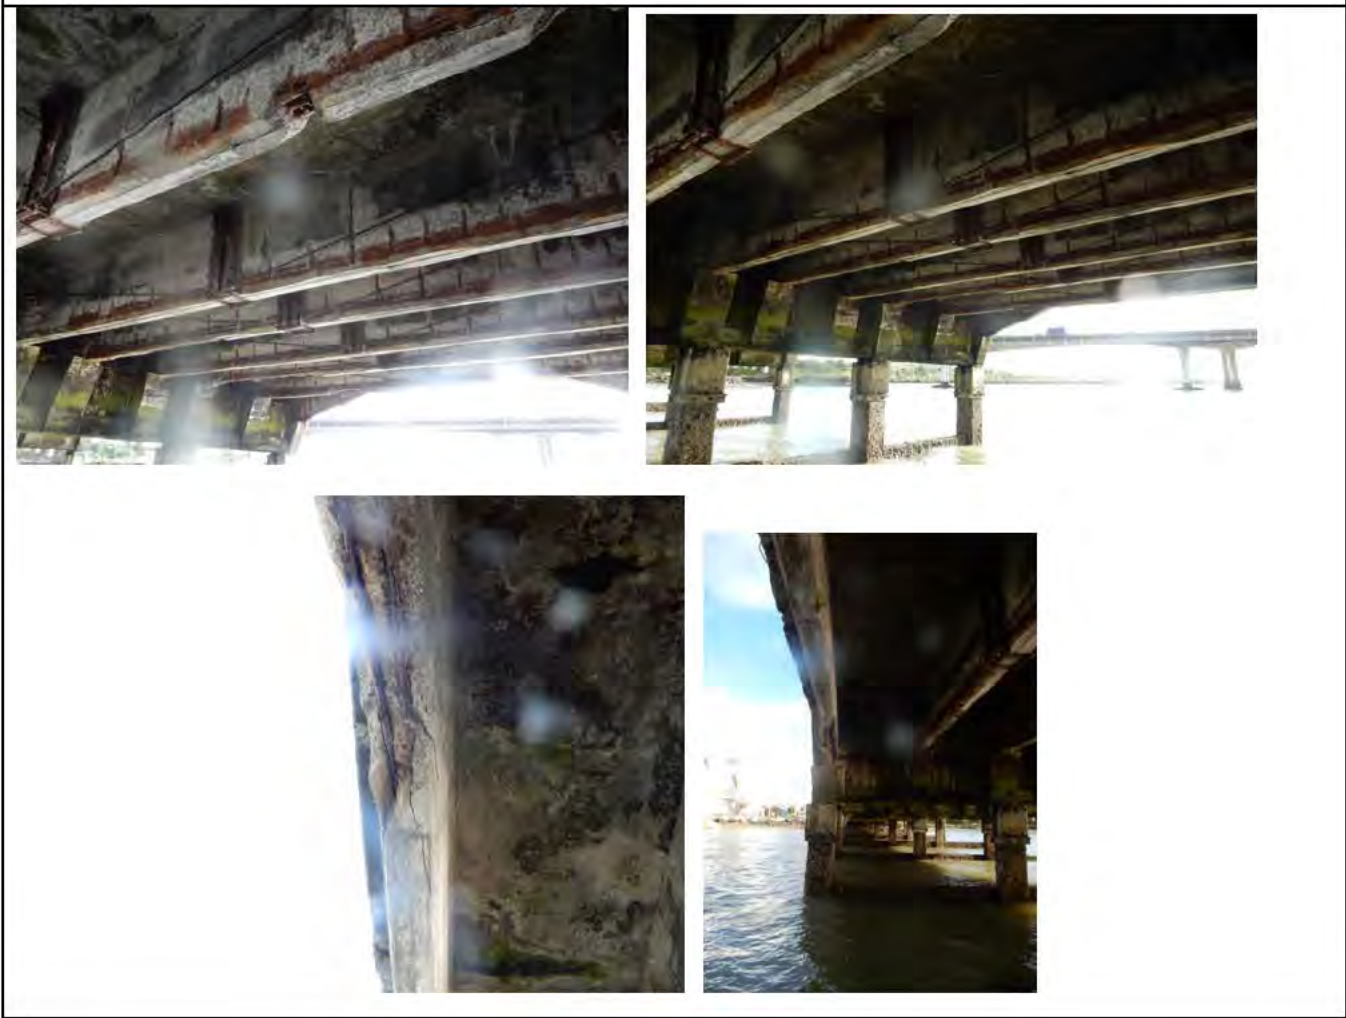
Comments: There are full depth cracks on the cross head beams under MGE1. There are stepped cracks to the soffit of all the cross beams as a result of delamination and rust jacking.

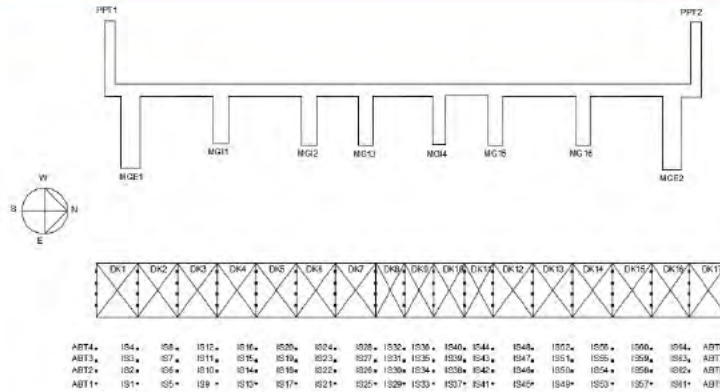
Comments: IS31 was spongy when struck and areas delaminated. There is also transverse cracking to the pile.

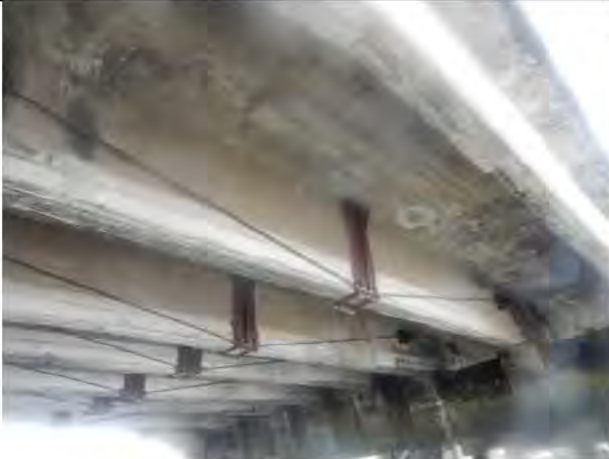
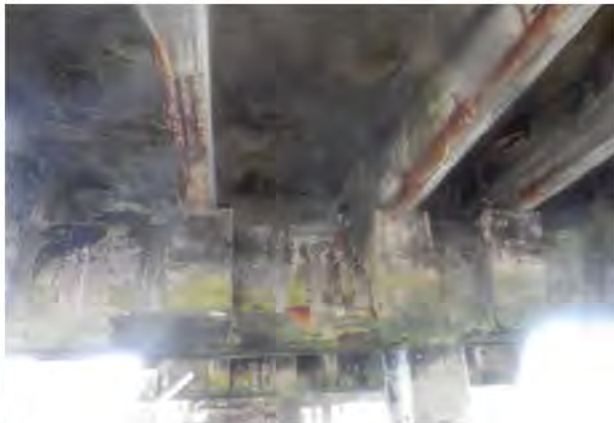
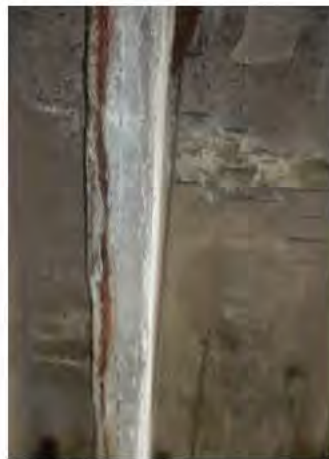
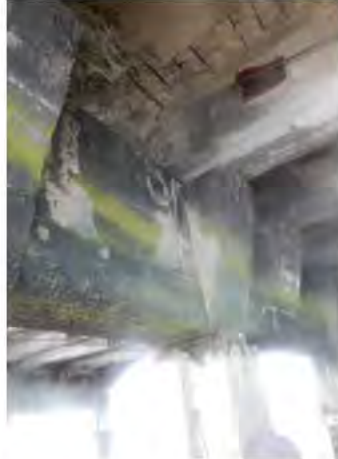
Comments: All elements on the deck have areas of delamination and loss of section to reinforcement. The soffit of the deck is a little better in this span compared to the previous spans as it is above the tidal range.

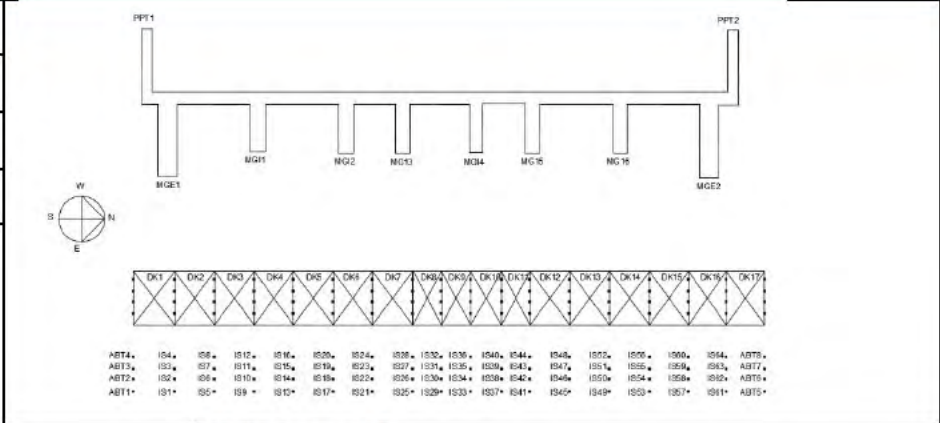
Comments: All elements on the deck have areas of delamination and loss of section to reinforcement. The soffit of the deck is a little better in this span compared to the initial spans as it is above the tidal range.

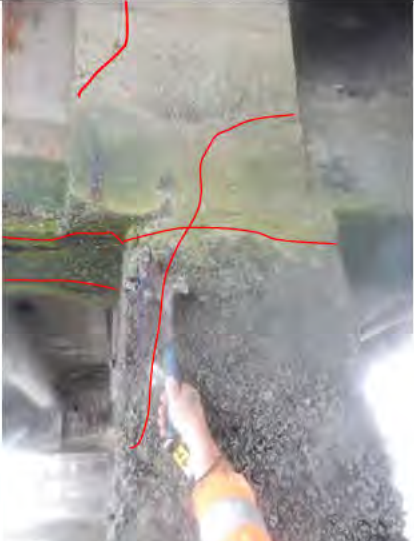
Component: All Elements
Defect Type: Spalling & Delamination
Extent: D
Severity: 5
Priority: HIGH

<p>Risk Severity: 5+</p>	<p>Risk Score: 20+</p>
<p>Comments: There transverse cracks on IS38 &amp; IS40. The piles sound and feel spongy when struck with a hammer and areas delaminated when hit.</p>	
<div style="display: flex; justify-content: space-around;"> <div style="text-align: center;">

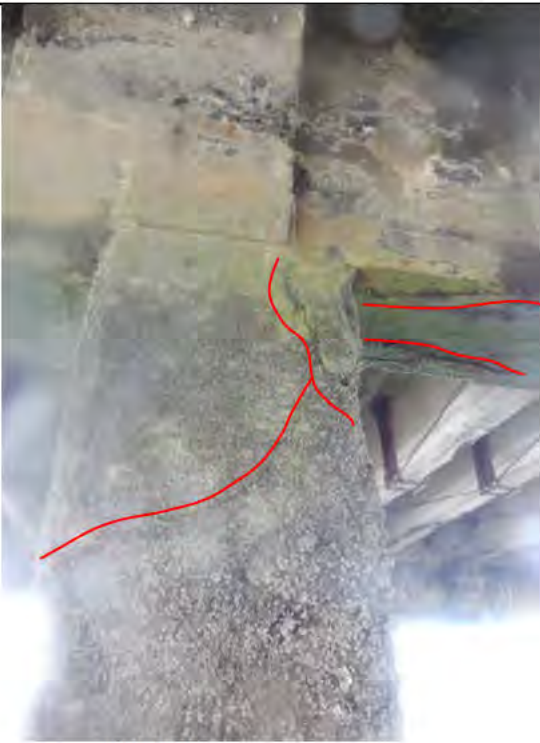
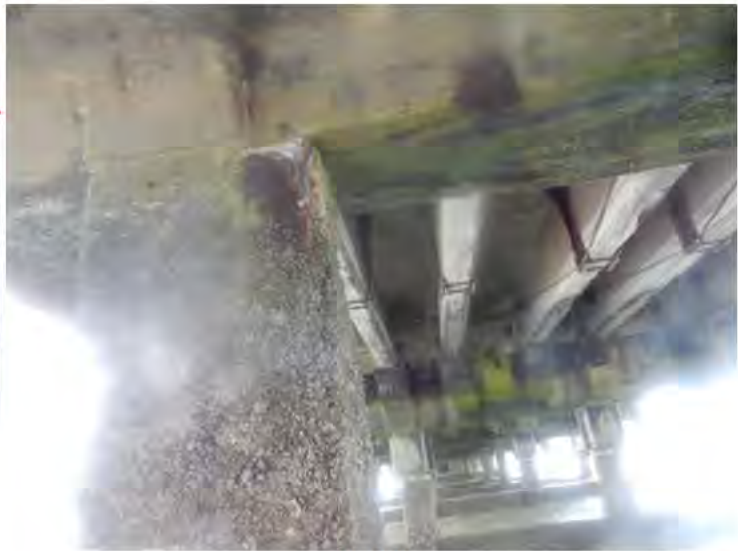
Component: IS45-IS48 Piers & Cross Head Beam  
 Defect Type: Spalling, Delamination and cracking  
 Extent: D  
 Severity: 5  
 Priority: HIGH

Comments: There is extensive cracking and delamination of the cross head beams and the tops of the piles. The concreted delaminated when struck and generally is spongy when hit.

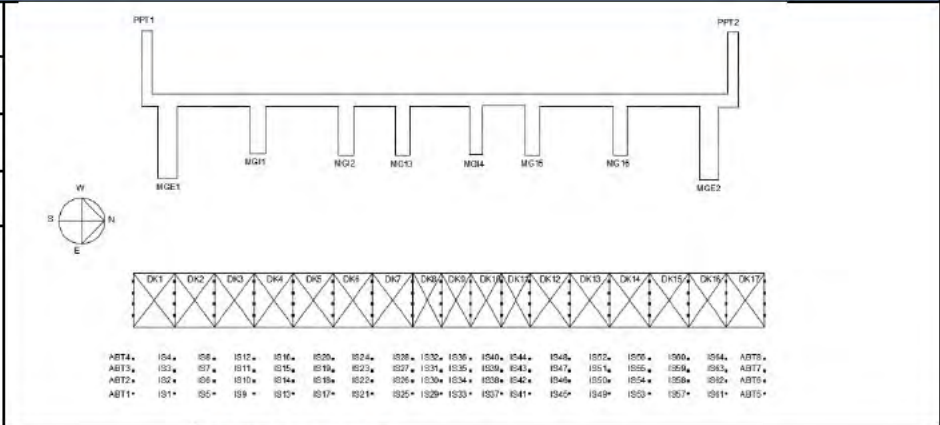
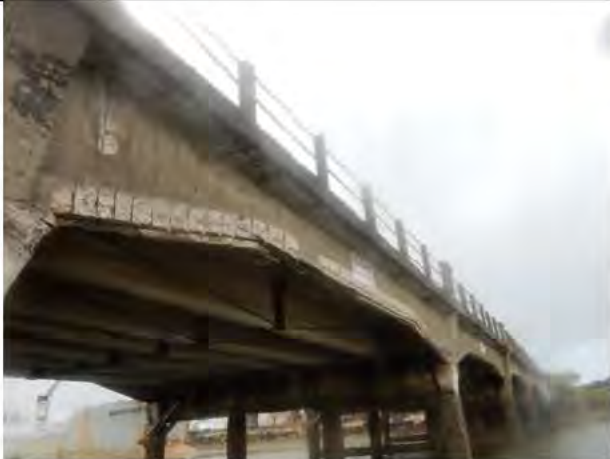
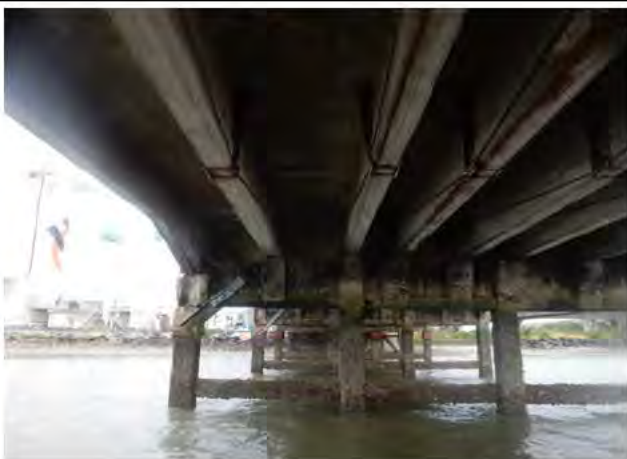
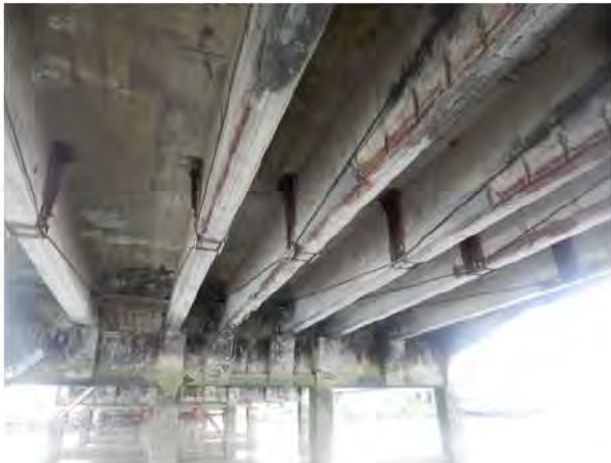
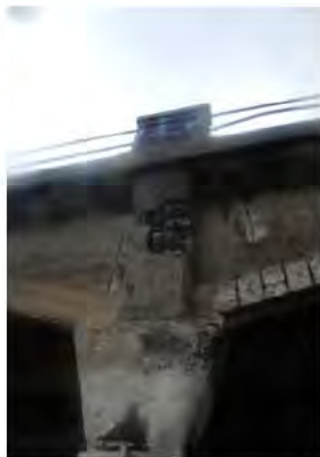
Component: All Elements  
 Defect Type: Spalling & Delamination  
 Extent: D  
 Severity: 5  
 Priority: HIGH

Comments: All elements on the deck have areas of delamination and loss of section to reinforcement. The soffit of the deck is a little better in this span compared to the initial spans as it is above the tidal range.

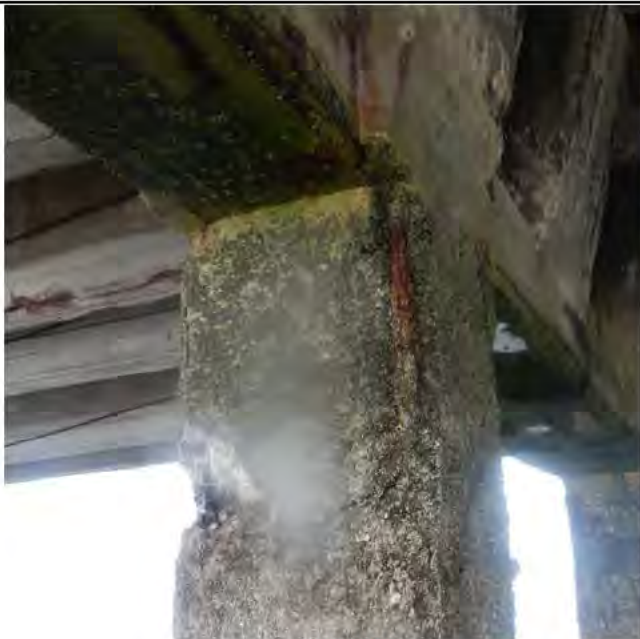
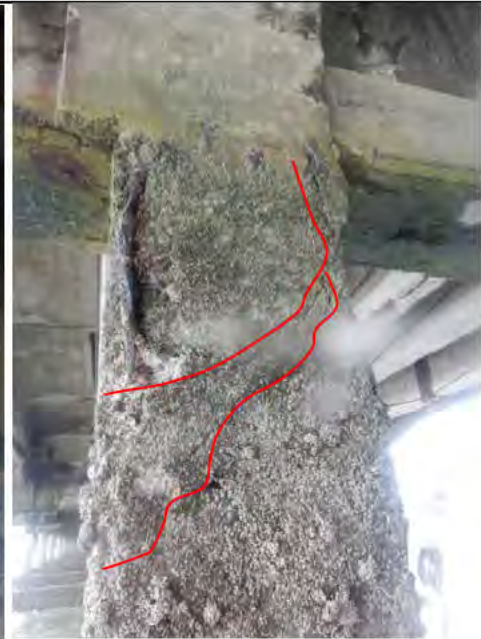
Component: IS45-IS48 Piers & Cross Head Beam
Defect Type: Spalling, Delamination and cracking
Extent: D
Severity: 5
Priority: HIGH

**Comments:** There is extensive cracking and delamination of the cross head beams and the tops of the piles. IS46 & IS47 main reinforcement has buckled in the corners there is extensive crush and cracking of the concrete at this location. The cross head is heavily delaminated at this location. The concrete generally is spongy when struck. The horizontal strut to pier connection has cacking and very spongy when struck.

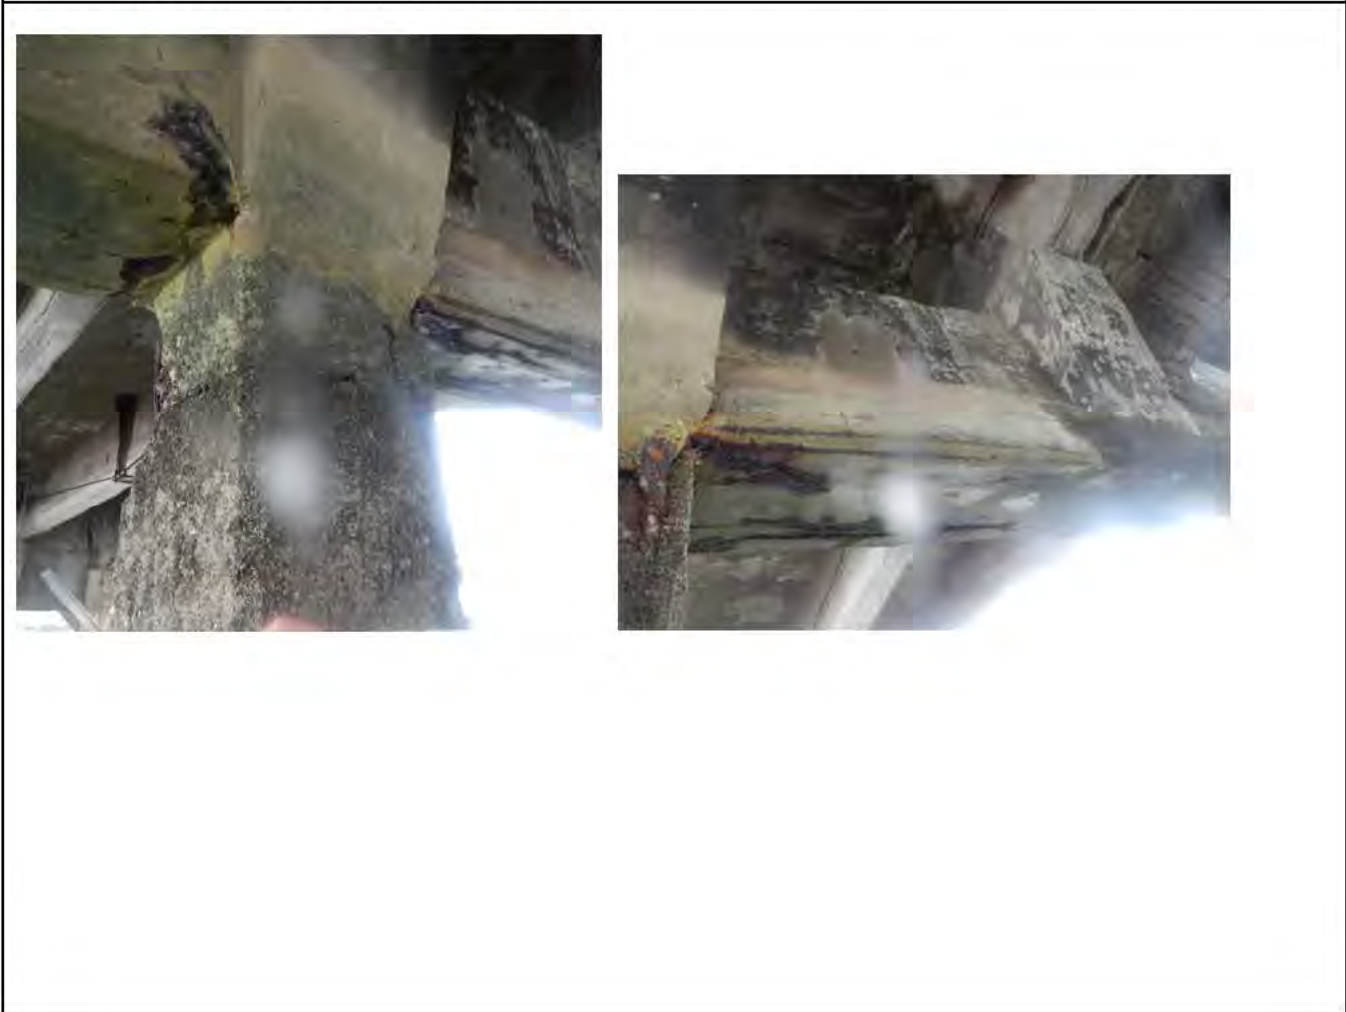
Component: IS45-IS48 Piers & Cross Head Beam
Defect Type: Spalling, Delamination and cracking
Extent: D
Severity: 5
Priority: HIGH

Comments: There is extensive cracking and delamination of the cross head beams and the tops of the piles. IS46 & IS47 main reinforcement has buckled in the corners there is extensive crush and cracking of the concrete at this location. The cross head is heavily delaminated at this location. The concreted generally is spongy when struck

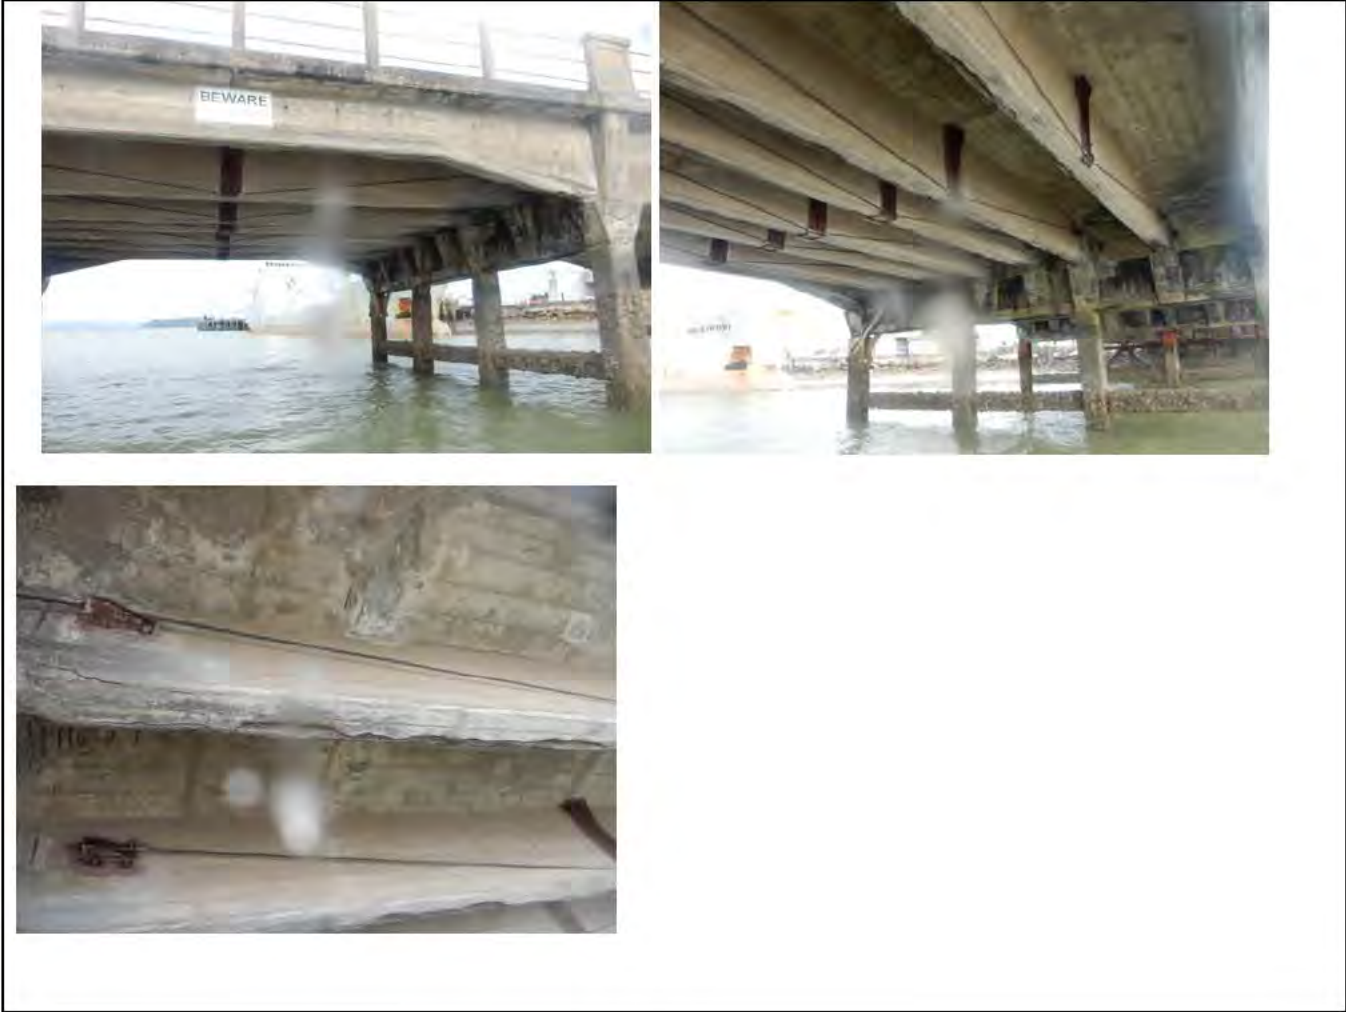
<p>Component: All Elements</p>	
<p>Defect Type: Spalling &amp; Delamination</p>	
<p>Extent: D</p>	
<p>Severity: 5</p>	
<p>Priority: HIGH</p>

Comments: All elements on the deck have areas of delamination and loss of section to reinforcement. The soffit of the deck is a little better in this span compared to the initial spans as it is above the tidal range.

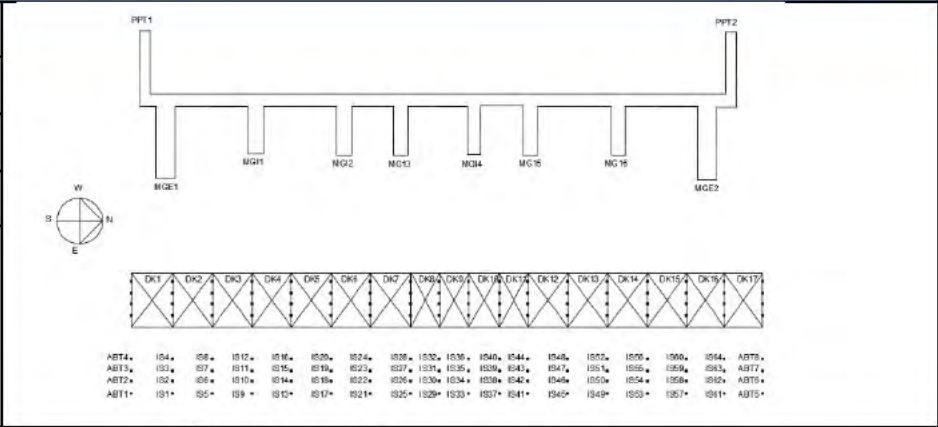
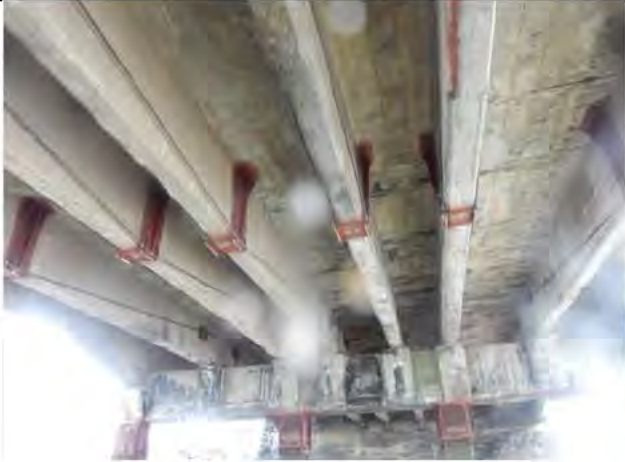
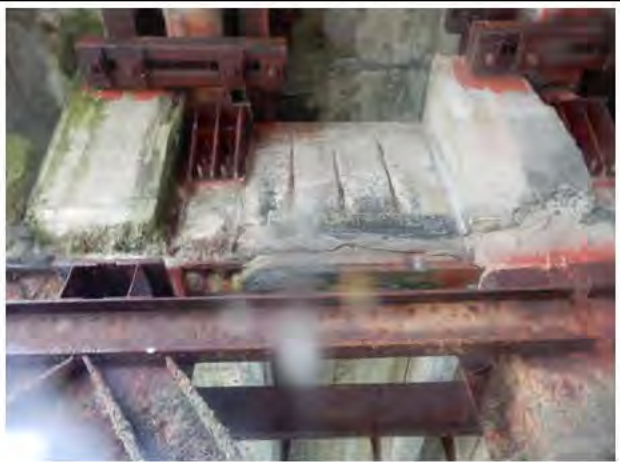
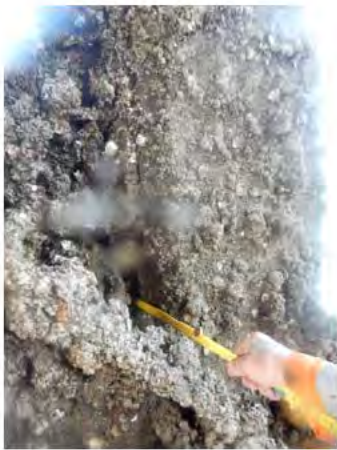
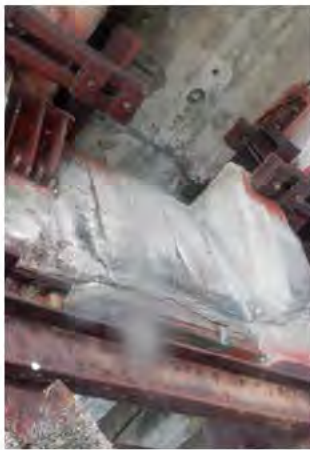
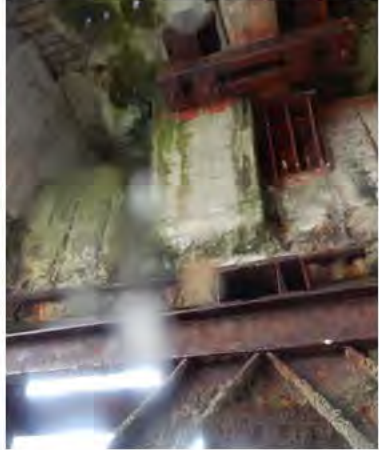
Component: All Elements
Defect Type: Spalling & Delamination
Extent: D
Severity: 5
Priority: HIGH

Comments: All elements on the deck have areas of delamination and loss of section to reinforcement. The soffit of the deck is a little better in this span compared to the initial spans as it is above the tidal range. The piers have been strapped up with supplementary steels following a boat strike a few years ago.

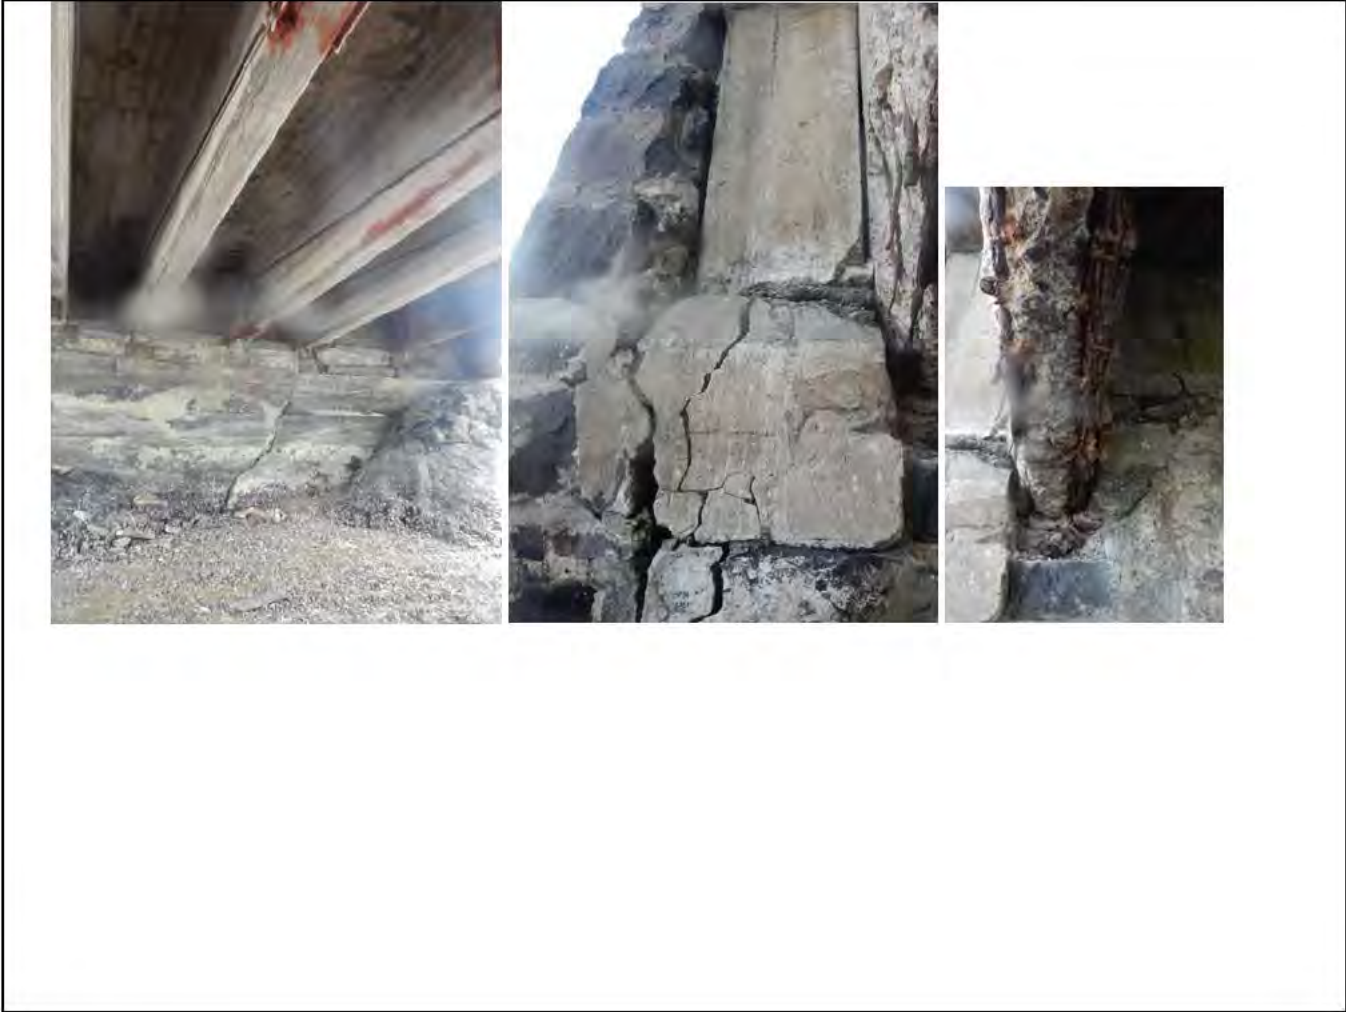
Component: All Elements  
 Defect Type: Spalling & Delamination  
 Extent: D  
 Severity: 5  
 Priority: HIGH

Comments: All elements on the deck have areas of delamination and loss of section to reinforcement. There are fracture to the abutment that surround the piles support at this location. The ends of the beams have heavily delaminated and loss of section to the reinforcement. The bed stones area are, missing, loose or heavily cracked.

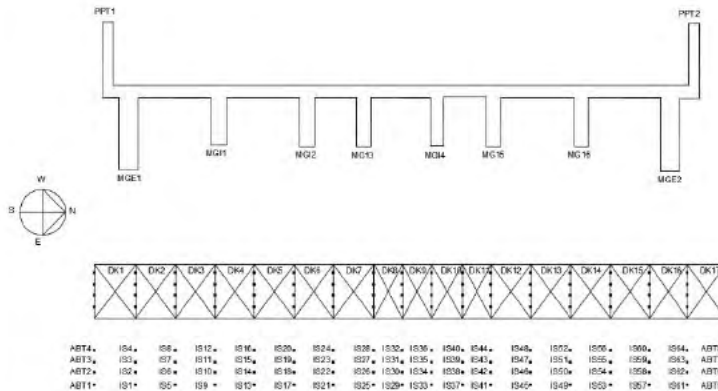
Defect Type: Spalling & Delamination

Comments: All elements on the deck have areas of delamination and loss of section to reinforcement. The ends of the beams have heavy delaminated and loss of section to the reinforcement. The previous post-tension system seems to be crushing the concrete and there appears to be shear cracks at the supports.

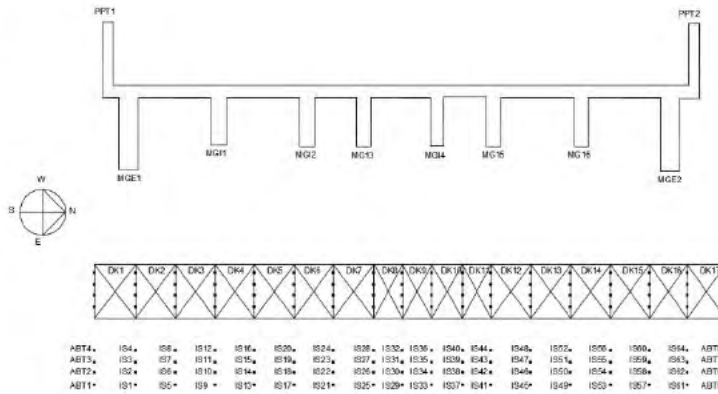
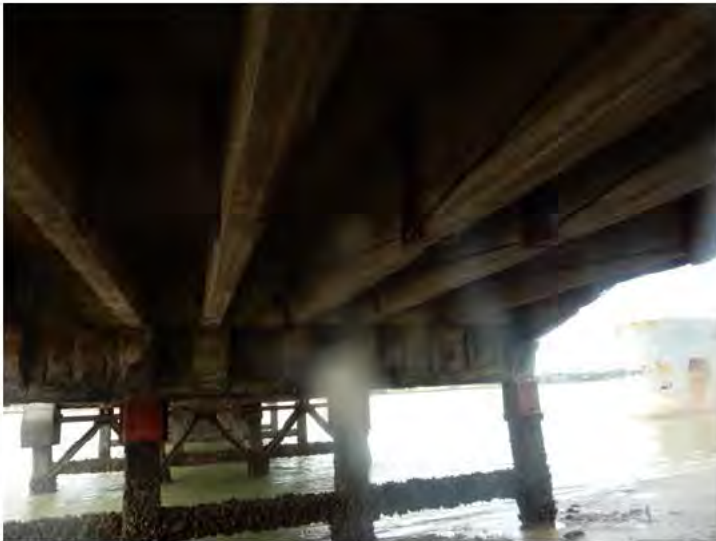
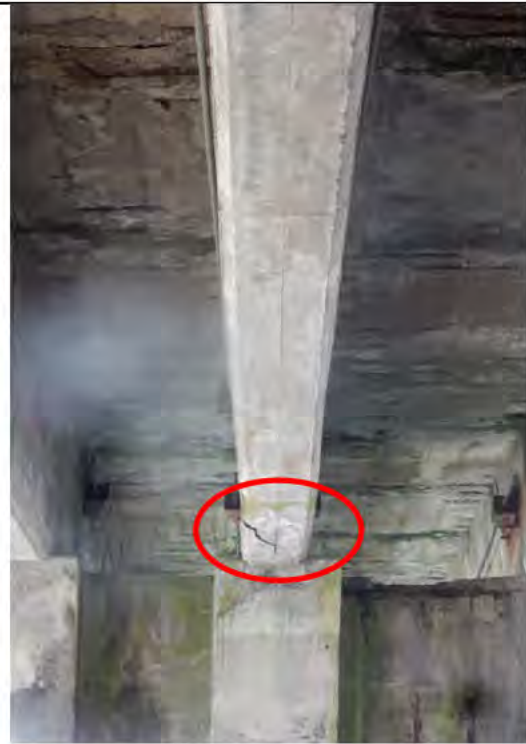
Defect Type: Spalling & Delamination and buckling

Comments: MGI3 appears to be buckling over IS51-51 at the end of the beam.

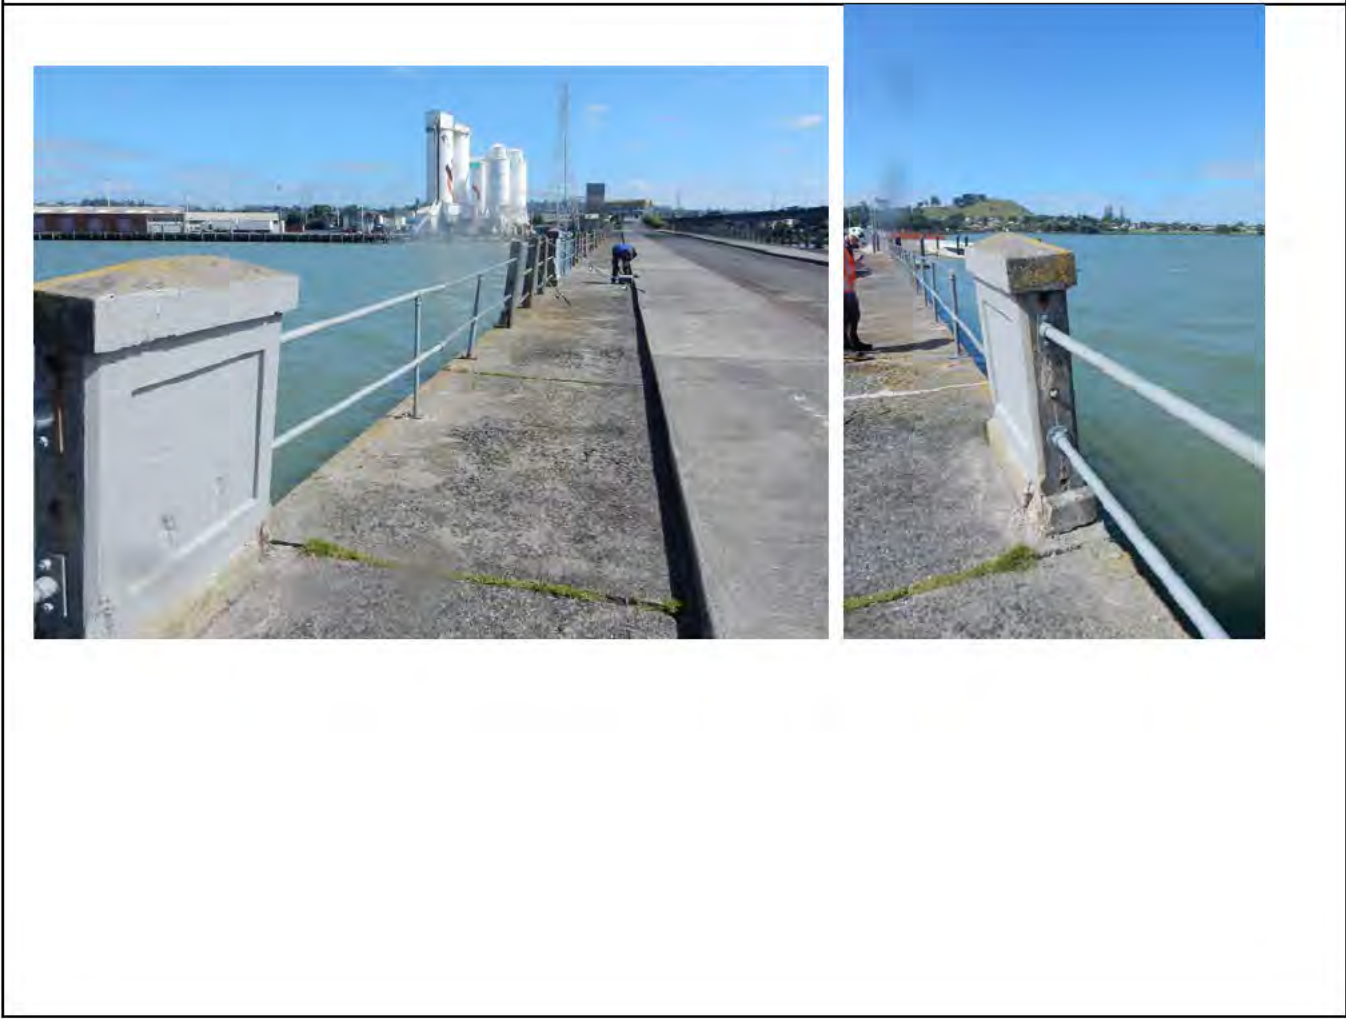
Component: Parapet
Defect Type: Leaning
Extent:
Severity:
Priority: HIGH

Comments: Parapet leaning on the west side. AMATrac has been raised to replace with new handrail.
