# Old Mangere Numerical Capacity Review

## January 2016

**AMA – SPECIAL INSPECTION**
**Old Mangere Bridge**

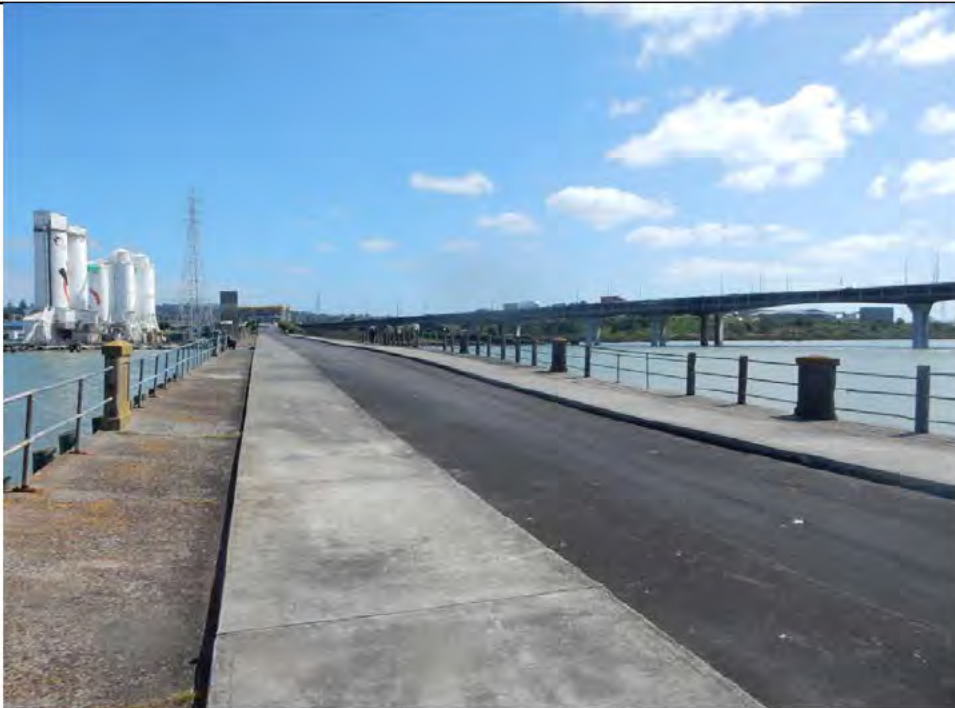
1. General View looking North (Note settlement of south span)
