## Methamphetamine Test Certificate

## Housing New Zealand Corporation Retest 1 Methamphetamine Assessment

Site Assessment Date	13 <sup>th</sup> July 2017
Sample Team	s 9(2)(a)
Report Author	
Report Checked by	
Key Technical Person	
Property Reference	TUS0002661
Works Order	WO1656541
Author Signature	KTP Signature
s 9(2)(a)	s 9(2)(a)

# Housing New Zealand Corporation Post-remediation Methamphetamine Assessment

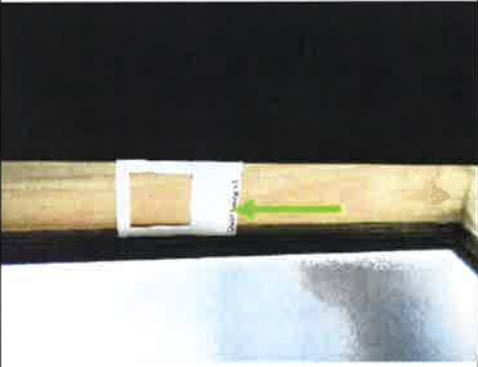
<p><b>Picture 1: Garage</b></p>	<p><b>Picture 2: Garage Window Frame – 0.19 µg/100cm<sup>2</sup></b></p>	<p><b>Picture 3: Lounge</b></p>	<p><b>Picture 4: Kitchen/Dining</b></p>
