Statement of Claim Checklist

Date: 24/11/10Author: GEORGE ALEXANDERS BATES
39 MARRIOTT'S ROAD
NORTH NEW BRIGHTON
CHRISTCHURCH 8083

1257554 2011 CHCH EQ - LAND ENGINEERING REPORT

22 FEB 2011 - EARTHQUAKE
NORTH NEW BRIGHTON, CHRISTCHURCH
(C120-091841) - 39 Marriotts Road

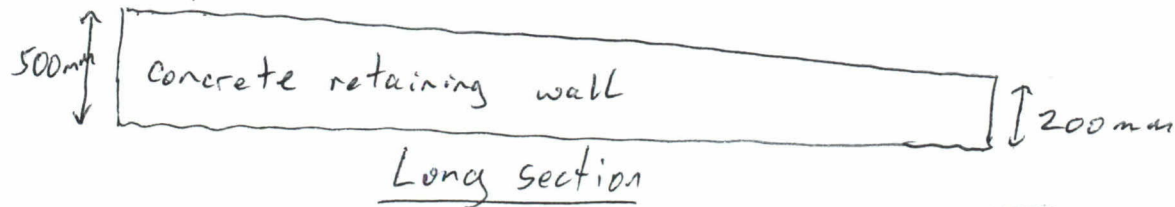
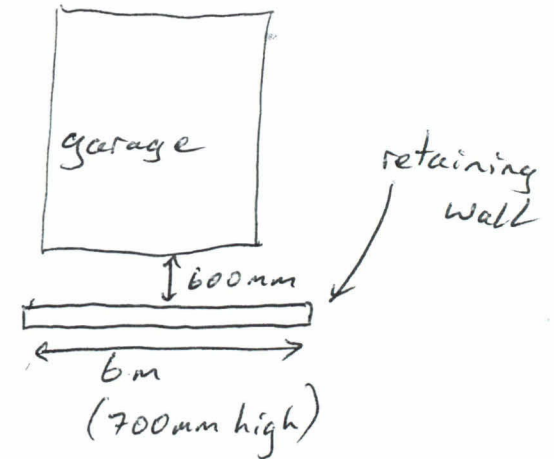
Retaining wall plan

Feature wall < 200mm high & not supporting anything

- ① remove ejected sand or silt
- ② locally repair undulations by trimming top of undulations or filling depressions.
- ③ replace both retaining walls with Type 1, 140mm block retaining walls (without surcharge), 1000mm max height, Footing width = 450mm, Key depth = 100mm. (See attached)
