25 June 2021

Land Information New Zealand  
Private Bag 4721  
Christchurch 8140

**RE: Level 5-10 Foyer Assessment - RNZ House, 155 The Terrace, Wellington**  
**(Our Reference: 18960.000.001\_01)**

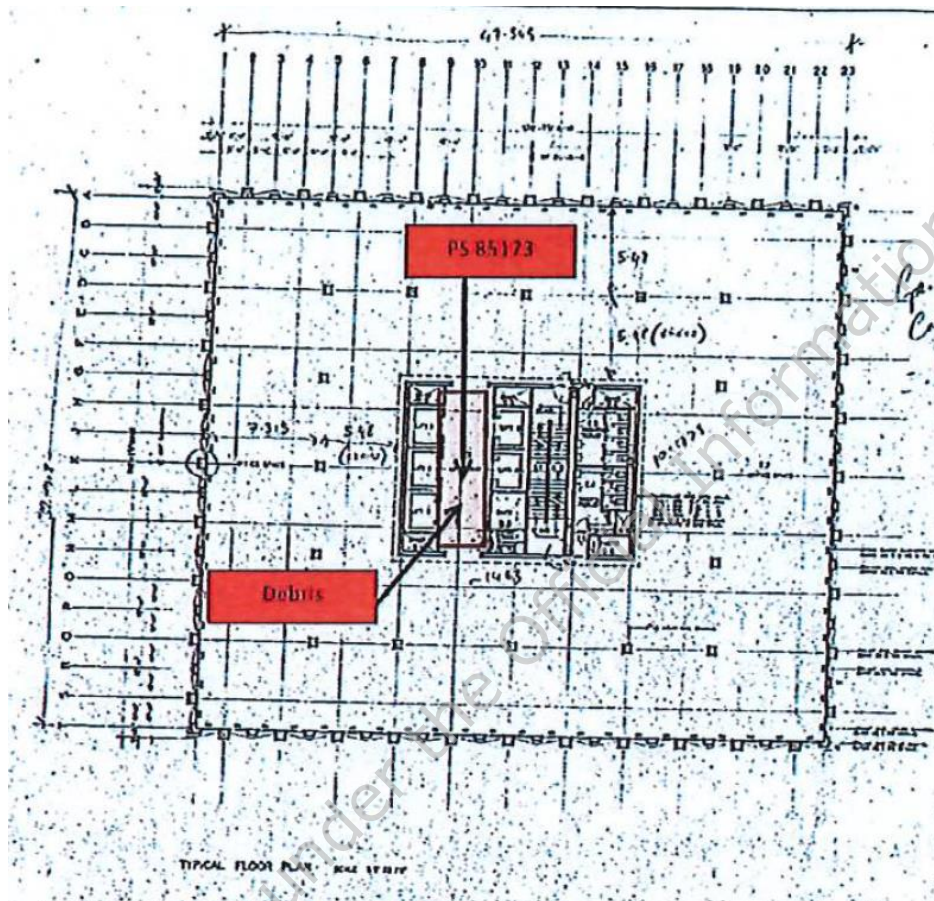
**Figure 1: General Floor Layout Level 5 RNZ House**

The survey identified asbestos insulation board (AIB) was present within the lift foyers of levels 5 – 10. A sample of the material was collected and analysed by an IANZ accredited laboratory and confirmed as asbestos. Based on the material type, damage, surface treatment and asbestos type FibreSafe classified the material risk as high risk. The Asbestos Management Plan (AMP) recommended the material be removed. The location the AIB was reported to be located on each Level was shown in a figure in the report. The Level 5 AMP figure has been reproduced below.

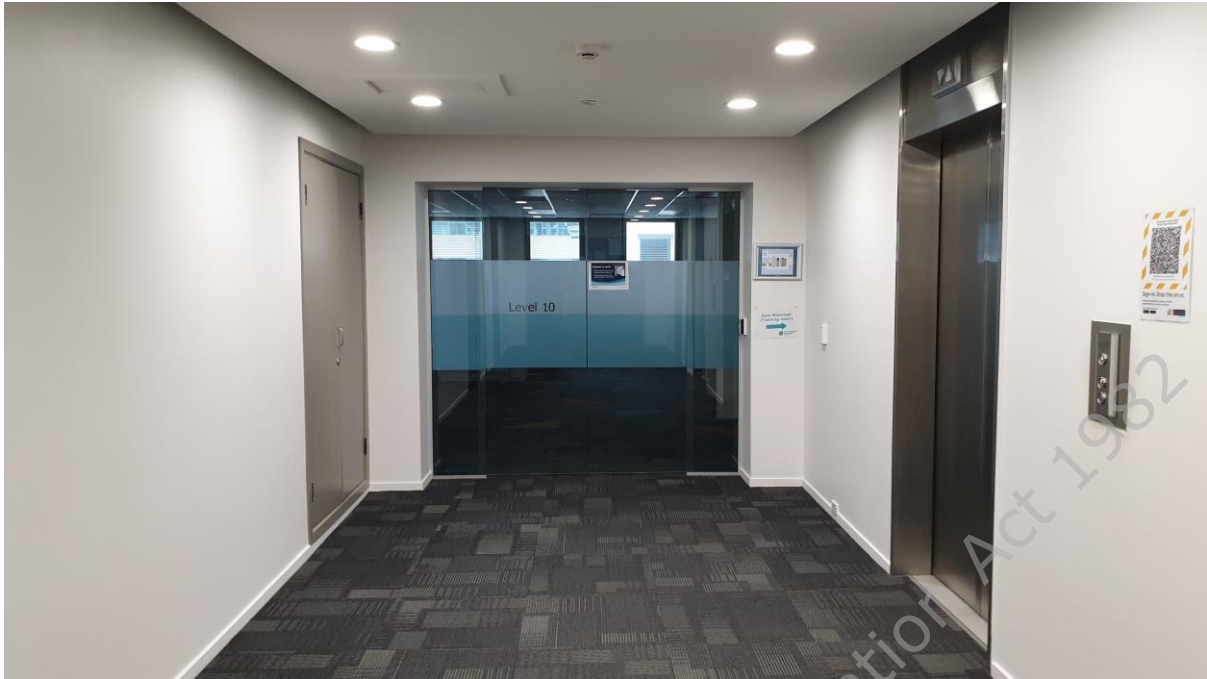
Level 10

Asbestos fibres were found to be present in the fibre cement sheet from the level 10 ceiling. The fibre cement sheet is located behind modern plasterboard lining on the ceiling. All other swab and bulk samples returned negative results when analysed for asbestos fibres (Certificates of analysis attached as Appendix 1).

As required by the Asbestos Regulations, the Asbestos Management Plan should be updated to reflect this additional information. The material should be routinely inspected (every two years is recommended), and its presence should be made known to site occupants or sub-contractors who may be required to work on the material or near to it.

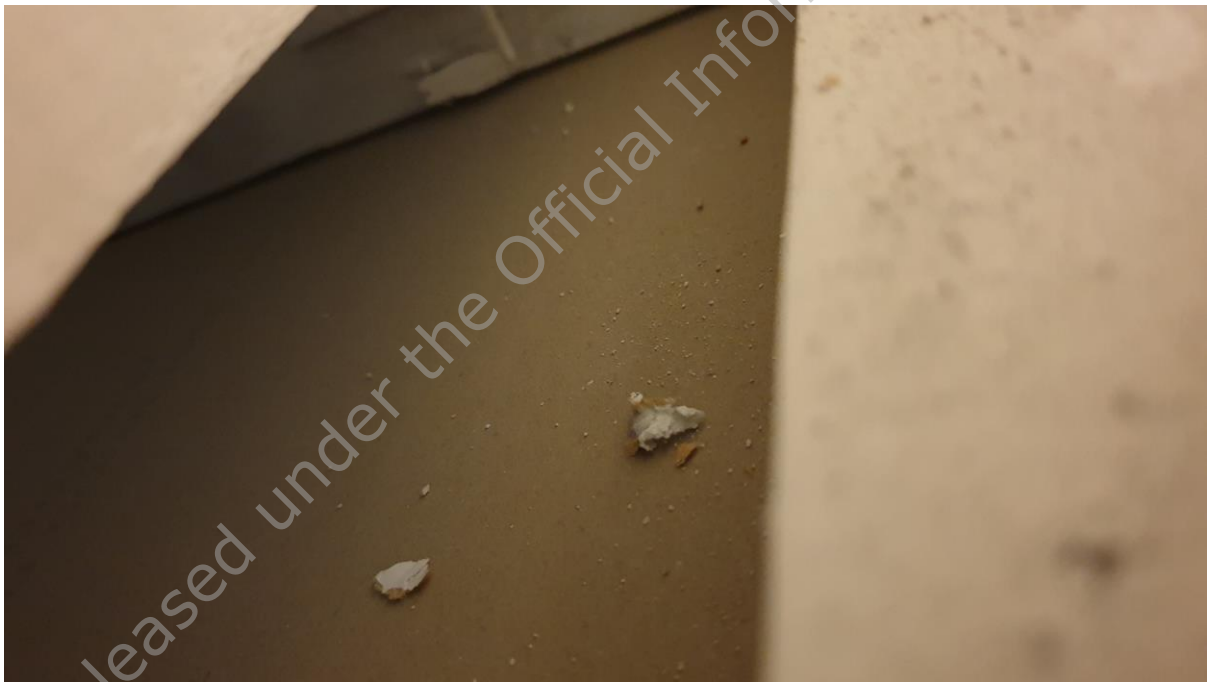
Level 9 through perimeter gap

No potential ACM was observed on levels 6 – 9 in the areas previously identified as containing high-risk asbestos insulation material. Based on our visual assessment it appears modern plasterboard is present and attached directly to timber framing.

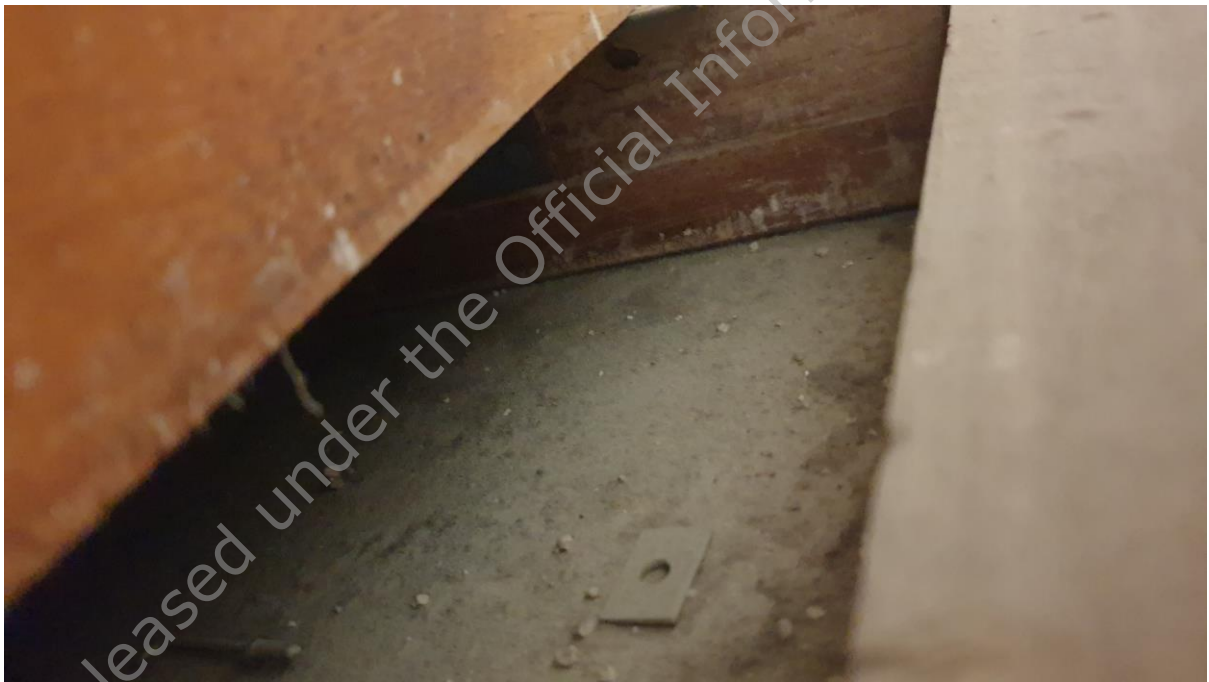
Level 5 through perimeter gap'

The asbestos containing material identified on levels 5 and 10 is not asbestos insulation board, which has a higher material risk due to its greater asbestos content and increased friability. The asbestos material identified on levels 5 and 10 is asbestos cement based sheeting which when in good condition is typically non-friable and less likely to release asbestos fibres when not disturbed.
