Transport Accident  
Investigation  
Commission

# Final report

***Aviation inquiry A0-2019-003  
Diamond DA42 aeroplane, ZK-EAP  
Controlled flight into terrain  
Kaimanawa Range, near Taupō  
23 March 2019***

November 2021

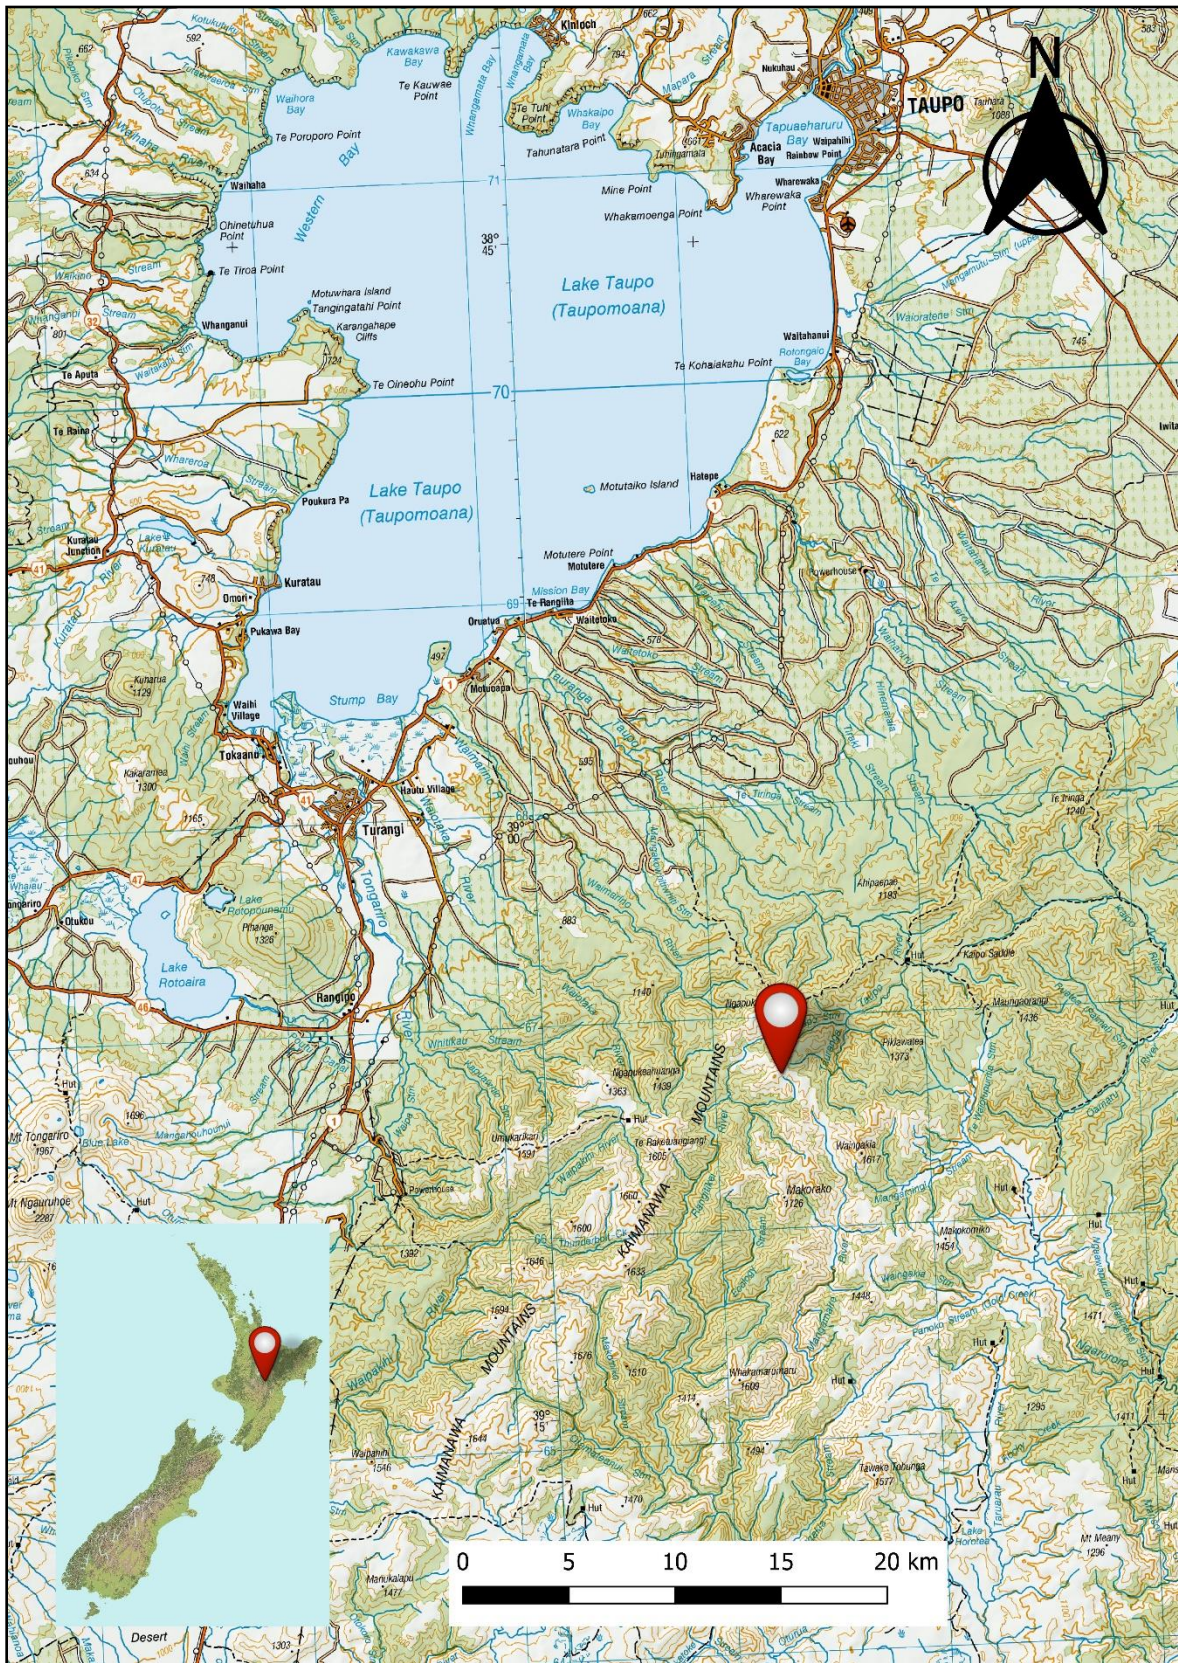
Figure 2: Location of accident reproduced on LINZ Topo250 map

- 2.36. The accident scene was situated at 4,500 feet (1,371 m) on sloping ground in the Kaimanawa Range, approximately 38 km south of Taupō Aerodrome (see Figure 2).
- 2.37. The aeroplane had first hit the ground with the left wing tip. The left wing had separated as a result. With the terrain sloping away, the remainder of the aeroplane had continued in the general direction of the original flightpath for a further approximately 250 m before striking the northern face of a gully. The initial ground scar made by the left wing tip and the location of the wreckage showed that the aeroplane had been in about a straight and level attitude when the ground strike occurred (see Figure 8).

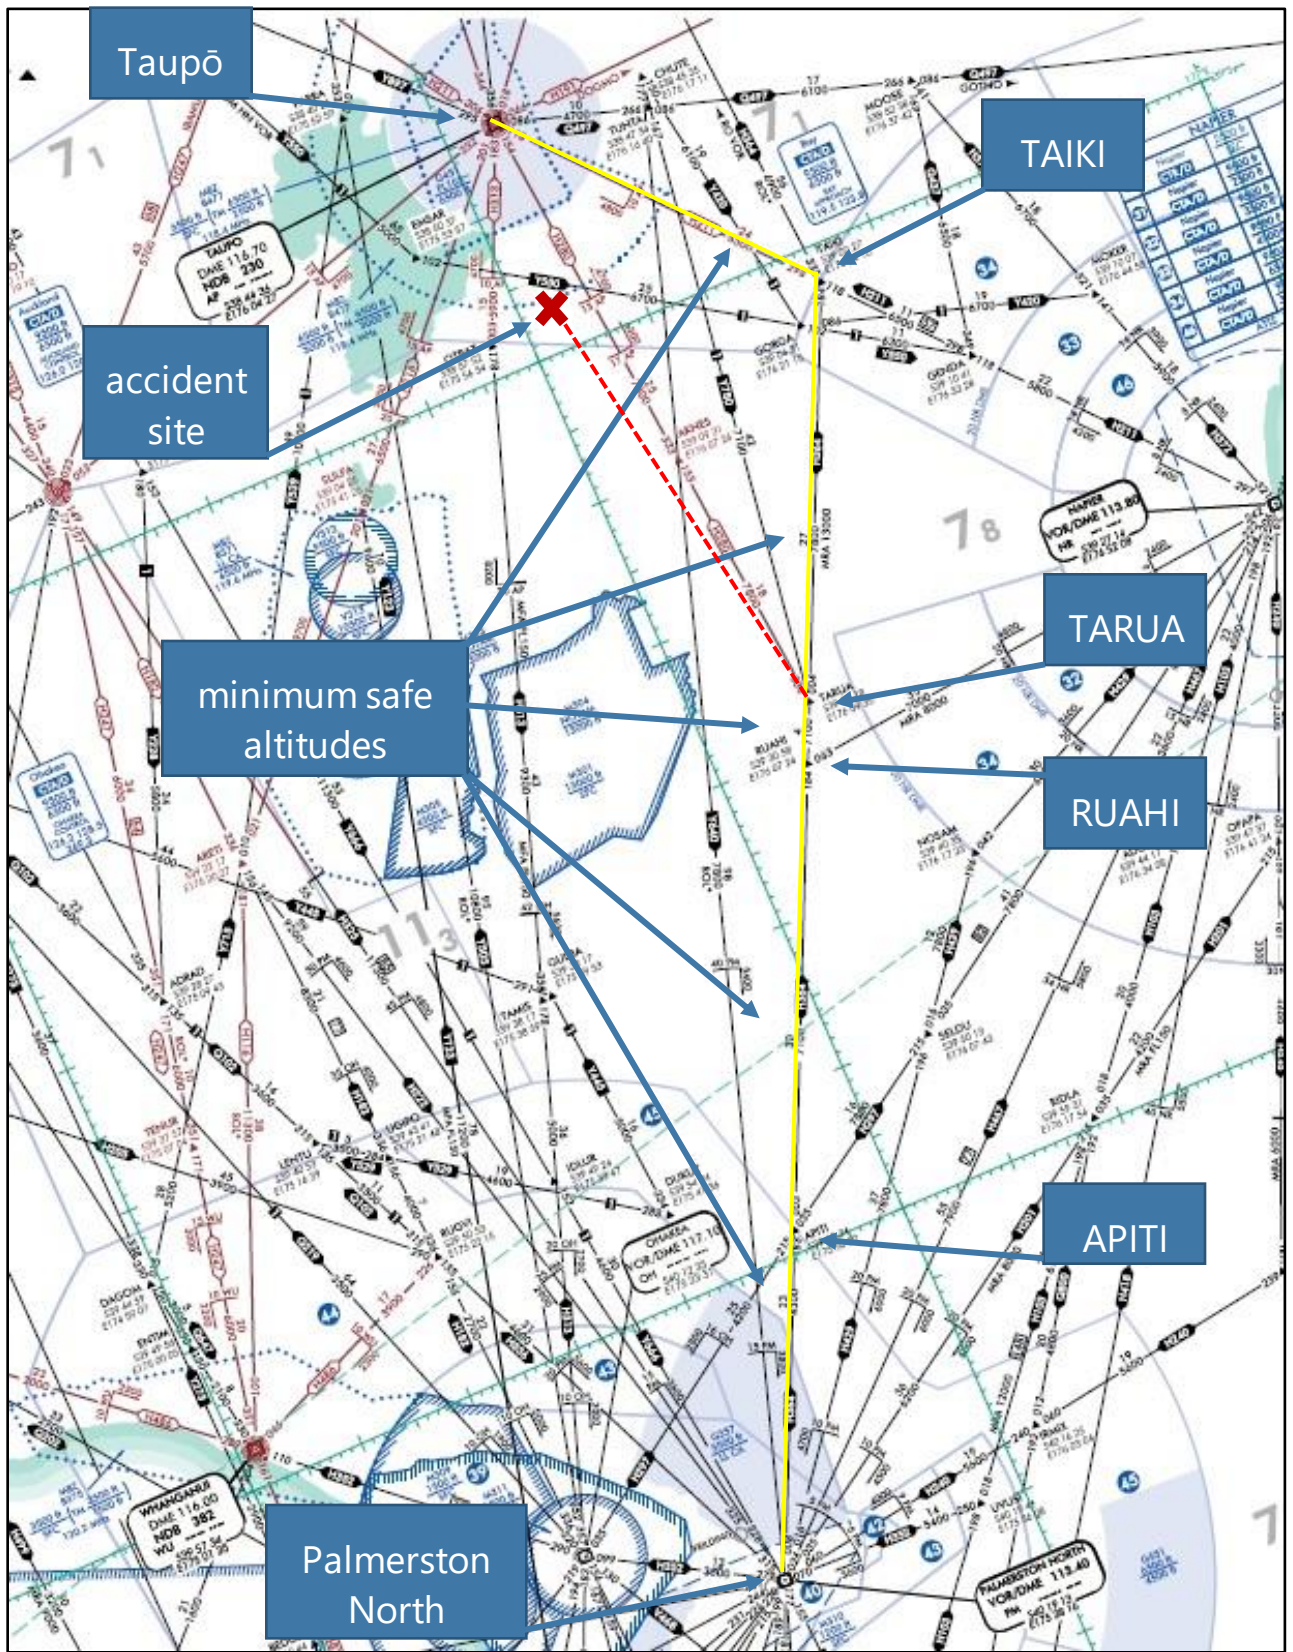
**Figure 3: Flight planned route  
(Not to be used for navigation)  
(Credit: Aeropath [Civil Aviation Authority])**

- 2.5. At 2205 the aeroplane was recorded on radar turning left as it passed TARUA. At the same time the pilot reported 'top of descent'<sup>11</sup> and the aeroplane was recorded as starting to descend from 9,000 feet. The FIO replied, advising that there was no reported traffic for the descent to Taupō, and asked, "Which runway lights would you like?".<sup>12</sup> At 2207, after two further calls by the FIO, the pilot responded and was given the local area altimeter pressure setting.

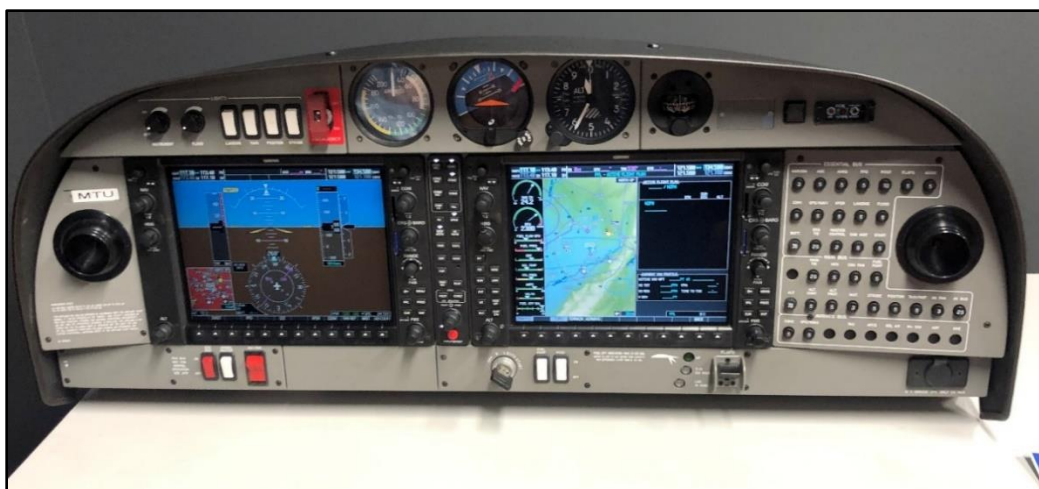
**Figure 4: The Diamond DA42 aeroplane G1000 instrument panel**

- 2.28. The aeroplane was equipped with a Garmin G1000 integrated flight instrument system and a three-axis GFC 700 digital autopilot. The G1000 system in the accident aircraft comprised two electronic display units. The display unit on the left was typically used as the primary flight display. The display unit on the right was typically used as a multifunctional display (MFD) (see Figure 4). The MFD could be used to programme flight plan data and display engine parameters and navigation information, including a moving map and terrain-conflict-proximity information. The functions could be moved between the two display units.

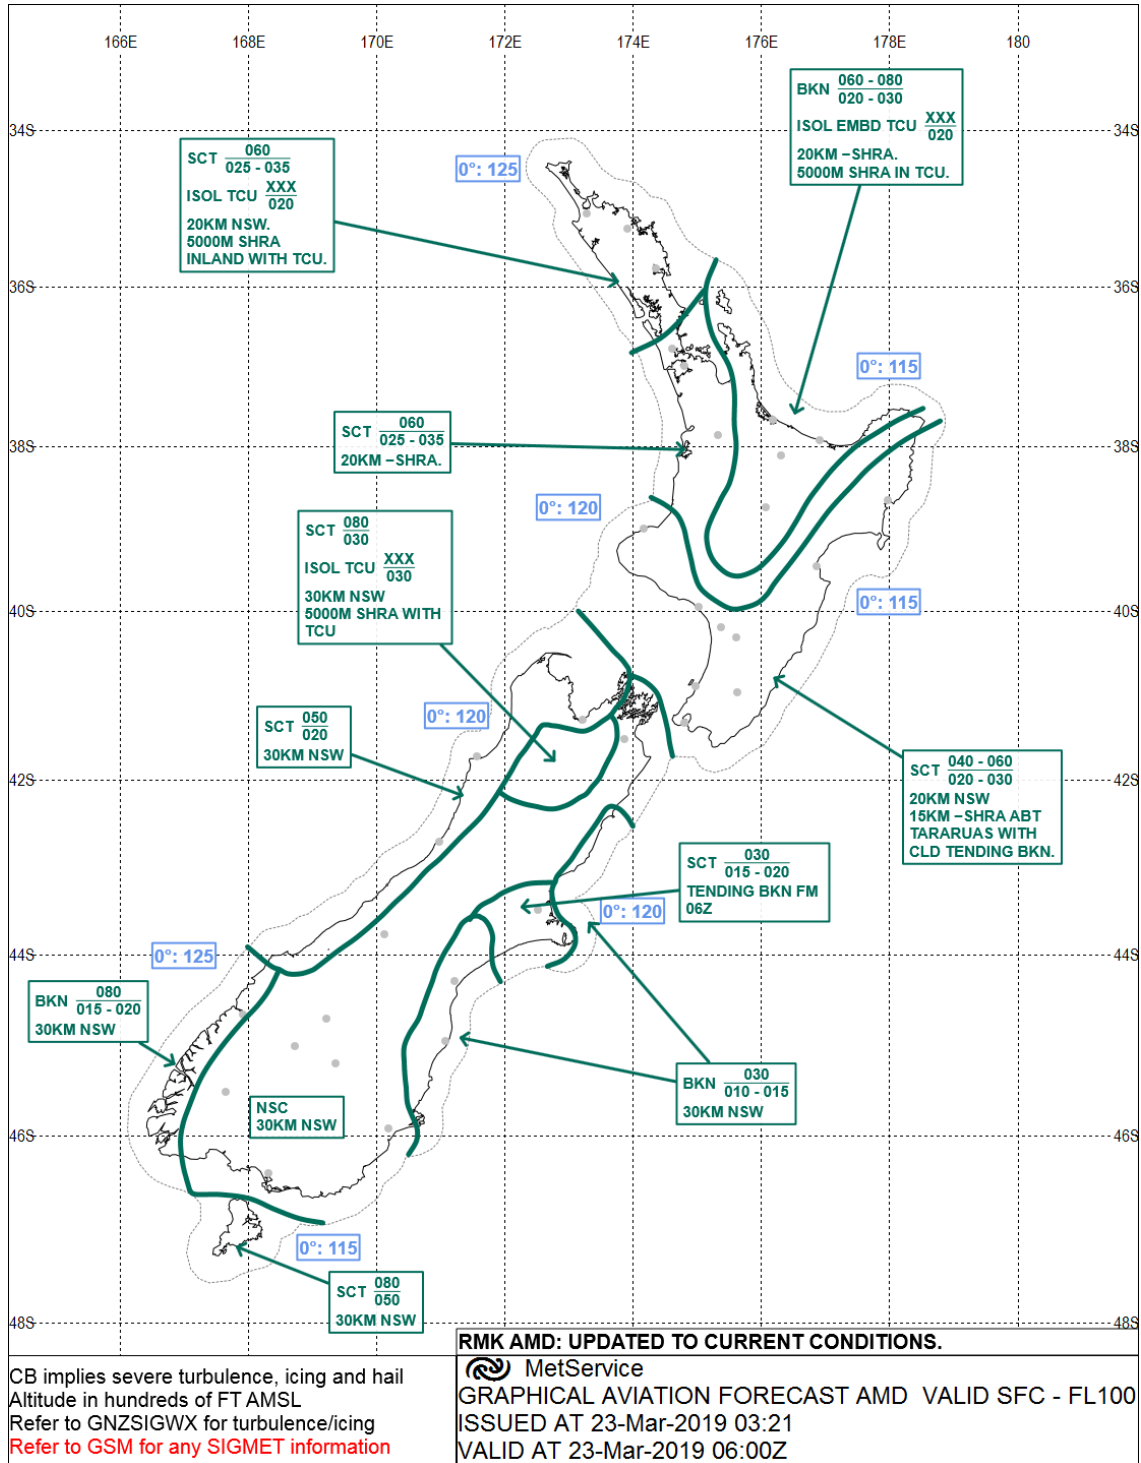
Figure 6: GAFOR before the accident

2.32. The graphical aviation forecast (GAFOR) valid for approximately three hours prior to the time of the accident (see Figure 6) specified for the Bay of Plenty and Taupō area broken cloud<sup>21</sup> between 2,000–3,000 feet (609–914 m) and 6,000–8,000 feet (1,828–2,438 m), isolated embedded towering cumulonimbus above 2,000 feet, 20 km visibility with showers and rain and 5 km visibility with showers and rain in towering cumulonimbus cloud.

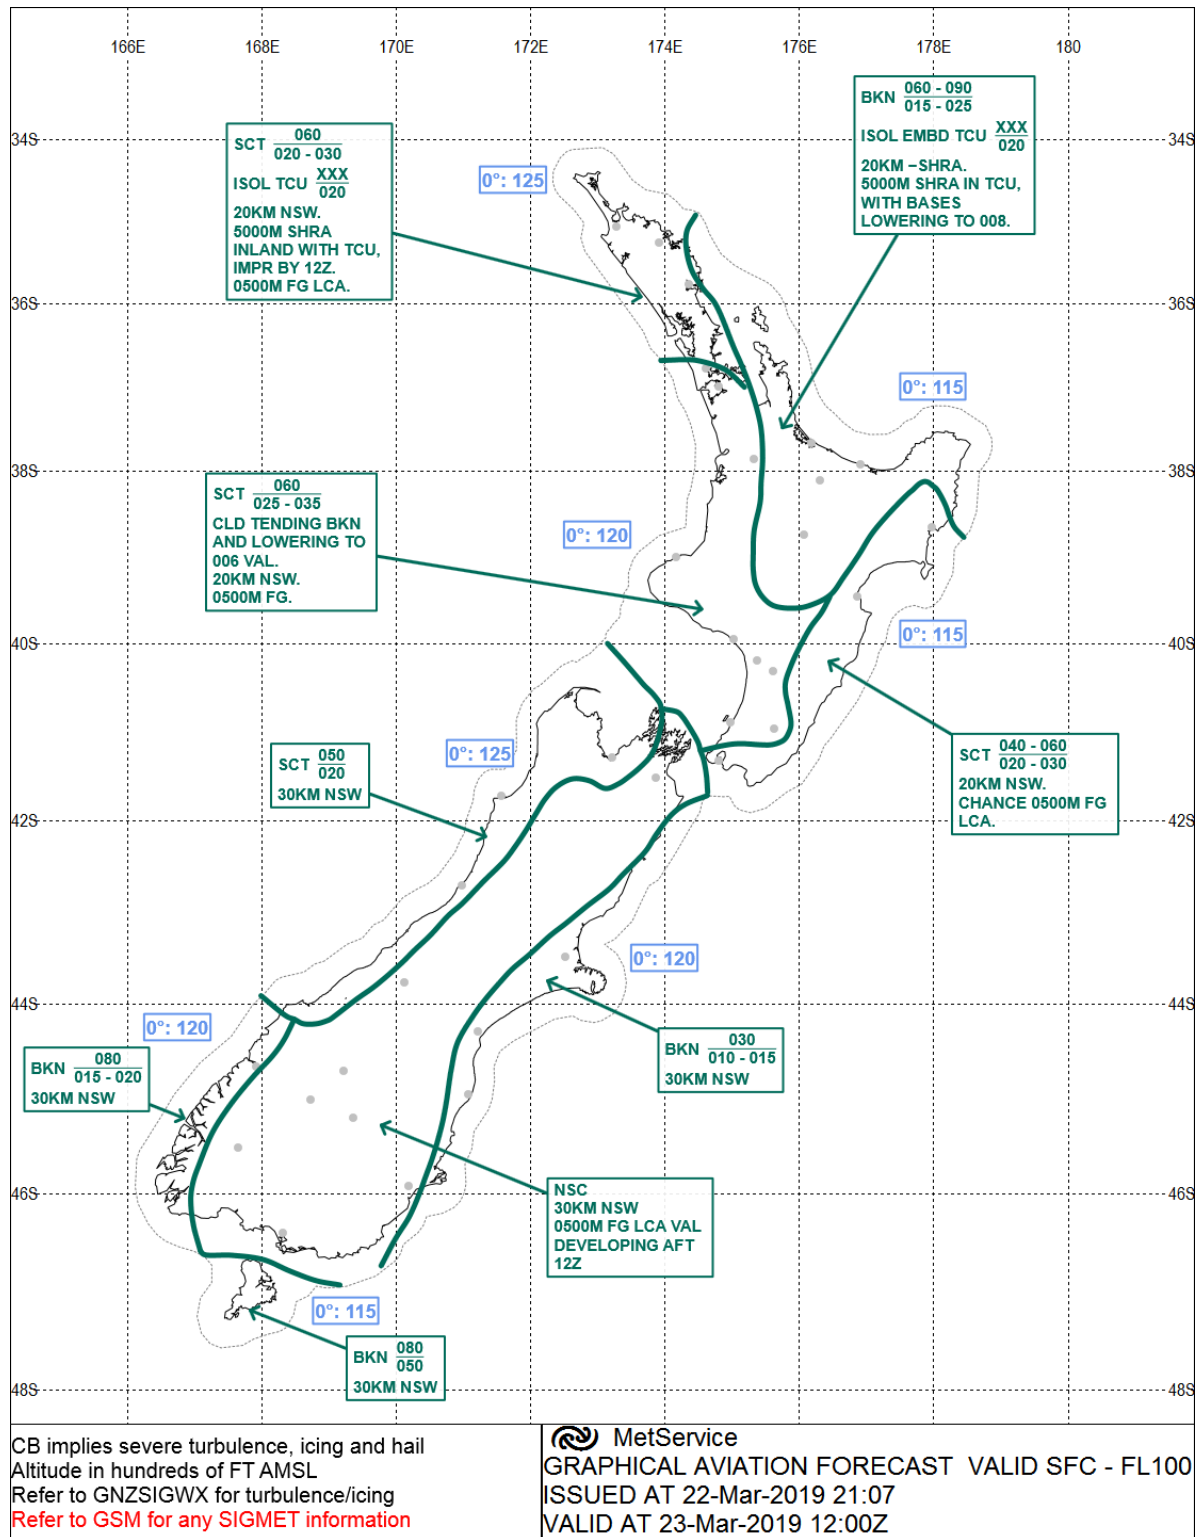
Figure 7: GRAFOR after the accident

The GRAFOR valid for approximately three hours after the time of the accident (see Figure 7) detailed broken cloud between 1,500-2,500 feet (457-762 m) and 6,000-9,000 feet (1,828-2,745 m), isolated embedded towering cumulonimbus above 2,000 feet (609 m), visibility 20 km with showers and rain and 5 km visibility with showers and rain in towering cumulonimbus cloud, with cloud bases lowering to 800 feet (243 m).
