Project Number: 5-C4006.00

# Petone to Melling Cycleway

## Pre-Opening Road Safety Audit

28 May 2024

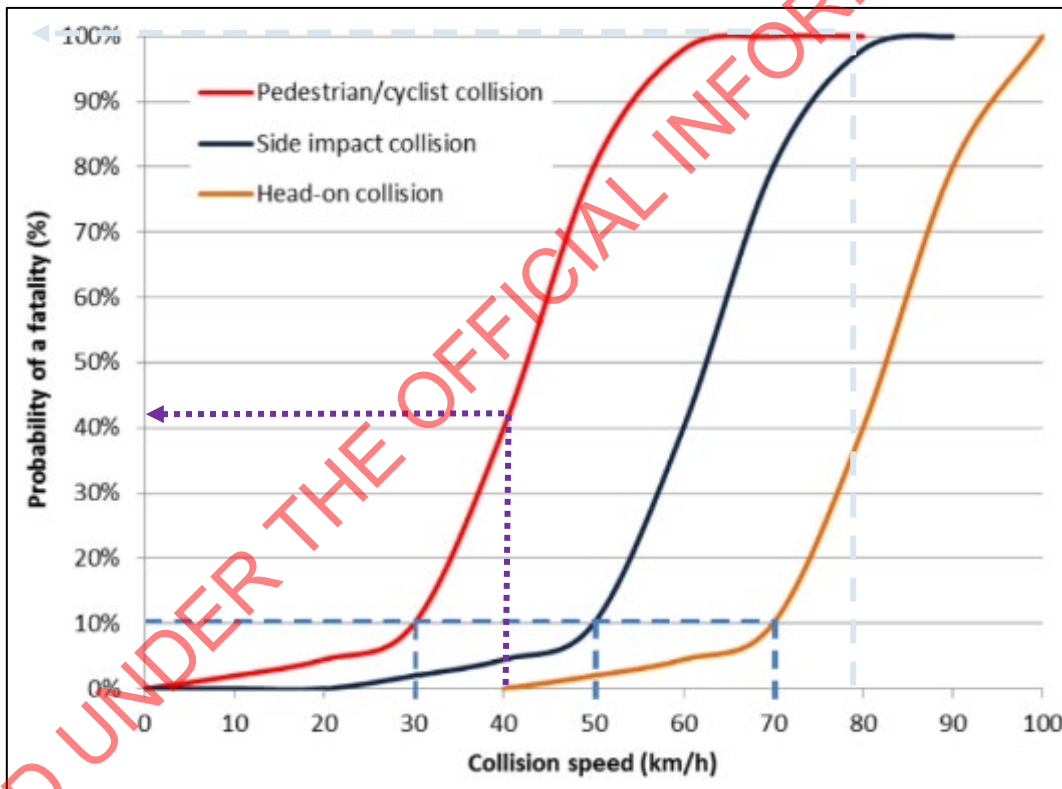
From the designs, the ramp gradient is shown to be 1:20 and the minimum platform height is shown as 75mm as shown below. From Waka Kotahi's Pedestrian Network Guidance<sup>2</sup>, it is recommended that a 1:15 ramp gradient is selected for a 30km/h speed at the platforms, and that a 1:20 ramp gradient is selected for a 40km/h speed. Additionally, a 100mm high platform is recommended and a 75mm high platform minimum is only to be used if there are a high volume of trucks anticipated. As shown below, the risk of death for a pedestrian/cyclist vs. vehicle collision at 30km/h is around 10%, but at 40km/h is around 45%. The speeds to avoid serious injury are lower again.

Figure 3: Relationships between a motorised vehicle collision speed and probability of a fatality for different crash configurations, from Austroads Guide to Road Safety Part 3: Safe Speed.

- 1 Confirm the in-situ platform height and ramp geometry in comparison to the Pedestrian Network Guidance standards, and survey vehicle speeds at the crossing.
- 2 If required, reconstruct the platform to achieve a speed reduction to at or below 30km/h.
- 3 Consider speed humps/cushions in advance of ramp.
- 4 Replace the '15' hump advisory speed supplementary plates with a more realistic speed closer to the platform geometry, i.e. '35'.

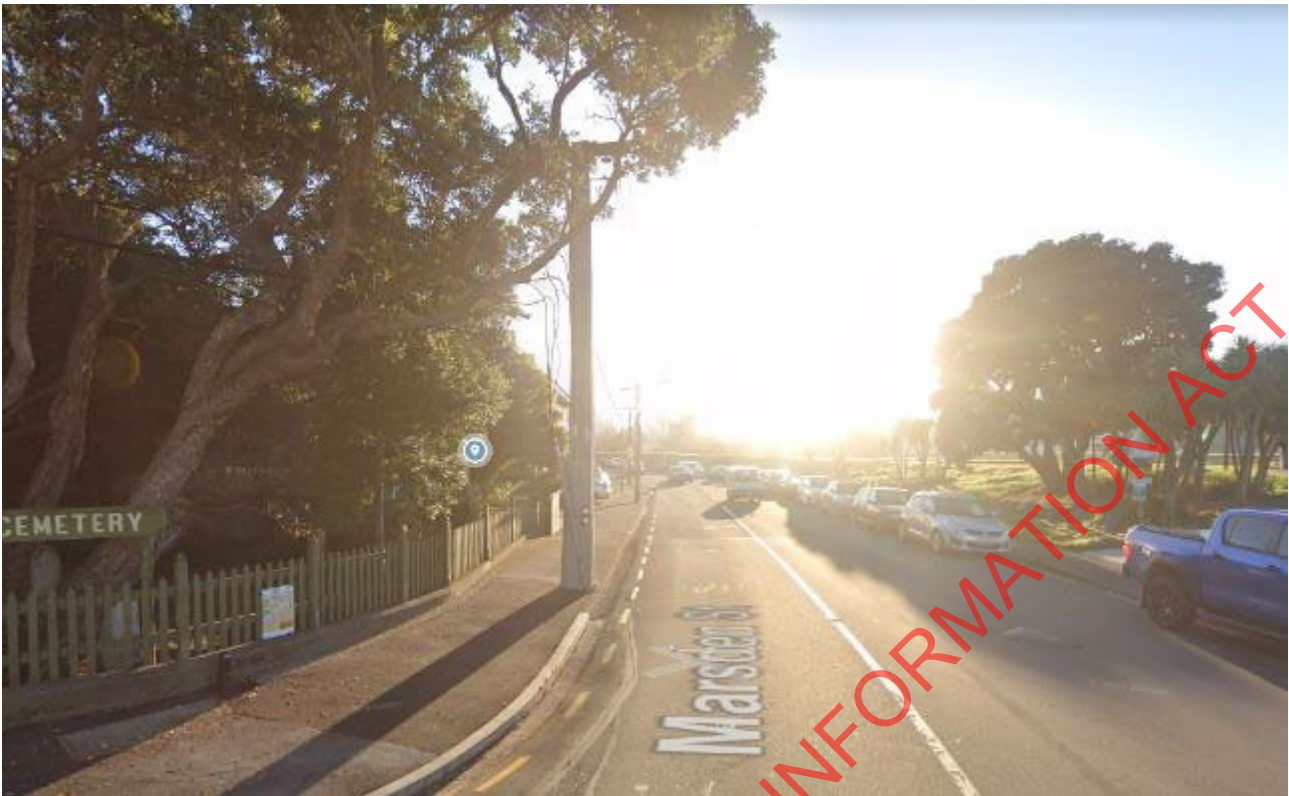
One other possible way where intervisibility may be obscured between drivers and crossing users is in the morning, when there is a risk of sunstrike due to the north-south alignment of Marsden Street aligning with the sun's position near the horizon at certain times of year. This is likely to be more of an issue in Winter when the sun rises further north and when the morning peak period coincides with sunrise. See Figure 5 below, from Google Street view in June 2021.

Figure 5: Marsden Street in the vicinity of the crossing, in June 2021 prior to crossing installation.

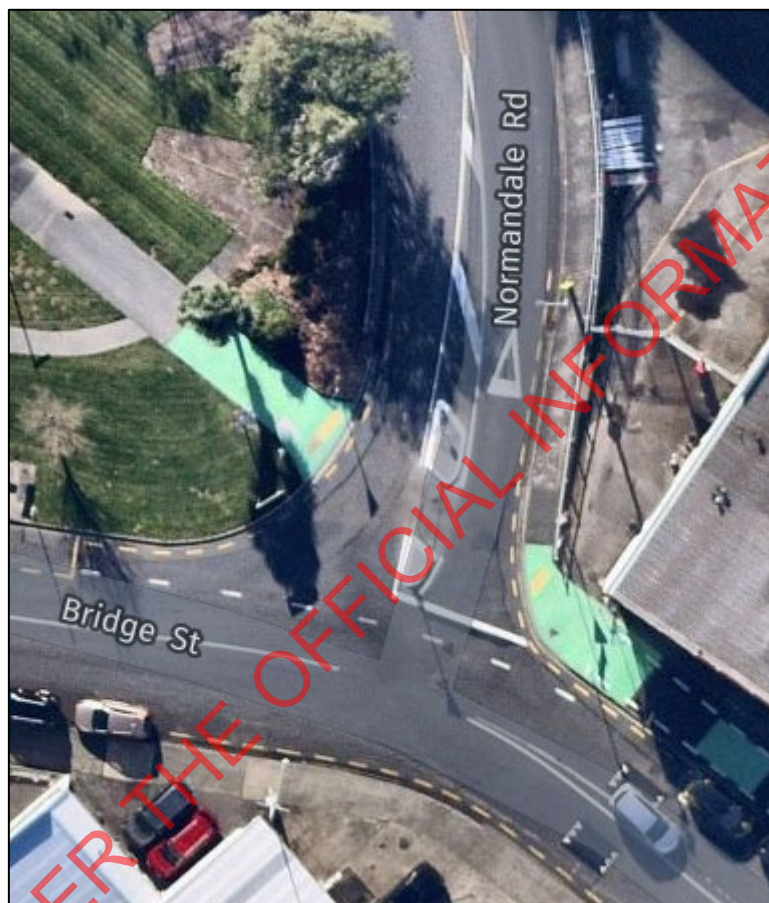
The shared path intersects with Normandale Road, close to where Normandale Road intersects with Bridge Street. Normandale Road is classed as an Urban Connector in the One Network Framework and has traffic volumes of <2,000 vehicles per day, according to Mobile Roads.

Vehicles have priority over pedestrians and cyclists who have a refuge to use when crossing the road.

Figure 10: Shared path crossing over Normandale Road near intersection with Bridge Street  
(Source: NearMap).

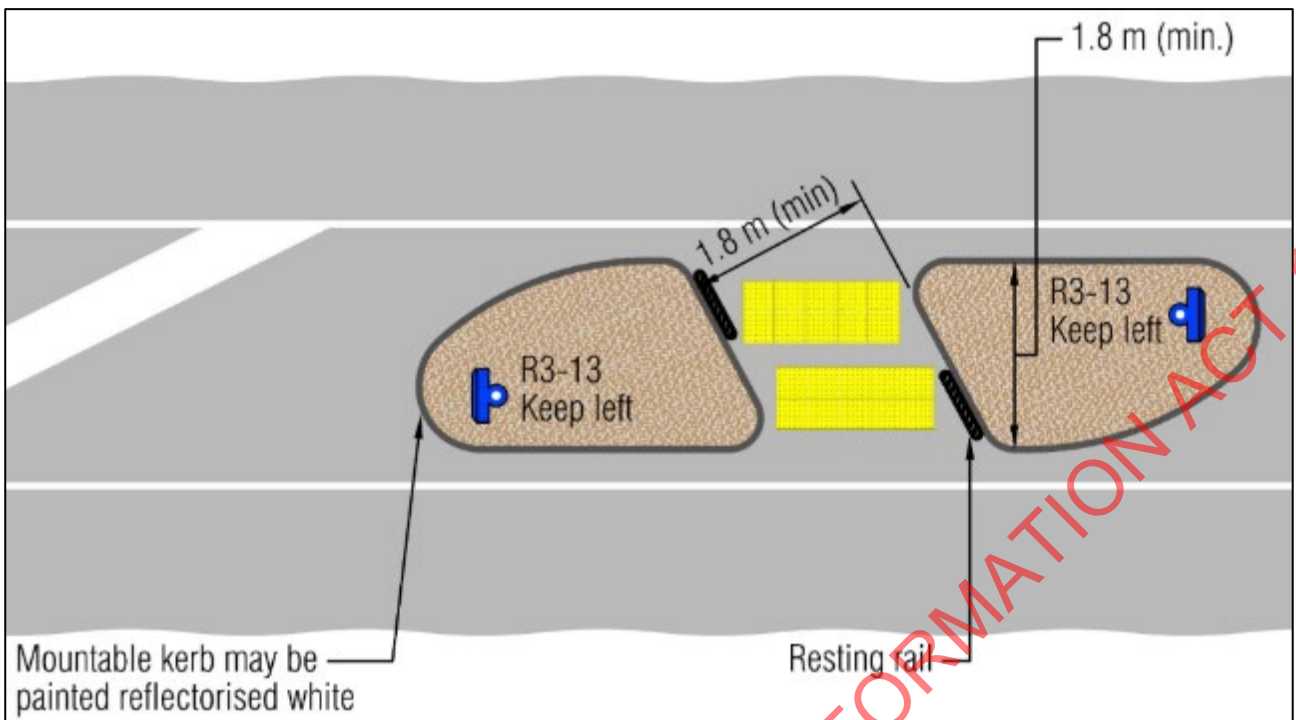
The median refuge as constructed is quite basic, missing some of the detail usually included with a refuge. There are no resting rails, no tactile pavers, and no edge markings along the side of the refuge to indicate delineation with the traffic lane. Figure 11 below shows an example of a pedestrian refuge from the TCD Manual. Note that this design is for a pedestrian only refuge. A shared path refuge is expected to be wider and deeper to accommodate bikes.

Figure 12: Example of a diagonal pedestrian refuge (Source: TCD Manual).

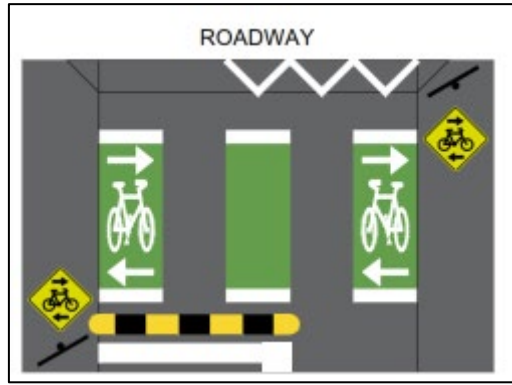
WU61 signs have been placed at the driveways to alert drivers to the presence of cyclists travelling in both directions. The SAT considers these signs could be better placed to better align with the guidance. The recommended layout is shown in Figure 18 below.

Figure 19: Correct high-use driveway treatment for cycle paths and shared paths.

The WU61 signage poles should be located clear of the cycle path or shared path, and pointing in a direction that faces an oncoming driver. The placement of the poles on Bridge Street are within the shared path which increases the risk of a cyclist crash if they hit the pole with their handlebars.

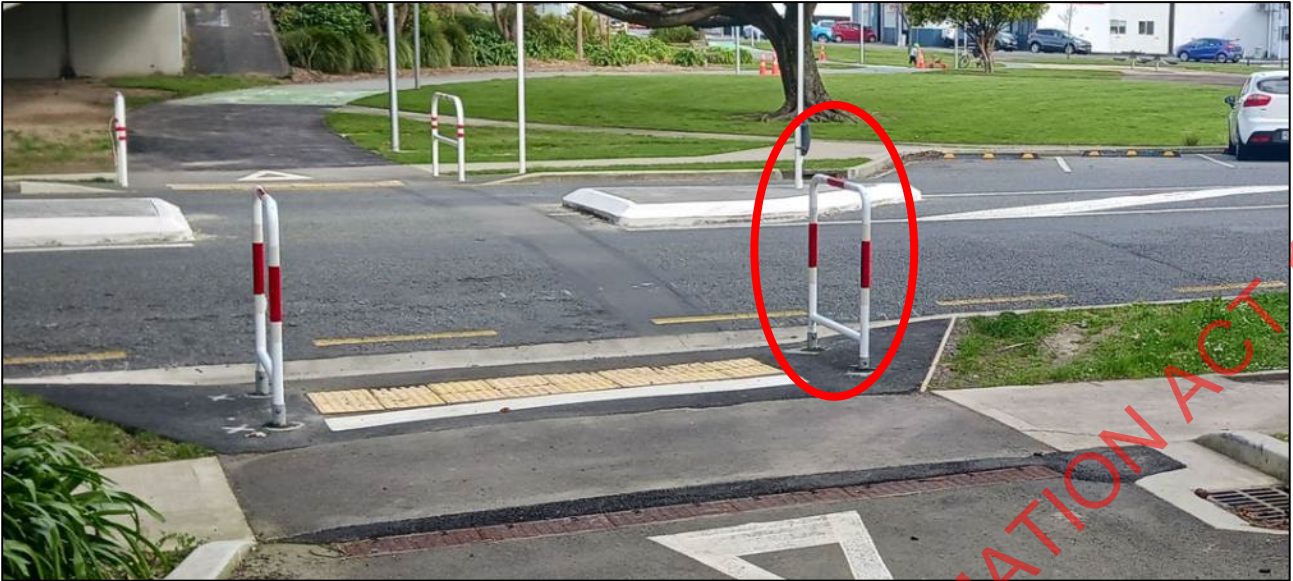
Figure 22: Pharazyn Street shared path crossing with right-hand hold rail on western side circled.

The SAT understands that the right-hand hold rail on the western side (circled in Figure 8) of the intersection is obstructing access for maintenance vehicles to the nearby pump station. Given this hold-rail is on the right-hand side of the path when most path users will be on the left-hand side, it is considered acceptable to remove this hold-rail to allow easier access for maintenance vehicles.

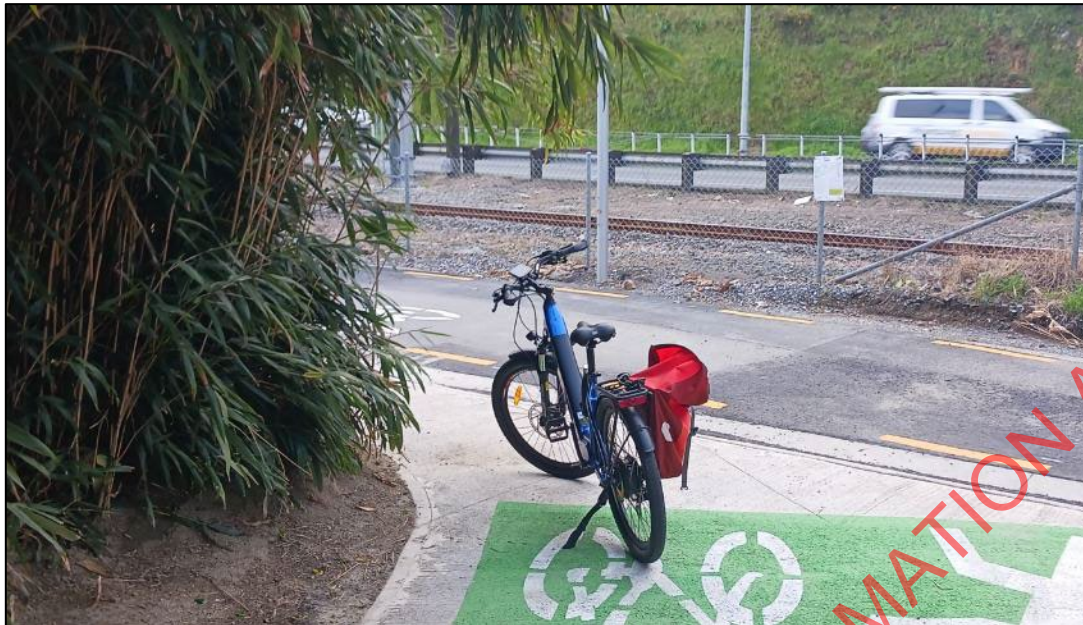
Where the shared path meets Parliament Street, there is a large bamboo plant which limits visibility between southbound path users and northbound traffic on Parliament Street. Traffic volumes are very low, as it largely an access street to a low number of properties. Therefore, the risk of a pedestrian or cyclist crash is low.

Figure 24: Where shared path meets Parliament Street.

Frequency:	Severity:	Rating:
<i>Crashes are likely to be Infrequent</i>	<i>Death or serious injury is Unlikely</i>	<i>The safety concern is Minor</i>
<b>Designer Response:</b>	The Designer agrees with Recommendation 37. Recommendation 38 is not warranted as a fence has been erected and vehicles no longer approach from the right (the right in Figure 24).	
<b>Safety Engineer:</b>	Agree with 37, recommend wayfinding signage northbound to reduce cyclists going off-route to private property HCC: agree with trimming. Noting upcoming Parliament st works to address other concerns.	
<b>Client Decision:</b>	<b>Add bamboo trimming to the asset owner's manual landscaping maintenance schedule. Wayfinding and traffic conflict will be addressed in upcoming Parliament St Greenway project.</b>	
<b>Action Taken:</b>	Added bamboo trimming to asset owner's manual.

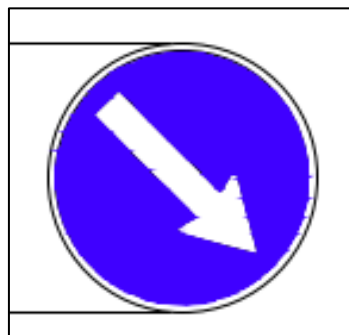
Figure 35: RG-17 sign that could be installed to remind northbound riders to stay right of the southbound bypass lane.

<b>Safety Engineer:</b>	Suggest adding a white arrow in the southbound lane adjacent to the first post in figure 34. If ongoing problem can resort to RG-17. Prefer markings alone as RG-17 can introduce a snag risk.	
<b>Client Decision:</b>	Install white southbound arrow in the southbound lane adjacent (SH2 side) to the first post in figure 34.	
<b>Action Taken:</b>	Included in package of works to contractor.

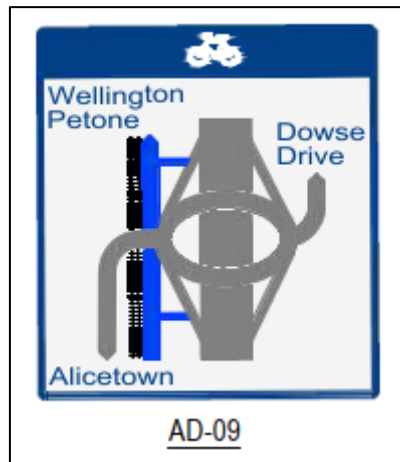
According to the designs, the sign shown in 36 is to be installed on approach to the start of the bypass. This sign is intended for people cycling on SH2, advising them of the upcoming bypass. There is too much information to comprehend quickly for someone riding on SH2.

The intention of the bypass is to reduce the risk to cyclists on SH2, by allowing them to bypass the Dowse interchange, rather than merging across the interchange's off-ramp and on-ramp. Cyclists may not understand the signage and thus continue through the interchange, rather than using the bypass as desired. This may contribute to increasing the risk of a cyclist vs vehicle crash as cyclists cross the off-ramp and on-ramp.

Figure 36: Proposed wayfinding signage for Dowse Interchange bypass.

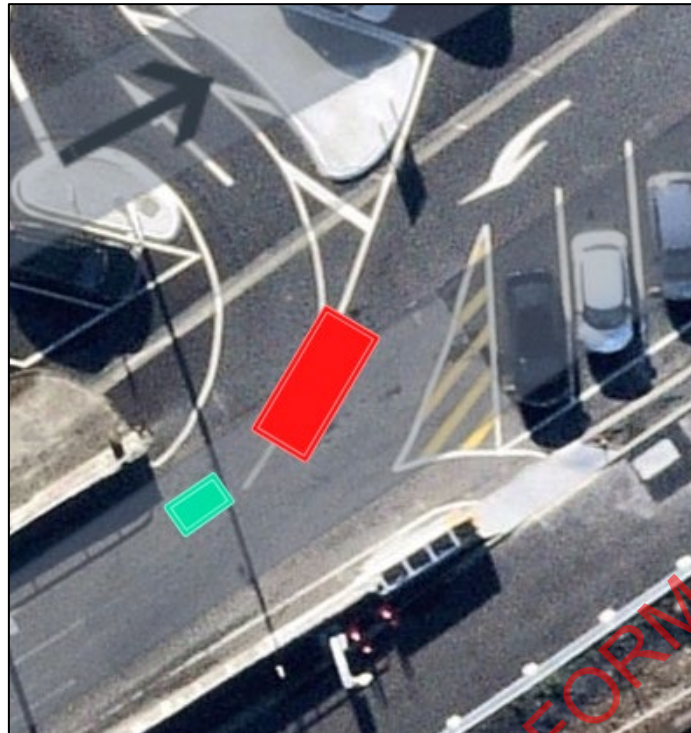
Another risk for cyclists accessing the P2M path via the entrance south of Petone Station is from Park and Ride car park users. Vehicles traveling the wrong way were observed several times by the SAT, as shown in Figure 37. Vehicles exiting the right way were observed to often cross the centre line. Vehicles exiting the wrong way and right way are likely to be tracking in the path of a cyclist waiting to turn right onto P2M, as shown in Figure 38.

Figure 39: Observed path of vehicles exiting Park and Ride into where a cyclist may be waiting to turn into P2M cycle path.

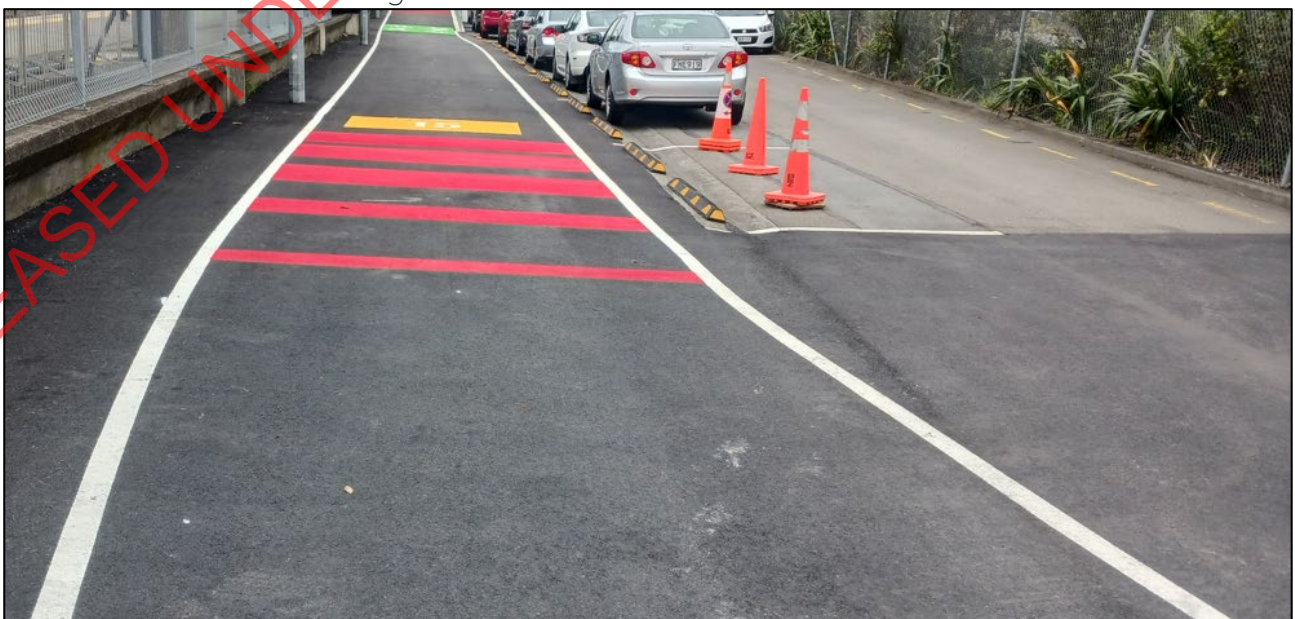
At the northern end of Petone Station, the cycle path passes adjacent to the end of the Park and Ride, as pictured in Figure 41. There is a risk of vehicle encroachment to the path as vehicles manoeuvre into car parking spaces. Without a physical barrier, there is also a risk of vehicles illegally parking over the path. This increases the risk of a cyclist vs vehicle crash and reduces the level of service for cyclists.

Figure 42: Northern end of Petone Station

Petone Station Park and Ride.

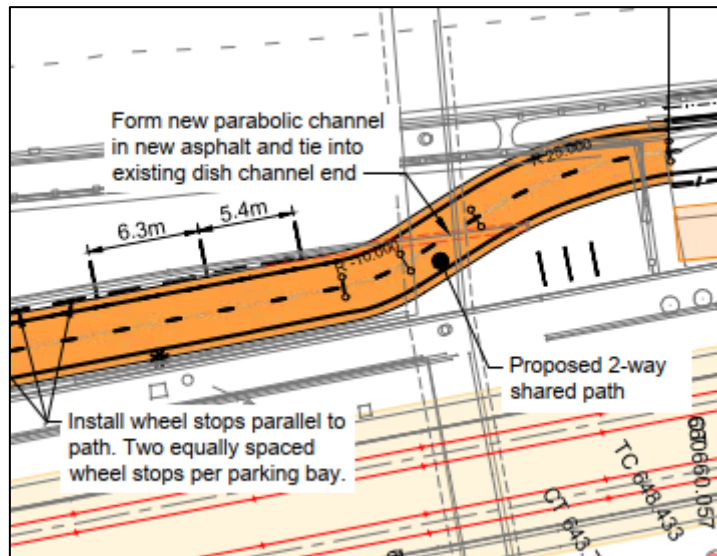
Figure 43: Detailed design drawings at northern end of Park and Ride.

Access beyond the Park and Ride is required for KiwiRail maintenance vehicles to access the track.

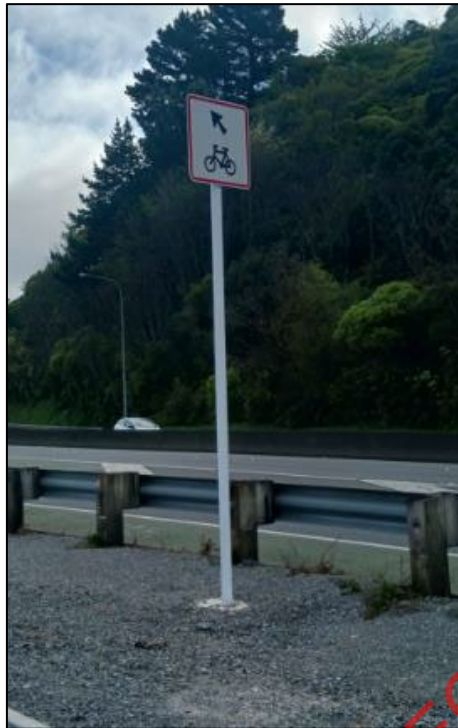
Signage on-site (Figure 46) indicated that using the bypass is mandatory for cyclists on SH2. This doesn't allow for cyclists who need to use the interchange to get to Alicetown or Maungaraki.

Figure 46: Regulatory signage on site, indicating cyclists must get off SH2.

According to Sheet 1 of the 'Sign Details' the sign should be advisory (with a black border), rather than regulatory (with a red border).

As part of the exercise to ensure good wayfinding at the Dowse interchange (as described in Chapter 11), the regulatory or advisory signage could be reviewed.

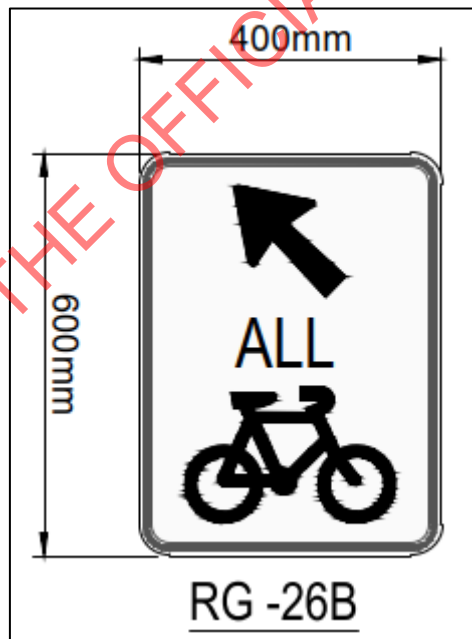
Figure 47: Advisory signage recommended for cyclists on SH2 to use Dowse bypass.

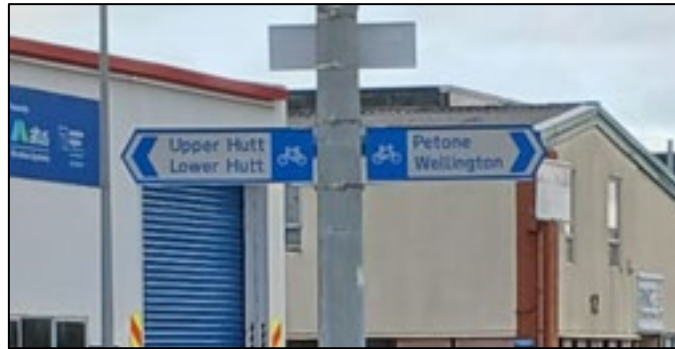
The SAT noted existing wayfinding and guide signage adjacent to the project. Once the Petone to Melling path opens, this will need to be removed to be replaced with wayfinding along the shared path connecting P2M to the Hutt River Trail. Having incorrect signage will lead to confusion for cyclists. Ensure redundant signage is removed as the Petone to Melling cycle path is opened.

Figure 48: Example of existing wayfinding signage on Bridge Street that will need to be relocated.

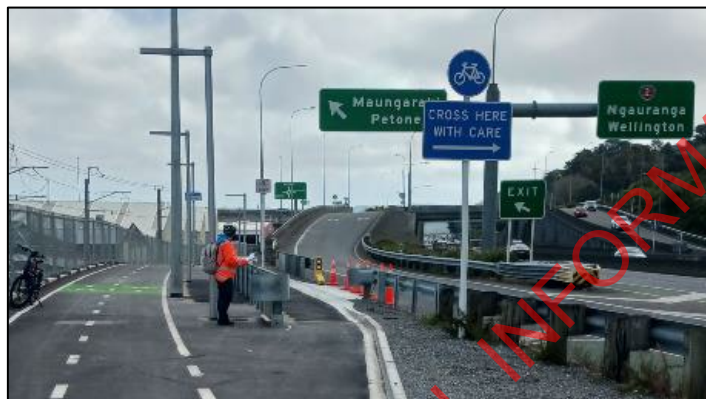
Figure 49: Cross Here With Care signs to be removed and replaced with signage to encourage SH2 riders to use Dowse bypass.

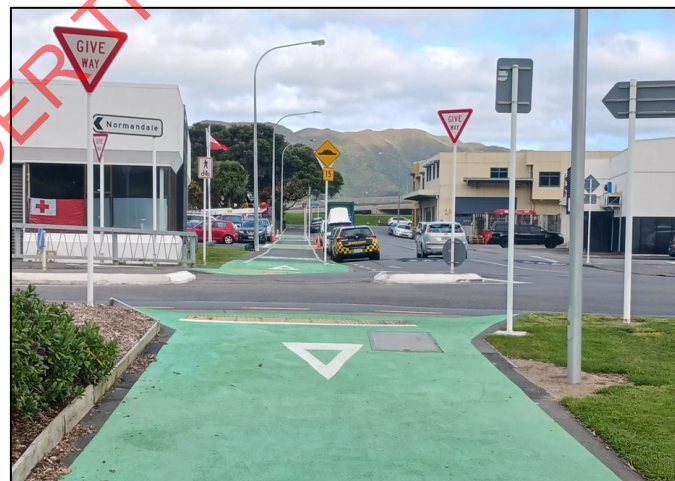
There is some inconsistency with the way the shared path is treated at different road crossings. For example, the crossing at Normandale Road includes solid green marking, while the crossing at Pharazyn Street does not include any green marking. The Pharazyn Street crossing includes hold-rails while the Normandale crossing does not.

Figure 50: Shared path approach to Normandale Road intersection.

Both crossings include Give Way markings which are laid as if the path is one-way when it is a two-way path. This is potentially confusing for users and could be reviewed, with a change to placing the Give Way sign and limit line on the left-hand side of the approach with a centre line. Solid green marking is not necessary.

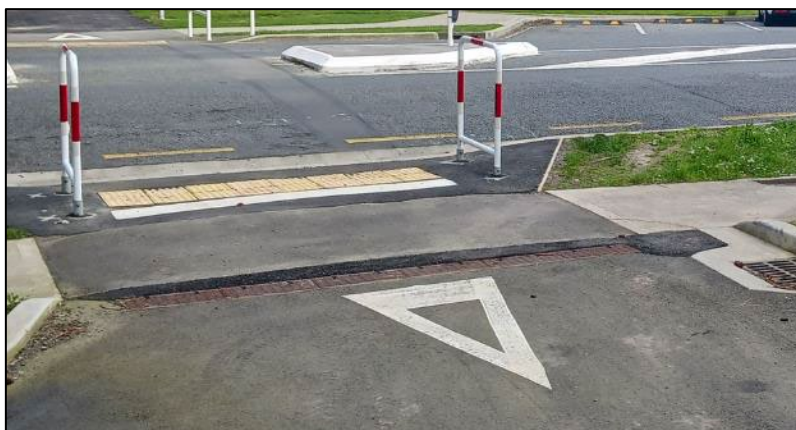
Figure 51: Shared path approach to Pharazyn Street.
