**Local Government Official Information & Meetings Act 1987 Request:**

1. Trish Wigley – Inspection Report 30 October 2023
2. Draft Report – Climbing Pole 25 January 2024
3. Email chain Playgroundcentre – compliance report 18 August 2024
4. Playsafe Play Report 2024
5. Caroline Bay Flying Fox Inspection Report August 2024

# PLAY REPORT 2024

## Caroline Bay Playground Flying Fox Inspection Report

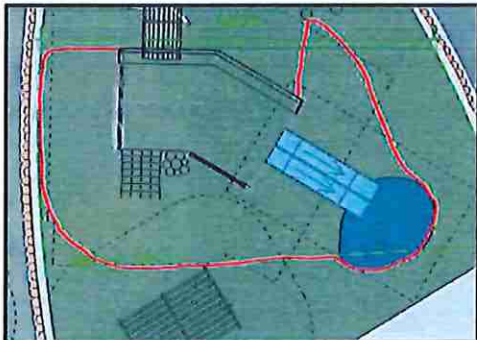
#### Area 1 – Jnr Fort

The shock pad thickness is correct in this area. We suspect that the recycled rubber included in the original shock pad is causing the issue. An area of turf similar to the below will be removed, more shock pad added and then finished with blue Pour'n'Play to achieve required CFH.

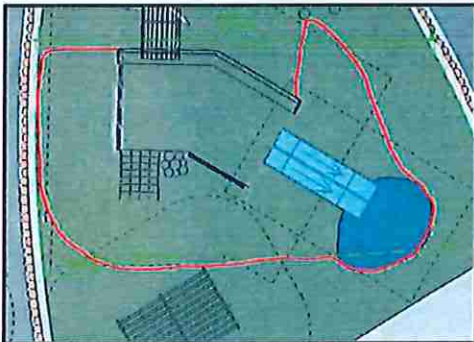
#### Area 1 – Jnr Fort

The shock pad thickness is correct in this area. We suspect that the recycled rubber included in the original shock pad is causing the issue. An area of turf similar to the below will be removed, more shock pad added and then finished with blue Pour'n'Play to achieve required CFH.

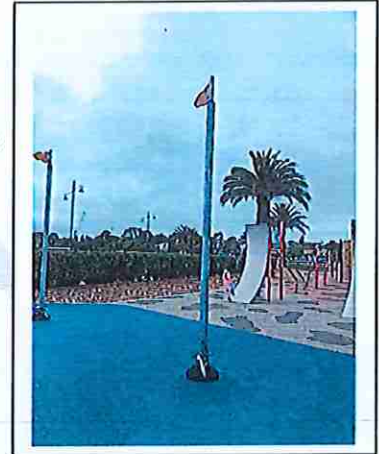
The foot device on both Altima poles, appear to move down the pole immediately, if any weight is removed, at a "walking type motion" rather than free falling.

Both foot devices appear to fall immediately when the participant load is removed & do not appear to remain elevated.

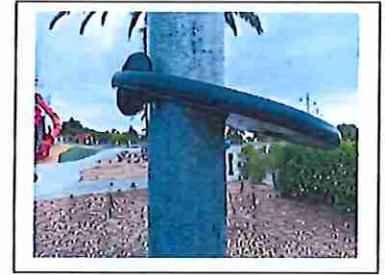
## HAND DEVICE

The hand device is rather "hit & miss" as-to whether it remains elevated when the participants weight is removed.

If the hand device does remain elevated, it does appear that it can fall reasonably quickly and randomly, whether the pole is knocked or not touched at all.

If the hand device does fall, the fall occurs reasonably fast, without any "walking type motion", and would certainly hurt if the hand device hits a C-Play participant.

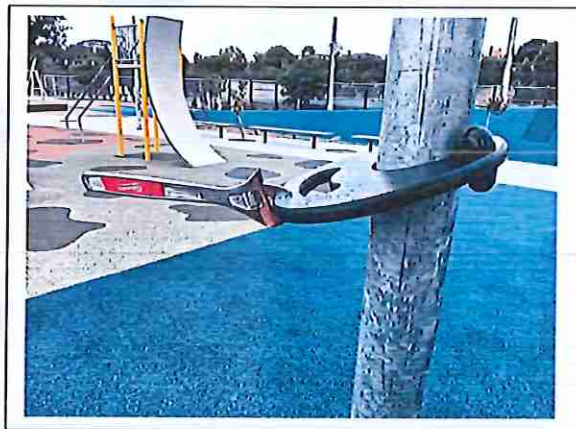
## HAND DEVICE TRIALS

Several trials were conducted to slow, or stop, the hand device descent. One trial achieved the slowing of the descent, by adding some weight to the hand-hold area. The image shows the adjustable spanner that was added to the hand-hold area, this did in fact, stop the descent.

**Please Note:** the adjustable spanner was only used for the trial, as that was all that was available.

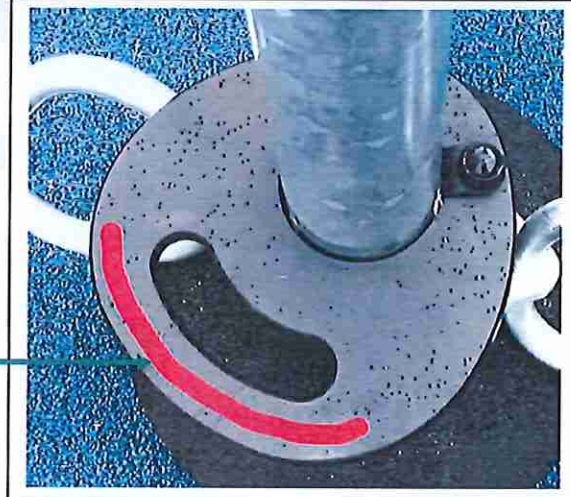
## POSSIBLE SOLUTION

This would not affect the hand-hold area.

And would stop the hand device rapid free-fall.

It is recommended that this issue along with the associated incidents be notified to Proludic Sport along with the above proposed solution, with the view to get their feedback, recommendations and/or alternative actions.

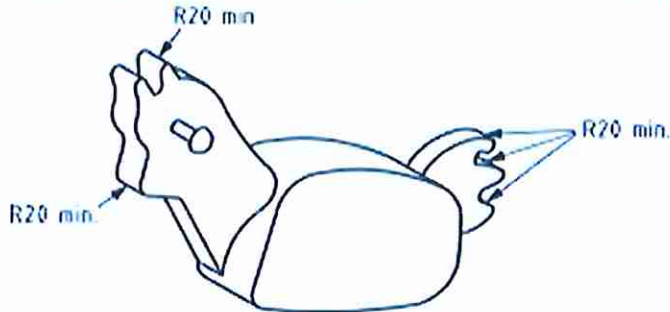
Figure 8 — Example for rounded side profile (Note in this example – the edges of the animal do not need to meet the 20mm requirement)

Agree with the horse head failing– picked up profile issue on my audit. But don't agree with equipment edging failure.

Those parts of the side profile, which may give an impact on children passing by or on the user shall not have projections with a radius of less than 20 mm (see Figure 8).

Disagree with the body of the horse having to meet 20mm radius. 3mm should be sufficient.

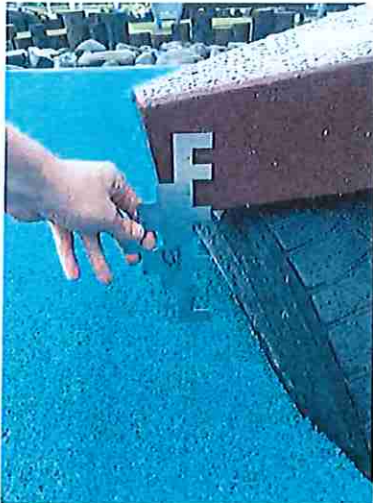
Disagree

Standards site 230mm ground clearance not required when dampening in effect - i.e. tyre damping was deemed sufficient by Keith in outdoor inspectors course.

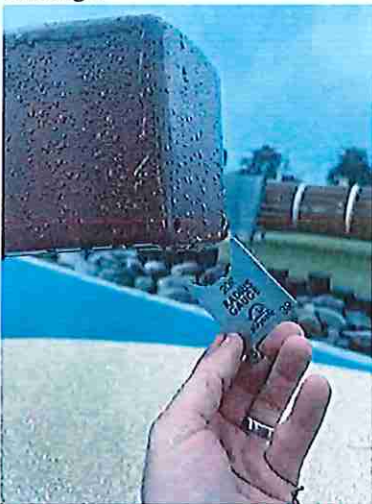
#### Finding 6

As above – 3mm required. Adam has misread the standard.

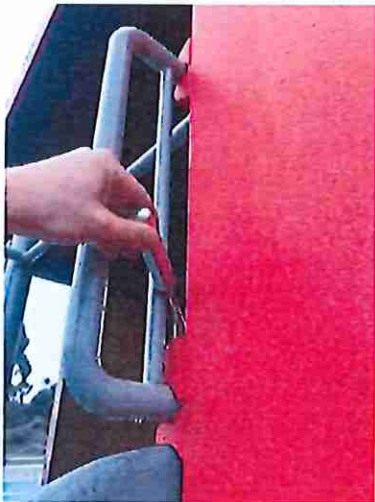
Issue 8

Note – possible the wood has warped – inconsistent opening.

Disagree with Adam's finding – evidence in EN 1176.1:2008

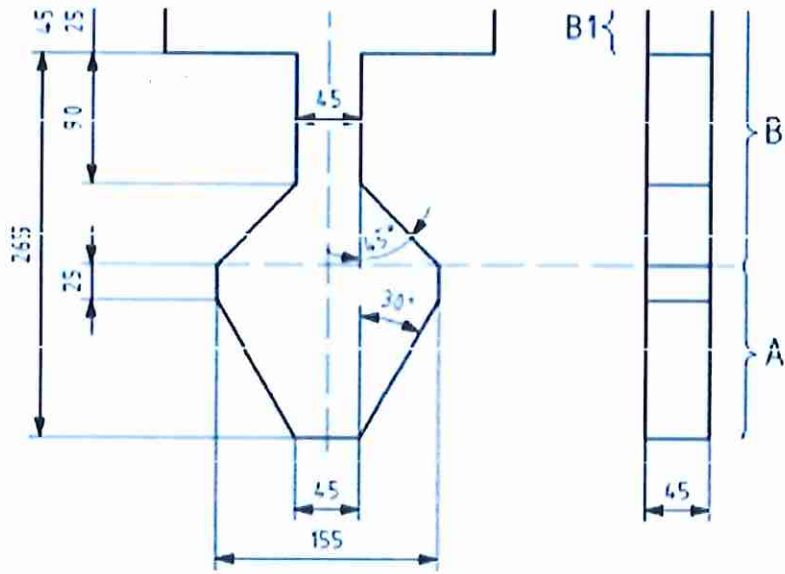
Opening is Partially bound, Procedure Applies.

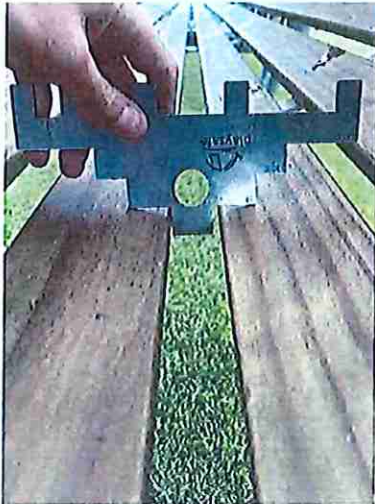
Finding 13

4.2.7.5 entrapment of foot - surfaces intended for running/walking. this tunnel is intended for crawling.

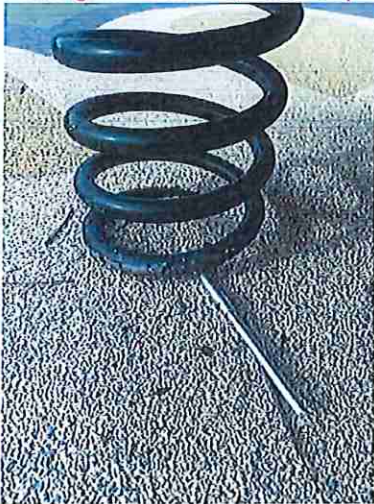
- Finding 15 – springs on Pohutukawa rocker. Appears the rocker has been installed too low. The safety surface when wetpour should allow for the replacement of the springs. At the bottom of the spring we supply 'plastic wedges' to prevent this being an entrapment. However due to the location, under the platform and wetpour offering some relief to squashing I would consider this acceptable and monitor. Becomes more of an issue if the spring needs replacing

Finding 15 – Correct, I didn't spot this. A small wedge would mitigate.

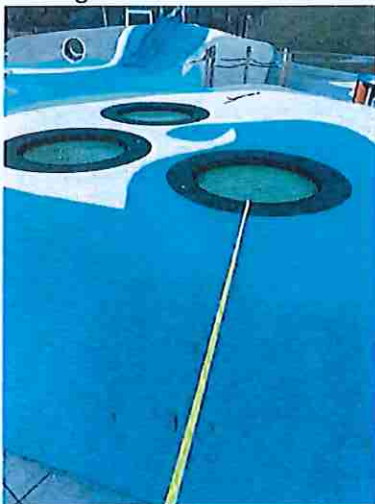
Finding 14

There is no rule in the 5828:2015 standards regarding trampolines. See certified equipment requirements by supplier/manufacturer for fall space requirements.

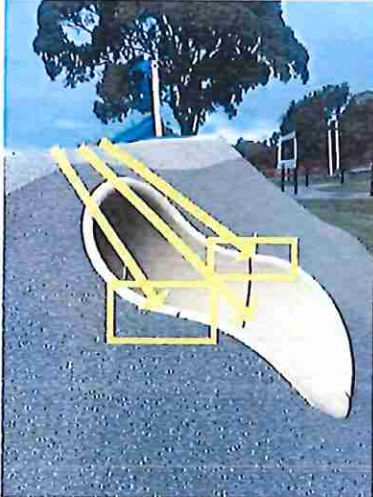
Question impact attenuation of plastic – fall from height of tunnel, not top of mound - ground level.

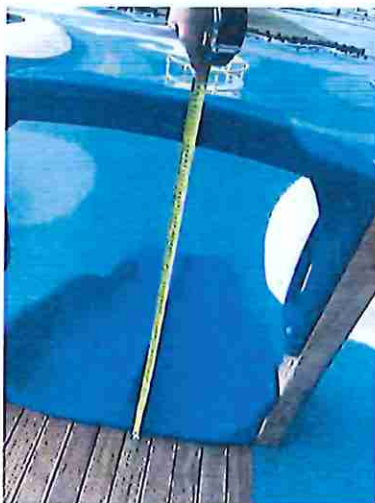
This rule only applies to attachment slides with a fall height greater than 1m. This is an embankment slide.

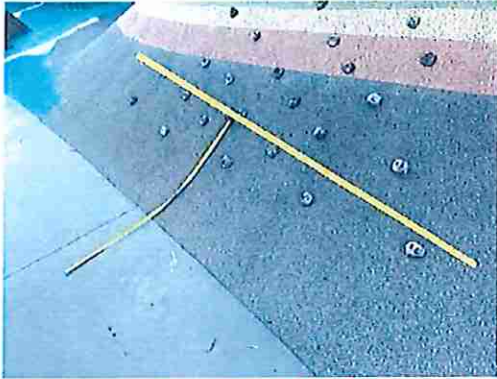
Finding 26

Disagree - Not a vertical fall. 35 degrees is not steep play. This is the ground.

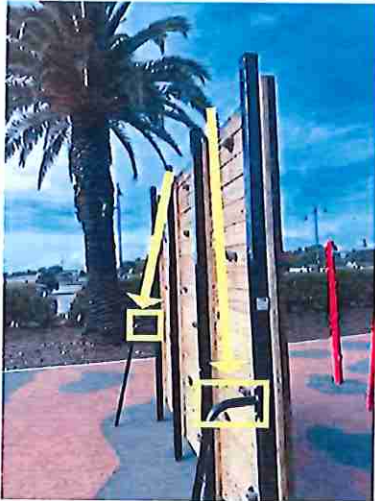
Disagree with adams measurement of fall to blunt support - This distance is a hand hold minus 1m to support bar, so the distance of the fall to impact is 640mm. if measured correctly. EN 1176.1:2008 figure 14.

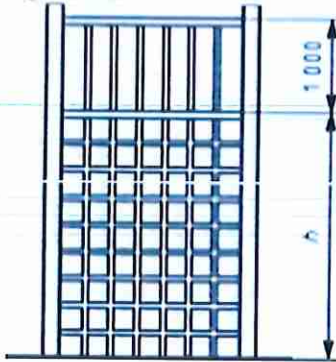
This is 4cm over the limit of fall within a play structure if Adam's measurement to full height is correct.

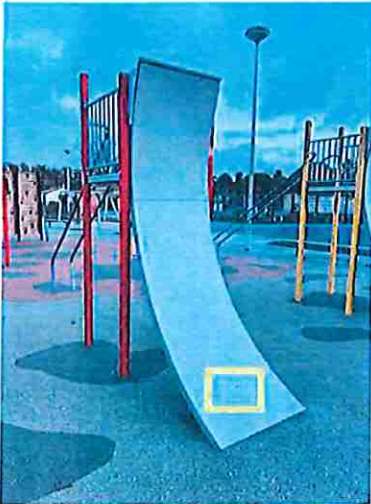
Finding 58

Disagree with Adams finding - The purpose of the finger entrapment ruling is to stop fingers getting caught during forced movement. The definition of forced movement can be argued for this equipment. I think common sense prevails in this situation, considering movement ceases on the ground.

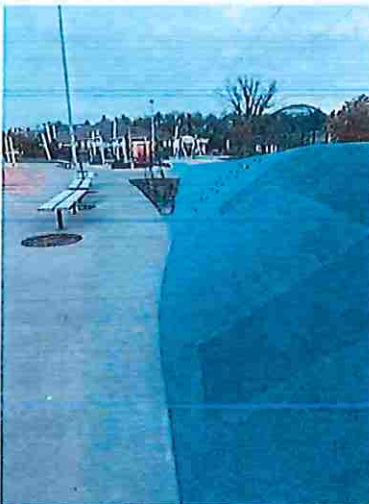
Disagree with Adam's findings. Free height of fall is defined as vertical height in the standards. These mounds are not slides, they have grip. They can be walked up and down.

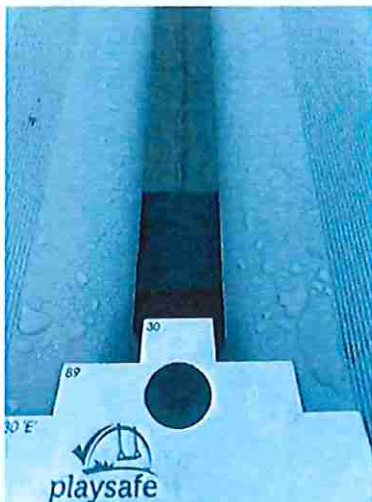
Disagree – not a surface designed for walking on.

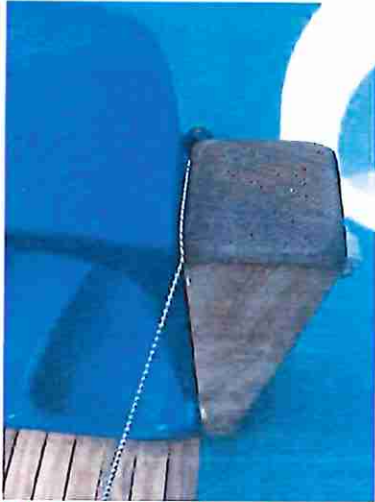
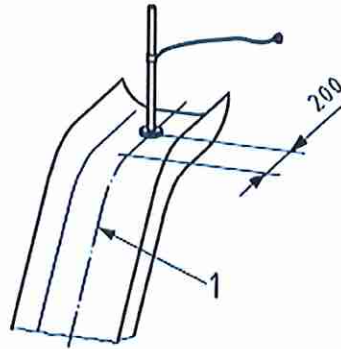
a) Narrow slide

I disagree with this toggle entrapment finding based on the following evidence.

Adam's toggle entrapment tool does not match that shown in the standard. It is missing the 400mm sliding pole, that is placed on the slide. I disagree

The tool is to be placed on the slide to preform the test.

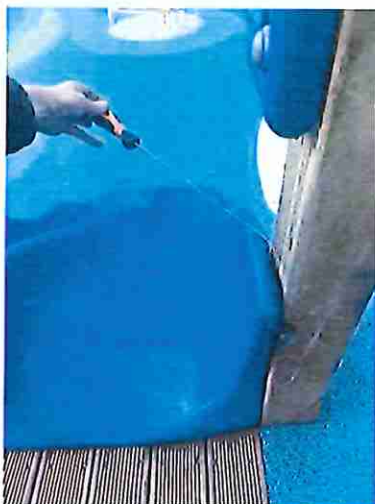
Adam wrote "Slide Type 1 -The slide run-out should be surrounded by an impact attenuating area that extends at least 1.0m on each side and at least 2.0m in front. This impact area should be free from any overlapping falling"

Doesn't say this in the standards.

Standard requirements are that free space cannot be overlapped. Slide free space is measured from the centre of the slide., extending 1m.

I need to check, but I thought the disc was out of the 1m free space. And had I was informed had a CFH of 1m.

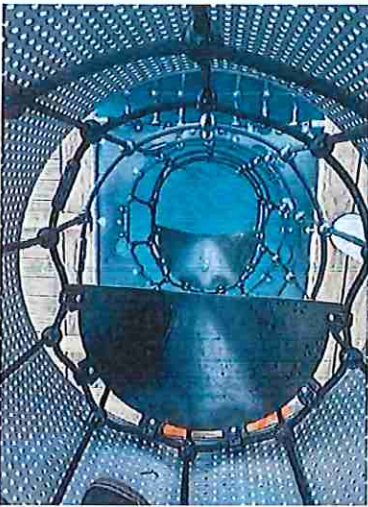
I questioned this with manufacturer at the time of completion, and the answer was because the angled fall the 'rubber valves' were placed to slow fall. Adams photo has been taken to increase the angle – the vertical fall is not as it appears in photos. I will let the manufacturer answer these ones.

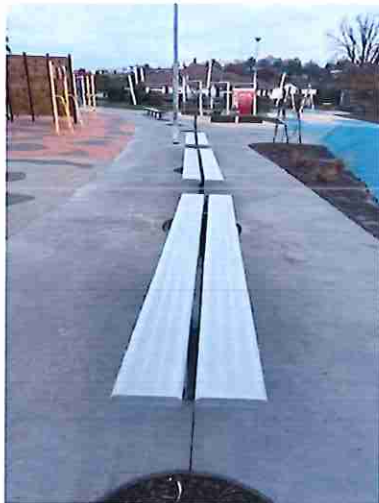
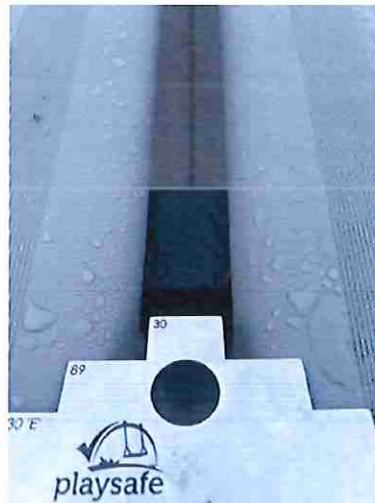
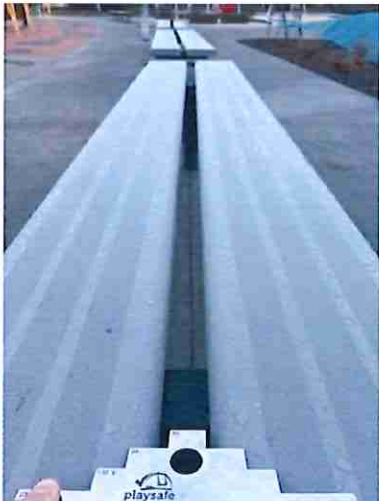
Potential foot/leg entrapment hazards exist due to gaps larger than 30mm in the direction of travel. These gaps do not comply with the entrapment

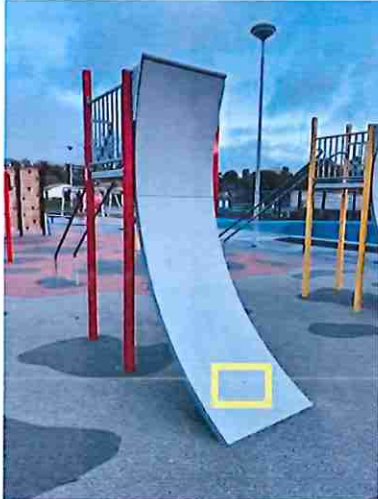
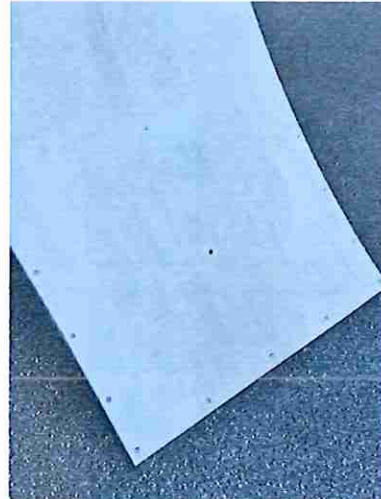
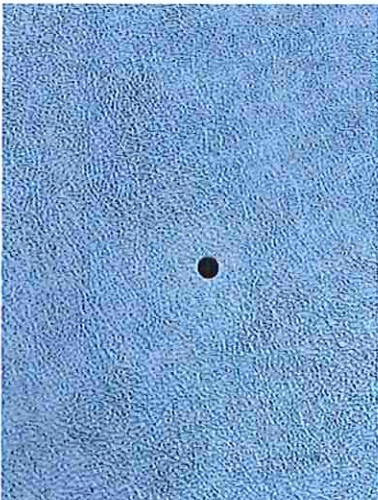
Issue / Finding 58

Missing fastenings - Replace.

Potential Entrapment - There is a potential entrapment risk due to an undesirable gap. It is recommended to block or fill the gap to prevent entrapment.

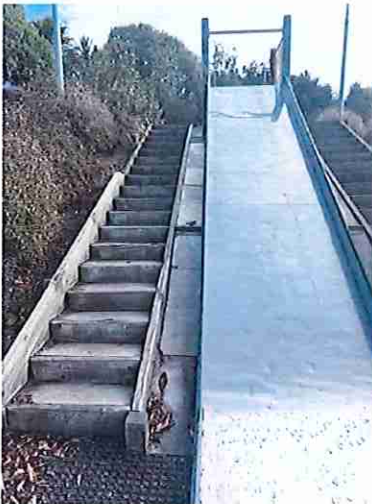
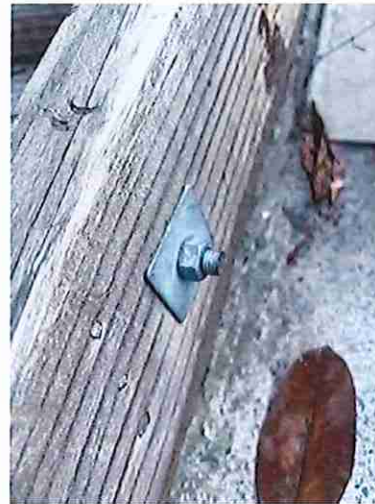
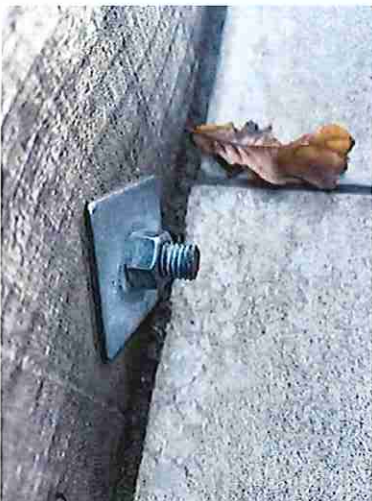
All exposed bolt threads should be cut off and bolt heads / nuts cap covered.

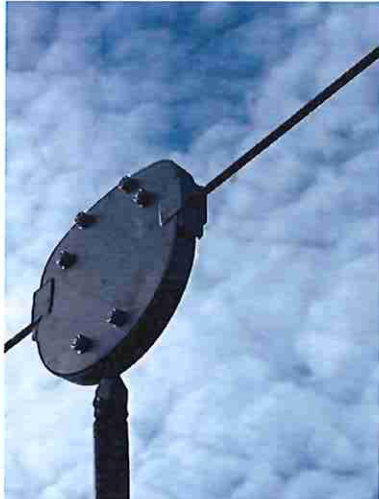
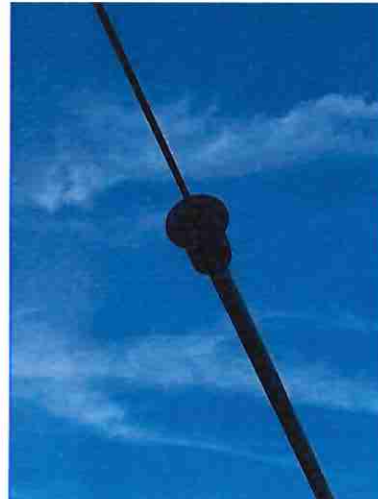
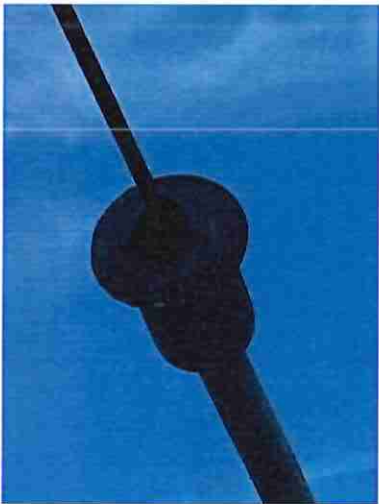
| <b>Activity/Equipment definition</b> | Rope Swing |
| <b>Issue</b> | Missing fastening/s – Rectify. |

| <b>Recommendation</b> | Replace |

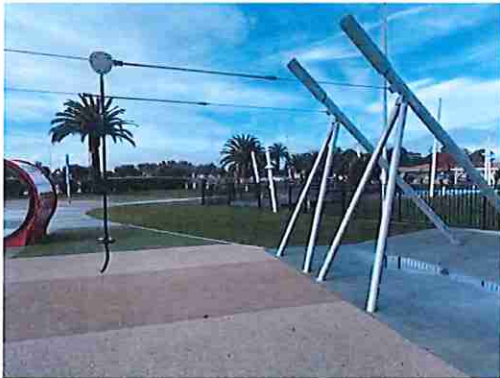
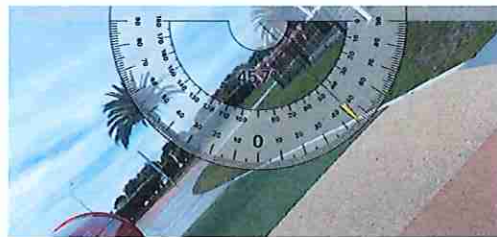
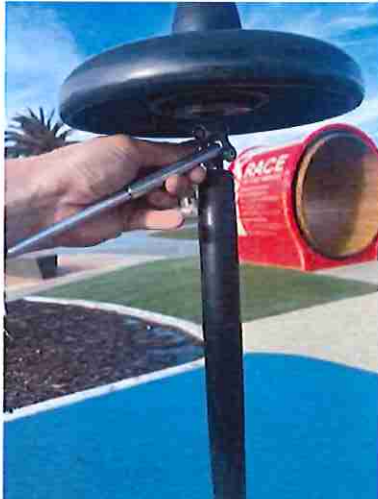
| <b>Activity/Equipment definition</b> | Pommel Seat Assembly |
| <b>Issue</b> | This item is damaged. |

| <b>Recommendation</b> | Replace |

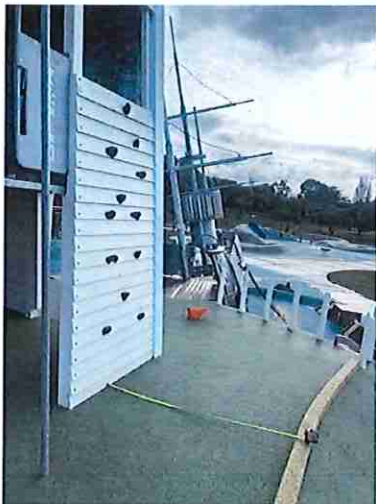
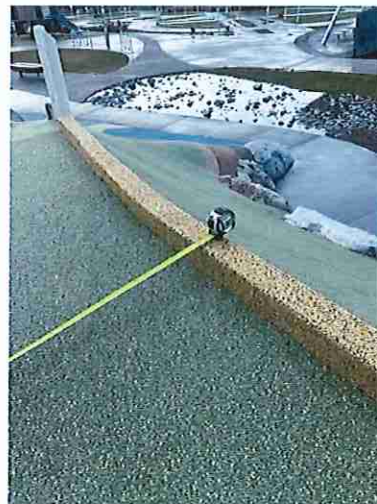
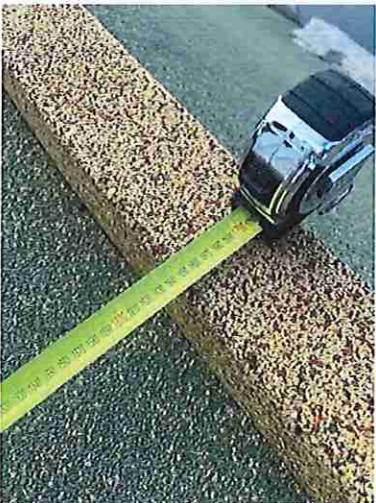
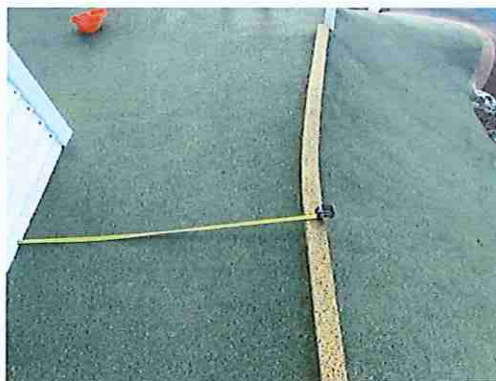
There is only 1640mm to the wetpour block nib. While the bank/slope forms an acceptable part of the falling space/impact area, it is uncertain if the raised solid wetpour block nib provides adequate impact attenuation for a 2500mm CFH. In my professional judgement a solid block of wetpour (without a shockpad interior, would struggle to achieve this critical fall height). Both the top face and edge radius could create a hard blunt object within the falling space, however I could not perform this test during inspection and recommend further impact testing to verify this - see summary note.

Considered/determined easily accessible.

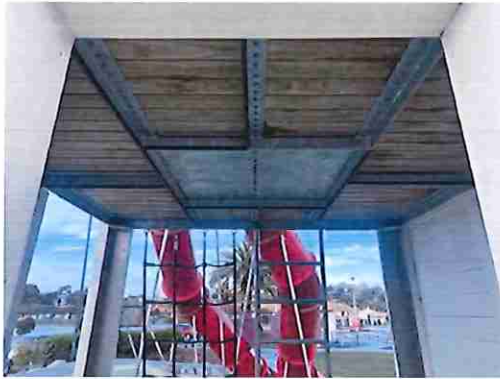
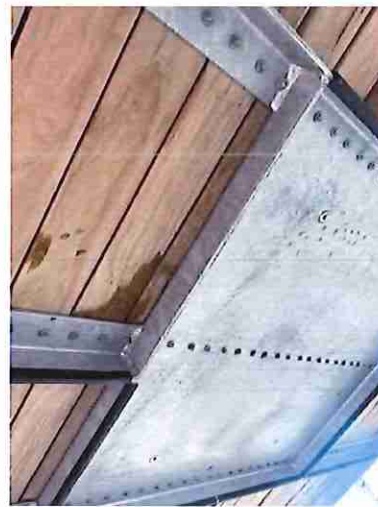
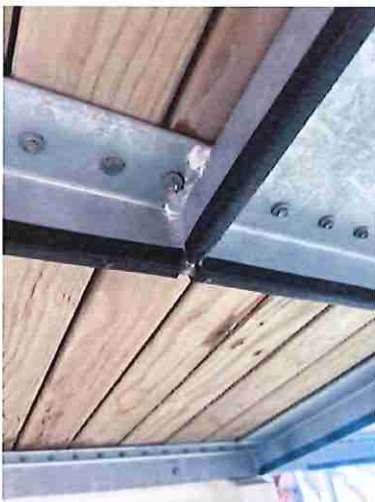
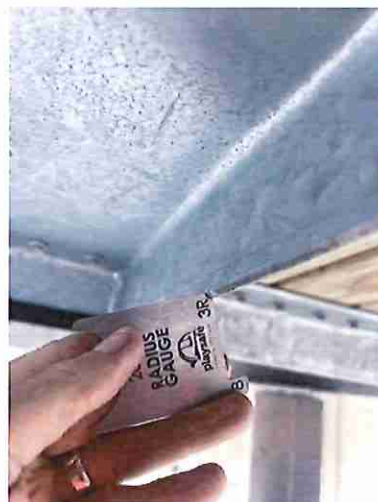
Issue / Finding 41

Missing parts.

Many missing rubber profiles, however I don't believe they are needed on this particular platform underside as the frames have an adequate min 3mm radius.

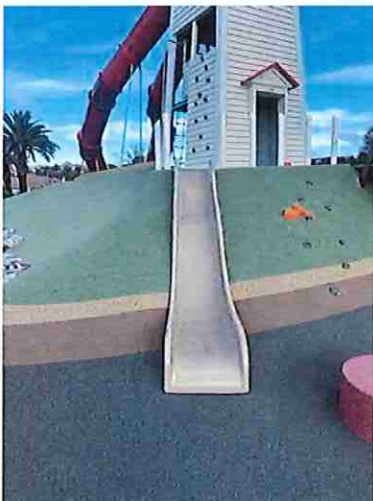
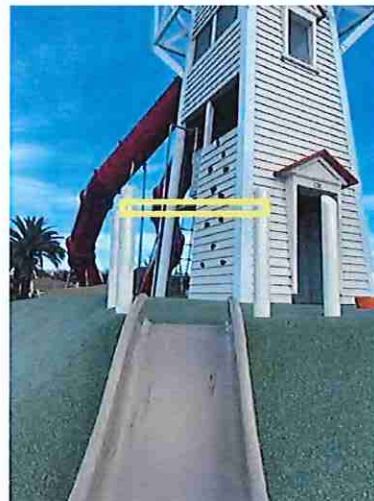
There is a potential risk of head and neck wedge entrapment due to the V-shaped gap that does not meet the requirements for neck wedge entrapment. According to the standard a partially bound opening is defined as any opening that has at least one side or portion open which could potentially trap and suspend a user by the neck. To mitigate this risk the gap should be less than 45mm wide or deep to ensure it does not pose a wedge probe entrapment hazard.

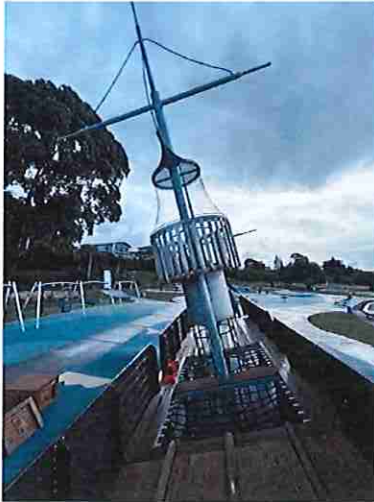
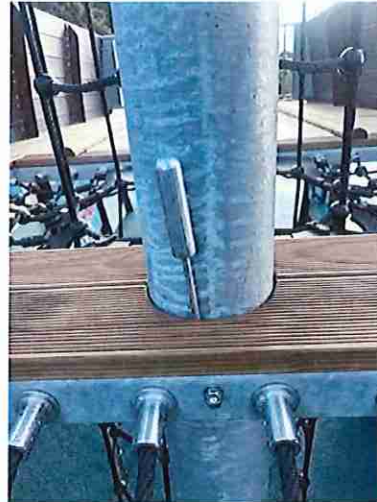
Missing fastening/s – Rectify.

Bolt is bent and missing nuts.

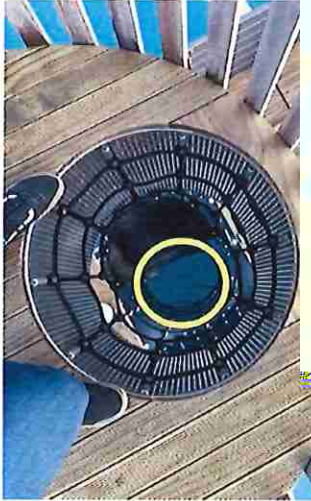
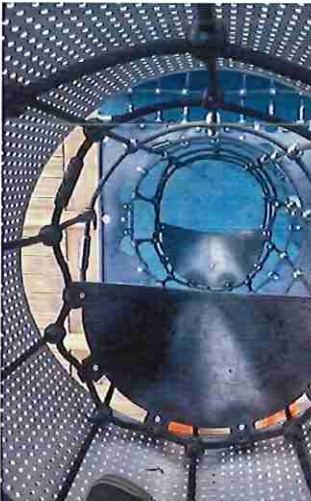
The flexing of the mast creates a pinch point between the mast and the platform. Although the 8mm finger probe does not fail, the tip does get pinched, causing concern. This gap will only get larger with timber shrinkage. I would suggest a packer, shroud or cowling over this variable gap.

Monitor/ Maintain

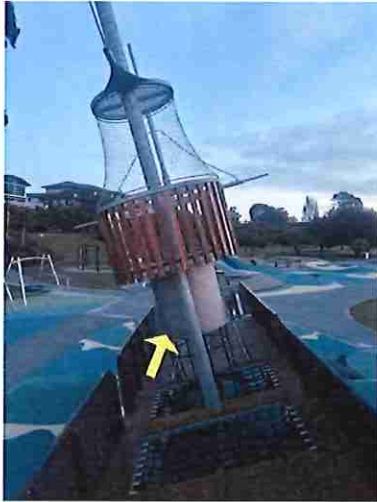
Photo 186

Due to the angle of the ship, the vertical rope net tube is not plumb or concentric with the perforated metal tube. This misalignment creates a finger pinch and crush hazard between the rigid plastic rope fittings and the perforated metal tube when user weight is applied to the net.

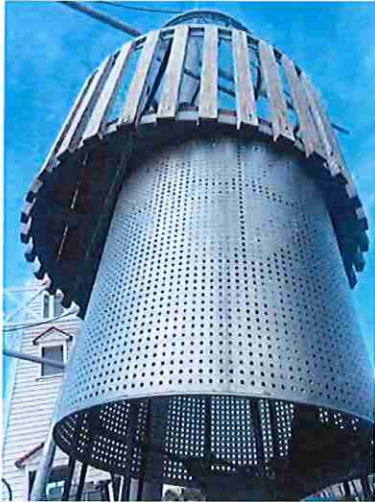
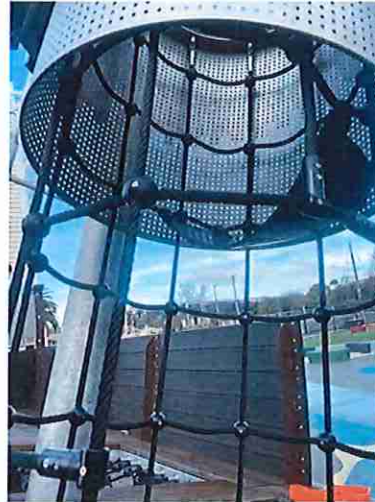
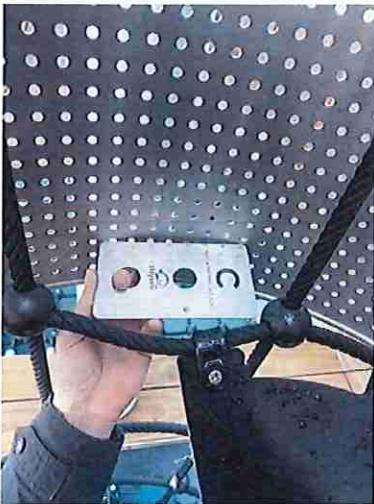
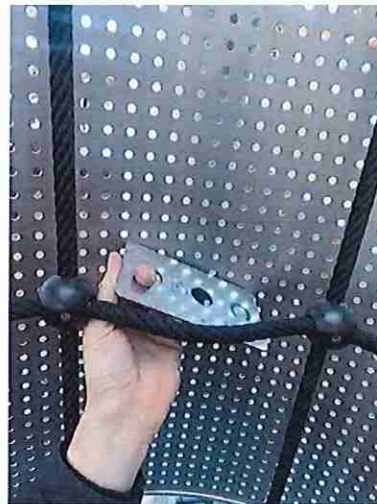
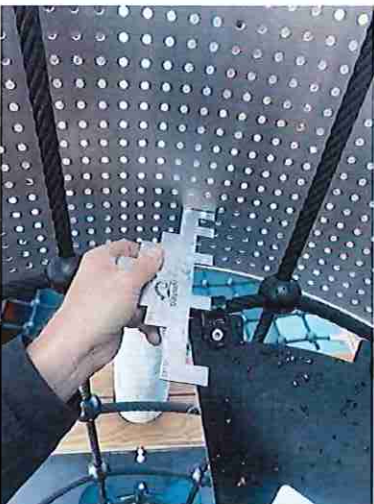
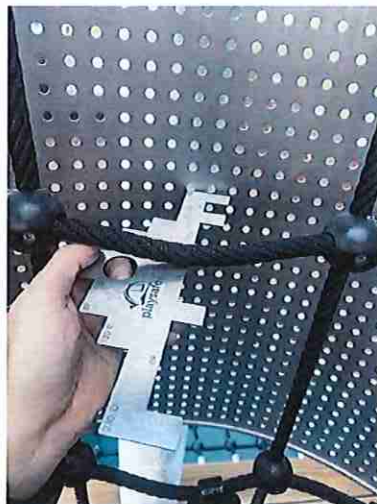
There is a potential risk of head and neck entrapment as the gap fails Probe C and D (Torso then Large Head) with dimensions between 89-230mm for free heights of fall greater than 600mm the requirement for head and neck entrapment is that the gap should be less than 89mm or greater than 230mm in diameter.

Due to the angle of the ship, the vertical rope net tube does not sit plumb or concentric to the perforated metal tube. This misalignment creates multiple instances of head entrapments that would fail Probes A, C, and D tests. Additionally, visibility and supervision in this area are limited, leading to an increased risk assessment.

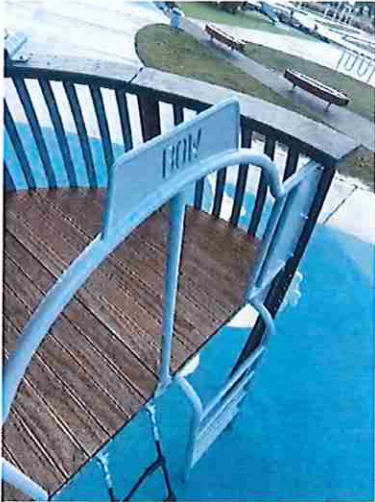
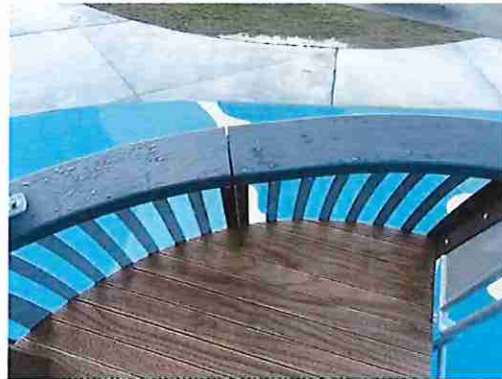
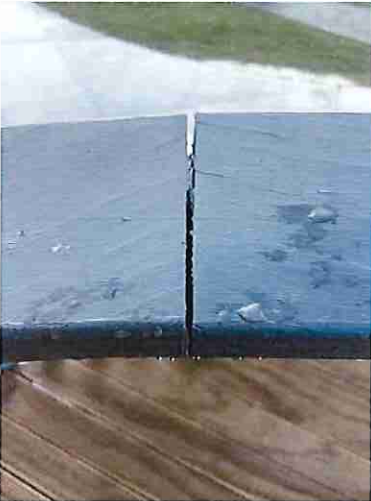
Potential Pinch Crush or Shear Point Hazard - The gap in question does not comply with the requirements for preventing pinch crush or shear injury. This poses a potential risk of injury to individuals who may inadvertently place their body parts within the gap leading to crush/shear risk.

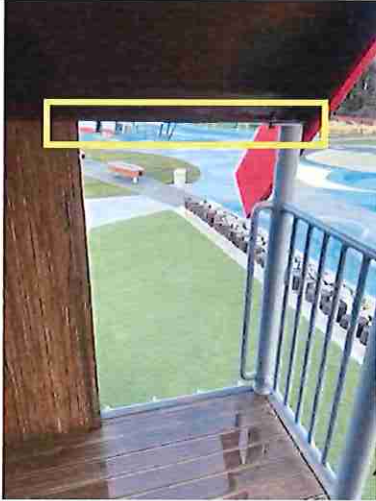
Photo 173

Component is damaged / failed.

Repair

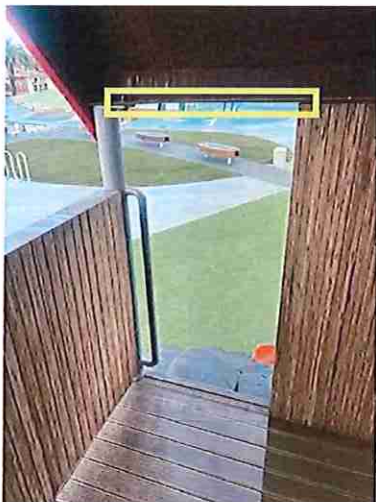
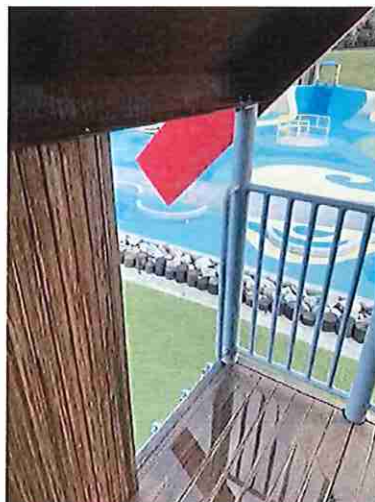
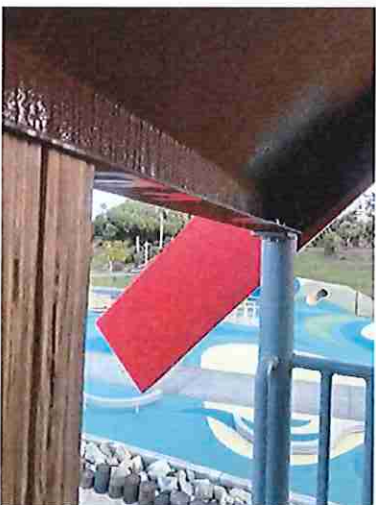
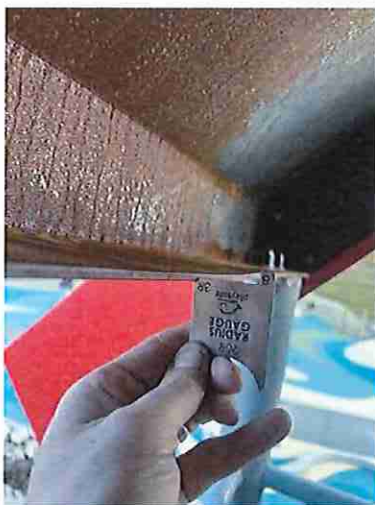
Scalping Hazard - Recommend a large radius be provided to this edge/projecting element. Rationale: a bump or bruise is acceptable however a laceration is not.

Scalping Hazard - Presents a facial/ forehead injury risk to users.

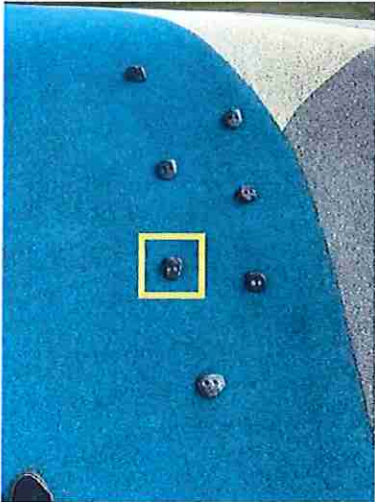
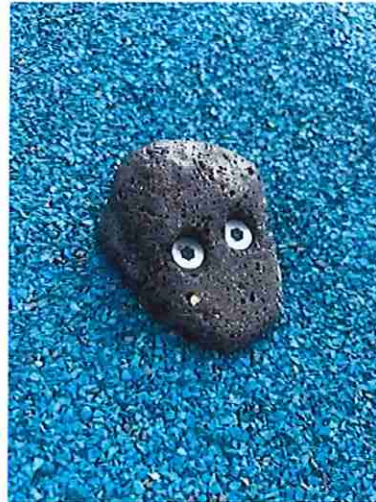
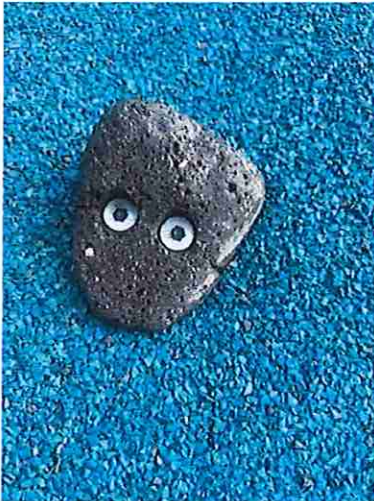
Missing fastening/s – Rectify.

Slide Opening / Starting Section - Potential Clothing Toggle Entrapment Hazard. The gap in the slide opening does not meet the requirements for preventing clothing toggle entrapment. This poses a risk of entanglement and potential strangulation for users wearing clothing with toggles or drawstrings. It is recommended to address this gap to ensure the safety of individuals using the slide.

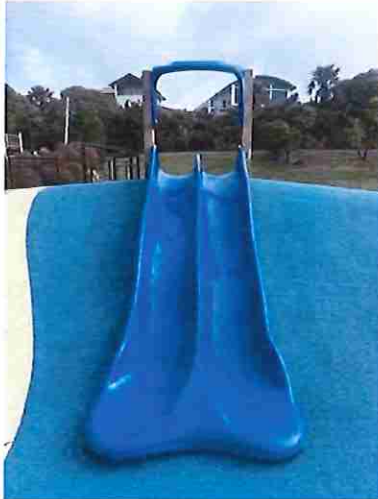
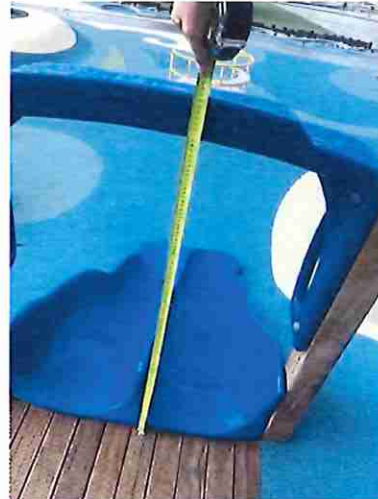
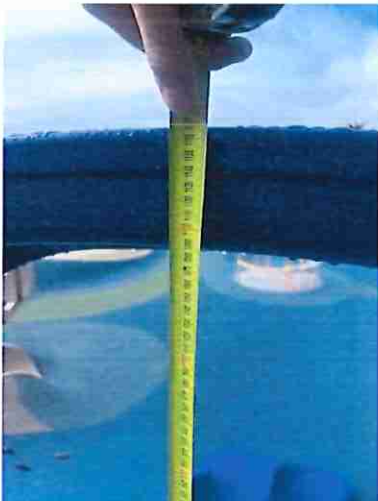
| <b>Issue</b> | The component has failed (broken). | |

| <b>Recommendation</b> | Replace | |

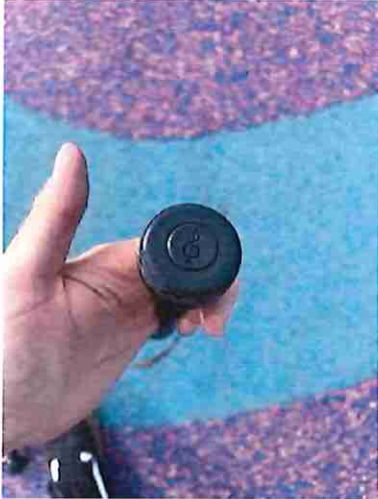
Missing lid cap/s

Repair

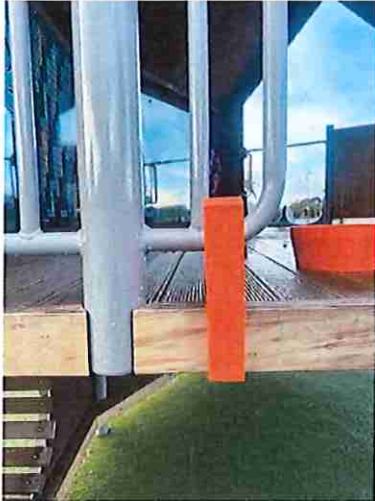
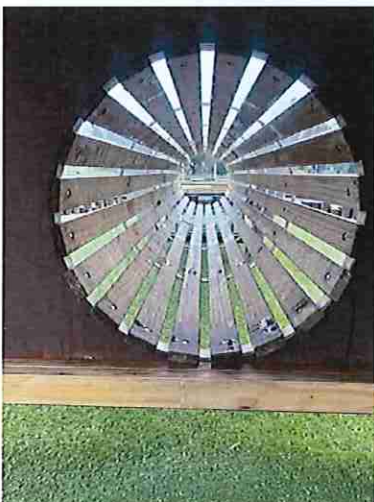
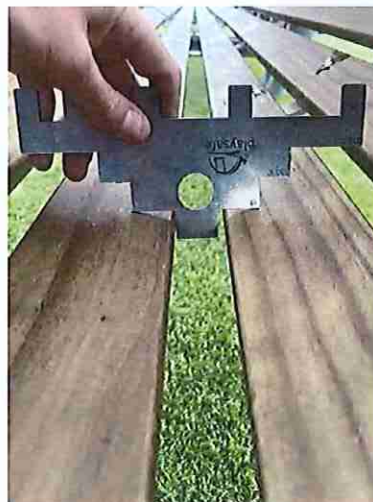
There is a potential risk of head and neck wedge entrapment due to the V-shaped gap that does not meet the requirements for neck wedge entrapment. According to the standard a partially bound opening is defined as any opening that has at least one side or portion open which could potentially trap and suspend a user by the neck. To mitigate this risk the gap should be less than 45mm wide or deep to ensure it does not pose a wedge probe entrapment hazard.

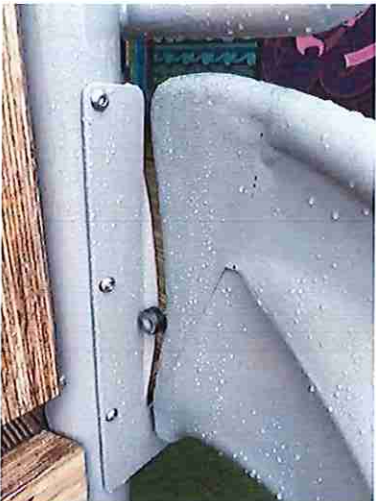
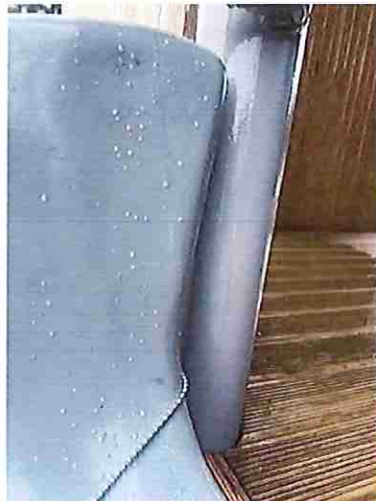
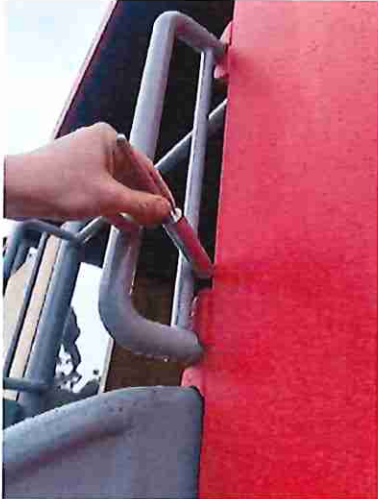
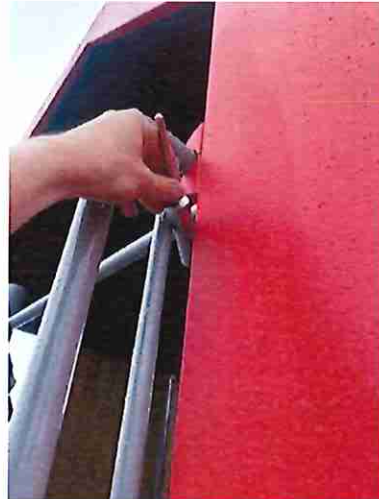
Slide Opening / Starting Section - Potential Clothing Toggle Entrapment Hazard. The gap in the slide opening does not meet the requirements for preventing clothing toggle entrapment. This poses a risk of entanglement and potential strangulation for users wearing clothing with toggles or drawstrings. It is recommended to address this gap to ensure the safety of individuals using the slide.

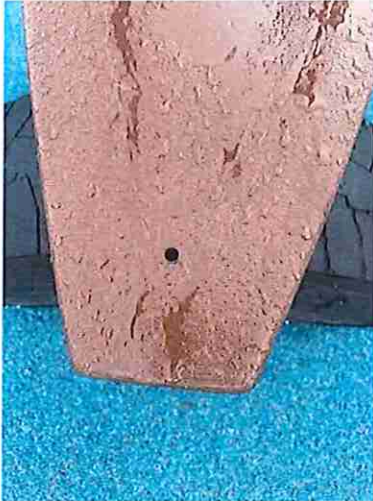
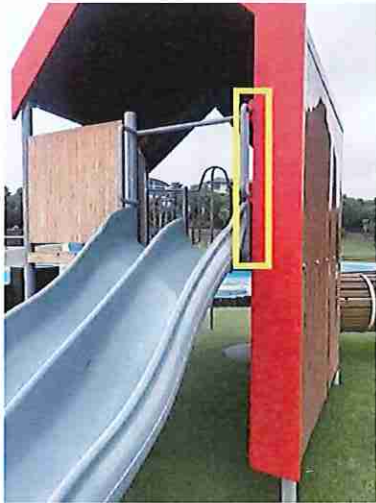
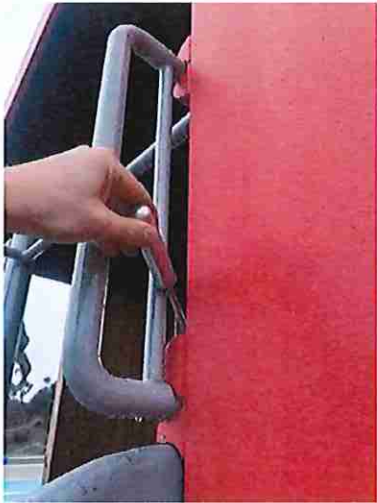
| <p>Probe does not freely enter but catches on entry. Hole is only on one end and serves no function - recommend this is promptly filled due to forced movement position.</p> | |

| <b>Recommendation</b> | Rectify |

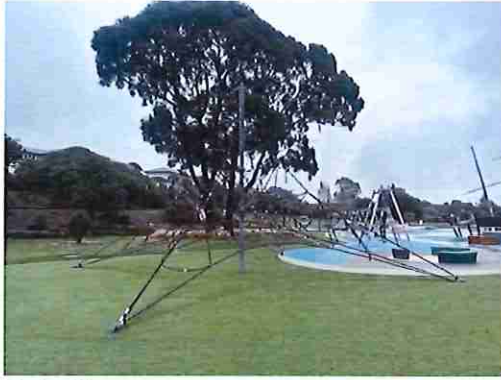
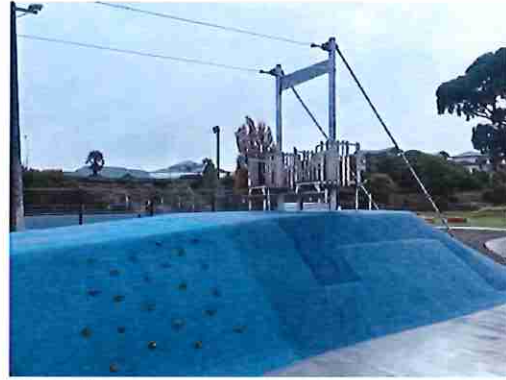
| <b>Issue</b> | All exposed bolt threads should be cut off and bolt heads / nuts cap covered. |
| <b>Risk Assessment</b> | Low/ Medium Risk |

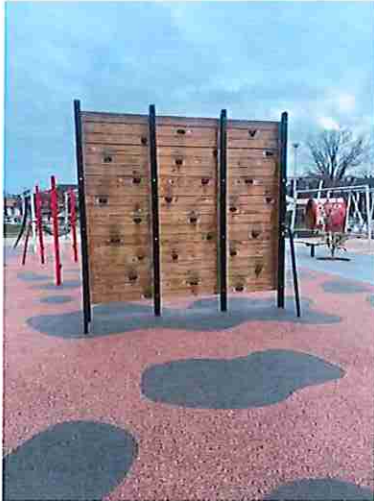
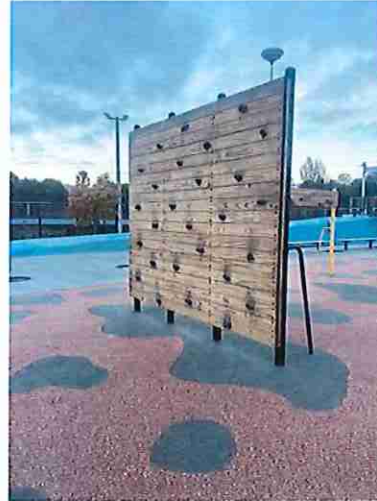
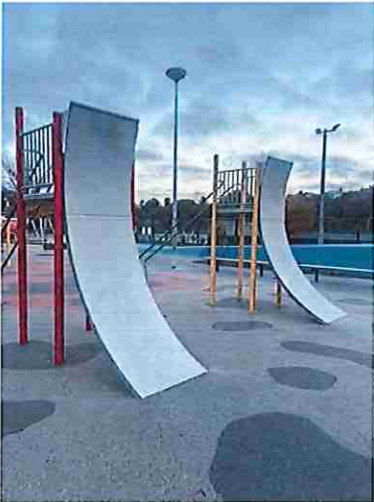
| <b>Test Result - Surface Max Critical Fall Height (CFH)</b> | Failed to meet some of the critical fall heights of the play equipment. |

The impact attenuation performance of this surface may be compromised and may not meet the requirements of the equipment fall heights. Recommend impact test.

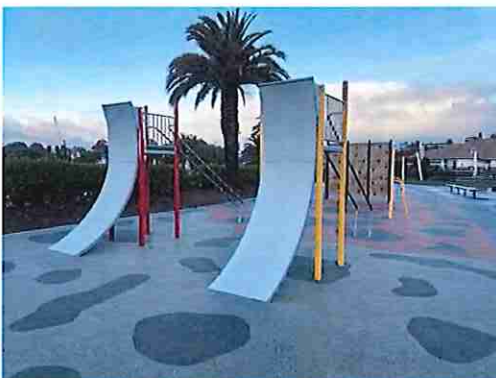
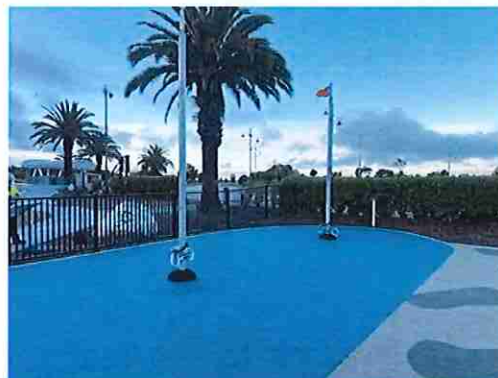
Failed to meet some of the critical fall heights of the play equipment.

Failed drops from Rockwall 2. Requires 2540 mm critical fall height and is achieving approximately 2400mm.

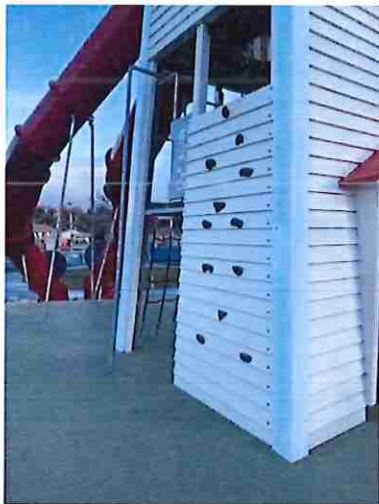
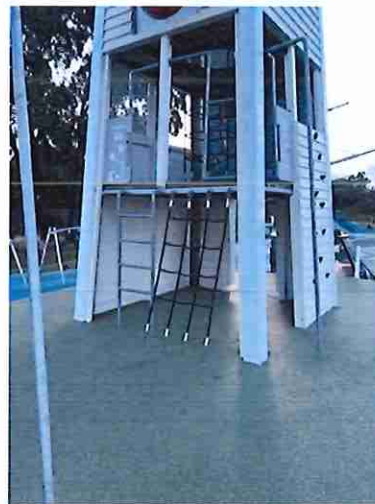
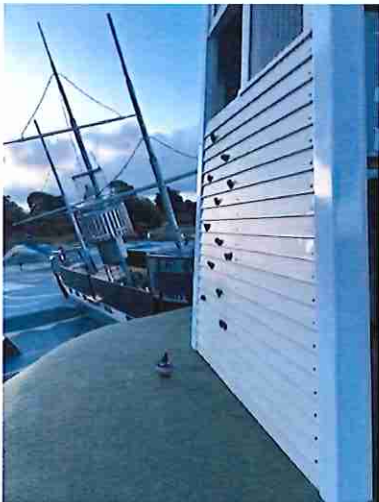
Failed to meet some of the critical fall heights of the play equipment.

Both the turf and the wetpour fail the 1850mm FHF requirement here.

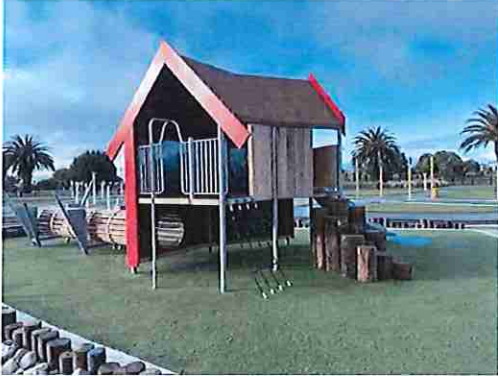
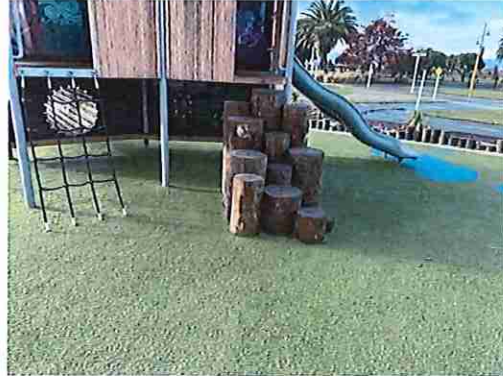
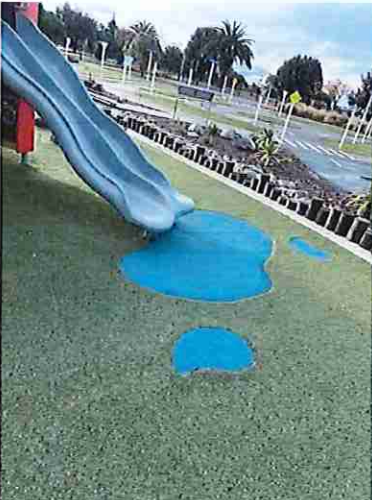
| <b>Test Result - Surface Max Critical Fall Height (CFH)</b> | Failed to meet some of the critical fall heights of the play equipment. |

The impact test on the turf around the entire structure fails to meet the minimum critical fall height requirements for this equipment. With a platform height of 1.5m, the tests around the log incline, fireman pole, and all platform openings do not pass.
