**Local Government Official Information & Meetings Act 1987 Request:**

1. Trish Wigley – Inspection Report 30 October 2023
2. Draft Report – Climbing Pole 25 January 2024
3. Email chain Playgroundcentre – compliance report 18 August 2024
4. Playsafe Play Report 2024
5. Caroline Bay Flying Fox Inspection Report August 2024

# PLAY REPORT 2024

## Caroline Bay Playground Flying Fox Inspection Report

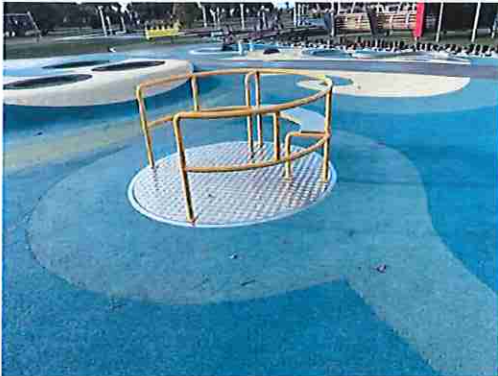
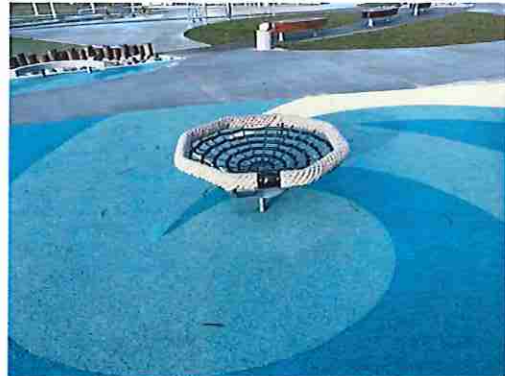
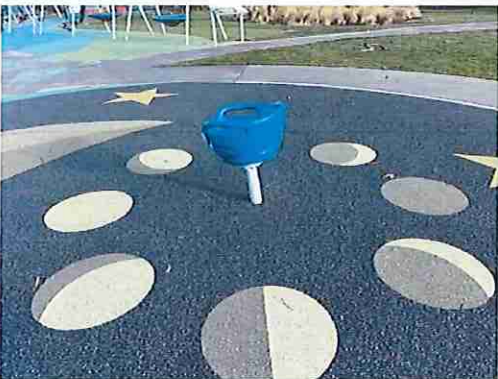
Failed to meet some of the critical fall heights of the play equipment.

Wetpour passes, Turf fails 1500mm, test indicates approx 1300mm CFH

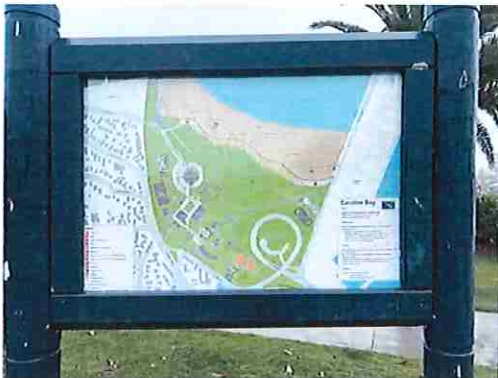
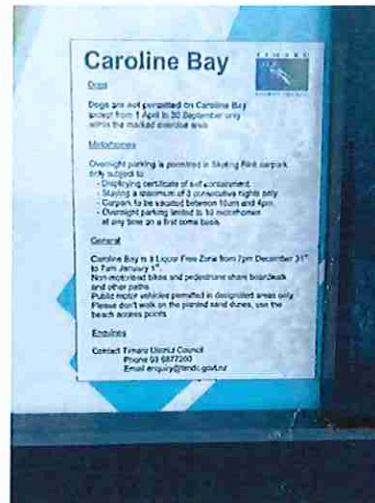
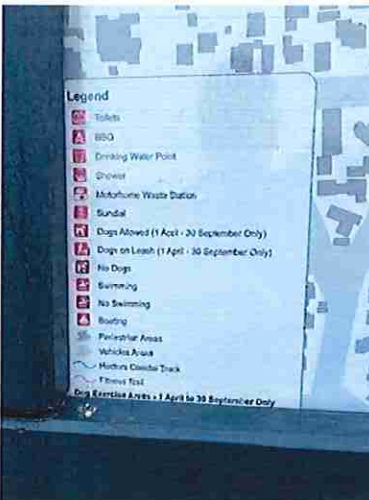
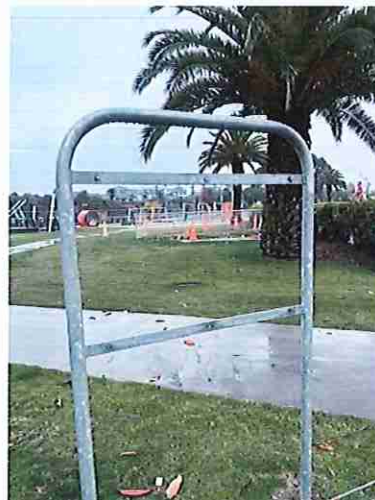
No - Adequate signage does not exist

No emergency details or address listed

Adequate signage not installed as per NZS5828. On the playground there should be a sign (pictogram) giving the following information: General emergency telephone number, telephone number to contact maintenance personnel, name of the playground, address of the playground; and other relevant local information. Playsafe also recommends the following content: Supervision Note, No Helmets to be worn on equipment along with the intended age range. Further info can be found here: <https://www.playsafe.co.nz/post/play-area-signage>

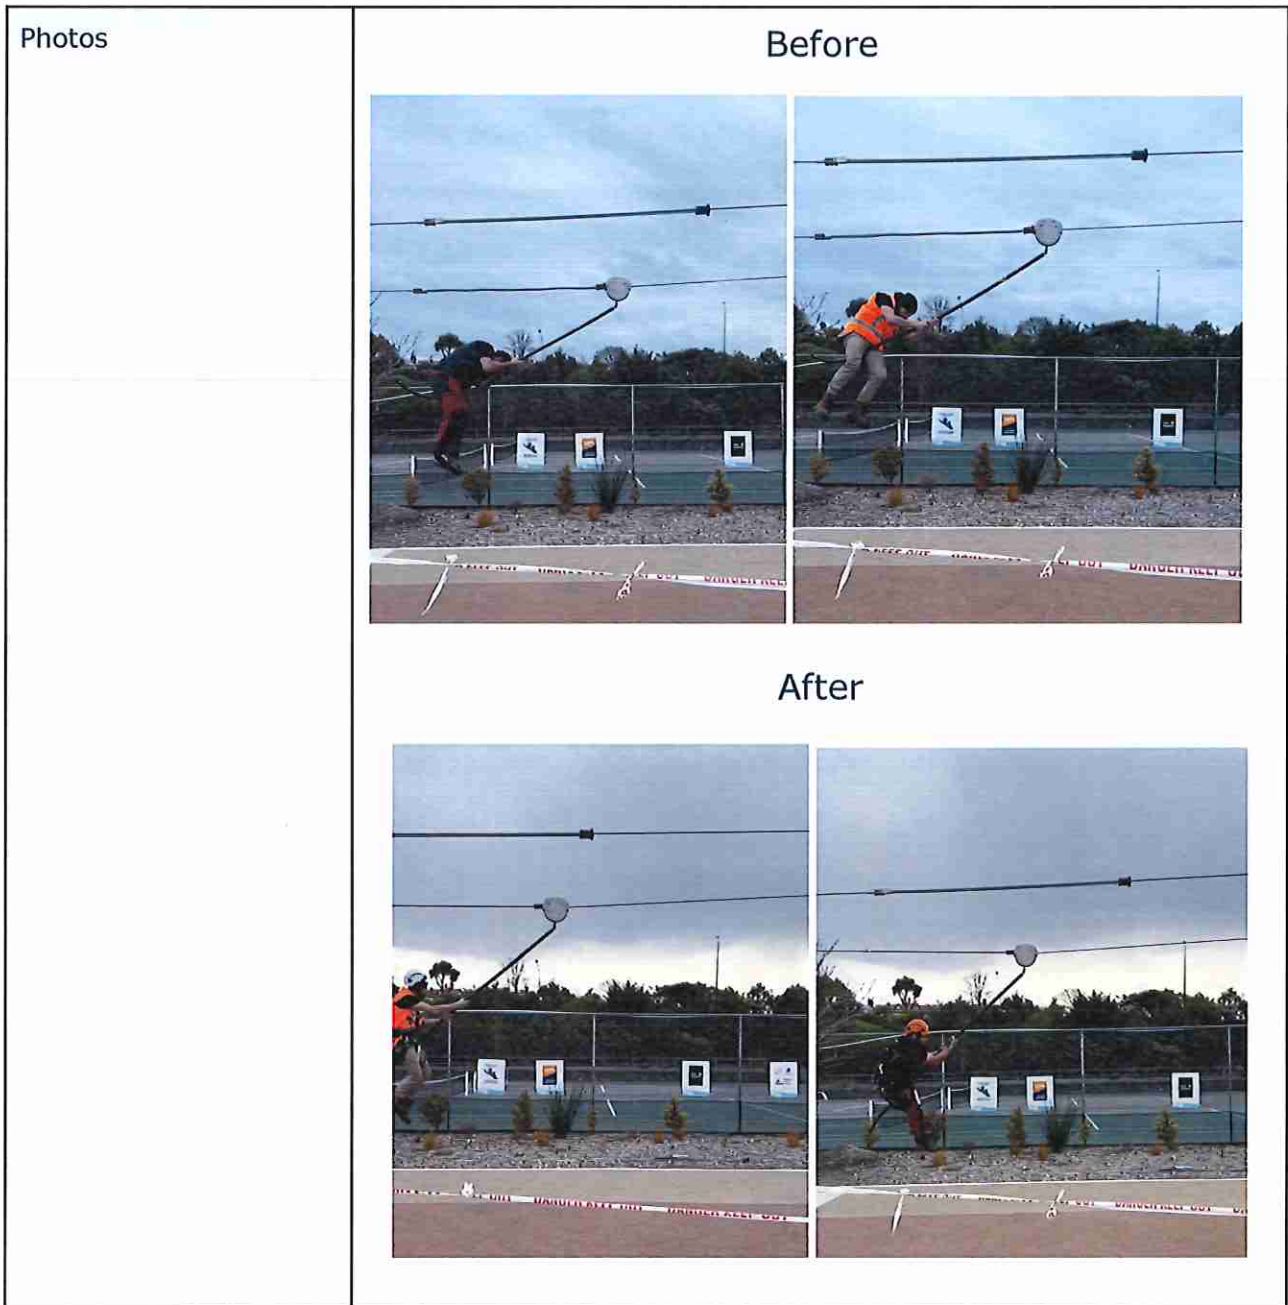
| <b>Additional Items</b> | Green | Orange | Red | Black |
|--|--|---|---|---|
| Notes | <p>Springs replaced to bring stopping under 45 degree angle.</p> <p>Ride height at minimum ground clearance at landing area.</p> <p>Seat height at take off ends quite high (may be hard for smaller users to hop on ride).</p> <p>No signage present.</p> | | | |

During the inspection the brake springs were replaced to bring the angle below 45 degrees at the braking zone, due to the nature of this flying fox and the design there are no other ways to decrease the speed or add additional gravity brake to the system.

- Monitor ride height and speed
- Monitor pulley sheath wear
