WHAA Detailed Seismic Assessment

16 Glenmore Street

Job Number: Revision: Date of issue:
N0541 A01 13 January 2025

Document Number:
N0541-RBG-WHA-XX-RP-ST-00001

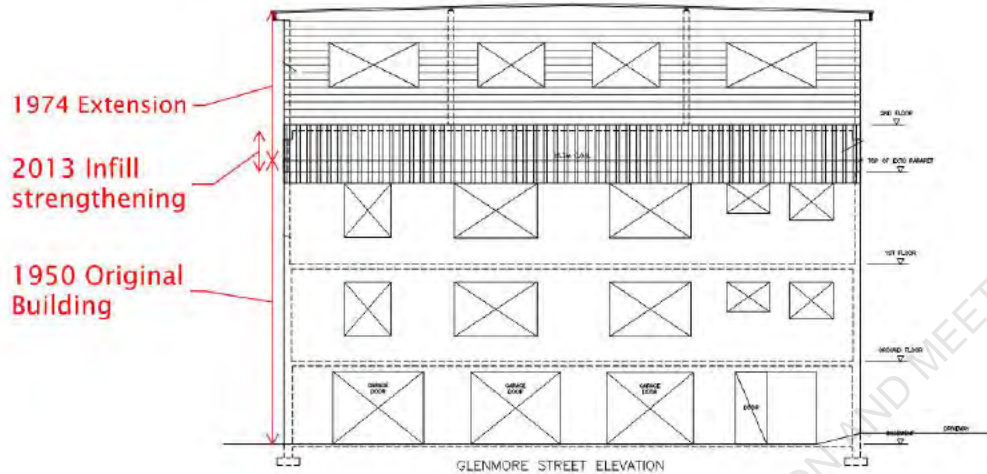
Figure 2: Front elevation of WHAA building

was strengthened in 2013 by adding some plywood infill walls beneath the 1974 extension. The building elevation from Glenmore street is shown below in Figure 2, which indicates the various construction stages.

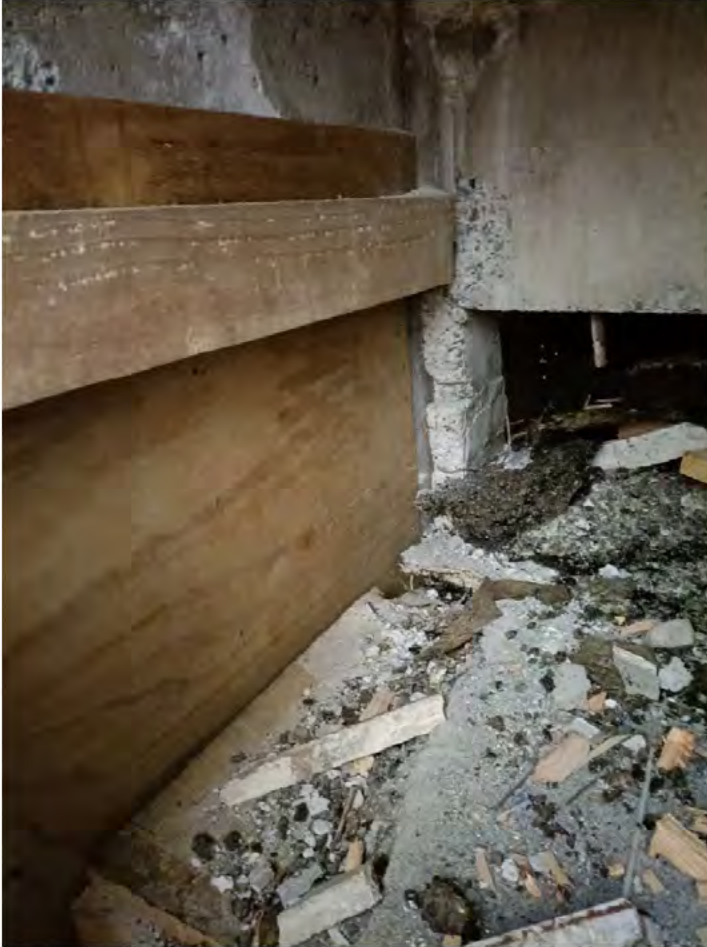
Interior of plywood wall on Glenmore Street elevation and cast-in steel beam

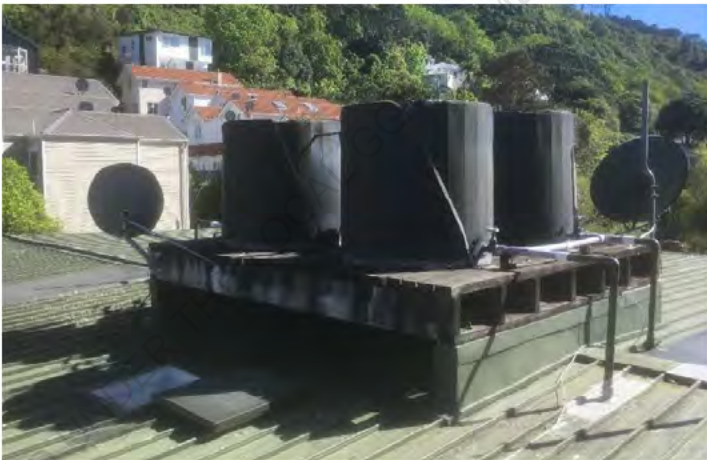
From the photos provided, there is a notional seismic restraint to the tanks on top of the platform, but this is likely to be inadequate for all but the lowest of seismic loads. The bolts connecting the platform to the support walls appear nominal, so the platform could become detached, and the joists for the platform appear to be unrestrained from rotation so can suffer rolling shear failures.

The tanks at roof level are supported on a timber platform with no apparent seismic system.

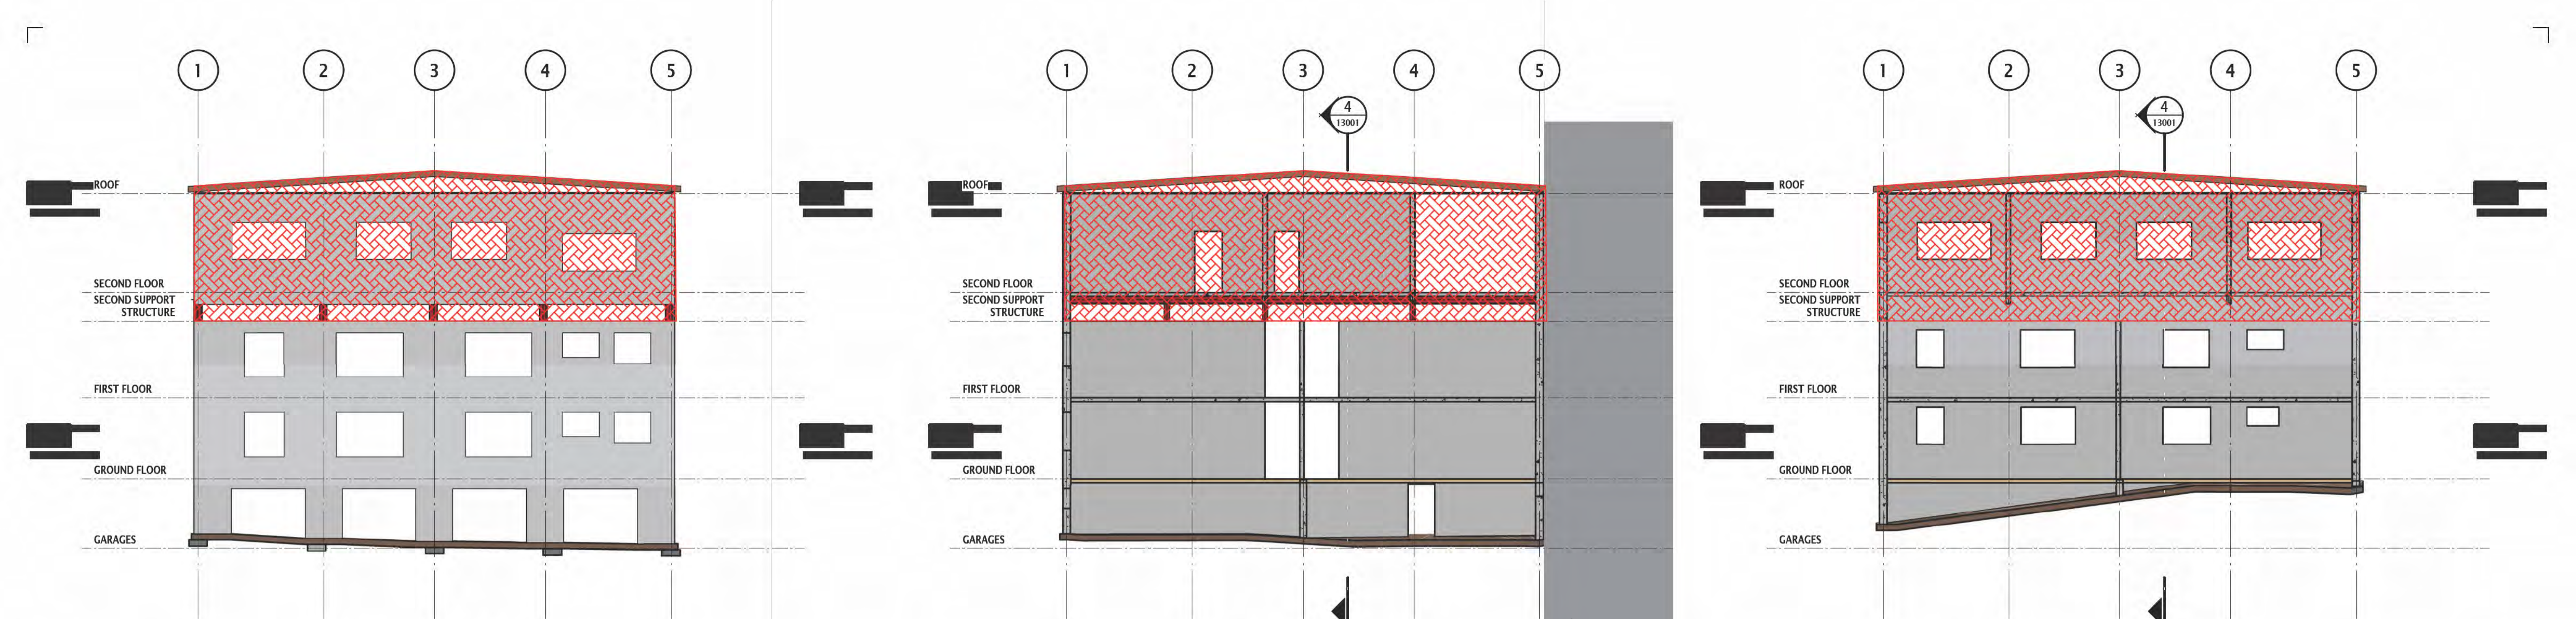
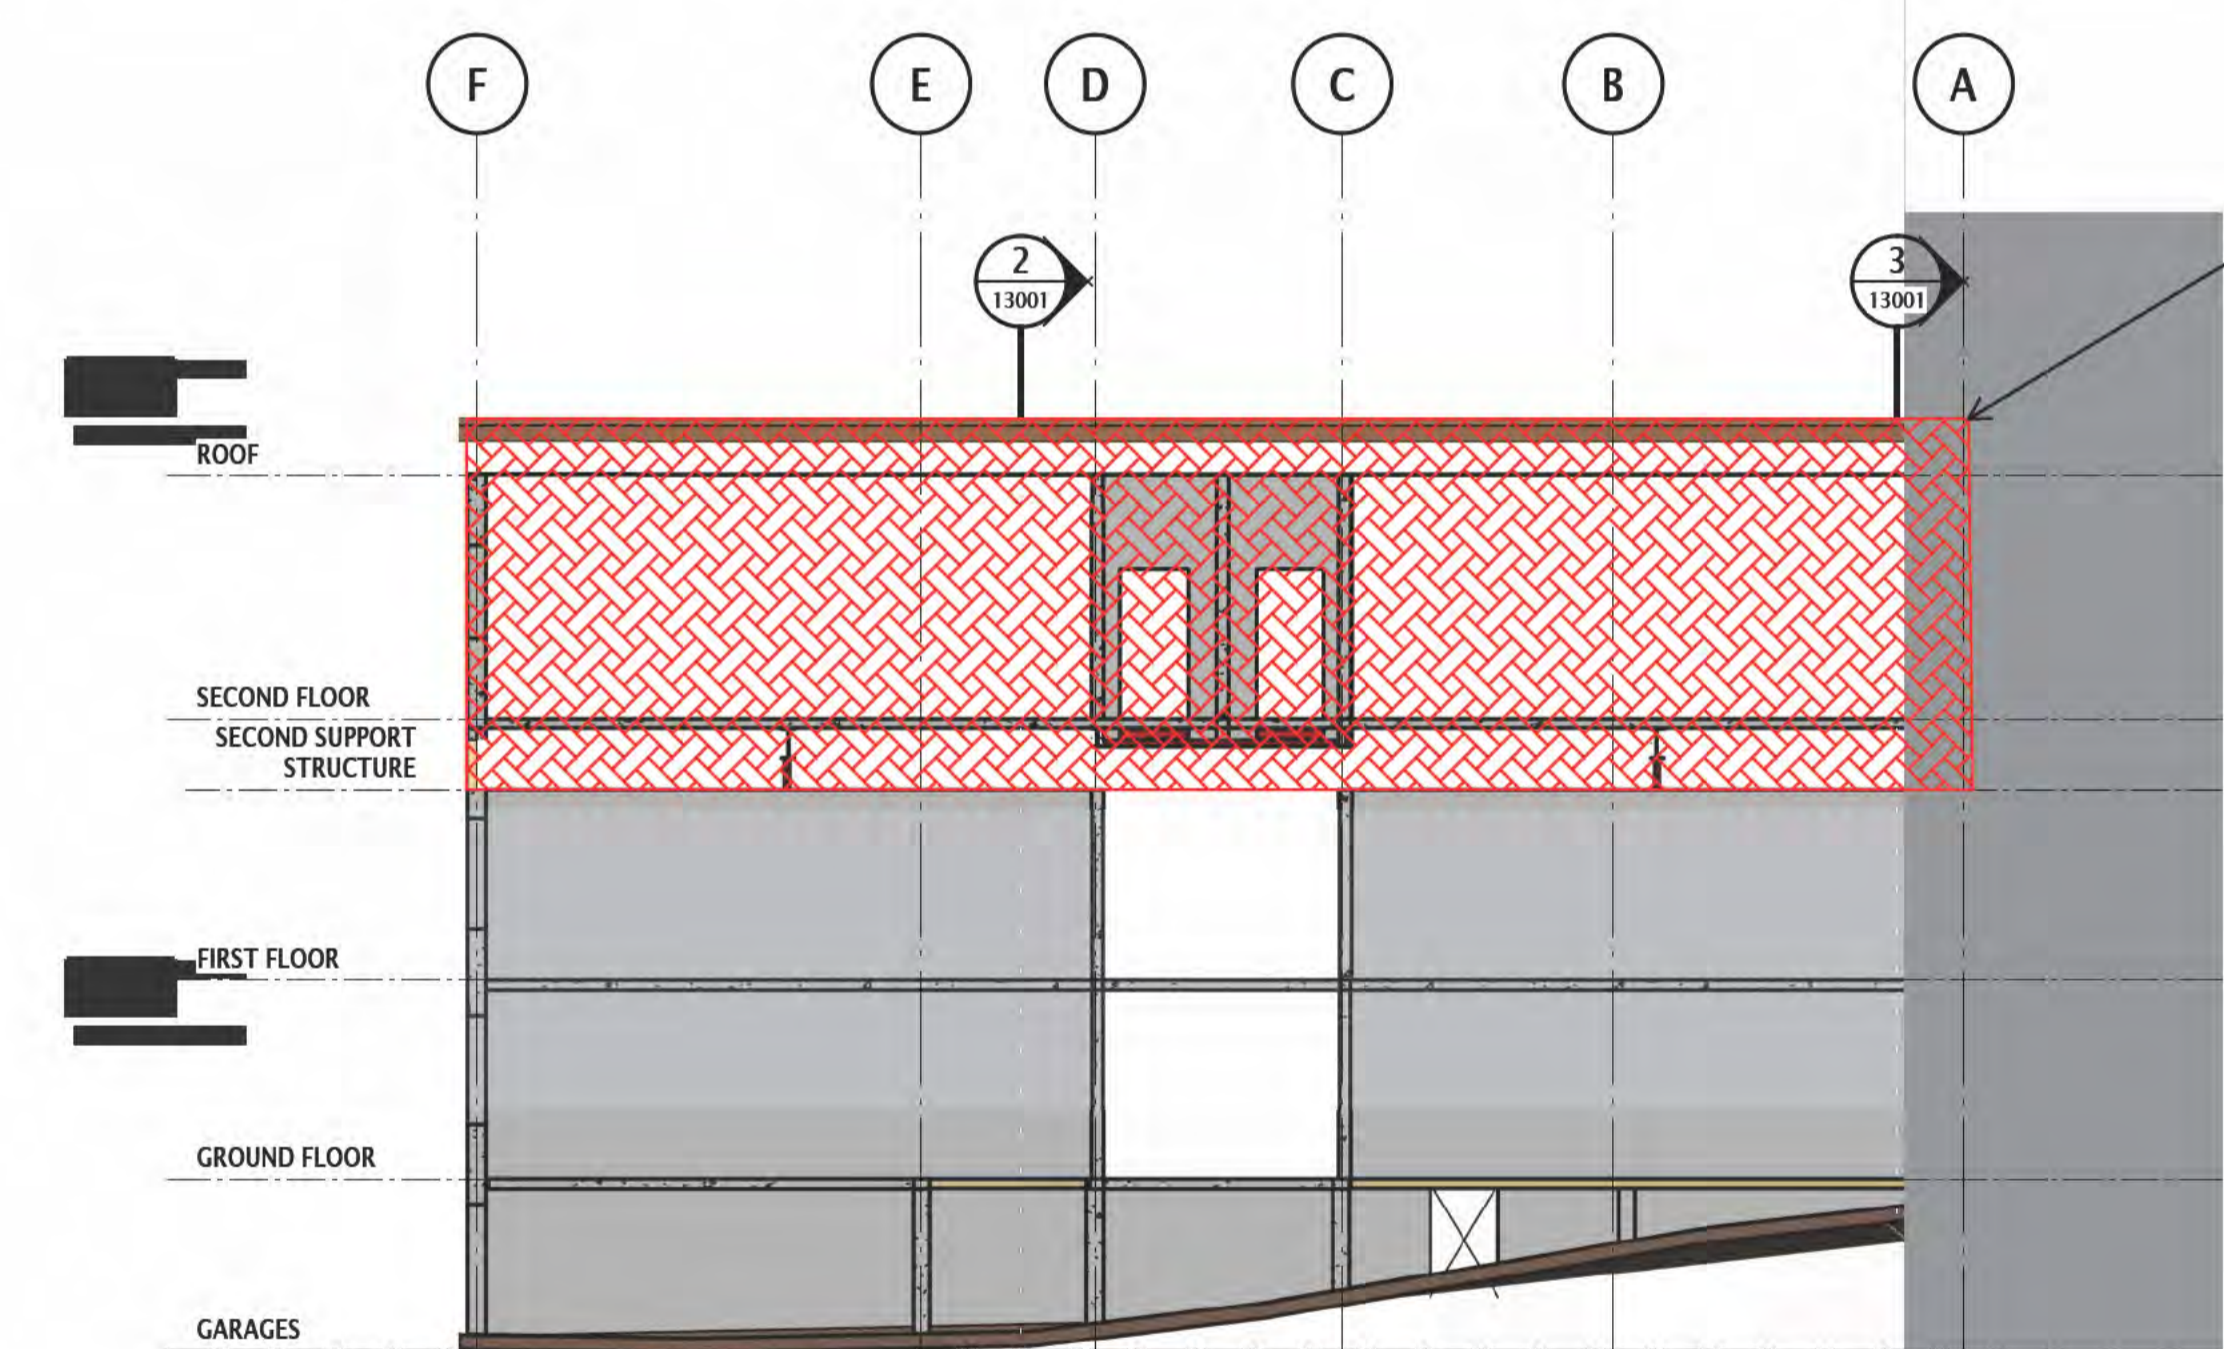
Drawing Number
N0541-WHAA-ZZ-SK-ST-00013

Demolish Second Floor and Supporting Structure
