**Silverdale Fire Station –  
147 Hibiscus Coast Road, Silverdale:  
Condition Assessment Report  
& Forward Maintenance Plan**

July 2012

## Executive Summary

**Date of Inspection:** 26 June 2012

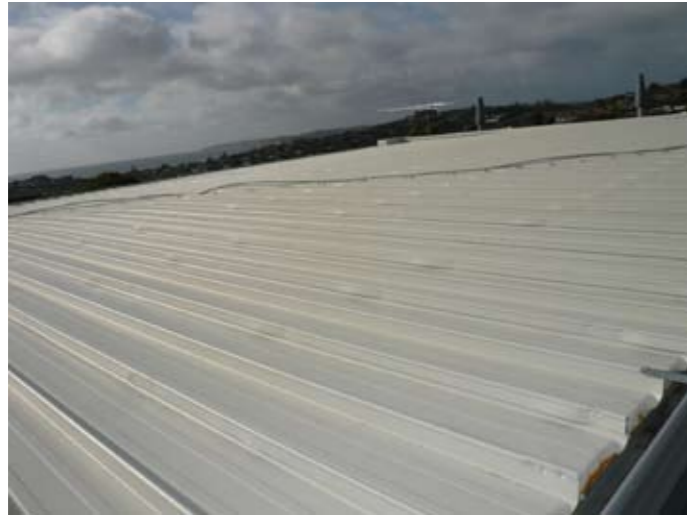
Photo 1

1.1.1	Profiled metal roofing	Roof likely to be original and is coming towards end of life - showing signs of corrosion. Staff have reported there were leaks in the past (refer 1.4.1 for resulting damage caused).	2	Allow to replace roof and set falls to comply with current code.	1	2		\$ 22,500												\$ 22,500

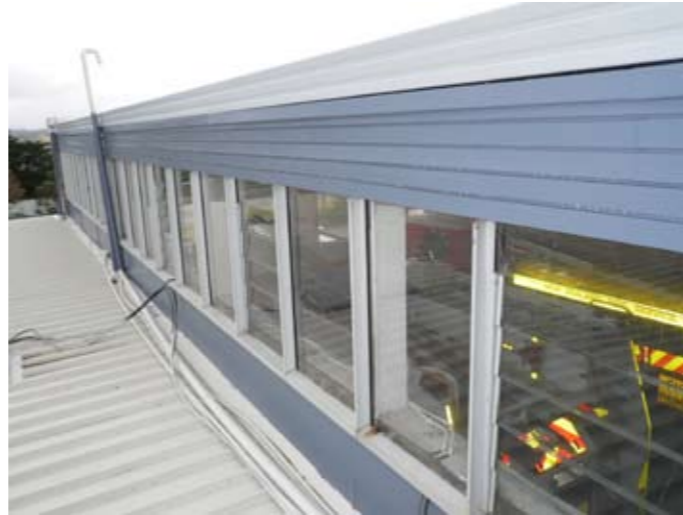
Photo 2

1.1.2	Perimeter metal box gutters	Gutters likely to be original and is coming towards end of life.	2	Allow to replace gutters and set falls to comply with current code.	2	2		\$ 3,600												\$ 3,600

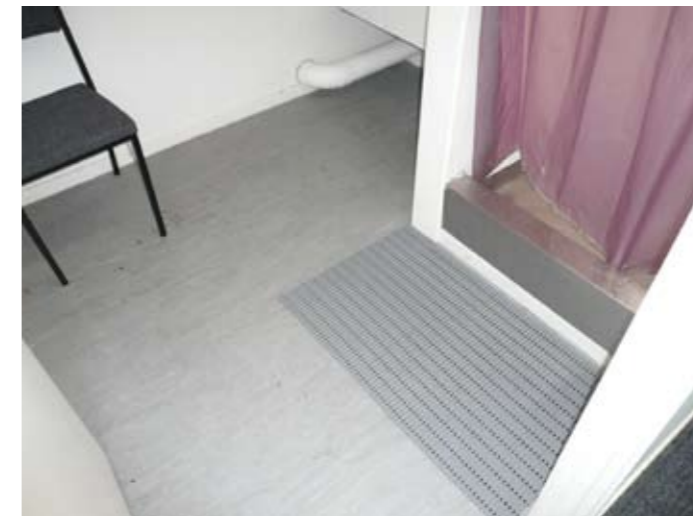
Photo 36

1.4.18	Floors	Vinyl.	2	No work required.	36	-		\$ -

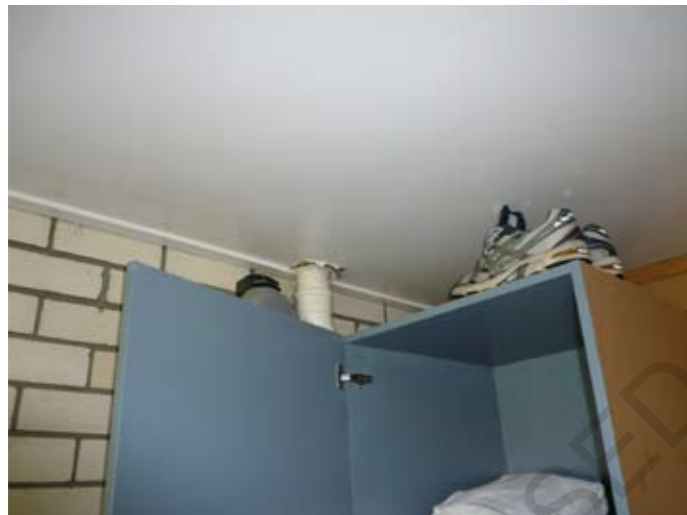
Photo 42

1.4.23	Walls	Painted plasterboard. And exposed brick. Random holes and damage noted on Southeast wall.	2	Repair damage and cyclical redecoration of all.	42	3		\$ 1,400	\$ 700										\$ 700

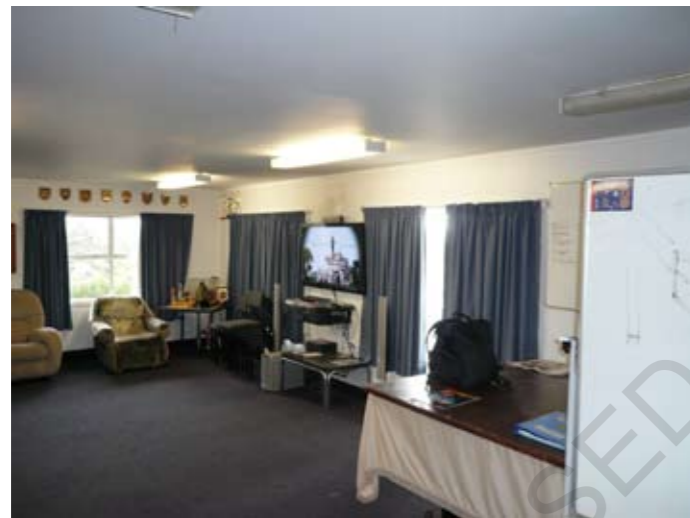
Photo 52

1.4.32	Walls	Painted plasterboard.	3	Cyclical redecoration.	52	3		\$ 1,050							\$ 1,050						
1.4.33	Ceilings	Exposed stained rafters and painted plasterboard.	4	Cyclical redecoration.	53	3		\$ 425							\$ 425

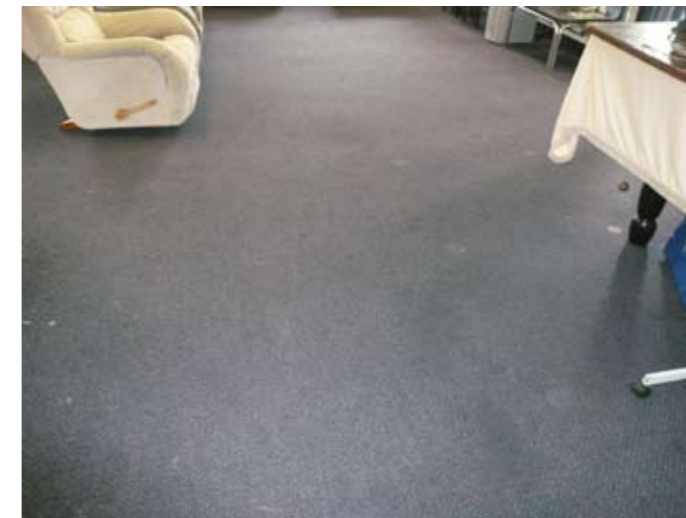
Photo 54

1.4.34	Floors	Carpet has come to end of life and requires replacement.	1	Allow to replace carpet immediately and cyclical replacement thereafter.	54	3		\$ 4,200							\$ 4,200

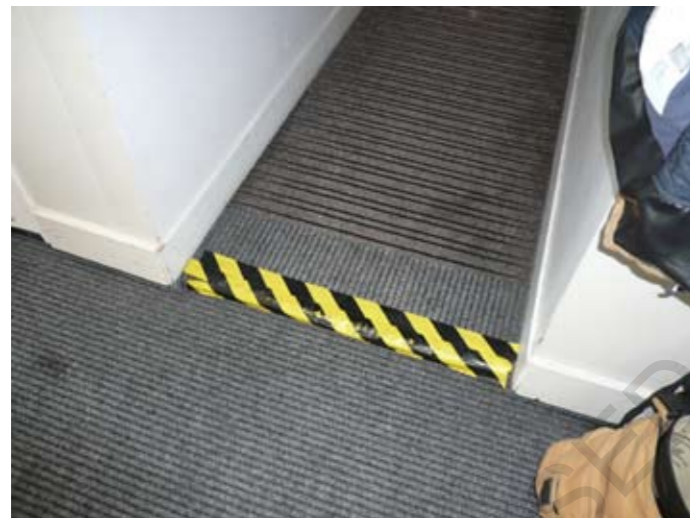
Photo 61

1.4.41	Floors	Carpet has come to end of life and requires replacement.	1	Allow to replace carpet immediately and cyclical replacement thereafter.	61	3		\$ 1,100								\$ 1,100					
<b>W.C.</b>

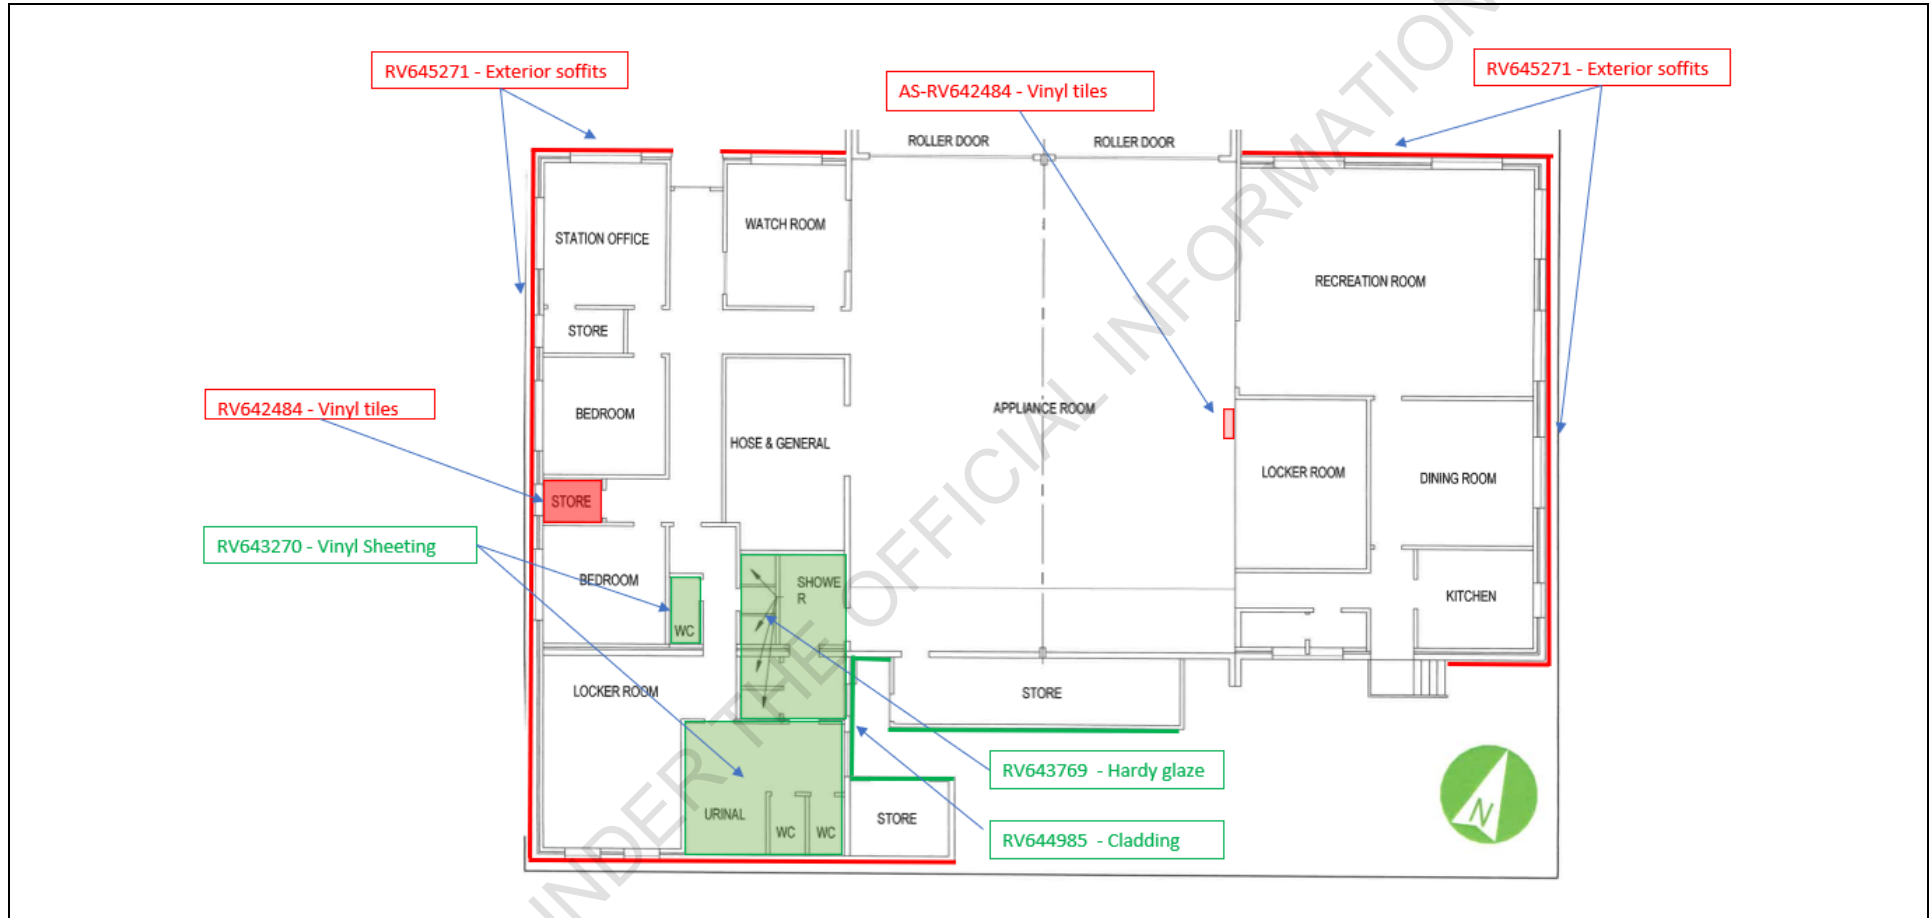
<p><b>Silverdale Fire Station</b> Ground Floor</p>

<table><tr style="background-color: red; color: white;"> <td>Asbestos Detected</td> </tr></table>

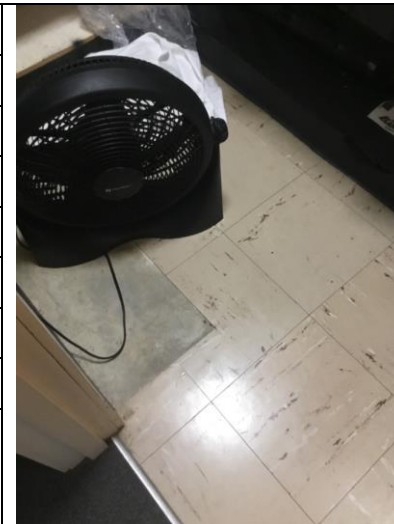
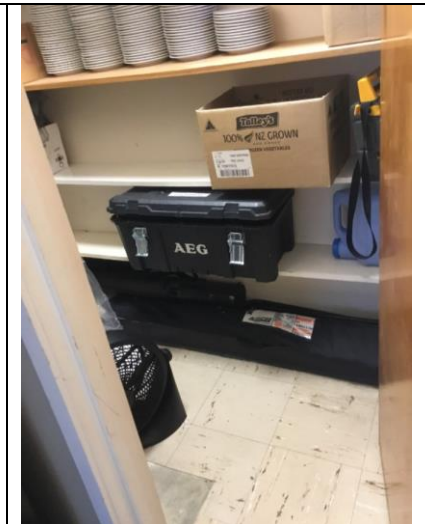
Reference Number	RV642484	Extent	4 m <sup>2</sup>
Date Identified	28 May 2020	Condition	Low damage
How Identified	Sampled	Friability	Non-friable
Surveyor Name	Ronaldo Vollenhoven	Accessibility	Accessible
Survey Address	149-153 Hibiscus Coast Highway, Te Hiku	Surface Treatment	Composite
Building	Silverdale Fire Station	Laboratory	Analytica Laboratories
Room	Bedroom 1 Store	Lab Test ID	RV642484
Floor	Ground floor	Test Result	Confirmed Asbestos RV642484
Item Location	Floor	Asbestos Type	Chrysotile
Product Type	Composite materials	Risk Assessment	8 - Low risk ACM

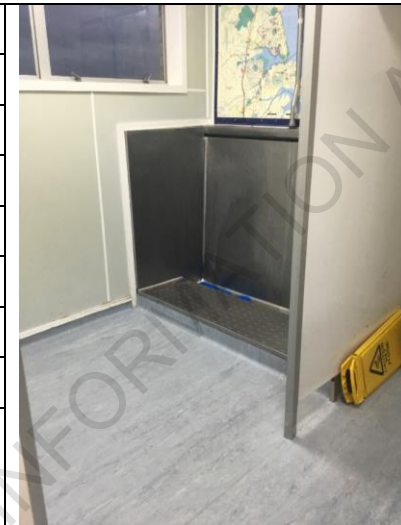
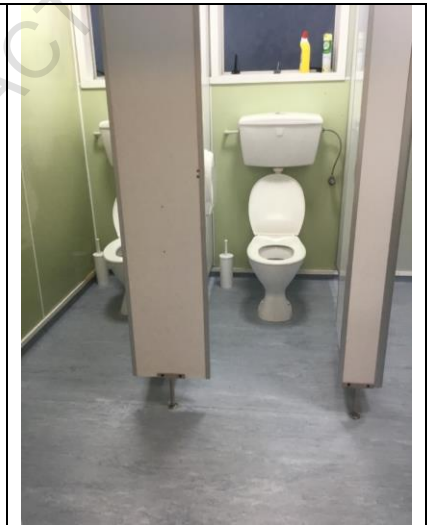
Reference Number	RV643769	Extent	25 m <sup>2</sup>
Date Identified	28 May 2020	Condition	Low damage
How Identified	Sampled	Friability	Non-friable
Surveyor Name	Ronaldo Vollenhoven	Accessibility	Accessible
Survey Address	149-153 Hibiscus Coast Highway, Te Hiku	Surface Treatment	Sealed
Building	Silverdale Fire Station	Laboratory	Analytica Laboratories
Room	Male shower Room	Lab Test ID	RV643769
Floor	Ground floor	Test Result	Not present (tested)
Item Location	Wall	Asbestos Type	No asbestos detected
Product Type	Cement products	Risk Assessment	N/A

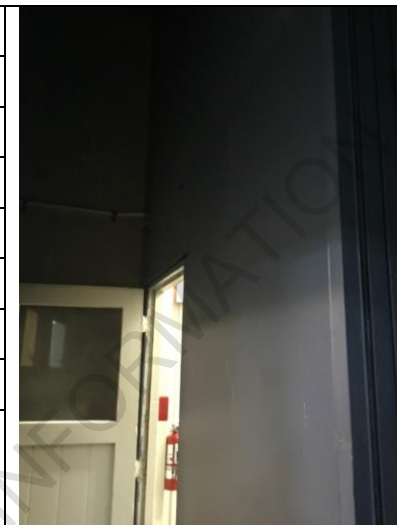
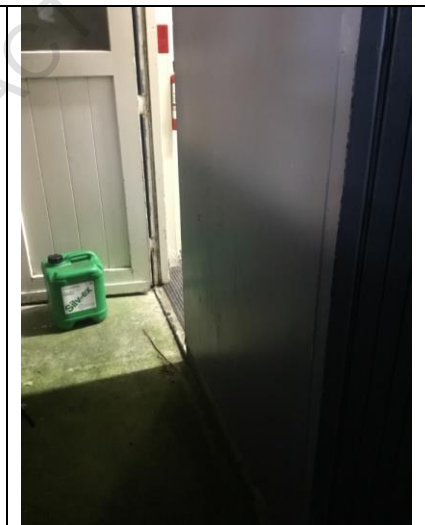
Reference Number	RV644985	Extent	N/A
Date Identified	28 May 2020	Condition	Low damage
How Identified	Sampled	Friability	Non-friable
Surveyor Name	Ronaldo Vollenhoven	Accessibility	Accessible
Survey Address	149-153 Hibiscus Coast Highway, Te Hiku	Surface Treatment	Sealed
Building	Silverdale Fire Station	Laboratory	Analytica Laboratories
Room	Southern exterior elevation	Lab Test ID	RV644985
Floor	Ground floor	Test Result	Not present (tested)
Item Location	Walls	Asbestos Type	No asbestos detected
Product Type	Cement products	Risk Assessment	N/A

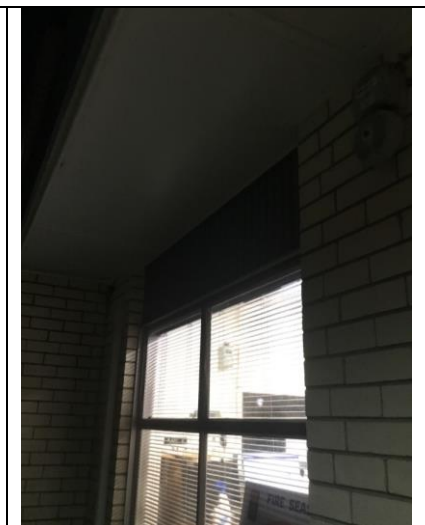
Reference Number	RV645271	Extent	40 m <sup>2</sup>
Date Identified	28 May 2020	Condition	Low damage
How Identified	Sampled	Friability	Non-friable
Surveyor Name	Ronaldo Vollenhoven	Accessibility	Accessible
Survey Address	149-153 Hibiscus Coast Highway, Te Hiku	Surface Treatment	Sealed
Building	Silverdale Fire Station	Laboratory	Analytica Laboratories
Room	Soffit linings	Lab Test ID	RV645271
Floor	Ground floor	Test Result	Confirmed Asbestos RV645271
Item Location	Exterior Sides	Asbestos Type	Chrysotile Crocidolite
Product Type	Cement products	Risk Assessment	10 - Medium risk ACM
