**Manly Fire Station –
Whangaporoa Road, Manly:
Condition Assessment Report
& Forward Maintenance Plan**

REVISED March 2013

Manly Fire Station : Forward Maintenance Plan

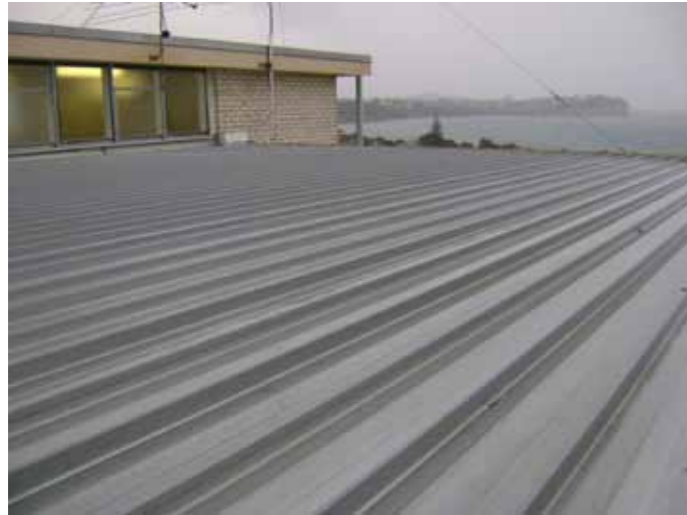
Photo 1

1.1	Roofs																					
	Roof A - Appliance Bay																					
1.1.1	Profiled galvanised metal roofing	Roof in serviceable condition. Roof fall does not comply with current code.	3	Allow to replace roof and set falls to comply with current code at end of serviceable life.	1	2	C	\$ 13,500														\$ 13,500

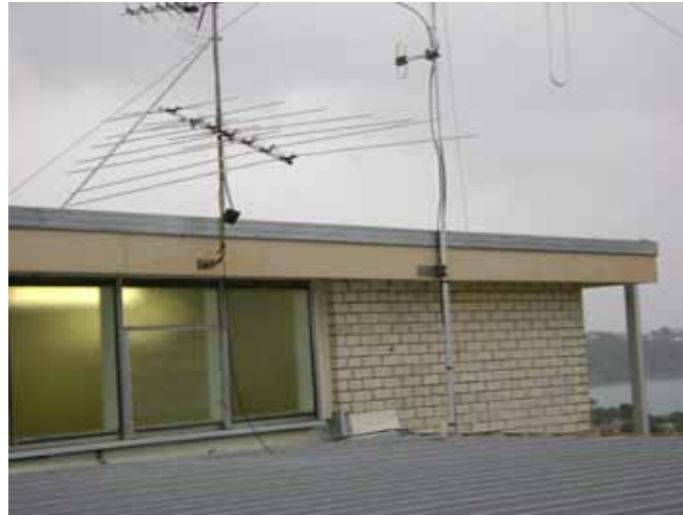
Photo 2

1.1.2	Profiled galvanised barge flashing	In serviceable condition.	3	Allow to replace at end of serviceable life.		2		\$ 3,900														\$ 3,900
1.1.3	Aerial and associated fixings	In a serviceable condition.	3	No action required.	2	-		\$ -

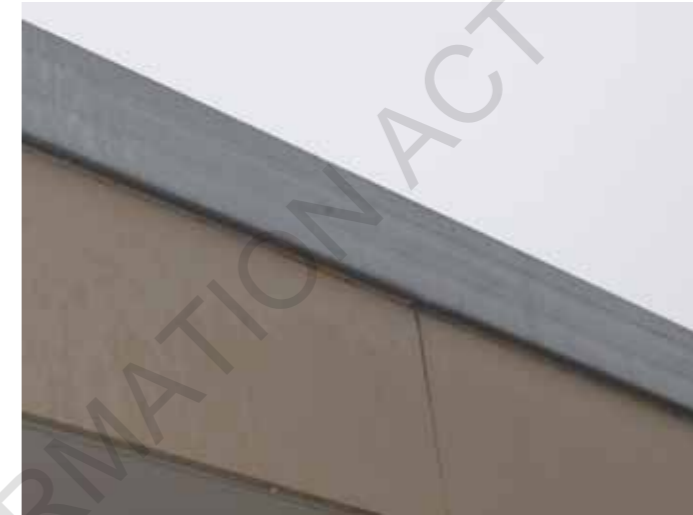
Photo 3

1.1.4	Metal box gutters	In a serviceable condition.	3	Allow to replace at end of serviceable life.		3		\$ 3,900														\$ 3,900
1.1.5	Compressed sheet fascia boards	In serviceable condition.	4	Re-finish during normal routine maintenance period.	3	3		\$ 780						\$ 780

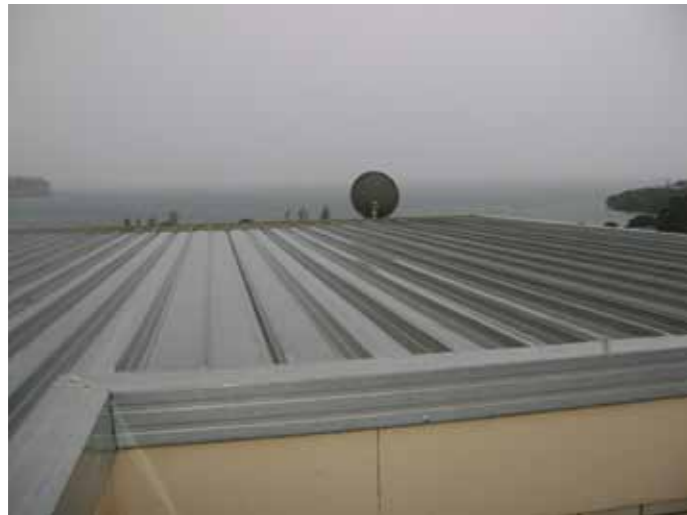
Photo 4

1.1.8	Profiled galvanised barge flashing	In serviceable condition.	3	Allow to replace at end of serviceable life.		2		\$ 3,450														\$ 3,450
1.1.9	Metal box gutters	In a serviceable condition.	3	Allow to replace at end of serviceable life.	4	3		\$ 3,450														\$ 3,450

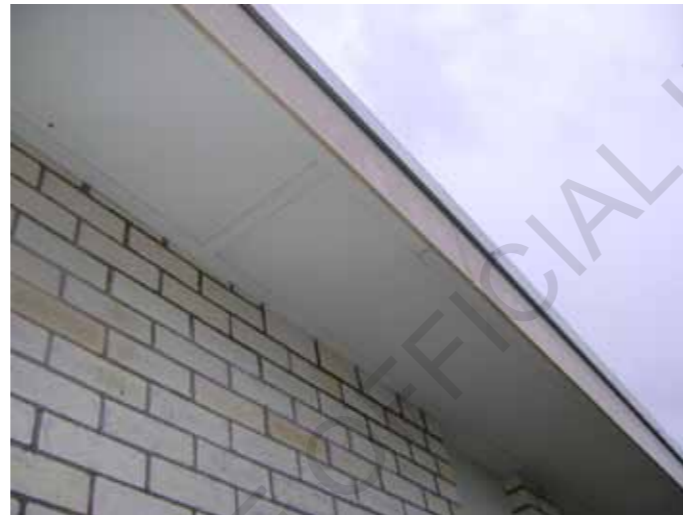
Photo 5

1.1.10	Compressed sheet fascia boards	In serviceable condition.	4	Re-finish during normal routine maintenance period.		3		\$ 850						\$ 850								
1.1.11	Soffits	In a serviceable condition. Will deteriorate over time.	4	Re-finish during normal routine maintenance period.	5	3		\$ 850						\$ 850

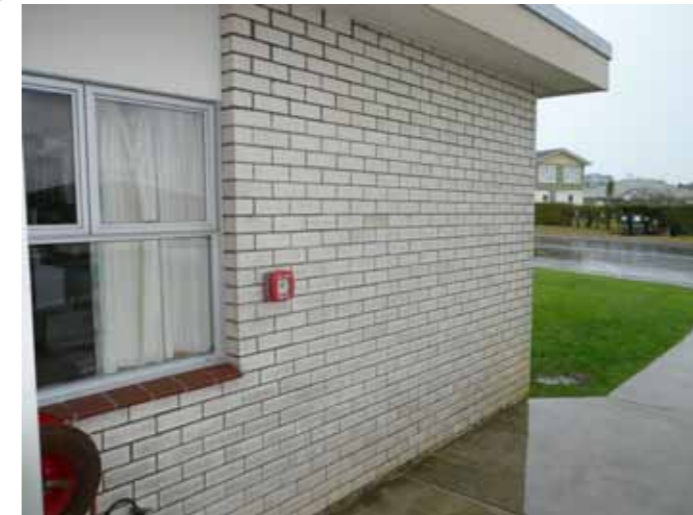
Photo 6

1.2	External Elevations																					
1.2.1	Brick faced walls	Brickwork and pointing in serviceable condition.	4	No work required.	6	-		\$ -

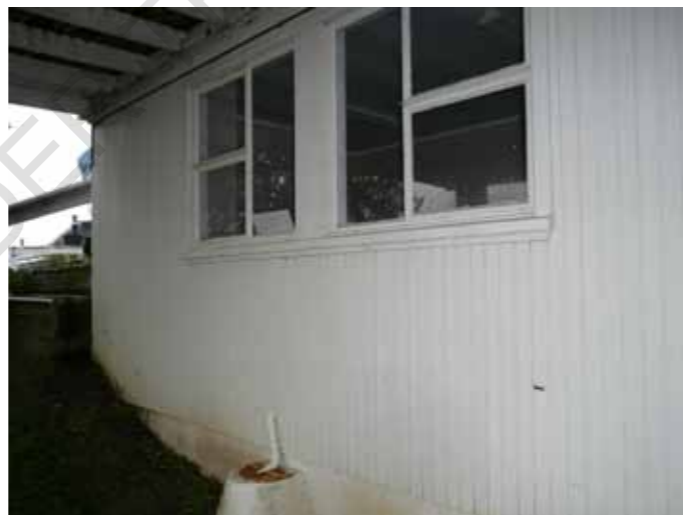
Photo 8

- The wall to the north east corner is buried increasing its susceptibility to rot. Further investigation required.

1.2.4	Vertical timber weatherboard type cladding at ground level under deck.	Base of the cladding at the North eastern corner is buried which makes it susceptible to rot.	2	Further investigation required. Provisional Sum for repairs in year 1.	8	2		\$ 10,750	\$ 2,250	\$ 8,500

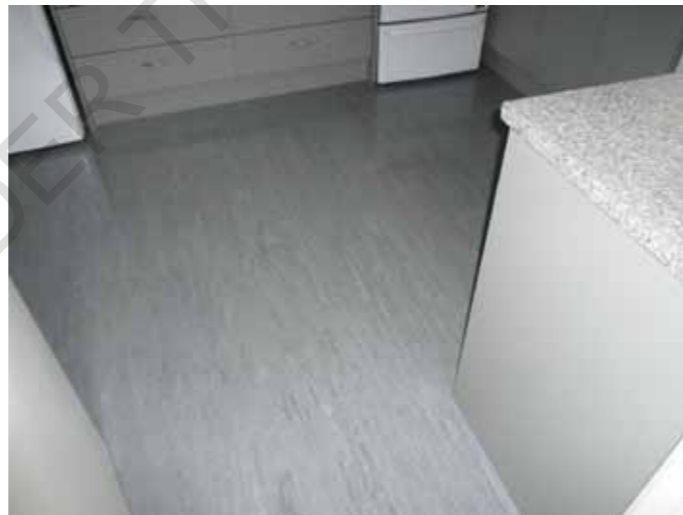
Photo 26

1.4.12	Floors	Vinyl.	4	Cyclical replacement.	26	3		\$ 1,850															
1.4.13	Built in cabinets and high-pressure laminate bench top	Cabinets and bench top appear to have been replaced in recent times and are in good condition.	4	Allow for replacement of cabinets and bench top at end of serviceable life.	27	2		\$ 350

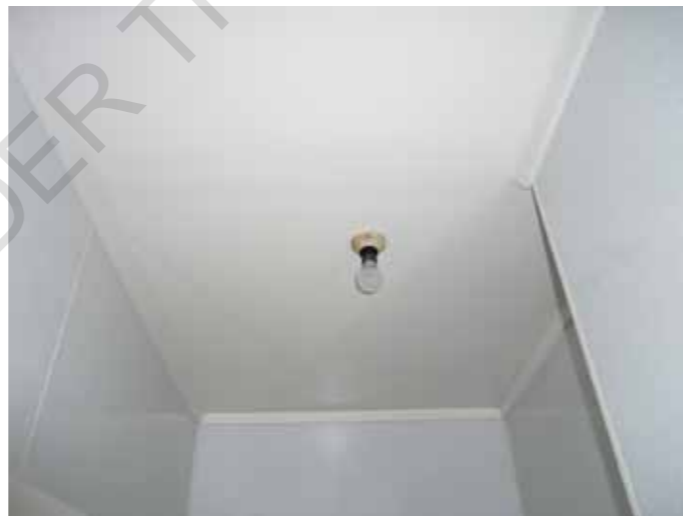
Photo 35

1.4.22	Ceilings	Painted plasterboard.	4	Cyclical redecoration.	35	3		\$ 300								\$ 300					
1.4.23	Floors	Vinyl.	4	Cyclical replacement.	36	3		\$ 1,100								\$ 1,100

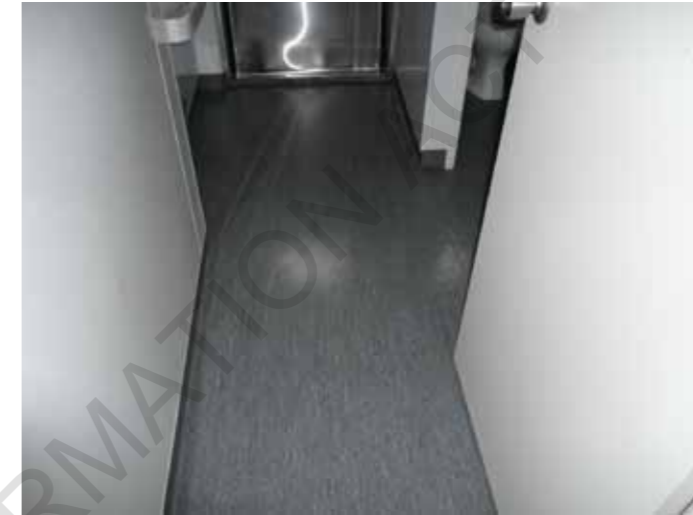
Photo 39

1.4.26	Floors	Vinyl.	4	Cyclical replacement.	39	3		\$ 1,200								\$ 1,200					
1.4.27	Shower Unit	In serviceable condition.	4	Allow to replace at end of serviceable life.	40	2		\$ -													
Laundry/Storage

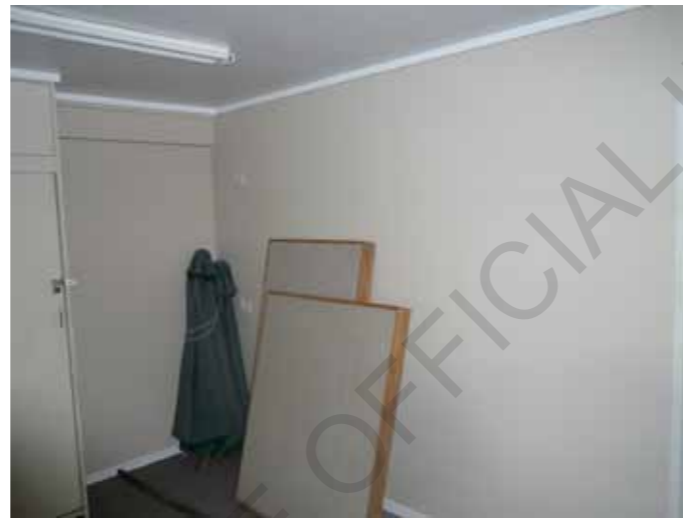
Photo 41

1.4.28	Walls	Painted plasterboard and plastered and painted concrete block. Concrete block walls are showing signs of deterioration and require refinishing.	2	Refinish concrete block walls and cyclical redecoration for all thereafter.	41	3		\$ 450	\$ 450

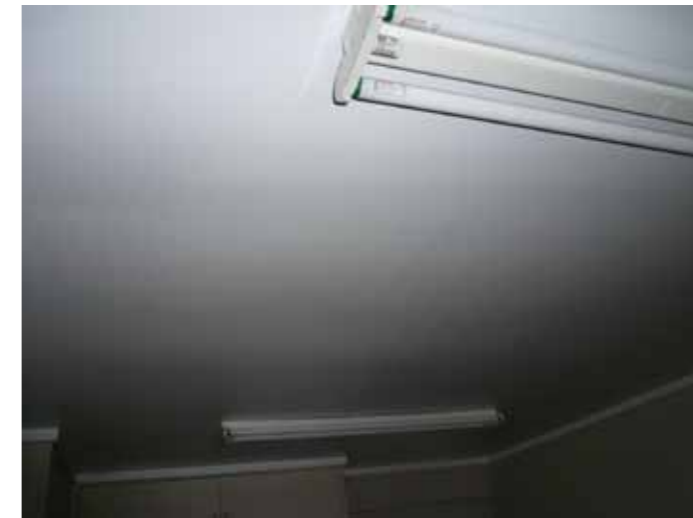
Photo 42

1.4.29	Ceilings	Painted plasterboard.	4	Cyclical redecoration.	42	3		\$ 200	\$ 200												
1.4.30	Floors	Carpet is nearing end of life and will soon require replacement.	2	Allow to replace carpet and cyclical replacement thereafter.	43	3		\$ 1,125	\$ 1,125												
Shower room/Storage

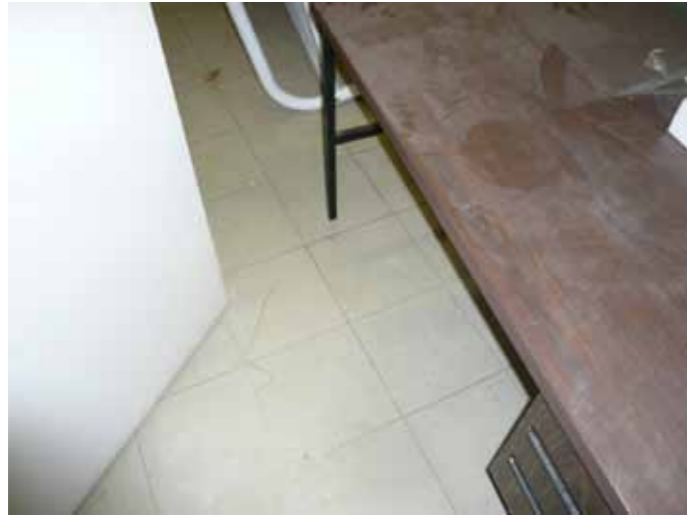
Photo 46

1.4.33	Floors	Vinyl.	2	Cyclical replacement.	46	3		\$ 1,250									\$ 1,250

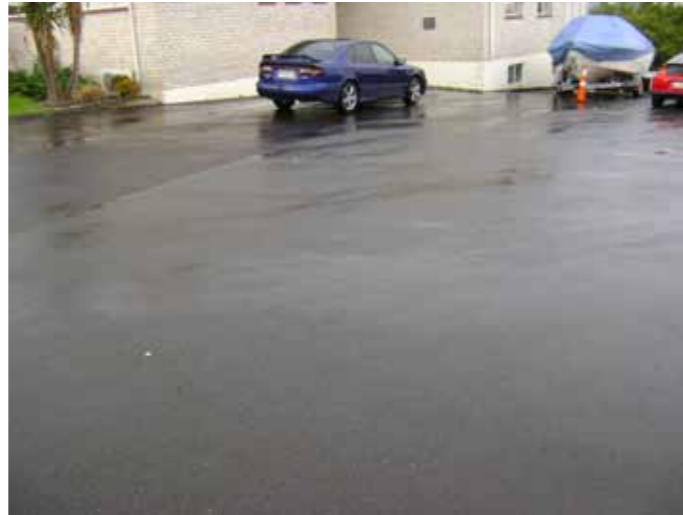
Photo 47

1.5.1	Asphalt yard area	Asphalt yard/parking area serviceable condition.	4	No work required.	47	-		\$ -													
1.5.2	Concrete driveway	Appears to have been replaced in recent times and so in good condition.	4	No work required.	48	-		\$ -													
2 Building Services

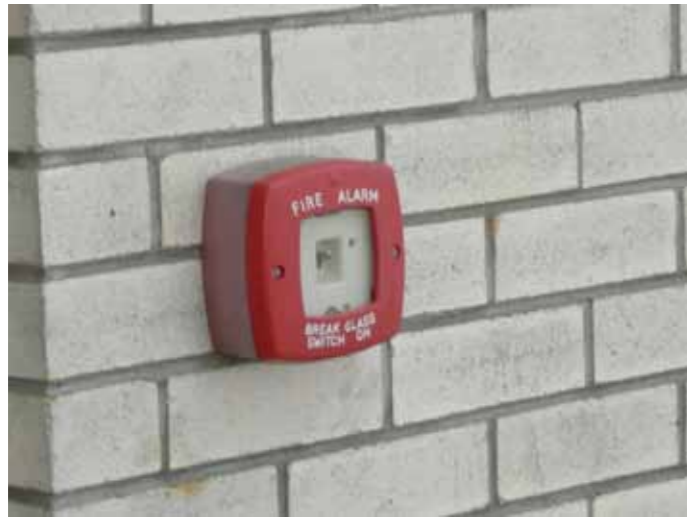
Photo 49

2.2.2	Fire Alarm System	Visually in a serviceable condition.	-	Annual test and inspection.	49	2		\$ -													
2.2.3	Sectional appliance bay door openers	Visually in a serviceable condition.	-	Annual test and inspection.	-	2		\$ -

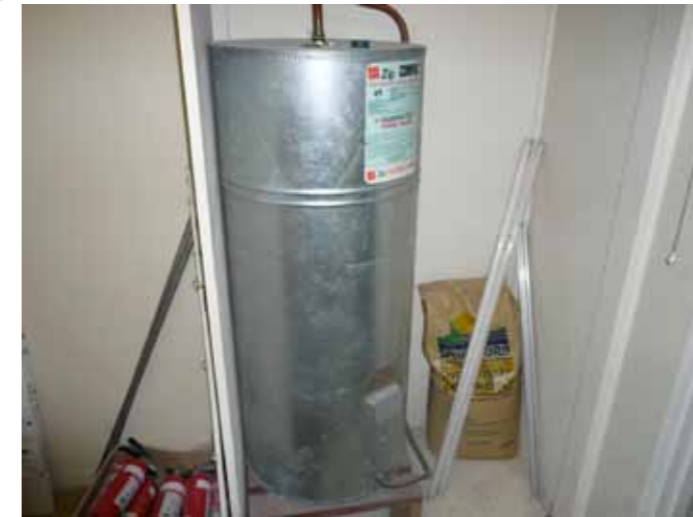
Photo 51

2.2 Hydraulic Services																					
2.2.1	Foul water systems	No reported defects.	-	No work required.	-	-		\$ -													
2.2.2	Hot water cylinder	No seismic restraint to hot water cylinder.	-	Install seismic restraint.	51	2	X	\$ 100	\$ 100

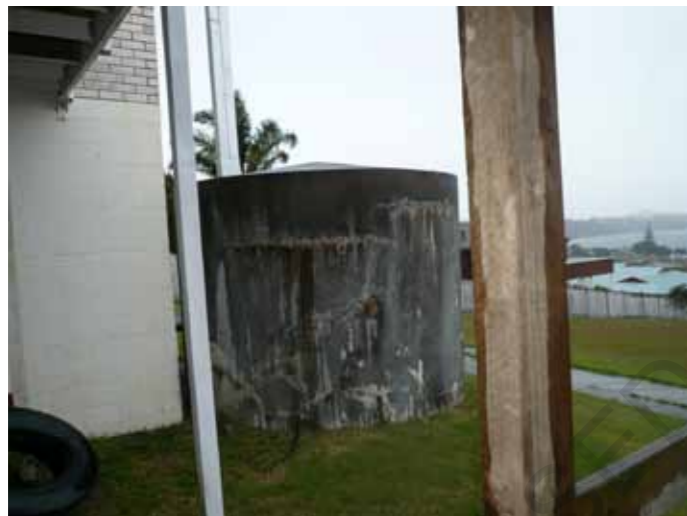
Photo 52

2.2.3	Rainwater Harvesting	Concrete water tank appears to be in poor condition with visible cracks.	-	Replace water tank.	52	1		\$ -													
2.2.4	Sanitary ware	Visually in a serviceable condition.	-	No work required.	-	-		\$ -													
Total																					
								\$ 104,150	\$ 4,125	\$ 8,500	\$ -	\$ -	\$ -	\$ 3,260	\$ 25,990	\$ 8,775	\$ -	\$ -	\$ 53,500

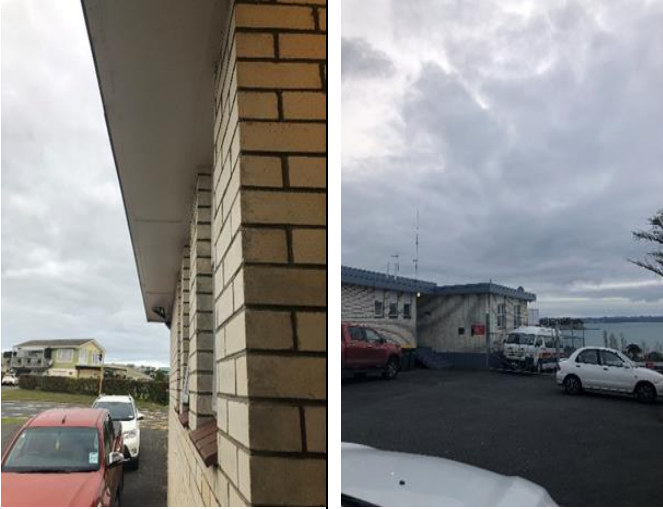
Manly Fire Station	Ground floor	Exterior soffits (RV379478)	8 – Low Risk ACM	<p><u>Manage & re-inspect periodically</u></p> <p>Leave in place & manage. Finish of material to be monitored and maintained.</p> <ul style="list-style-type: none"> • Never sand, grind or waterblast the material. • Cutting or drilling of the material must be performed in a controlled way (see the 'Asbestos Regulations', Clause 18) to prevent possible fibre release. • Workers (PCBUs) undertaking work that disturbs this material should do so in accordance with Worksafe's 'ACOP for the Management & Removal of Asbestos'. • Re-inspect condition 3-yearly. 	Every 3 years – March 2023	<p>Low risk ACM. Exterior location. Material has low damage, with a very low chance of disturbance. Activities such as light cleaning, or painting are permitted.</p> <p>Fibre cement sheet.</p>

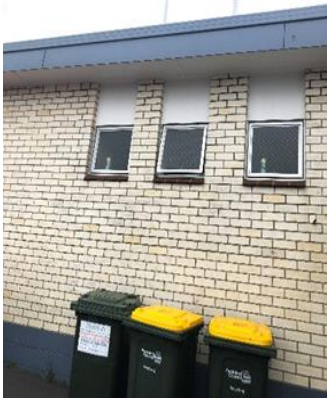
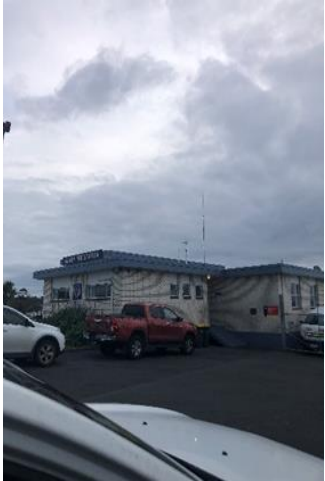
Manly Fire Station	Ground floor	Exterior fascia boards (Presumed)	8 – Low Risk ACM	<p><u>Manage & re-inspect periodically</u></p> <p>Leave in place & manage. Finish of material to be monitored and maintained.</p> <ul style="list-style-type: none"> • Never sand, grind or waterblast the material. • Cutting or drilling of the material must be performed in a controlled way (see the 'Asbestos Regulations', Clause 18) to prevent possible fibre release. • Workers (PCBUs) undertaking work that disturbs this material should do so in accordance with Worksafe's 'ACOP for the Management & Removal of Asbestos'. • Re-inspect condition 3-yearly. 	Every 3 years – March 2023	<p>Low risk ACM. Exterior location. Material has low damage, with a very low chance of disturbance. Activities such as light cleaning, or painting are permitted.</p> <p>Fibre cement sheet.</p>

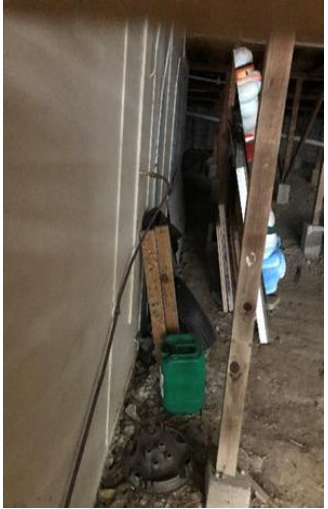
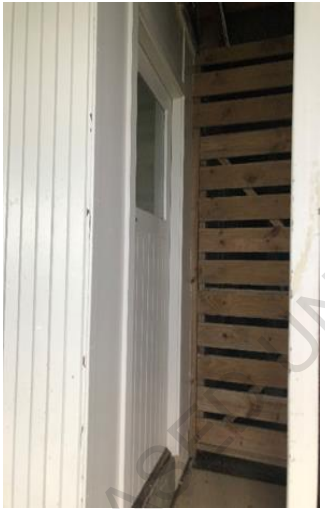
Manly Fire Station	Ground floor	Baseboard cladding (RV379955)	9 - Medium risk ACM	<p><u>Manage & re-inspect periodically</u></p> <p>Leave in place & manage. Finish of material to be monitored and maintained.</p> <ul style="list-style-type: none"> • Never sand, grind or waterblast the material. • Cutting or drilling of the material must be performed in a controlled way (see the 'Asbestos Regulations', Clause 18) to prevent possible fibre release. • Workers (PCBUs) undertaking work that disturbs this material should do so in accordance with Worksafe's 'ACOP for the 	Every 3 years – March 2023	<p>Exterior location. Material has low damage, with a very low chance of disturbance. Activities such as light cleaning, or painting are permitted.</p> <p>Fibre cement sheet.</p>

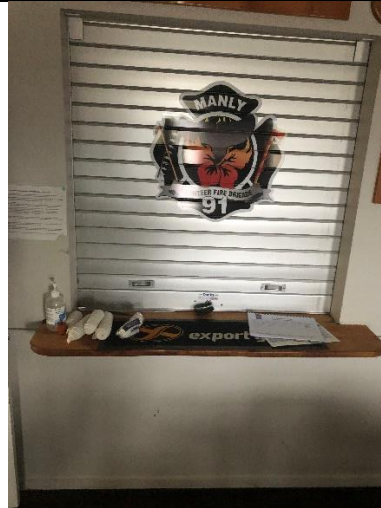
Date Identified	05 Mar 2020	Condition	N/A		
How Identified	N/A	Friability	N/A		
Surveyor Name	Ronaldo Vollenhoven	Accessibility	Accessible		
Survey Address	960 Whangaparaoa Road, Manly, Te Hiku	Surface Treatment	N/A		
Building	Manly Fire Station	Laboratory	Analytica Laboratories		
Room	Kitchen	Lab Test ID	N/A		
Floor	Ground floor	Test Result	Not present (Not Tested)		
Item Location	No suspect materials found	Asbestos Type	N/A		
Product Type	N/A	Risk Assessment	N/A

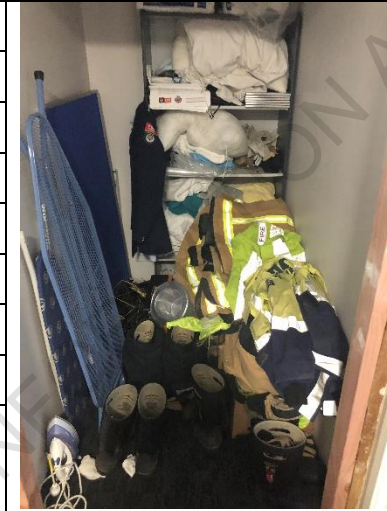
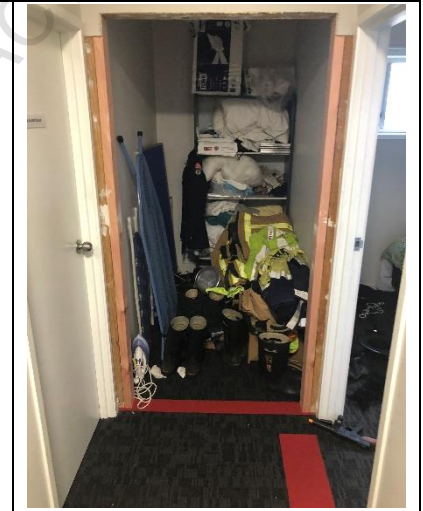
Reference Number	N/A	Extent	N/A
Date Identified	05 Mar 2020	Condition	N/A
How Identified	N/A	Friability	N/A
Surveyor Name	Ronaldo Vollenhoven	Accessibility	Accessible
Survey Address	960 Whangaparaoa Road, Manly, Te Hiku	Surface Treatment	N/A
Building	Manly Fire Station	Laboratory	Analytica Laboratories
Room	Laundry	Lab Test ID	N/A
Floor	Ground floor	Test Result	Not present (Not Tested)
Item Location	No suspect materials found	Asbestos Type	N/A
Product Type	N/A	Risk Assessment	N/A

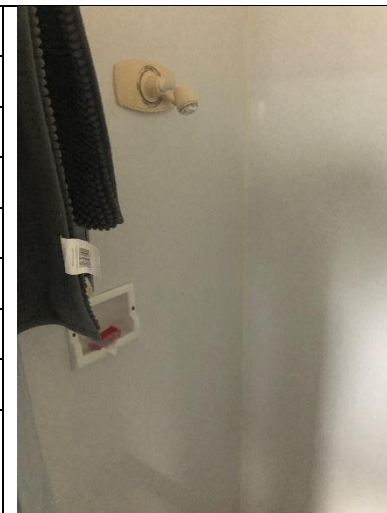
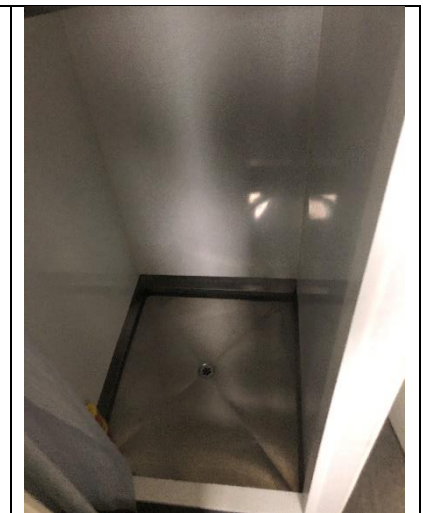
Reference Number	N/A	Extent	N/A
Date Identified	05 Mar 2020	Condition	N/A
How Identified	N/A	Friability	N/A
Surveyor Name	Ronaldo Vollenhoven	Accessibility	Accessible
Survey Address	960 Whangaparaoa Road, Manly, Te Hiku	Surface Treatment	N/A
Building	Manly Fire Station	Laboratory	Analytica Laboratories
Room	Shower room	Lab Test ID	N/A
Floor	Ground floor	Test Result	Not present (Not Tested)
Item Location	No suspect materials found	Asbestos Type	N/A
Product Type	N/A	Risk Assessment	N/A

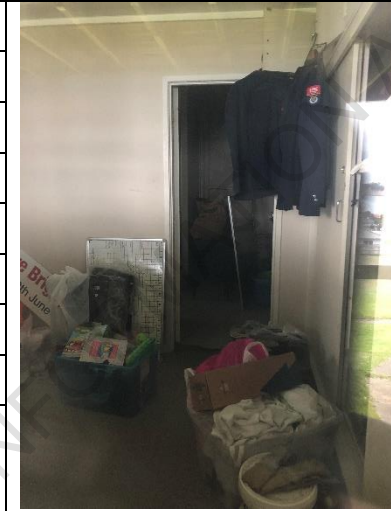
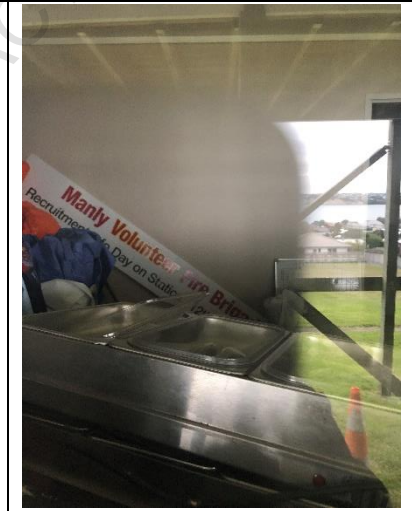
Reference Number	N/A	Extent	N/A
Date Identified	05 Mar 2020	Condition	N/A
How Identified	N/A	Friability	N/A
Surveyor Name	Ronaldo Vollenhoven	Accessibility	Accessible
Survey Address	960 Whangaparaoa Road, Manly, Te Hiku	Surface Treatment	N/A
Building	Manly Fire Station	Laboratory	Analytica Laboratories
Room	Subfloor training room	Lab Test ID	N/A
Floor	Ground floor	Test Result	Not present (Not Tested)
Item Location	No suspect materials found	Asbestos Type	N/A
Product Type	N/A	Risk Assessment	N/A

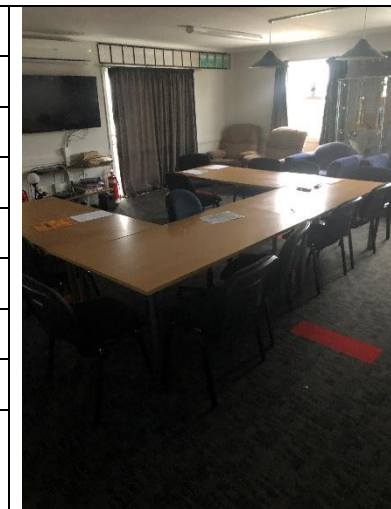
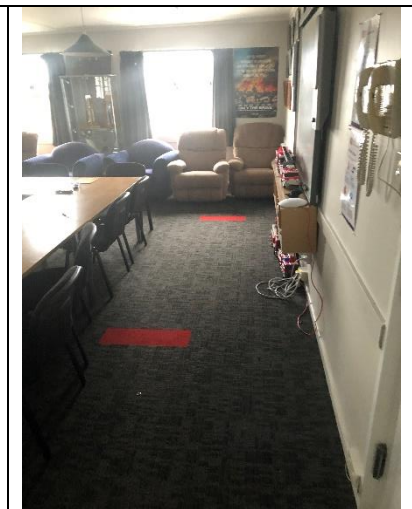
Reference Number	N/A	Extent	N/A
Date Identified	05 Mar 2020	Condition	N/A
How Identified	N/A	Friability	N/A
Surveyor Name	Ronaldo Vollenhoven	Accessibility	Accessible
Survey Address	960 Whangaparaoa Road, Manly, Te Hiku	Surface Treatment	N/A
Building	Manly Fire Station	Laboratory	Analytica Laboratories
Room	Meeting room	Lab Test ID	N/A
Floor	Ground floor	Test Result	Not present (Not Tested)
Item Location	No suspect materials found	Asbestos Type	N/A
Product Type	N/A	Risk Assessment	N/A
