**OFFICIAL INFORMATION REQUEST: FIBRE OPTIC INSPECTION SYSTEM (REF: 3610)**

# Motueka Wastewater I&I Assessment Using Distributed Temperature Sensing

Goodman Park Pump Station Catchment  
Final Report

30<sup>th</sup> April 2024

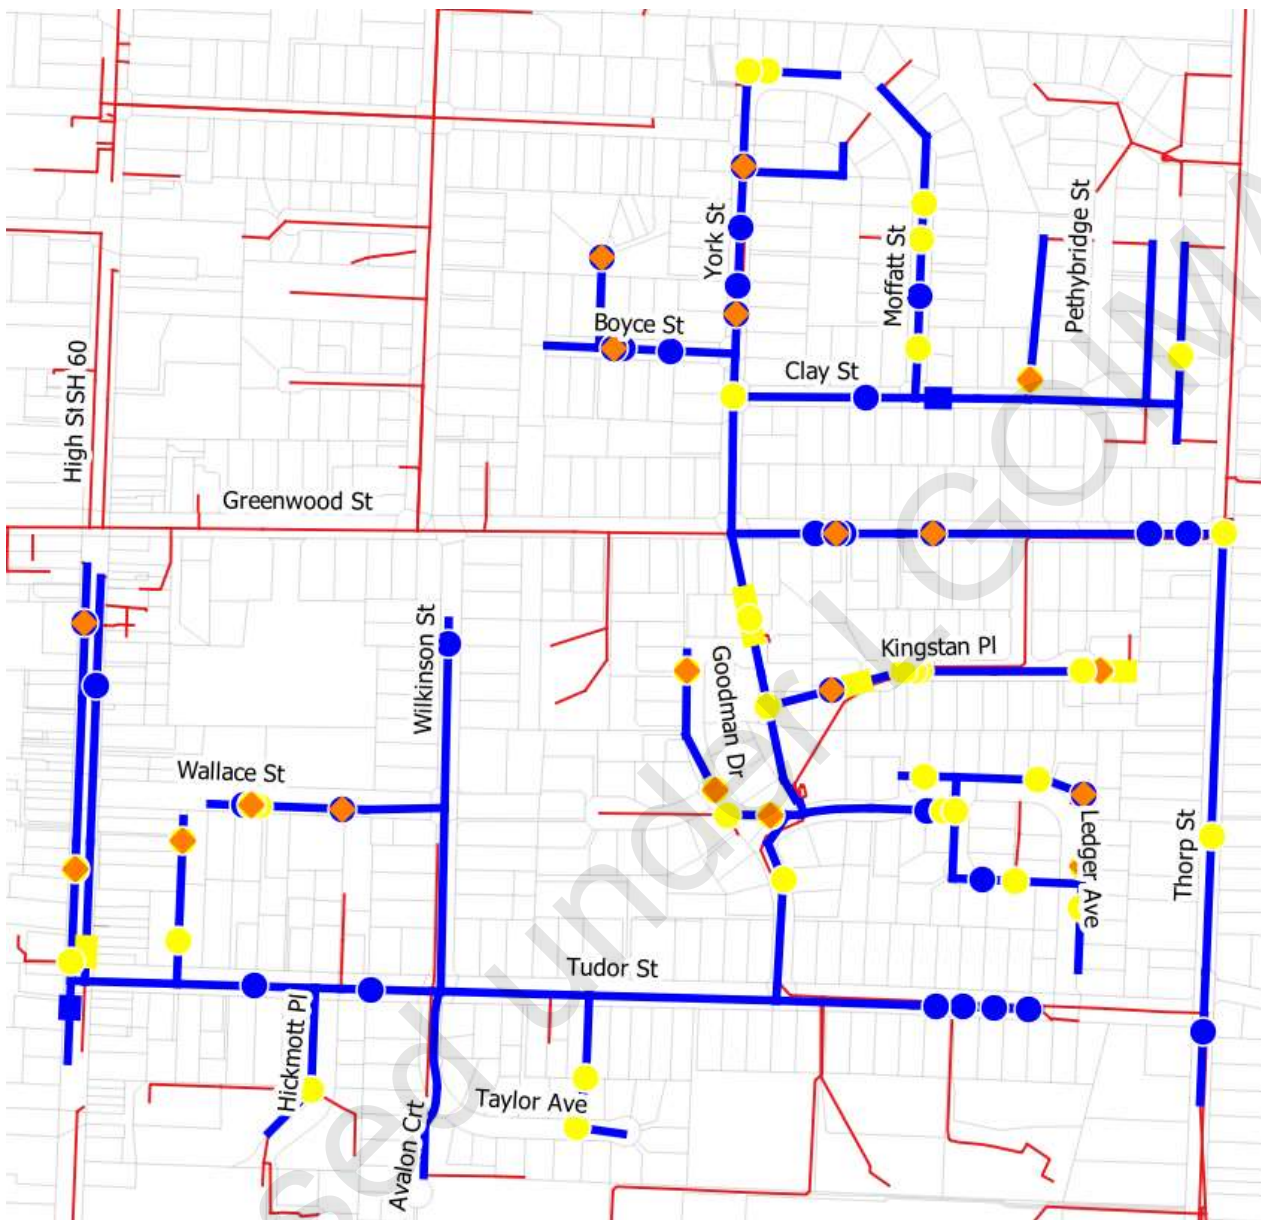
Figure 8-1 Graphical Summary of DTS Results

- 31 stormwater inflow sources.
- 2 combined stormwater inflow and rain dependent infiltration source.
- 26 groundwater infiltration sources.
- 7 combined stormwater inflow and groundwater infiltration sources.
- 5 combined rain dependent infiltration and groundwater infiltration sources.
- 4 combined stormwater inflow, rain dependent infiltration and groundwater infiltration sources.

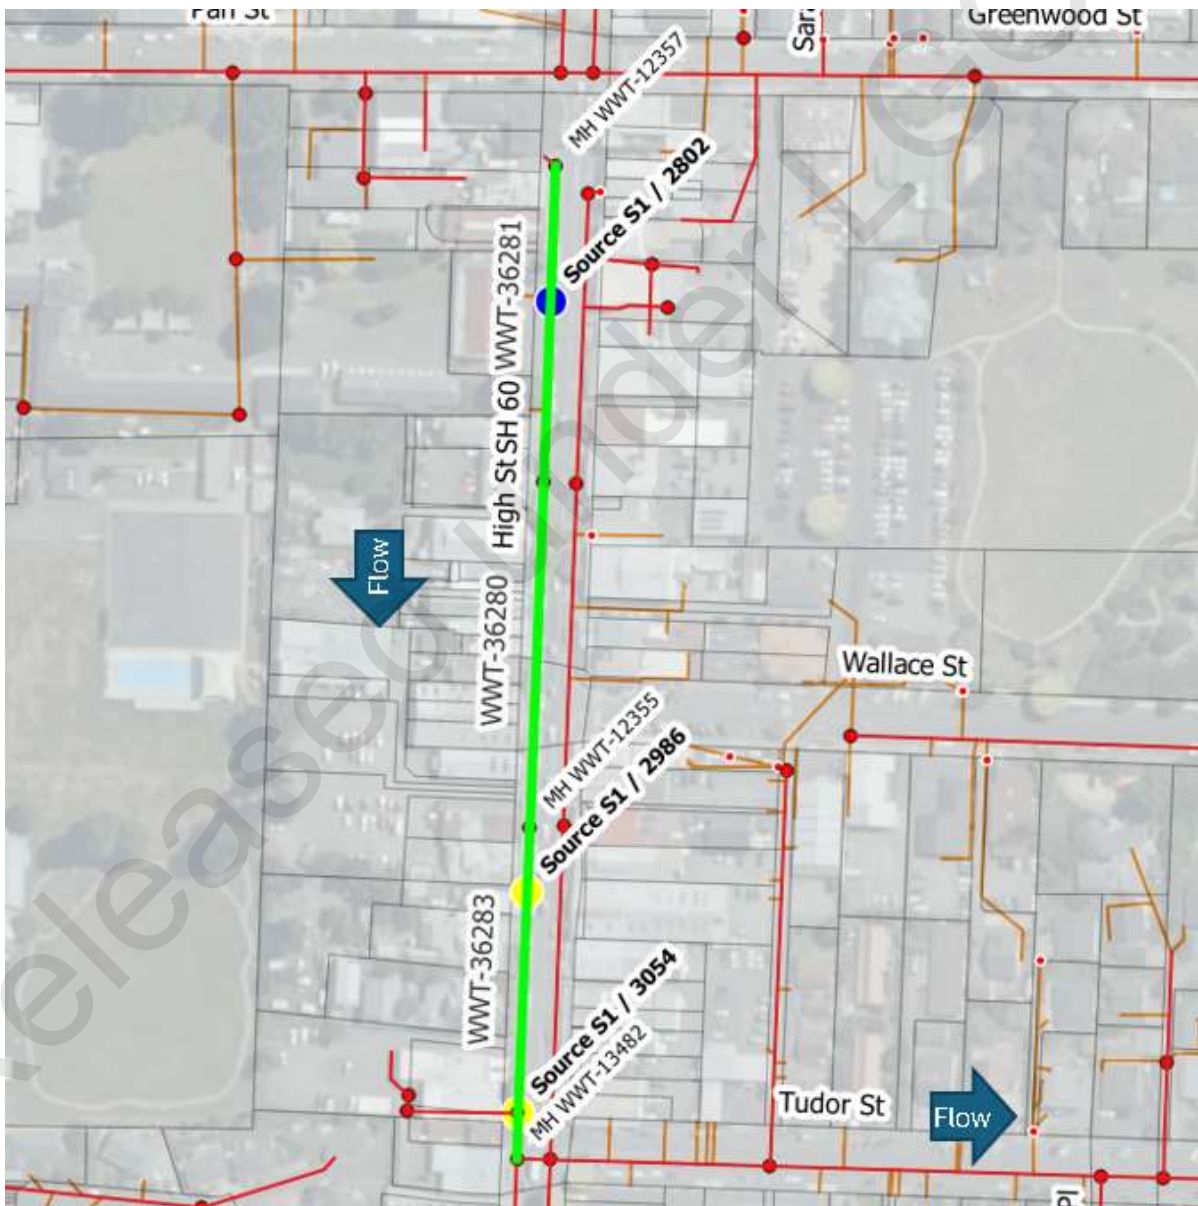
### Source Identification Map

- Stormwater inflow source S1 / 2802\*\* in Pipe 36281 at 140 High Street. <new>
- Groundwater infiltration source S1 / 2986\*\* in Pipe 36283 at 196 High Street. <new>
- Groundwater infiltration source S1 / 3054 at Manhole 12354 at 218 High Street. <new>

1. Upstream manhole 12357 @ 124 High Street @ 2758 m.
2. Downstream manhole 13482 @ 226 High Street @ 3068 m.

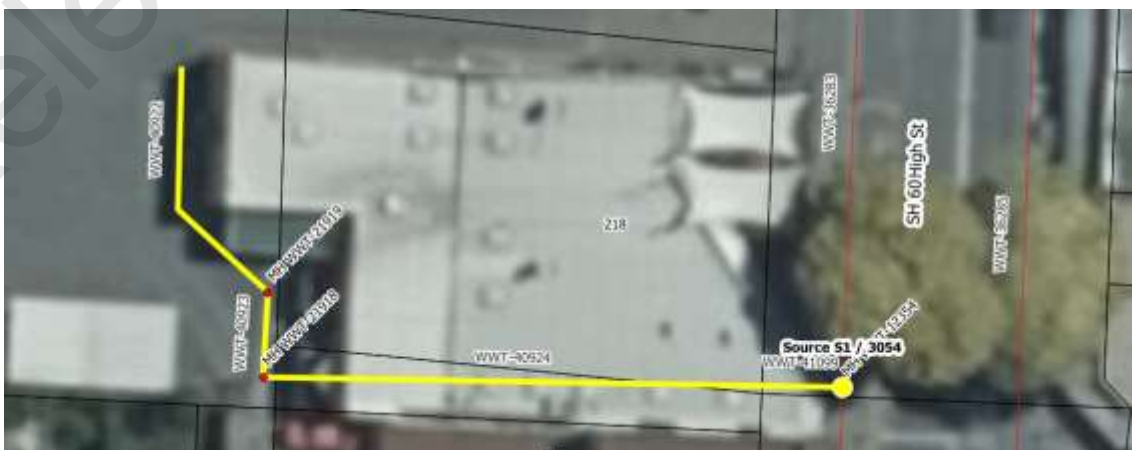
### Source Location Map

Asset	Manhole 12354.
Address	218 High Street.
DTS signal	Strong, At manhole 12354.
Analysis	Temperature differential below 0°C during low wastewater flows in the early hours of the morning indicating ground water infiltration.
Recommendation	<p>Inspection of manhole 12354 checking for signs of deterioration and infiltration.</p> <p>The DTS I&amp;I signal was detected at a manhole connected to a section of the catchment that was not directly monitored using DTS.</p> <p>Inspection of the upstream catchment looking for signs of I&amp;I is also recommended.</p> <p>Inspections: Manholes 12354, 21918, 21919. Pipes 49924, 40923, 40922. Property 218 High Street)</p>

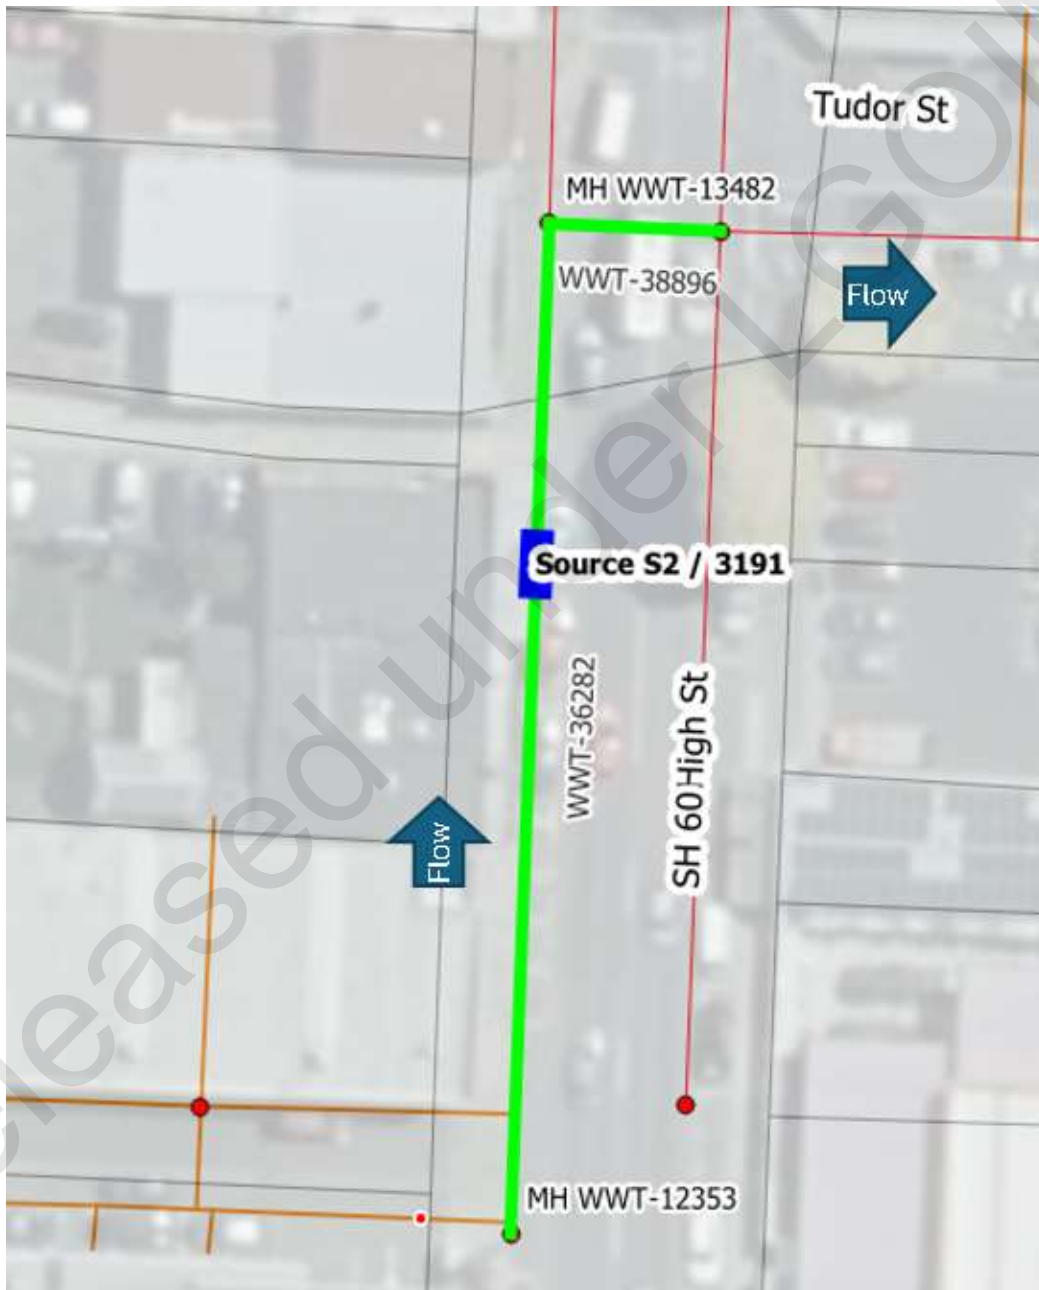
### Source Identification Map

- Stormwater inflow source S2 / 3191 in Pipe 36282 at 230 High Street. <new>

1. Upstream manhole 12353 @ 238 High Street @ 3151 m.
2. Downstream manhole 14925 @ 219 High Street @ 3220 m

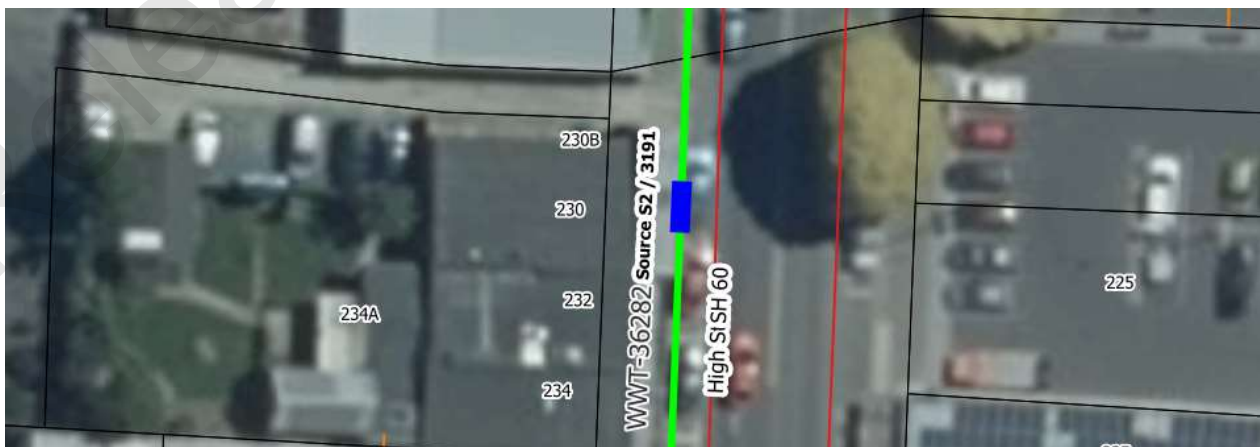
### Source Location Map

Asset	Pipe 36282 DN150, 59m, Asbestos Cement, 1949.
Address	230 High Street.
DTS signal	Strong, 20m ±3m upstream of manhole 13482.
Analysis	Reduction in temperature during rainfall indicating stormwater inflow.
Recommendation	CCTV inspection of pipe 36282 to determine the connection point of laterals not shown on the GIS map (230 High St.). Inspection of nearby connected properties (230 High St.) looking for deterioration and inflow.
Note	Use the CCTV data to update the connection points for the laterals not shown in the GIS map. Include property inspections only if they are within five metres of the DTS signal.

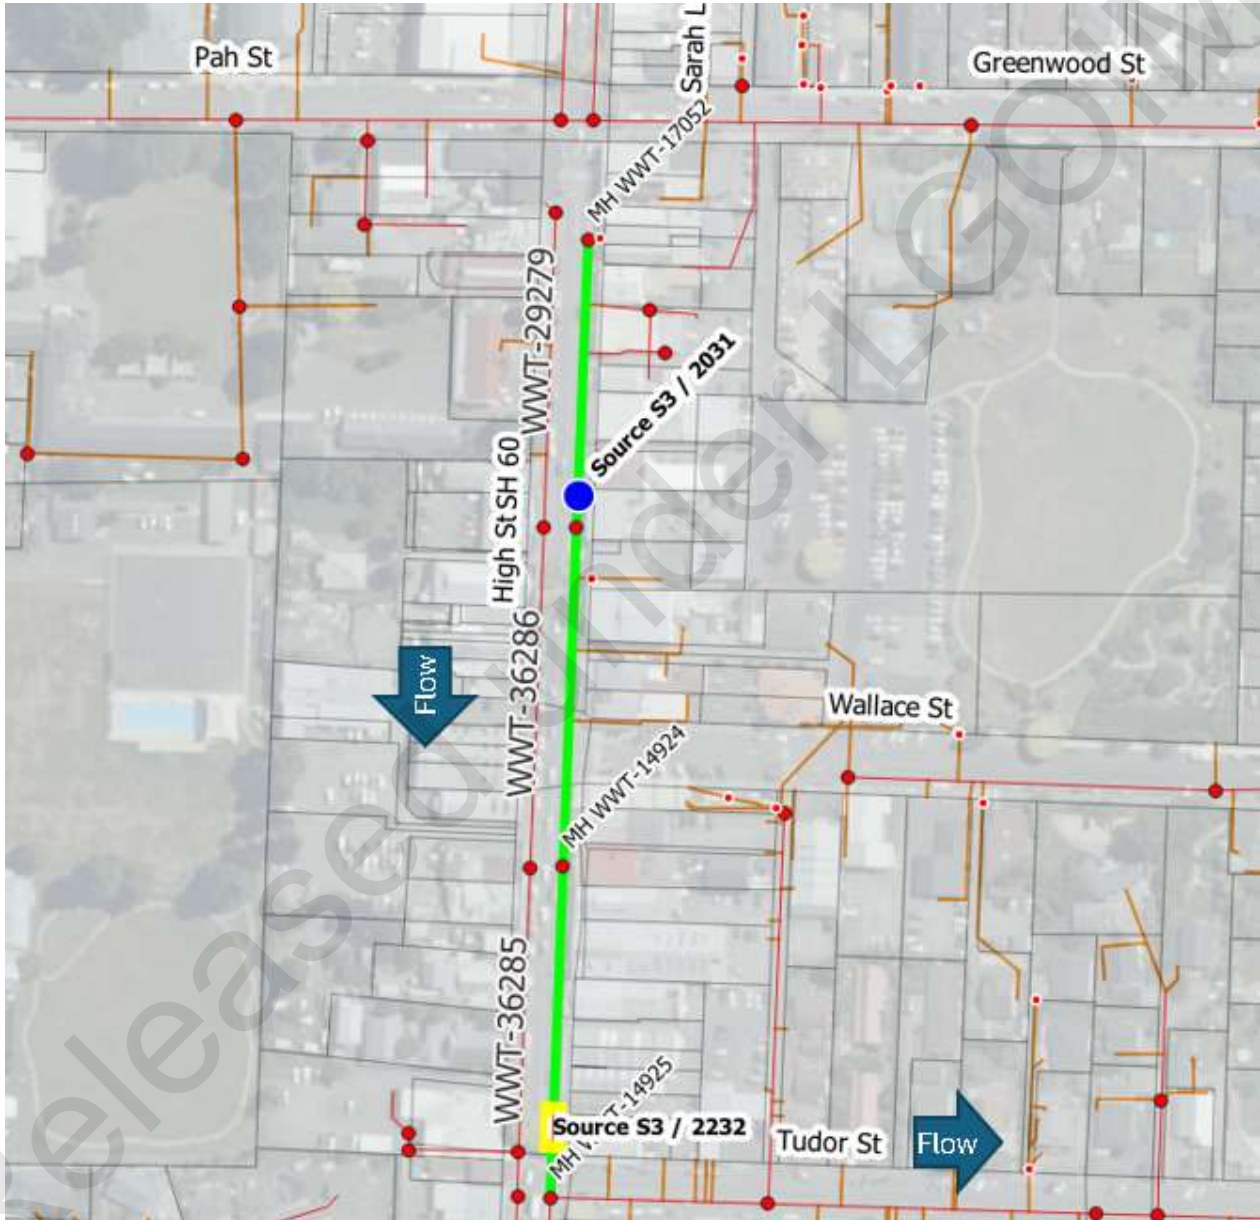
Source Identification Map

- Stormwater inflow source S3 / 2031 in Pipe 29279 at 157 High Street. <new>
- Groundwater infiltration source S3 / 2232 in Pipe 36285 at 219 High Street. <new>

1. Upstream manhole 17052 @ 131 High Street @ 1950m.
2. Downstream manhole 14925 @ 219 High Street @ 2252 m.

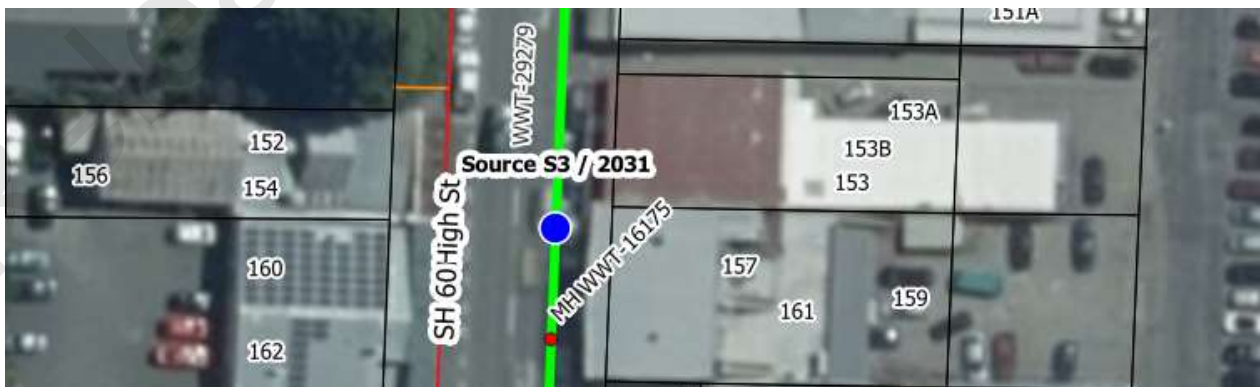
Source Location Map

Asset	Pipe 29279 DN150, 89m, Concrete, 1949.
Address	157 High Street.
DTS signal	Strong, 10m ±3m upstream of manhole 16175.
Analysis	Reduction in temperature during rainfall indicating stormwater inflow.
Recommendation	CCTV inspection of pipe 29279 to determine the connection point of laterals not shown on the GIS map (157, 159, 161 High St.). Inspection of nearby connected properties (157, 159, 161 High St.) looking for deterioration and inflow.
Note	Use the CCTV data to update the connection points for the laterals not shown in the GIS map. Include property inspections only if they are within five metres of the DTS signal.

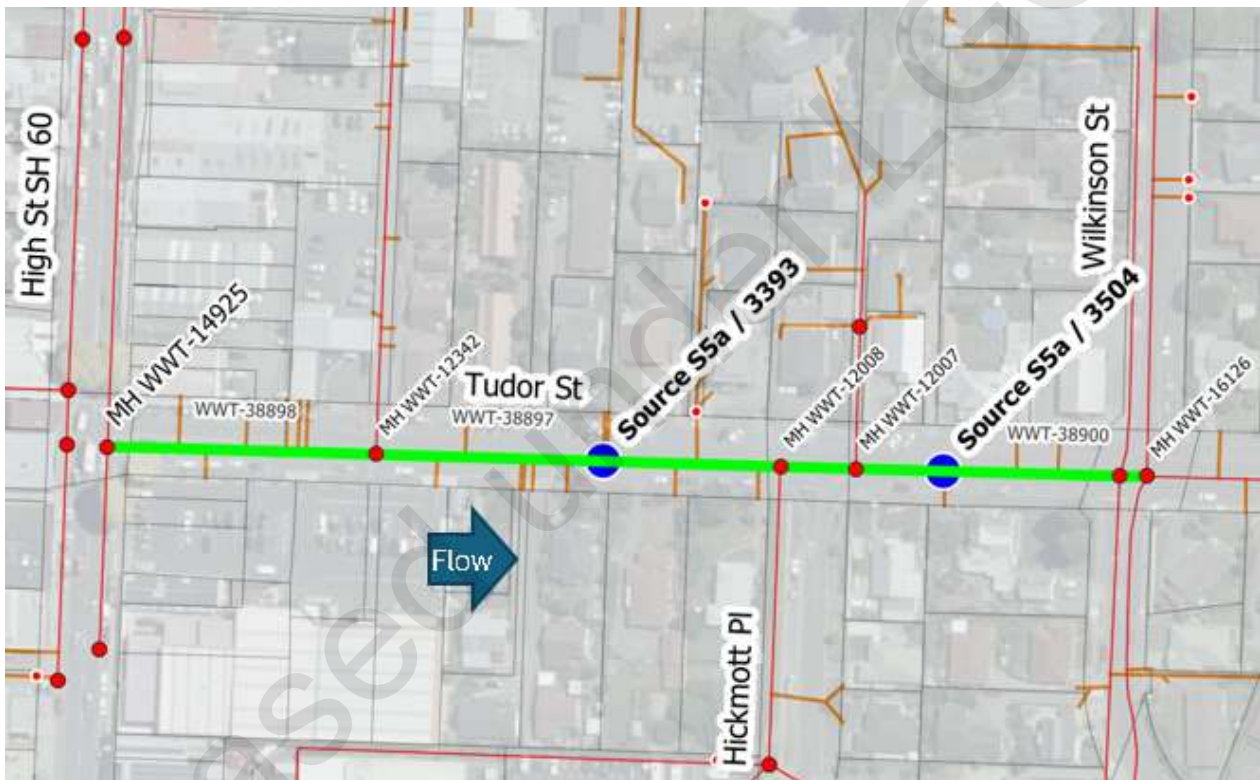
#### Source Identification Map

- Stormwater inflow source S5a / 3393 in Pipe 38897 at 18 Tudor Street. <new>
- Stormwater inflow source S5a / 3504 in Pipe 38900 at 27 Tudor Street. <new>

1. Upstream manhole 14925 @ 219 High Street @ 3242 m.
2. Downstream manhole 16126 @ 35 Tudor Street @ 3555 m.

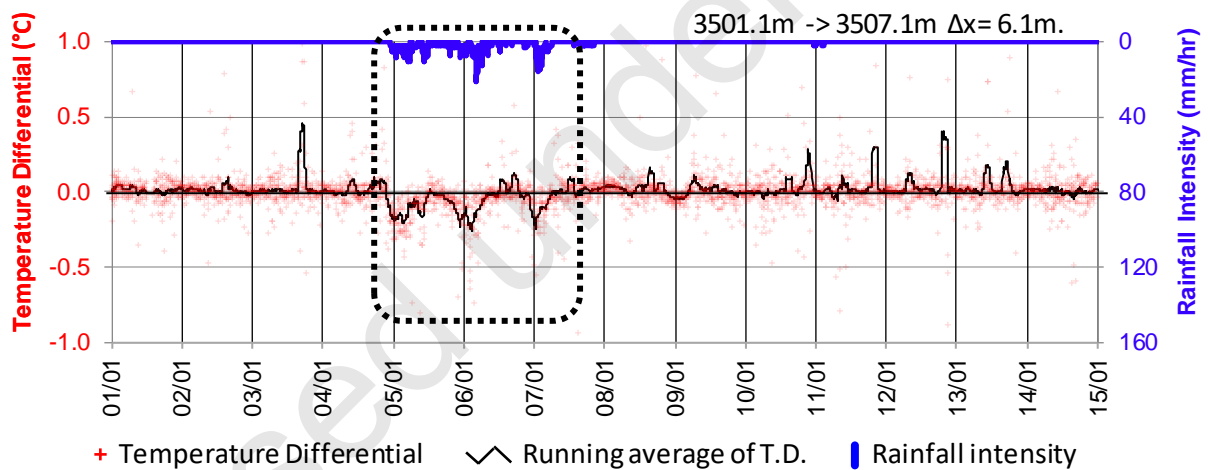
Source Analysis Plot – Temperature Difference vs Time

Asset	Pipe 38900	DN225, 67m, uPVC, 2008.
Address	27 Tudor Street.	
DTS signal	Medium. 21m ±3m downstream of manhole 12007.	
Analysis	Reduction in temperature during rainfall indicating stormwater inflow.	
Recommendation	Inspection of nearby connected properties (27 Tudor St.) looking for deterioration and/or SW connections.	
Note	The DTS signal suggests a stormwater inflow, likely from a private property, requiring a hydraulic connection to surface features. As the wastewater main is underground and unlikely to have direct stormwater entry, it has not been included in the CCTV inspection.

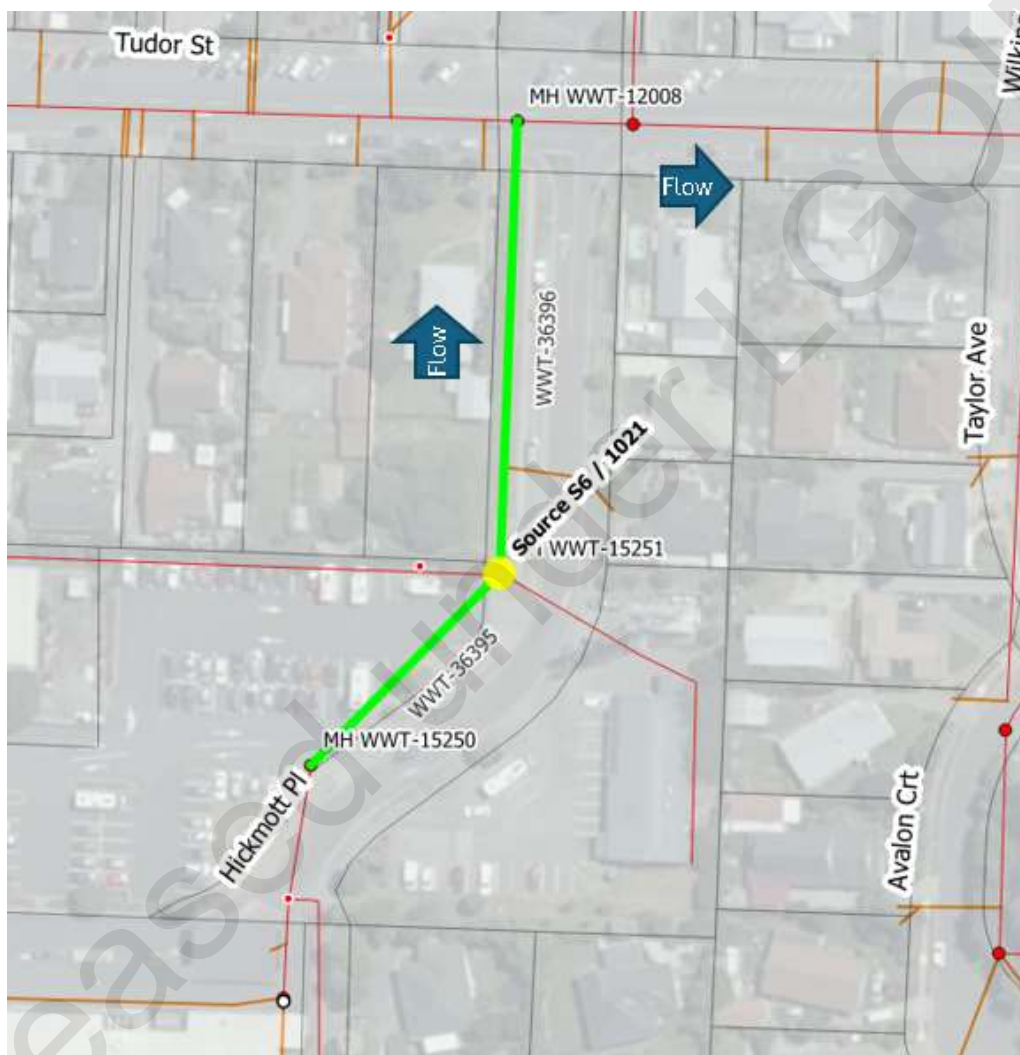
### Source Identification Map

- Groundwater infiltration source S6 / 1021 in Manhole 15251 at 8 Hickmott Place. <new>

1. Upstream manhole 15250 @ 8 Hickmott Place @ 978 m.
2. Downstream manhole 12008 @ 21 Tudor Street @ 1097 m.

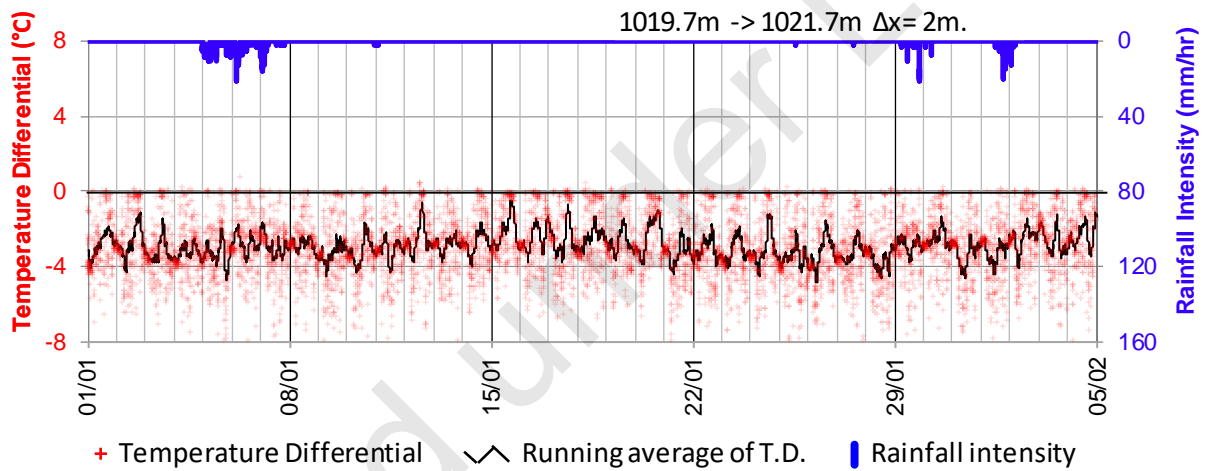
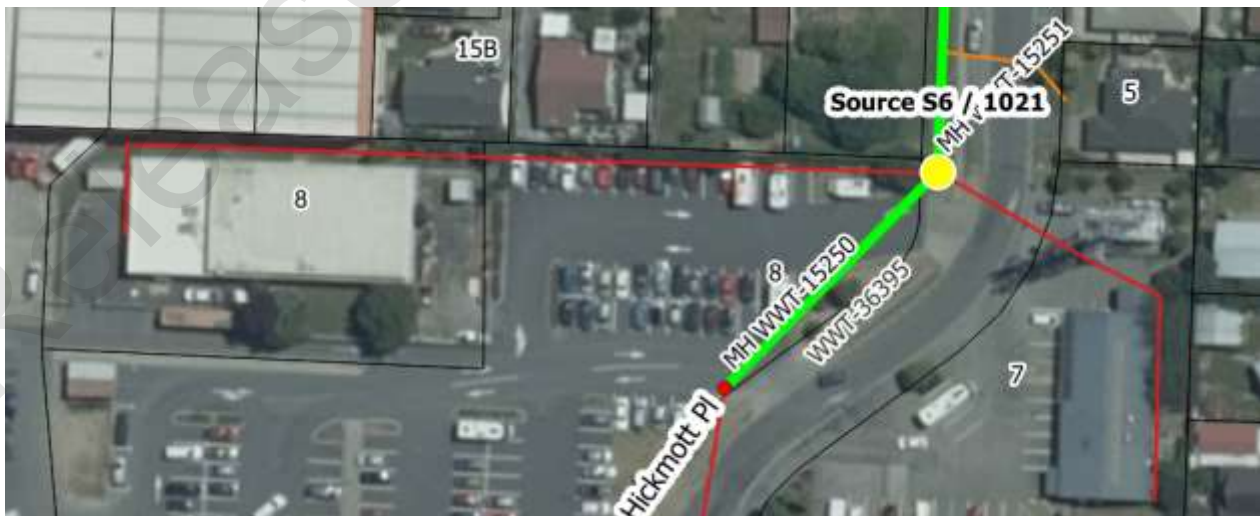
## A.6.1 Source S6 / 1021 <new>

Asset	Manhole 15251.
Address	8 Hickmott Place.
DTS signal	Strong, At manhole 15251.
Analysis	Temperature differential consistently below 0°C indicating GWI.
Recommendation	Inspection of manhole 15251 checking for signs of deterioration and infiltration. Inspection of nearby connected properties (7 & 8 Hickmott Pl.) looking for deterioration and infiltration.

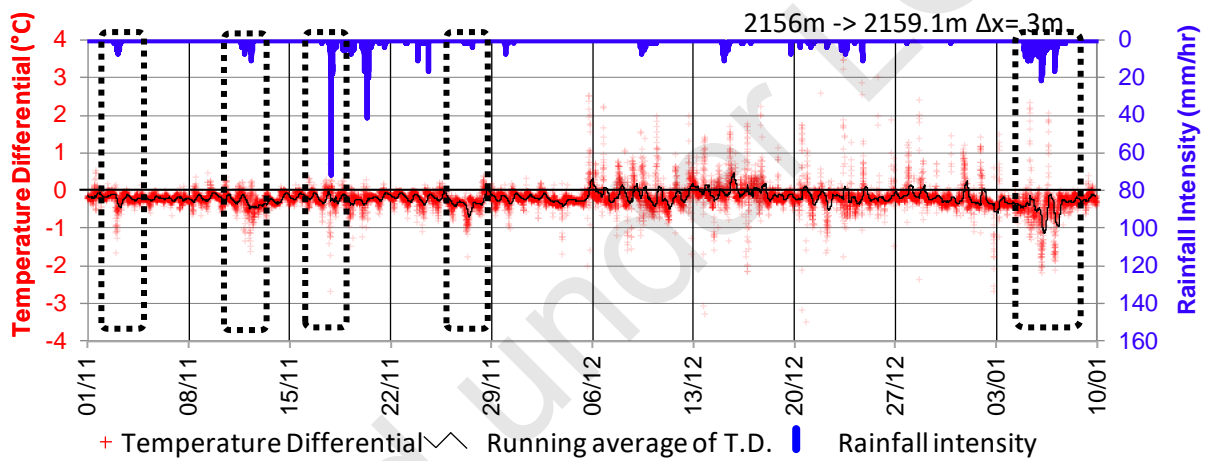
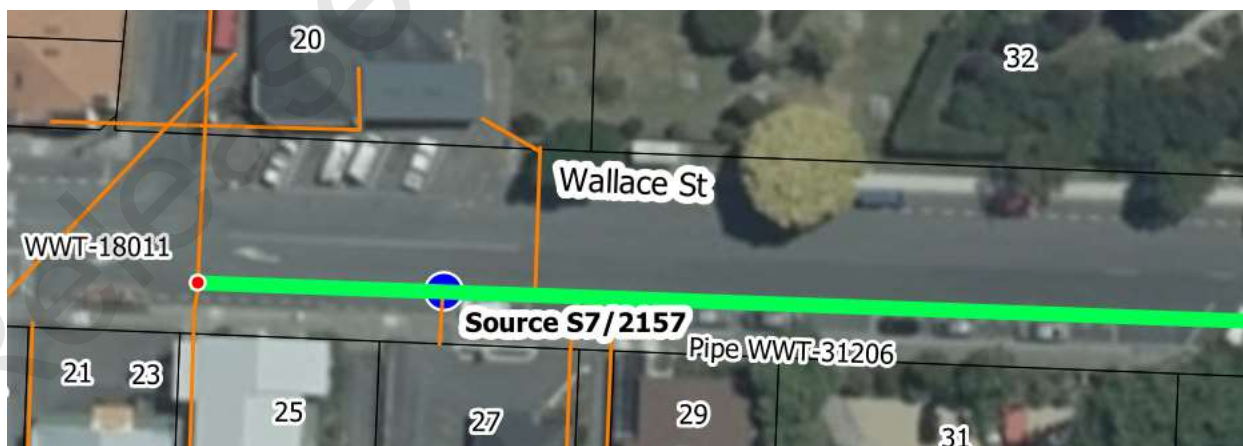
## A.7.1 Source S7 / 2157

Asset	Pipe 31206	DN150, 114m, PVC, 1984.
Address	27 Wallace Street.	
DTS signal	Strong, 25m ±3m downstream of manhole 18011.	
Analysis	Reduction in temperature during rainfall indicating stormwater inflow.	
Recommendation	Inspection of nearby connected properties (27 Wallace Street) looking for deterioration and/or stormwater connections.

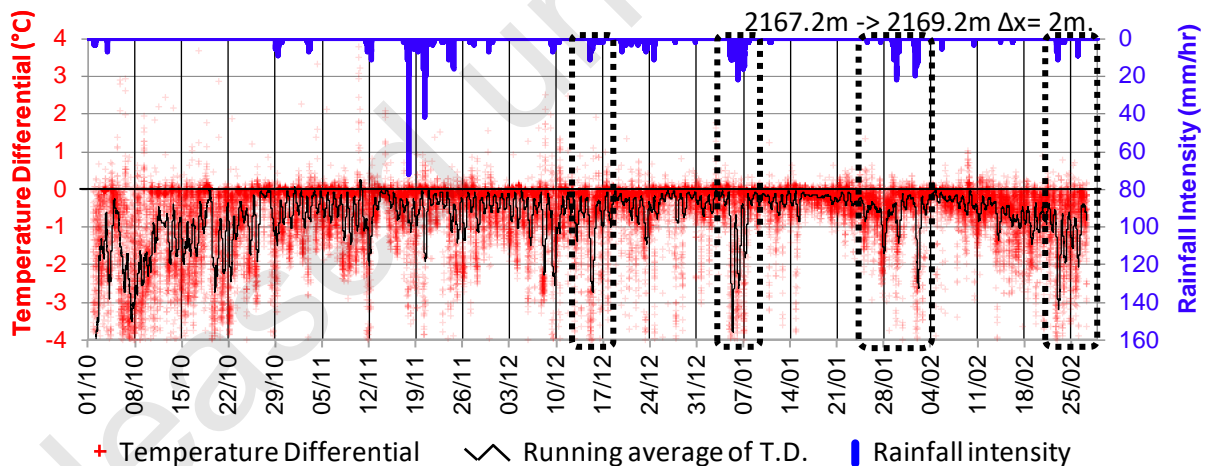
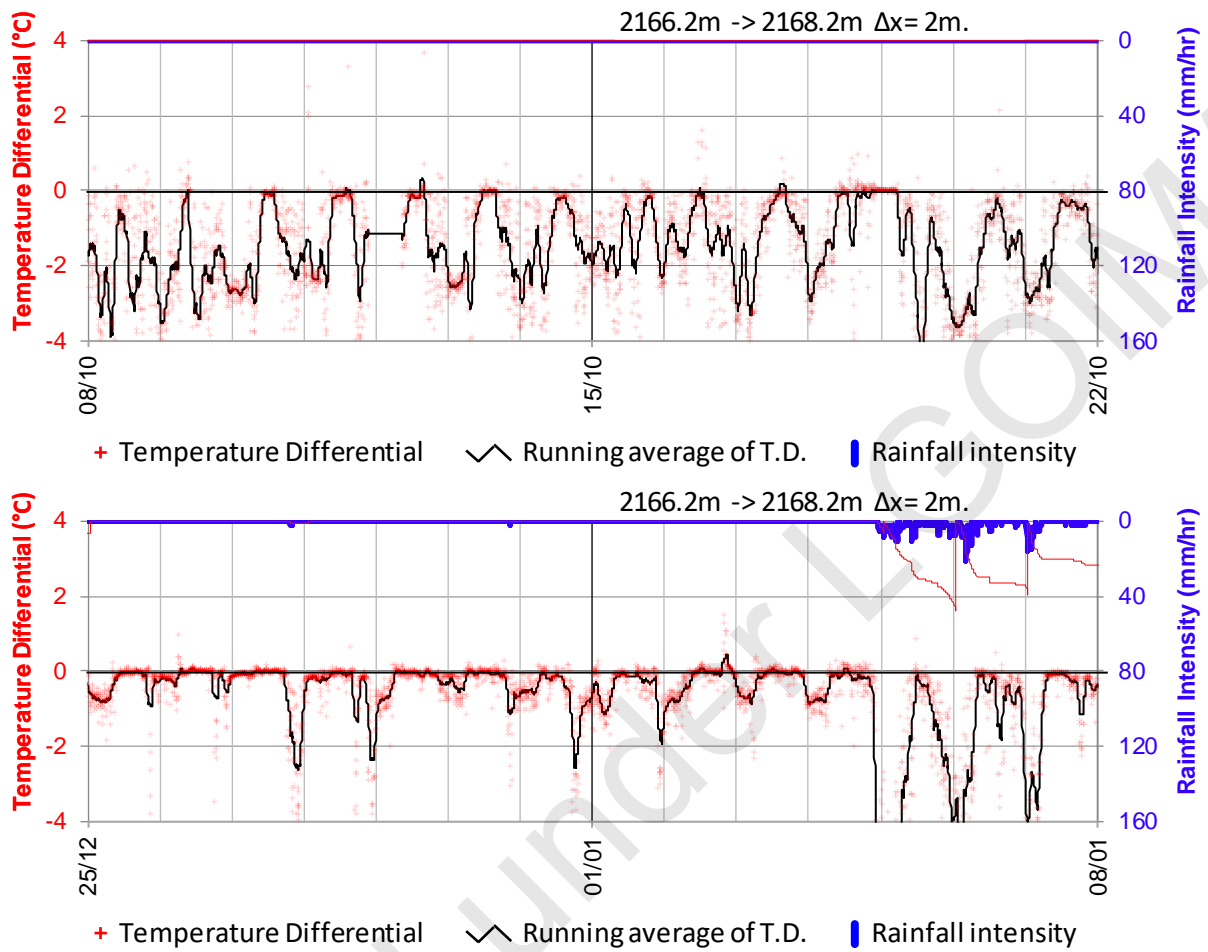
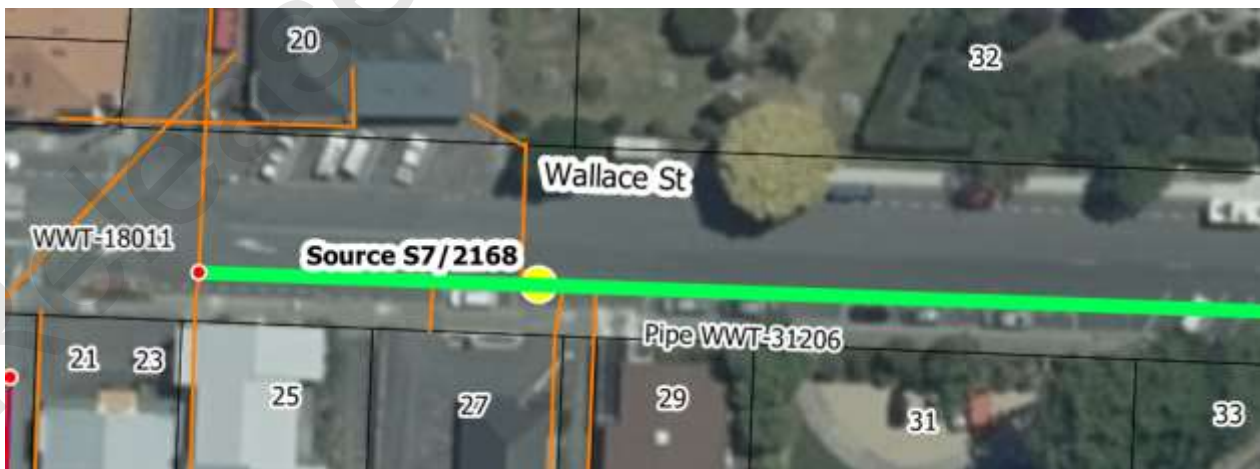
## A.7.2 Source S7 / 2168

Asset	Pipe 31206	DN150, 114m, PVC, 1984.
Address	27 Wallace Street.	
DTS signal	Strong, 36m ±3m downstream of manhole 18011.	
Analysis	Reduction in temperature during rainfall indicating stormwater inflow. Reduction in temperature in the early hours of the morning indicating ground water infiltration.	
Recommendation	Inspection of nearby connected properties (20 and 27 Wallace Street) looking for deterioration and/or stormwater connections.	
Note	The inspection of 27 Wallace Street is provided in the recommendations for S7 / 2157.

In the plot **above**, during the first four weeks of monitoring, it appears that **during dry weather** there are temperature depressions of equivalent magnitude to what is observed during rain events. In the plot above the black trace is a rolling 12-hour average temperature differential. This long timespan for the rolling average was used to highlight the response to rain events.

The plots below present close-up views of the data from October and December 2022 using a 2-hour rolling average for the black trace to highlight diurnal patterns. Close-up inspection of the data during this period indicates that the temperature depression during dry weather conditions is occurring in the late hours of the evening and the early hours of the morning. This is consistent with groundwater infiltration that is constantly occurring but is not significant enough to change the temperature of the wastewater during the hours of peak wastewater flow rates.

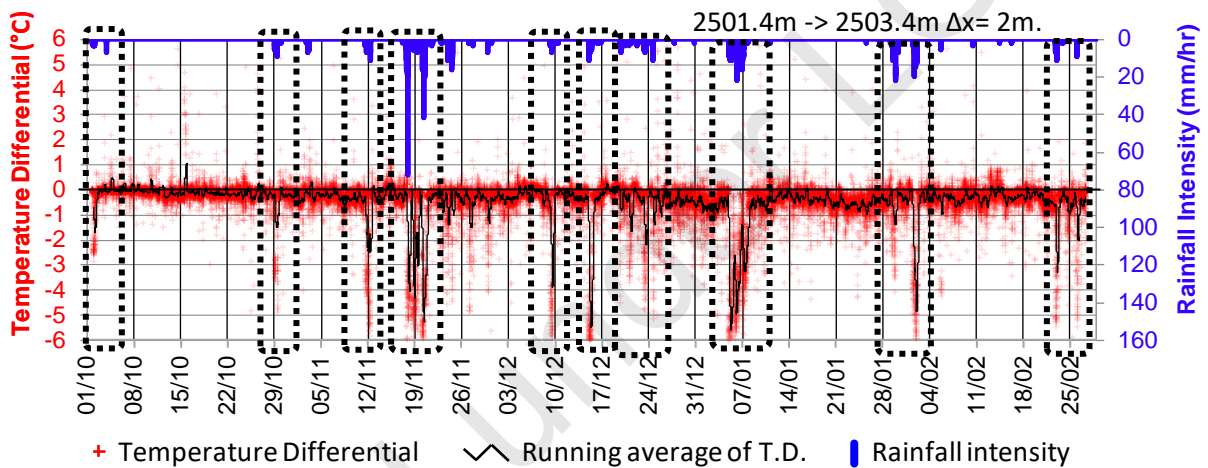
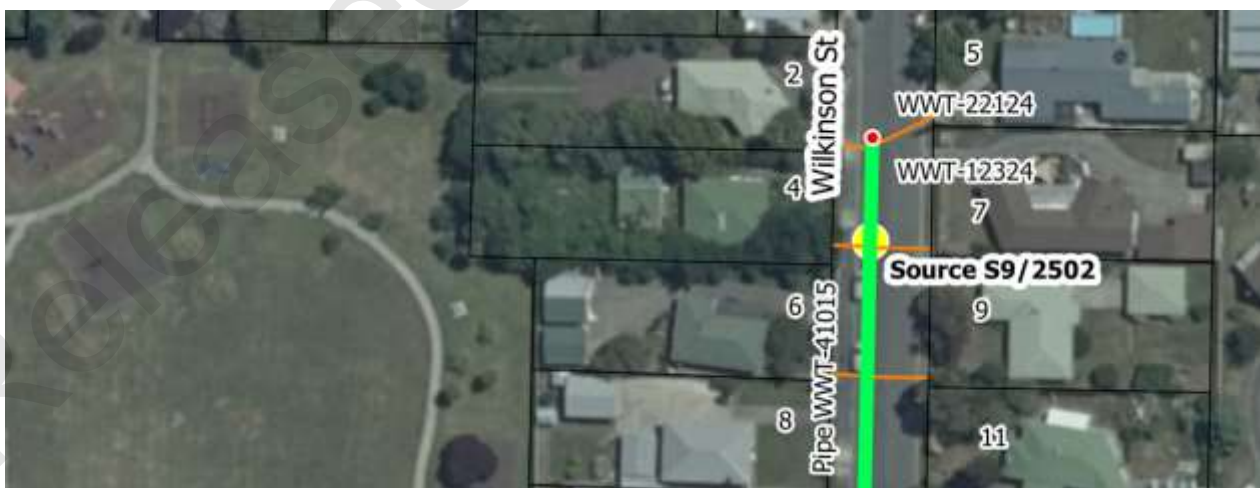
## A.9.1 Source S9 / 2502

Asset	Pipe 41015	DN150, 138m, uPVC, 2010.
Address	4 Wilkinson Street.	
DTS signal	Strong, 17m ±3m downstream of manhole 12324.	
Analysis	Reduction in temperature during rainfall indicating stormwater inflow.	
Recommendation	Inspection of nearby connected properties (4 and 7 Wilkinson Street) looking for deterioration and/or stormwater connections.

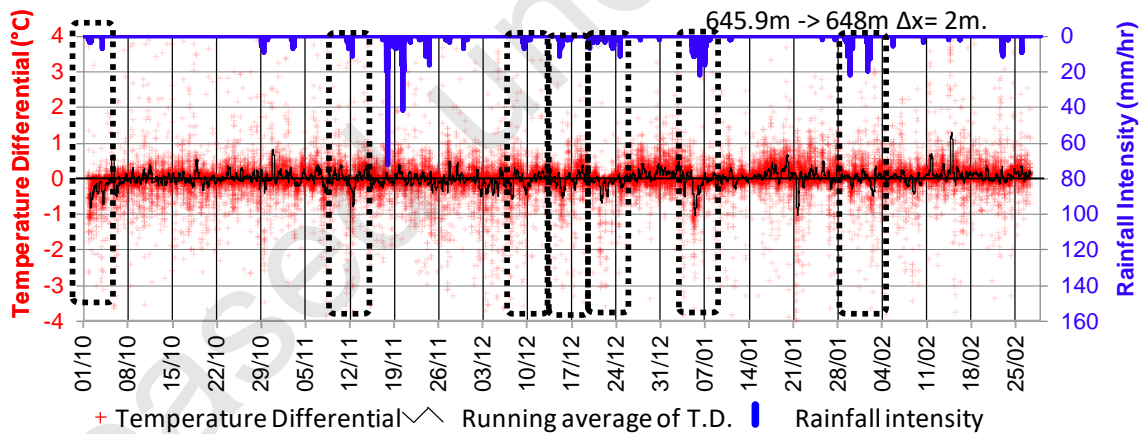
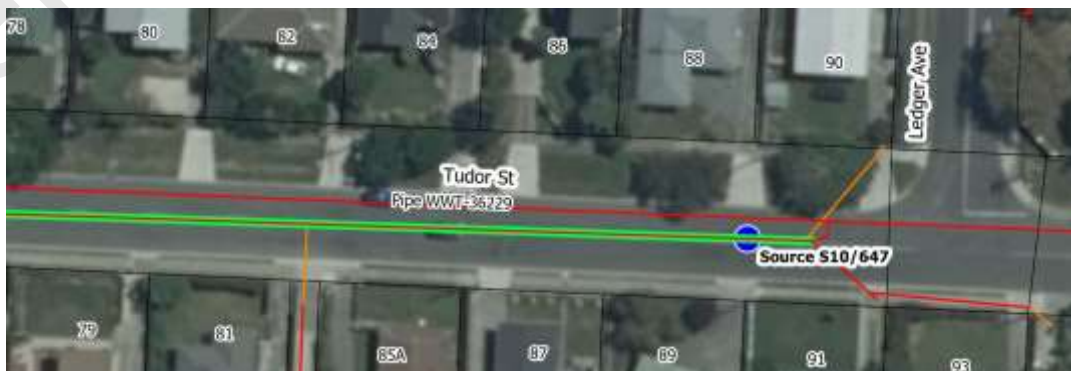
## A.10.1 Source S10 / 647

Asset	Pipe 36229 DN150, 93m, Concrete, 1949.
Address	88 Tudor St.
DTS signal	Strong, 8m ±3m downstream of manhole 12317.
Analysis	Reduction in temperature during rainfall indicating stormwater inflow.
Recommendation	CCTV inspection of pipe checking for signs of deterioration and sources of inflow. Use CCTV records to identify where each property is connected to the wastewater main. This should be done for the full length of pipe 36229, not just near 88 Tudor Street. Inspection of nearby connected properties (88, 89, and 91 Tudor Street) looking for deterioration and/or stormwater connections.
Note	Use the CCTV data to update the connection points for the laterals not shown in the GIS map. Include property inspections only if they are within five metres of the DTS signal. Inspection of 91 Tudor Street has been included because it is not fully clear if 91 Tudor Street is serviced by the lateral in the footpath in front of the driveway of 91 Tudor Street. CCTV records will show if the lateral for 91 Tudor Street connects to the wastewater main near source S10 / 647.

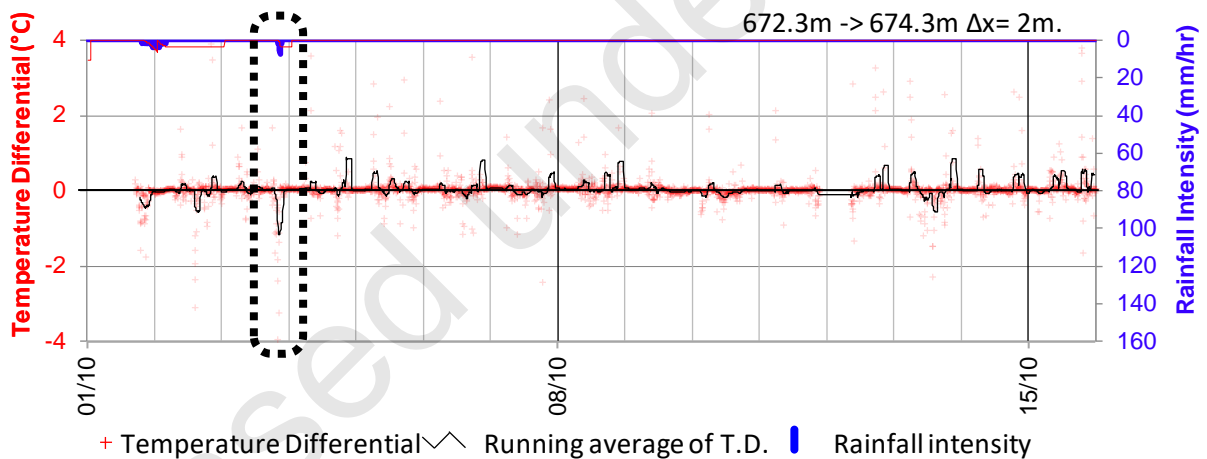
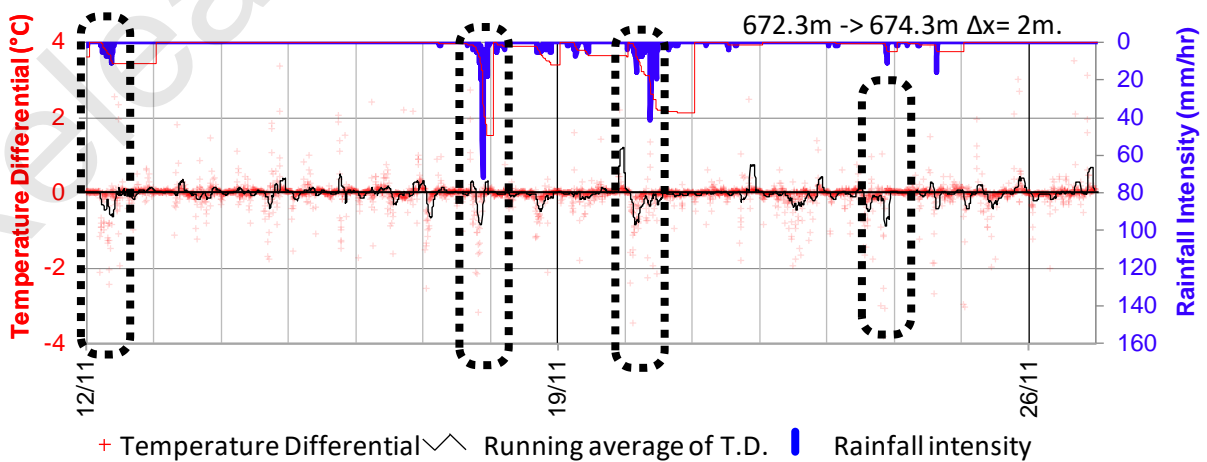
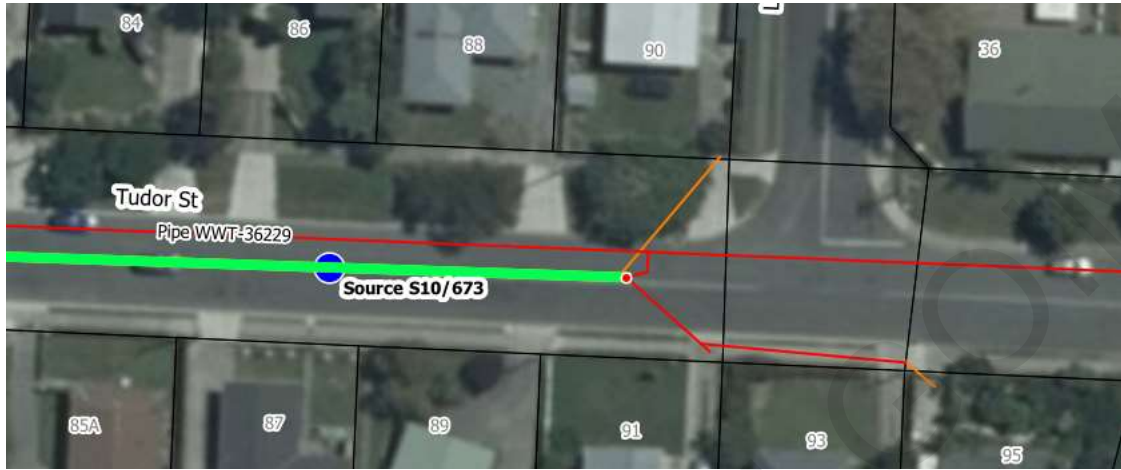
## A.10.2 Source S10 / 673

Asset	Pipe 36229	DN150, 93m, Concrete, 1949.
Address	86 Tudor St.	
DTS signal	Medium, 34m ±3m downstream of manhole 12317.	
Analysis	Reduction in temperature during rainfall indicating stormwater inflow.	
Recommendation	CCTV inspection of pipe 36229 to determine the connection point of laterals not shown on the GIS map (86 and 87 Tudor Street.). Inspection of nearby connected properties (86 and 87 Tudor Street) looking for deterioration and/or stormwater connections.	
Note	Use the CCTV data to update the connection points for the laterals not shown in the GIS map. CCTV inspection for pipe 36229 is included under the recommendations for I&I source S10 / 647. Include property inspections only if they are within five metres of the DTS signal.

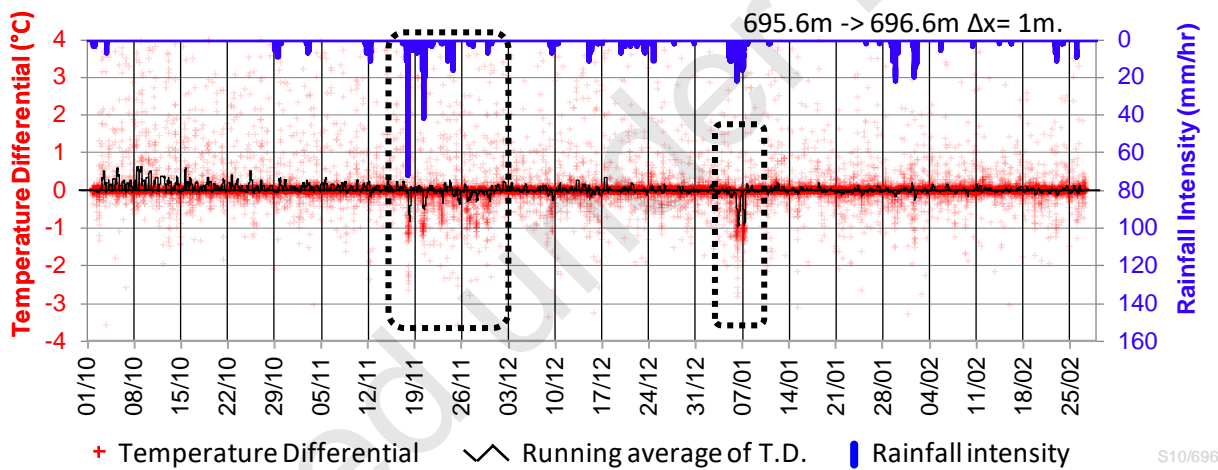
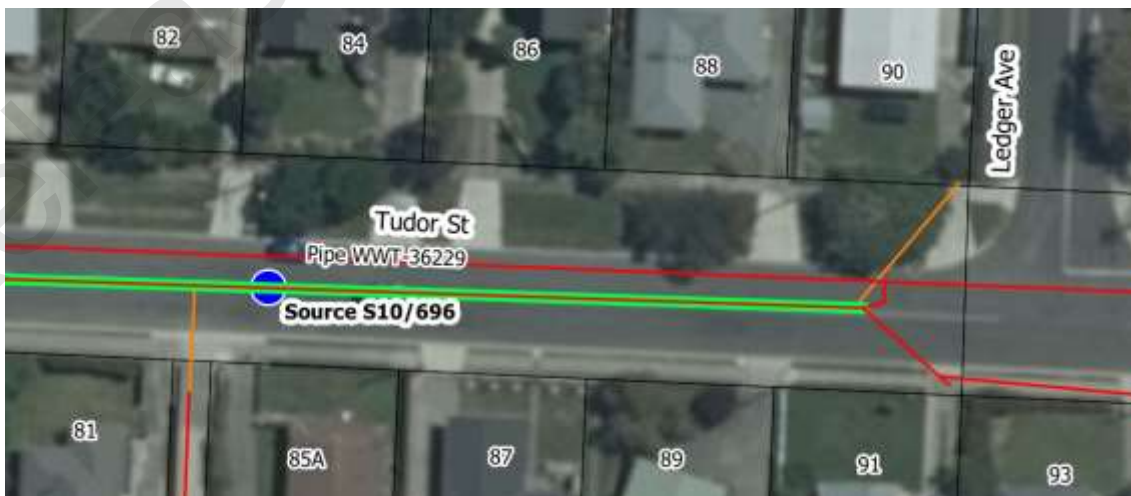
### A.10.3 Source S10 / 696

Asset	Pipe 36229	DN150, 93m, Concrete, 1949.
Address	84 Tudor Street	
DTS signal	Strong, 57m ±3m downstream of manhole 12317.	
Analysis	Reduction in temperature during rainfall indicating stormwater inflow.	
Recommendation	Inspection of nearby connected properties (84 and 85A Tudor Street) looking for deterioration and/or stormwater connections.	
Note	Use the CCTV data to update the connection points for the laterals not shown in the GIS map. Include property inspections only if they are within five metres of the DTS signal.
