**OFFICIAL INFORMATION REQUEST: FIBRE OPTIC INSPECTION SYSTEM (REF: 3610)**

# Motueka Wastewater I&I Assessment Using Distributed Temperature Sensing

Goodman Park Pump Station Catchment  
Final Report

30<sup>th</sup> April 2024

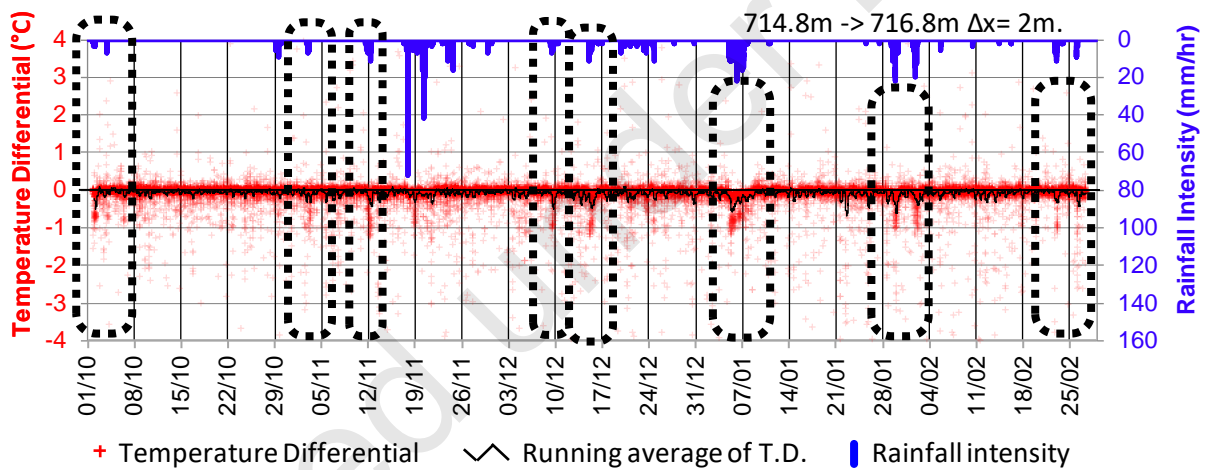
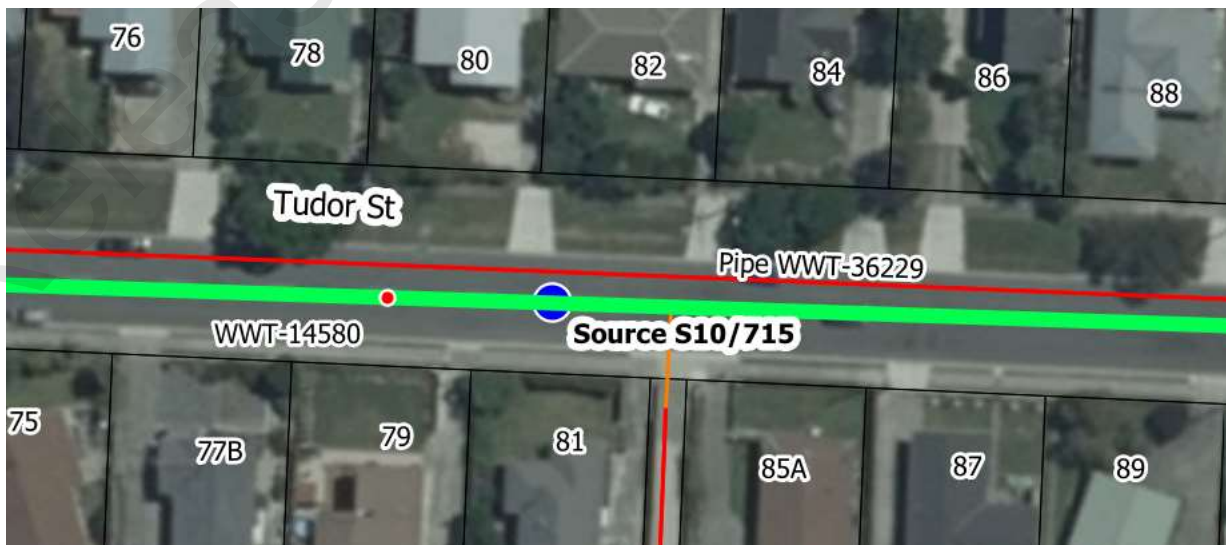
### A.10.4 Source S10 / 715

Asset	Pipe 36229	DN150, 93m, Concrete, 1949.
Address	82 Tudor Street.	
DTS signal	Strong, 17m ±3m upstream of manhole 14580.	
Analysis	Reduction in temperature during rainfall indicating stormwater inflow.	
Recommendation	Inspection of nearby connected properties (81 and 82 Tudor Street) looking for deterioration and/or stormwater connections.	
Note	Use the CCTV data to update the connection points for the laterals not shown in the GIS map. Include property inspections only if they are within five metres of the DTS signal.

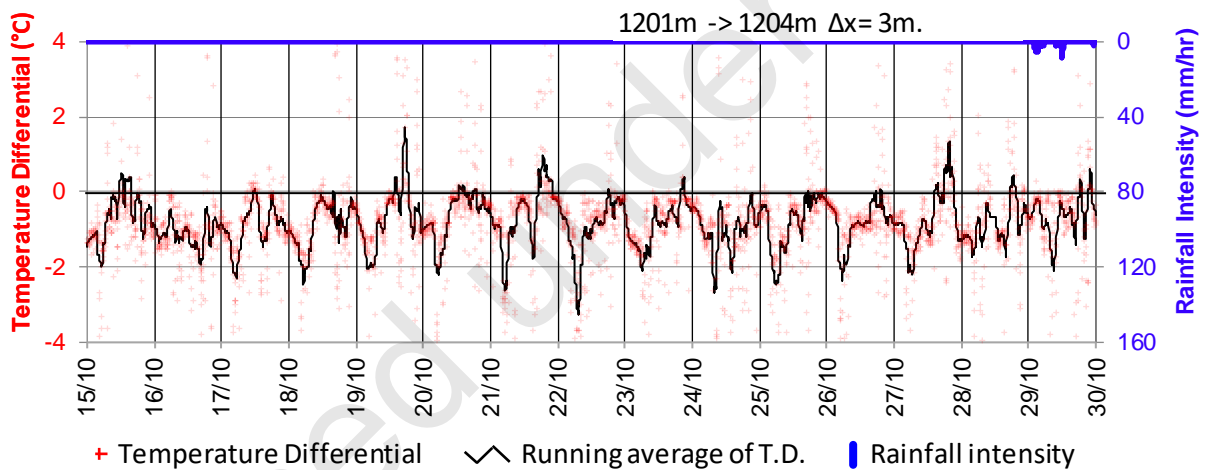
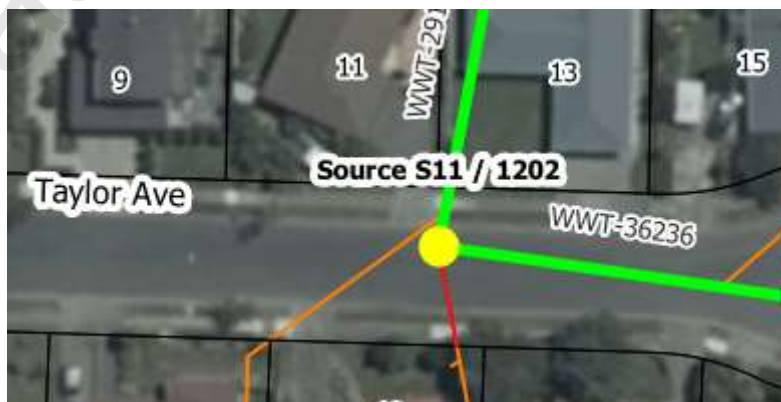
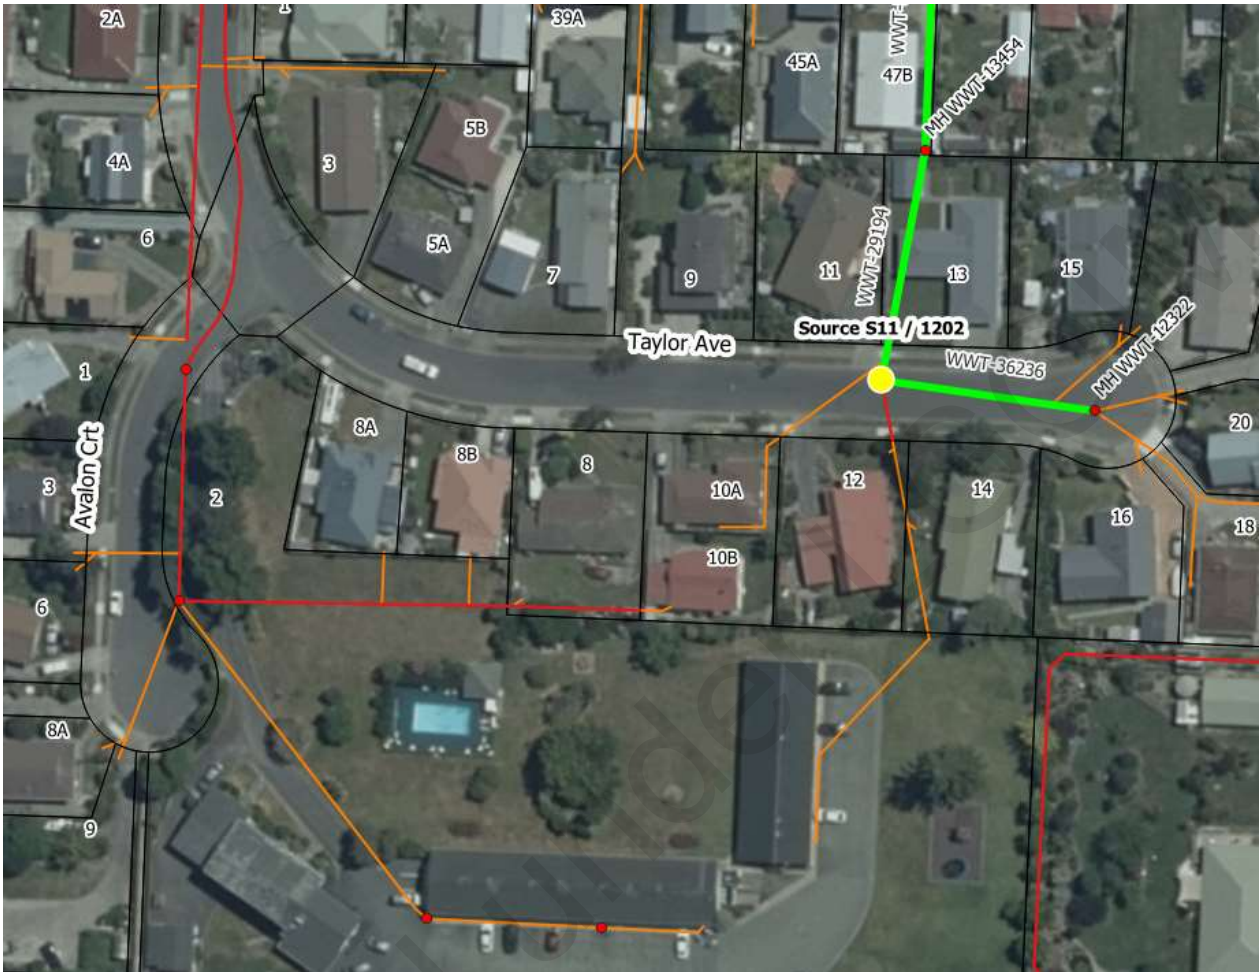
### A.11.1 Source S11 / 1202

Asset	Manhole 12321.
Address	12 Taylor Street.
DTS signal	Strong, At manhole 12322.
Analysis	<p>Temperature differential below 0°C during low wastewater flows in the early hours of the morning indicating ground water infiltration.</p> <p>The source is identified as infiltration so is expected to be a below ground fault or deterioration either in the public wastewater network or a private lateral.</p>
Recommendation	<p>Inspection of manhole 12321 checking for signs of deterioration and infiltration.</p> <p>Inspection of nearby connected properties (12 and 14 Taylor Ave., 2 Avalon Court) looking for deterioration and infiltration.</p>

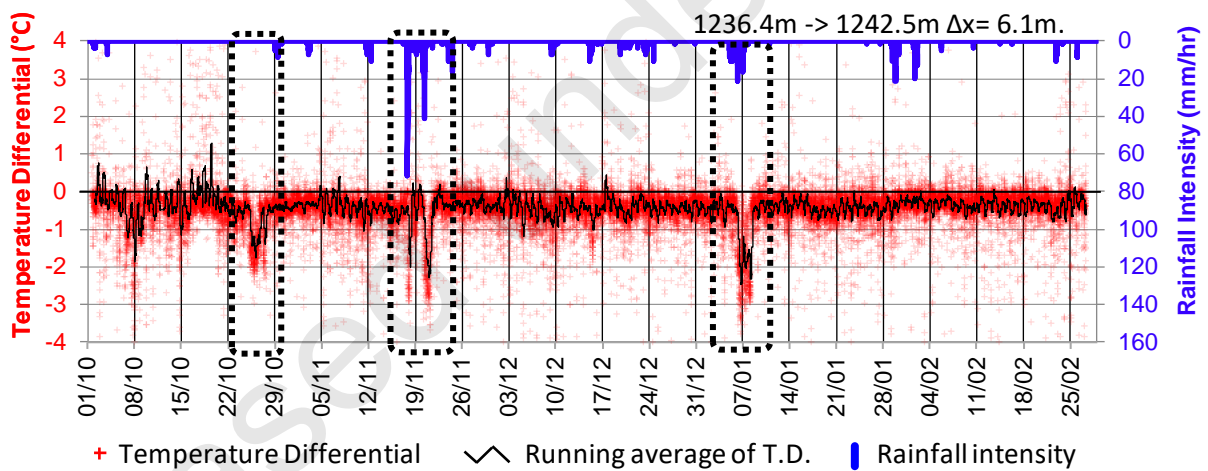
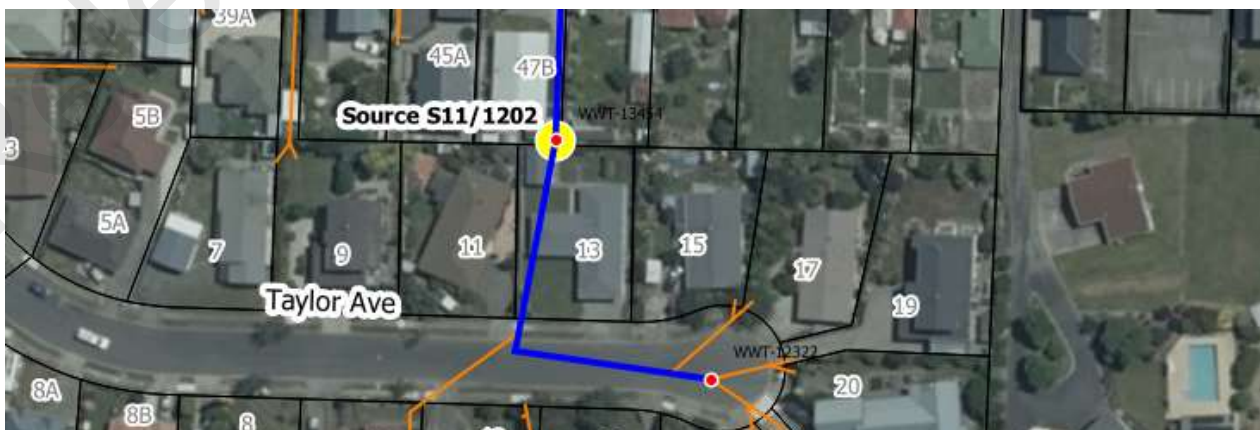
## A.11.2 Source S11 / 1240

Asset	Manhole 13454
Address	47B Tudor Street
DTS signal	Strong, At manhole 13454.
Analysis	Temperature differential generally below 0°C and correlated with rain indicating groundwater infiltration and stormwater inflow.
Recommendation	Inspection of manhole checking for signs of infiltration and inflow including poor construction, poor lid seal, and/or flow through lid keyholes. Inspection of connected properties (11, 13 Taylor Avenue, and 47B Tudor Street) looking for deterioration and/or stormwater connections.
Note	The location of the laterals for these three properties is not shown on the GIS map. A manhole inspection will confirm which properties connect at/near the manhole.

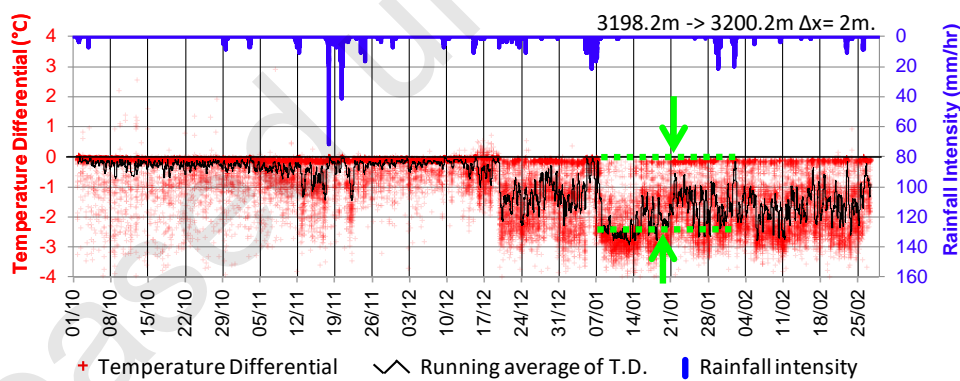
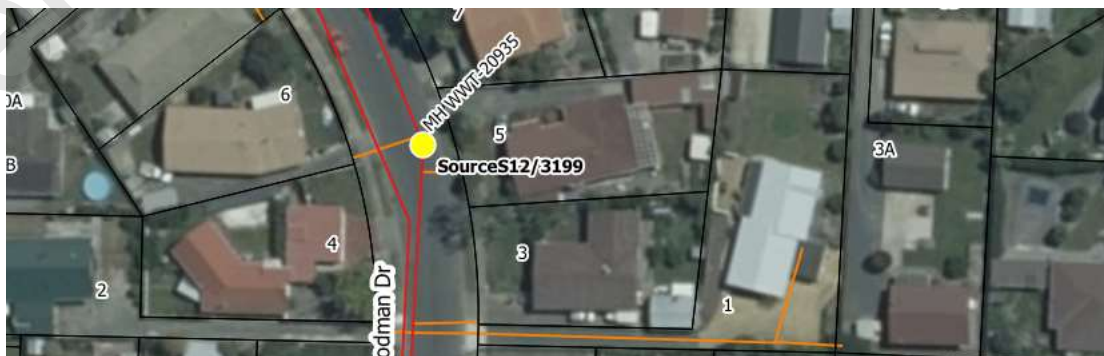
### A.12.1 Source S12 / 3199

Asset	Manhole 20935
Address	6 Goodman Drive.
DTS signal	Strong, at Manhole 20935.
Analysis	Temperature differential generally below 0°C and correlated with rain indicating stormwater inflow, rainfall dependent infiltration, and groundwater infiltration.
Recommendation	Inspection of manhole checking for signs of infiltration and inflow including poor construction, poor lid seal, and/or flow through lid keyholes. Inspection of connected properties (4, 5 and 6 Goodman Drive) looking for deterioration, infiltration, and/or stormwater connections.
Note	The signal in the GIS data is centred on the manhole. The extent and magnitude of the temperature drop support assessing the wastewater main for five metres either side of the manhole (using a Push Camera or similar). Also, inspection of the adjacent properties connected within five meters from the manhole is warranted. It is not clear from the GIS map if the lateral for 4 Goodman Drive is combined with 2 Goodman Drive, or if the lateral for 4 Goodman Drive connects at or near manhole 20935.

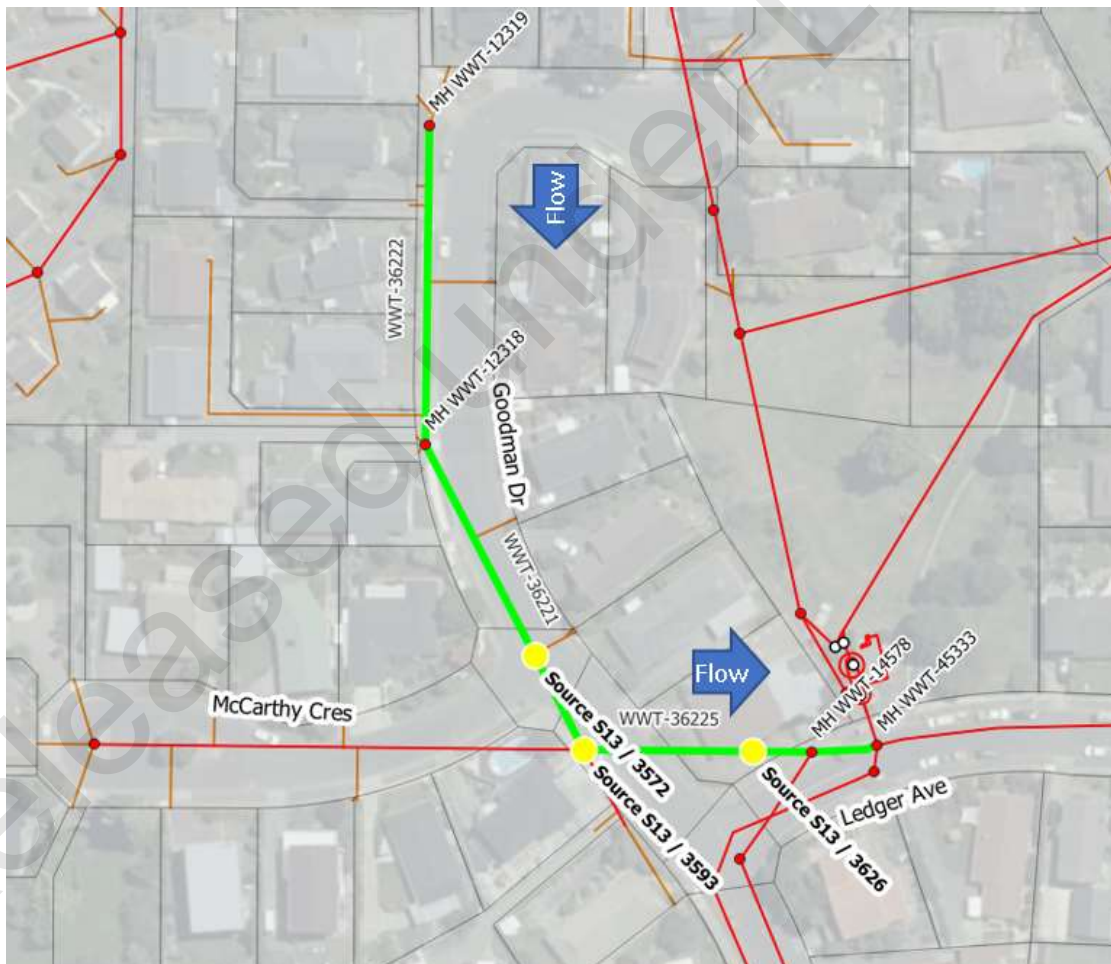
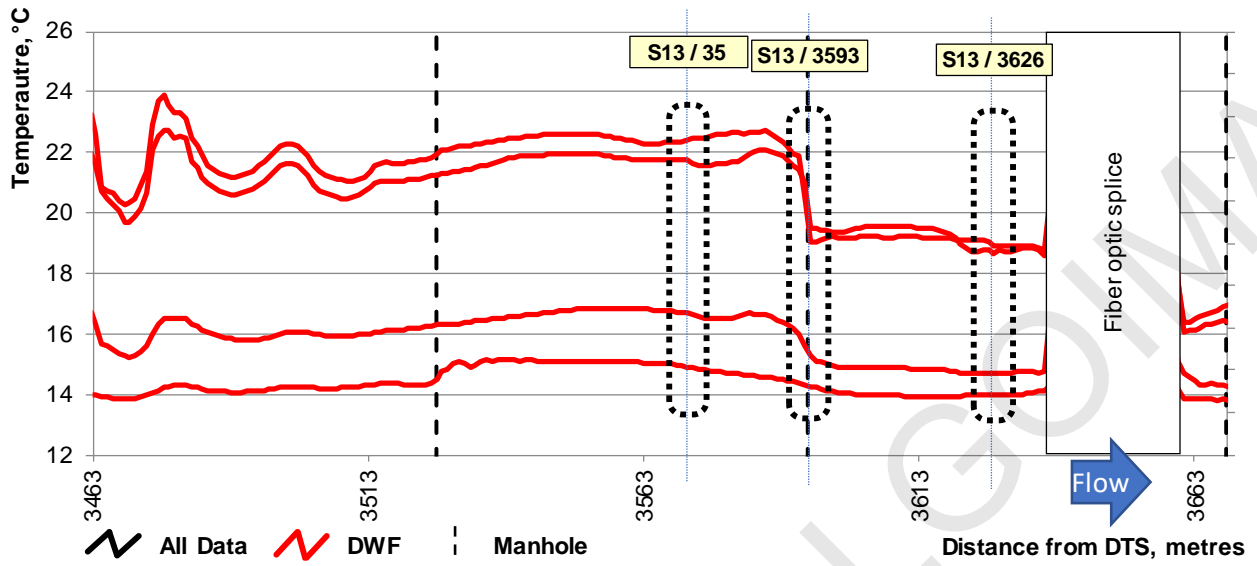
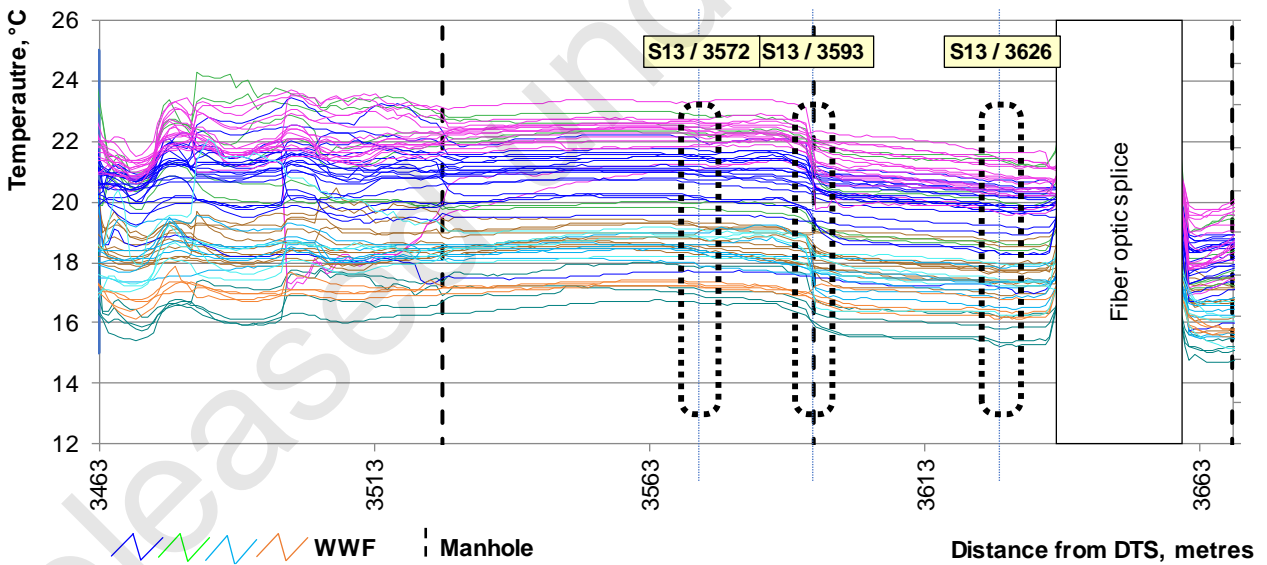
- Groundwater infiltration source S13 / 3572\*\* in Pipe 36221 at 13A Goodman Drive
- Groundwater infiltration source S13 / 3593 in manhole 16123 at 12 Goodman Drive.
- Groundwater infiltration source S13 / 3626\*\* in Pipe 36225 at 11 Goodman Drive.

Source S13 / 3477 was identified as a groundwater infiltration source in the earlier interim reports. Further analysis indicates that the DTS data pattern was caused by differential solar heating of the ground rather than groundwater infiltration at this location. Source S13 / 3477 has been deleted from the list of locations recommended for further investigation.

The 'early morning temperature drop' between points upstream and downstream of this location that was previously reported as being caused by cool groundwater infiltration entering the pipe has been reassessed. The temperature difference appears to be caused by the cable at the upstream point warming during the low flow hours in the early morning, whereas the temperature of the downstream point did not warm to the same extent. This is indicated in the plot below by the temperature for the upstream point (black line) continuing to rise between midnight and early morning. The downstream temperature (light blue line) remained at a relatively constant temperature during the same time. This can occur in the early hours of the morning when and where there is negligible wastewater flow. The cable temperature can be dominated by ground temperatures rather than wastewater/groundwater inputs. The temperature of cable on the upstream side increases as it absorbs stored heat from the solar heated ground level paved surface. Less heat is absorbed and released to the wastewater pipe and cable that is located below vegetated ground cover.

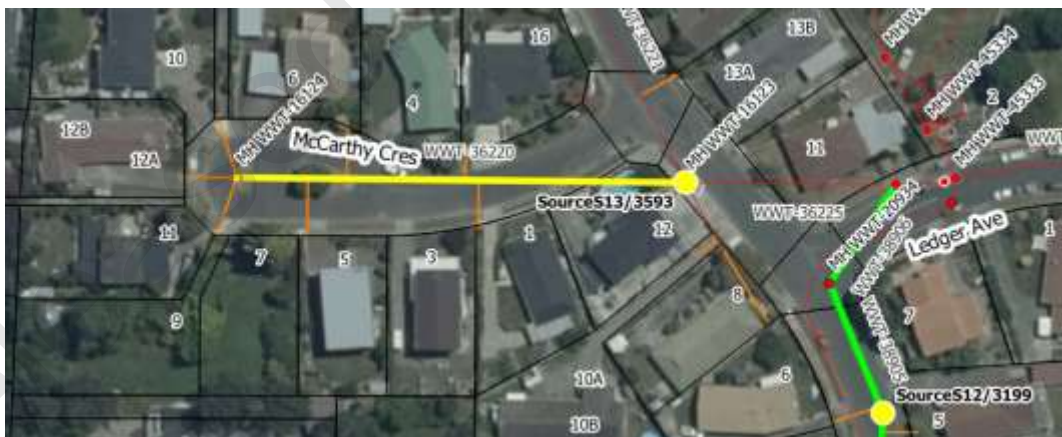
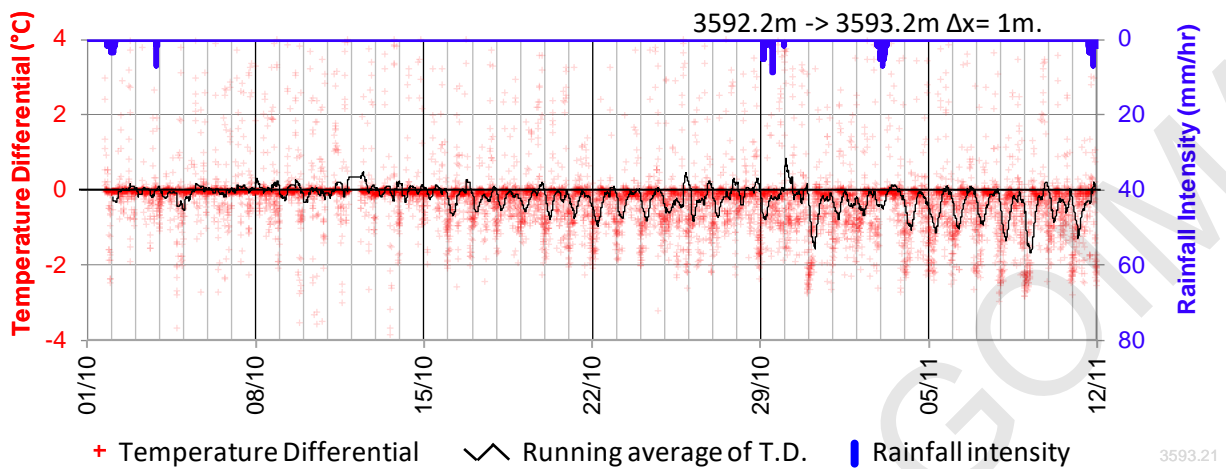
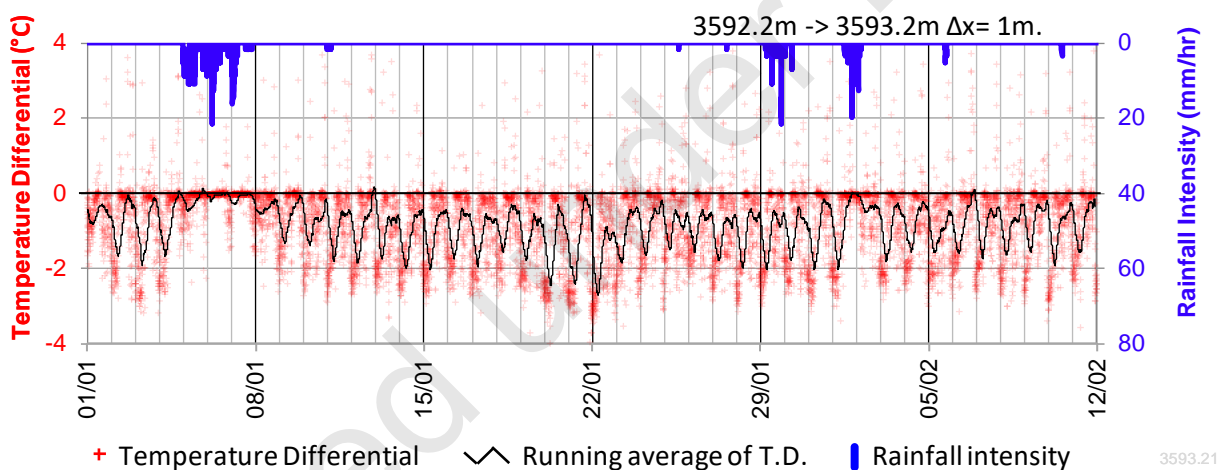
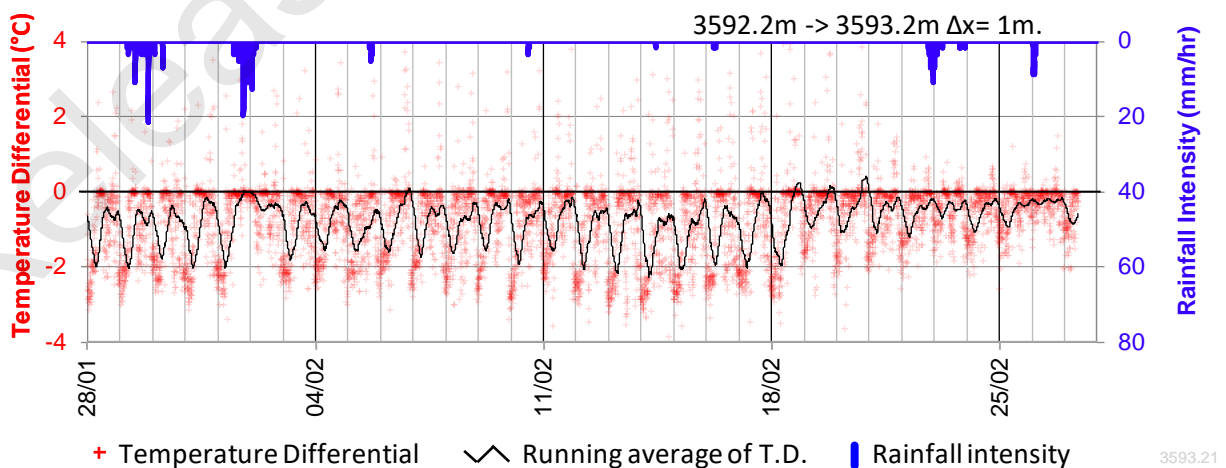
Asset	Manhole 16123
Address	12 Goodman Drive.
DTS signal	Strong, at Manhole 16123 and/or the unmonitored upstream catchment.
Analysis	Reduction in temperature in the early hours of the morning indicating ground water infiltration. The wastewater main in McCarthy Crescent was not directly monitored by DTS so the DTS data cannot be used to pinpoint where in McCarthy Crescent might the source(s) of I&I are located.
Recommendation	Inspection of manholes 16123 and 16124 checking for signs of deterioration and infiltration. CCTV inspection of pipe 36220 checking for signs of deterioration and infiltration. Any connection into this pipe should be inspected, including any properties (4, 6,10, 12A, 12B, 11, 9, 7, 5, 3, 1 McCarthy Crescent, and 8, 10A, 10B, 12, 16 Goodman Drive. As part of the property inspections, it is recommended to enquire if there were any construction works starting in October 2022 that may have led to discharges or groundwater infiltration into the wastewater network.

Note	There appears to be a discrete increase in the groundwater infiltration starting on the 16/10/2023 that is not related rainfall. This may have been caused by construction works affecting wastewater assets in the unmonitored catchment.

Source Analysis Plot – Temperature Difference vs Time – Groundwater infiltration starting on 16<sup>th</sup> October 2022.

Source Analysis Plot – Temperature Difference vs Time – Typical throughout summer of 2022 / 2023.

Source Analysis Plot – Temperature Difference vs Time – Possible end or reduction of GWI in late February.

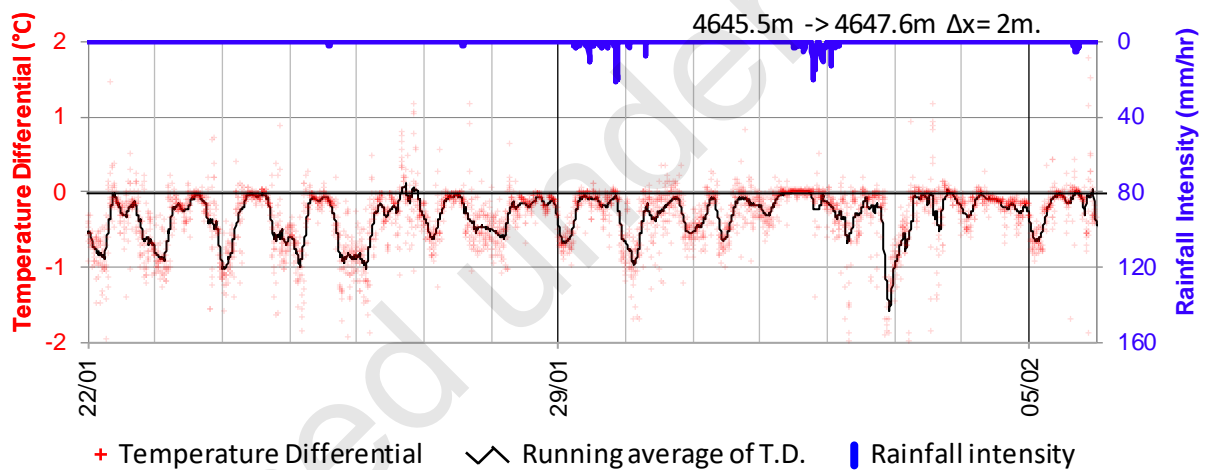
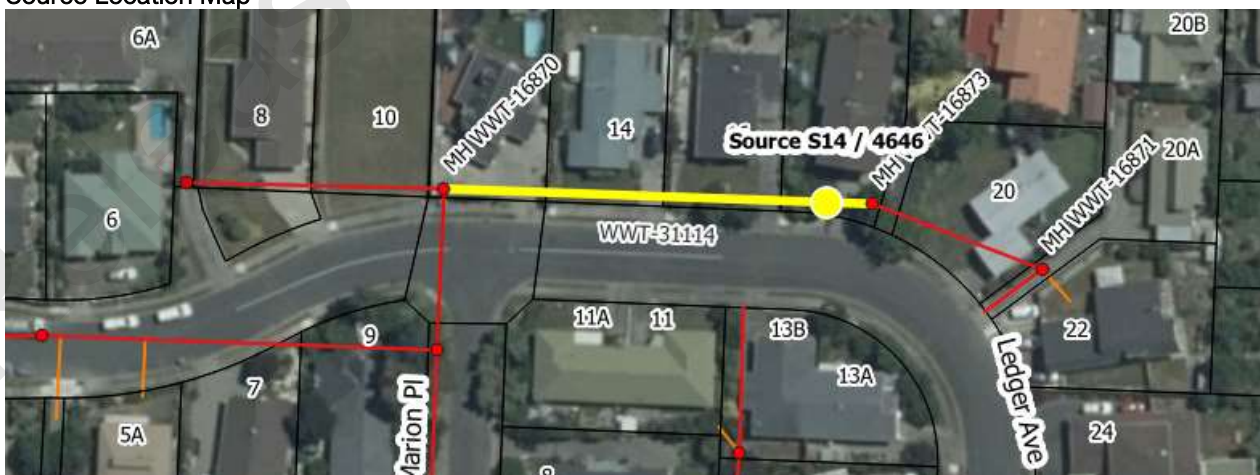
### A.14.1 Source S14 / 4646

Asset	Pipe 31114 DN150, 67m, PVC, 1977.
Address	18 Ledger Avenue.
DTS signal	Strong, 7m ±3m downstream of manhole 16873.
Analysis	Reduction in temperature in the early hours of the morning indicating ground water infiltration.
Recommendation	CCTV inspection of pipe 31114 checking for signs of deterioration and infiltration and to determine the connection point of laterals not shown on the GIS map (18 Ledger Ave.). Inspection of nearby connected properties (18 Ledger Ave.) looking for deterioration and infiltration.
Note	Use the CCTV data to update the connection points for the laterals not shown in the GIS map. Include property inspections only if they are within five metres of the DTS signal.

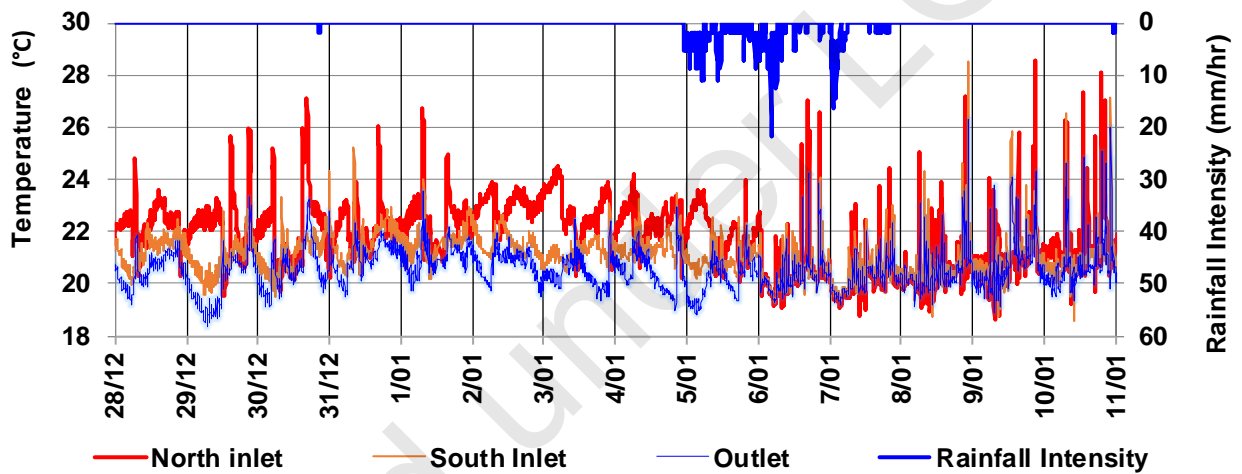
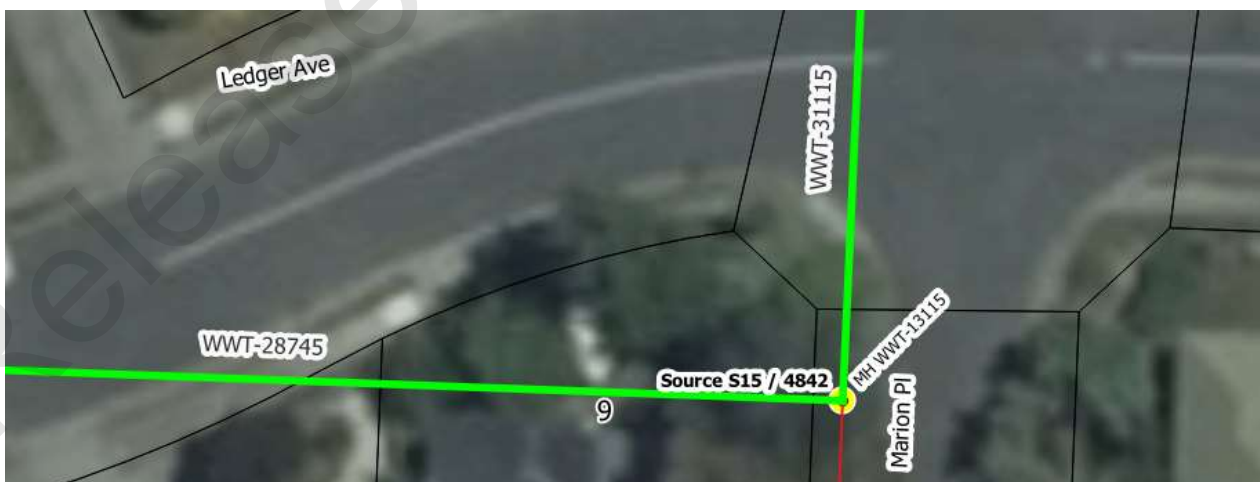
### A.15.1 Source S15 / 4842 <new>

Asset	Manhole 13115.
Address	9 Ledger Avenue.
DTS signal	Strong. At manhole 16870.
Analysis	Temperature differential below 0°C during low wastewater flows in the early hours of the morning indicating ground water infiltration.
Recommendation	Inspection of manhole 13115 checking for signs of deterioration and infiltration.

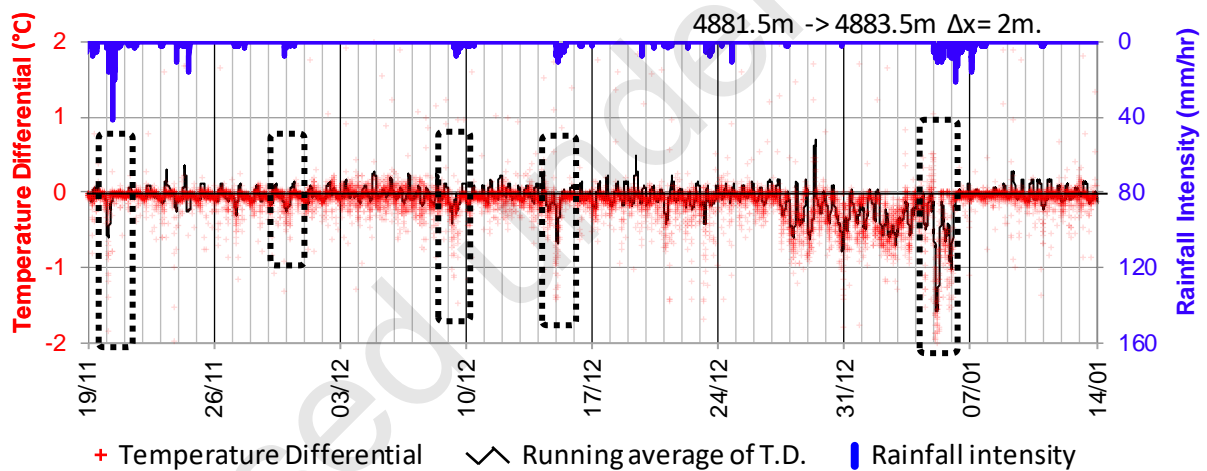
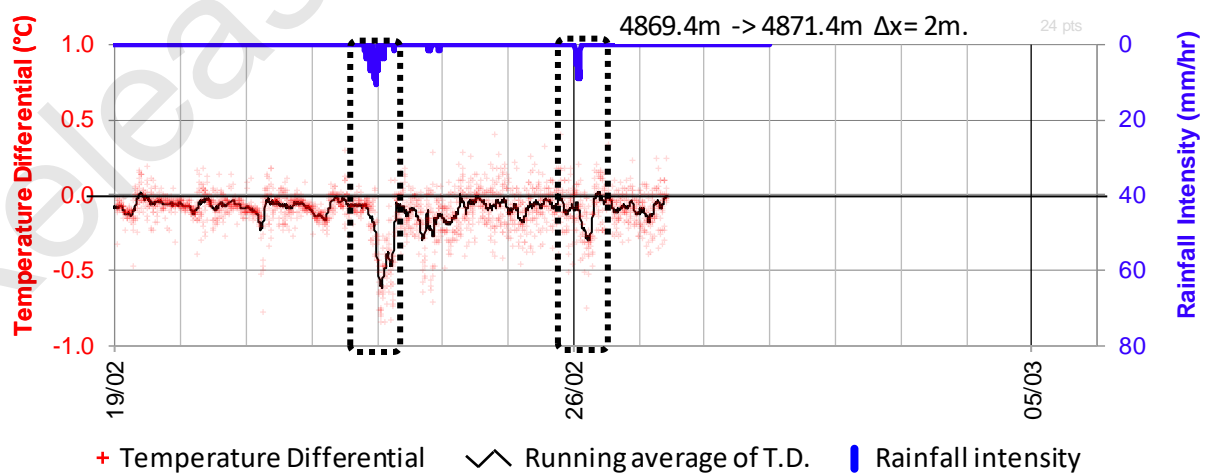
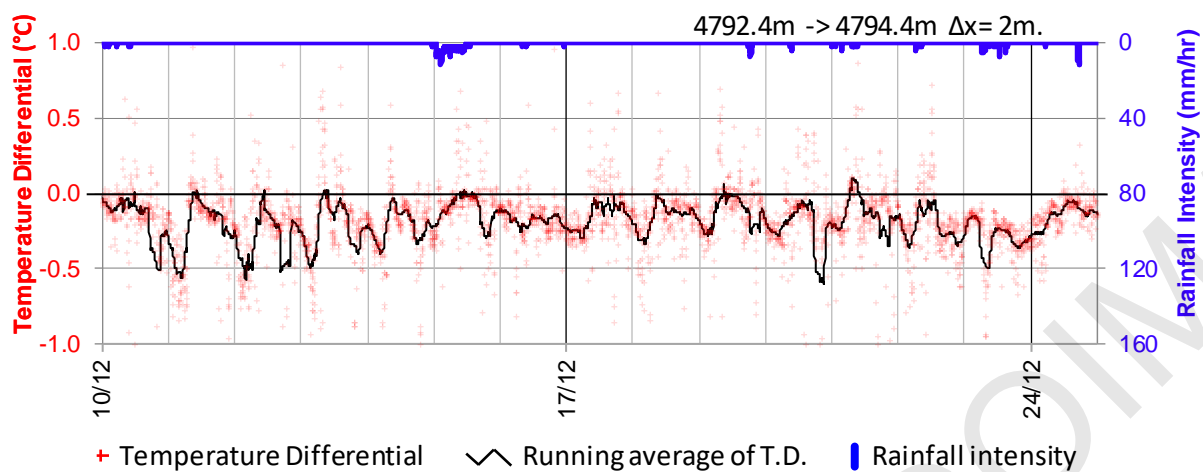
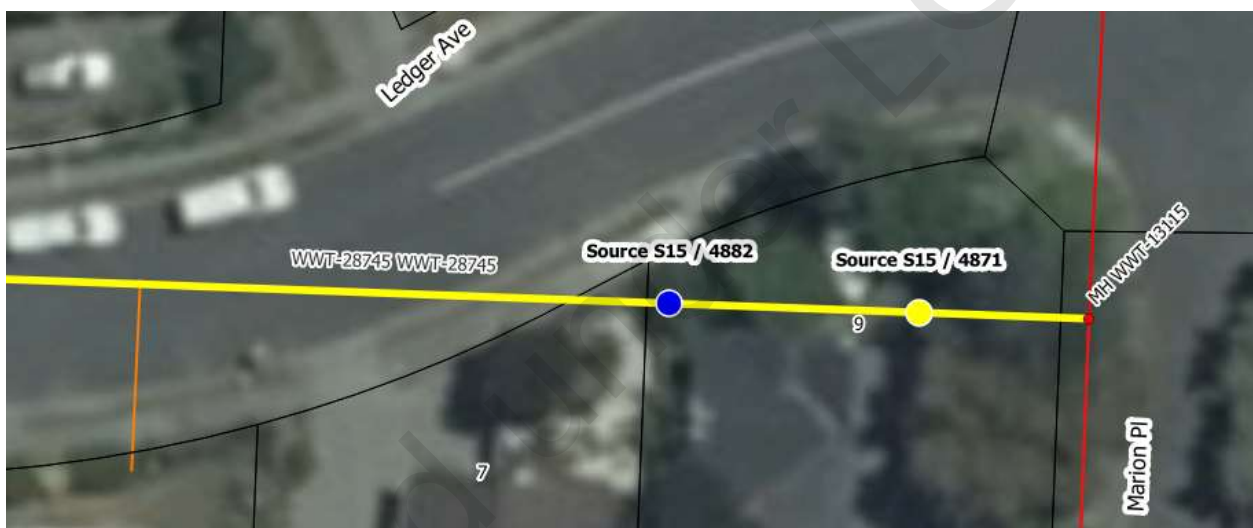
## A.15.2 Source S15 / 4882 and S15 / 4872

Asset	Pipe 28745 DN150, 62m, PVC, 1977.
Address	9 Ledger Avenue.
DTS signal	Strong, 42m and 52m $\pm$ 3m upstream of manhole 14576.
Analysis	Reduction in temperature in the early hours of the morning indicating ground water infiltration. Reduction in temperature during rainfall indicating stormwater inflow.
Recommendation	CCTV inspection of pipe 28745 checking for signs of deterioration and infiltration and to determine the connection point of laterals not shown on the GIS map (9 Ledger Ave.). Inspection of nearby connected properties (9 Ledger Ave.) looking for deterioration, infiltration, and inflow.
Note	Two separate signals were found within the boundaries of 9 Ledger Avenue.

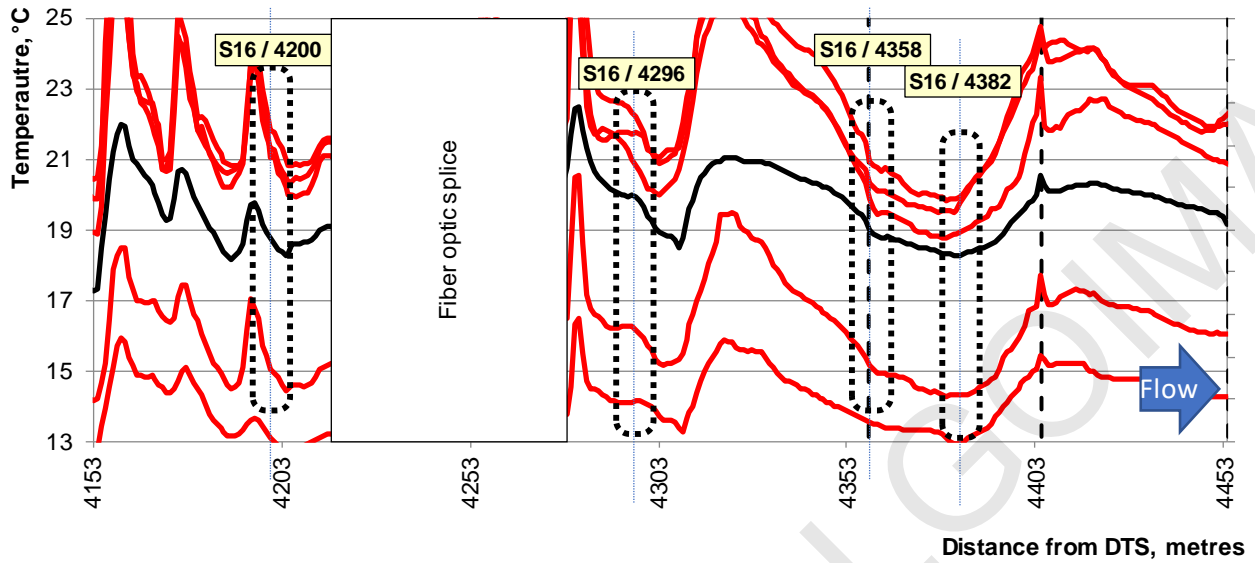
The temperature spikes between 4150 m and 4200 m are caused by solar heating of vehicle driveways transferring heat to the wastewater pipe. The cooler sections in-between have soil, grass, or vegetation above the wastewater pipe.

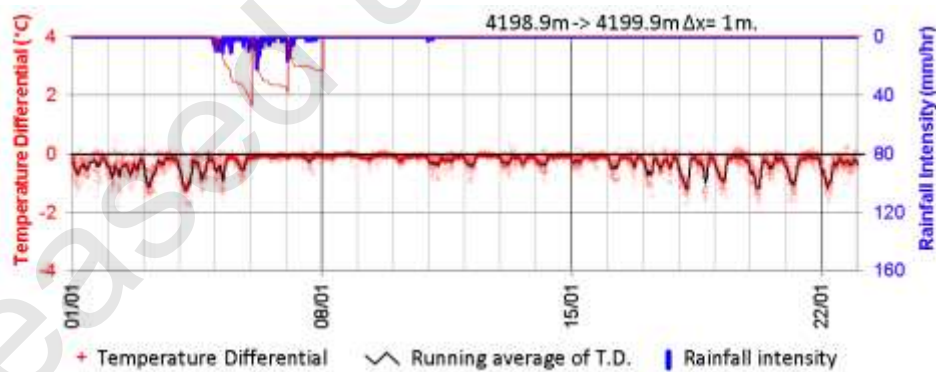
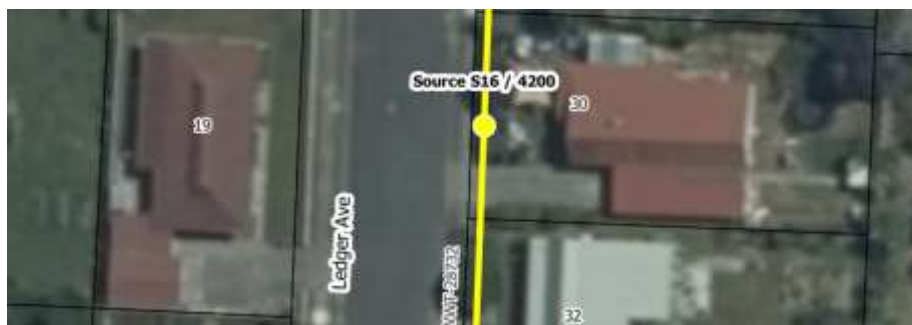
Asset	Pipe 28732 DN150, 64m, PVC, 1977.
Address	30 Ledger Avenue.
DTS signal	Strong, 17m ±3m upstream of manhole 14958.
Analysis	Reduction in temperature in the early hours of the morning indicating ground water infiltration.
Recommendation	CCTV inspection of pipe 28732 checking for signs of deterioration and infiltration and to determine the connection point of laterals not shown on the GIS map (30 Ledger Ave.). Inspection of nearby connected properties (30 Ledger Ave.) looking for deterioration and infiltration.
Note	<p>Use the CCTV data to update the connection points for the laterals not shown in the GIS map. Inspection of the private properties has been included to assess if the laterals are contributing infiltration. Include property inspections only if they are within five metres of the DTS signal.</p> <p>The masking of I&amp;I during and following rain events indicates significant upstream I&amp;I. No sources of I&amp;I were clearly identified from the DTS data upstream of the point. This is due to the significant thermal gradients caused by solar heating of driveways impacting the DTS data.</p> <p>Given the age of the pipe, remediation of significant amounts of the upstream catchment may be required.</p>

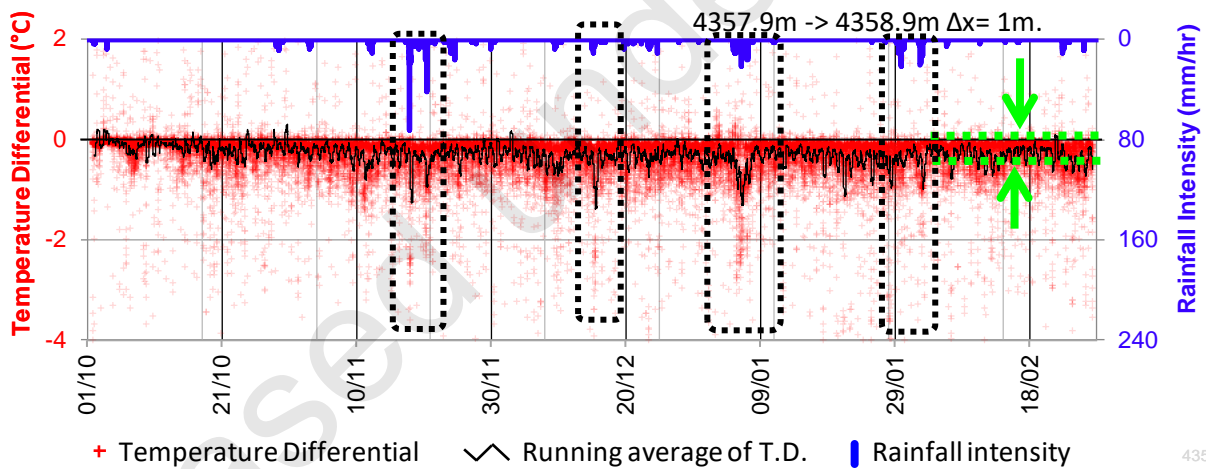
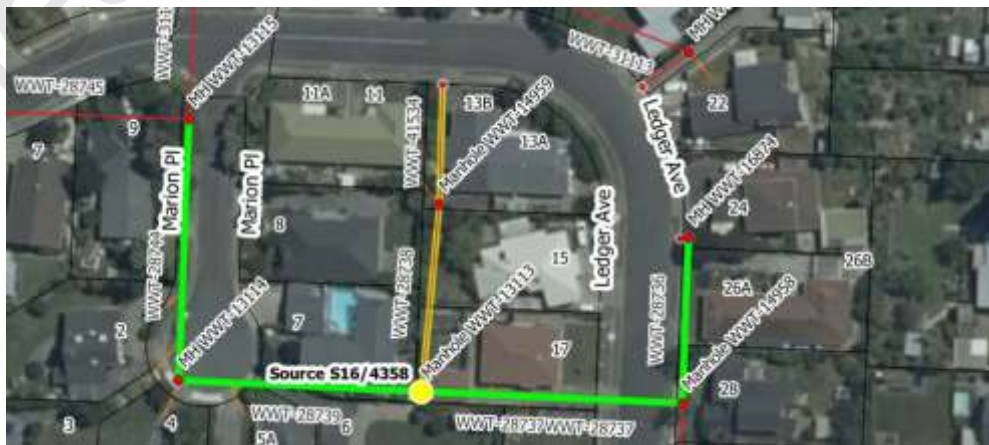
## A.16.2 Source S16 / 4358

Asset	Manhole 13113.
Address	6 Marion Place.
DTS signal	Strong, at manhole 13113.
Analysis	Temperature differential generally below 0°C indicating groundwater infiltration. Temperature drop is correlated with rainfall indicating stormwater inflow.
Recommendation	Inspection of manholes 13113, 14959, and Flushing Point 41698 (at footpath boundary) checking for signs of deterioration and infiltration. CCTV inspection of pipes 28738 and 41534 checking for signs of deterioration and infiltration. Any connection into this pipe should be inspected, including any properties (8 Marion Place, 11, 11A, 13A, 13B, 15 Ledger Avenue).
Note	Use the CCTV data to update the connection points for the laterals not shown in the GIS map. Include property inspections only if they are within five metres of the DTS signal.

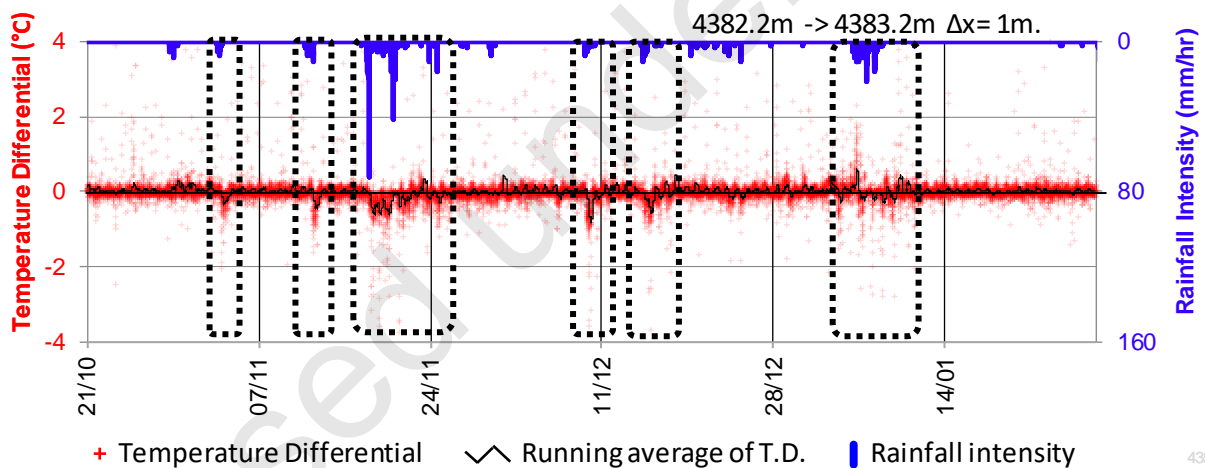
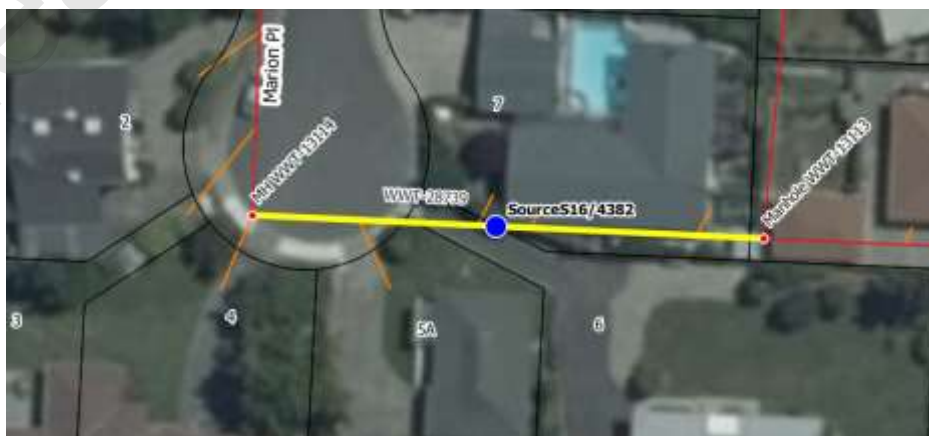
### A.16.3 Source S16 / 4382

Asset	Pipe 28739 DN150, 46m, PVC, 1977.
Address	6 Marion Place.
DTS signal	Strong, 22 m upstream of manhole 13114.
Analysis	Immediate and delayed reduction in temperature correlated with rainfall indicating stormwater inflow and rainfall dependent infiltration.
Recommendation	CCTV inspection of pipe 28739 to determine the connection point of laterals not shown on the GIS map. Inspection of nearby connected properties (6 and 7 Marion Place) looking for deterioration and/or stormwater connections.
Note	Use the CCTV data to update the connection points for the laterals not shown in the GIS map. Include property inspections only if they are within five metres of the DTS signal.

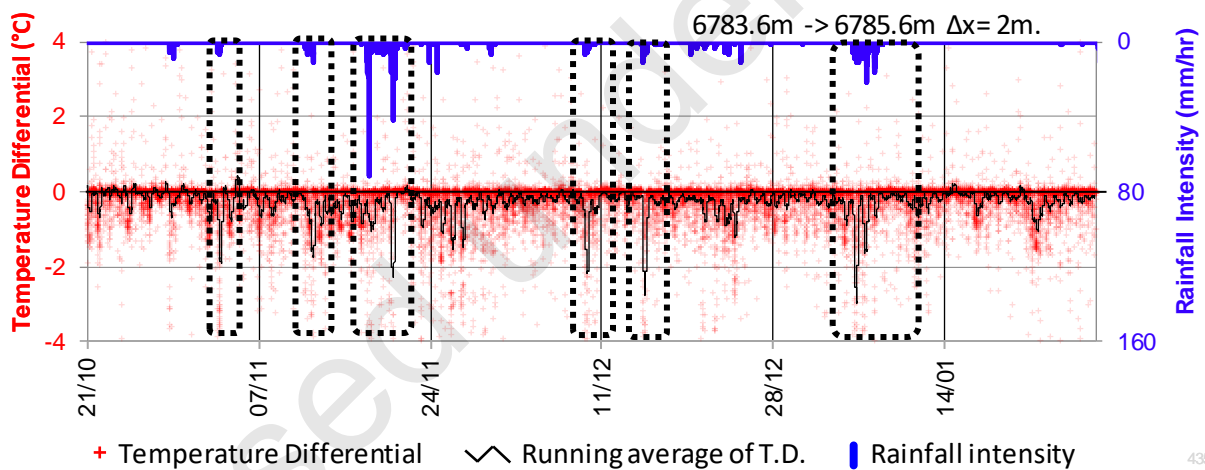
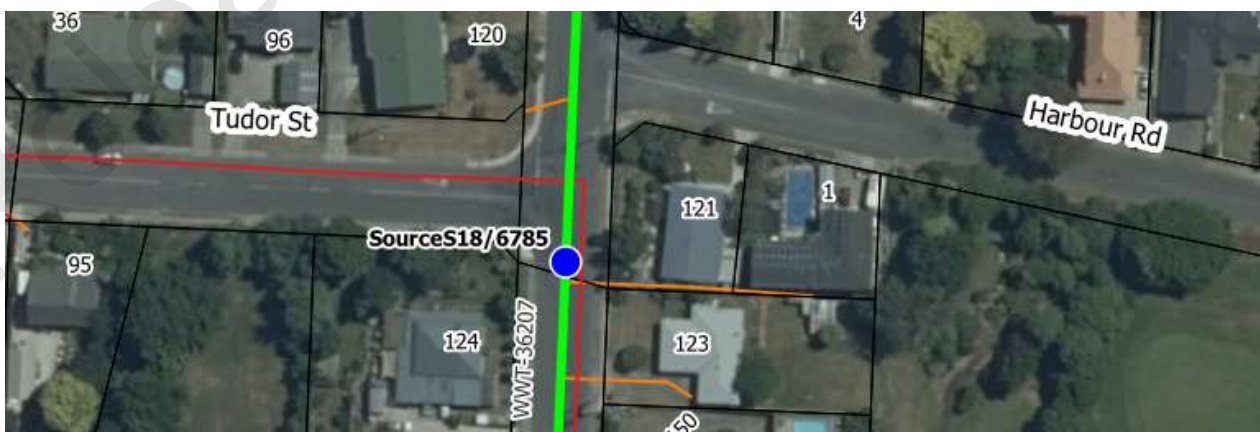
### A.18.1 Source S18 / 6785

Asset	Pipe 36207 DN150, 96m, PVC Class B, 1954.
Address	121 Thorp Street.
DTS signal	Strong, 45m ±5m upstream of manhole 12313.
Analysis	Reduction in temperature during rainfall indicating stormwater inflow.
Recommendation	CCTV inspection of pipe 36207 to determine the connection point of laterals not shown on the GIS map. Inspection of nearby connected properties (121 and 124 Thorp Street, 1 Harbour Road) looking for deterioration and/or stormwater connections.
Note	Use the CCTV data to update the connection points for the laterals not shown in the GIS map. Include property inspections only if they are within five metres of the DTS signal.
