**OFFICIAL INFORMATION REQUEST: FIBRE OPTIC INSPECTION SYSTEM (REF: 3610)**

# Motueka Wastewater I&I Assessment Using Distributed Temperature Sensing

Goodman Park Pump Station Catchment  
Final Report

30<sup>th</sup> April 2024

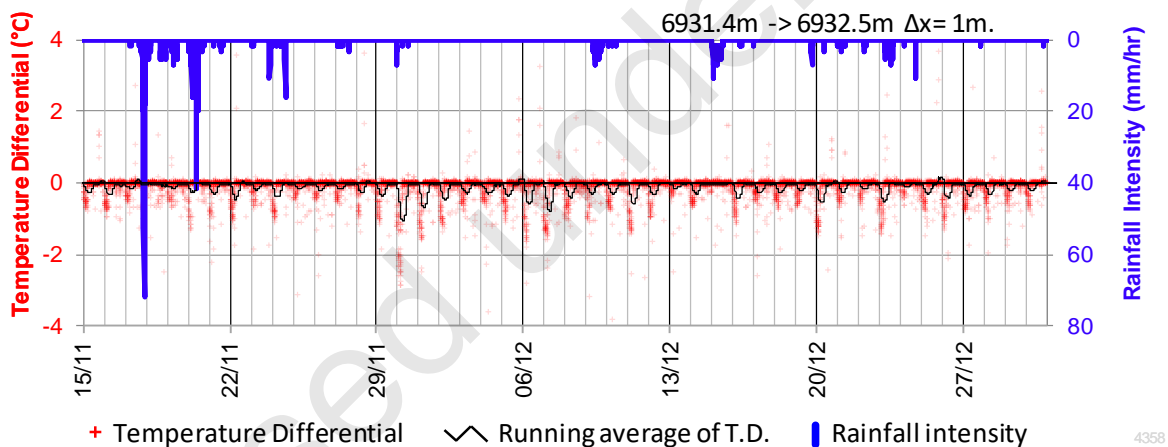
## A.18.2 Source S18 / 6932

Asset	Pipe 28728 DN150, 108m, Concrete, 1949.
Address	107 Thorp Street.
DTS signal	Strong, 8m ±5m upstream of manhole 12312.
Analysis	Reduction in temperature in the early hours of the morning indicating ground water infiltration.
Recommendation	CCTV inspection of pipe 28728 checking for signs of deterioration and infiltration and to determine the connection point of laterals not shown on the GIS map. Inspection of nearby connected properties (107 and 110 Thorp Street) looking for deterioration and infiltration.
Note	Use the CCTV data to update the connection points for the laterals not shown in the GIS map. Include property inspections only if they are within five metres of the DTS signal.

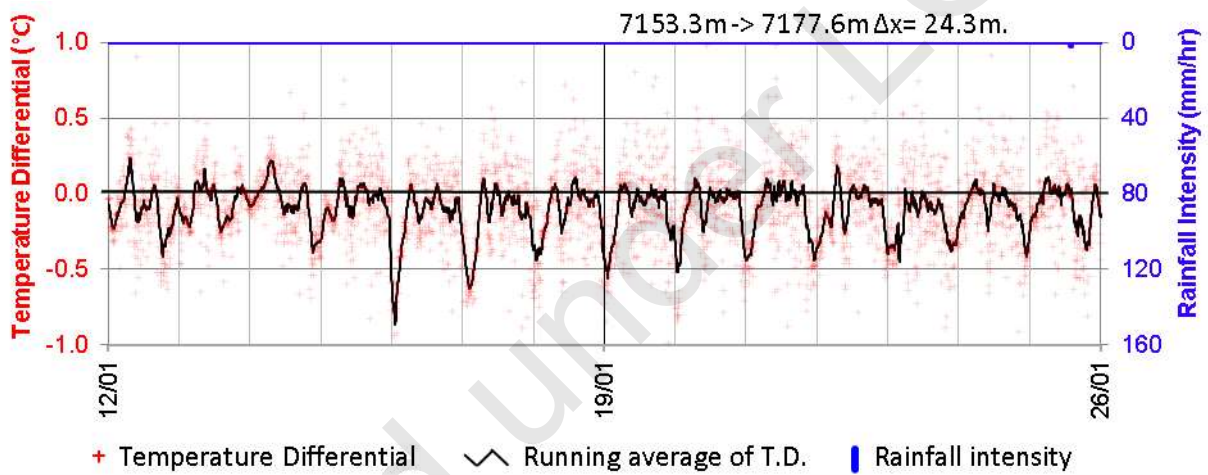
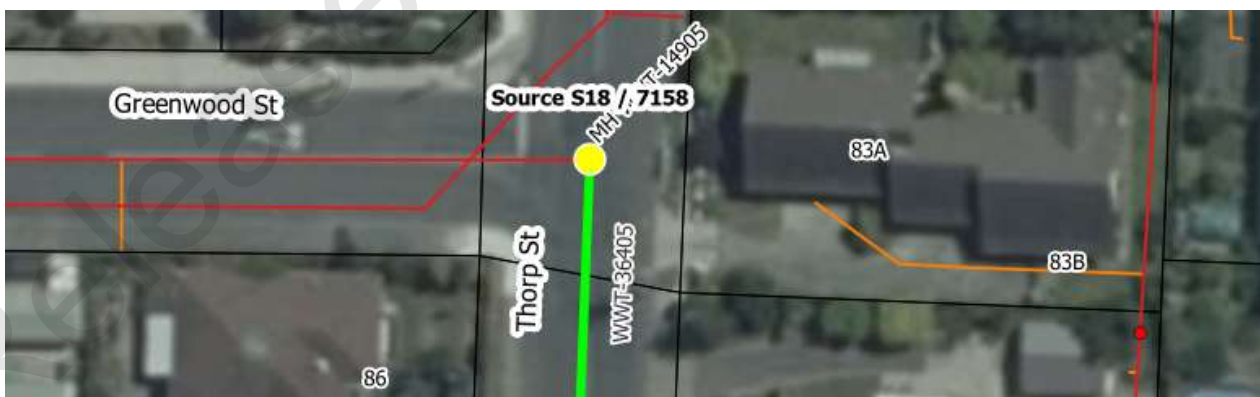
### A.18.3 Source S18 / 7158

Asset	Manhole 14905
Address	83A Thorp Street.
DTS signal	Medium. At manhole 14905.
Analysis	Reduction in temperature in the early hours of the morning indicating ground water infiltration.
Recommendation	Inspection of manhole checking for signs of deterioration and infiltration.

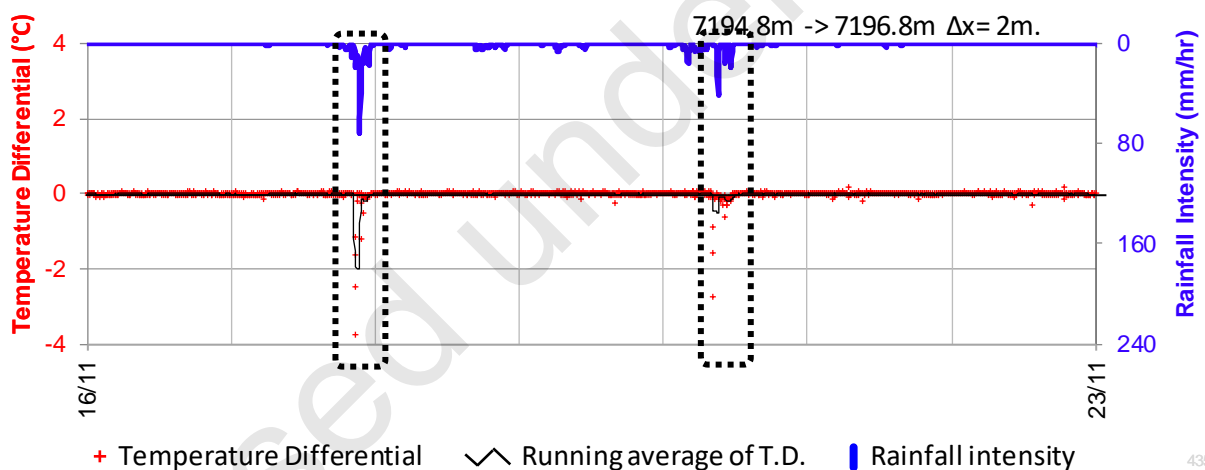
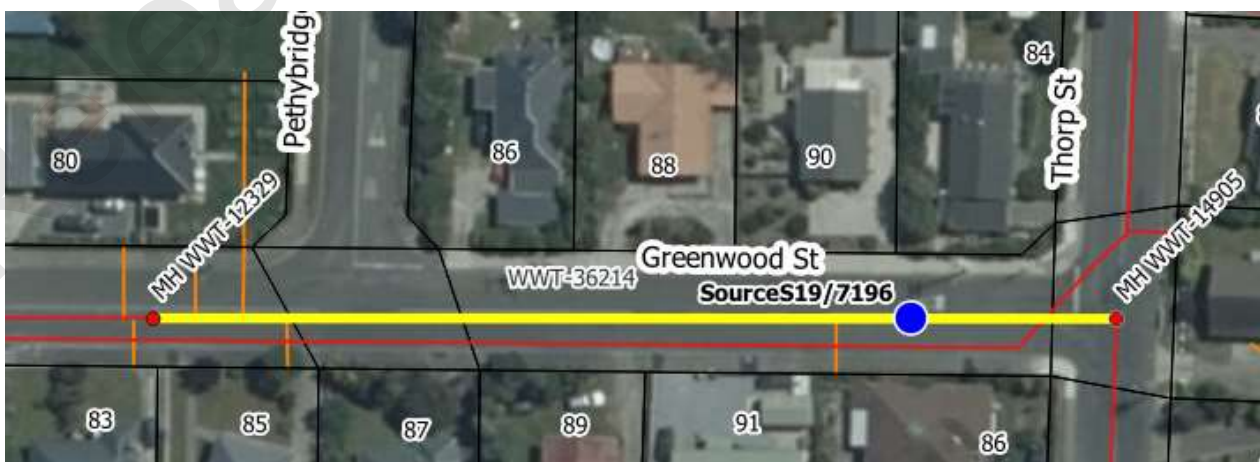
### A.19.1 Source S19 / 7196

Asset	Pipe 36214 DN150, 121m, Concrete, 1949.
Address	84 Thorp Street (on Greenwood Street frontage).
DTS signal	Medium, 27m ±5m downstream of manhole 14905.
Analysis	Reduction in temperature during rainfall indicating stormwater inflow.
Recommendation	CCTV inspection of pipe 36214 to determine the connection point of laterals not shown on the GIS map. Inspection of nearby connected properties (84 Thorp Street) looking for deterioration and/or stormwater connections.
Note	Use the CCTV data to update the connection points for the laterals not shown in the GIS map. Include property inspections only if they are within five metres of the DTS signal.

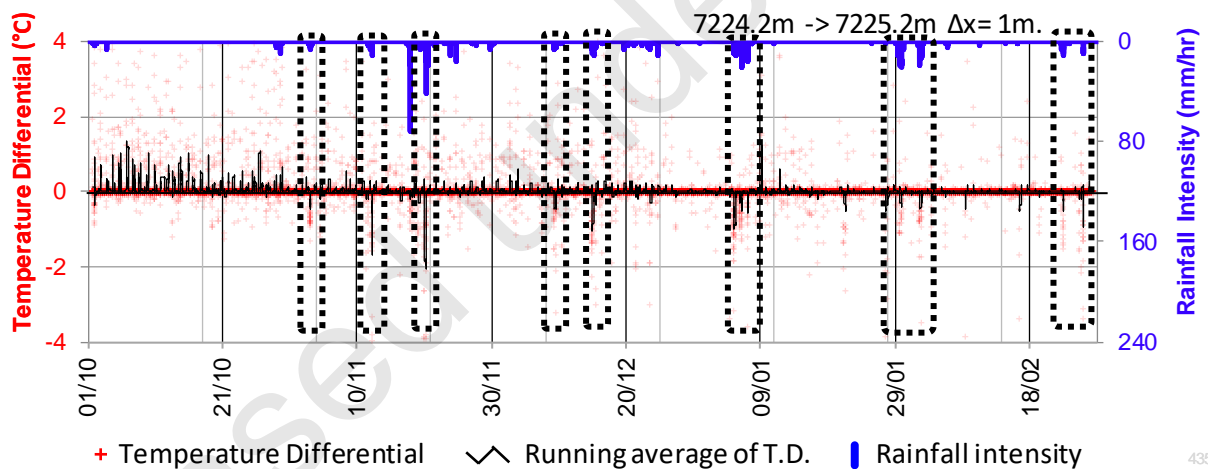
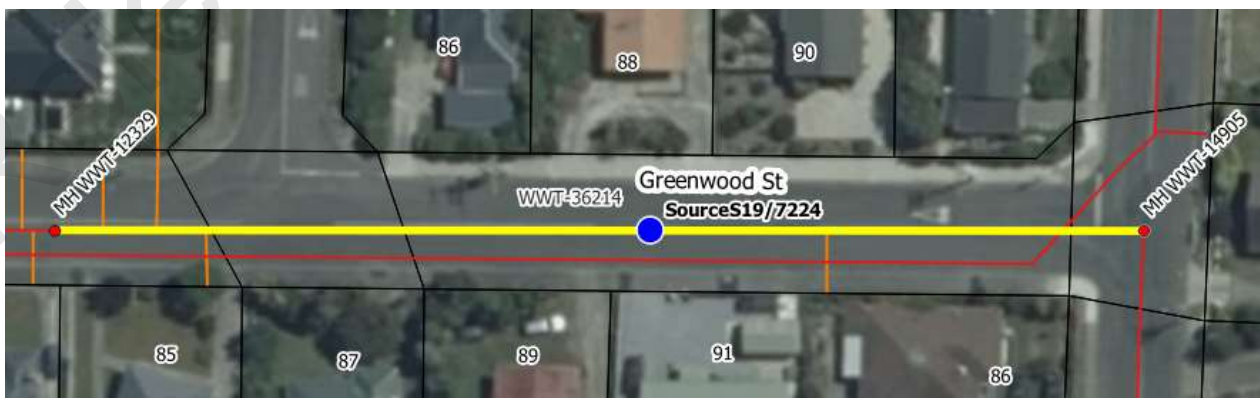
## A.19.2 Source S19 / 7224

Asset	Pipe 36214 DN150, 121m, Concrete, 1949.
Address	88 Greenwood Street.
DTS signal	Strong, 67m ±5m upstream of manhole 12329.
Analysis	Reduction in temperature during rainfall indicating stormwater inflow.
Recommendation	CCTV inspection of pipe 36214 to determine the connection point of laterals not shown on the GIS map. Inspection of nearby connected properties (88 and 91 Greenwood Street) looking for deterioration and/or stormwater connections.
Note	CCTV inspection for this pipe is included under the recommendations for another I&I source. Use the CCTV data to update the connection points for the laterals not shown in the GIS map. Include property inspections only if they are within five metres of the DTS signal.

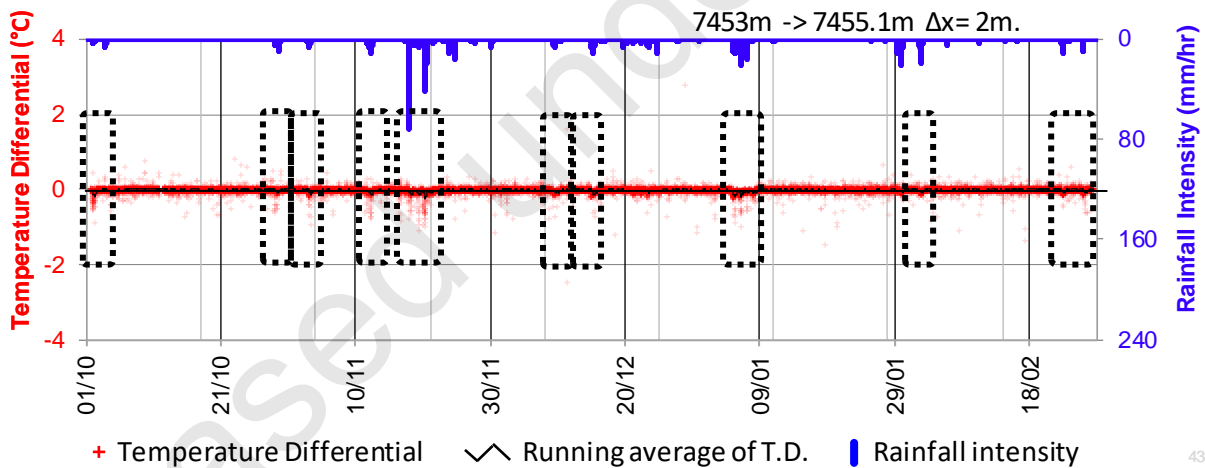
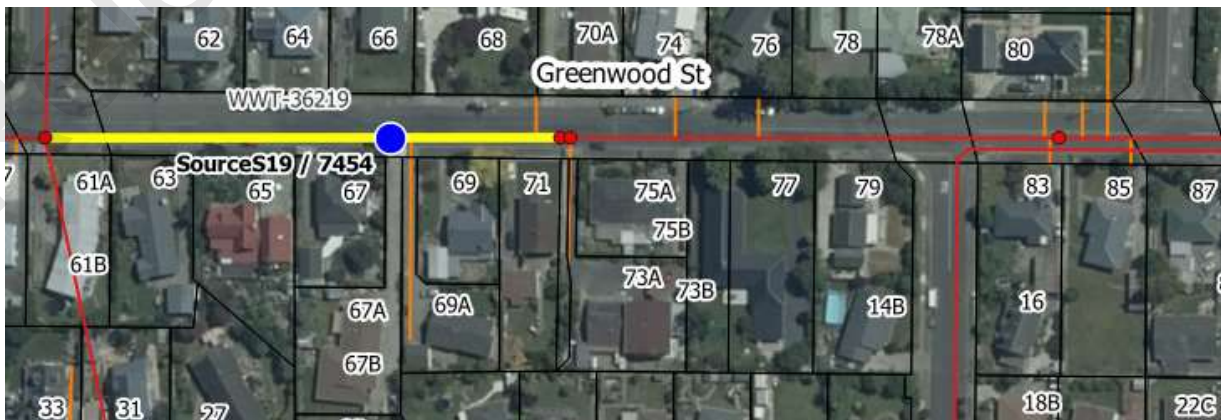
### A.19.3 Source S19 / 7454

Asset	Pipe 36219 DN150, 123m, Concrete, 1949.
Address	67A Greenwood Street.
DTS signal	Medium, 84m ±6m upstream of manhole 14912.
Analysis	Reduction in temperature during rainfall indicating stormwater inflow.
Recommendation	CCTV inspection of pipe 36219 to determine the connection point of laterals not shown on the GIS map (66, 67, 67A, 67B Greenwood St.). Inspection of nearby connected properties (66, 67, 67A, 67B, 69, 69A Greenwood St.) looking for deterioration and inflow.
Note	Use the CCTV data to update the connection points for the laterals not shown in the GIS map. Include property inspections only if they are within six metres of the DTS signal. CCTV inspection for pipe 36219 is included under the recommendations for I&I source S19 / 7475.

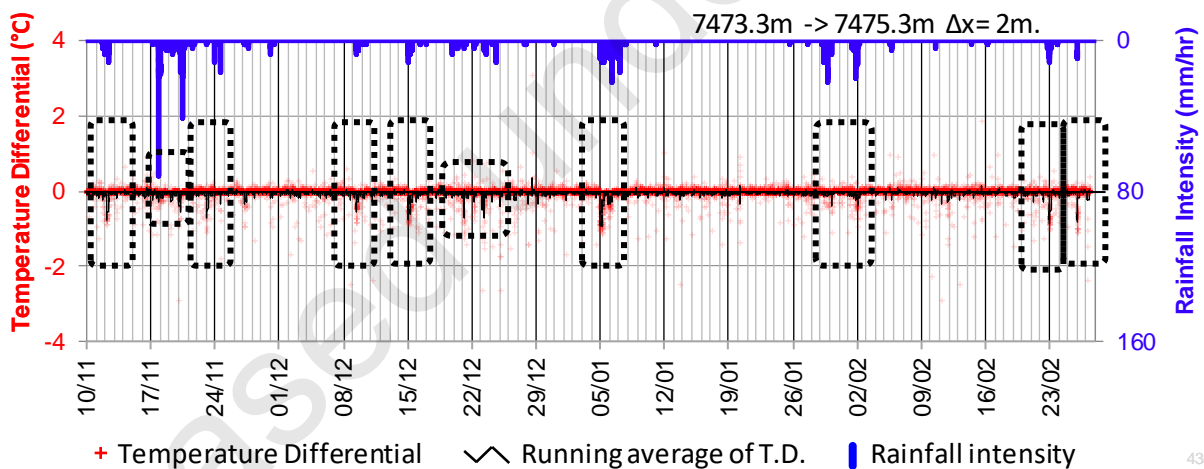
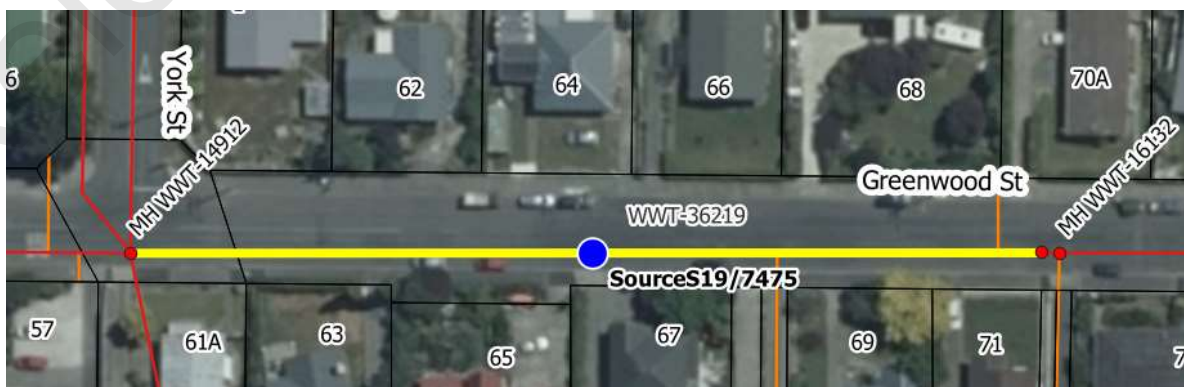
## A.19.4 Source S19 / 7475

Asset	Pipe 36219 DN150, 123m, Concrete, 1949.
Address	67 Greenwood Street.
DTS signal	Strong, 63m ±5m upstream of manhole 14912.
Analysis	Reduction in temperature during rainfall indicating stormwater inflow.
Recommendation	CCTV inspection of pipe 36219 to determine the connection point of laterals not shown on the GIS map. Inspection of nearby connected properties (64 and 67 Greenwood Street) looking for deterioration and/or stormwater connections.
Note	Use the CCTV data to update the connection points for the laterals not shown in the GIS map. Include property inspections only if they are within five metres of the DTS signal. Property inspection of 67 Greenwood Street is listed under the recommendations for I&I source S19 / 7454.

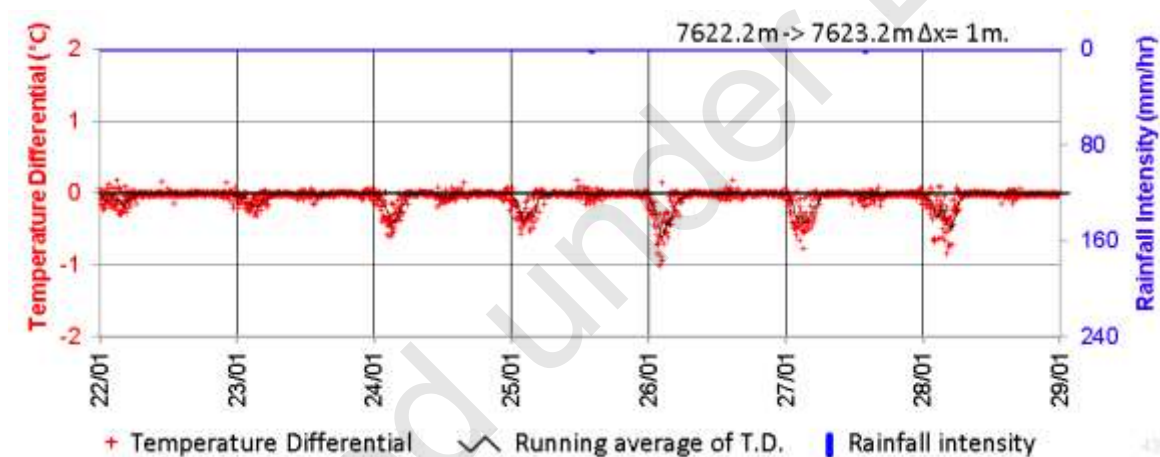
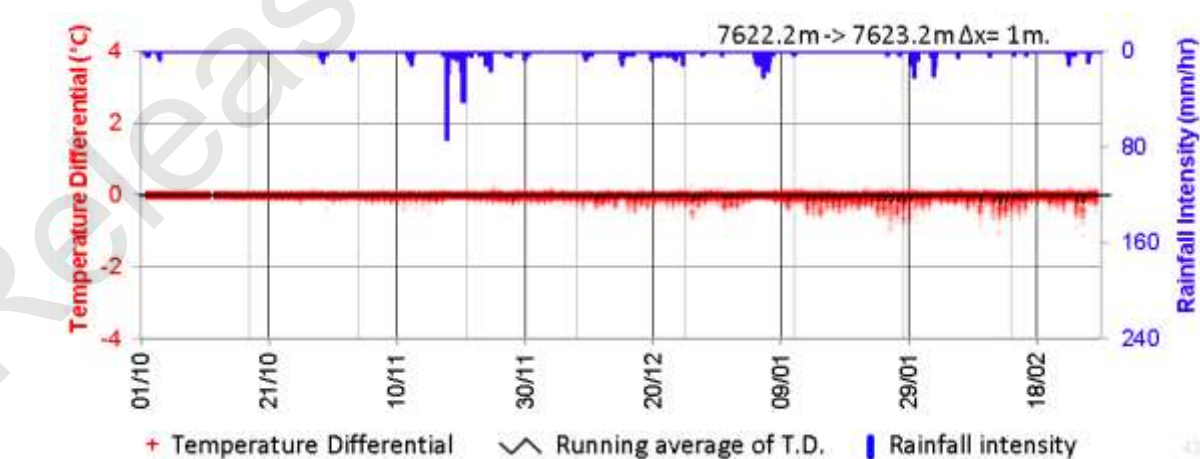
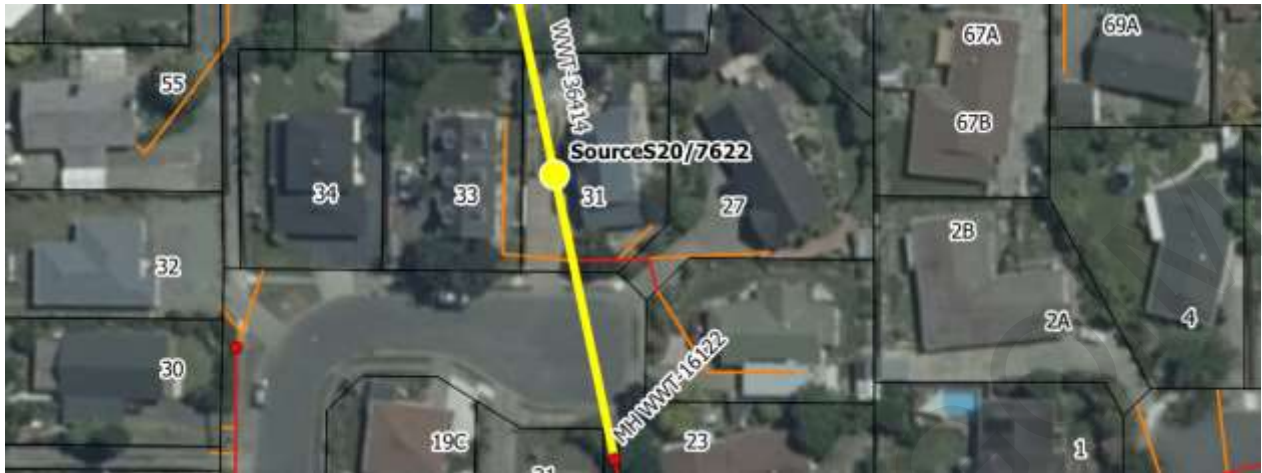
### A.20.1 Source S20 / 7622

Asset	Pipe 36414	DN300, 106m, Concrete, 1949.
Address	31 Goodman Drive.	
DTS signal	Strong, 43m ±4m upstream of manhole 16122.	
Analysis	Reduction in temperature in the early hours of the morning indicating ground water infiltration. The infiltration signal varies from nothing during extended dry periods to a strong signal for multiple weeks after rain, indicating rainfall dependent infiltration.	
Recommendation	CCTV inspection of pipe 36414 checking for signs of deterioration and infiltration. This CCTV inspection is listed under source S20 / 7629.

Source Analysis Plot – Temperature Difference vs Time – showing a clear temperature drop each morning.

Source Analysis Plot – Temperature Difference vs Time – showing variation during dry and wet conditions.

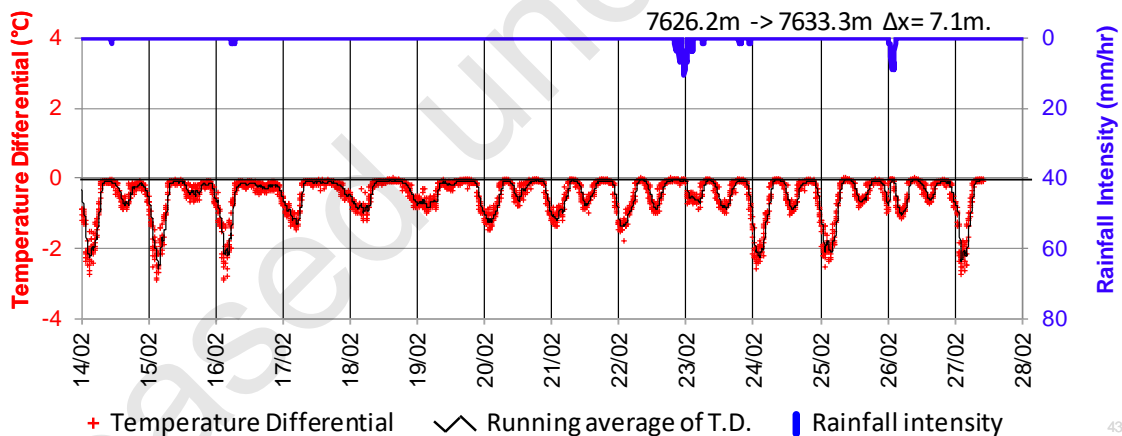
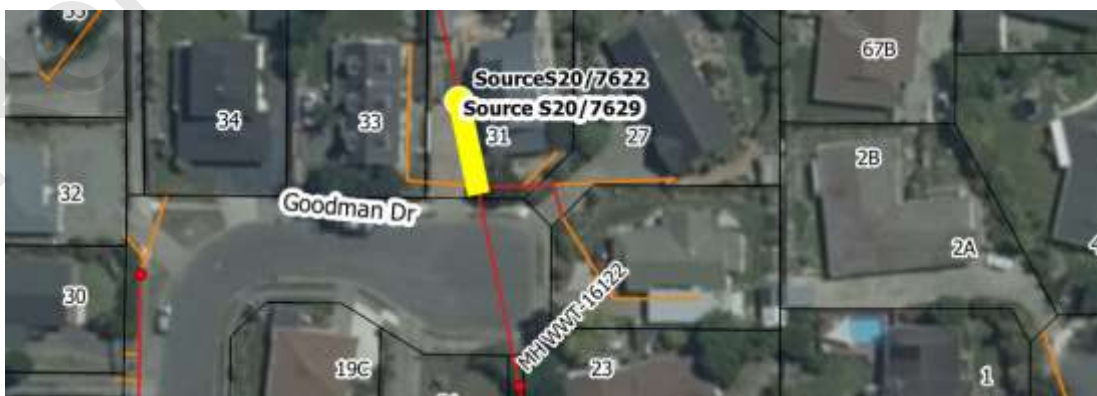
## A.20.2 Source S20 / 7629

Asset	Pipe 36414 DN300, 106m, Concrete, 1949.
Address	31 Goodman Drive.
DTS signal	Strong, 32m to 39m ±4m upstream of manhole 16122. The temperature drop extends over a length of the pipe. Source S20/7622 may be a separate source of I&I or Sources S20/7622 and S20/7629 may be considered a single source spread over a longer length of the wastewater main.
Analysis	Reduction in temperature in the early hours of the morning indicating ground water infiltration. The infiltration signal varies from nothing during extended dry periods to a strong signal for multiple weeks after rain, indicating rainfall dependent infiltration.
Recommendation	CCTV inspection of pipe 36414 checking for signs of deterioration and infiltration. Inspection of nearby connected properties (25, 27, 31, 33 Goodman Drive) looking for deterioration and infiltration.
Note	Inspection of the private properties has been included to assess if the laterals are contributing infiltration.

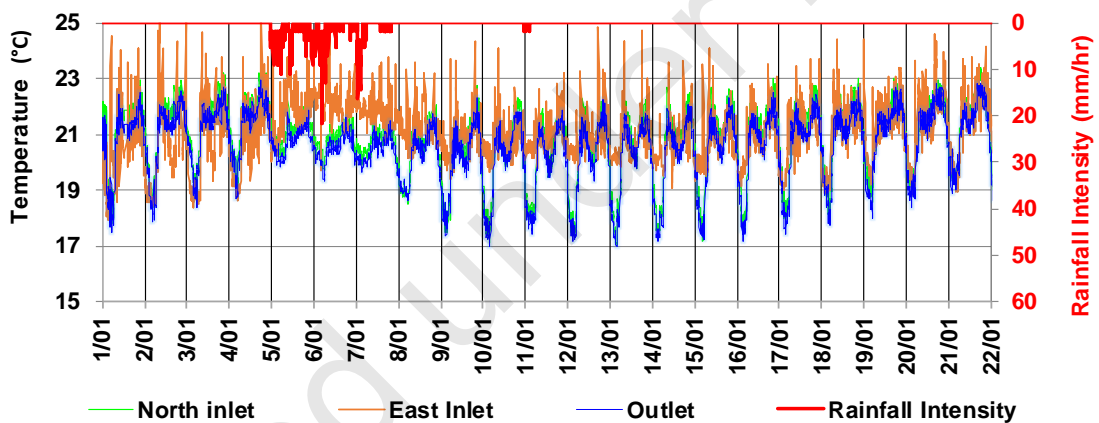
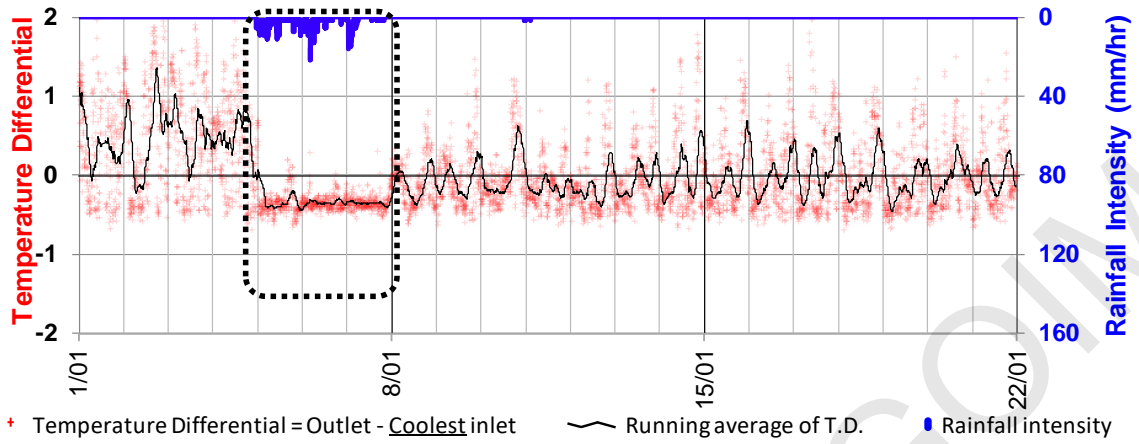
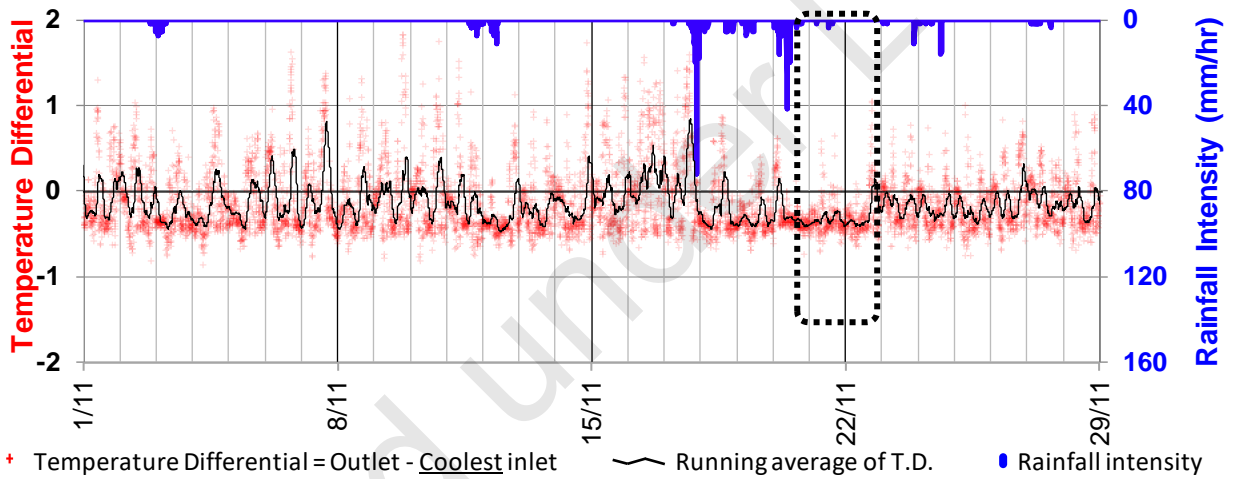
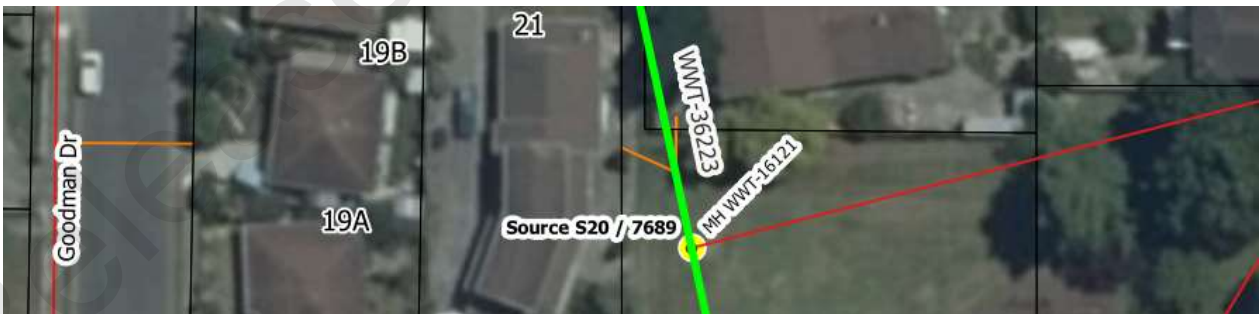
### A.20.3 Source S20 / 7689 <new>

Asset	Manhole 16121.
Address	Ledger Goodman Park.
DTS signal	Strong. At manhole 16122.
Analysis	Reduction in temperature in the early hours of the morning indicating ground water infiltration. Immediate and delayed reduction in temperature correlated with rainfall indicating stormwater inflow and rainfall derived infiltration.
Recommendation	Inspection of manhole 16121 checking for signs of poor construction, poor lid seal, surface inflow through cover keyholes, infiltration and/or inflow.

In the plot above it is difficult to visually observe the difference between the temperature of the northern inlet and the outlet. The difference between the temperature of the coolest inlet to the manhole and the outlet of the manhole is plotted below. This plot of temperature difference highlights when the outlet temperature is cooler than the inlet temperatures. The first plot below indicates stormwater inflow as the temperature difference ends when the rain stops. The second plot indicates rain dependent infiltration as the temperature difference continues for an extended period after the rain ends.

Source Analysis Plot – Temperature Difference vs Time showing stormwater inflow and GWI

Source Analysis Plot – Temperature Difference vs Time showing rain dependent infiltration

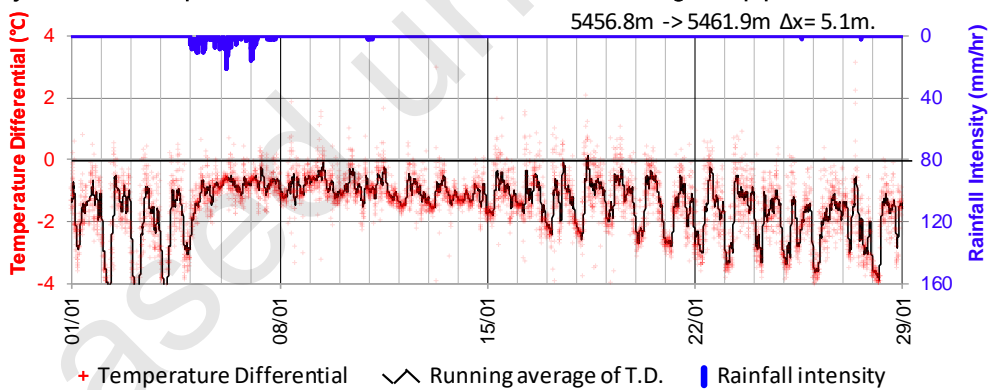
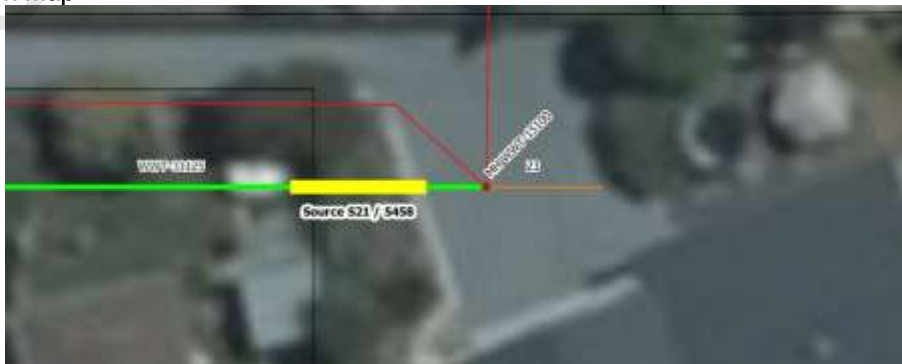
### A.21.1 Source S21 / 5458

Asset	Pipe 31125 DN150, 100m, Asbestos Cement, 1978.
Address	23 Kingstan Place.
DTS signal	Medium, 3-8m ±5m downstream of manhole 15100.
Analysis	Reduction in temperature in the early hours of the morning indicating ground water infiltration.
Recommendation	CCTV inspection of pipes checking for signs of deterioration and infiltration. Inspection of nearby connected properties (98A Thorp Street) looking for deterioration and infiltration.
Note	CCTV inspection for pipe 31125 is included under the recommendations for I&I source S21 / 5474. Use the CCTV data to update the connection points for the laterals not shown in the GIS map (98A Thorp Street). Include property inspections only if they are within five metres of the DTS signal. This analysis included assessment of the impacts of differential solar heating of ground surfaces. Solar differentials were assessed not to be the cause of the observed wastewater temperature differentials.

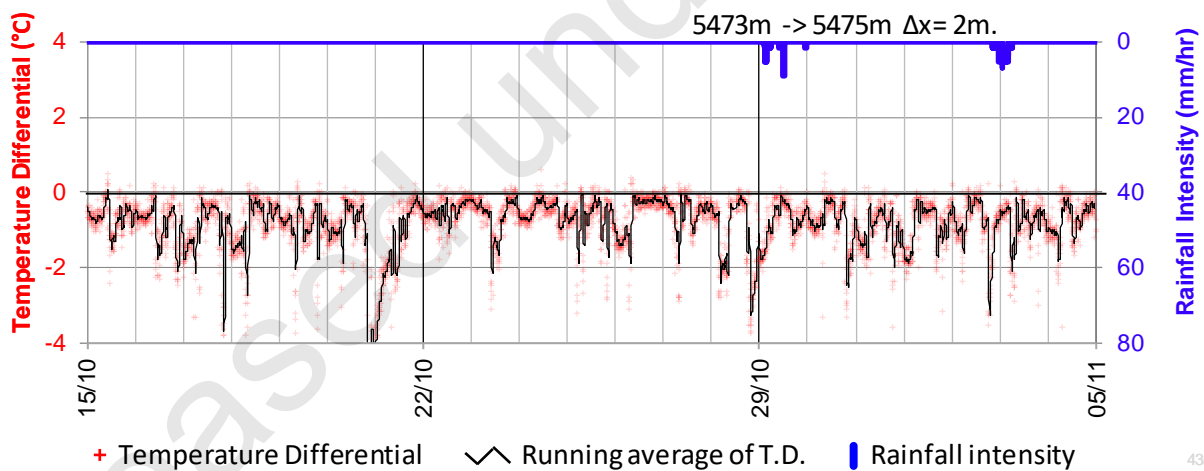
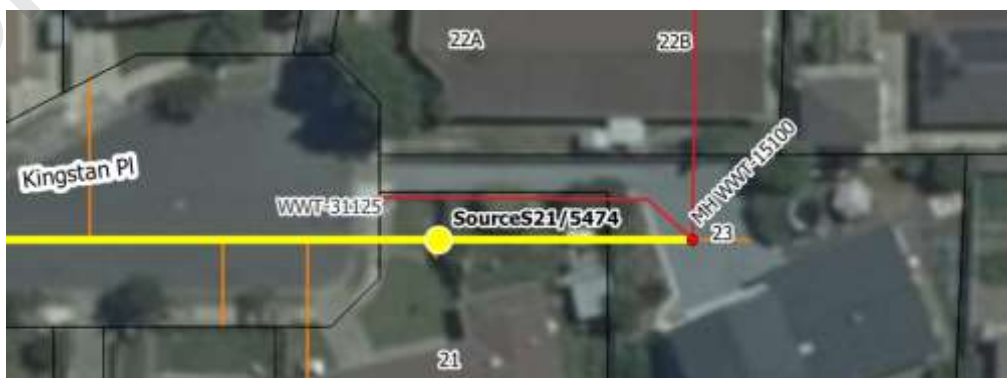
## A.21.2 Source S21 / 5474

Asset	Pipe 31125 DN150, 100m, Asbestos Cement, 1978.
Address	21 Kingstan Place.
DTS signal	Medium, 20m ±5m downstream of manhole 15100.
Analysis	Temperature differential generally below 0°C indicating GWI. The source is identified as infiltration so is expected to be a below ground fault or deterioration either in the wastewater main or a private lateral.
Recommendation	CCTV inspection of pipe 31125 checking for signs of deterioration and infiltration and to determine the connection point of laterals not shown on the GIS map (22A Kingstan Place). Inspection of nearby connected properties (21 and 22A Kingstan Place) looking for deterioration and infiltration.
Note	Use the CCTV data to update the connection points for the laterals not shown in the GIS map. Include property inspections only if they are within five metres of the DTS signal.

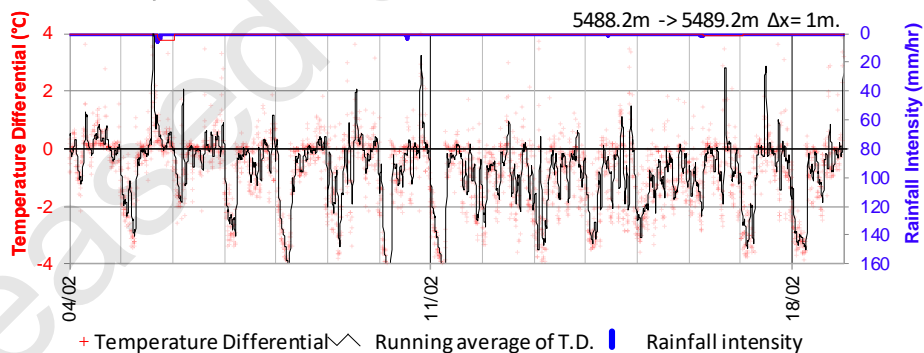
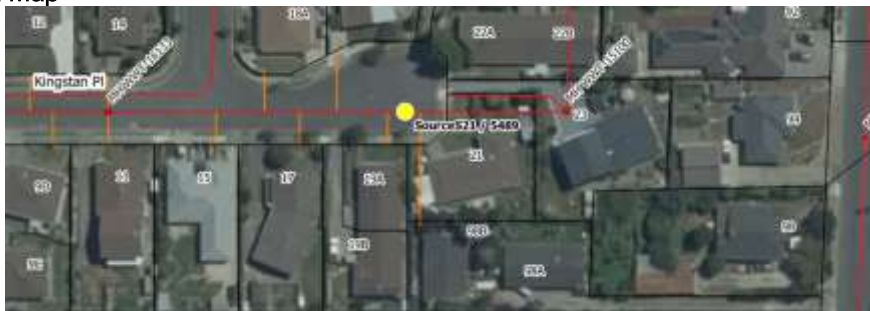
### A.21.3 Source S21 / 5489

Asset	Pipe 31125 DN150, 100m, Asbestos Cement, 1978.
Address	19A Kingstan Place.
DTS signal	Medium, 67m ±5m upstream of manhole 16133.
Analysis	Reduction in temperature in the early hours of the morning indicating ground water infiltration.
Recommendation	CCTV inspection of pipe 31125 checking for signs of deterioration and infiltration. Inspection of nearby connected properties (19A, 19B, 22A Kingstan Place, 98B Thorp Street) looking for deterioration and infiltration.
Note	<p>These four lateral inspections are included due to uncertainty if the groundwater source is in the wastewater main, or the nearby laterals.</p> <p>CCTV inspection of pipe 31125 is included under the recommendations for source S21 / 5474.</p> <p>The groundwater intrusion signal was seasonal. The DTS data for same location did not exhibit any I&amp;I patterns in October 2022.</p> <p>This DTS signal strength is assessed to be 'medium' rather than 'strong' despite the large temperature difference. The 'medium' rating is because the temperature difference is influenced more by the upstream temperature rising in the early hours of the morning rather than the downstream temperature reducing. It is expected that the downstream temperature is impacted by cool groundwater from a leak in a lateral at a location that is not affected by solar heating from the road pavement.</p>

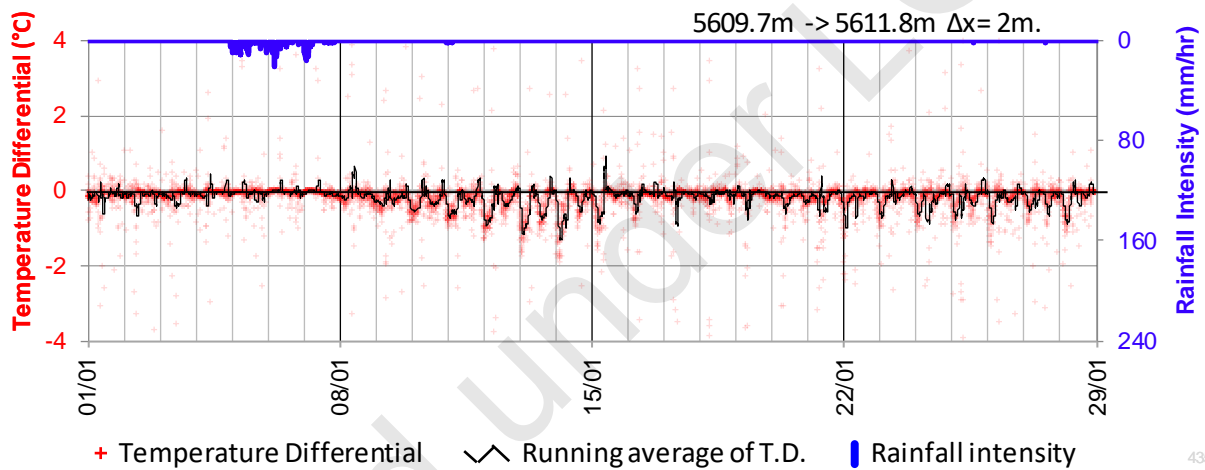
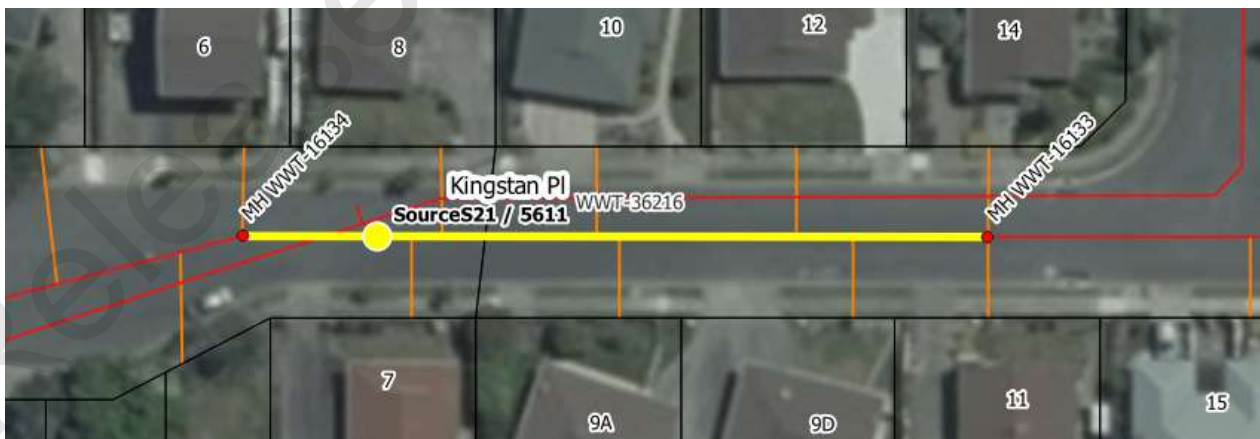
### A.21.4 Source S21 / 5611

Asset	Pipe 36216	DN150, 67m, Asbestos Cement, 1978.
Address	7 Kingstan Place.	
DTS signal	Strong, 12m ±5m upstream of manhole 16134.	
Analysis	Reduction in temperature in the early hours of the morning indicating ground water infiltration.	
Recommendation	CCTV inspection of pipe 36216 checking for signs of deterioration and infiltration.

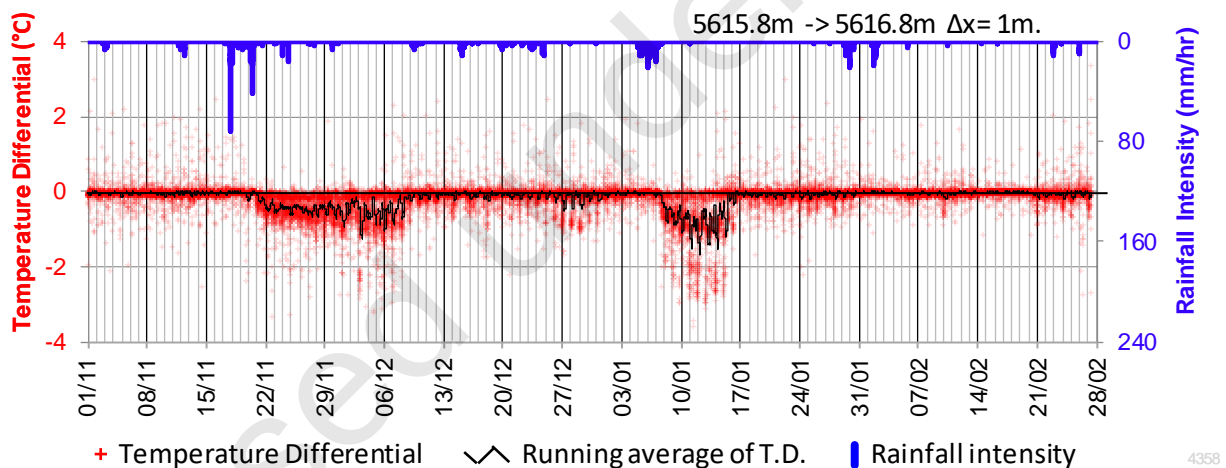
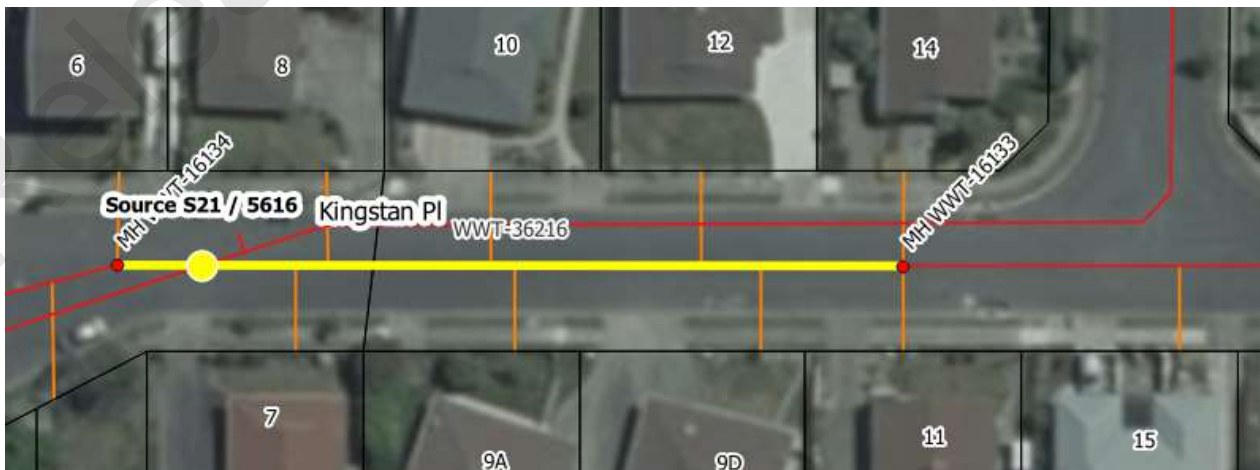
## A.21.5 Source S21 / 5616

Asset	Pipe 36216 DN150, 67m, Asbestos Cement, 1978.
Address	7 Kingstan Place.
DTS signal	Strong, 6m ±5m upstream of manhole 16134.
Analysis	Reduction in temperature in the early hours of the morning indicating ground water infiltration. Reduction in temperature for an extended period after rain indicating rainfall dependent infiltration.
Recommendation	CCTV inspection of pipe 36216 checking for signs of deterioration and infiltration.
Note	CCTV inspection for pipe 36216 is included under the recommendations for I&I source S21 / 5611.

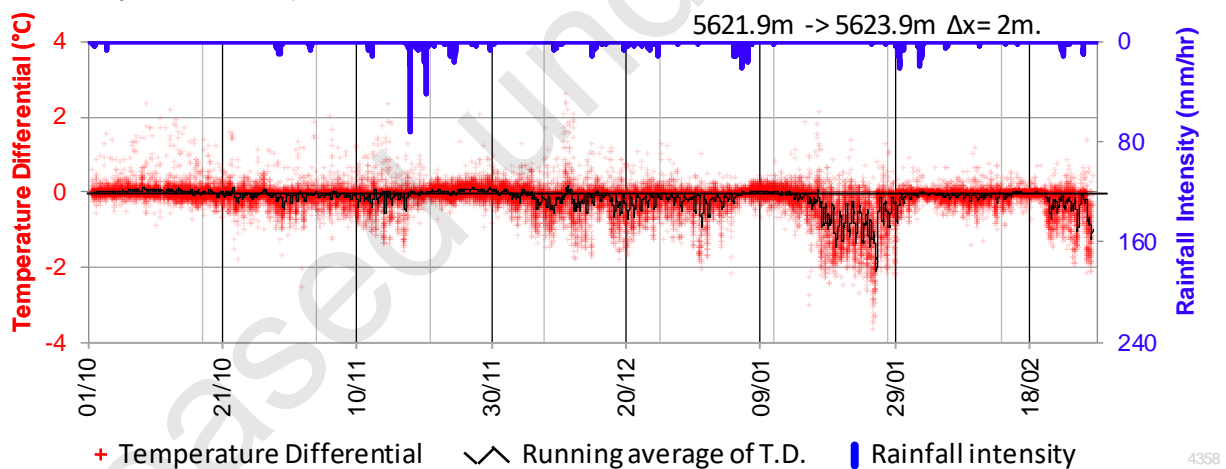
## A.21.6 Source S21 / 5623

Asset	Manhole 16134.
Address	6 Kingstan Place.
DTS signal	Strong, At manhole 16134.
Analysis	<p>Reduction in temperature in the early hours of the morning indicating ground water infiltration.</p> <p>Reduction in temperature for an extended period after rain indicating rainfall dependent infiltration.</p> <p>The temperature drop observed during dry periods is reduced during rain events. This indicates infiltration is masked by upstream rainfall dependent inflow and infiltration.</p>
Recommendation	<p>Inspection of manhole 16134 checking for signs of deterioration and infiltration.</p> <p>Inspection of nearby connected properties (6 Kingstan Pl.) looking for deterioration and infiltration.</p>
Note	The masking of I&I during rain events indicates significant upstream I&I. Given the age and pipe materials, remediation of significant amounts of the upstream catchment may be required.

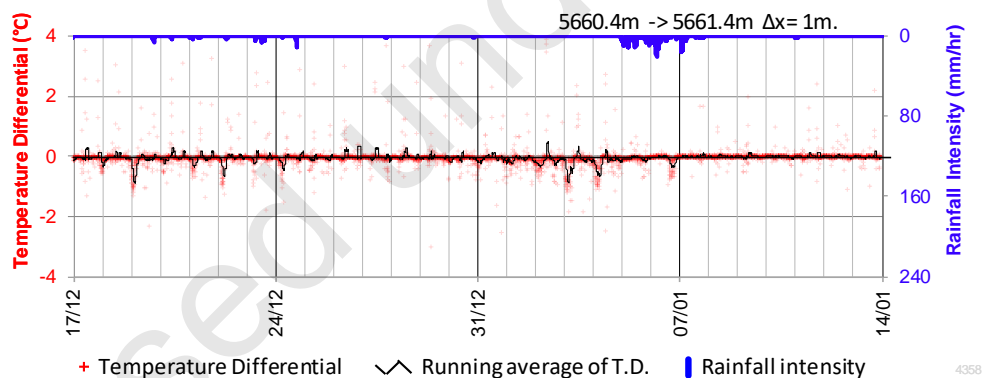
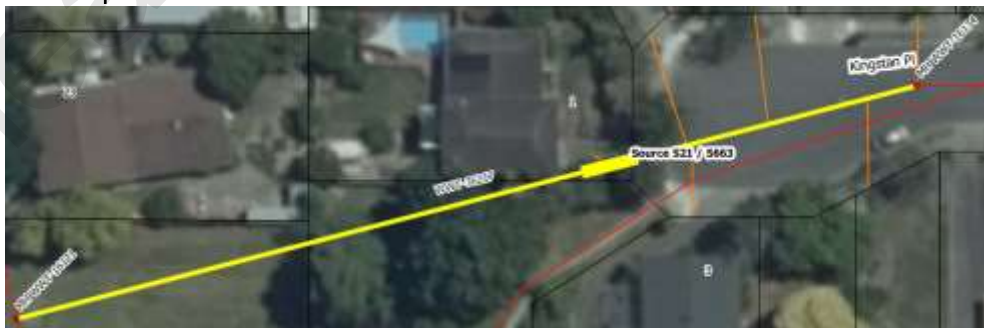
### A.21.7 Source S21 / 5663

Asset	Pipe 36217 DN150, 103m, Asbestos Cement, 1978.
Address	1 Kingstan Place.
DTS signal	Medium, 65m to 71m±5m upstream of manhole 16121.
Analysis	<p>Reduction in temperature in the early hours of the morning indicating ground water infiltration.</p> <p>Reduction in temperature for an extended period after rain indicating rainfall dependent infiltration.</p> <p>The temperature drop observed during dry periods is reduced during rain events. This indicates infiltration is masked by upstream rainfall dependent inflow and infiltration.</p>
Recommendation	<p>Inspection of pipe 36217 checking for signs of deterioration and infiltration.</p> <p>Inspection of nearby connected properties (1 Kingstan Pl.) looking for deterioration and infiltration.</p>
Note	The masking of I&I during rain events indicates significant upstream I&I. Given the age and pipe materials, remediation of significant amounts of the upstream catchment may be required.

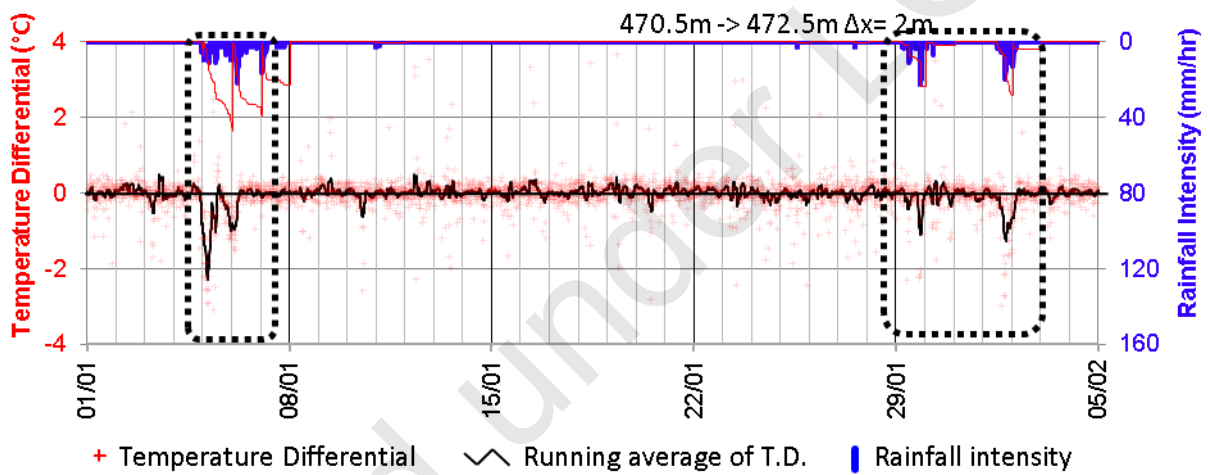
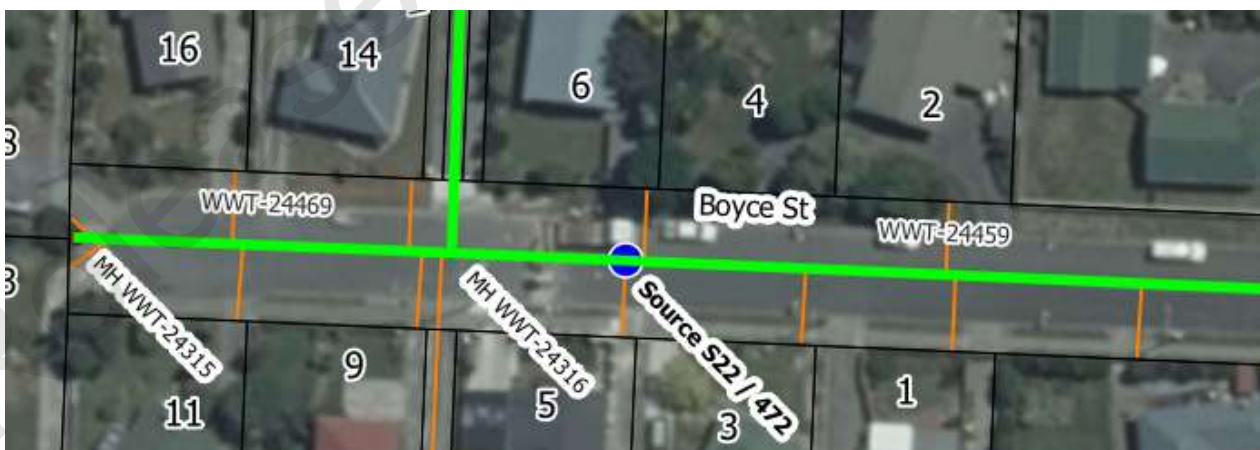
### A.22.1 Source S22 / 472 <new>

Asset	Pipe 24459	DN150, 101m, uPVC, 2012.
Address	5 Boyce Street.	
DTS signal	Strong. 18m ±3m downstream of manhole 24316.	
Analysis	Reduction in temperature during rainfall indicating stormwater inflow.	
Recommendation	Inspection of nearby connected properties (5 & 6 Boyce St.) looking for deterioration and/or SW connections.

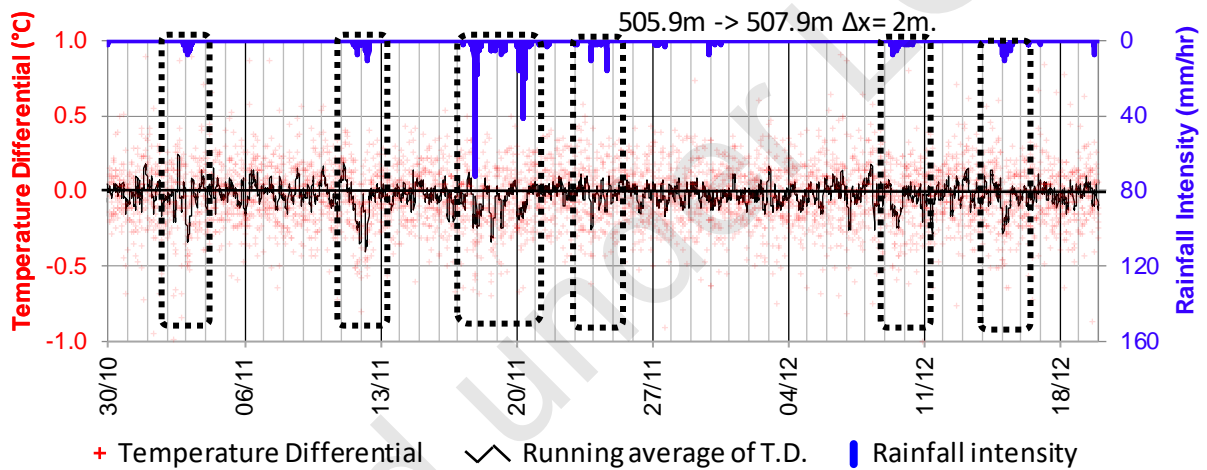
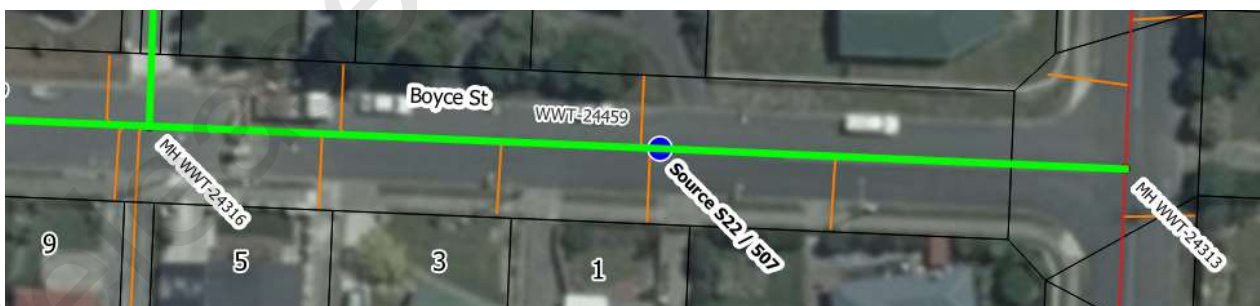
## A.22.2 Source S22 / 507 <new>

Asset	Pipe 24459	DN150, 101m, uPVC, 2012.
Address	1 Boyce Street.	
DTS signal	Strong. 54m ±4m downstream of manhole 24316.	
Analysis	Reduction in temperature during rainfall indicating stormwater inflow.	
Recommendation	Inspection of nearby connected properties (1 & 2 Boyce St.) looking for deterioration and/or SW connections.
