**OFFICIAL INFORMATION REQUEST: FIBRE OPTIC INSPECTION SYSTEM (REF: 3610)**

# Motueka Wastewater I&I Assessment Using Distributed Temperature Sensing

Goodman Park Pump Station Catchment  
Final Report

30<sup>th</sup> April 2024

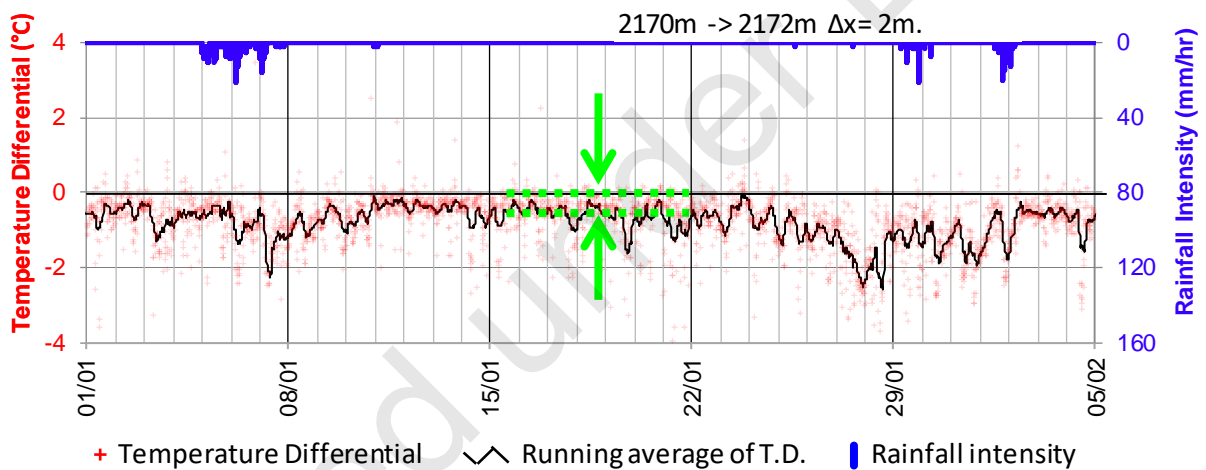
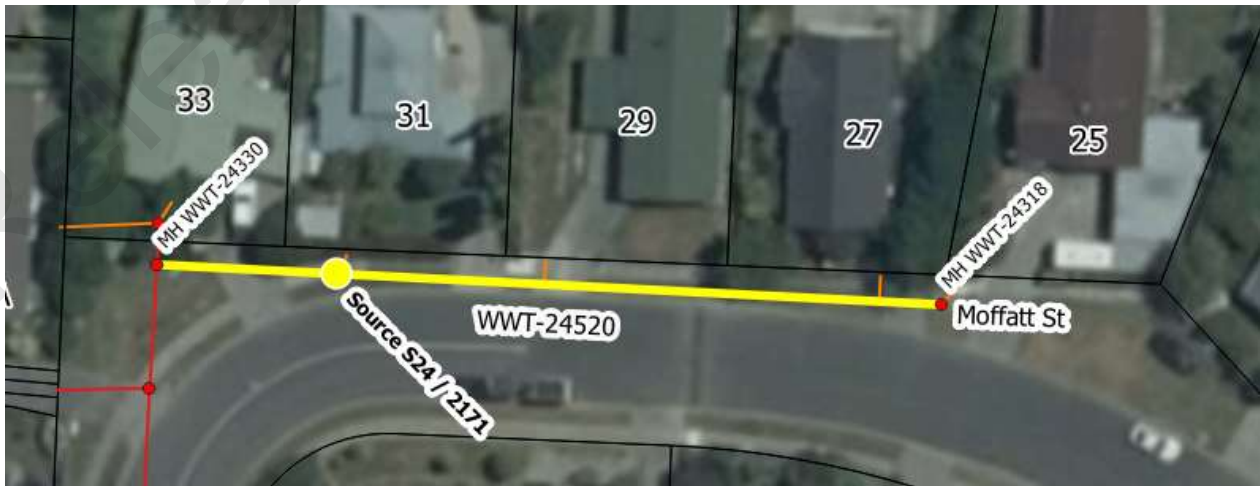
## A.24.1 Source S24 / 2171 <new>

Asset	Pipe 24520	DN150, 66m, 2012
Address	31 Moffatt Street.	
DTS signal	Strong. 15m ±3m upstream of manhole 24330.	
Analysis	Reduction in temperature in the early hours of the morning indicating ground water infiltration.	
Recommendation	CCTV inspection of pipe 24520 checking for signs of deterioration and infiltration. Inspection of nearby connected properties (31 Moffatt St.) looking for deterioration and infiltration.

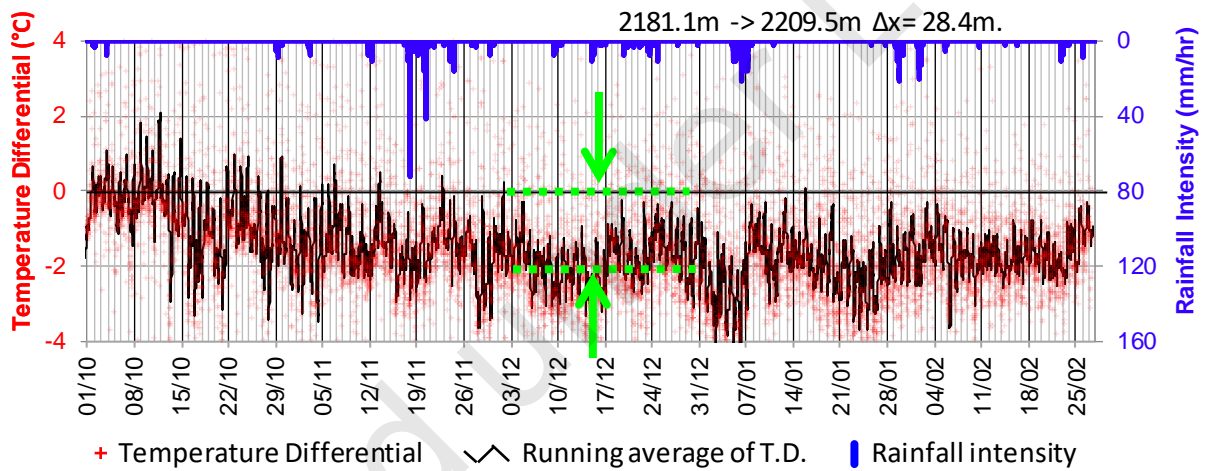
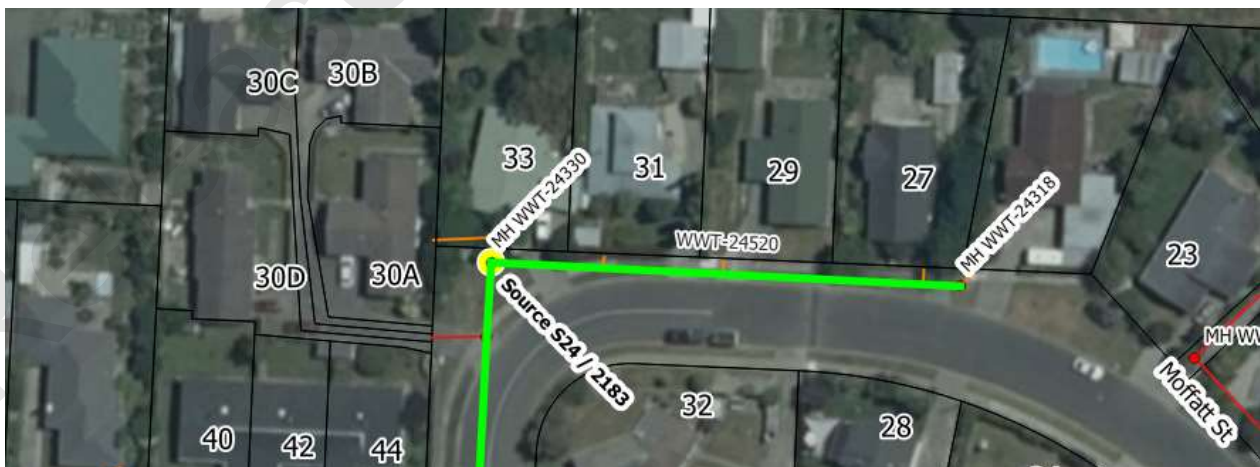
## A.24.2 Source S24 / 2183 <new>

Asset	Manhole 24330.
Address	33 Moffatt Street.
DTS signal	Strong. At manhole 24330.
Analysis	Temperature differential consistently below 0°C indicating GWI.
Recommendation	Inspection of manhole 24330 checking for signs of deterioration and infiltration. Inspection of nearby connected properties (33 & 30A Moffatt St.) looking for deterioration and infiltration.

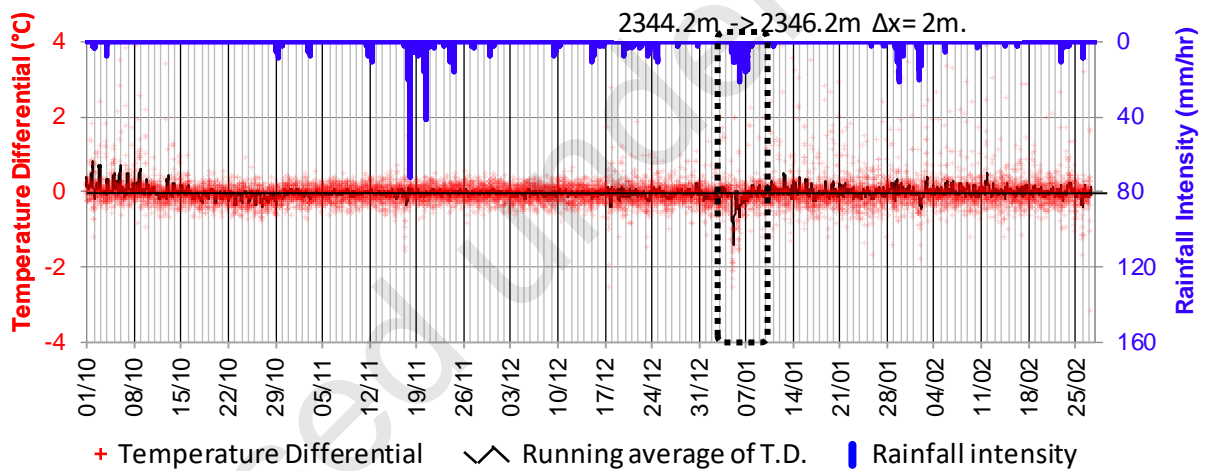
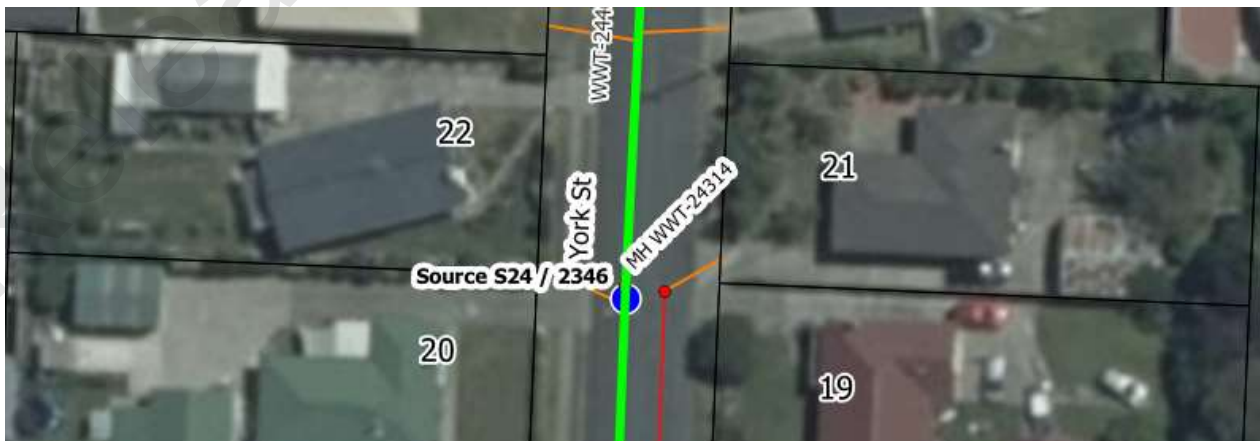
### A.24.3 Source S24 / 2346 <new>

Asset	Manhole 24314.
Address	22 Moffatt Street.
DTS signal	Medium. 1m ±3m downstream of manhole 24314.
Analysis	Reduction in temperature during rainfall indicating stormwater inflow.
Recommendation	Inspection of manhole 24314 checking for signs of poor construction, poor lid seal, surface inflow through cover keyholes, and/or inflow. Inspection of nearby connected properties (22 Moffatt St.) looking for deterioration and infiltration.
Note	This DTS signal is assessed as 'medium' rather than 'strong' because although the pattern characteristic of stormwater inflow was very clear for 5 <sup>th</sup> -7 <sup>th</sup> January 2023, it was not observed for most other rain events.

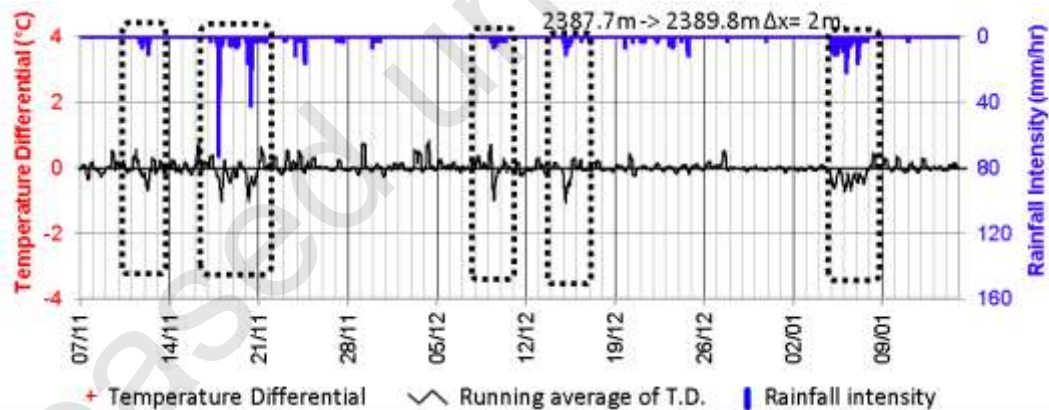
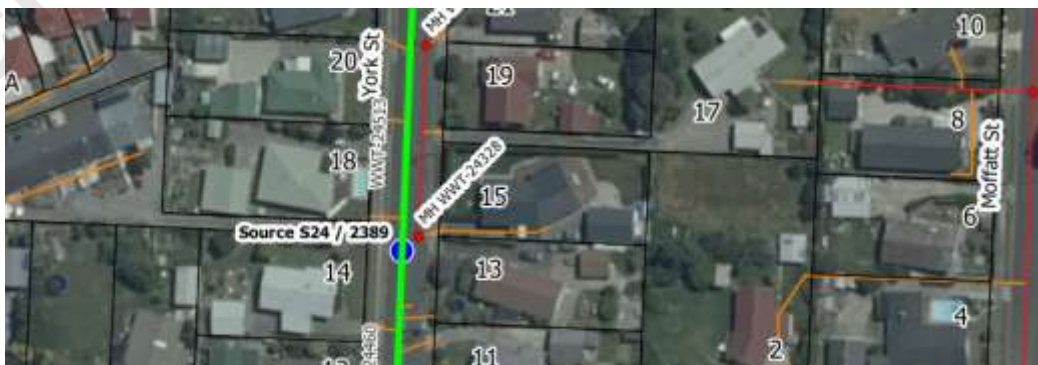
### A.24.4 Source S24 / 2389 <new>

Asset	Pipe 24513 DN150, 45m, uPVC, 2012
Address	15 Moffatt Street.
DTS signal	Strong. 45m ±3m downstream of manhole 24314.
Analysis	Reduction in temperature during rainfall indicating stormwater inflow.
Recommendation	Inspection of manholes 24327 and 24328 checking for signs of poor construction, poor lid seal, surface inflow through cover keyholes, and/or inflow. Inspection of nearby connected properties (15, 17, 19, 21 York St.) looking for deterioration and infiltration.
Note	The DST signal location is a buried node with connection to an unmonitored part of the catchment. DTS signal indicates stormwater inflow which would require a hydraulic connection to ground level features. Therefore, inspection of the unmonitored connected catchment is recommended. The GIS map indicates there is a lateral to the driveway of 17 York Street. It also shows a lateral from the east side of the 17 York Street house connected to the wastewater main in Moffatt Street. Inspect the lateral entering the driveway of 17 York Street.

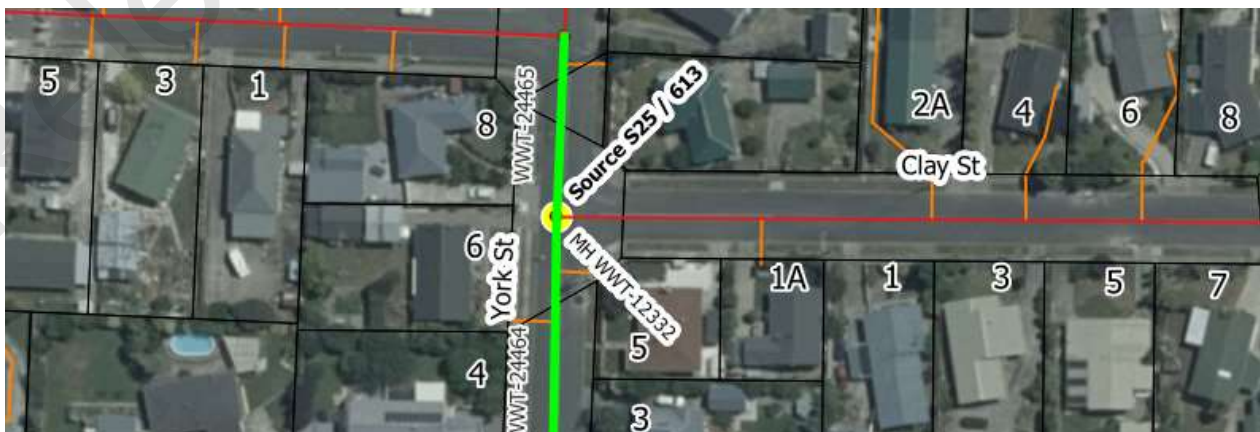
### A.25.1 Source S25 / 613 <new>

Asset	Manhole 12332.
Address	6 York Street.
DTS signal	Strong. At manhole 12332.
Analysis	Groundwater infiltration leak observed during installation of DTS cable. Refer to photo.
Recommendation	Inspection of manhole 12332 checking for signs of deterioration and infiltration.

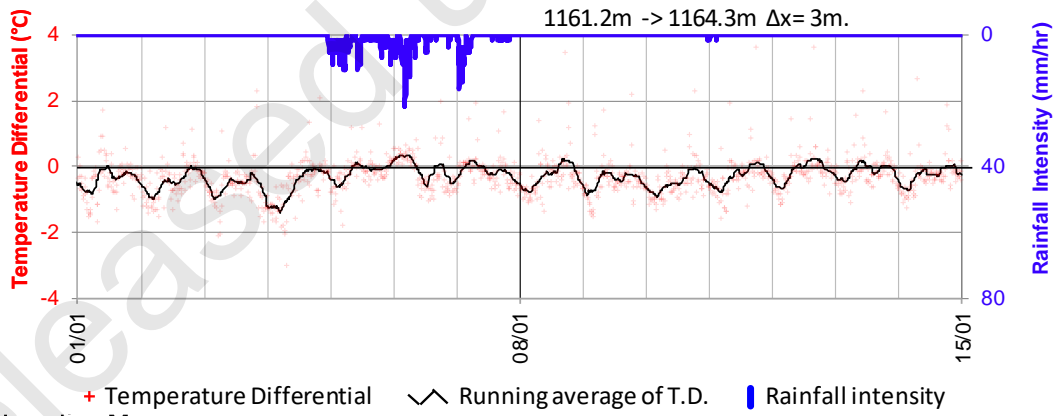
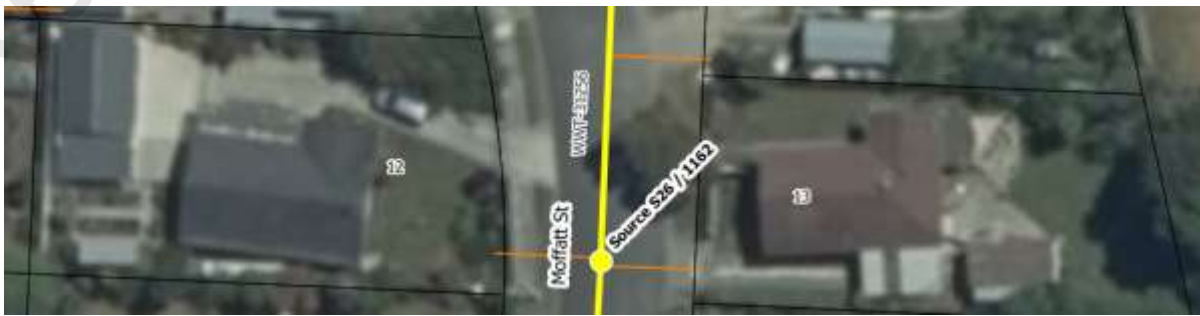
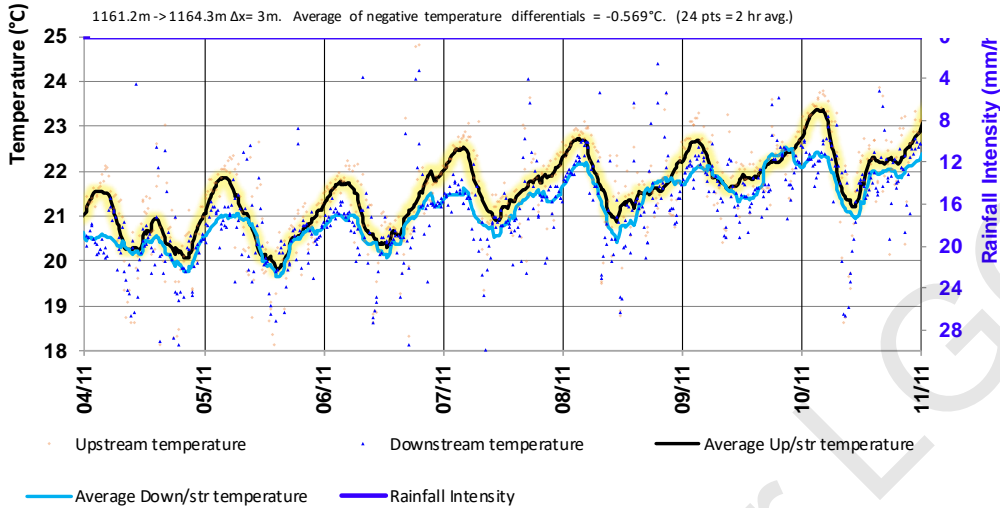
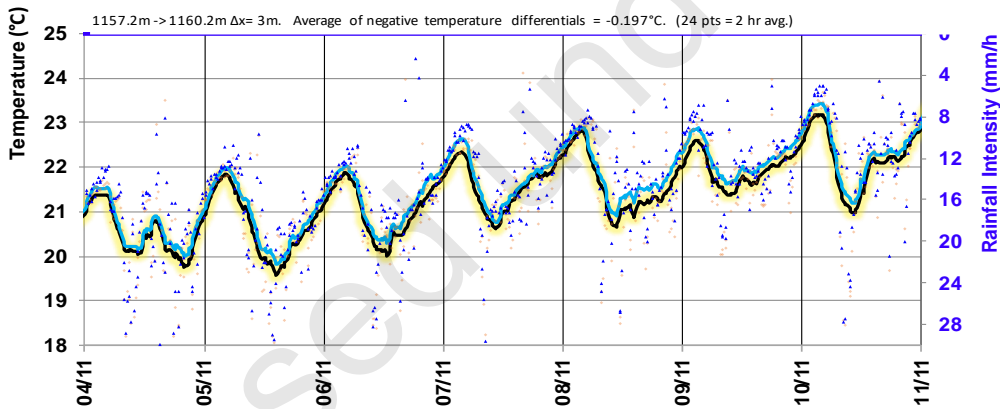
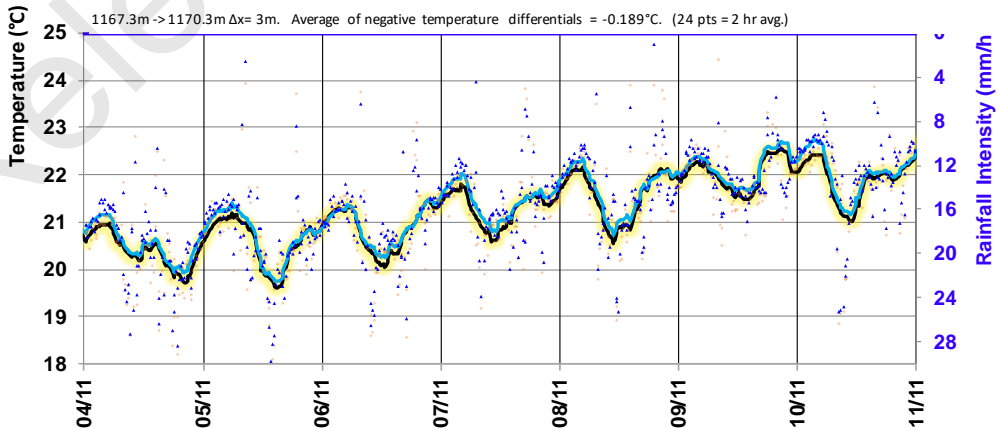
## A.26.1 Source S26 / 1162 <new>

Asset	Pipe 31256 DN150, 76m, Asbestos Cement, 1977.
Address	12 Moffatt Street.
DTS signal	Medium. 32m ±3m upstream of manhole 12337.
Analysis	<p>During summer, this section of pipe absorbs heat from the ground due to solar heating of the road. This is especially noticeable in early morning low-flow hours when the DTS-measured temperature can be dominated by ground heat transfer. A temperature comparison spanning 3 m at the point of interest (1162m), is shown on the next page in the 'Source Analysis Plot – Temperature vs Time at 1162m'. A source of cooler <b>groundwater infiltration</b> at the point of interest is indicated by the downstream temperature increasing significantly less during the early hours of the morning compared to the point 3m upstream.</p> <p>Additional temperature comparisons at pairs of points 3m apart, located four metres upstream and five metres downstream of the point of interest are provided in the plots on the next page. These temperatures rise and fall together during early morning hours. The existence of a temperature differential at the point of interest, but not 4-5 metres either side of the point of interest further supports the assessment that groundwater infiltration is occurring at the point of interest.</p>

Ground water temperature in the early hours of the morning appears to be moderated by groundwater infiltration. The point 3m upstream more is significantly heated by the ground which stores solar heat absorbed by from the road.

Recommendation	CCTV inspection of pipe 31256 checking for signs of deterioration and infiltration. Inspection of nearby connected properties (12 and 13 Moffatt St.) looking for deterioration and infiltration.

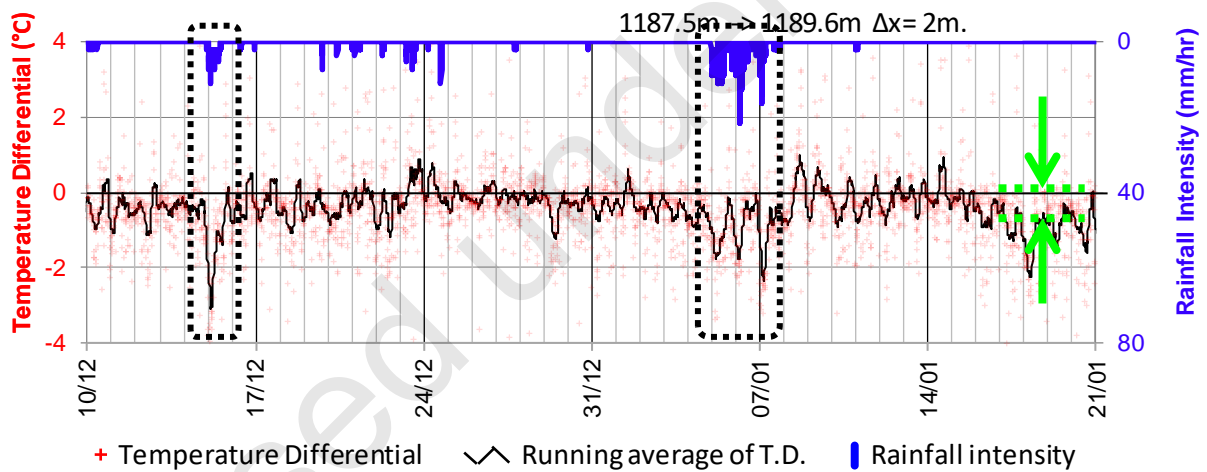
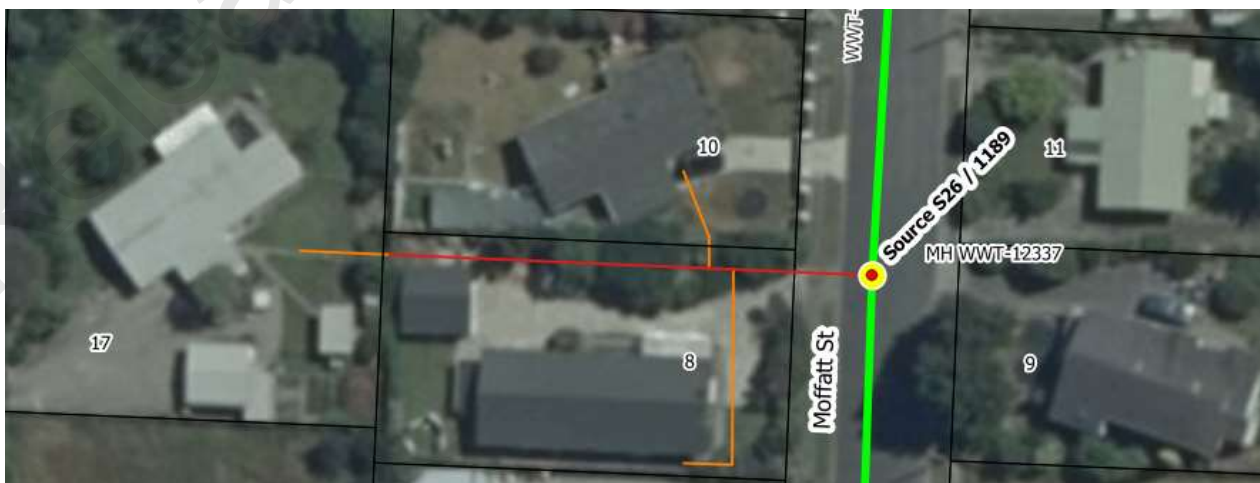
## A.26.2 Source S26 / 1189 <new>

Asset	Manhole 12337.
Address	12 Moffatt Street.
DTS signal	Medium. At manhole 12337.
Analysis	Temperature differential correlated with rain indicating stormwater inflow. Temperature differential often below 0°C during the early morning and/or for periods of multiple days indicating groundwater infiltration.
Recommendation	Inspection of manhole 12337 checking for signs of poor construction, poor lid seal, surface inflow through cover keyholes, infiltration and/or inflow. Inspection of nearby connected properties (8 & 10 Moffatt St., 17 York St.) looking for deterioration, stormwater connections, infiltration and/or inflow.

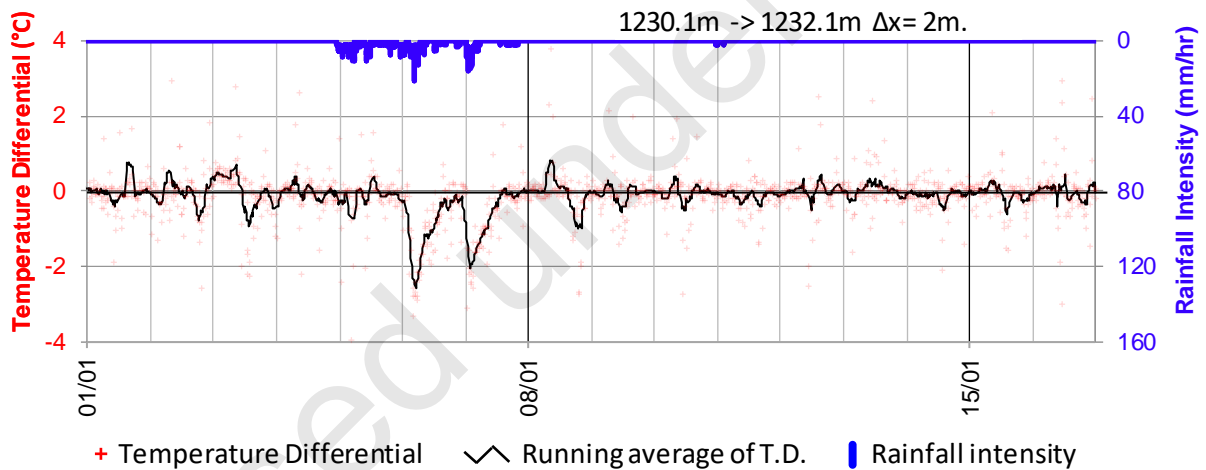
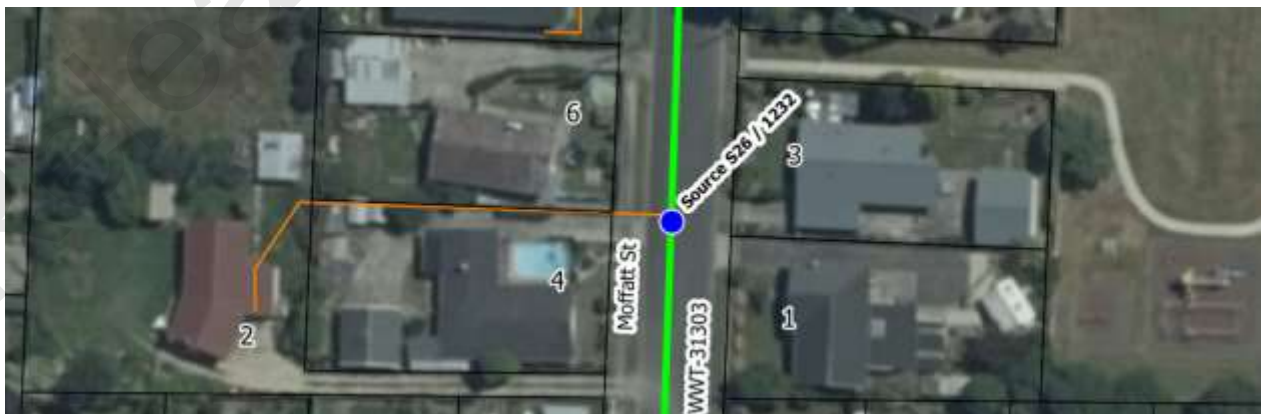
### A.26.3 Source S26 / 1232 <new>

Asset	Pipe 31303 DN150, 117m, Asbestos Cement, 1971.
Address	2 Moffatt Street.
DTS signal	Strong. 42m ±3m downstream of manhole 12337.
Analysis	Reduction in temperature during rainfall indicating stormwater inflow.
Recommendation	CCTV inspection of pipe 31303 to determine the connection point of laterals not shown on the GIS map (3 & 6 Moffatt St.). Inspection of nearby connected properties (2, 3, 6 Moffatt St.) looking for deterioration, stormwater connections, and/or inflow.
Note	Use the CCTV data to update the connection points for the laterals not shown in the GIS map. Include property inspections only if they are within five metres of the DTS signal.

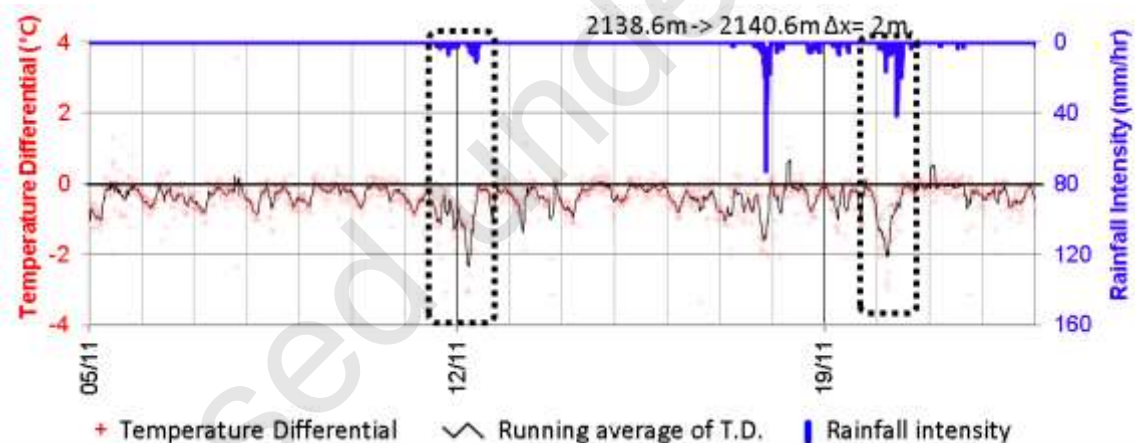
### Source Analysis Plot – Temperature Difference vs Time – Indicating stormwater inflow

Asset	Pipe 31262 DN225, 117m, Concrete, 1973.
Address	74 Thorp Street.
DTS signal	Strong. 35m ±3m upstream of manhole 13712.
Analysis	Reduction in temperature in the early hours of the morning indicating ground water infiltration. Reduction in temperature for an extended period after rain indicating rain derived infiltration.
Recommendation	CCTV inspection of pipe 31262 checking for signs of deterioration and infiltration. Inspection of nearby connected properties (74 Thorp St.) looking for deterioration, infiltration, stormwater connections, and/or inflow.
Note	Use the CCTV data to update the connection points for the laterals not shown in the GIS map. Include property inspections only if they are within five metres of the DTS signal.

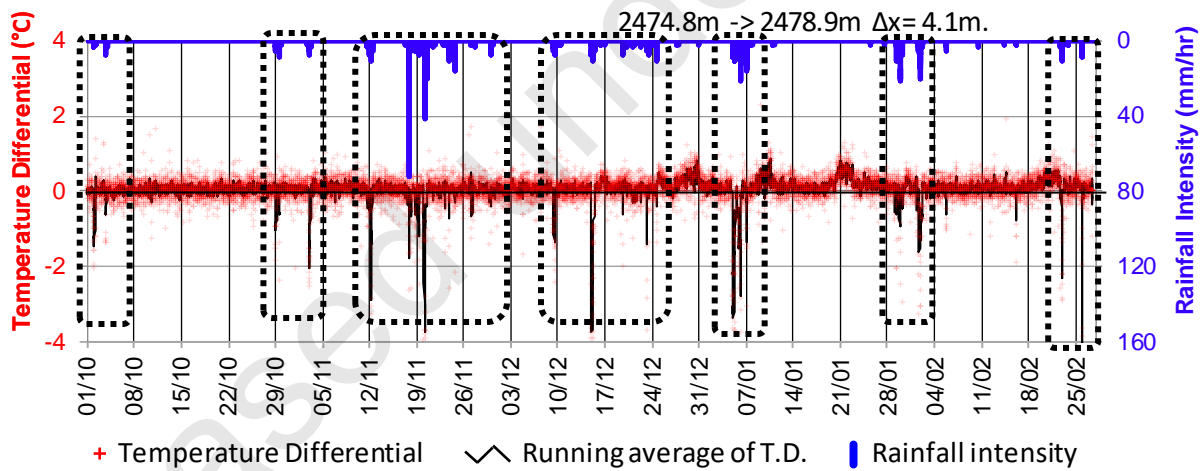
Source Analysis Plot – Temperature Difference vs Time

Asset	Pipe 31302 Pipe 31304	DN225, 47m, Concrete, 1971. DN225, 38m, Concrete, 1973.
Address	11 Clay Street.	
DTS signal	Strong. 18m ±5m upstream of manhole 12331.	
Analysis	Reduction in temperature during rainfall indicating stormwater inflow.	
Recommendation	CCTV inspection of pipes 31302, 31304 to determine the connection point of laterals not shown on the GIS map (11 & 12 Clay St.). Inspection of nearby connected properties (11 & 12 Clay St.) looking for deterioration, stormwater connections, and/or inflow.	
Note	Use the CCTV data to update the connection points for the laterals not shown in the GIS map. Include property inspections only if they are within five metres of the DTS signal. Pipes 31302 and 31304 are joined by a buried node rather than a manhole.

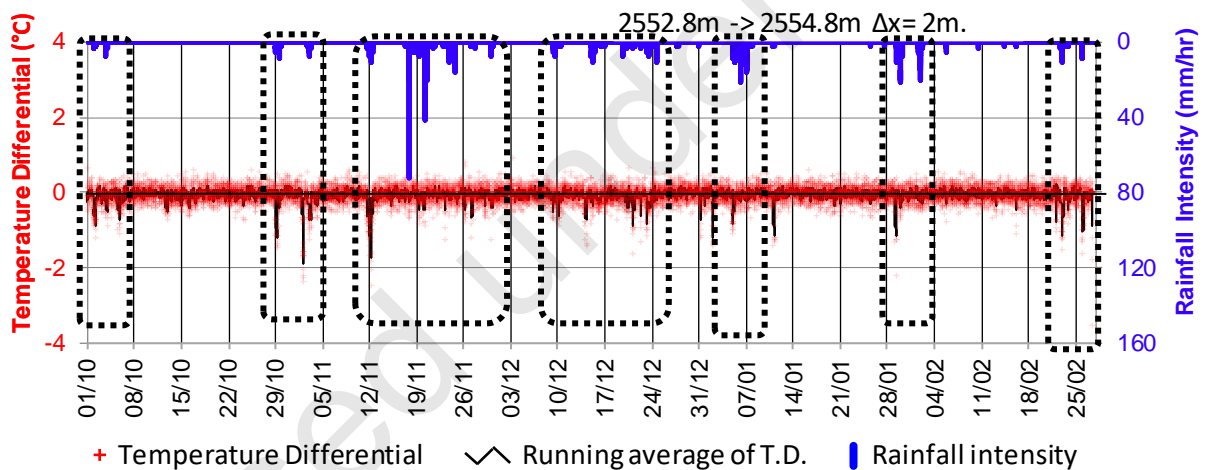
#### Source Analysis Plot – Temperature Difference vs Time

Asset	Pipe 31301 DN225, 134m, Concrete, 2000.
Address	5 Clay Street.
DTS signal	Strong. 36m ±5m downstream of manhole 12331.
Analysis	Reduction in temperature during rainfall indicating stormwater inflow.
Recommendation	CCTV inspection of pipe 31301 to determine the connection point of laterals not shown on the GIS map (5 Clay St.). Inspection of nearby connected properties (5 Clay St.) looking for deterioration, stormwater connections, and/or inflow.
Note	Use the CCTV data to update the connection points for the laterals not shown in the GIS map. Include property inspections only if they are within five metres of the DTS signal. Inspect 6 Clay Street if a source of stormwater inflow is not found at 5 Clay Street.

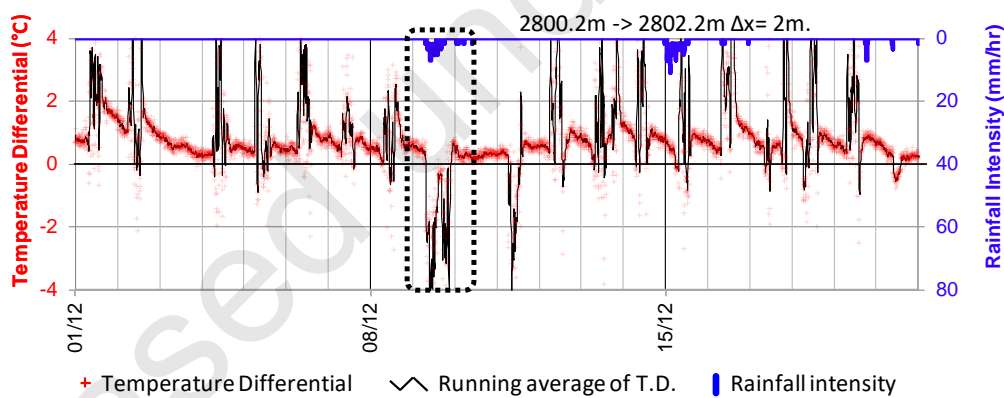
### Source Analysis Plot – Temperature Difference vs Time

Asset	Pipe 36281 DN150, 98m, Concrete, 1949.
Address	140 High Street.
DTS signal	Weak. 42m ±5m downstream of manhole 12357.
Analysis	Reduction in temperature during rainfall indicating stormwater inflow.
Recommendation	Inspection of nearby connected properties (140 High St.) looking for deterioration and/or SW connections.
Note	<p>When checking the lateral, look for connection or leakage from the stormwater assets in the footpath that are very close to the alignment of the lateral.</p> <p>The daily heat spike during office/school hours indicates there are significant hot water discharges during those hours. It may be worth the owner checking for unintended sources of hot water discharges.</p> <p>This DTS signal is assessed as 'weak' rather than 'strong' because the pattern characteristic of stormwater inflow was not observed for other rain events.</p>

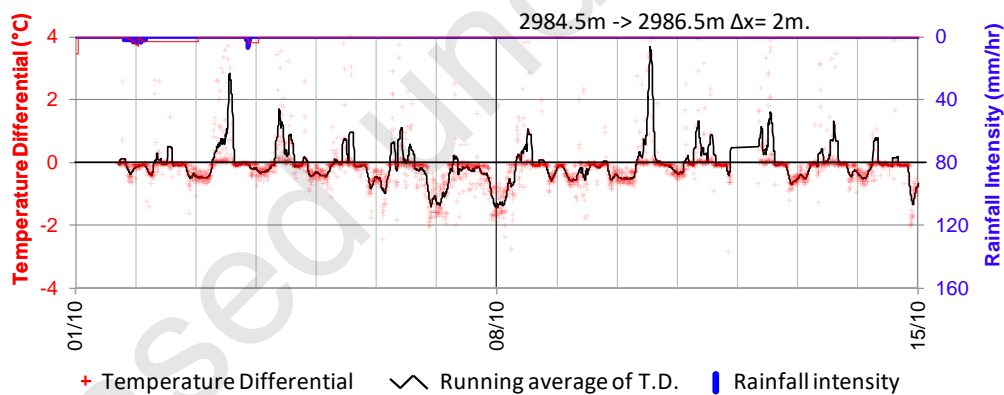
Asset	Pipe 36283 DN150, 88m, Concrete, 1949.
Address	196 High Street.
DTS signal	Weak. 21m ±5m downstream of manhole 12355.
Analysis	Reduction in temperature in the early hours of the morning indicating ground water infiltration.
Recommendation	CCTV inspection of pipe 36283 checking for signs of deterioration and infiltration and to determine the connection point of laterals not shown on the GIS map (196 High St.). Inspection of nearby connected properties (196 High St.) looking for deterioration and infiltration.
Note	Use the CCTV data to update the connection points for the laterals not shown in the GIS map. Include property inspections only if they are within five metres of the DTS signal. This DTS signal is assessed as 'weak' because the pattern characteristic of early morning ground water infiltrations was inconsistent and entirely absent for some periods.

Source Analysis Plot – Temperature Difference vs Time – showing early morning groundwater infiltration signals

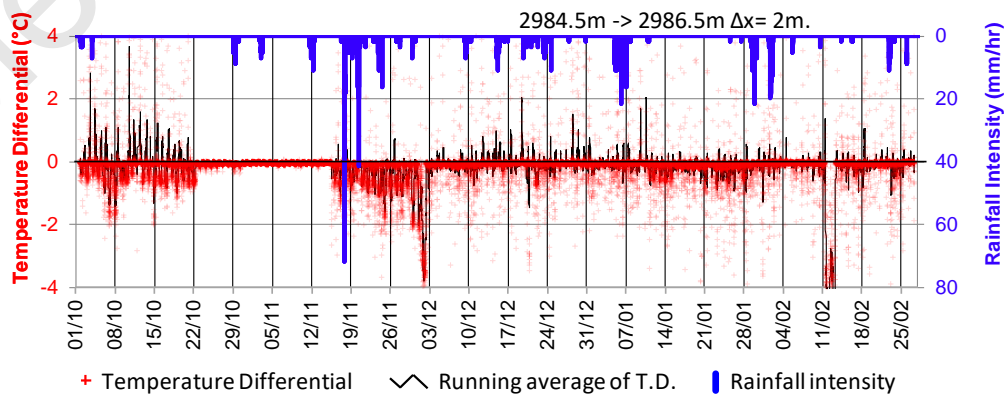
Source Analysis Plot – Temperature Difference vs Time – showing inconsistency with a period without signals

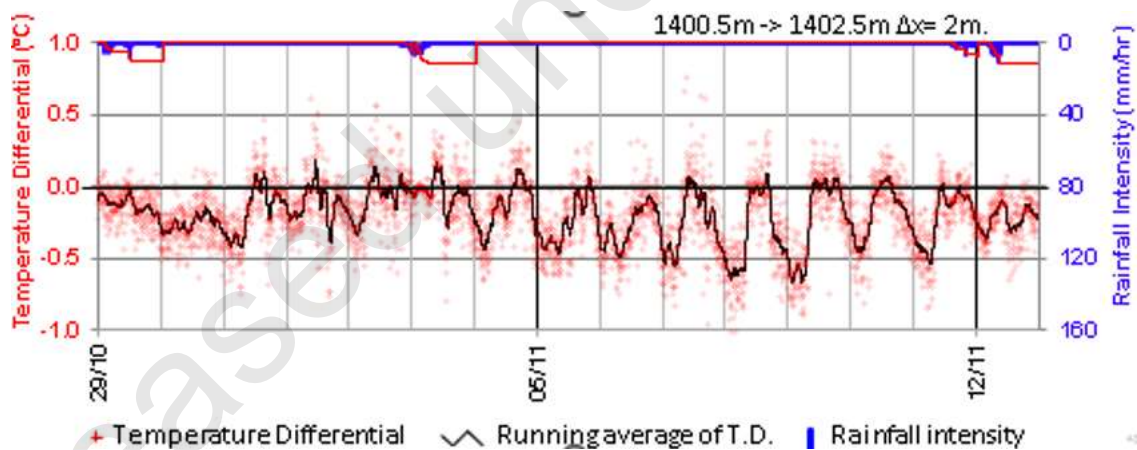
Source Analysis Plot – Temperature Difference vs Time

Asset	Pipe 36238 DN150, 122m, Concrete, 1996.
Address	191B High Street (on Hart Lane frontage)
DTS signal	Weak. 16m ±3m downstream of Manhole 12006.
Analysis	Reduction in temperature in the early hours of the morning indicating ground water infiltration.
Recommendation	CCTV inspection of pipe 36238 checking for signs of deterioration and infiltration and to determine the connection point of laterals not shown on the GIS map (191A, 191B High St.). Inspection of nearby connected properties (191A, 191B High St.) looking for deterioration and infiltration.
Note	Use the CCTV data to update the connection points for the laterals not shown in the GIS map. Include property inspections only if they are within five metres of the DTS signal. CCTV inspection for pipe 36238 is included under the recommendations for I&I source S4 / 1477.

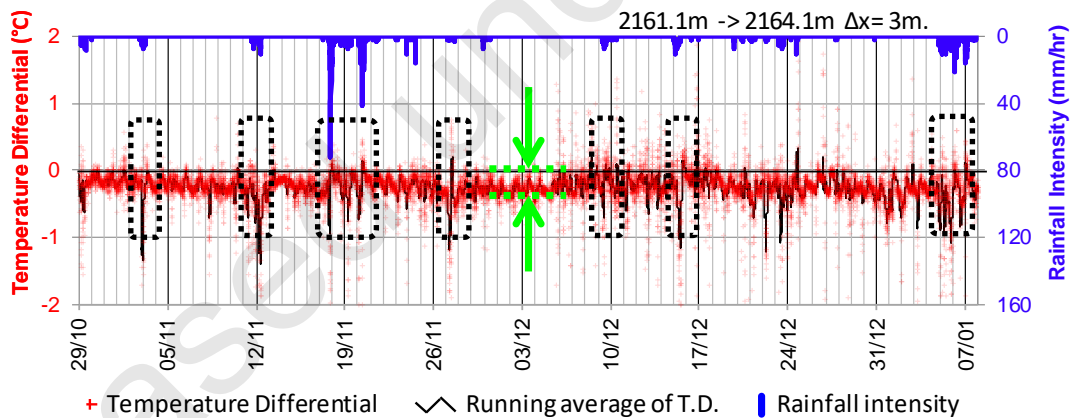
#### Source Analysis Plot – Temperature Difference vs Time

Asset	Pipe 31206 DN150, 114m, PVC, 1984.
Address	27 Wallace Street.
DTS signal	Weak, 25m to 34m±3m downstream of manhole 14093.
Analysis	Temperature differential generally below 0°C indicating groundwater infiltration. Reduction in temperature during rainfall indicating stormwater inflow.
Recommendation	Consider CCTV inspection of pipe 31206 checking for signs of deterioration, infiltration, and inflow.
Note	DTS signal indicates stormwater inflow which would require a hydraulic connection to ground level features. The GIS data set does not indicate any assets or connections at this location that have surface connections. Use CCTV data to check for surface connections, including pipe faults, and disconnected or terminated lateral connections that could be hydraulically connected to the surface. Signal strength rating is weak because it is difficult to ascertain if the reduction in temperature along this section of pipe is a separate source of I&I, or is it related to the sources at 2157m and 2168m or is it 'natural' cooling along the length of the pipe.

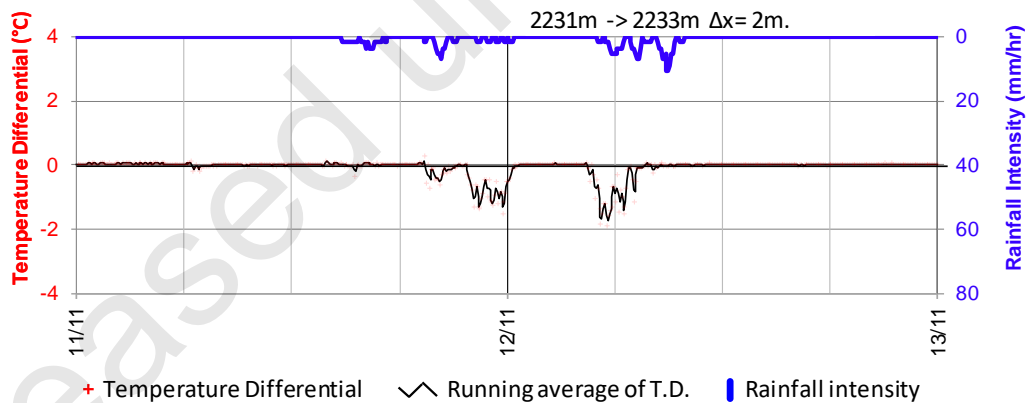
Source Analysis Plot – Temperature Difference vs Time

Asset	Pipe 31206 DN150, 114m, PVC, 1984.
Address	31 Wallace Street.
DTS signal	Weak, 17m ±3m upstream of manhole 14093.
Analysis	Reduction in temperature during rainfall indicating stormwater inflow. This is a weak DTS signal because it is observed briefly at the start of some (but not all) rain events.
Recommendation	Consider CCTV inspection of pipe 31206. Use CCTV data to check for surface connections, including pipe faults, and disconnected or terminated lateral connections that could be hydraulically connected to the surface. Consider inspection of nearby connected properties looking for deterioration and inflow.
Note	CCTV inspection for pipe 31206 is included under the recommendations for I&I source S7 / 2160. DTS signal indicates stormwater inflow which would require a hydraulic connection to ground level features. The GIS data set does not indicate any assets or connections at this location that have surface connections. Use CCTV data to check for surface connections, including pipe faults, and disconnected or terminated lateral connections that could be hydraulically connected to the surface.

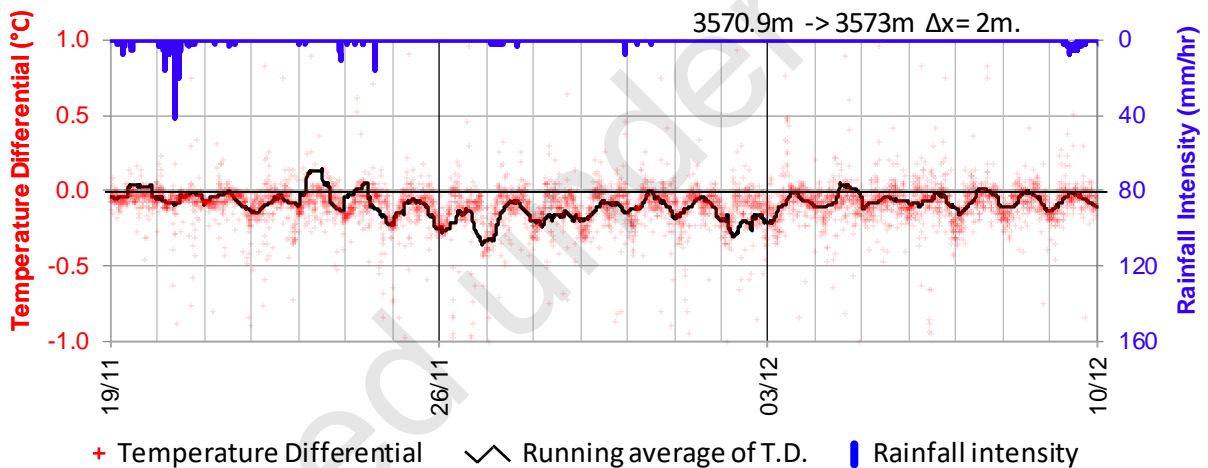
### Source Analysis Plot – Temperature Difference vs Time

Asset	Pipe 36221	DN150, 66m, Asbestos Cement, 1974.
Address	13A Goodman Drive.	
DTS signal	Very weak, 21m ±3m upstream of manhole 16123.	
Analysis	Reduction in temperature in the early hours of the morning indicating ground water infiltration.	
Recommendation	Consider CCTV inspection of pipe 36221 checking for signs of deterioration and infiltration. Consider inspection of nearby connected properties (13A, 13B, 15 Goodman Drive) looking for deterioration and infiltration.

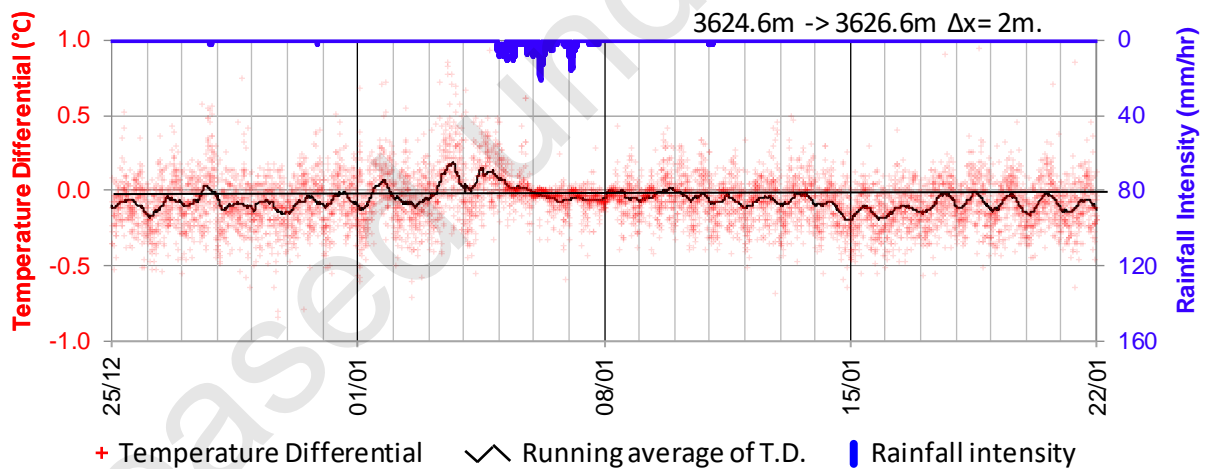
### Source Analysis Plot – Temperature Difference vs Time

Asset	Pipe 36225 DN150, 44m, PVC, 1974.
Address	11 Goodman Drive.
DTS signal	Weak, 12m ±3m upstream of manhole 14578.
Analysis	Reduction in temperature in the early hours of the morning indicating ground water infiltration.
Recommendation	Consider CCTV inspection of pipe 36225 checking for signs of deterioration and infiltration and to determine the connection point of laterals not shown on the GIS map (11 Goodman Drive). Consider inspection of nearby connected properties (11 Goodman Drive) looking for deterioration and infiltration.
Note	Use the CCTV data to update the connection points for the laterals not shown in the GIS map. Include property inspections only if they are within five metres of the DTS signal. The masking of I&I during rain events indicates significant upstream I&I.

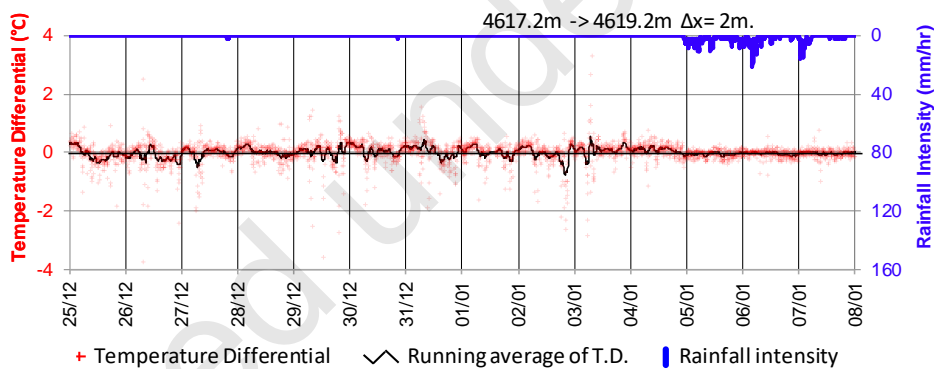
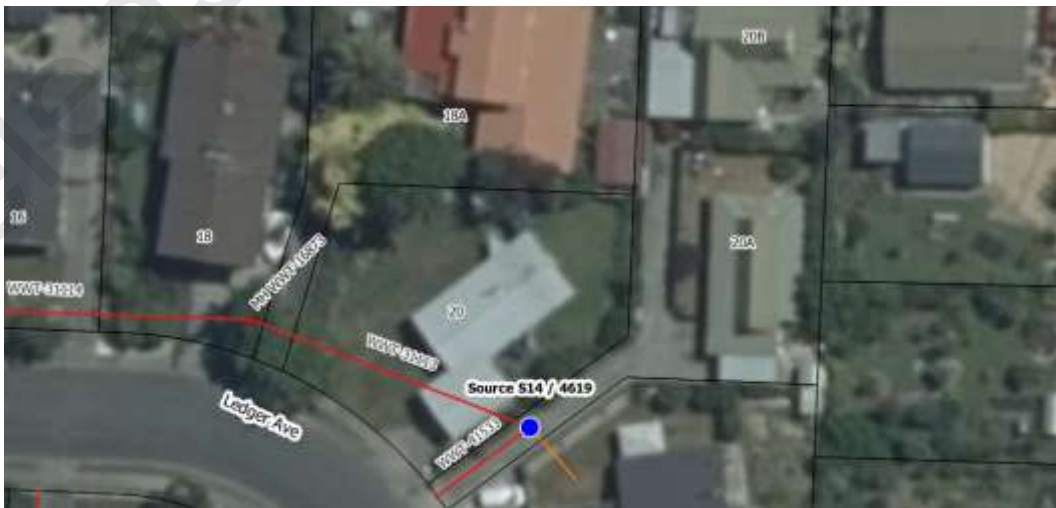
Asset	Manhole 16871.
Address	20A Ledger Avenue.
DTS signal	Weak, At manhole 16871.
Analysis	The normal temperature variations between two points analysed downstream of the manhole disappear during rain events. This indicates there is at least one source of stormwater inflow in the upstream catchment.
Recommendation	Consider inspection of manhole 16871 checking for signs of poor construction, poor lid seal, surface inflow through cover keyholes, and/or inflow. Consider inspection of nearby connected properties (20A, 20B, 22 Ledger Ave.) looking for deterioration or stormwater connections.
Note	Inspect the 80mm PVC flushing pipe 41533 looking for deterioration or stormwater connections.

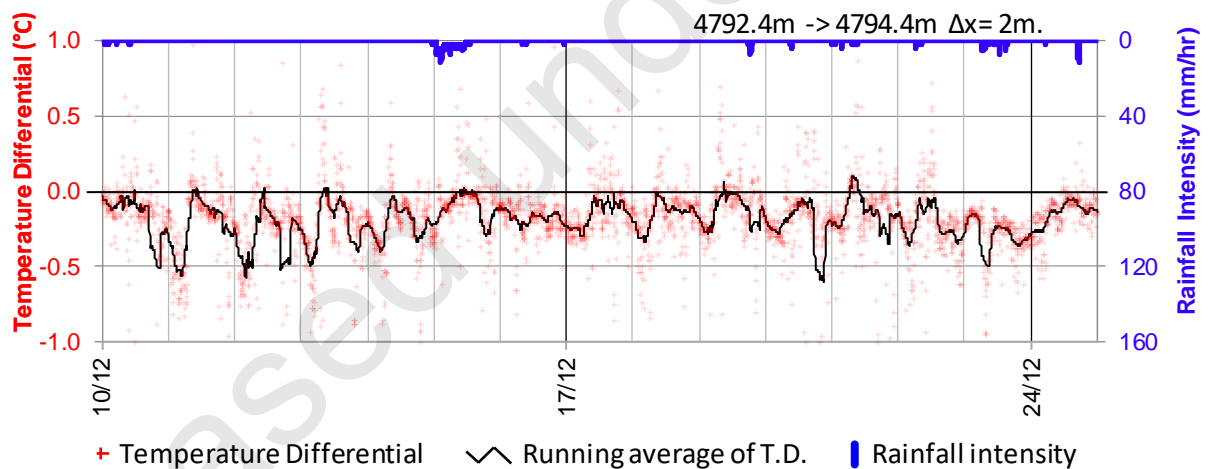
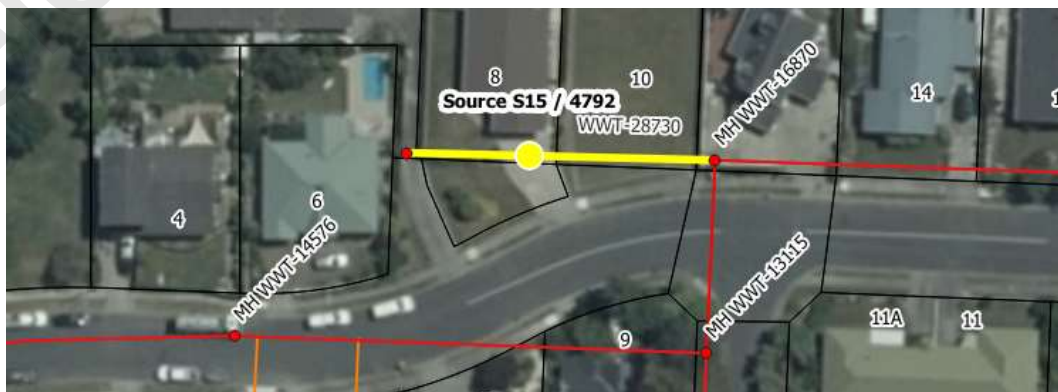
## B.1.9 Source S15 / 4792

Asset	Pipe 28730 DN150, 41m, PVC, 1977.
Address	8 Ledger Avenue.
DTS signal	Weak, 24m ±3m upstream of manhole 16870.
Analysis	Reduction in temperature in the early hours of the morning indicating ground water infiltration.
Recommendation	Consider CCTV inspection of pipe 28730 checking for signs of deterioration and infiltration and to determine the connection point of laterals not shown on the GIS map (8 Ledger Ave.). Consider inspection of nearby connected properties (8 Ledger Ave.) looking for deterioration and infiltration.
Note	Use the CCTV data to update the connection points for the laterals not shown in the GIS map. Include property inspections only if they are within five metres of the DTS signal.

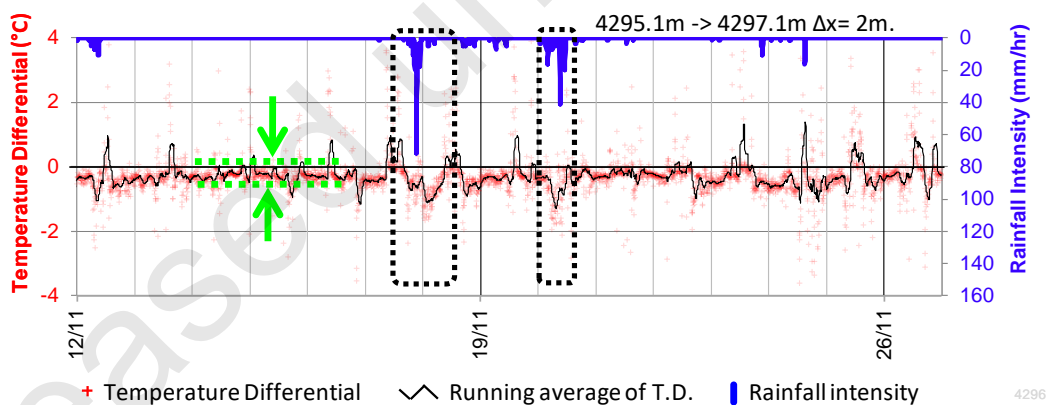
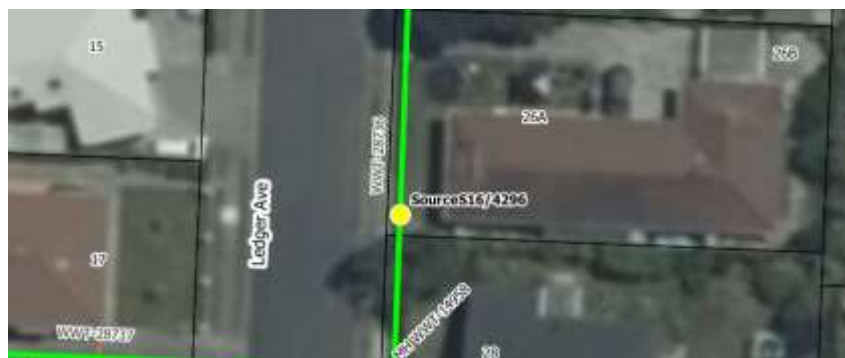
## B.1.10 Source S16 / 4296

Asset	Pipe 28736 DN150, 32m, PVC, 08 / 06 / 1977.
Address	26A / 26B Ledger Avenue.
DTS signal	Weak, 13±3m upstream of manhole 14958.
Analysis	<p>Temperature differential is generally below 0°C indicating groundwater infiltration. Temperature drop is correlated with rainfall indicating rainfall dependent infiltration and/or stormwater inflow.</p> <p>There are also temperature drops over the next 5-10m downstream of this point indicating groundwater infiltration in November 2022 but not in the months before or after.</p>
Recommendation	<p>Consider CCTV inspection of pipe checking for signs of deterioration and infiltration. Consider inspection of connected properties (26A and 26B Ledger Avenue) looking for signs of deterioration, infiltration, and/or stormwater connections.</p> <p>When reviewing CCTV footage pay close attention to the section of pipe 8m either side of the boundary between 26A and 28 Ledger Avenue.</p>

Note	Use the CCTV data to update the connection points for the laterals not shown in the GIS map. Include property inspections only if they are within five metres of the DTS signal.
