**OFFICIAL INFORMATION REQUEST: FIBRE OPTIC INSPECTION SYSTEM (REF: 3610)**

# Motueka Wastewater I&I Assessment Using Distributed Temperature Sensing

Goodman Park Pump Station Catchment  
Final Report

30<sup>th</sup> April 2024

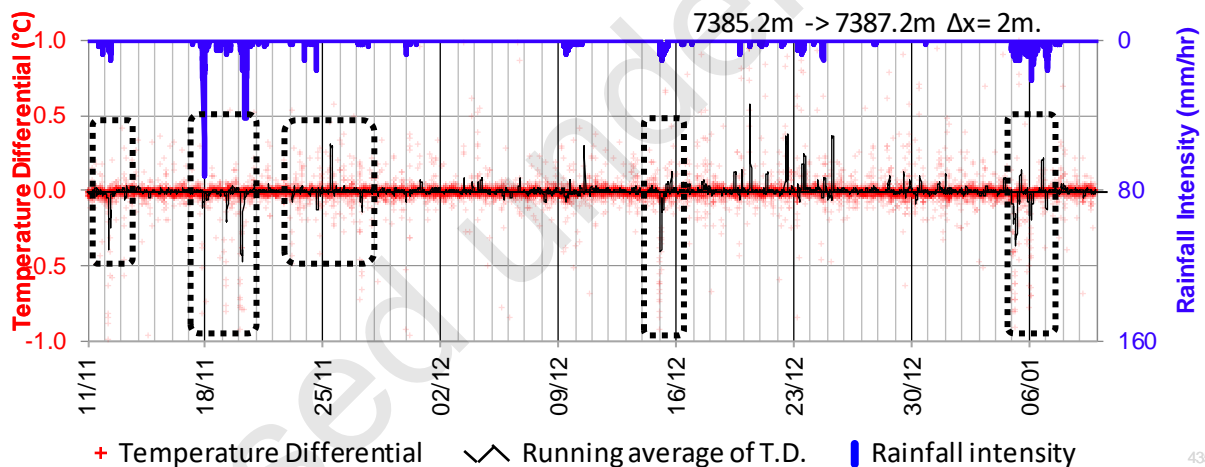
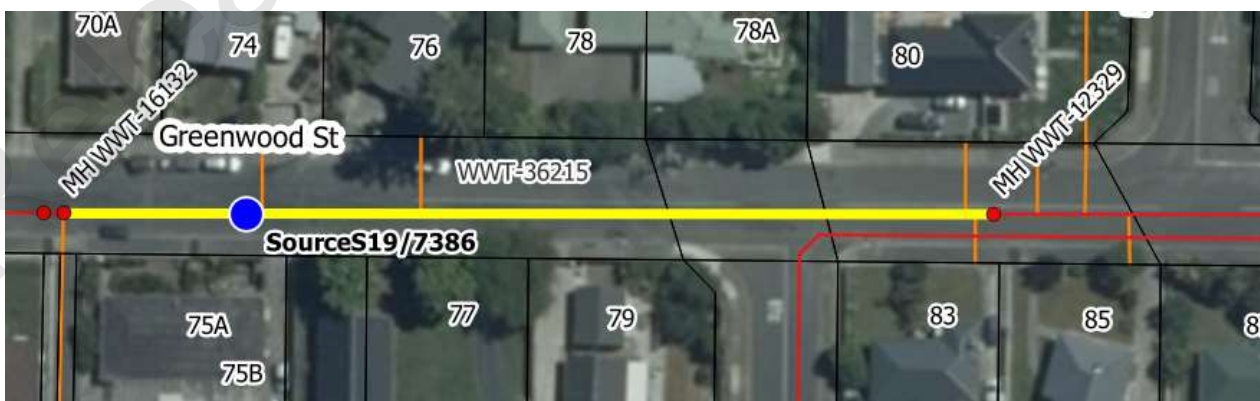
### B.1.11 Source S19 / 7386

Asset	Pipe 36215 DN150, 116m, Concrete, 1949.
Address	75A Greenwood Street.
DTS signal	Weak, 24m ±6m upstream of manhole 16132.
Analysis	Reduction in temperature during rainfall indicating stormwater inflow.
Recommendation	Consider CCTV inspection of pipe 36215 to determine the connection point of laterals not shown on the GIS map. Consider inspection of nearby connected properties (74, 75A and 75B Greenwood Street) looking for deterioration and/or stormwater connections.
Note	Use the CCTV data to update the connection points for the laterals not shown in the GIS map. Include property inspections only if they are within five metres of the DTS signal.

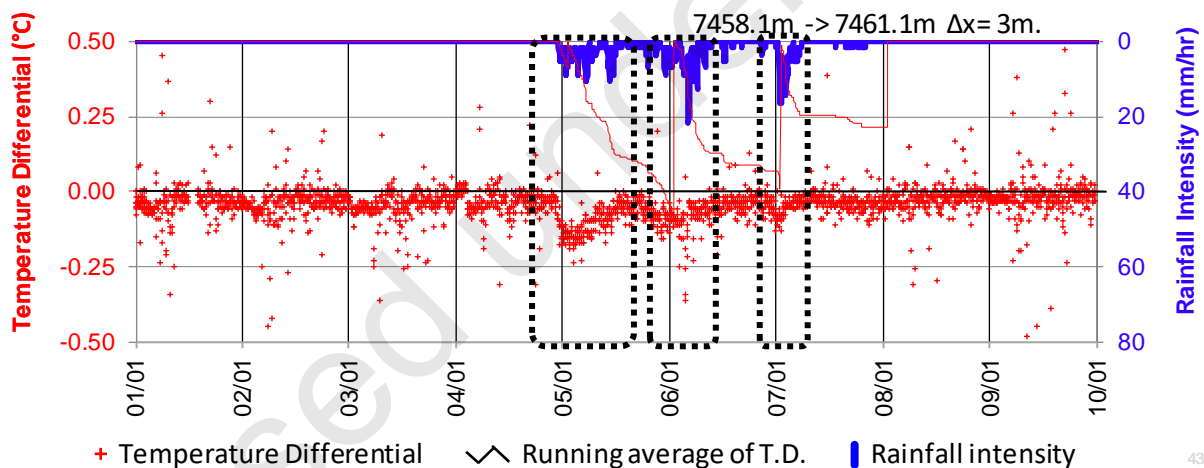
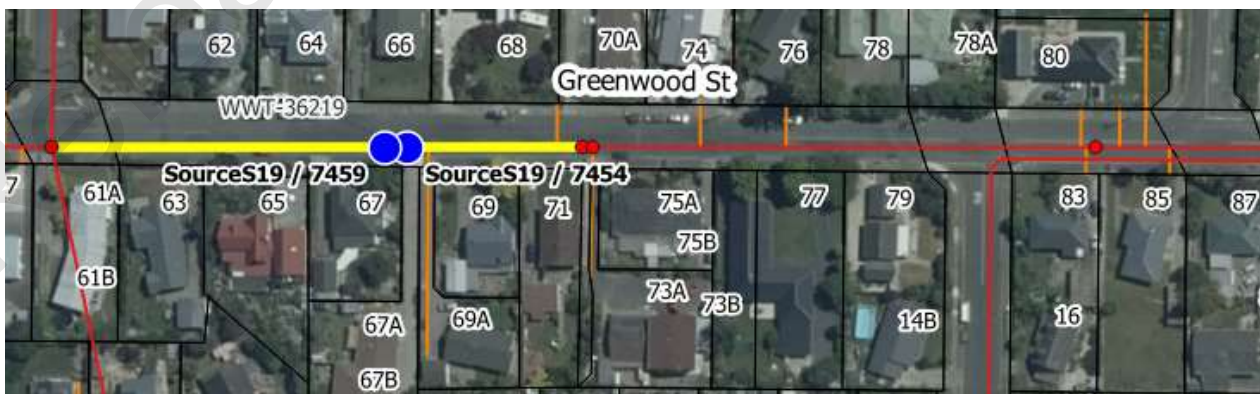
## B.1.12 Source S19 / 7459

Asset	Pipe 36219 DN150, 123m, Concrete, 1949.
Address	67 Greenwood Street.
DTS signal	Weak, 79m ±6m upstream of manhole 14912.
Analysis	Reduction in temperature during rainfall indicating stormwater inflow.
Recommendation	CCTV inspection of pipe to determine the connection point of laterals not shown on the GIS map (66, 67 Greenwood St.). Inspection of nearby connected properties (66, 67 Greenwood St.) looking for deterioration and inflow.
Note	CCTV inspection of pipe and property inspection of 66 and 67 Greenwood Street are listed under the recommendations for I&I source S19 / 7454 and S19 / 7475.

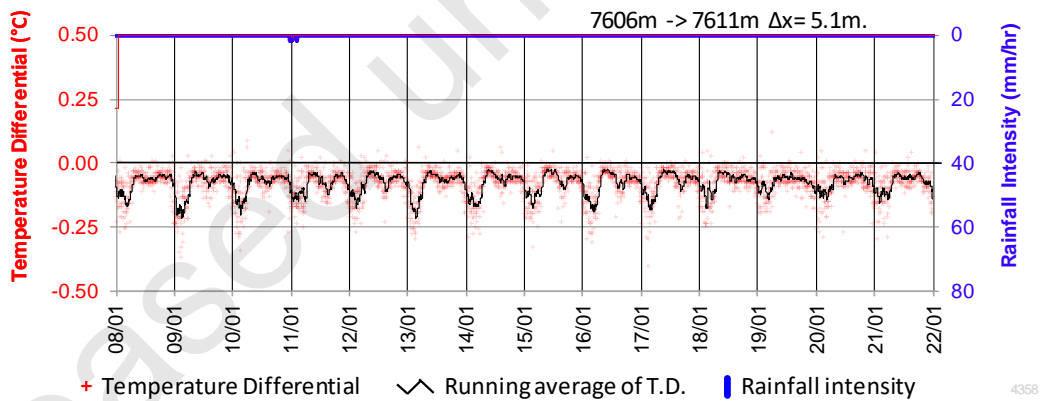
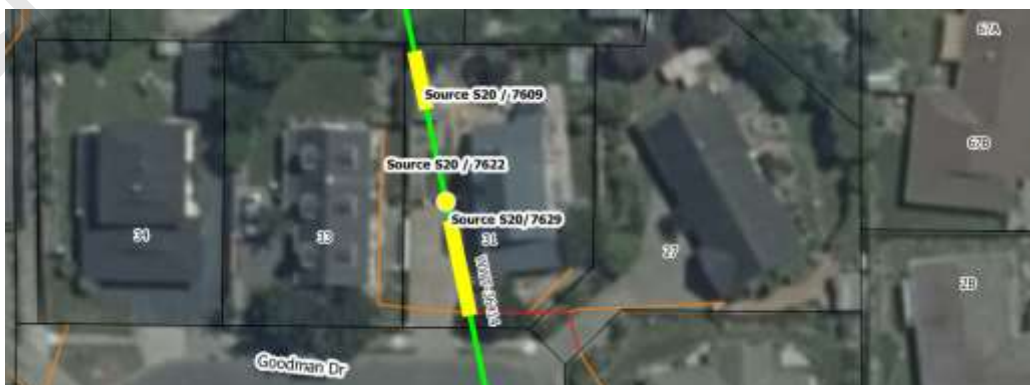
### B.1.13 Source S20 / 7609

Asset	Pipe 36414 DN300, 106m, Concrete, 1949.
Address	31 Goodman Drive.
DTS signal	Weak. 47m to 53m ±4m upstream of manhole 16122.
Analysis	Reduction in temperature in the early hours of the morning indicating ground water infiltration.
Recommendation	Consider CCTV inspection of pipe 36414 checking for signs of deterioration and infiltration. This CCTV inspection is listed under source S20 / 7629.
Note	This is a very weak signal. It is weaker than would normally be reported. It has been included because it is in a part of the catchment that would be expected to have a significant wastewater flow, even during the early hours of the morning. Therefore, a very small temperature drop may indicate a significant leak. It is rated as a weak signal, because the temperature drop is very small of a magnitude that may only be caused by ground temperature differences due to changes in ground cover and sun exposure along the pipe.

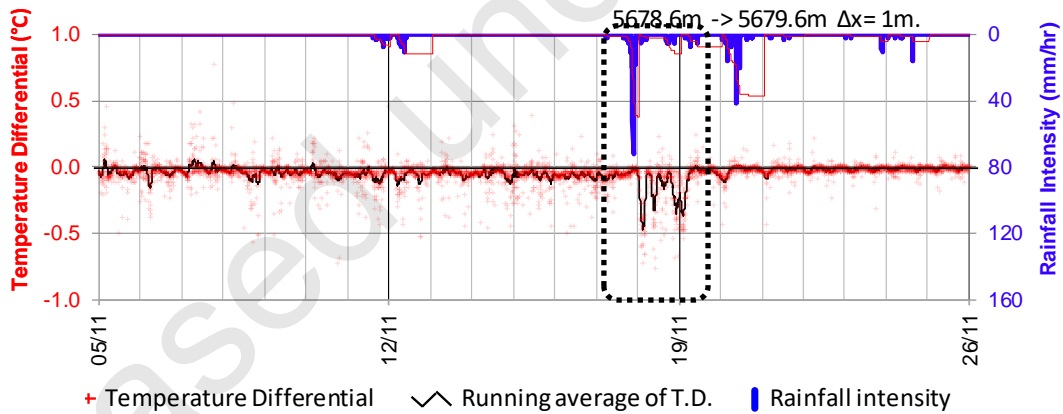
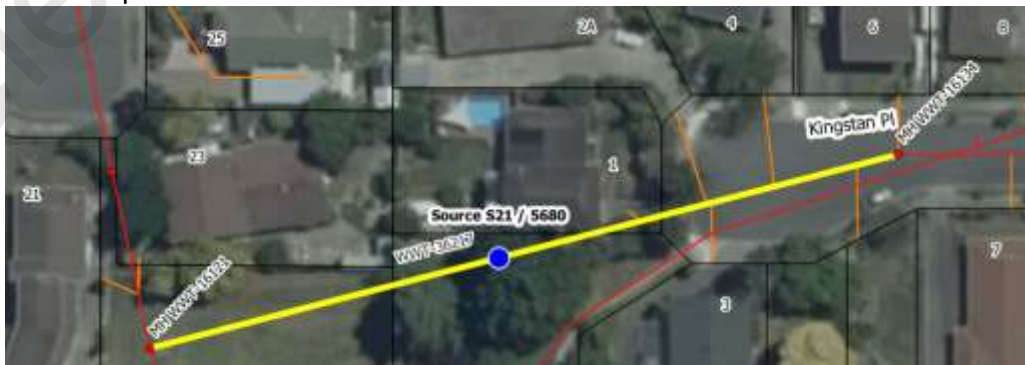
### B.1.14 Source S21 / 5680

Asset	Pipe 36217 DN150, 103m, Asbestos Cement, 1978.
Address	Goodman Park.
DTS signal	Weak, 48m ±5m upstream of manhole 16121.
Analysis	Reduction in temperature during rainfall indicating stormwater inflow.
Recommendation	Consider CCTV inspection of pipe to identify if there are any connection points or faults that could result in stormwater inflow. CCTV inspection for pipe 36217 is included under the recommendations for I&I source S21 / 5663.
Note	DTS signal indicates stormwater inflow which would require a hydraulic connection to ground level features. The GIS data set does not indicate any assets or connections at this location that have surface connections. Use CCTV data to check for surface connections, including pipe faults, and disconnected or terminated lateral connections that could be hydraulically connected to the surface. This signal is described as a weak signal. This is because the location exhibited what appears to be a DTS stormwater inflow signal for the rain event of the 19th November 2022 but not for any other rain events.

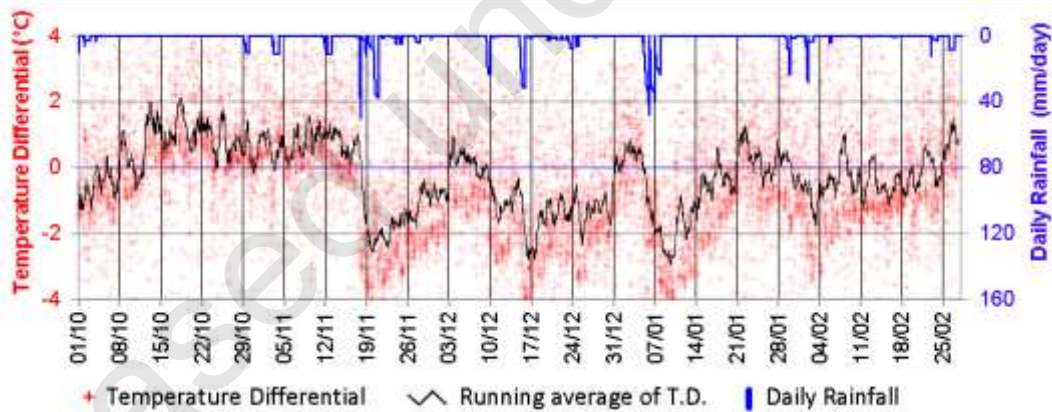
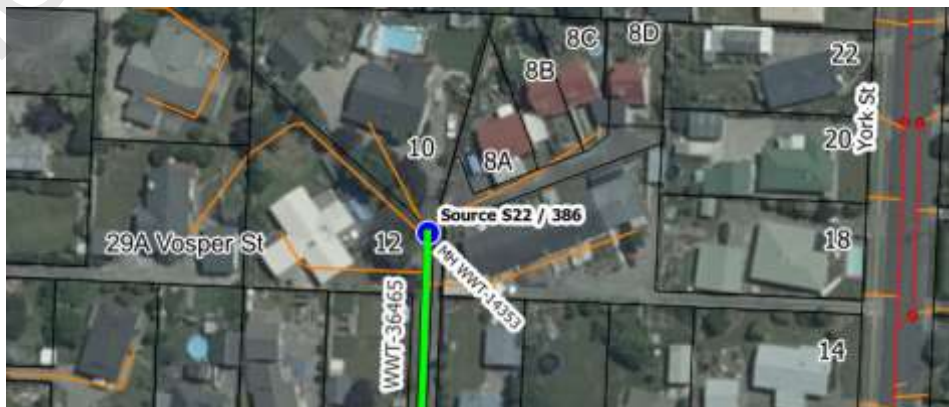
### B.1.1 Source S22 / 386 <new>

Asset	Manhole 14353.
Address	10 Boyce Street.
DTS signal	Weak. At manhole 14353.
Analysis	Comparing the wastewater temperature at the upstream manhole to the temperature of the wastewater near the bottom of Boyce Street shows that the temperature at the upstream manhole reduces much more during rainfall than does the wastewater in the downstream network. Based on this it is assessed there is rainfall dependent infiltration and inflow at the upstream manhole or from the connected laterals.
Recommendation	Inspection of manhole 14353 checking for signs of poor construction, poor lid seal, surface inflow through cover keyholes, infiltration and/or inflow. Inspection of nearby connected properties (8A, 8B, 8C, 8D, 10 Boyce St., and 29A York St.) looking for deterioration, stormwater connections, infiltration and/or inflow.

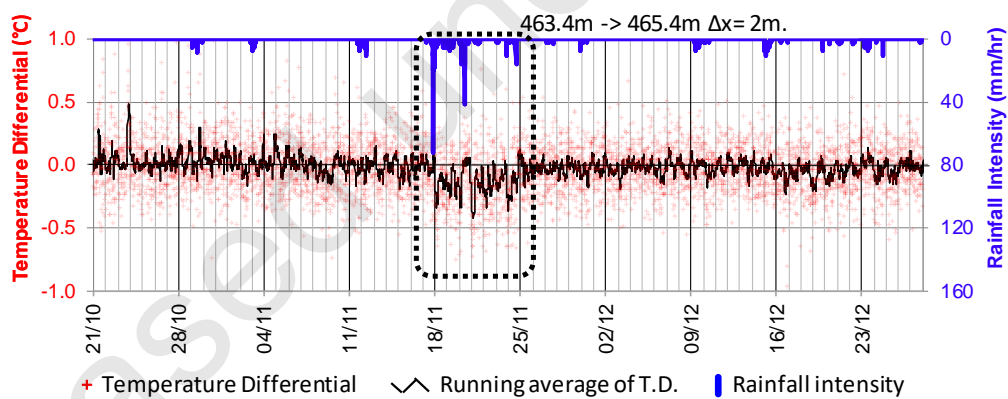
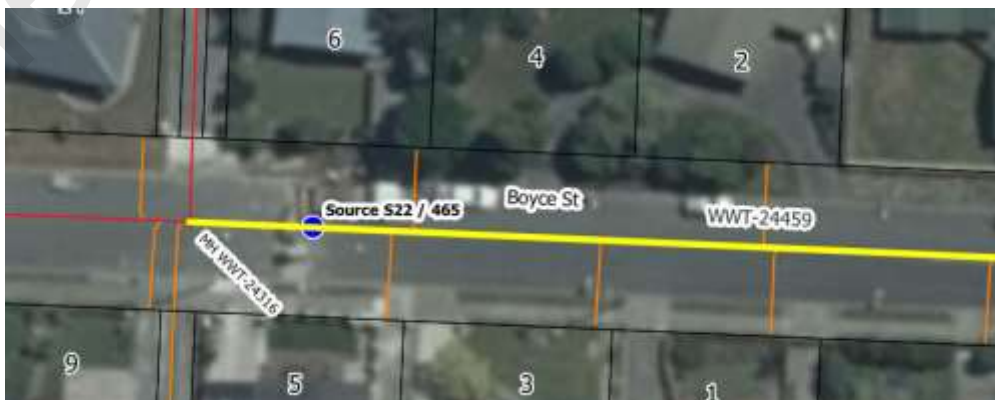
## B.1.2 Source S22 / 465 <new>

Asset	Pipe 24459 DN150, 101m, uPVC, 2012.
Address	6 Boyce Street.
DTS signal	Weak. 11m ±4m downstream of manhole 24316.
Analysis	Reduction in temperature during rainfall indicating stormwater inflow.
Recommendation	CCTV inspection of pipe 24459 to identify any possible hydraulic connections to the surface.
Note	<p>DTS signal indicates stormwater inflow which would require a hydraulic connection to ground level features. The GIS data set does not indicate any assets or connections at this location that have intentional surface connections.</p> <p>Check for any unintended hydraulic connection to the stormwater pipe that crosses the wastewater pipe at this point. The connection could be via exfiltration of stormwater to pipe bedding and infiltration from the pipe bedding to the wastewater main.</p> <p>This DTS signal is assessed as 'weak' rather than 'strong' because the pattern characteristic of stormwater inflow was not observed for other rain events.</p> <p>This DTS signal is also assessed as 'weak' because the magnitude of the signal is small.</p>

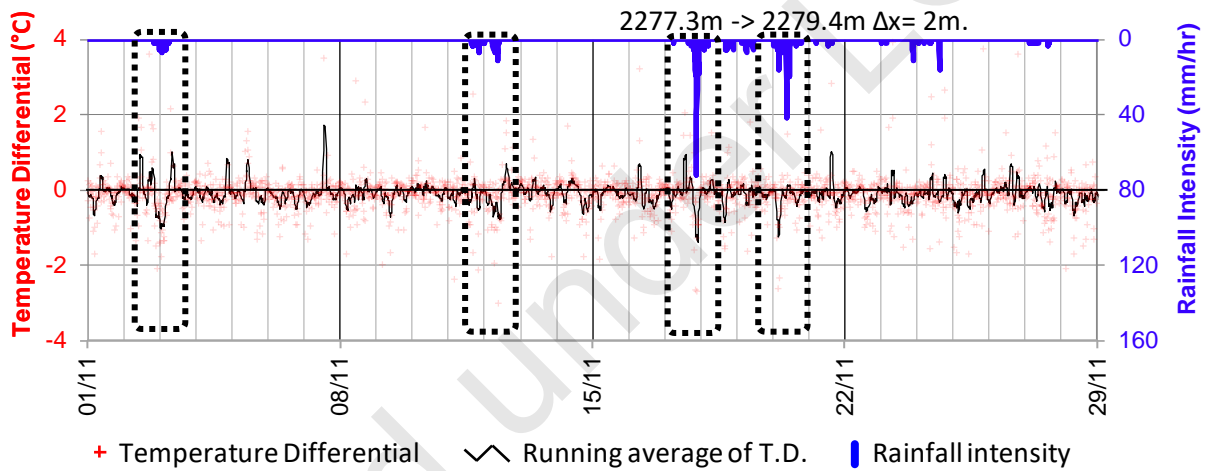
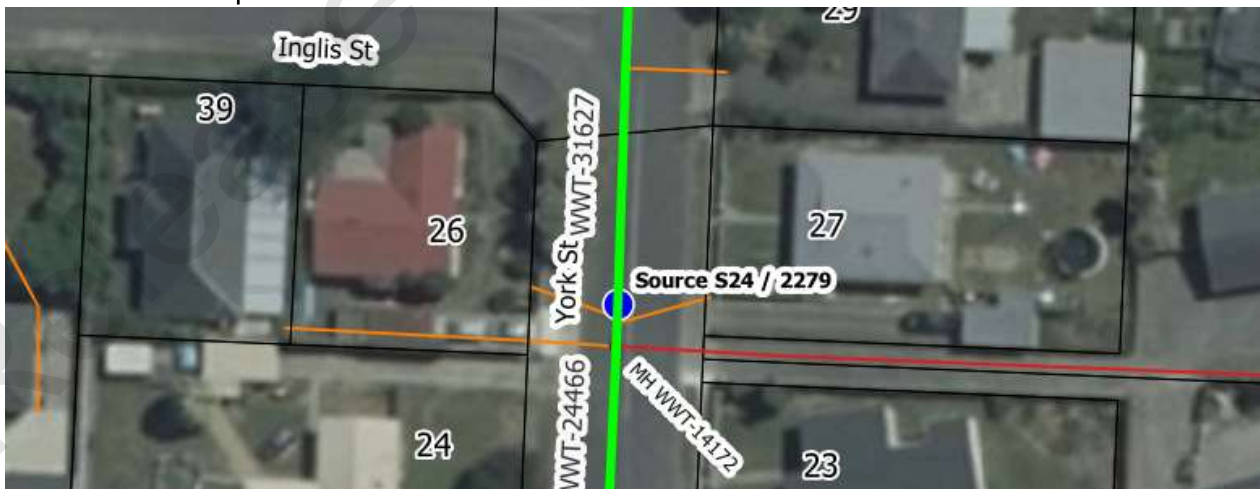
### B.1.3 Source S24 / 2279 <new>

Asset	Pipe 31627	DN150, 64m, Concrete, 1977.
Address	26 York Street.	
DTS signal	Weak. 4m ±4m upstream of manhole 14172.	
Analysis	Reduction in temperature during rainfall indicating stormwater inflow.	
Recommendation	Inspection of nearby connected properties (26 and 27 York St.) looking for deterioration and/or SW connections.	
Note	This signal is assessed as weak because there are similar but larger temperature differentials on some dry days.

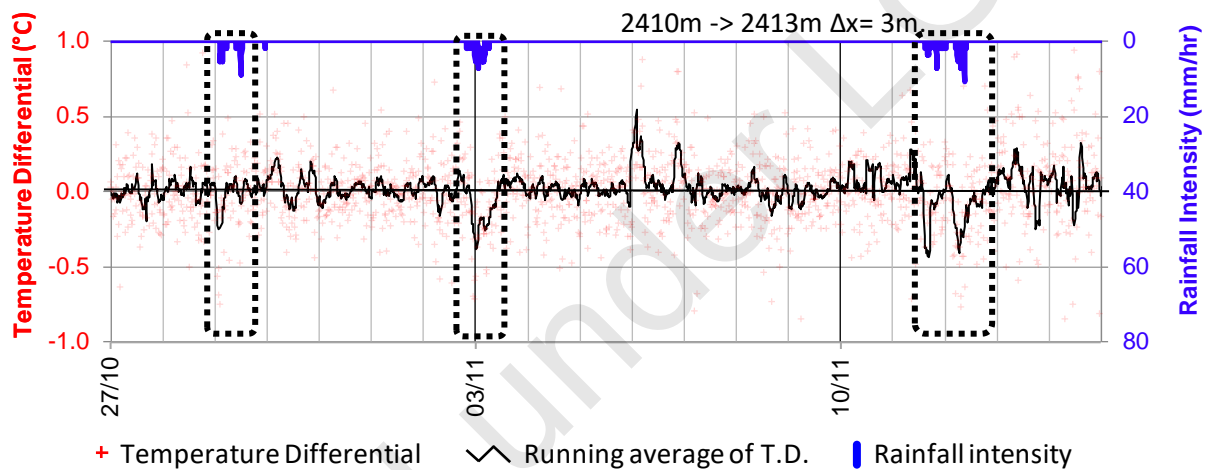
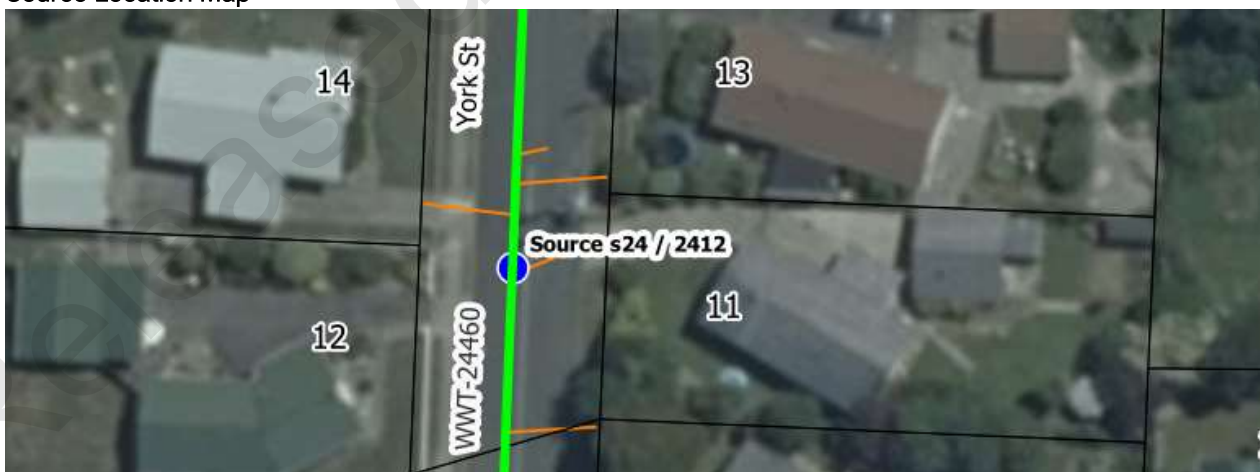
## B.1.4 Source S24 / 2412 <new>

Asset	Pipe 24460	DN150, 50m, uPVC, 2012.
Address	11 York Street.	
DTS signal	Weak. 29m ±4m upstream of manhole 24313.	
Analysis	Reduction in temperature during rainfall indicating stormwater inflow.	
Recommendation	Inspection of nearby connected properties (11 York St.) looking for deterioration and/or SW connections.	
Note	This DTS signal is assess as 'weak' because the magnitude of the signal is small.

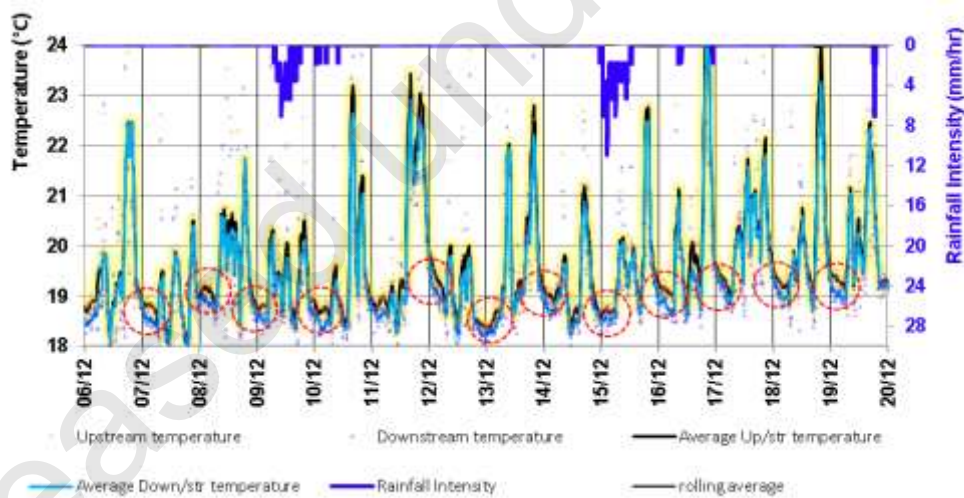
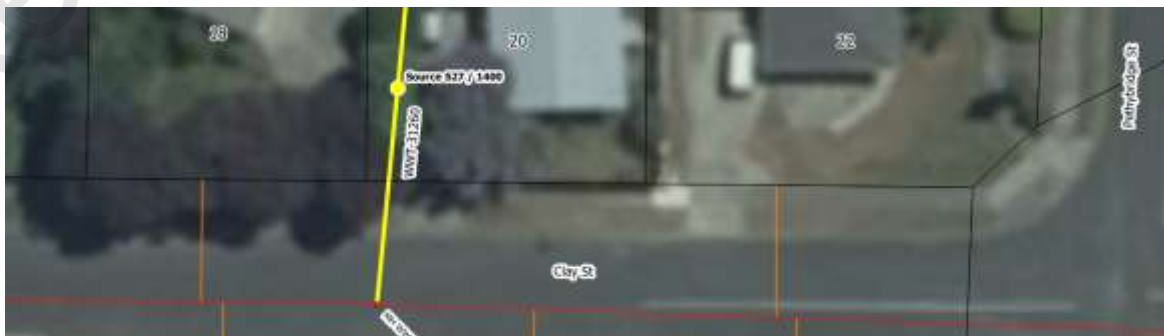
## B.1.5 Source S27 / 1400 <new>

Asset	Pipe 31260 DN225, 119m, Asbestos Cement, 1973.
Address	20 Clay Street.
DTS signal	Weak. 15m ±5m upstream of manhole 12330.
Analysis	Reduction in temperature in the early hours of the morning indicating ground water infiltration.
Recommendation	CCTV inspection of pipe 31260 checking for signs of deterioration and infiltration and to determine the connection point of laterals not shown on the GIS map (20 Clay St.). Inspection of nearby connected properties (20 Clay St.) looking for deterioration and infiltration.
Note	Use the CCTV data to update the connection points for the laterals not shown in the GIS map. Include property inspections only if they are within five metres of the DTS signal.

For this location, a plot showing the upstream and downstream temperatures reveals the temperature differences indicating groundwater infiltration better than the default type of plot. The cooler downstream temperatures in the early hours of the morning are highlighted using the red circles.
