Christchurch Water Supplies Water Safety Plan

Volume B: Christchurch/Lyttelton Water Safety Plan

Christchurch City Council

Revision 6

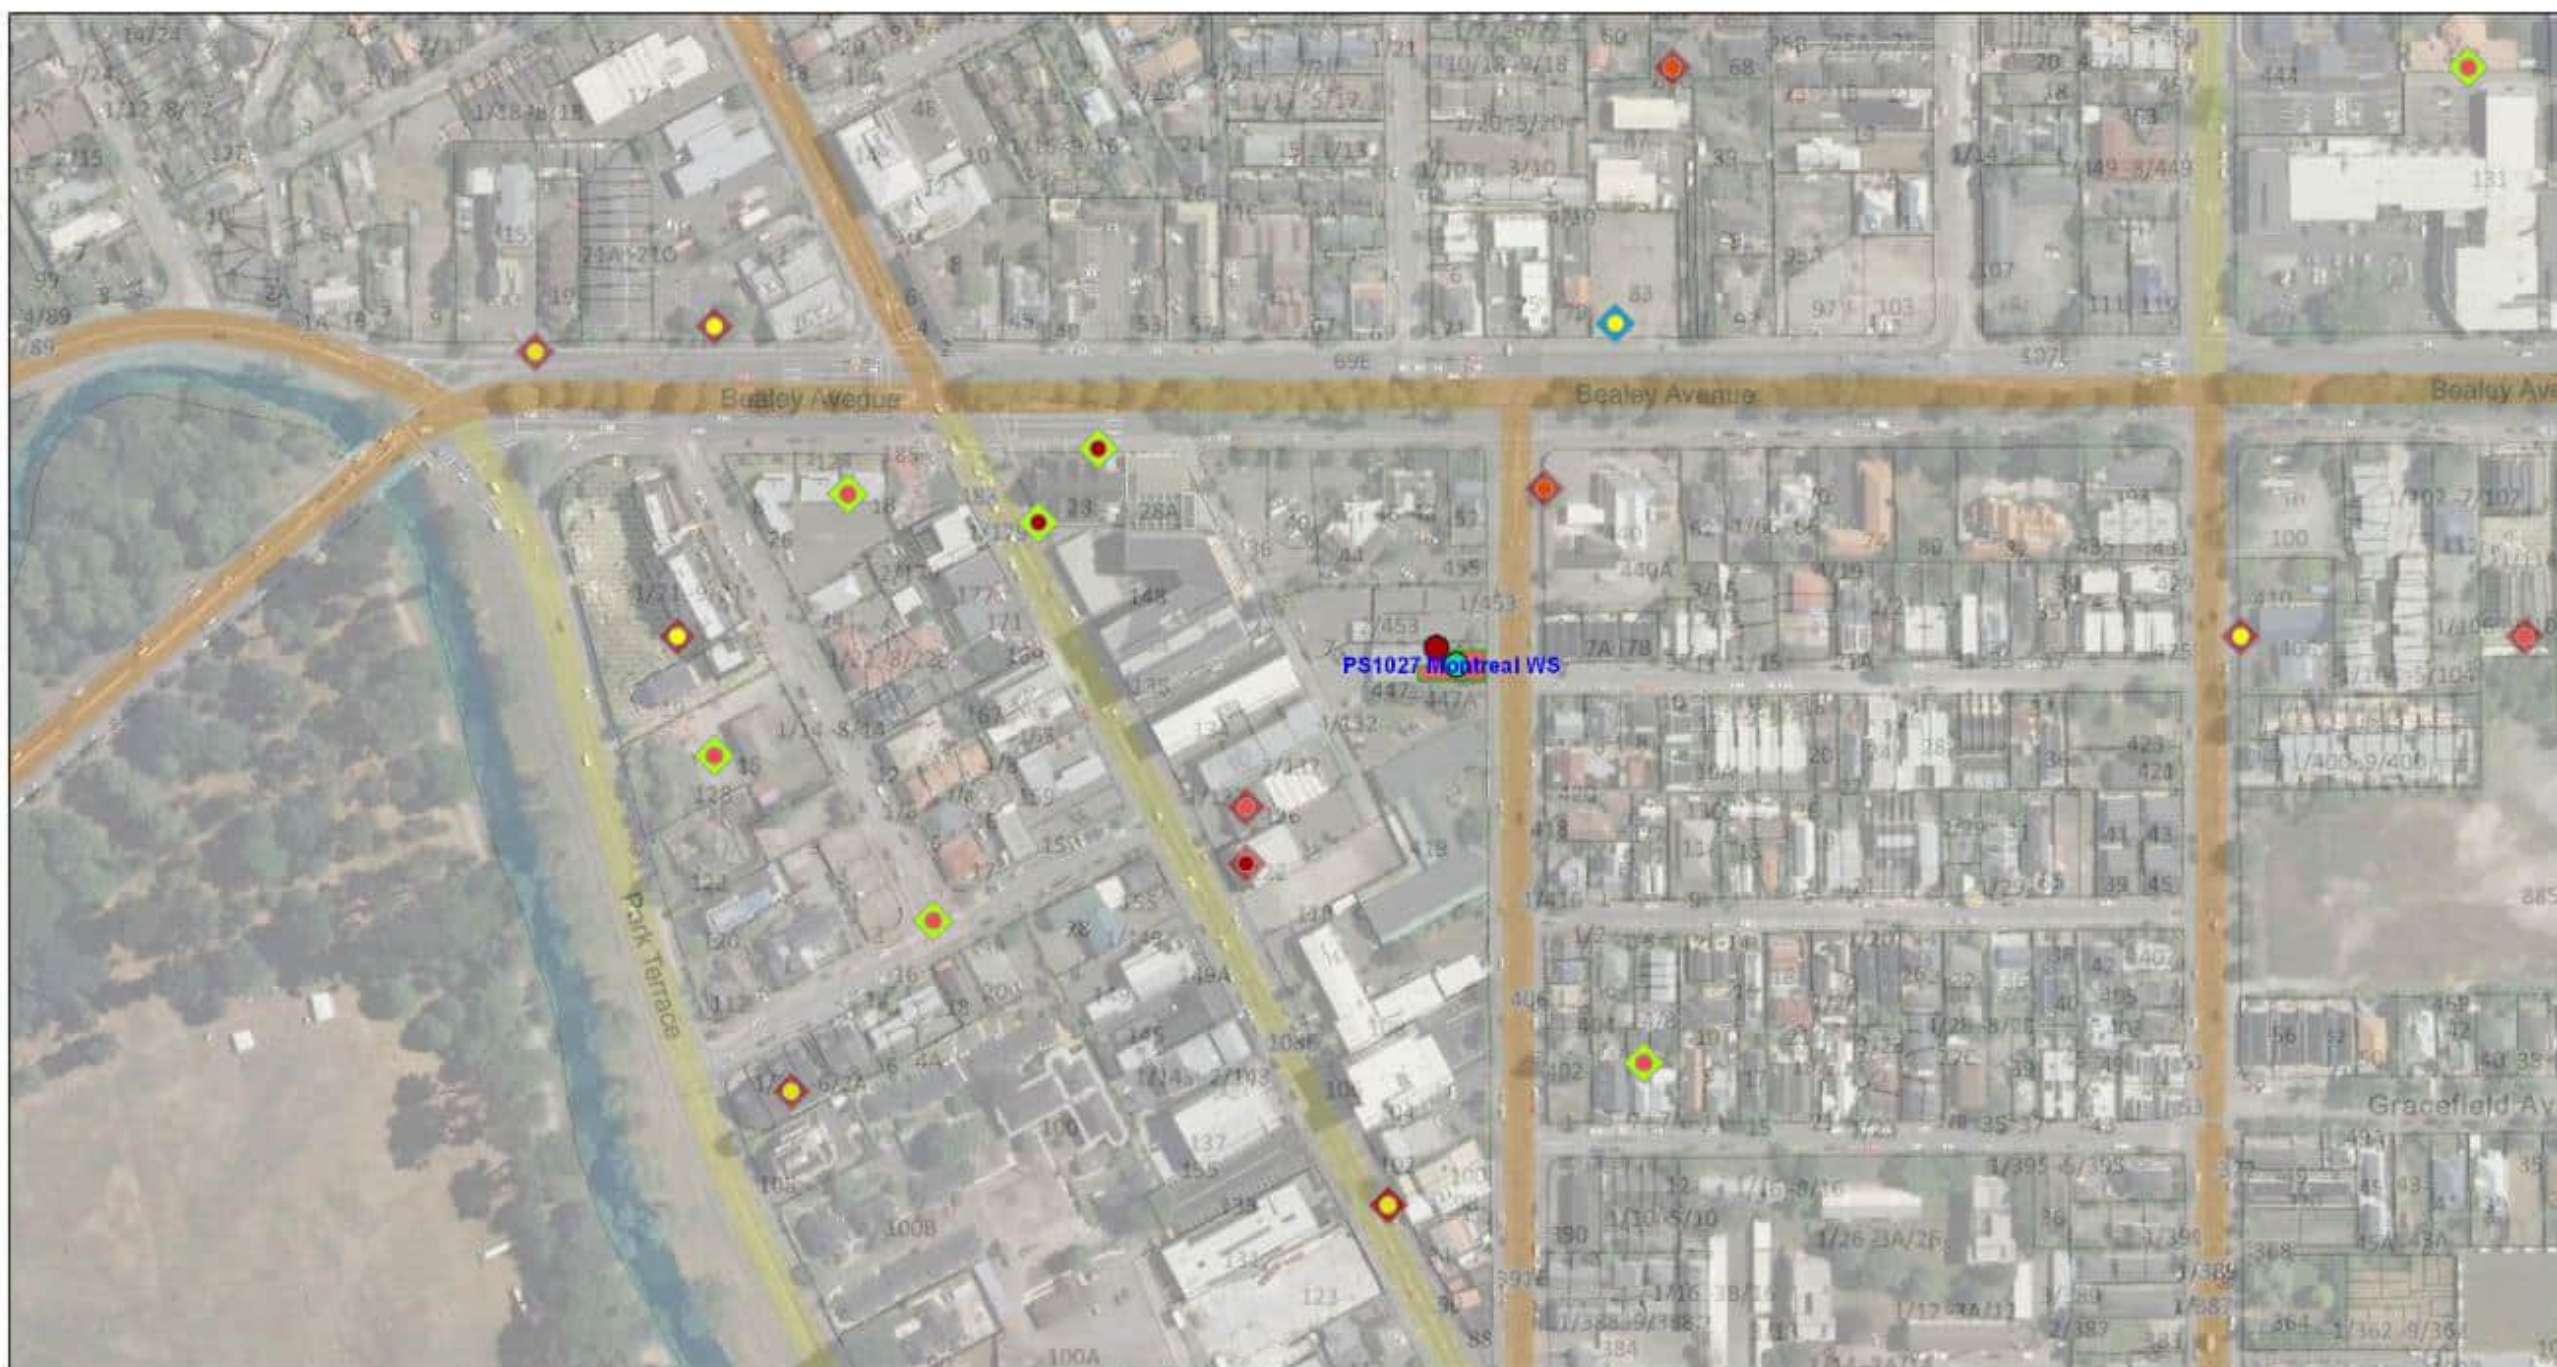
Private Bores and CCC Water Supply Wells

| <p>Private Wells Assumed to Be Active - By Aquifer</p> <ul style="list-style-type: none"> Unknown Shallow Unconfined Aquifer 1 Aquifer 2 Aquifer 3 Aquifer 4 Aquifer 5 | <p>Private Wells Assumed to Be Active - By Function</p> <ul style="list-style-type: none"> Water Level Observation Geotechnical / Geological Investigation Domestic Supply Irrigation Domestic and Stockwater Commercial / Industrial Sewer Flushing Other | <p>CCC Water Supply Wells</p> <ul style="list-style-type: none"> Aquifer 1 Aquifer 2 Aquifer 3 Aquifer 4 Aquifer 5 |

Modelling of wells at Denton (unconfined) and Effingham (confined) pump stations confirmed that no particles reach the bores within one year of entering shallow groundwater for any of these scenarios. These results provide confirmation that private bores near Council water supply wells are unlikely to provide a pathway for contamination and are therefore unlikely to affect water quality.

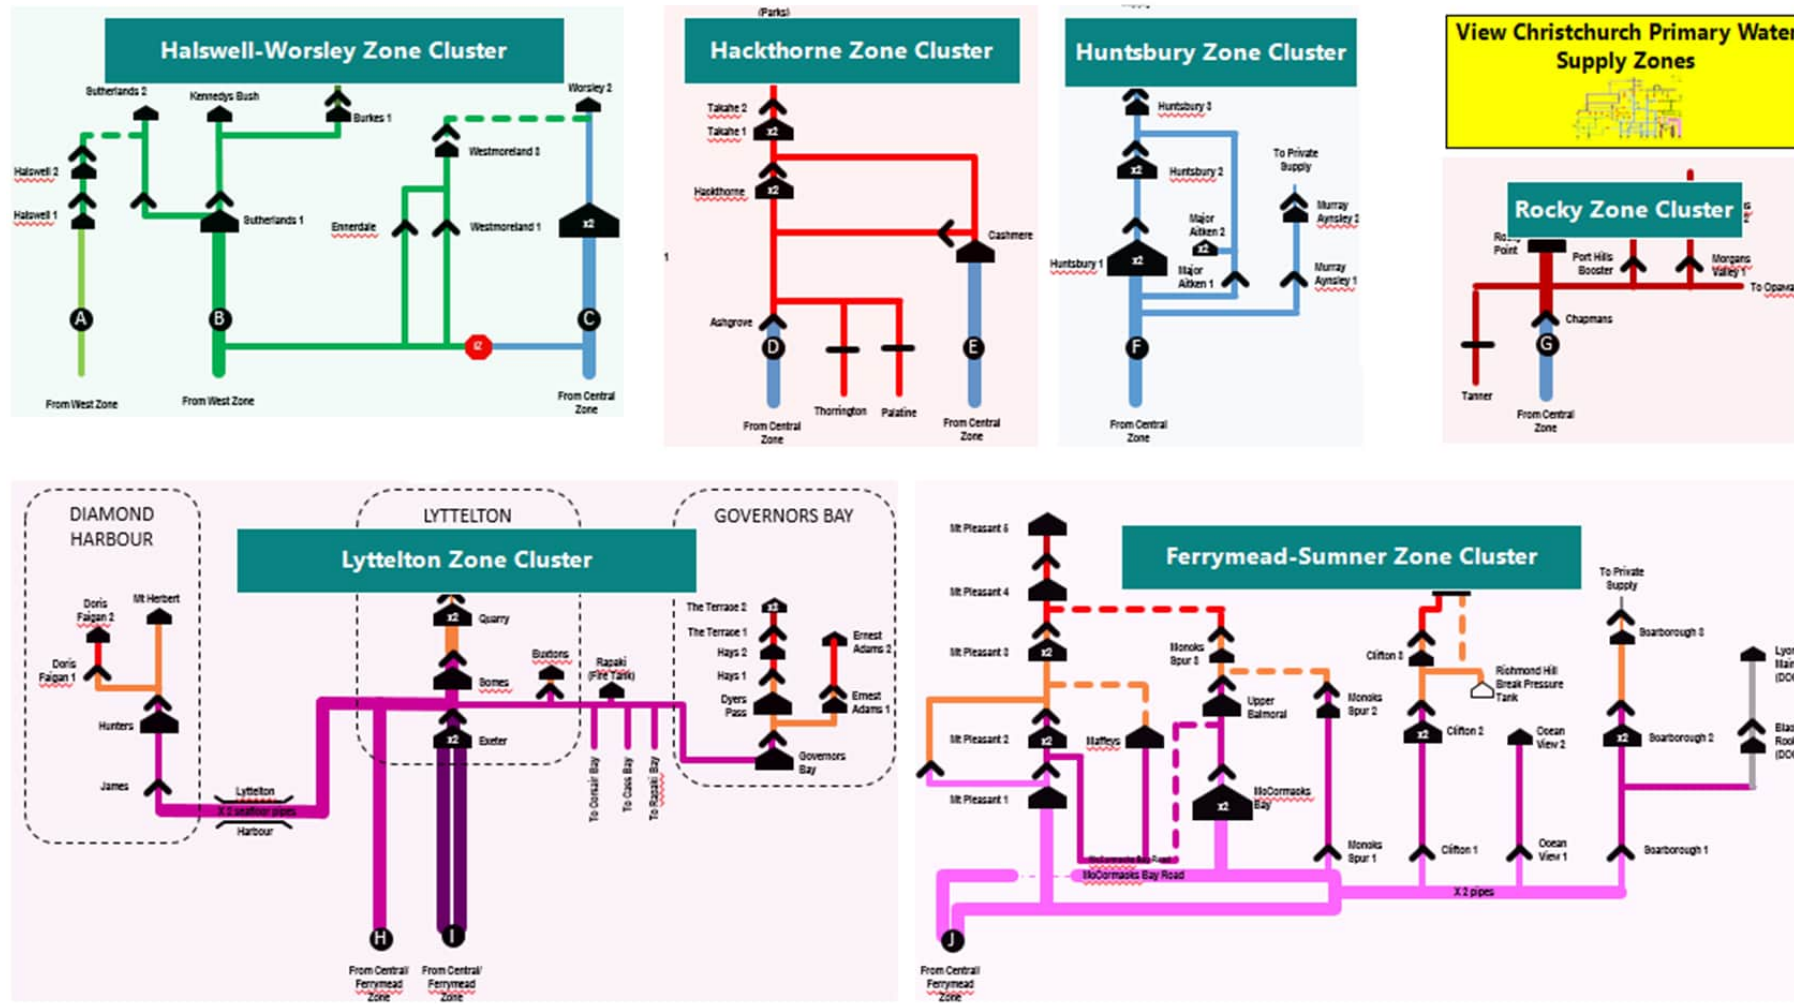
Figure 2-16: Secondary Water Supply zones

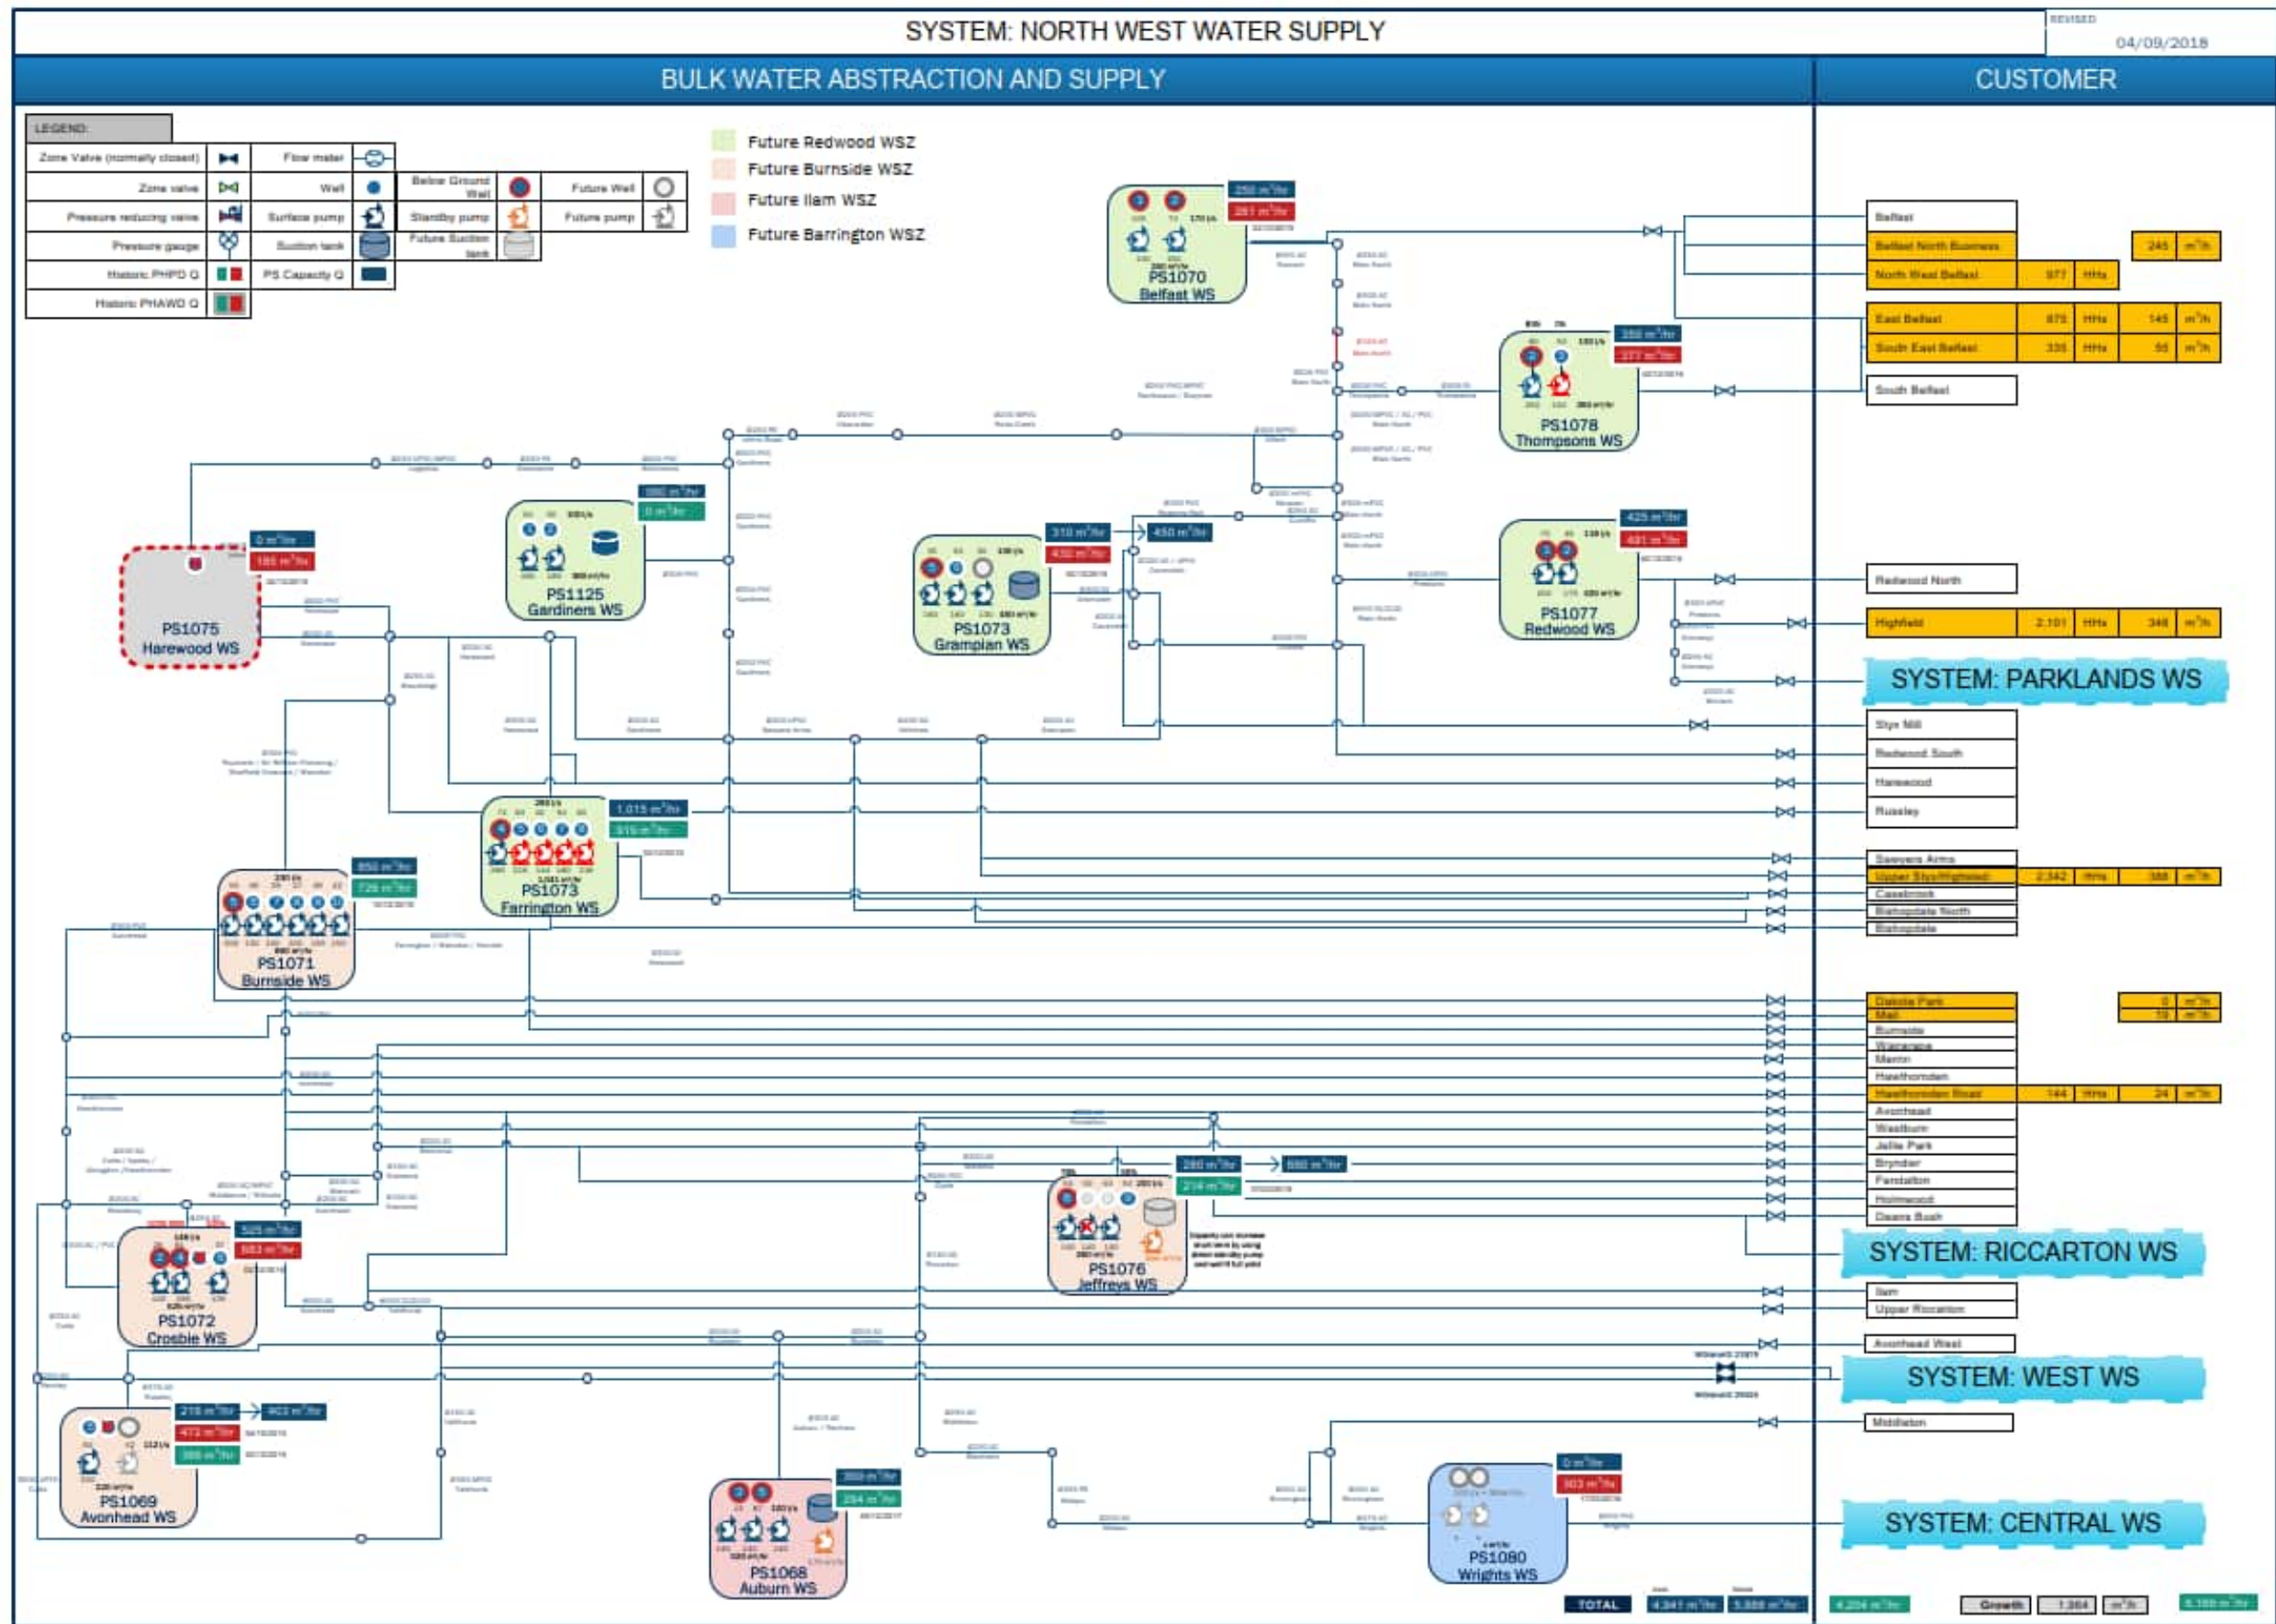
Figure 2-18: System schematic – Northwest

- Figure 2-18 – Northwest: [18/927171](#)
- Figure 2-19:– Ferrymead – Lyttelton Harbour Basin: [19/349006](#)
- Figure 2-20 – Rawhiti: [18/1006613](#)
- Figure 2-21 – Hackthorne: [19/985079](#)

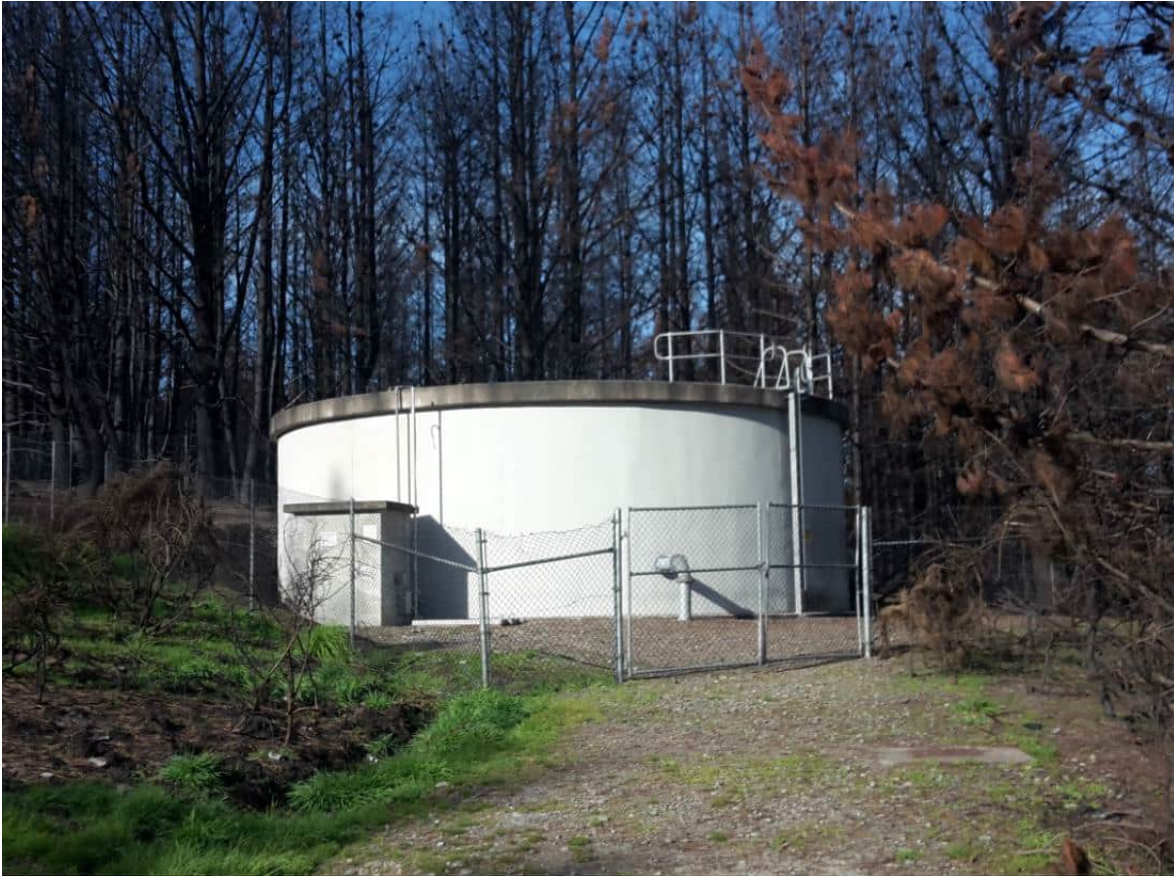
Figure 2-23: Example of above-ground reservoir – Worsleys 2 reservoir

Most reservoirs on the hills are located fully above ground. A small number have one wall partially built into the sloping terrain. Examples are provided in Figure 2-23 and Figure 2-24.

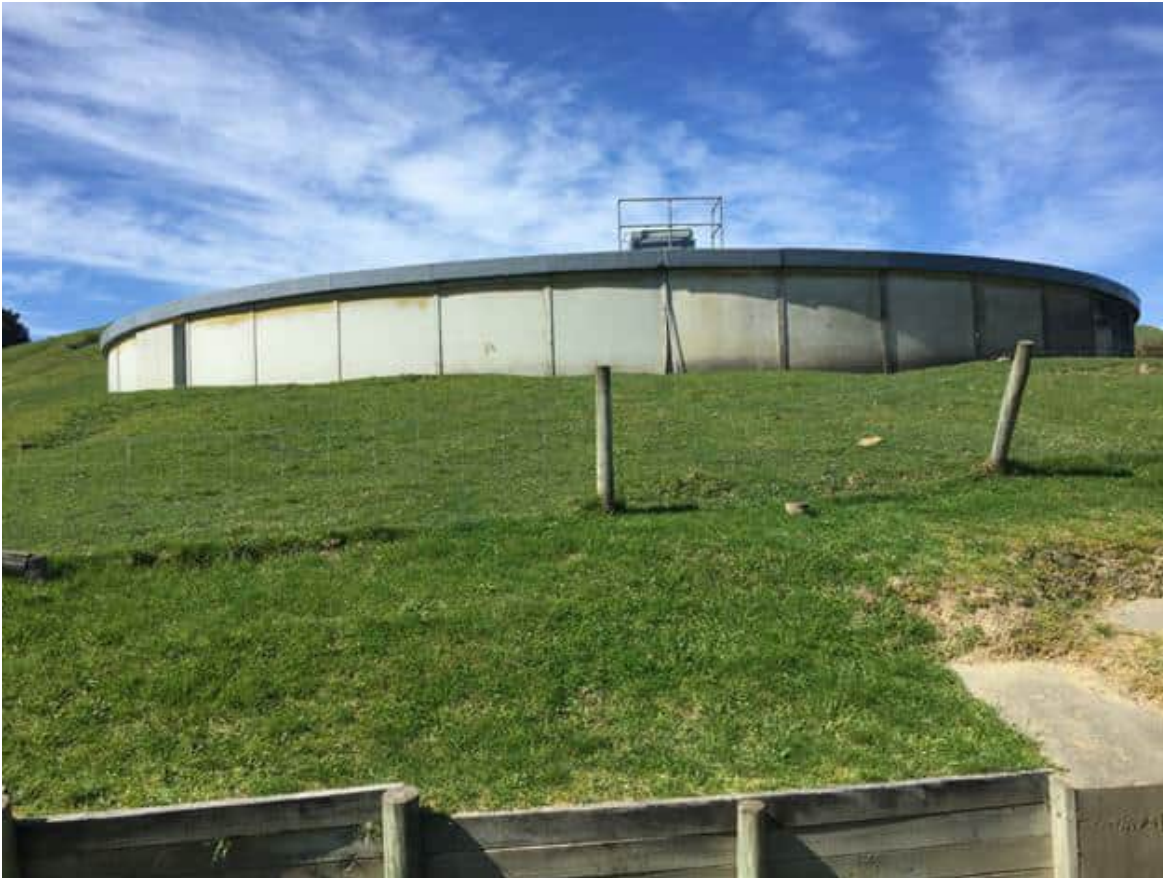
Figure 2-24: Example of reservoir partially built into hill – Sutherlands 1 Reservoir

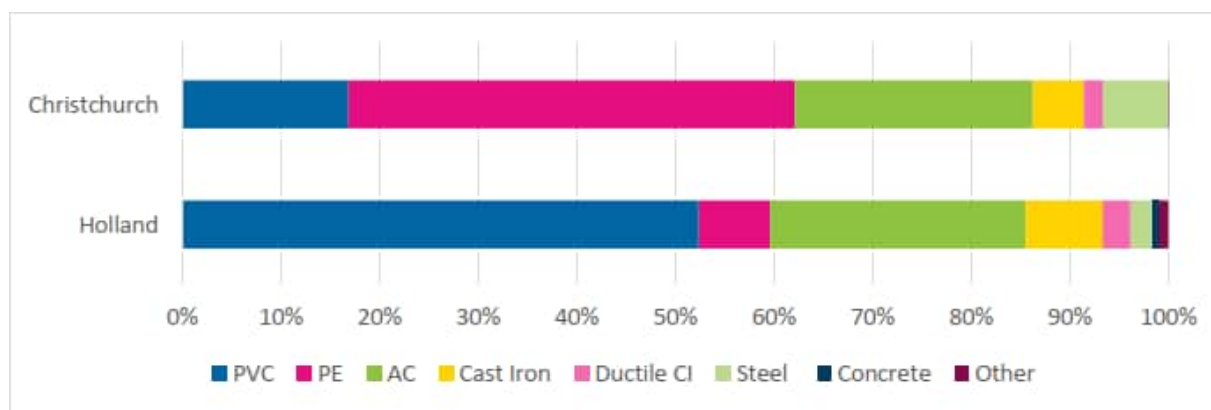
Figure 2-29: Water supply pipe material comparison between Christchurch and Holland

The study includes a comparison of pipe materials which is shown in Table 2-10 and Figure 2-29. It can be seen that Christchurch has a slightly higher proportion of resilient pipe materials (PVC and PE) than Holland.

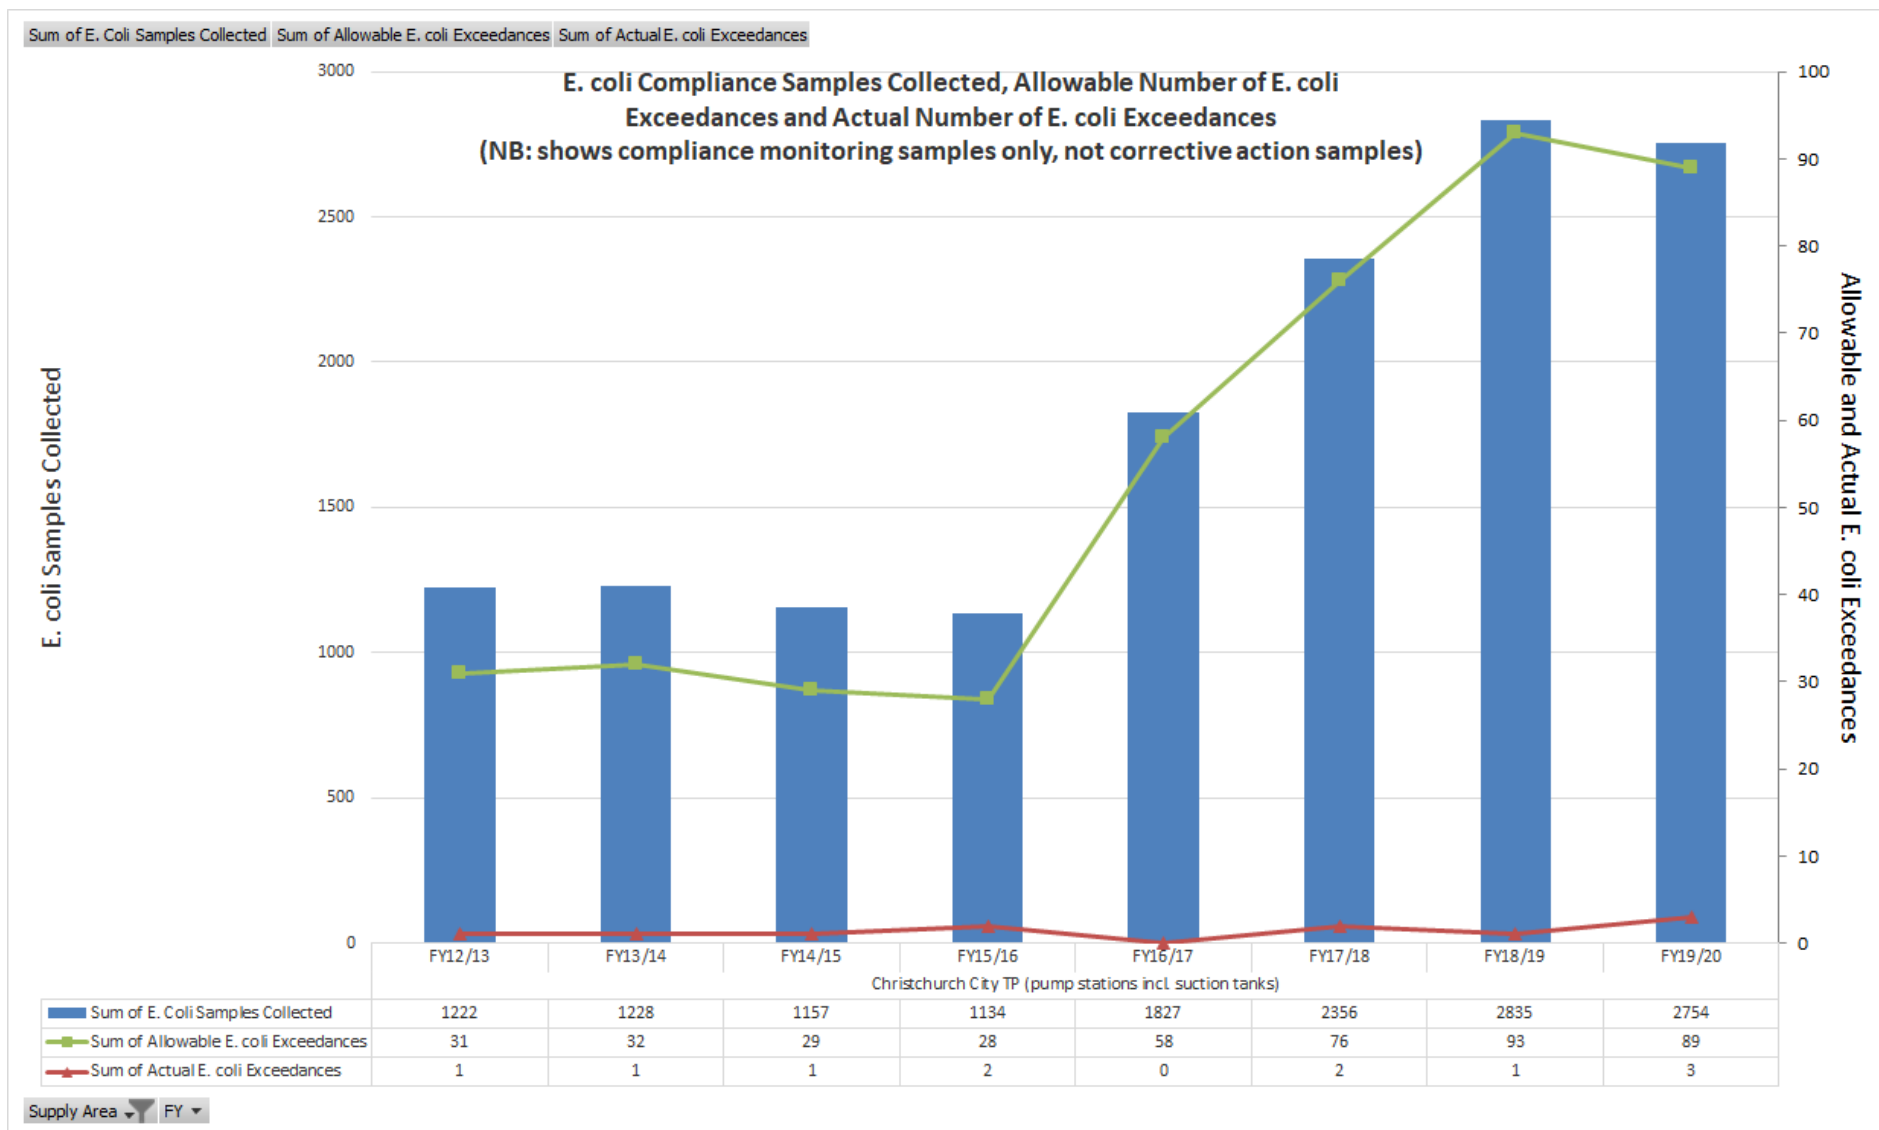
Figure 2-33: Christchurch City Treatment Plants – E. coli compliance samples collected (blue), allowable number of E. coli exceedances (green) and actual number of E. coli exceedances (red)

Figure 2-33 to Figure 2-35 provide the history of allowed versus actual E. coli transgression events for Christchurch City treatment plants (TP) – actually pump stations but called treatment plants for the purposes of the drinking water register – Christchurch City distribution system and Lyttelton Harbour Basin distribution system between FY 2012/13 and FY 2019/20. Only data for full financial years is represented as sample numbers were officially validated by the Drinking Water Assessor in the annual drinking water compliance survey which takes place in July each year for the previous financial year. The graphs illustrate an excellent track record of high quality water being delivered to water consumers.
