Guidance on House Repairs and Reconstruction Following the Canterbury Earthquake

**A Summary of Geotechnical and Structural Engineering
Recommendations to Guide House Repairs and Reconstruction**

This draft was prepared during October 2010, with the objective of providing a basis for rapid guidance to organisations involved in the repair and reconstruction of houses affected by this earthquake. The principal focus is the construction and insurance sectors and local authorities, and their professional advisers and contractors. The earthquake and its effects are complex, and it is acknowledged that the full picture about how residential structures responded to liquefaction effects has yet to be established, with research being ongoing. It may well be that some aspects of the recommendations in document are added to or changed over time.

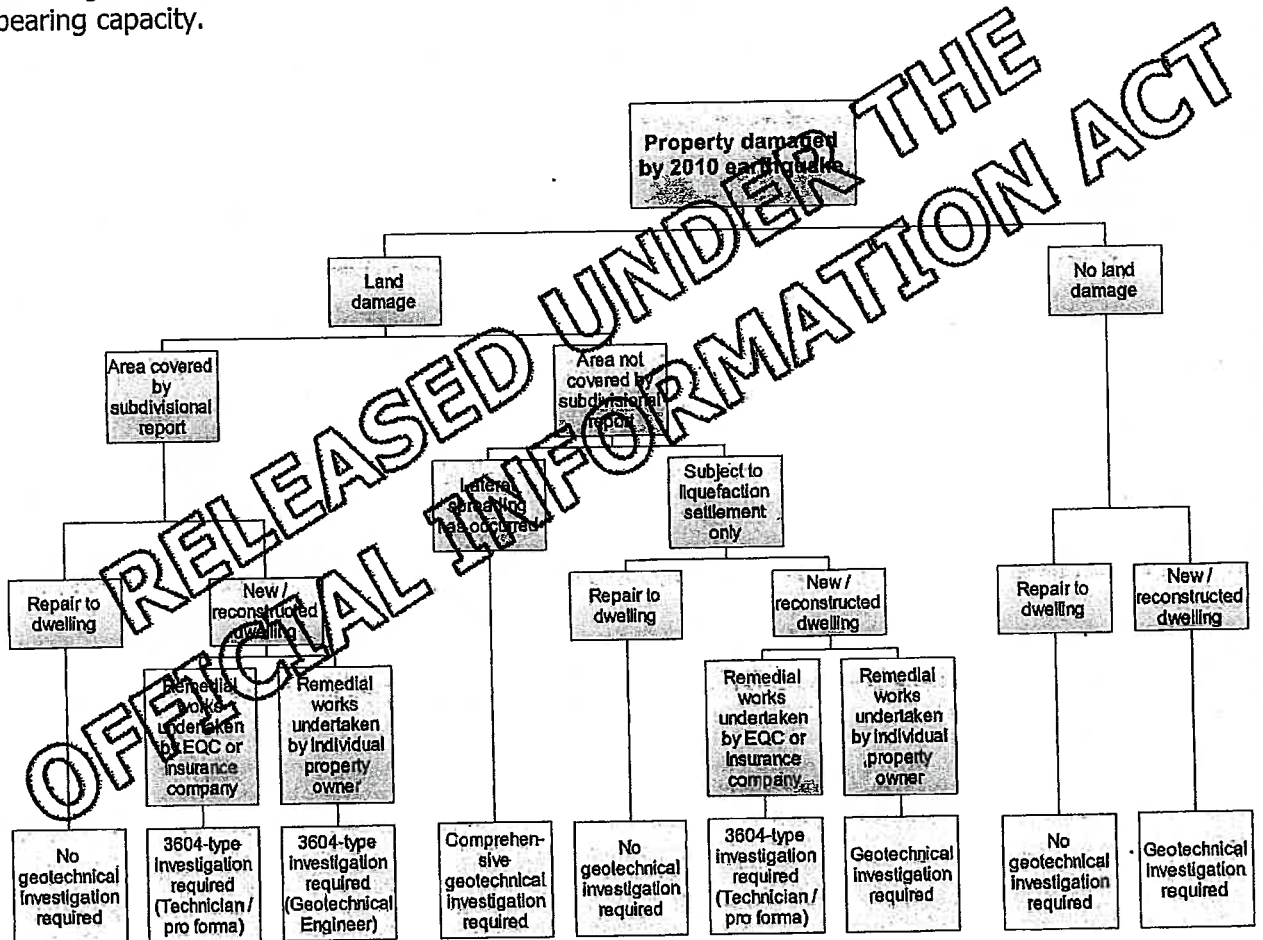
Figure 1: Summary of relationship between individual site investigation and land damage

Field investigations for individual sites may therefore be limited to Scala Penetrometer Testing and hand augers to confirm that the upper 2m of land meets NZS 3604 requirements for static bearing. It is expected that these reports need not be more than a one page letter or template detailing the observed damage, and providing confirmation that the upper 2m provides sufficient bearing capacity.

The overall process outlined on the previous pages is summarised in Figure 7.2:

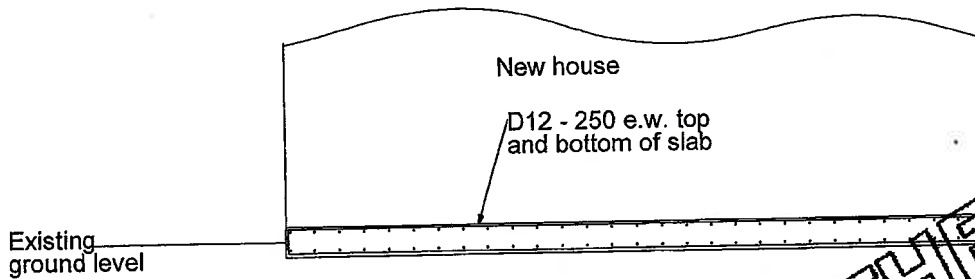
New Foundation Option 2

Option 2 - Construct a thick slab foundation over the existing soil (no special soil preparation)

Note: NZS 3604 ground clearances adjacent to house foundation must be complied with
