SELWYN DISTRICT COUNCIL

Hororātā Water Safety Plan

This document number is **DW-SEL-00-WSP-0001**.

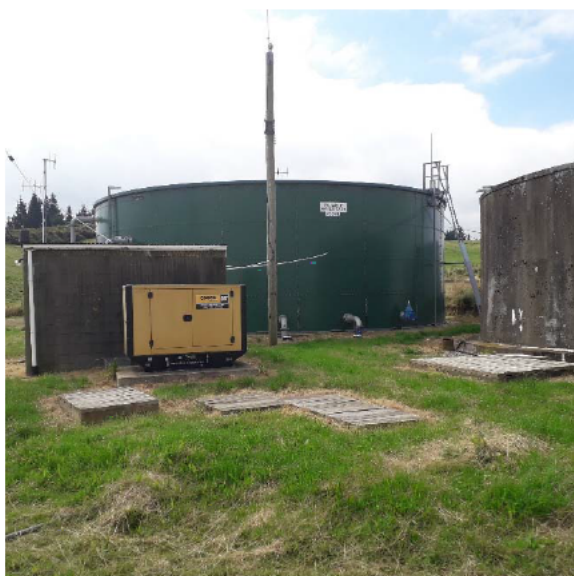
Component	Details
Name	Atkins Road Reservoir
Asset tag	645962
Functionality	Balance and storage tank
Condition	Refer to inspection reports for condition details and recommendations.
Above or below ground	Above
Capacity (m ³)	490 m ³
Material	Steel (Tasman Tank)
Year of install	2015
Roofed	Yes
Vermin-proof	Yes
Run-off directed off roof	Yes

Figure 2:2 shows the Atkins Road Reservoir.

Figure 2:2: Atkins Road Reservoir

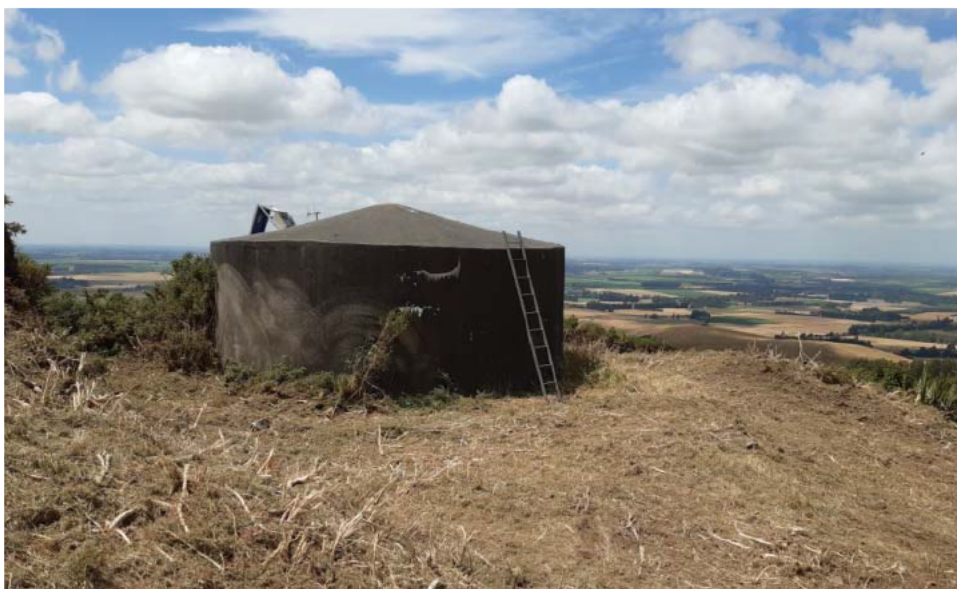
Component	Details
Name	Harper Hills Reservoir
Asset tag	542234
Functionality	Balance and storage tank
Condition	Refer to inspection reports for condition details and recommendations.
Above or below ground	Above
Capacity (m ³)	90 m ³
Material	Concrete
Year of install	1982
Roofed	Yes
Vermin-proof	Yes
Run-off directed off roof	Yes

Figure 2:3 shows the Harper Hills Reservoir.

Figure 2:3: Harper Hills Reservoir

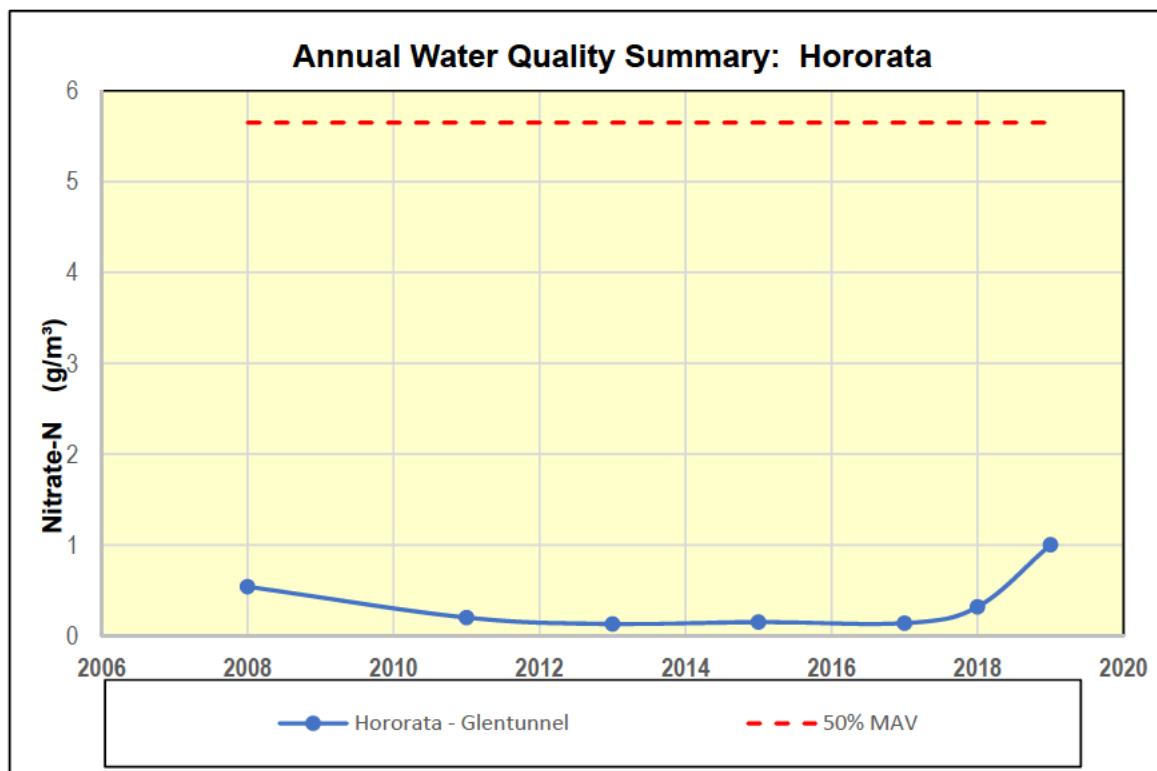
Nitrate trends for the Hororātā Water scheme are shown in Figure 2:4 as Nitrate-N annual results (2008-2019) for all water supply sources. Annual chemical analysis is used to identify trends or exceedances in 50 % MAV which may trigger the requirement for more frequent testing.

Figure 2:4 Hororātā Water Quality Summary Nitrate, 2008 – 2019
